THE CITY OF WINNIPEG  
**ST JAMES CIVIC CENTRE FACILITY EXPANSION**  
**2055 NESS AVENUE**

# **APPENDICES**

City of Winnipeg  
**St. James Civic Centre New Additions and Building  
Geotechnical Investigation**

# **Hazardous Building Materials Assessment**

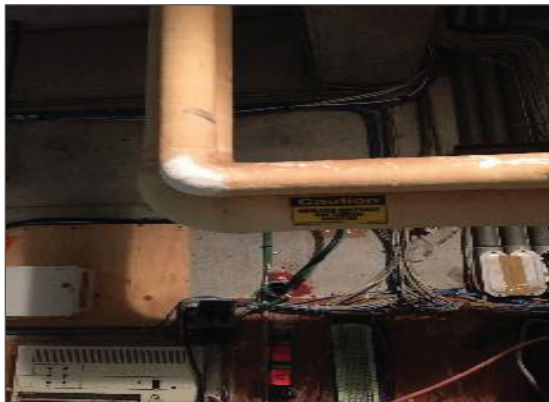
Photograph No. 1: Asbestos-containing parging cement present on fittings, elbows, valves and tee's of the Domestic, hot water, steam system.

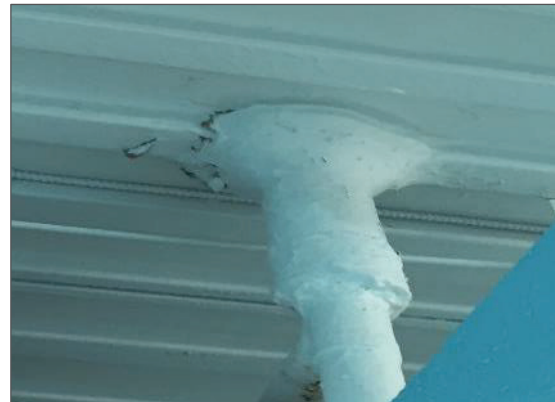
Photograph No. 2: Asbestos-containing parging cement on rain water leader fittings.

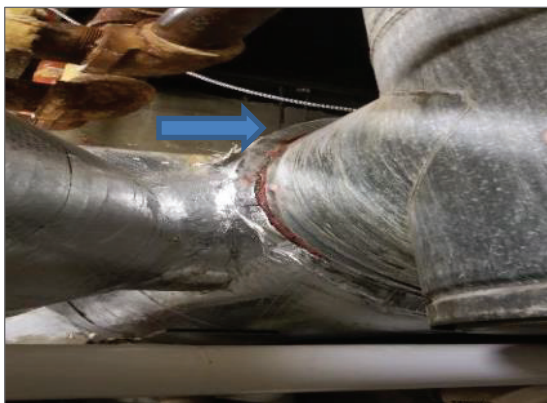
Photograph No. 21: Non-asbestos red/brown mastic on uninsulated ducting within the basement (Samples 0003A-C).

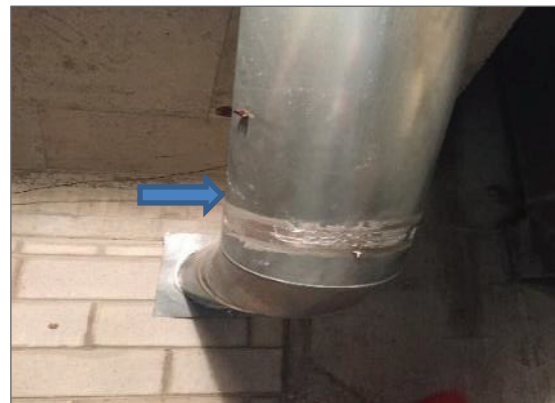
Photograph No. 22: Non-asbestos grey mastic on uninsulated ducting throughout the building.

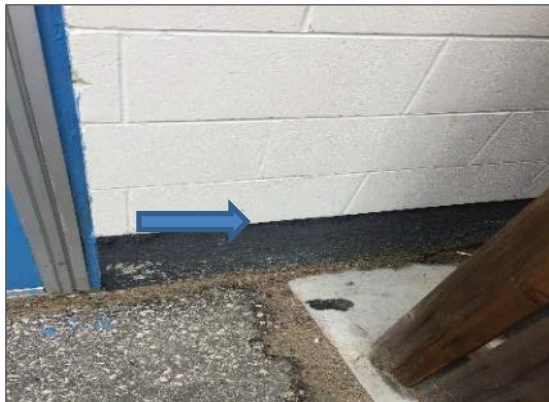
Stucco containing chrysotile asbestos is present as exterior finish on the lower 1' – 4' of the building (Samples 0055A-C).

Photograph No. 27: Asbestos-containing stucco on lower exterior walls (Samples 0055A-C).

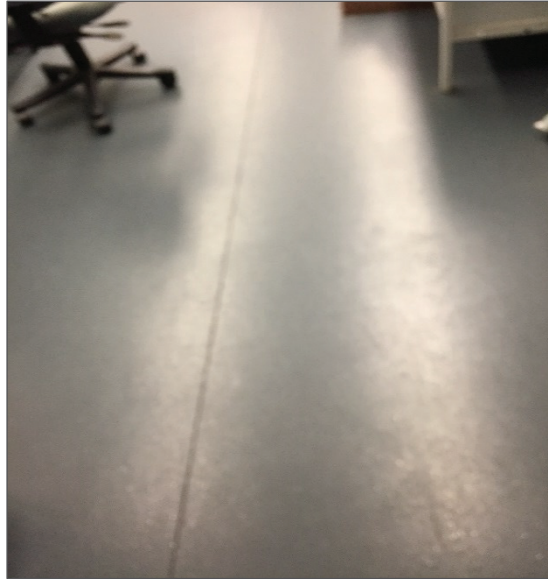
Photograph No. 8: Non-asbestos vinyl sheet flooring within the pool entrance Loc.39 (Rubber).

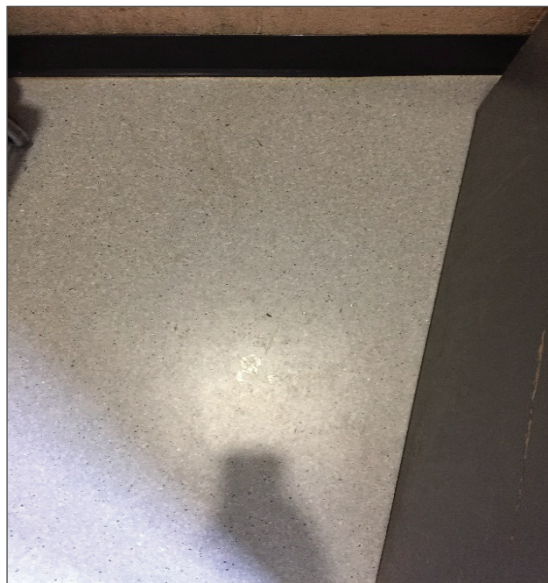
Photograph No. 9: Non-asbestos vinyl sheet flooring within the utility room Loc.53 (Rubber).

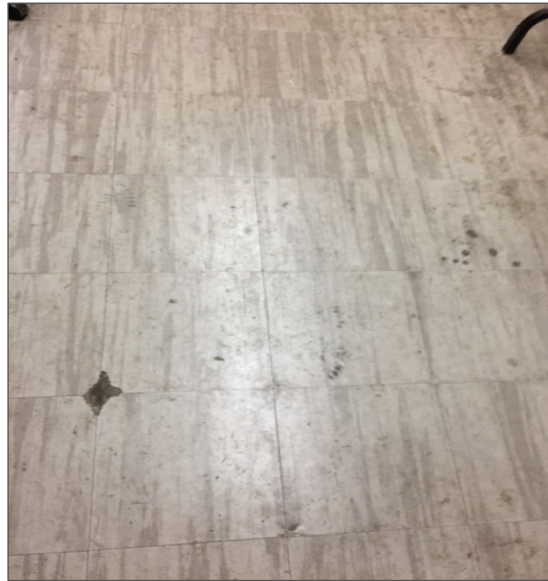
Photograph No. 12: Asbestos-containing vinyl floor tiles within the rink sound room Loc.15 (Samples 0023A-C).

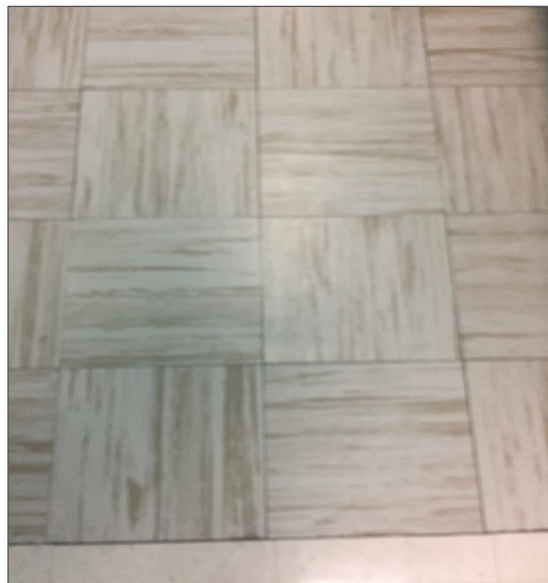
Photograph No. 13: Asbestos-containing vinyl floor tiles within pool corridor and office Loc.'s 38 and 43 (Samples 0033A-C).

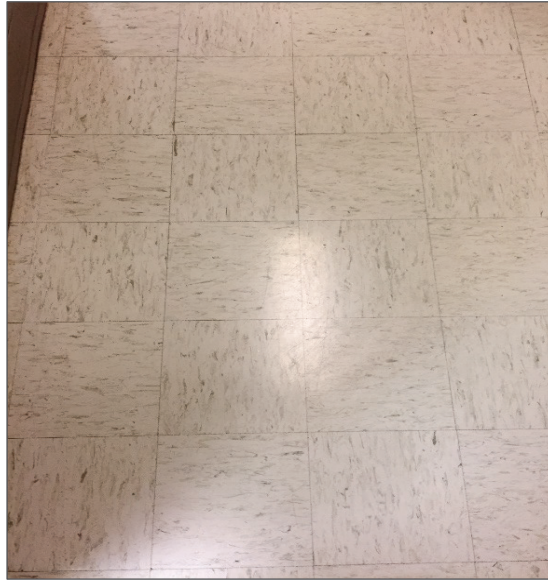
Photograph No. 16: Asbestos-containing vinyl floor tiles within the auditorium and adjacent rooms Loc.48 (Samples 0039A-C).

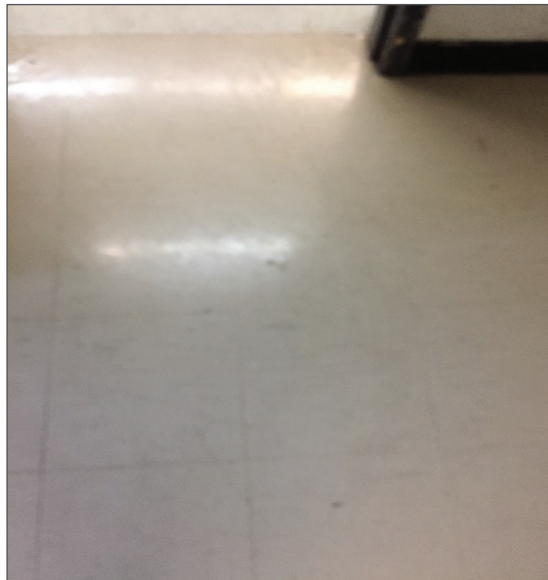
Photograph No. 17: Non-asbestos vinyl floor tiles within the corridors Loc.'s 52 and 58 (Samples 0038A-C).

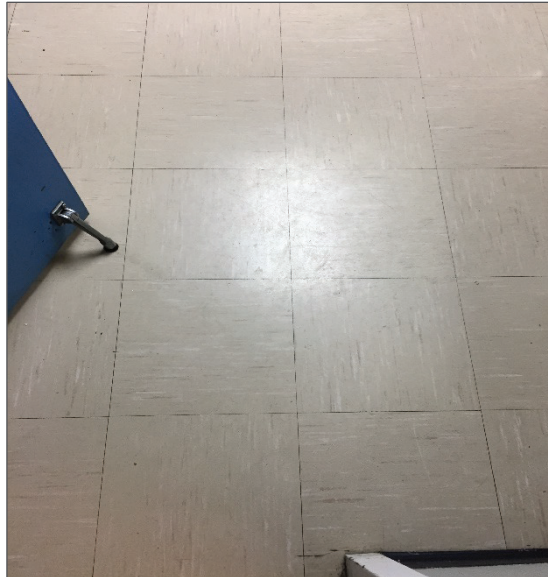
Photograph No. 18: Asbestos-containing vinyl floor tiles within the staff room Loc.59 (Samples 0046A-C).

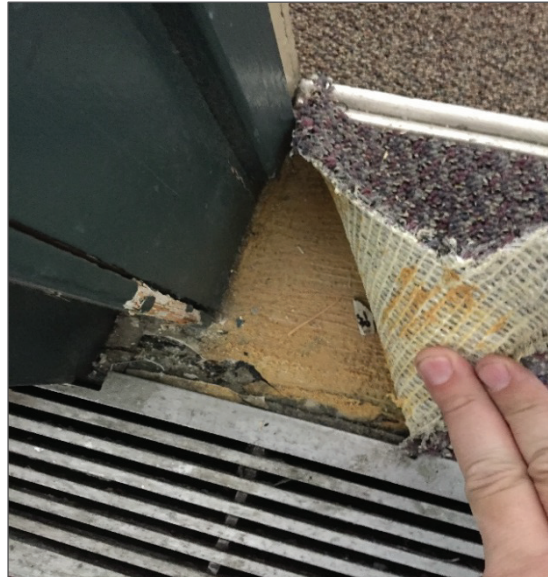
Photograph No. 20: Asbestos-containing vinyl floor tiles within the mezzanine board room and storage room under carpeting Loc.'s 66 and 67 (Samples 0053A-C).

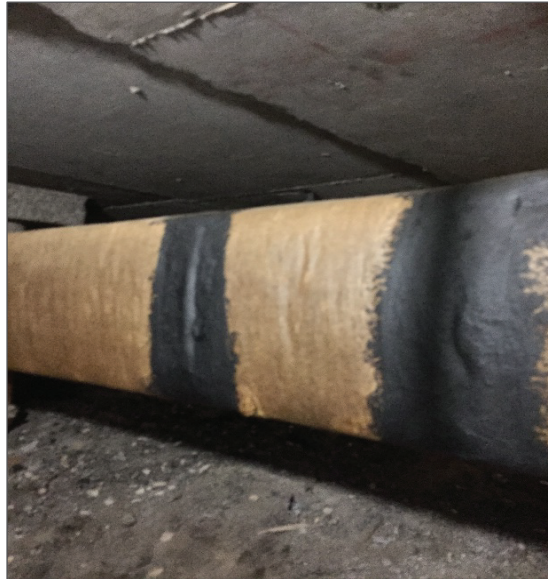
Photograph No. 24: Asbestos-containing black tar mastic on ducting within the south crawlspace (Samples 0007A-C).

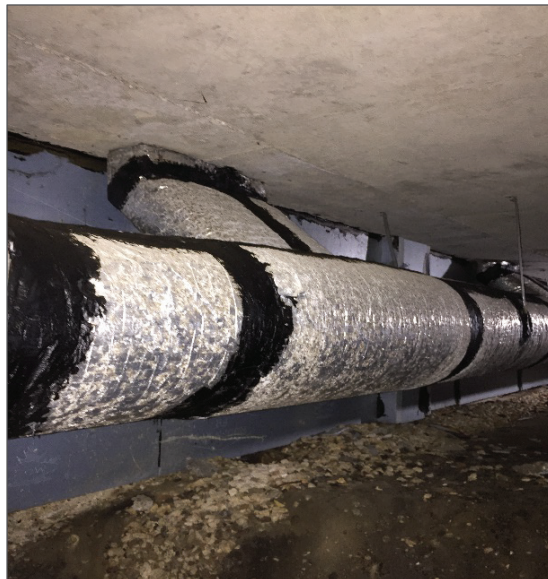
Photograph No. 25: Asbestos-containing black tar mastic on ducting within the south crawlspace (Samples 0009A-C).

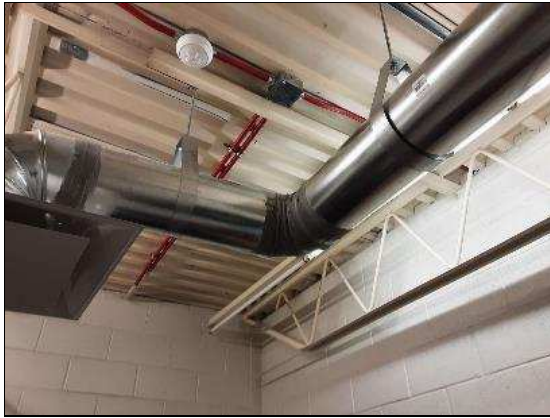
Grey and black duct mastic present at seams / joints on the exterior of ducts throughout the assessed area does not contain asbestos (2018 analysis).

V0000 (None), Duct, Mastic, Grey,  
Storage Room (Location #: 3)

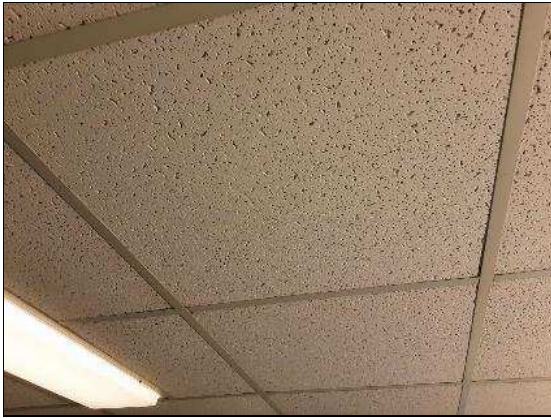
V0000 (None), Ceiling, Ceiling Tiles (lay-in), Men's Washroom  
(Location #: 10)

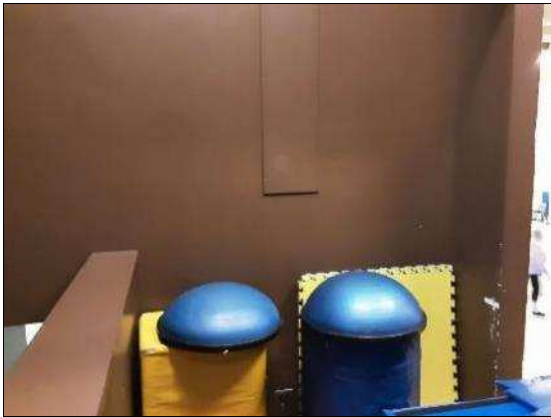
Plaster present on walls throughout the assessed area does not contain asbestos (samples S0002A-B and 2018 analysis).

S0002A (None), Wall, Plaster, Stage (Location #: 2)

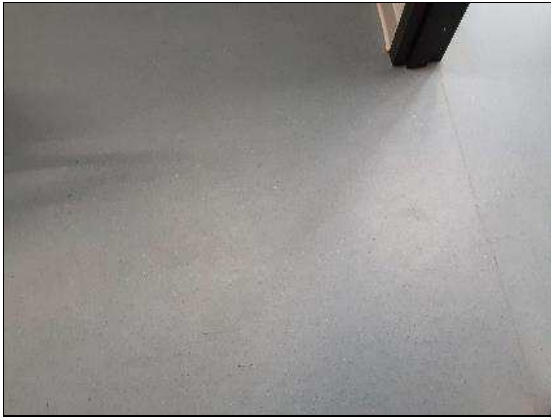
V0000 (None), Floor, Vinyl Sheet Flooring, Stairway To Stage  
(Location #: 5)

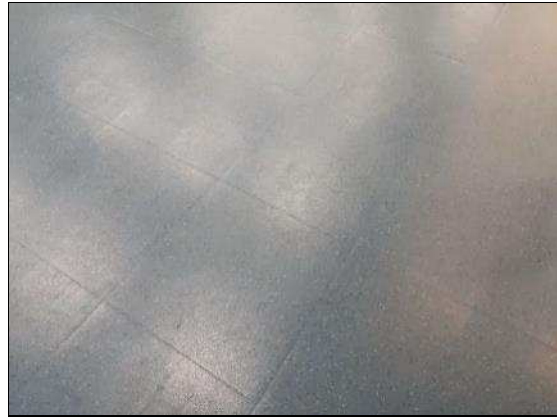
V0000 (None), Floor, Matt Flooring,  
Foyer (Location #: 15)

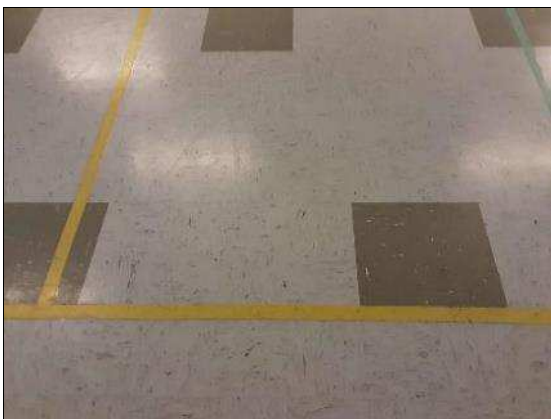
V9000 (Confirmed Asbestos), Floor, Vinyl Floor Tile and  
Mastic, Auditorium (Location #: 1)

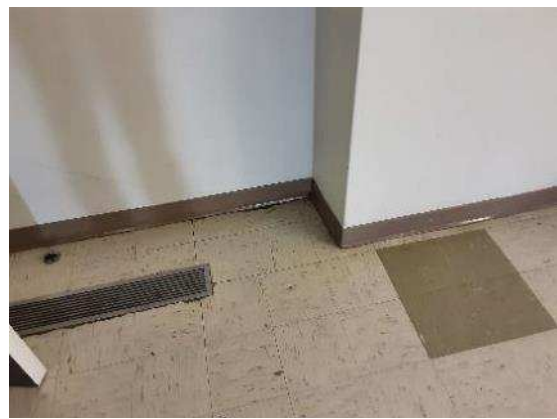
Adhesive behind tan, beige and black baseboards does not contain asbestos (Samples S0001A-C, S0004A-C and S0005A-C).

S0001B (None), Wall, Base, Adhesive/mastic, Auditorium  
(Location #: 1)

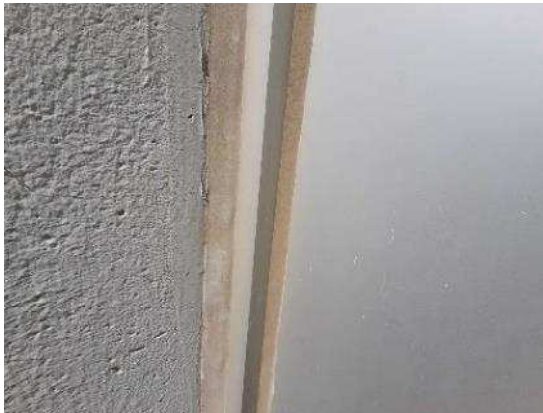
Grey, beige and black caulking at window frames, on the building exterior and roof does not contain asbestos (samples S0009A-C, S0012A-C and 2018 analysis).

S0012A (None), Wall, Caulking,  
Exterior Of Building (Location #: 19)

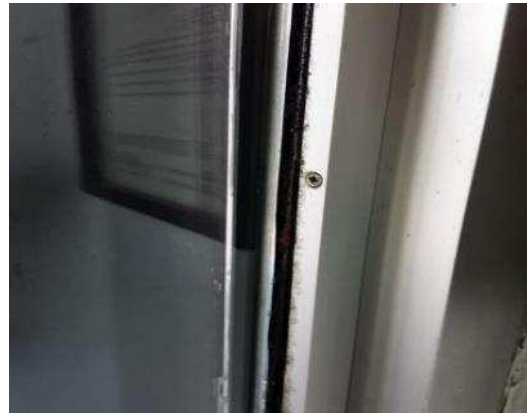
S0009C (None), Other, Caulking,  
Foyer (Location #: 15)

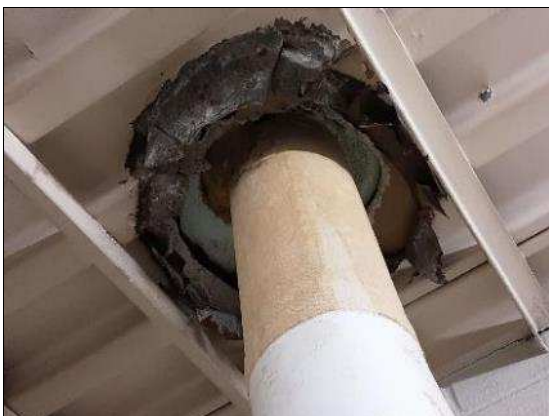
Tar paper located above the metal deck found at a pipe penetration does not contain asbestos (samples S0003A-C).

S0003C (None), Other, Tar Paper,  
Storage Room (Location #: 3)

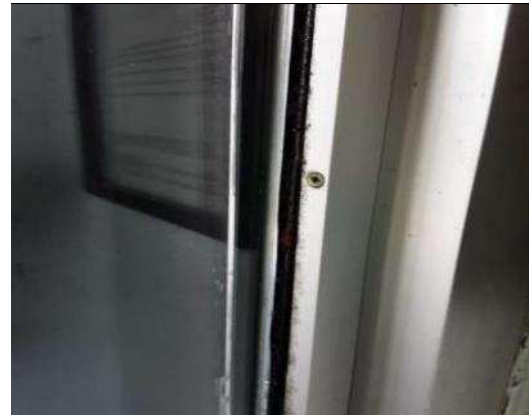
Black caulking is present at window and door frames at the Main Entrance (sample P0001) and contains <0.2 mg/kg PCBs. The material is a non-PCB solid based on the threshold (50 mg/kg).

P0002 (None), Caulking, Foyer  
(Location #: 15)

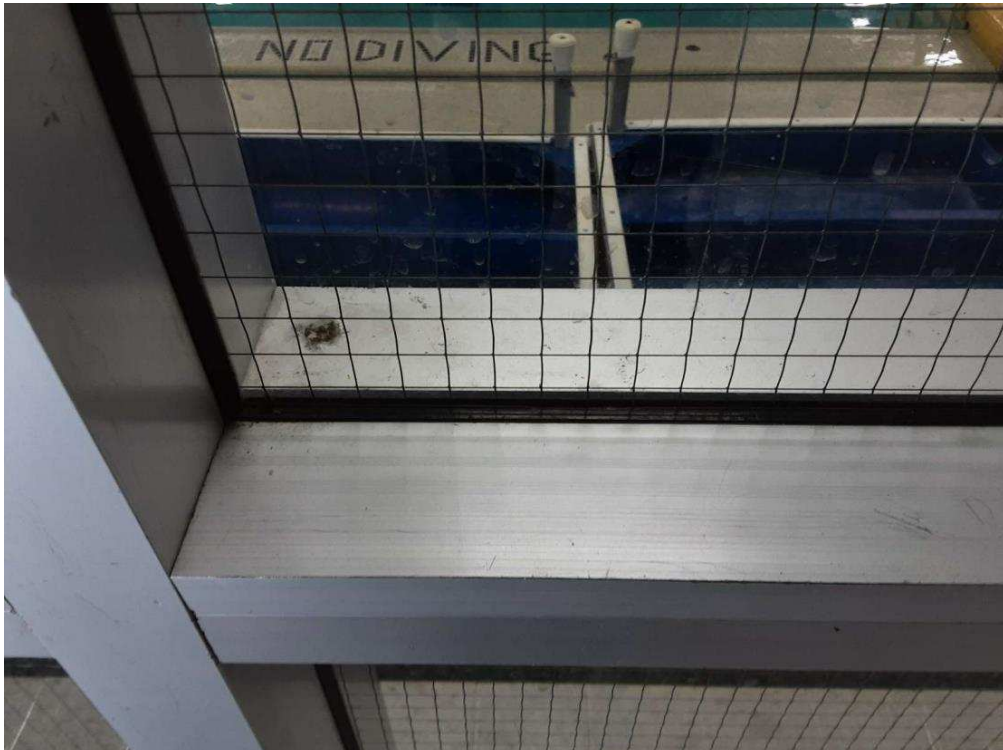
S0008C (None), Other, Window, Butyl Tape, Foyer (Location #: 15)

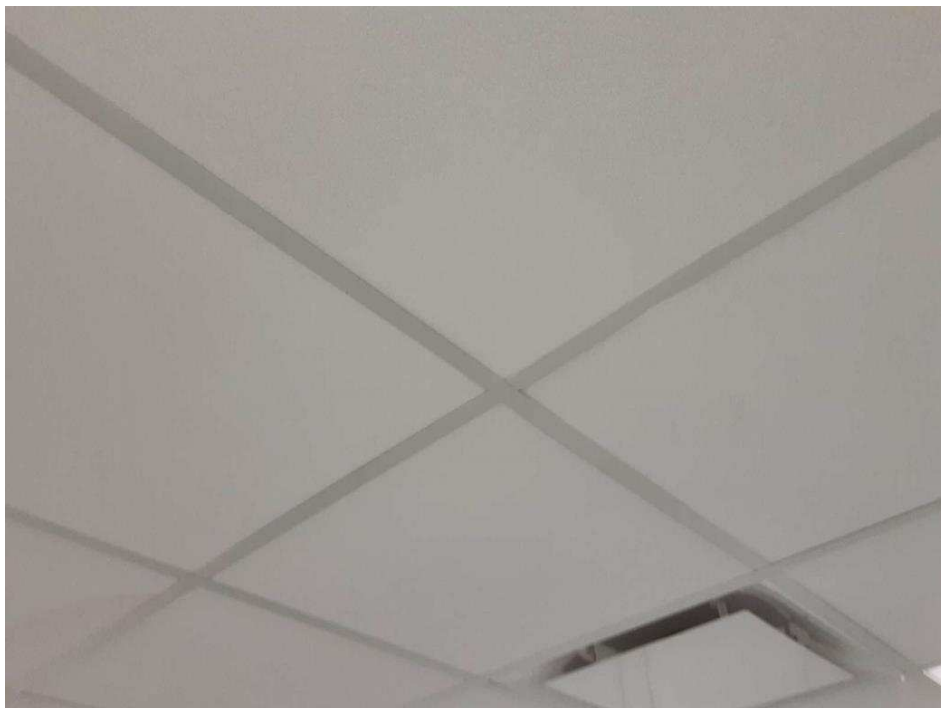
V0000 (None), Ceiling, Ceiling Tiles (lay-in), Classroom (Location #: 14)

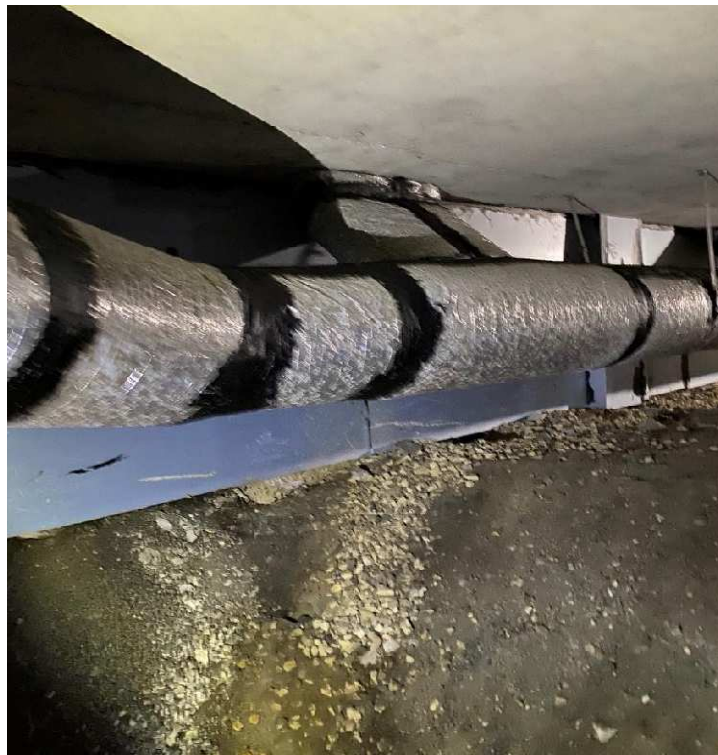
V9000, (Asbestos), Duct, black mastic, Crawlspace (Location # 22)

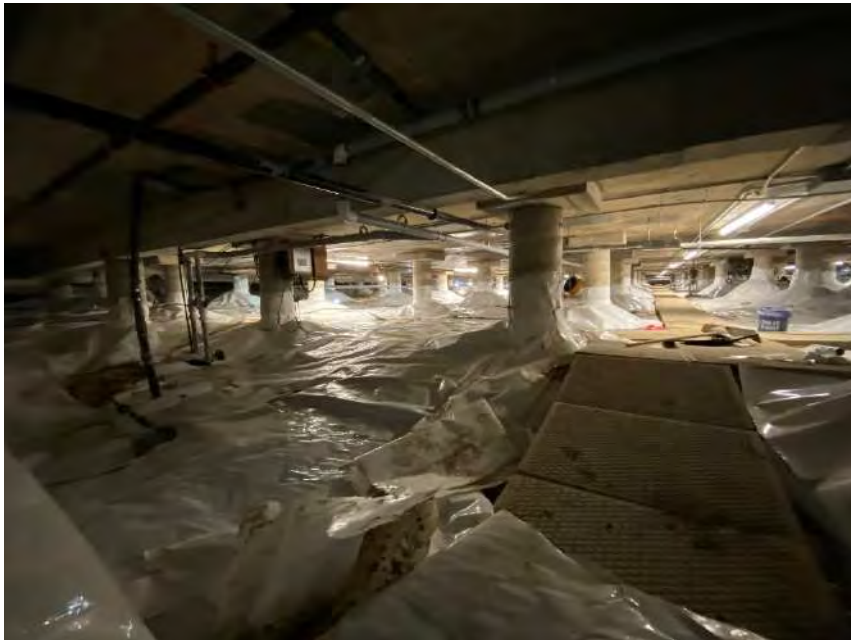
Photograph 32 – Interior, Arena crawlspace

*Looking inward at the crawlspace located under the Arena, currently being worked on.*

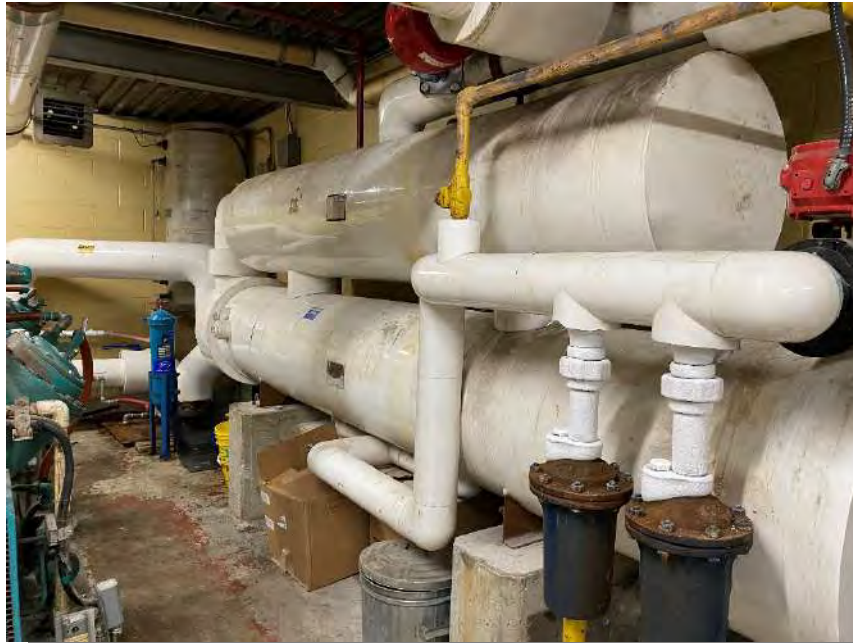
Photograph 37 – Interior, ammonia tanks  
*Looking at ammonia tanks stored to the north of the Arena.*

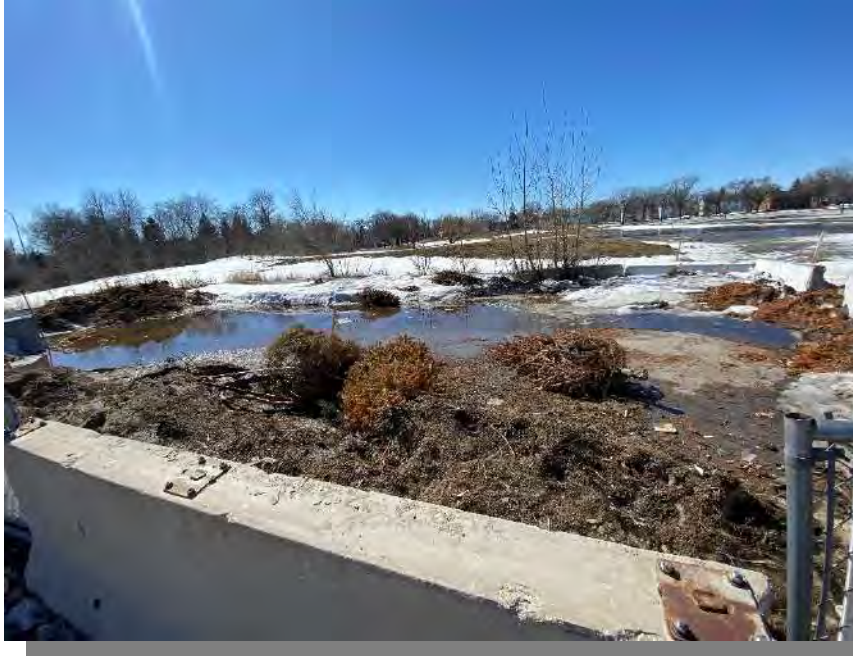
Photograph 47 – Exterior, stormwater catch basin

*Looking southwest from the west elevation towards an apparent stormwater catch basin with ponded water.*
