CITY OF WINNIPEG

WASTEWATER LIFT STATION CONDITION ASSESSMENT PHASE II - 2020

Document XII: Tylehurst Lift Station Assessment

Date: 2021-04-29

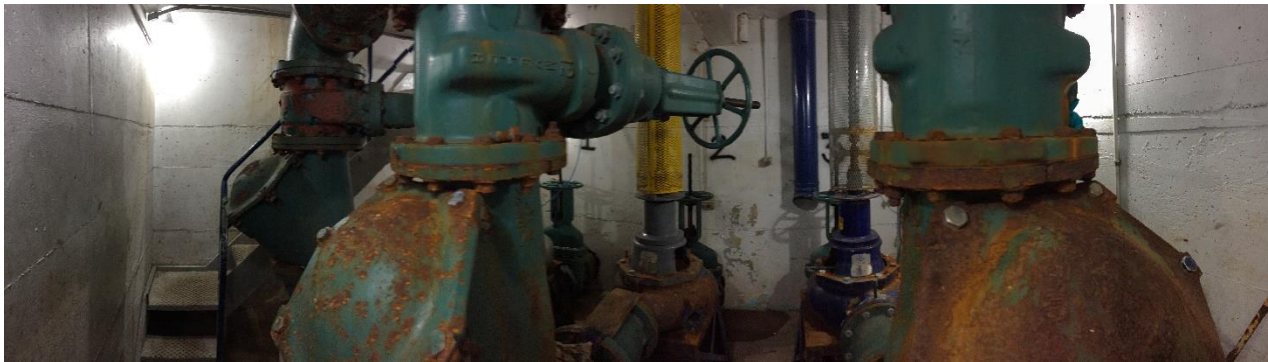
Tylehurst Lift Station Dry Well

P-101 is a Flowserve and P-102, P103 are identical Ingersoll-Dresser pumps. Each pump is rated for 149.8 L/sec at a Total Dynamic Head (TDH) of 9.8 m, operating at a constant speed. Operation Staff noted bearing issues on the pumps.

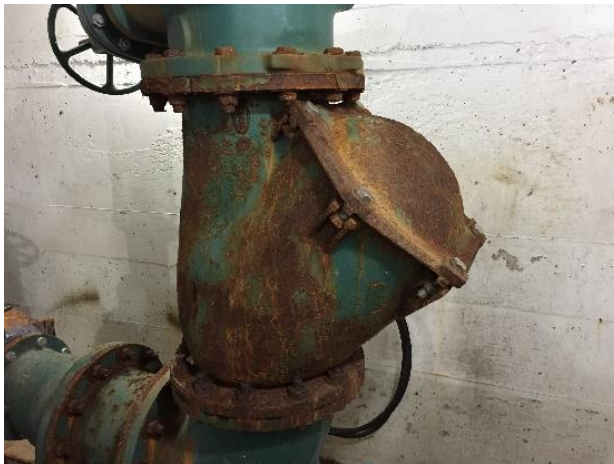
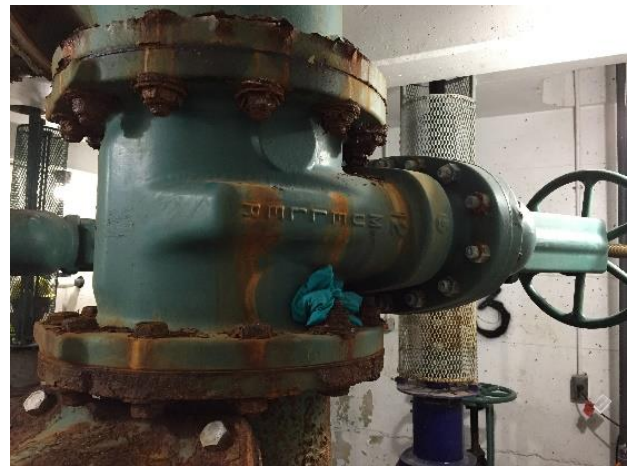
VALVE	DESCRIPTION	SIZE	CONDITION	IMPORTANCE	ACTION
GAV-101A	Gate Valve	300 mm	Fair	Intermediate	Mid Term
GAV-101B	Gate Valve	300 mm	Fair	Intermediate	Mid Term
GAV-102A	Gate Valve	300 mm	Fair	Intermediate	Mid Term
GAV-102B	Gate Valve	300 mm	Fair	Intermediate	Mid Term
GAV-103A	Gate Valve	300 mm	Fair	Intermediate	Mid Term
GAV-103B	Gate Valve	300 mm	Fair	Intermediate	Mid Term
GAV-110	Gate Valve	300 mm	Fair	Important	Mid Term
GAV-111	Gate Valve	300 mm	Fair	Important	Mid Term
GAV-201	Gate Valve	500 mm	Excellent	Intermediate	None
CHV-101	Ball Check Valve	300 mm	Fair	Important	Short Term
CHV-102	Ball Check Valve	300 mm	Fair	Important	Short Term
CHV-103	Ball Check Valve	300 mm	Poor	Important	Short Term

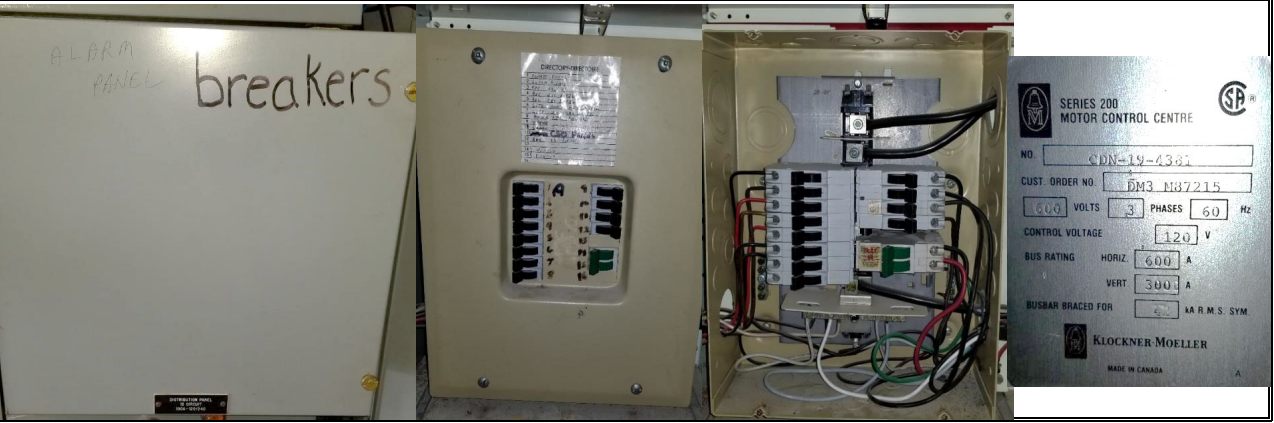
PHOTOGRAPHS

Equipment Remaining Service Life: <i>Issues for Discussion:</i>	Rating 1 (> 90% lifecycle remain) Rating 2 (> 75% lifecycle remain) Rating 3 (> 50% lifecycle remain) Rating 4 (> 25% lifecycle remain) Rating 5 (obsolete)	4	0.5

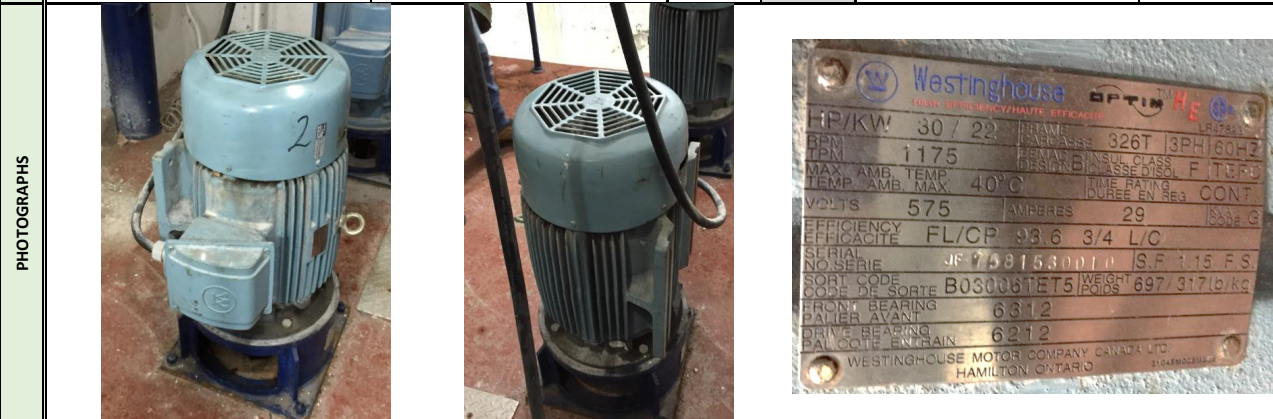
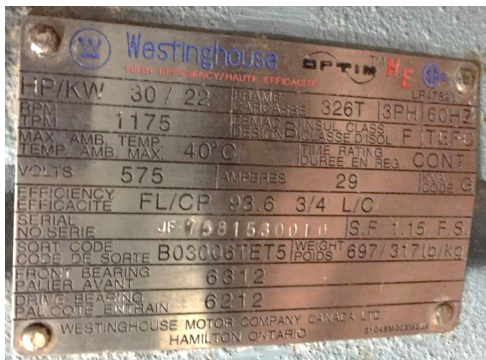
Canadian Electrical Code Issues Identified: <i>Issues for Discussion:</i> Rating 1 (No issues) Rating 3 (Non compliant - current code) Rating 5 (Non compliant - legacy code)		5	0.4						
Wiring Terminations Visual Inspection: <i>Issues for Discussion:</i> Rating 1 (Connections tight, labelled) Rating 2 (Missing Labels) Rating 3 (Loose / Disorganized wiring) Rating 4 (Inappropriate wiring) Rating 5 (Combination of above)		2	0.1						
Occurrences of Maintenance Issues: <i>Issues for Discussion:</i> Rating 1 (None) Rating 2 (Intermittent) Rating 3 (Consistent but occasional) Rating 4 (Frequent) Rating 5 (Constant)		2	0.4						
Meets City Electrical Design Standards: <i>Issues for Discussion:</i> Rating 1 (Yes) Rating 3 (No - current standards) Rating 5 (No - legacy standards)		3	0.25						
Fitness for Purpose	Has the Capacity been Reached? <i>Issues for Discussion:</i> Rating 1 (Below service factor) Rating 2 (Occasional within service factor) Rating 3 (Frequent within service factor) Rating 4 (Always Within Service Factor) Rating 5 (> Service Factor)	1	0.5	RECOMMENDATIONS: COST ESTIMATE

Equipment Remaining Service Life: <i>Issues for Discussion:</i> Rating 1 (> 90% lifecycle remain) Rating 2 (> 75% lifecycle remain) Rating 3 (> 50% lifecycle remain) Rating 4 (> 25% lifecycle remain) Rating 5 (obsolete)	4	0.25
