Slope Failure on Northbound Lagimodiere Blvd between Betournay St and Elizabeth Rd

Geotechnical Investigation and Slope Instability Assessment Report

Project Number: 0015 037 00

Date: September 14, 2020

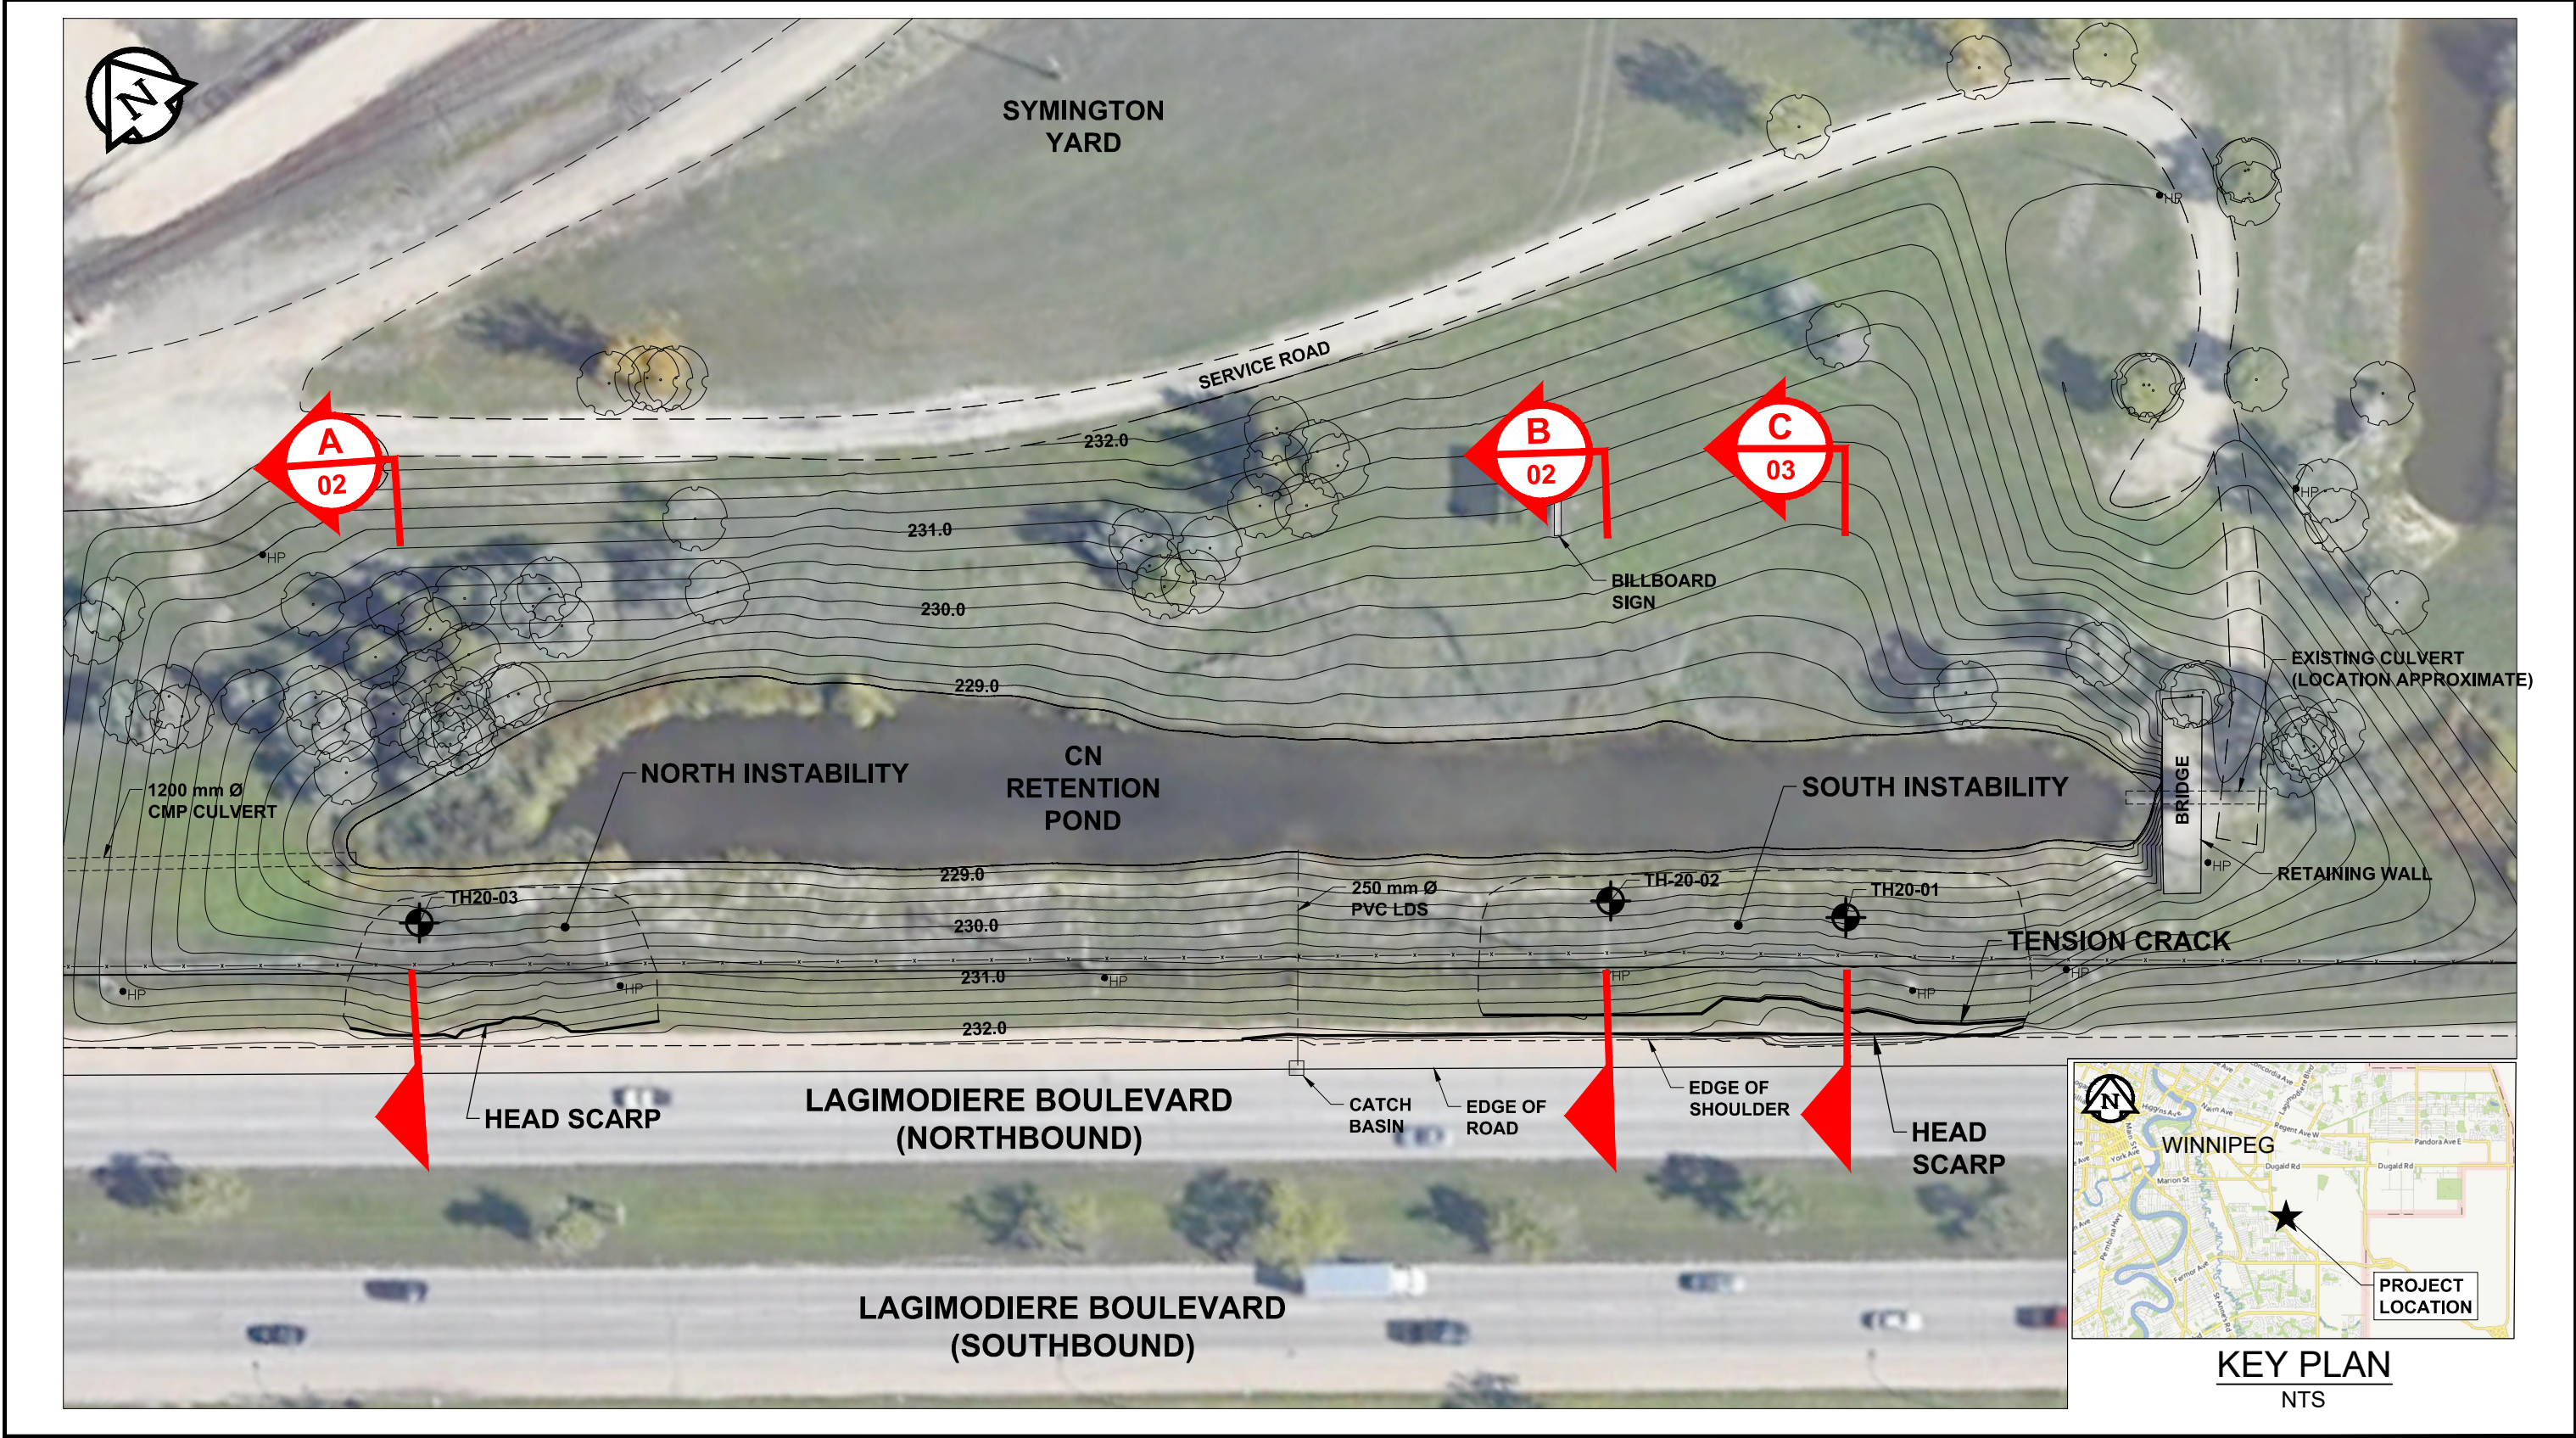
A site reconnaissance was completed by Michael Van Helden, P.Eng. of TREK on February 23, 2020 and subsequently on April 1, 2020 as part of the sub-surface investigation. The existing west pond slope stands approximately 7 m in height at about a 4H:1V to 5H:1V slope. At the time of the site visit, a 0.5 to 1.0 m high head scarp and various tension cracks were observed in two general areas – the north and south instability areas. The north instability is located at the north end of the pond and extends a distance of approximately 40 m. The south instability is located at the south end of the pond and extends a distance of approximately 80 m. The head scarps (tension cracks) for both instabilities are located at or just upslope of the edge of shoulder, but outside the main traffic lanes of Lagimodiere Blvd. Based on the visual assessment, the slope instability poses an imminent risk to public and road safety, and therefore stabilization is required. Photos 1 and 2 show the instability head scarps of the south and north instabilities, respectively. The site location and plan view extents of the instabilities are shown in Figure 01. Site photos are included in Appendix A.

A topographic survey was performed at the site on May 06 and May 14, 2020 by TREK. Test holes and instrumentation locations and elevations, topography and relevant site features were measured as part of the survey. Site features and elevation contours generated from the survey are shown on Figure 01 and cross-sections of the existing conditions are shown on Figures 02 to 04.

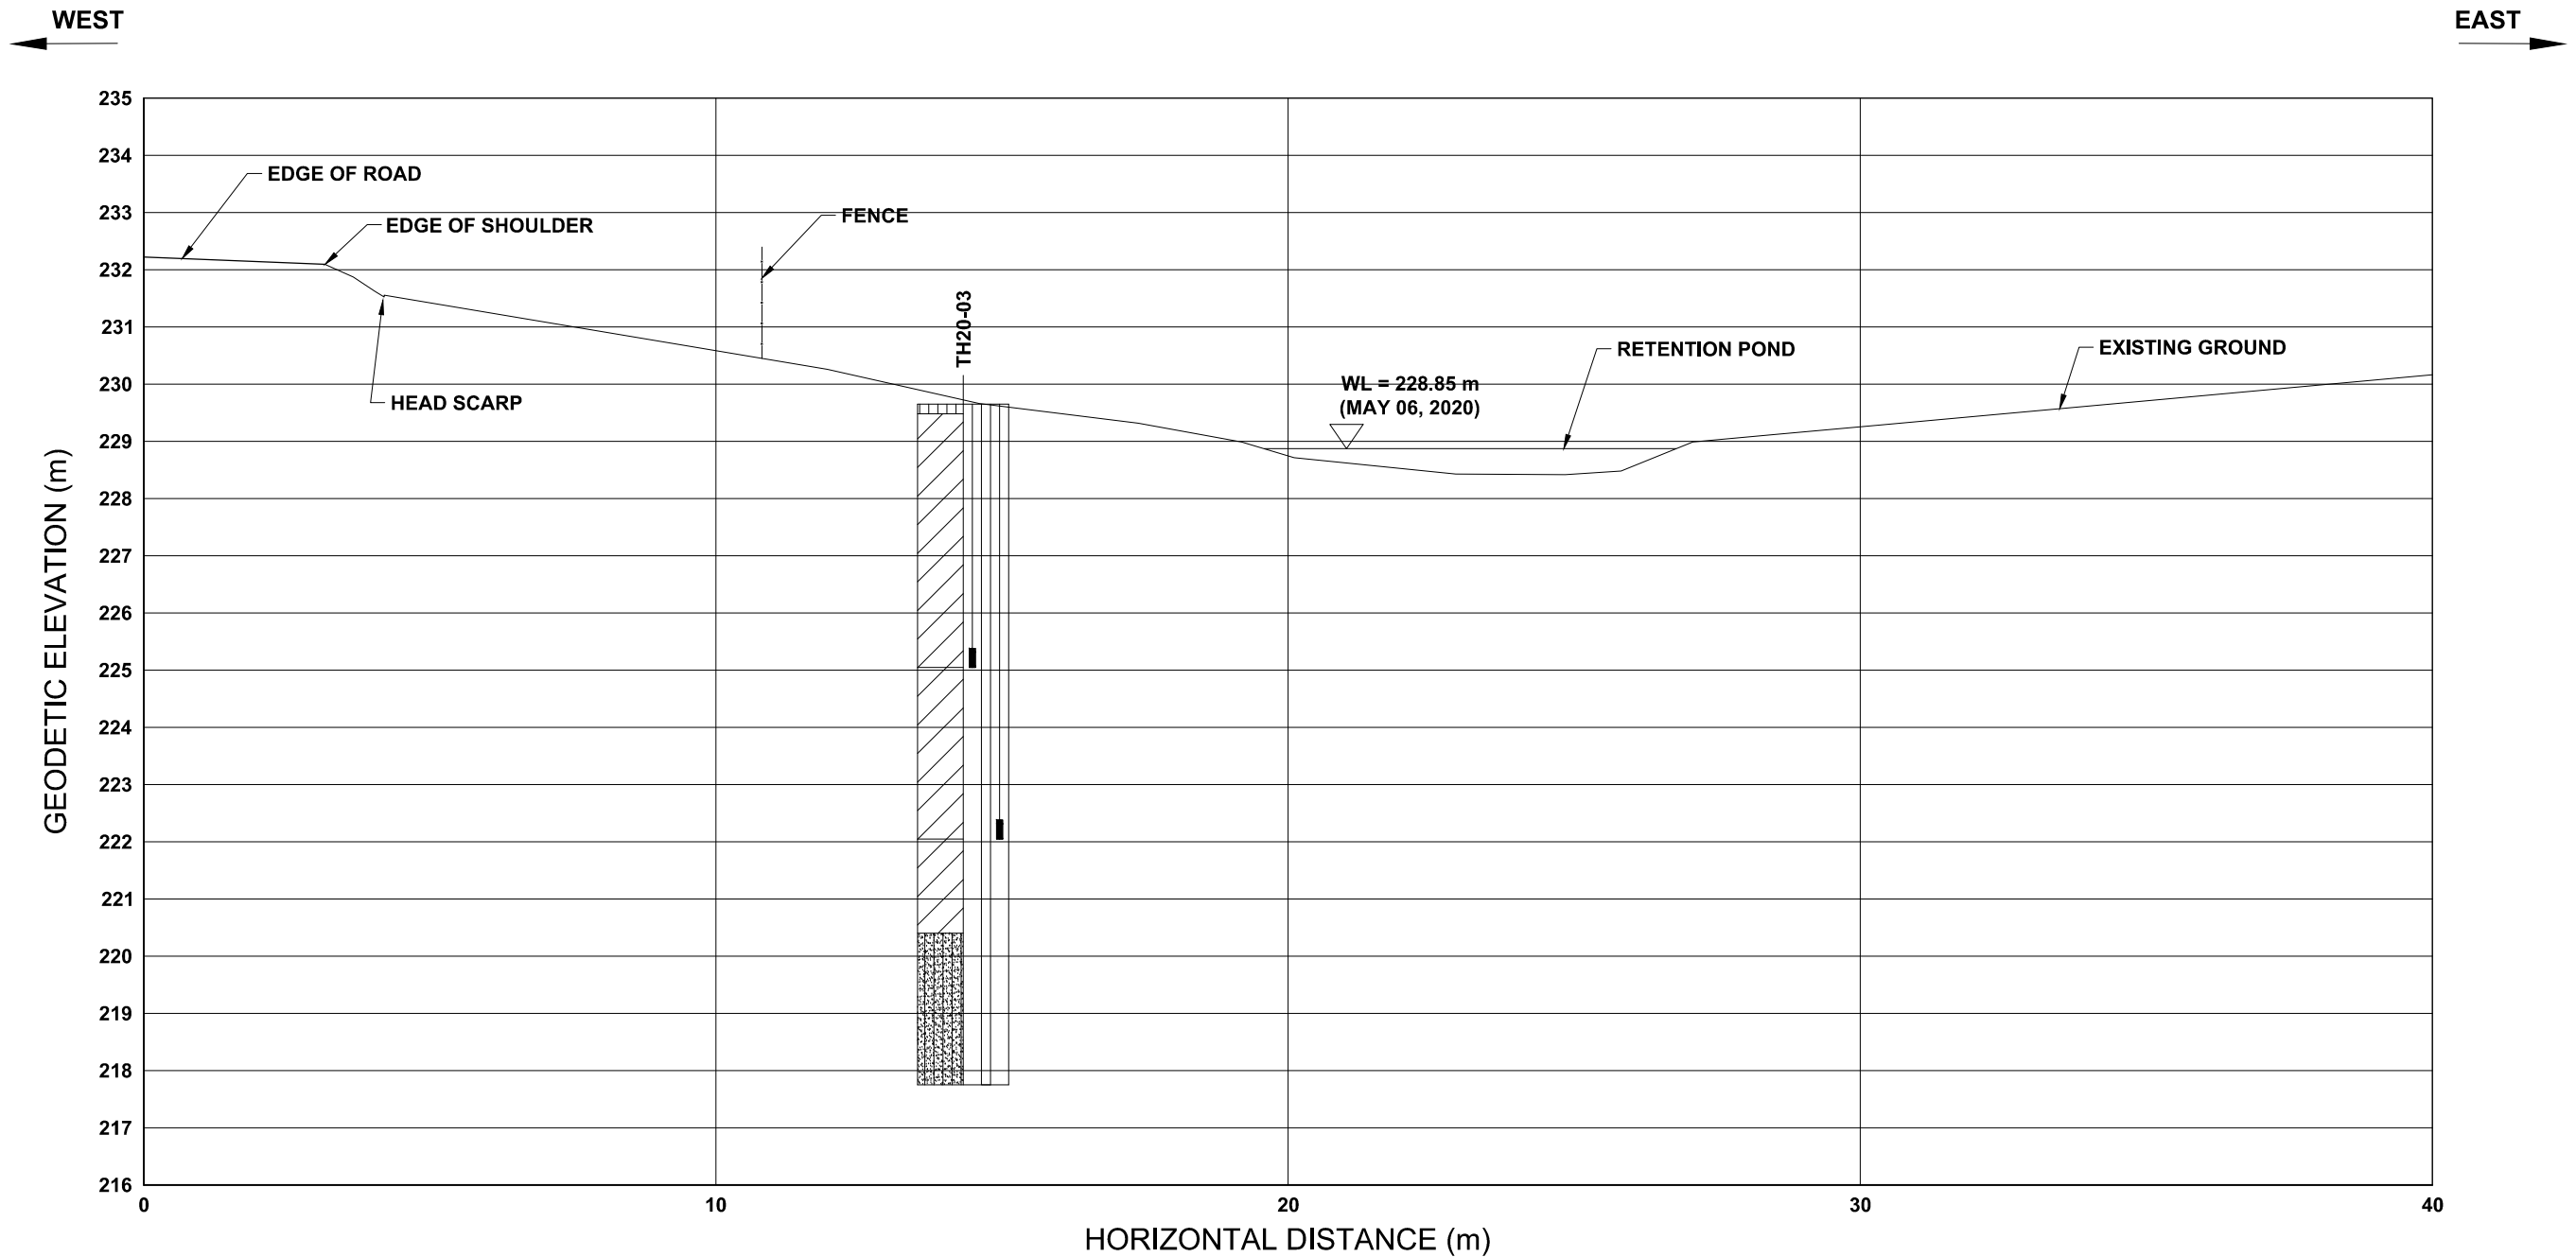
A
01 **CROSS-SECTION**
SCALE (H:V) = 1:1

A slope stability analysis was conducted to determine the existing stability of the road embankment and pond slope under critical conditions (post-failure) and to evaluate remedial alternatives to improve stability. The cross-section generated from the site survey was used in the assessment of the riverbank. Figure 01 shows the site plan indicating the location of the cross-section.

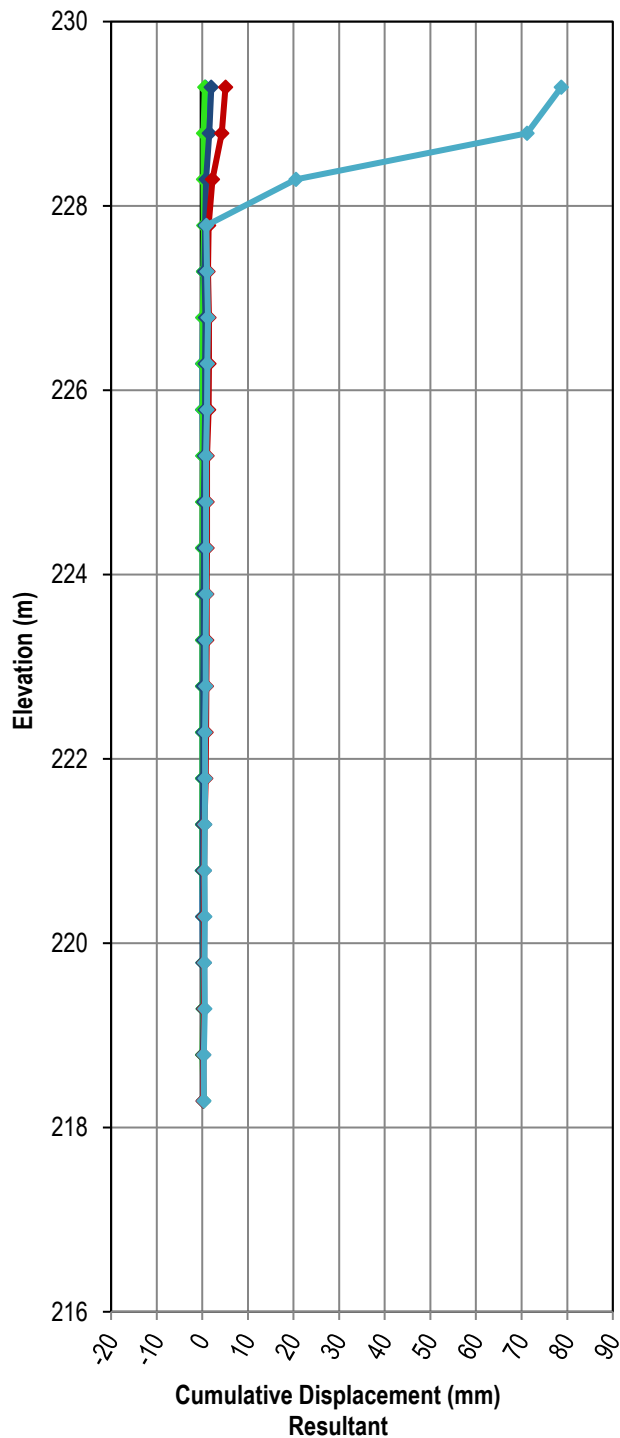
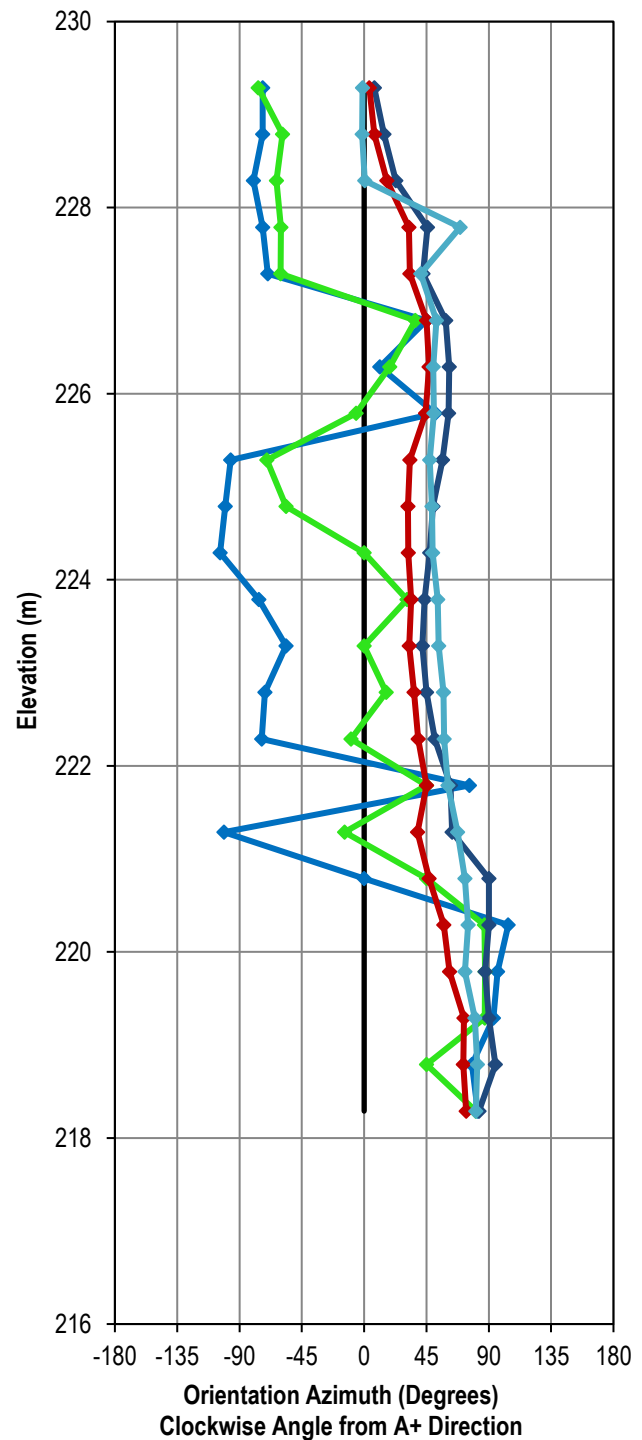
SI20-01

Slope inclinometer (SI) casings were used to monitor for shear movements. The SI's were monitored on four occasions after drilling, including a baseline reading on May 14, 2020 and subsequent readings on May 29, June 16 and July 03, 2020. Traffic gravel was placed at the top of the instabilities on June 29, 2020 (prior to the latest SI reading) to restore the shoulder for traffic safety purposes. Inclinometer monitoring results are included in Appendix C and show negligible movement until after placement of traffic gravel. Thereafter, approximately 50 mm and 4 mm of movement was observed in SI-01 and SI-02, respectively, occurring at shallow depths ranging from 2 to 3 m below ground surface.

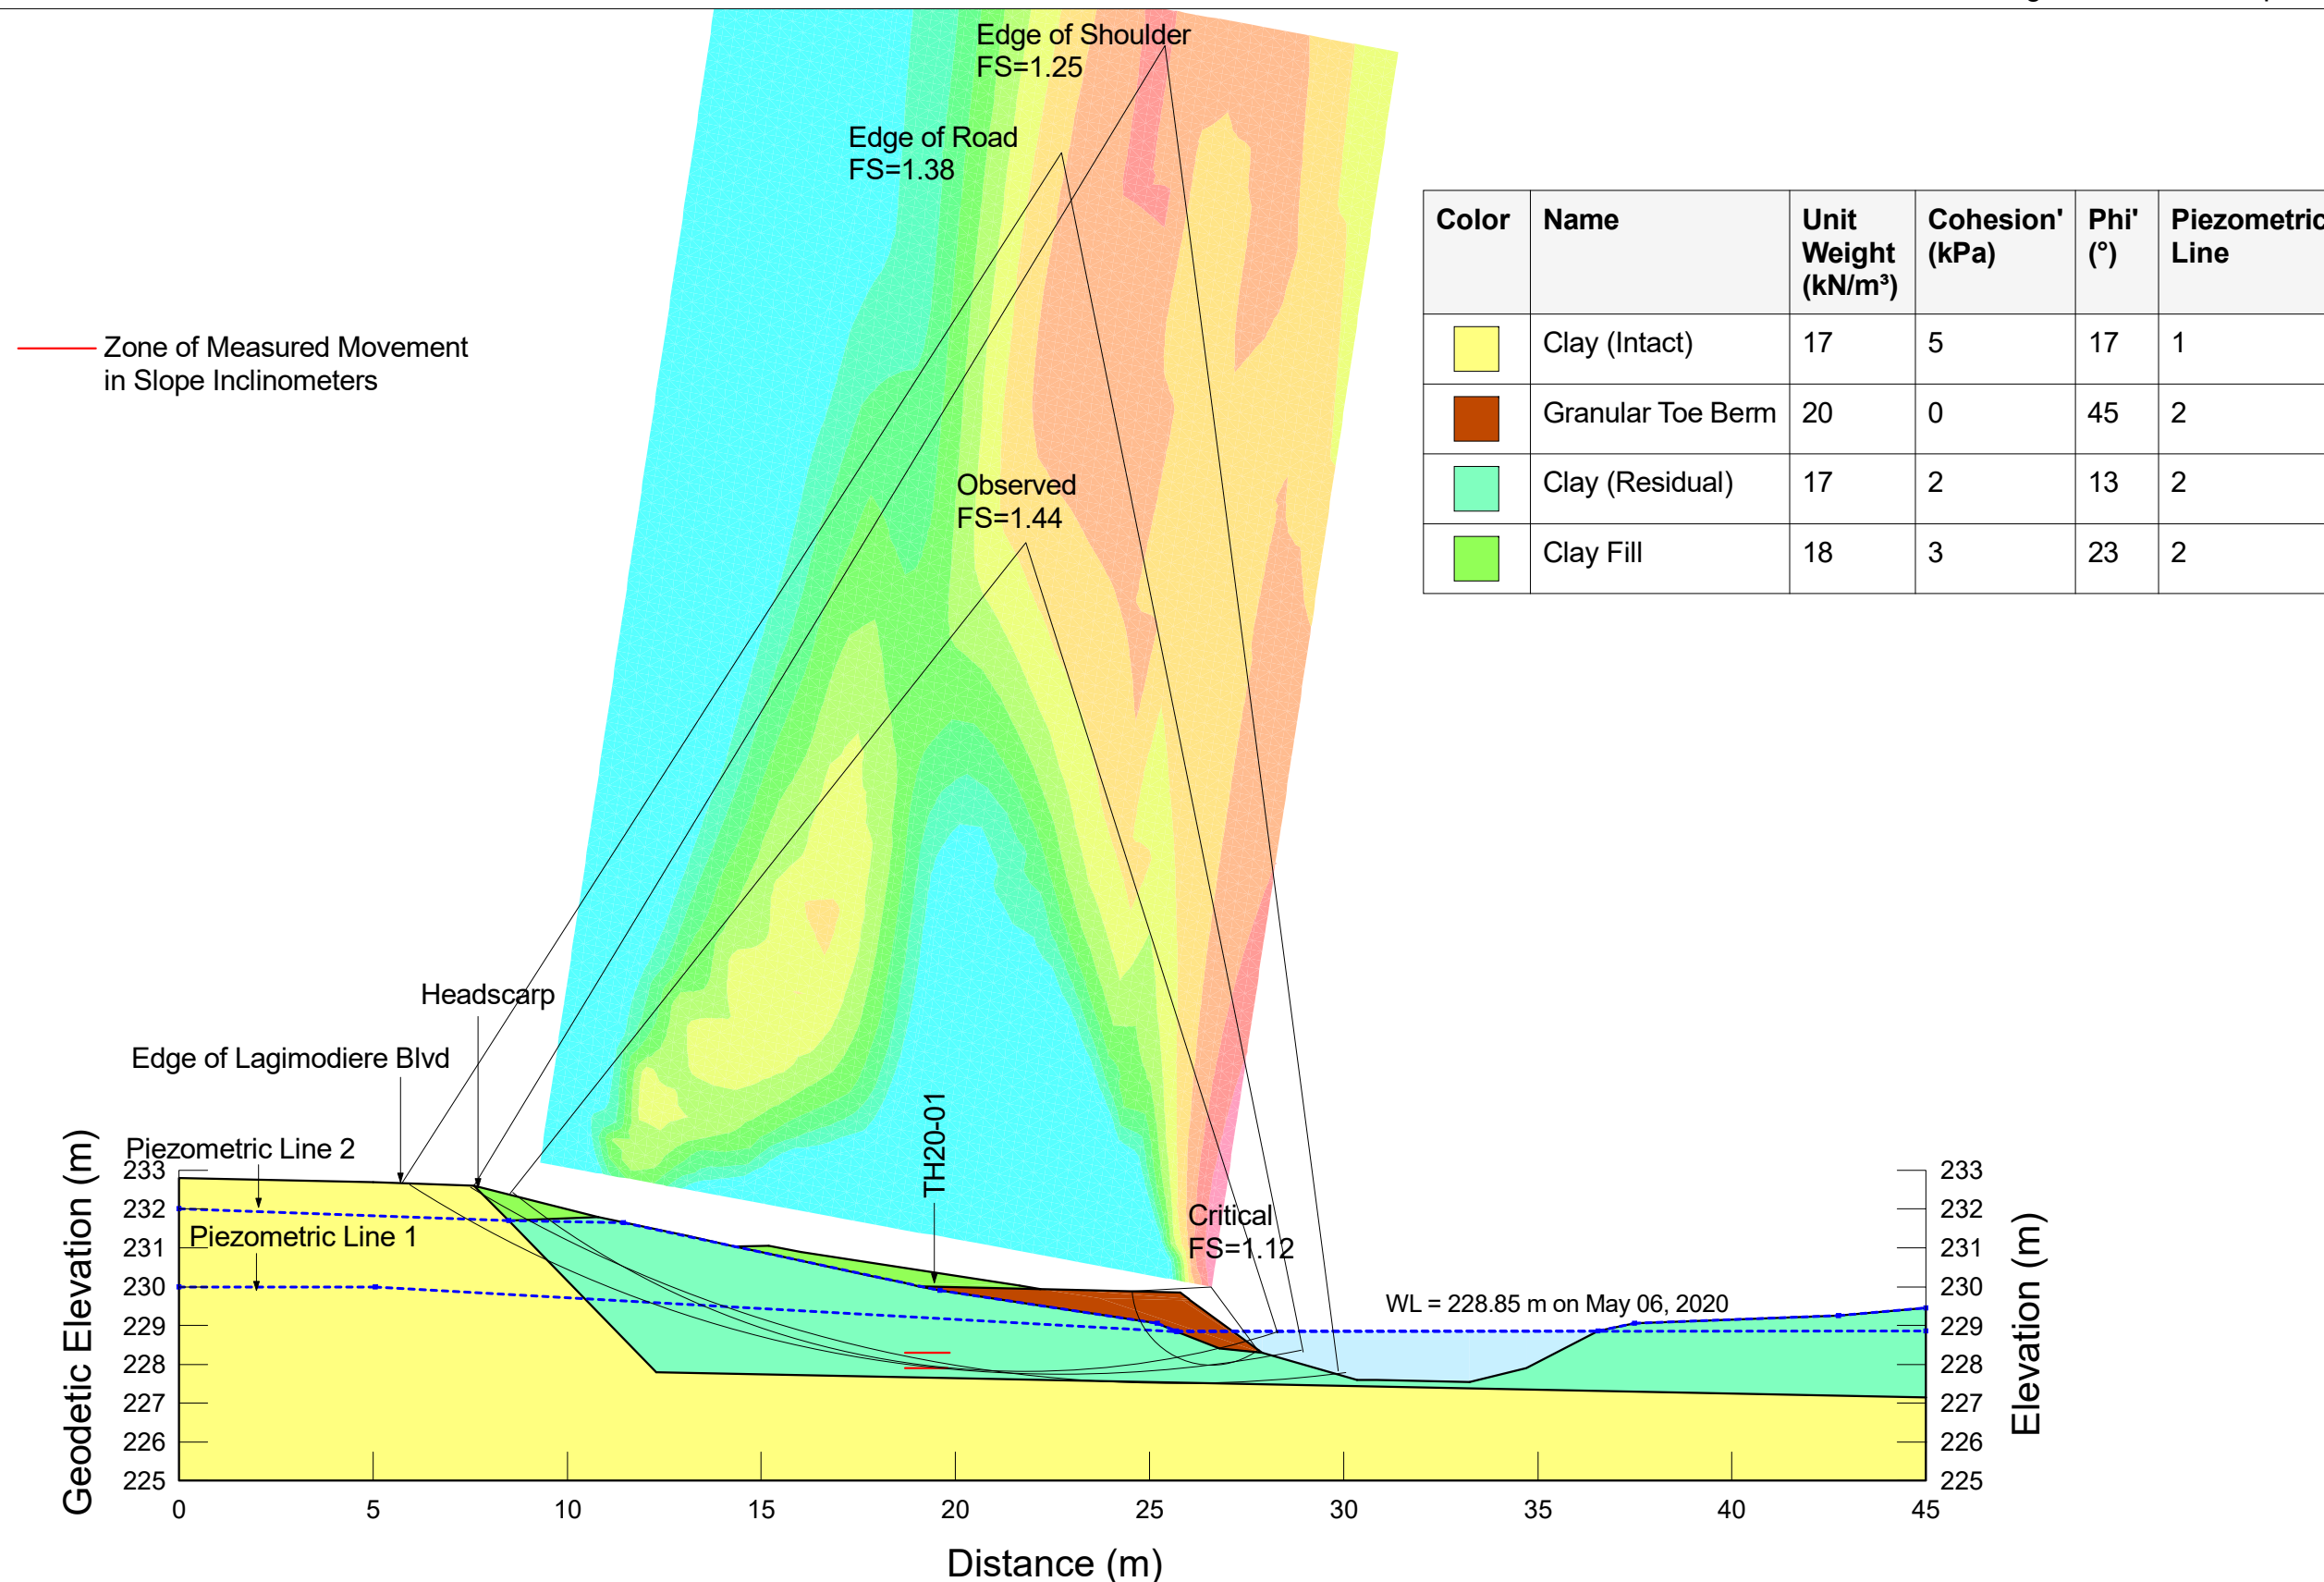
Figure D-06

Stability Case	Cross-section	Slip Surface	Factor of Safety (Change from Baseline)	Figure No. (Appendix D)
Back-Analysis (Post-Failure Geometry)	A (north)	Critical / Observed Edge of Shoulder Edge of Roadway	1.01 (baseline) 1.01 1.32	D-01
	C (south)	Critical / Observed Edge of Shoulder Edge of Roadway	1.01 (baseline) 1.06 1.20	D-02
Rockfill Ribs (1:1 Replacement Ratio) and Regrading to Original Grades	A (north)	Critical / Observed Edge of Shoulder Edge of Roadway	1.30 (+21%) 1.29 (+21%) 1.52 (+12%)	D-03
	C (south)	Critical / Observed Edge of Shoulder Edge of Roadway	1.36 (+42%) 1.25 (+22%) 1.38 (+19%)	D-04
Rockfill Toe Berm and Slope Flattening (6.3H:1V upslope of berm)	A (north)	Critical / Observed Edge of Shoulder Edge of Roadway	1.46 (+36%) 1.24 (+16%) 1.47 (+8%)	D-05
	C (south)	Critical / Observed Edge of Shoulder Edge of Roadway	1.44 (+50%) 1.25 (+22%) 1.38 (+19%)	D-06
