The City of Winnipeg

High Risk River Crossings Condition Assessment Report Water Crossings

AECOM
99 Commerce Drive 204 477 5381 tel
Winnipeg, MB, Canada R3P 0Y7 204 284 2040 fax
www.aecom.com

November 2, 2016

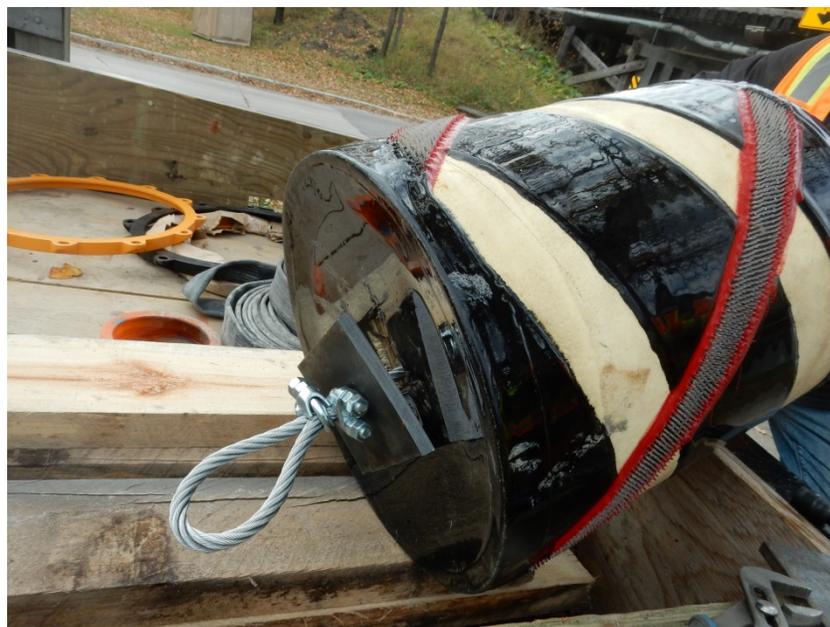
Figure 2: Modified Foam Cleaning Pig

- A foam pig became lodged in the pipe and broke the tow rope while cleaning the Goulet-Doucet Water Main. The pig was stuck on the east bank of the Seine River. An external excavation was required to retrieve the pig. The pig was lost due to a defect in the tow rope embedded within the foam pig and an accumulation of disbonded coating debris from the steel crossing increasing drag on the assembly. Subsequent to the incident, Tri-Core installed steel cables through the pigs for towing, see Figure 2.

The cleaning process was undertaken using a combination of traditional high pressure flushing technology and foam pigging. New sanitized flushing equipment was utilized to remove debris from the pipeline, and foam pigs used to confirm the adequacy of the cleaning operations and swab the pipe for debris. Tethered pigging was utilized by Tri-Core Projects Manitoba Ltd. (Tri-Core), the support contractor, for all crossings, further reducing the risk associated with cleaning operations. Tri-Core encountered issues with the strength and manufacture of the tow ropes on their foam pigs used on the water crossing sites, which resulted in them losing a pig within the Goulet-Doucet water main crossing. Issues with the foam pigs were rectified with the installation of 12.5 mm steel cable and steel plates onto the existing foam pigs, see Figure 2

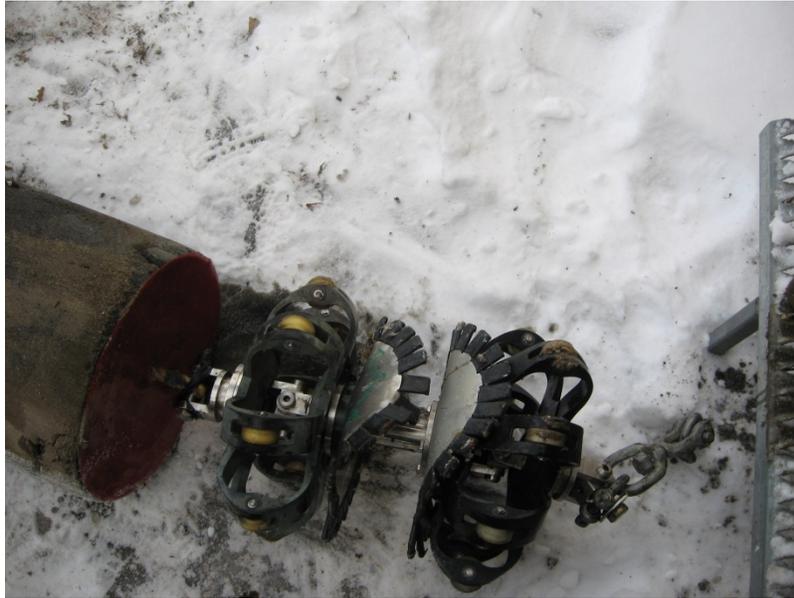
Figure 3: Gauge Pig with Foam Swab

To reduce the risk of getting a tool stuck within the pipeline and/or damaging the tool; a gauge pig with aluminum fins was pulled through the line prior to the inspection. As an example, Figure 3 shows a gauge pig with bent fins, caused by a partially closed gate valve on the Munroe-Polson sewer siphon.

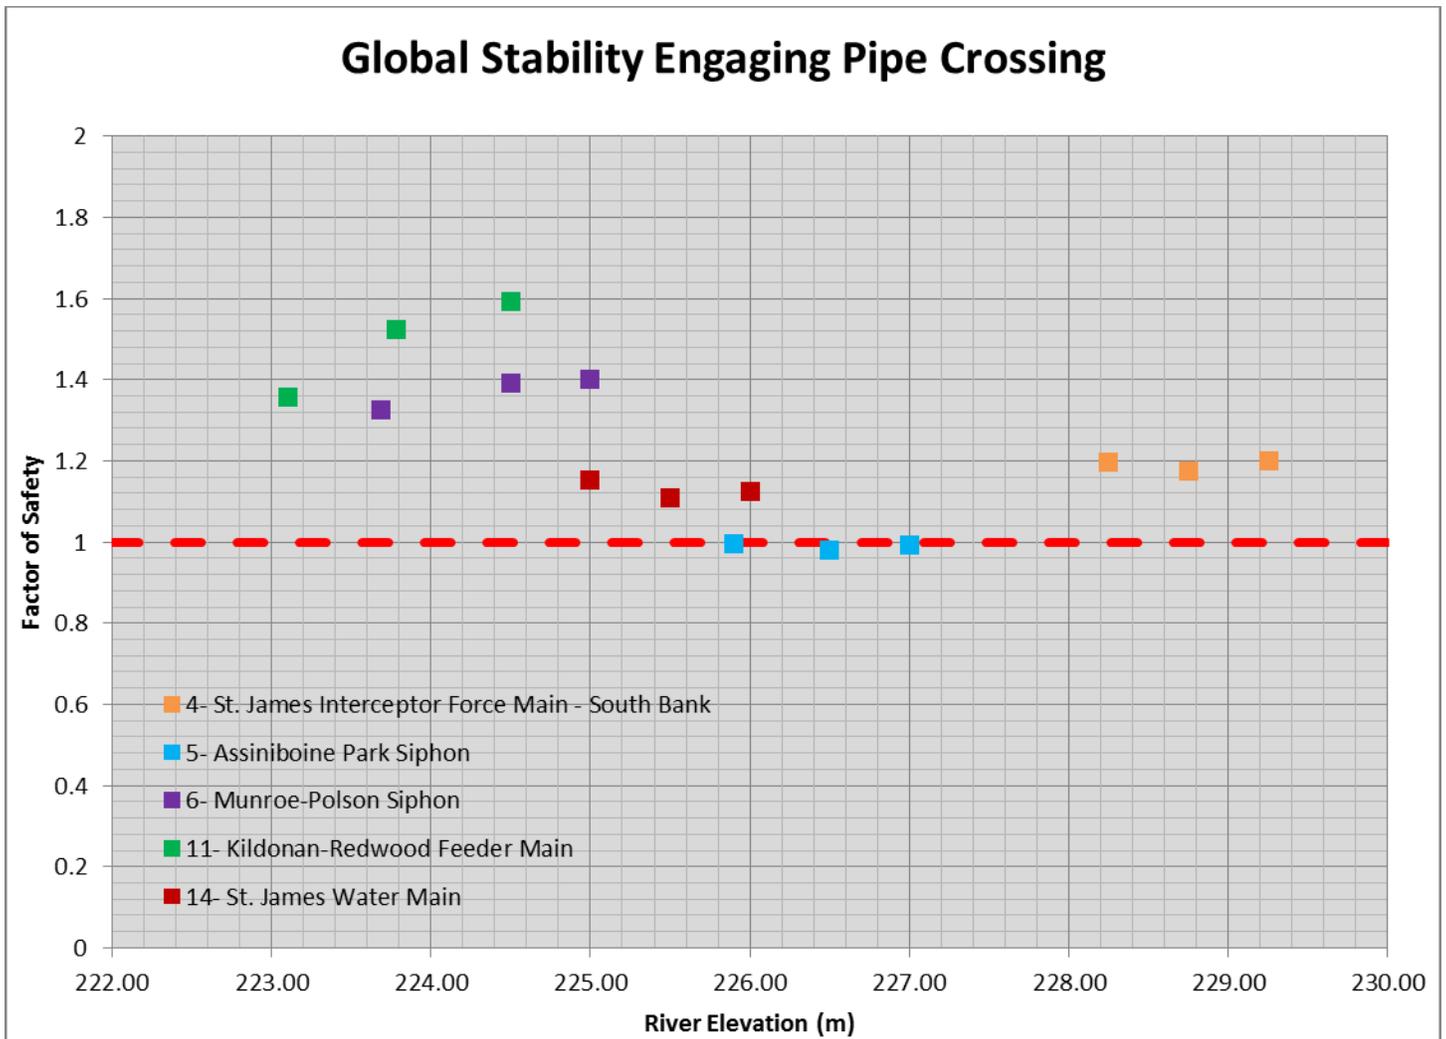
Figure 9: Global Stability Factor of Safety against Bank Failure where Failure Surface Contacts Pipe Profile

Table 2 summarizes the factor of safety for a failure plane that engages the pipe, illustrated as a function of river elevation in Figure 9. In the case the two water crossings analyzed, Site 11 is generally stable at the upper bank area, but prone to toe instability, and Site 14 is prone to slope failure due to the near-vertical slope face at the river's edge. Both sets of modelling results reflect observations made during the site inspections.

Site	Location	Bank	River or Creek	Factor of Safety Affecting Pipe
11	Kildonan-Redwood Feeder Main	East	Red River	1.3 to 1.6
14	St. James Water Main	South	Assiniboine River	1.1 to 1.2

The analysis has demonstrated a potential failure surface near the riverbank toe that could engage the pipe at Site 11, Kildonan-Redwood Feeder Main. With continued erosion this can result in retrogressive failure farther upslope as support is reduced for upper bank soil blocks. Erosion measures should be implemented to reduce the potential for toe and subsequent upper bank failure. Global factor of safety ranges from about 1.1 to 1.2 based on this isolated cross-section and reinforce the potential for global instability.

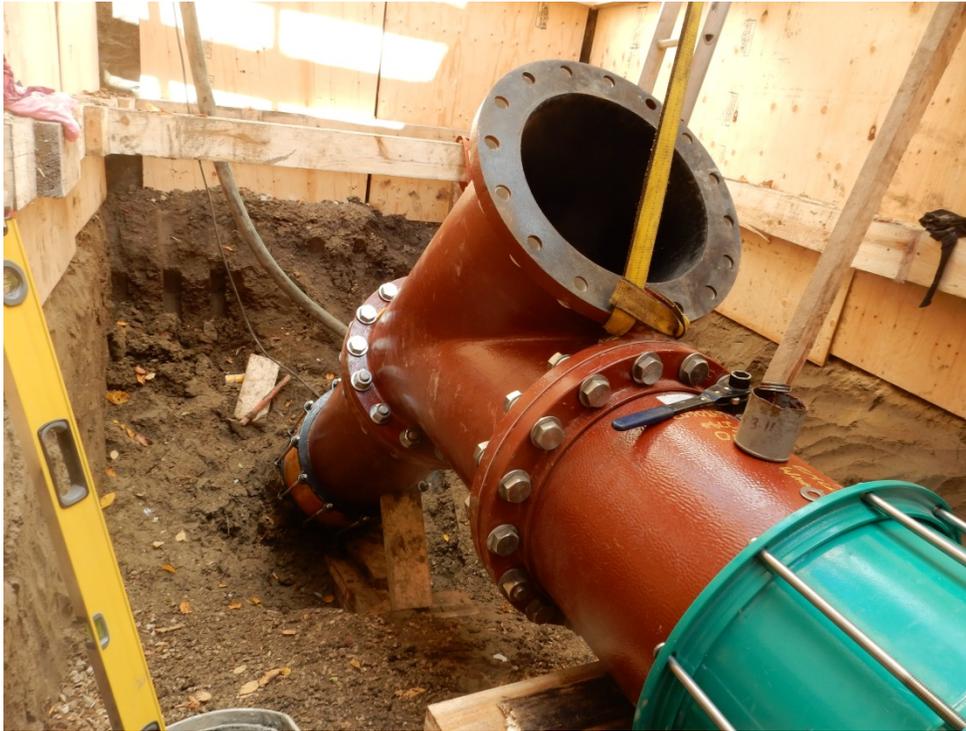
Figure 11: Launch Assembly – St. James Water Main (South Side)

- The existing cast iron piping which was believed to be Victaulic jointed was found to be a traditional lead joint pipe. Outside diameter variations in the 1930's vintage cast iron pipe resulted in difficulties in procuring proper couplings for the modification work.

- Further there was no thrust block at the vertical bends on the south bank of the river. Modifications to the original launch wye configuration were required to complete the inspection. Additional piping was removed and the launch wye was installed to act as a 45 degree vertical bend, see Figure 11

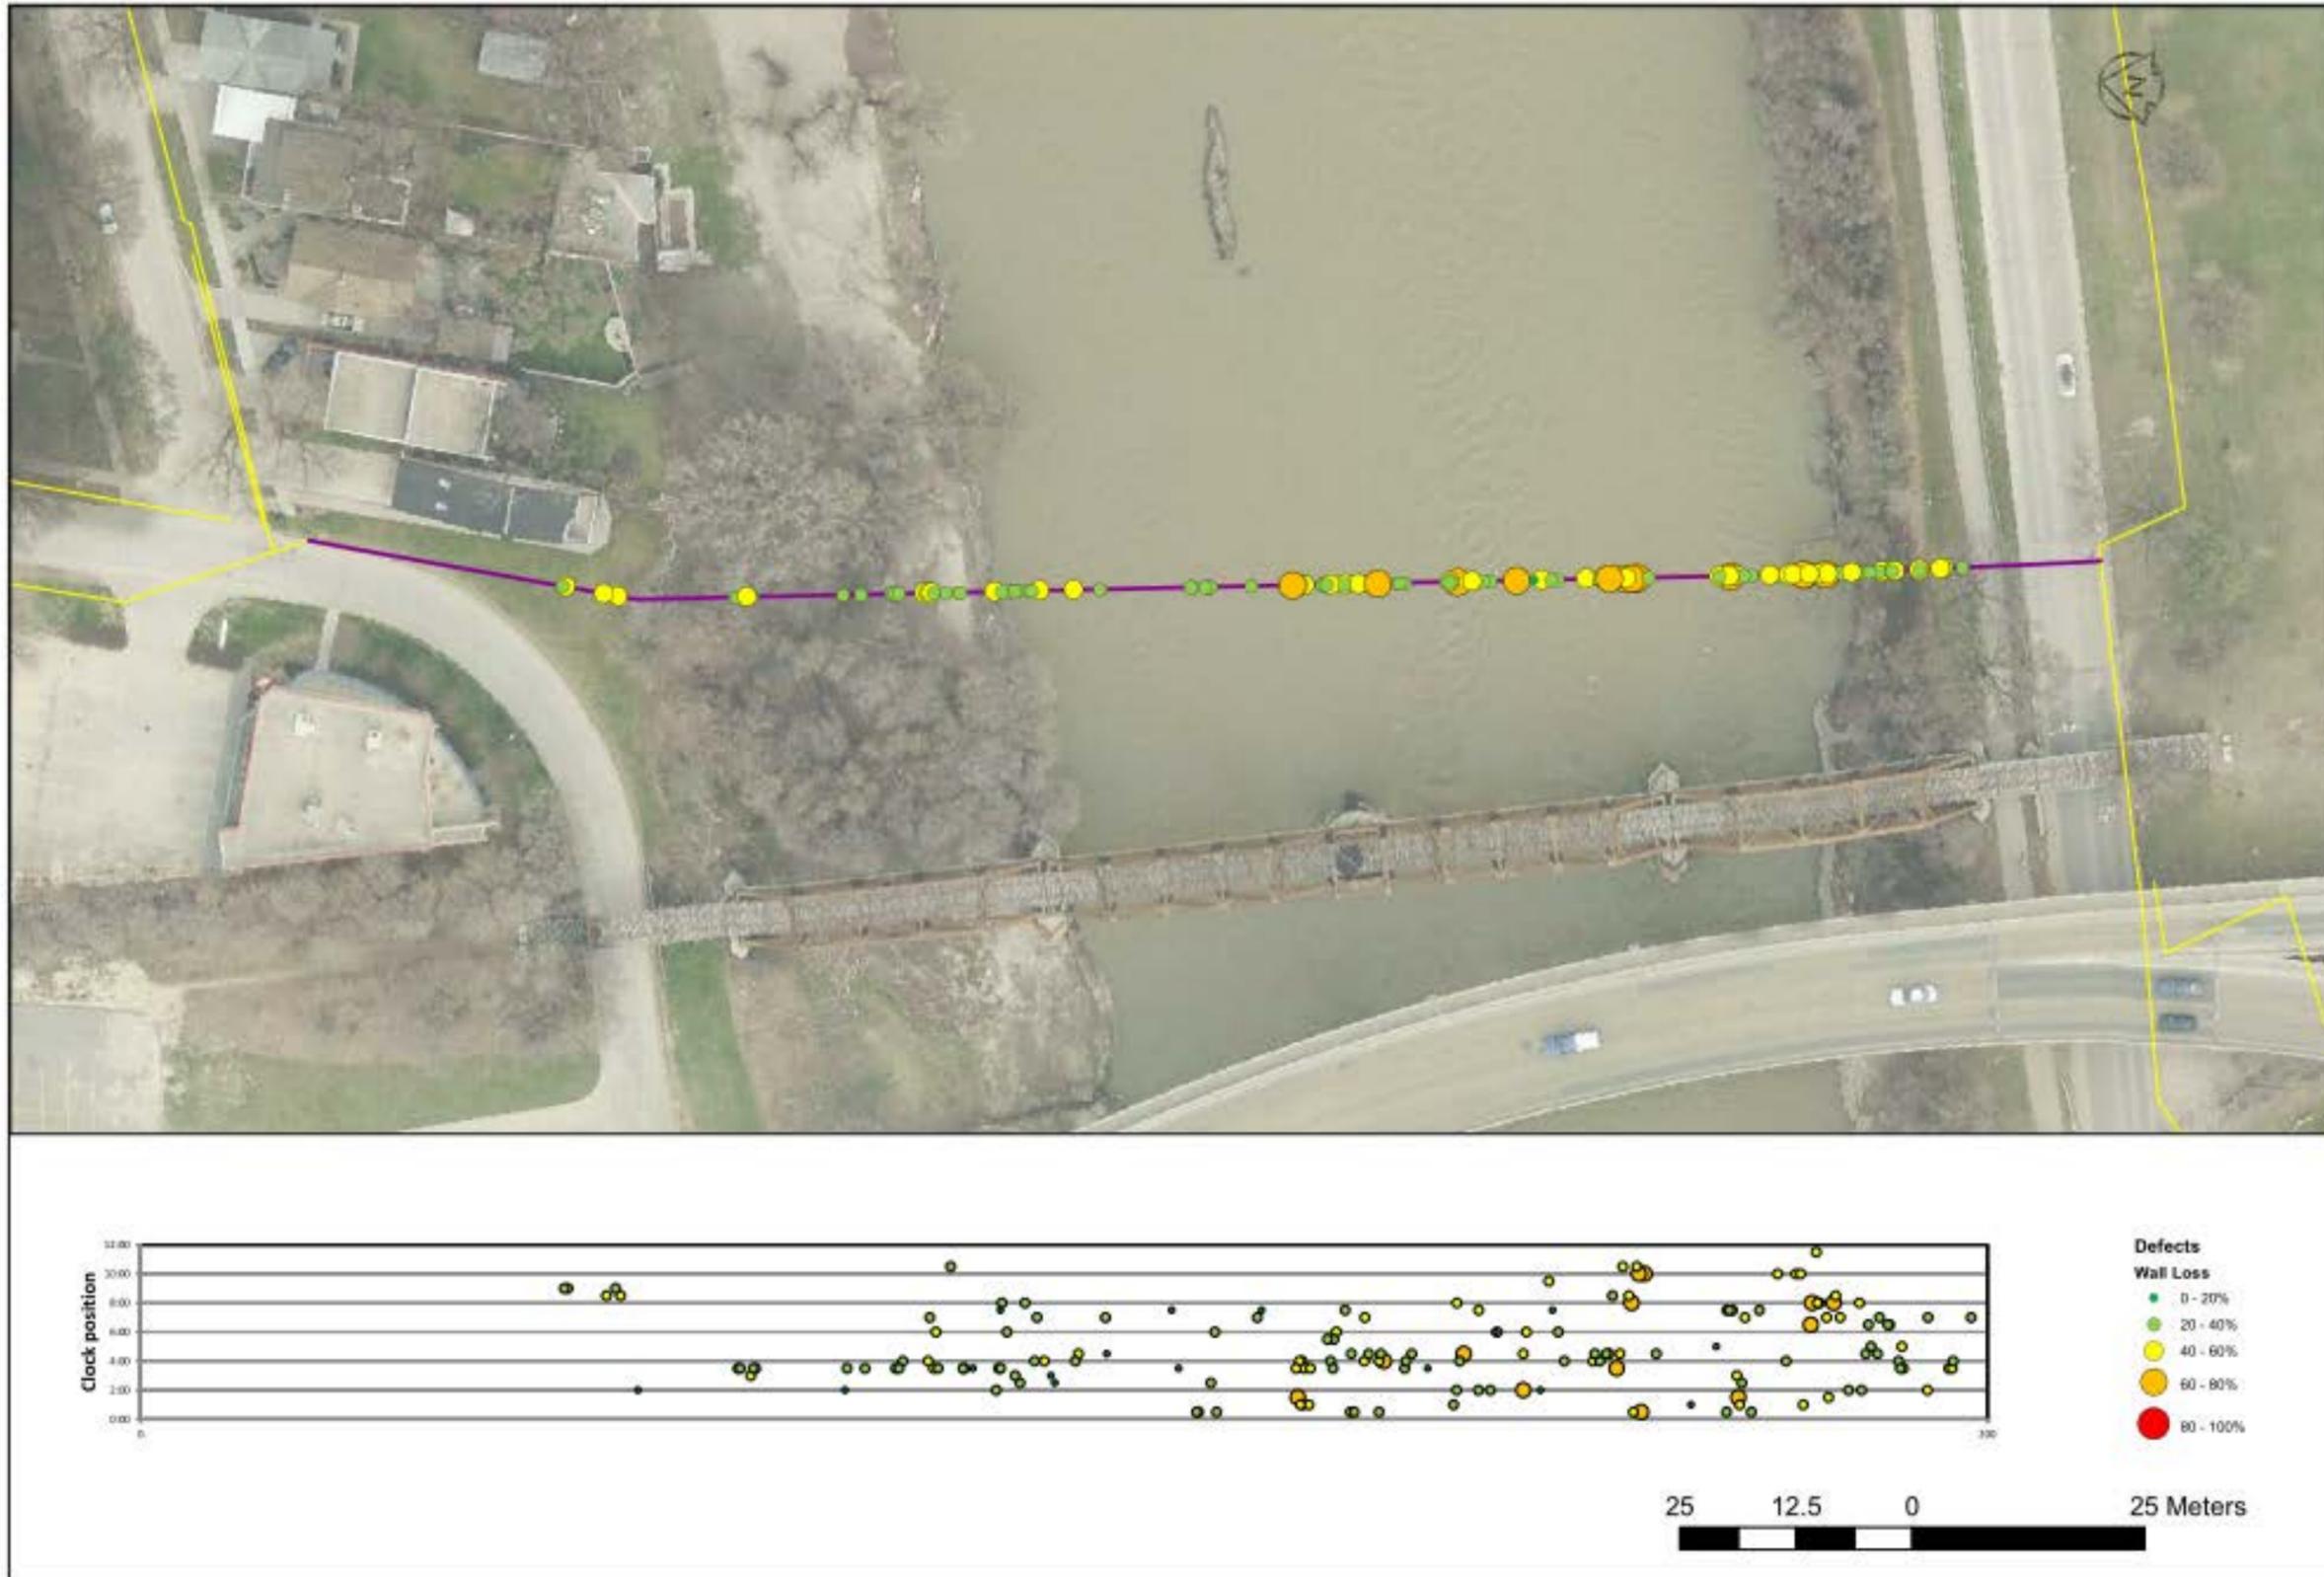
Figure 12: Site 14 – St. James Water Main

A detailed overview of the severity and spatial distribution for the St. James Water Main has been presented in Figure 12. Spatial mapping of defects for sites 10 and 12 have not been produced due to the wide spread deterioration of the Maryland Bridge Water Main and the good condition (zero defects) of the Goulet-Doucet Water Main. A detailed analysis of the reported corrosion defects has been included in Section 6.1.

Site 14 - St. James Watermain

Below is a discussion on the results of the inline inspections undertaken by PICA. A Special defect map for the St. James Water Main crossing is presented in Figure 12.

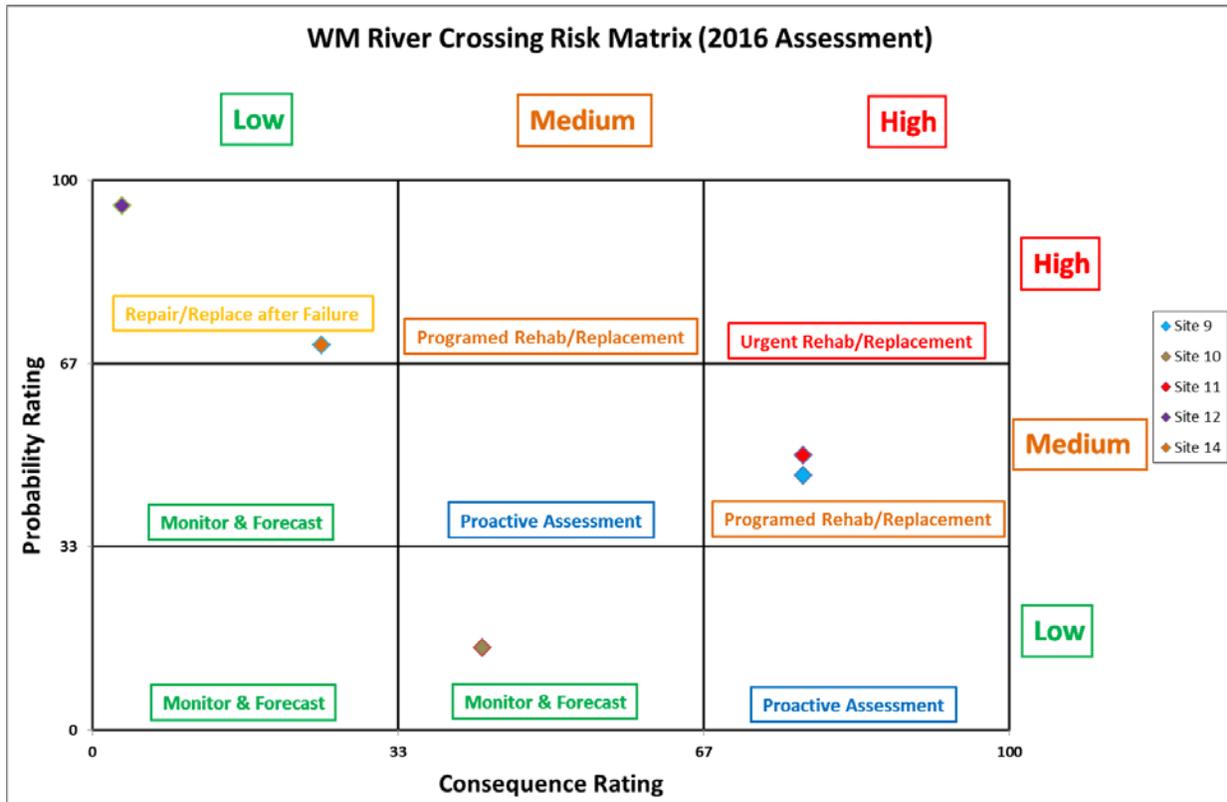
Figure 18: Risk Matrix – 2016 Assessment

In generating updated risk ratings the greater of the pipe condition and geotechnical ratings were used to calculate risk. The updated risk matrix (see Figure 18) depicts the risk rating for each crossing based on an actual determination of both the condition of the pipe and the river bank stability of each crossing location. Note, river bank stability has been assessed in the context of the risk it poses to the pipe.

While Site 9 and Site 11 were not inspected as part of this program, they have been included in the risk matrix to illustrate their current risk rating and the need to undertake inspection of these assets. The probability rating for site 11 was increased from that determined in the water main criticality study due to geotechnical concerns at this site.

Site 14 was not assessed as part of the water main criticality study. Thus a consequence rating was estimated based on the crossings redundancy in the regional water system and diameter.

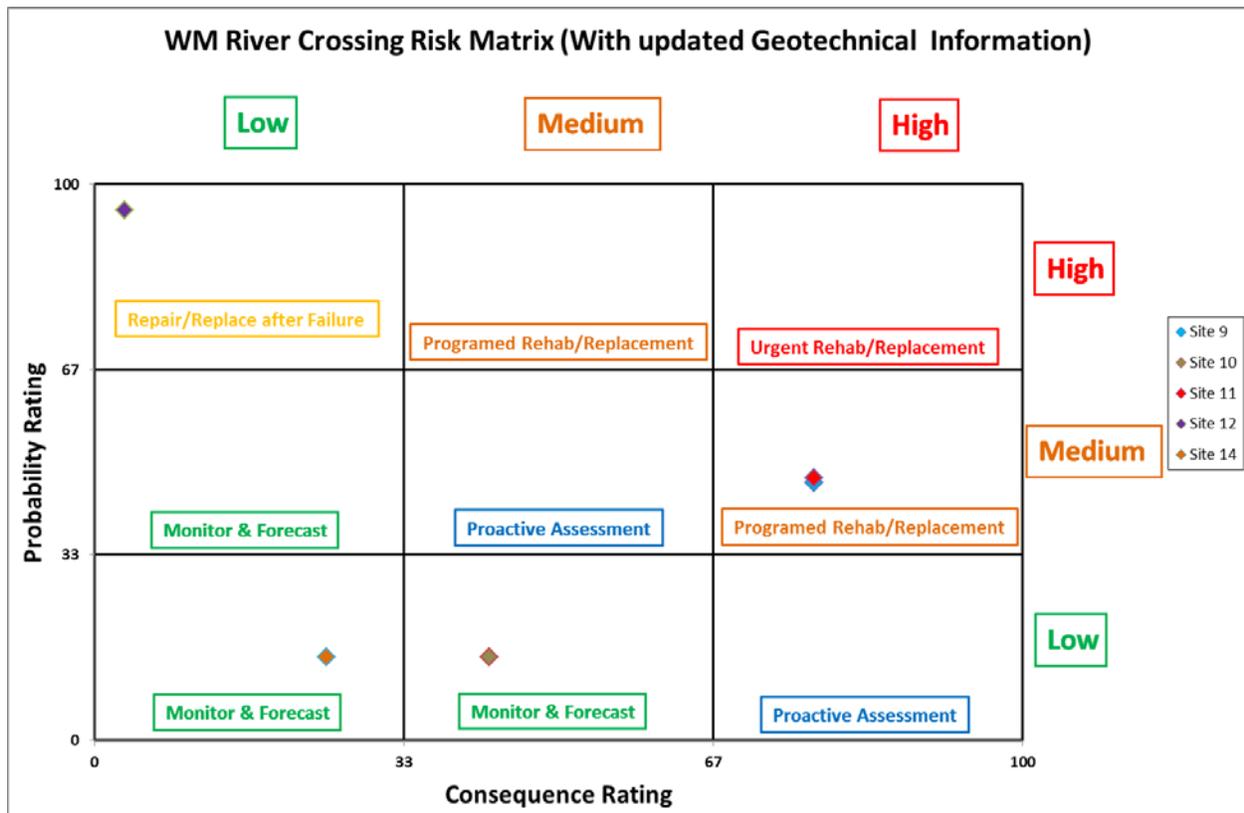
Figure 19: Risk Matrix – With Resolved Geotechnical Issues

Figure 19 was prepared to illustrate the risk profile of the water crossings with all of the geotechnical concerns addressed and mitigated.

Beyond the current slope stability issues identified in Section 4, a majority of the sites require some form of river bank stabilization. This ranges from minor regrading and armoring (placement of rip rap) to major regrading (possibly beyond the extents of the City’s right of way), armoring and revegetation. It would be prudent to address the issues identified in Section 4, including toe erosion and scarps in the short term. If left unchecked, erosion will continue to weaken the bank and will result in significantly costlier repairs.

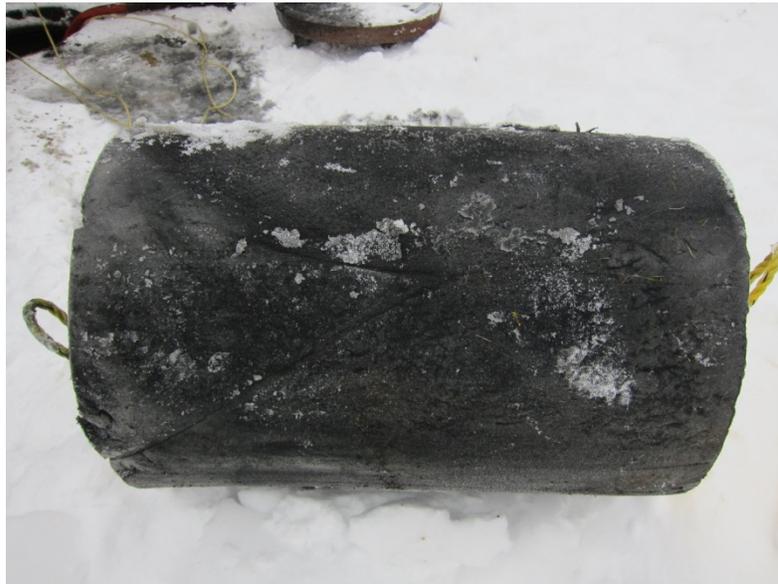
Figure 1: Cleaning Pig Used on the St. James Siphon in 2012

The 600 mm pipe was partially cleaned during 2012 works, by deployment of a soft foam pig. During this attempt, the foam pig was largely undamaged (see Figure 1), which is indicative of minimal obstruction. This site was also inspected by SONAR in 2012. Based on preliminary SONAR data and the 2012 cleaning, it is expected that cleaning requirements for this site will be minimal, and the risk associated with the cleaning process is low.

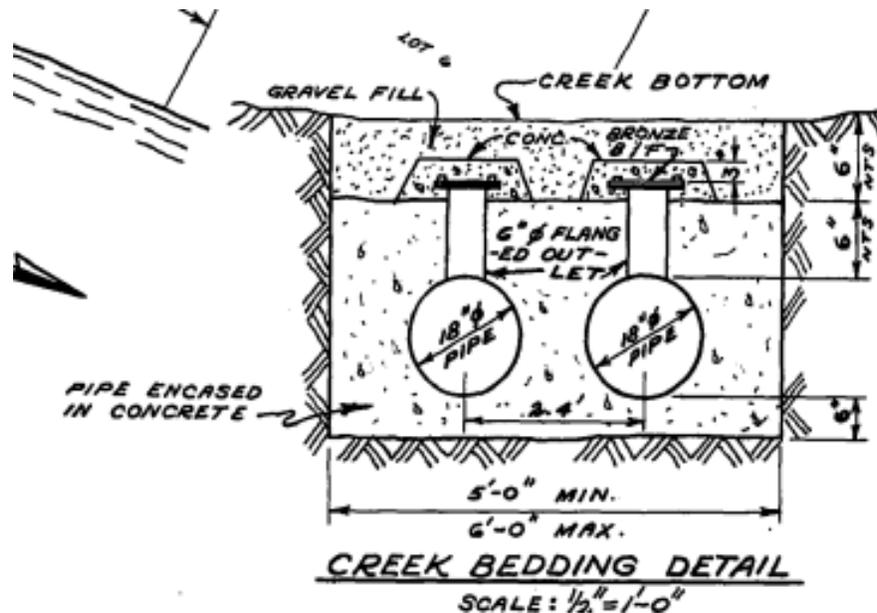
Figure 3: St. James Siphon Bedding Detail

The creek crossing detail shown on Record Drawing 425, indicate the crossing is encased in concrete (see Figure 3). This detail is sufficient to prevent buoyancy of the pipeline when completely empty. The encasement will also offer a high level of structural protection to the physical section of the pipeline under the creek. Other areas of the pipeline are located in areas that could be repaired by conventional excavations, in the unlikely event of a pipeline blockage or damage. Due to the redundancy of this crossing, risk of loss of service to upstream areas is low.

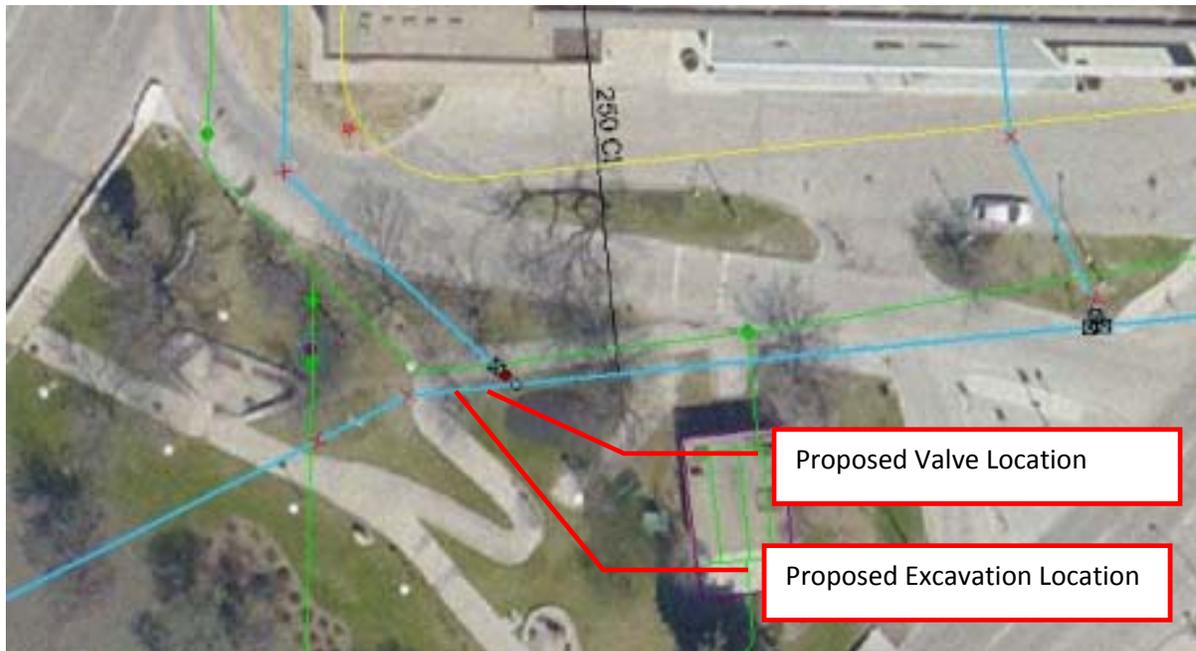
Figure 5: Maryland Proposed Valve

Due to the size of the main, it is not expected to result in significant changes in service in the area. However, it is located in close proximity to a hospital, and as such, water quality concerns and redundancy of service could be a concern. It is also noted that due to system configuration and valving, one service line to the Misericordia Hospital will be required to be taken out of service during excavations. The effects and of disruption could be minimized by installation of an additional main line valve as depicted in Figure 5.

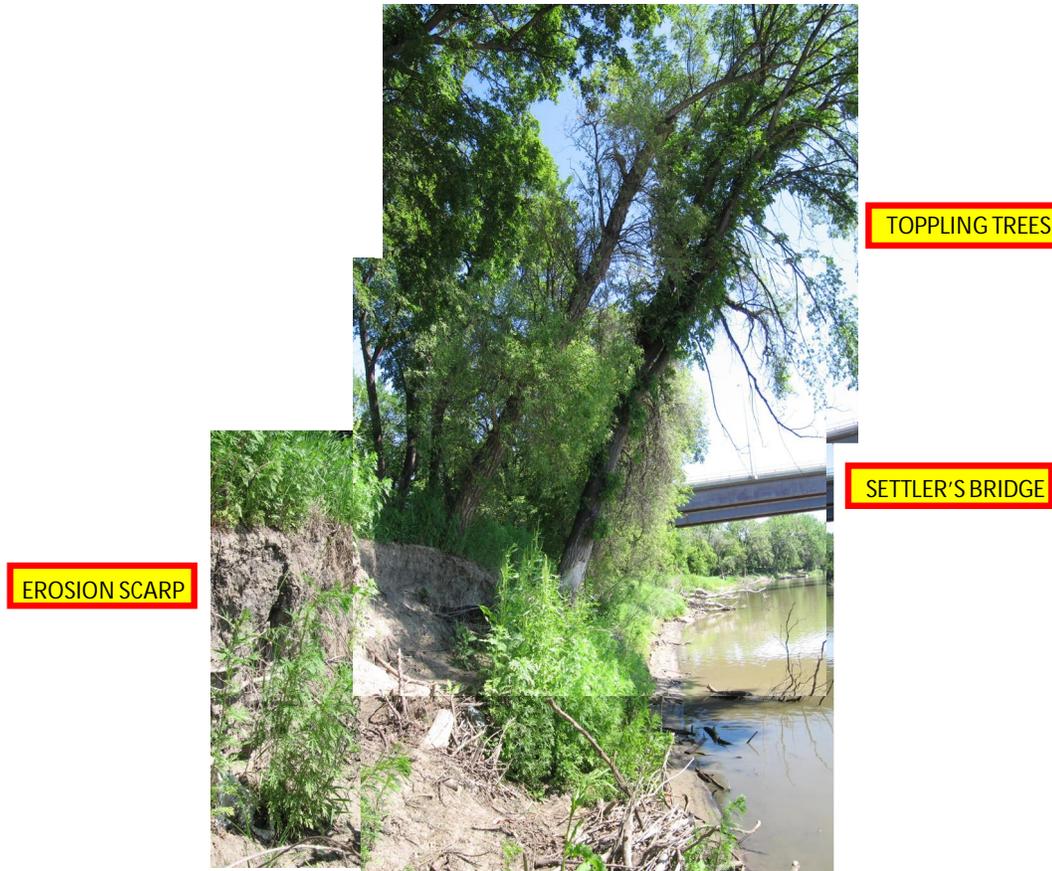
A scarp exists about 7m from the river edge with a height of 0.9m to 1.2m and extends 24m south (upstream) of the crossing alignment. Large trees located close to the top of the scarp are leaning with trees north of the crossing (downstream) having significant lean (Figure 2). Hydro poles located near the pedestrian / bicycle path and bridge (cables crossing over the river) are vertical and show no evidence of distress.

A vertical erosion face is present at the water's edge (200mm to 300mm high). No erosion protection is present and it appears that erosion of alluvial soil is occurring during high water events.

Figure 2 – Vertical erosion face and toppling trees at river edge.

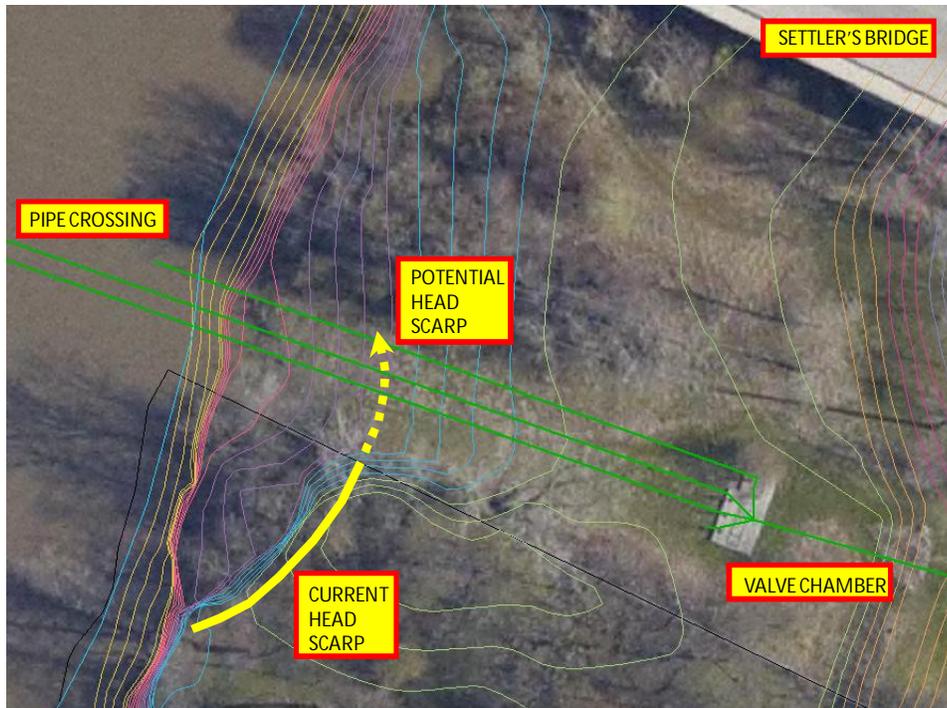
An arcuate head scarp about 1.5m high is located south (upstream) of the ROW on the property of 60 Whellams Lane. Contours from 1998 show the scarp location in Figure 3 along with a potential extrapolation of the scarp across the ROW. Relative to the toe of the rip rap at the ROW, the head scarp is located about 20m from the river edge. The north limb of the scarp terminates at the south property line of the ROW (fence line). The south limb extends to the river edge. It appears that past grading of the ROW masks the presence of the scarp in the ROW. A potential failure surface may extend into the ROW. No tension cracks are present in the ROW. The toe of the river bank downslope of the arcuate head scarp is near-vertical and about 3m high with extensive erosion. The

toe has also receded farther in the upslope direction (conversely the rip rap protected toe at the ROW extends farther into the river channel).

Figure 3 – Scarp south (upstream) of ROW on east bank from 1998 contour data.

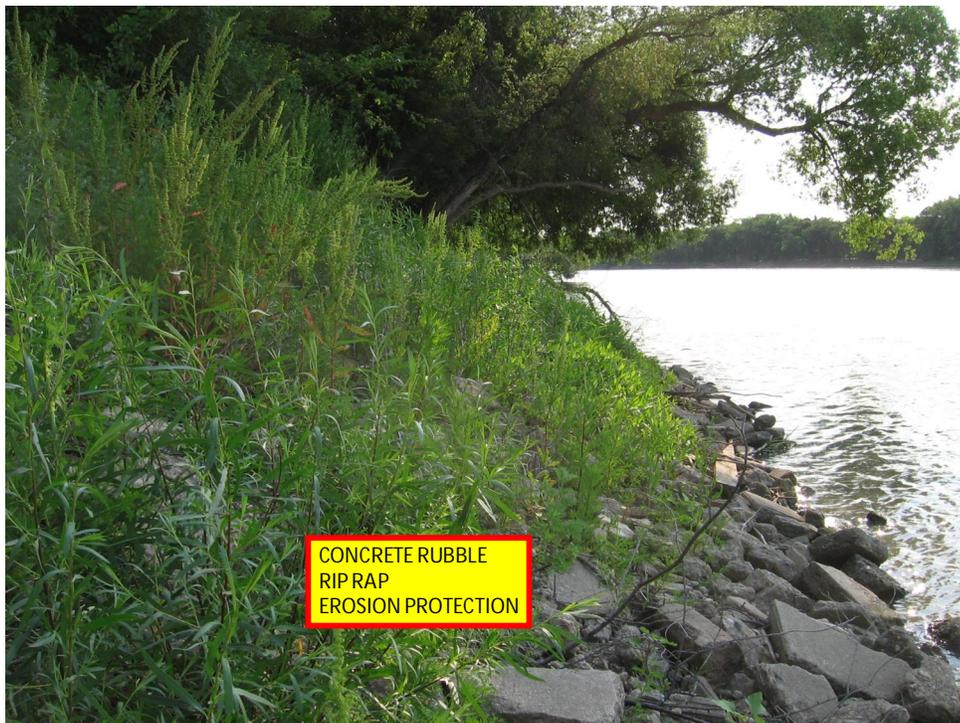
This site is located at the intersection of Scotia Street and Newton Avenue (469 Scotia Street), south of Kildonan Park. The upper bank is manicured lawn and sparse trees (some of large diameter near the top of the bank) surrounding the station. The lower bank is steep and armored with concrete rubble rip rap (Figure 4). Field stone rip rap is present surrounding the outfall pipe. There is no indication of structural distress at the station nor is there evidence of river bank instability. Property north (downstream) of the crossing has concrete stairs leading down the river bank to the river edge and are in good condition suggesting no evidence of bank displacement, though retaining walls have rotated into the river. Limestone rip rap extends to properties farther upstream.

Figure 4 – Concrete rubble used for rip rap as erosion protection.

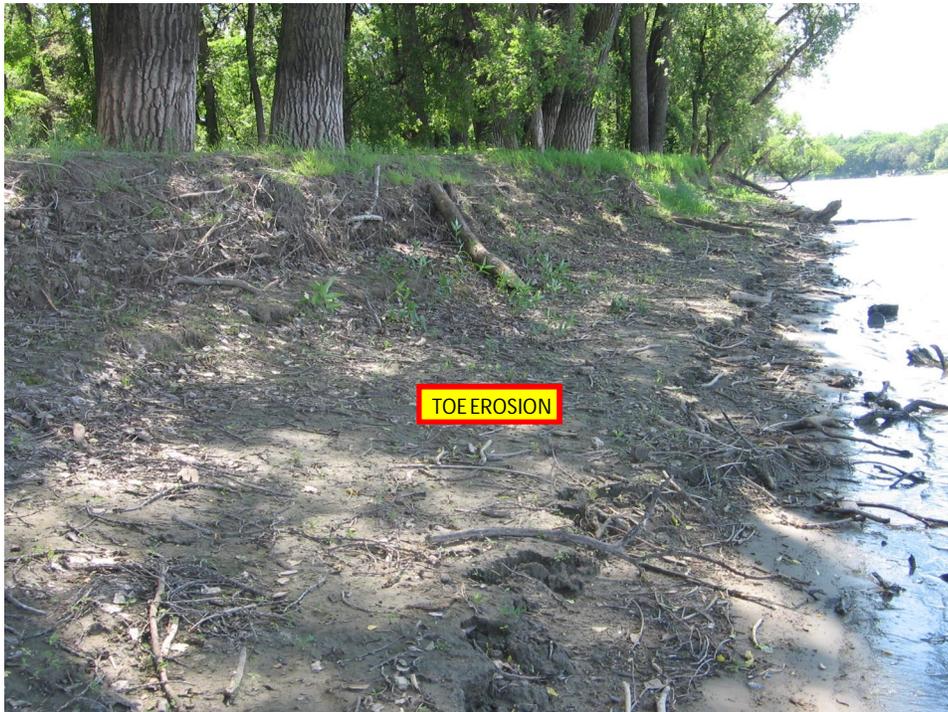
Located in Fraser's Grove Park, the site consists of a shallow long slope leading from a berm that carries a pedestrian / bicycle path (that also forms part of the City's primary dike system) to the river edge. The terrain is manicured grass with large trees and no significant underbrush except near the river edge. At the river edge there is evidence of toe erosion (Figure 5) but no bank instabilities. Runoff erosion channels have also formed at some locations. Wave action has carved 150mm steps in the alluvial soil at some locations. No erosion protection is present.

Figure 5 – Erosion at bank toe.

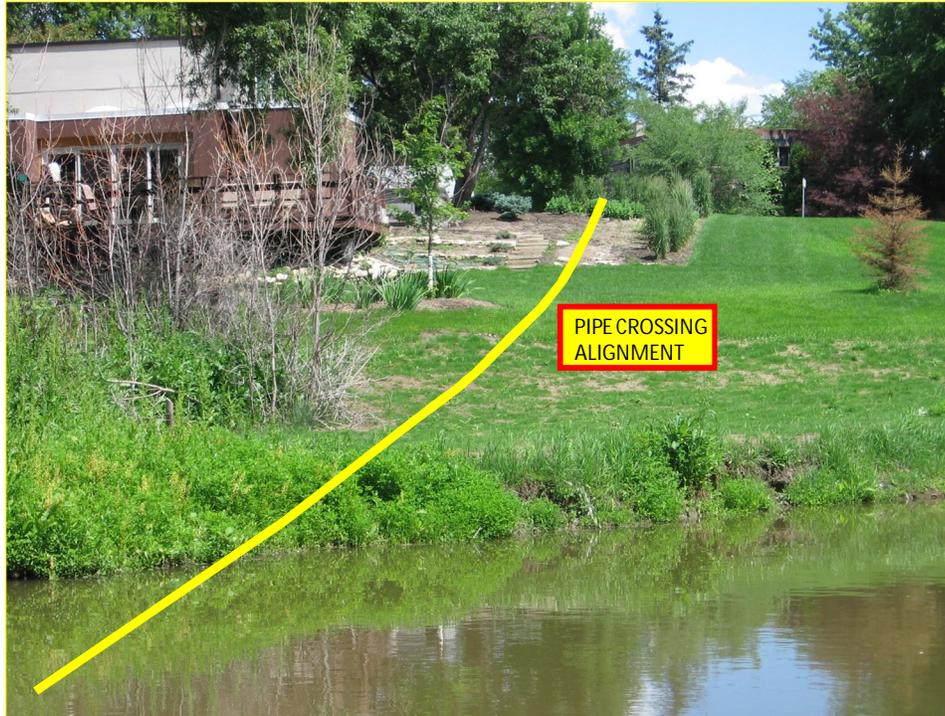
The interceptor crosses through the residential property at 2610 Assiniboine Crescent passing immediately southeast of the dwelling and through a landscaped garden. The remainder of the surficial terrain is manicured lawn. The bank is gently sloping with no evidence of instability or erosion. The shoreline has a 600mm vertical edge (Figure 6) and appears to be a stable edge with no erosion. No erosion protection is present.

Figure 6 – Gentle slope on north bank with vertical edge of bank.

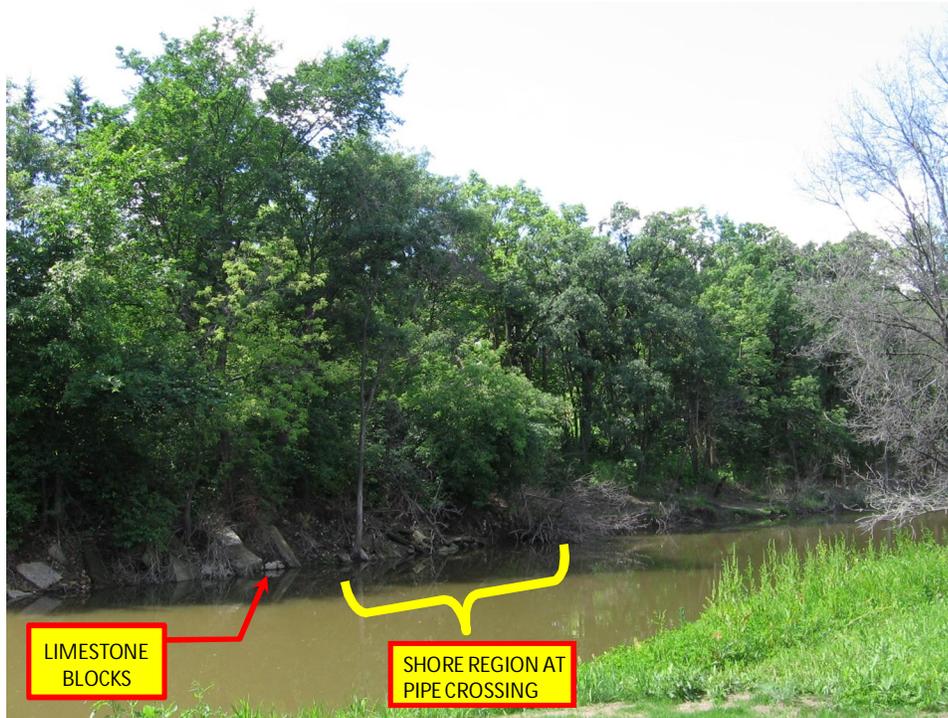
The interceptor alignment passes through the northwest corner of 147 Ashcroft Point. The site is heavily treed with both large trees and underbrush. There is no evidence of river bank instability or erosion. Though the bank can be categorized as alluvial soil, erosion remains in check due to armoring at the riverbank toe consisting of large concrete rubble and large carved limestone blocks (Figure 7).

Figure 7 – Steep south bank with sparse limestone blocks and rubble at river edge.

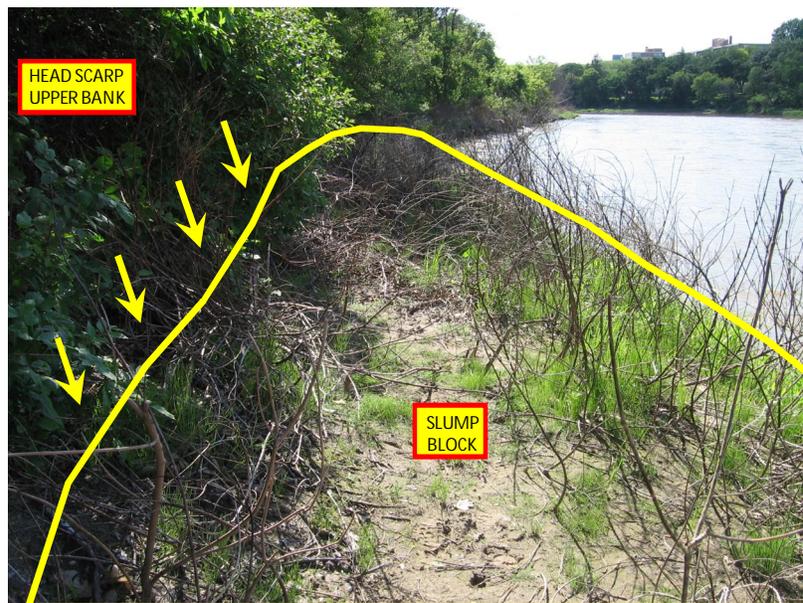
The south bank is located on Assiniboine Park Drive within Assiniboine Park and immediately north of the zoo. The bank is heavily treed with predominantly smaller trees and underbrush. A slump block (bank failure) extends across the pipe crossing alignment and is about 95m-long, parallel to the river, and about 6m wide at the crossing location (Figure 8 and Figure 9). The head scarp ranges from

1.2m to 2.1m in height. The soil at the scarp appeared fresh and may suggest relatively recent displacements. Erosion is not significant at the toe with the bank height at the river edge of 900mm. The river edge is near-vertical and well vegetated. Dead willows were present on the slump block.

Figure 8 – Top of slump block facing upstream (west) from location of pipe crossing.

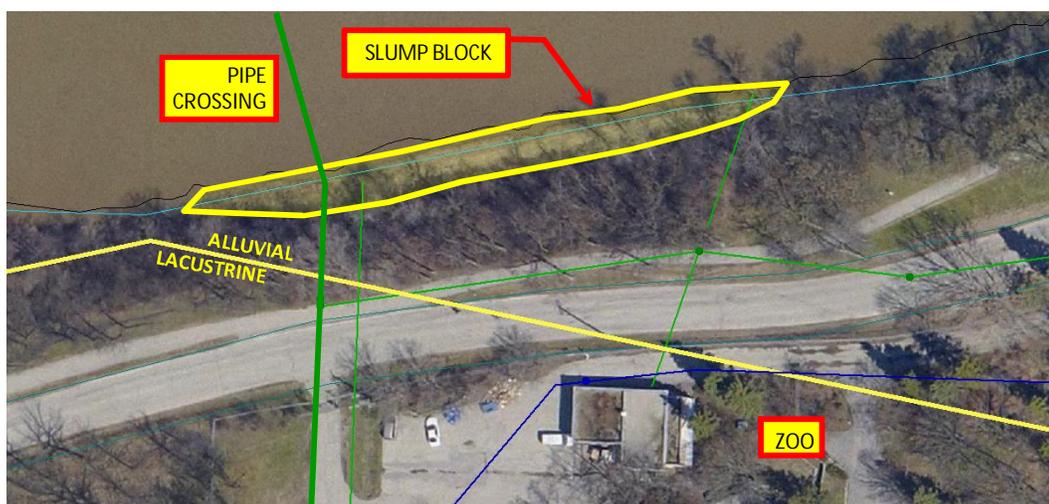
Figure 9 – Extent of slump block relative to pipe crossing.

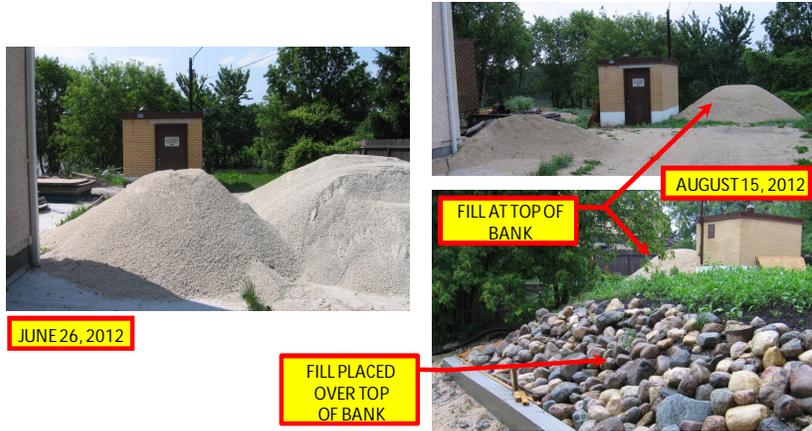
adjacent to the chamber building along with construction of a concrete pad near the south edge of the property and rock landscape feature with concrete grade beam over the top of the bank (Figure 11). Placement of additional fill material at the top of a river bank has a destabilizing effect and is to be avoided.

Figure 11 – Fill placed at and over top of bank on ROW by neighbouring property owner.

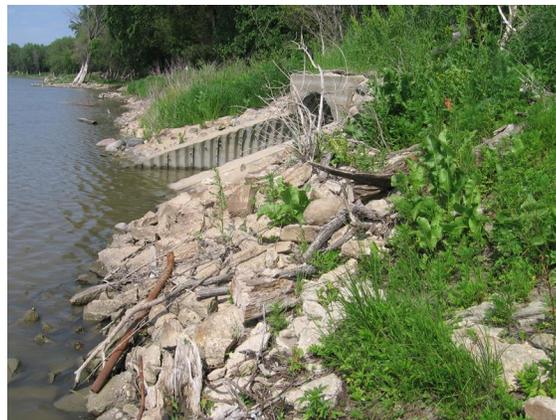
The mid bank and lower bank is treed with tall grass within the ROW. Similar to the west bank, the outfall structure is monolithic and in good condition. Grouted rip rap is present upstream and downstream of the wing walls with minor cracking. There are no cracks in the monolithic structure. Loose limestone rip rap extends across the remainder of the property toe (Figure 12). There is no evidence of river bank instability in upper bank.

Figure 12 – Rip rap erosion protection at river bank toe.

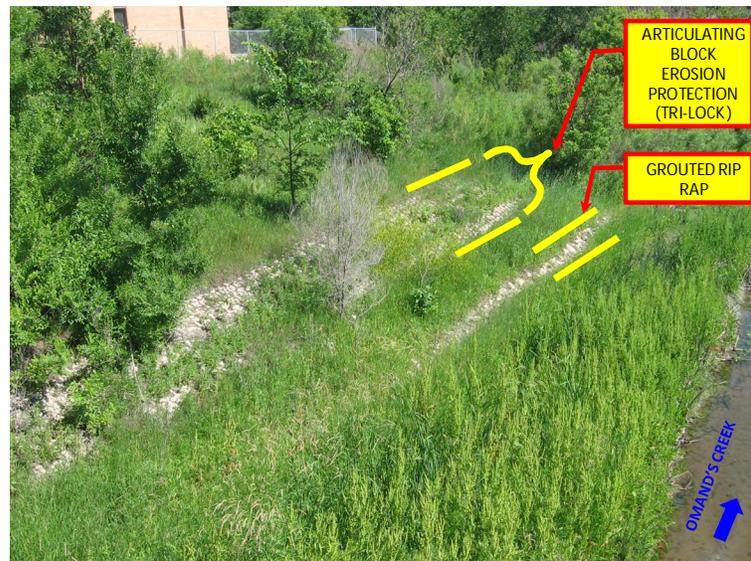
Site 7 is located on Omand's Creek immediately south of the Portage Avenue bridge crossing. It's also located west of 1420 Portage Avenue. Since the site is contained within a small area it is treated here in its entirety. The slopes on both banks have been graded and protected with concrete articulating blocks (Tri-Lock) and grouted rip rap (Figure 14). The erosion protection is located at discrete locations on the bank surface and appears to coincide with specific water elevation events. The articulating blocks are about 3m wide and located on a higher portion of the bank. The grouted rip rap contains about 300mm diameter limestone and is about 600mm wide and is closest to the creek edge. Both types of erosion protection extend parallel along the creek for a distance of 30m south of the bridge abutment.

The banks are vegetated with tall grass and low shrubs. Presumably, the grading of the channel, erosion protection, and vegetation are a result of construction related to the piping buried at this location and the adjacent bridge. In this sense the channel is manmade as opposed to natural and the original design continues to function adequately with no evidence of bank instability. Further there is no evidence of structural distress in the bridge facade.

Figure 14 – Articulating block erosion protection (Tri-Lock) and grouted rip rap on east bank. Photograph taken from bridge at Portage Avenue.

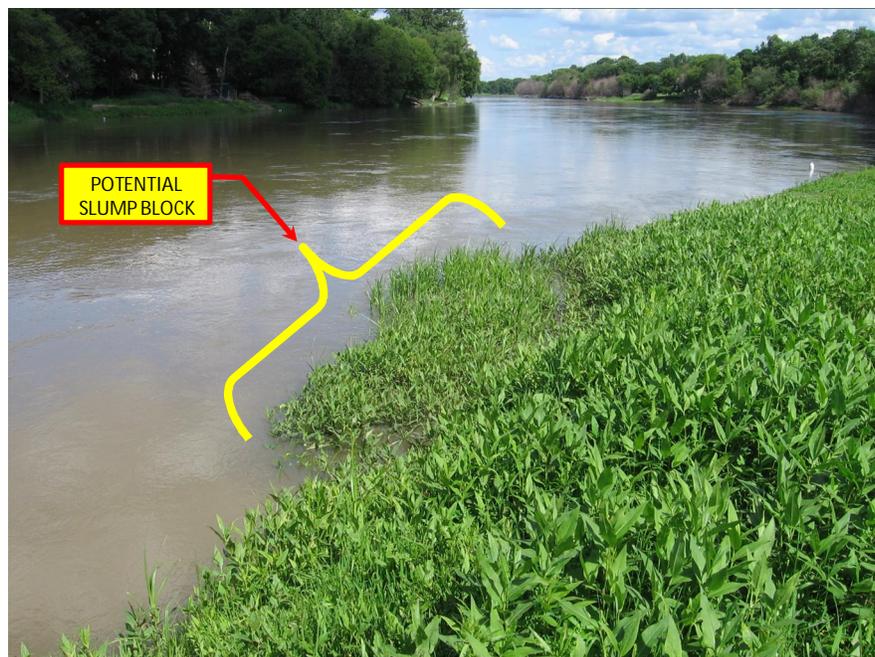
The south bank is located at Southboine Drive at the end of Berkley Street with a ROW between 6161 Southboine Drive and 385 Berkley Street. The ROW is a graded bank. Manicured lawns exist on the ROW and adjacent properties. Trees are present on the adjacent properties. The lower bank on the adjacent properties consists of a small berm about 1.5m to 2.4m high and a gulley upslope of the berm which is part of the river morphology. There is no evidence of bank instabilities on the upper bank. The bank toe shows possible evidence of a small slump block but this feature was partially submerged at the time of our inspection and may only be an erosion feature. No erosion protection is present at the bank toe.

Figure 17 – Partially submerged potential slump block at river bank toe at crossing location.
