The City of Winnipeg

High Risk River Crossings Condition Assessment Report Water Crossings

AECOM
99 Commerce Drive 204 477 5381 tel
Winnipeg, MB, Canada R3P 0Y7 204 284 2040 fax
www.aecom.com

November 2, 2016

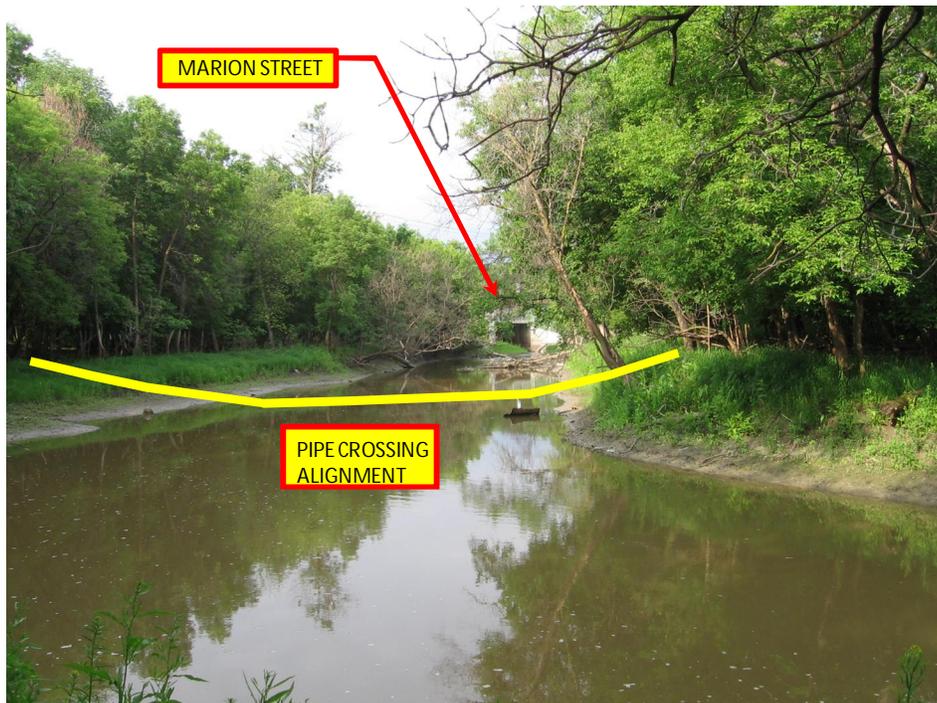
The east bank is located at the end of Goulet Street off Youville Street. The bank has a steeper upper bank at the end of the street that leads down to a broad floodplain that extends to the edge of the present river channel proper (Figure 18). Some fill has been placed at the upper bank. Based on measurements from the current geographic information system (GIS) the location of the bend in the pipe alignment is located on the flood plain. The location of the elbow and potentially the pipe alignment is marked by a low berm (less than 300mm high) that is likely the mounded trench backfill. The lower bank is vegetated with mature trees and low underbrush (less than 300mm tall). There is no evidence of river bank instability. Minor erosion is present at the river edge with a 900mm high erosion scarp. Grasses offer the only form of erosion protection with no other hard armoring.

Figure 18 – Flood plain at crossing location.

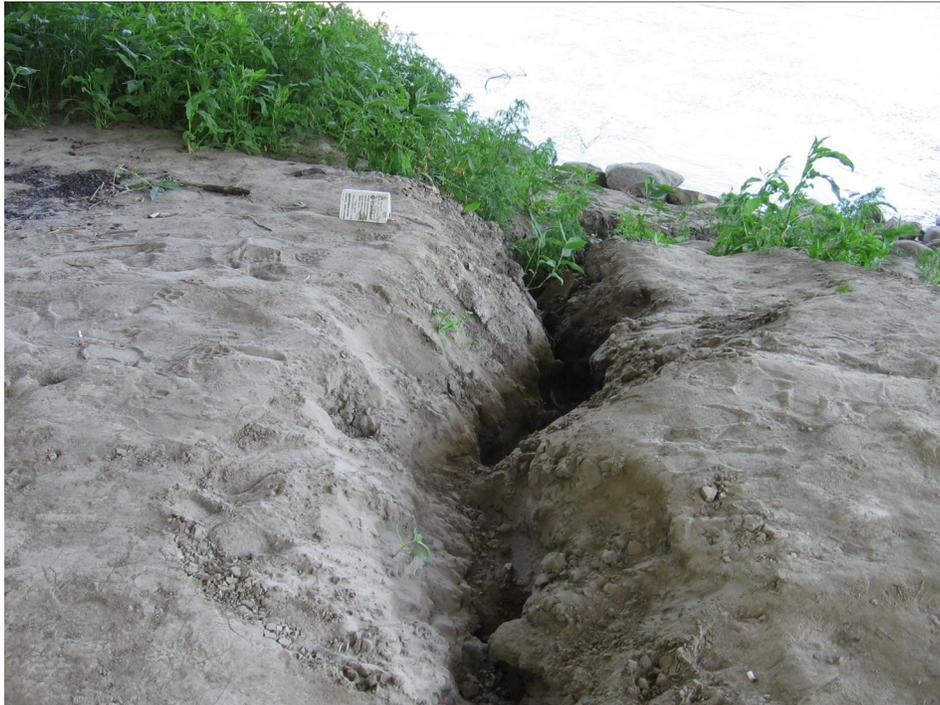
The north bank is located south of Misericordia Hospital at Cornish Avenue and the south bank is located at the intersection of Academy Road at Wellington Crescent. Both banks have similar characteristics with a steepened upper bank leading downslope to a flat bench followed by a steep toe at the river edge. The riverbank toes are about 1.5m high. Drainage near the bridges and leading to the river flows without erosion protection and as a result is producing deep erosion gulleys (600mm to 800mm deep) as shown in Figure 20. The exposed soils are silts and fine sands (alluvial deposits). The north bank is treed with low standing willows at the pipe crossing and the south bank consists of young trees and grass vegetation. There is no evidence of rip rap at the toe of either bank though occasional boulders are present. Dessication cracks were present in the soil on the lower bench but there is no evidence of tension cracks related to bank instability.

Figure 20 – Gully erosion near bridge pier without erosion protection on lower bank.

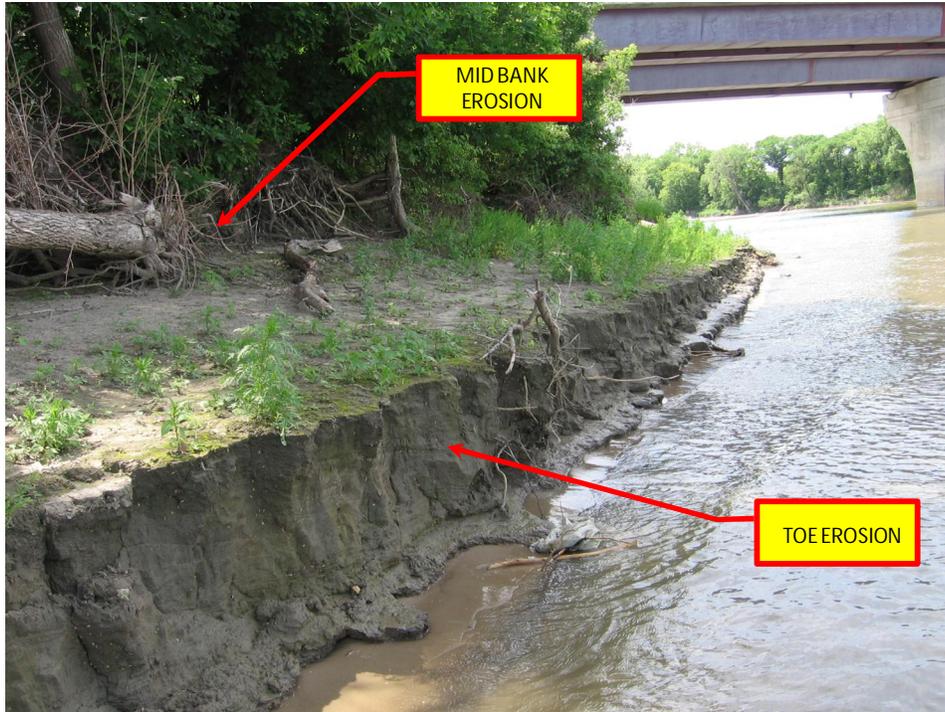
Located immediately north of Settler's Bridge, this site is located east of Henderson Highway and consists of a forested bank on the inside bend of the river. The upper bank is a flat tree-covered plain with no evidence of river bank instability. The active area affected by river currents at the bank toe is eroding with a 900mm scarp at the high water level and a 600mm scarp at the shoreline at the river edge. There is no evidence of further instability issues. Exposed soils are alluvial silt. Rip rap is present near the bridge location but no erosion protection is at the crossing location.

Figure 22 – Toe and mid bank erosion on east bank facing (upstream) south.

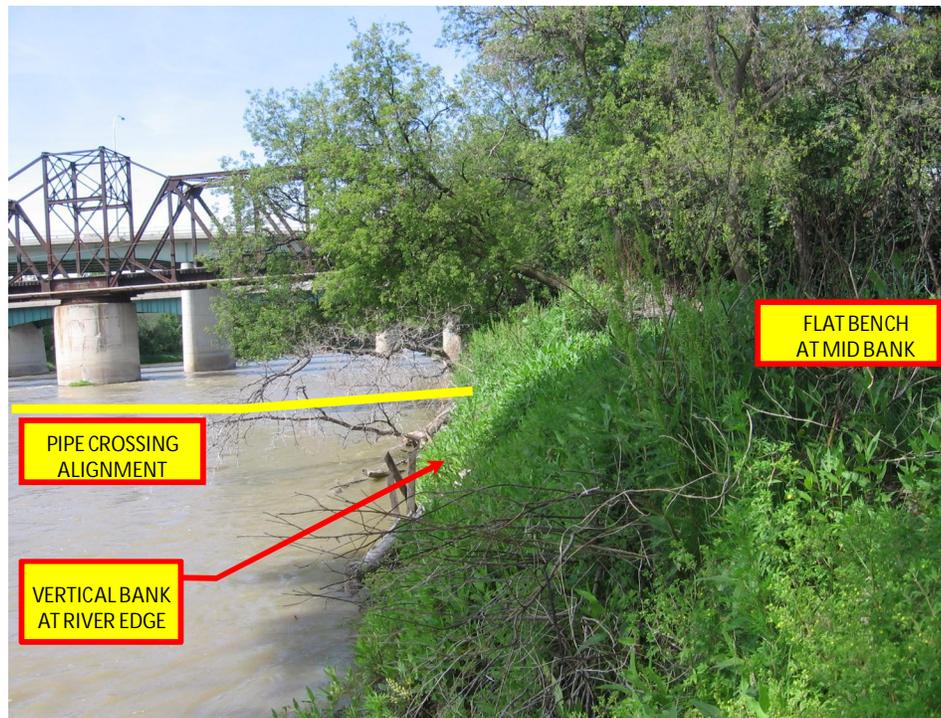
Active erosion occurs at the bank face at the river edge. No erosion protection is present east of the railway bridge. There is no evidence instability on the upper bank or the bench leading to the river edge.

Figure 23 – Toe erosion with vertical bank at river edge at pipe crossing alignment.

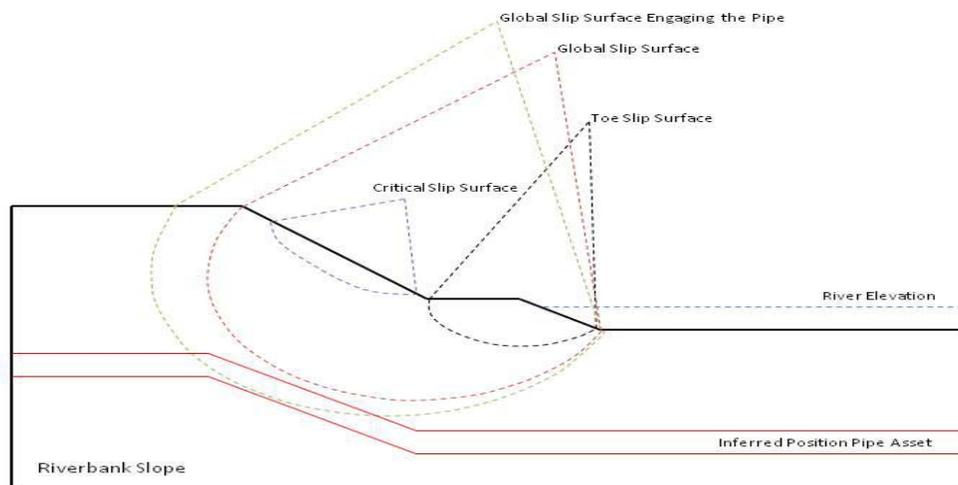
Figure 1: Assessed Slip Surfaces within Analysis

- **Global Slip Surface Engaging Pipe (GS+P):** is defined as a slip surface that meets the criteria of a global slip surface and encompasses part of the buried pipe.

- **Toe Slip Surface (TS):** is defined as a slip surface that is localised to the toe of the slope, which has a minimum depth of 0.5m. At some locations the FS of this slip surface may be lower than the critical or global FS. Instability at the toe of the slope may reduce the FS for the global or critical slip surfaces. Retrogressive failures starting at the toe may also work towards the riverbank.

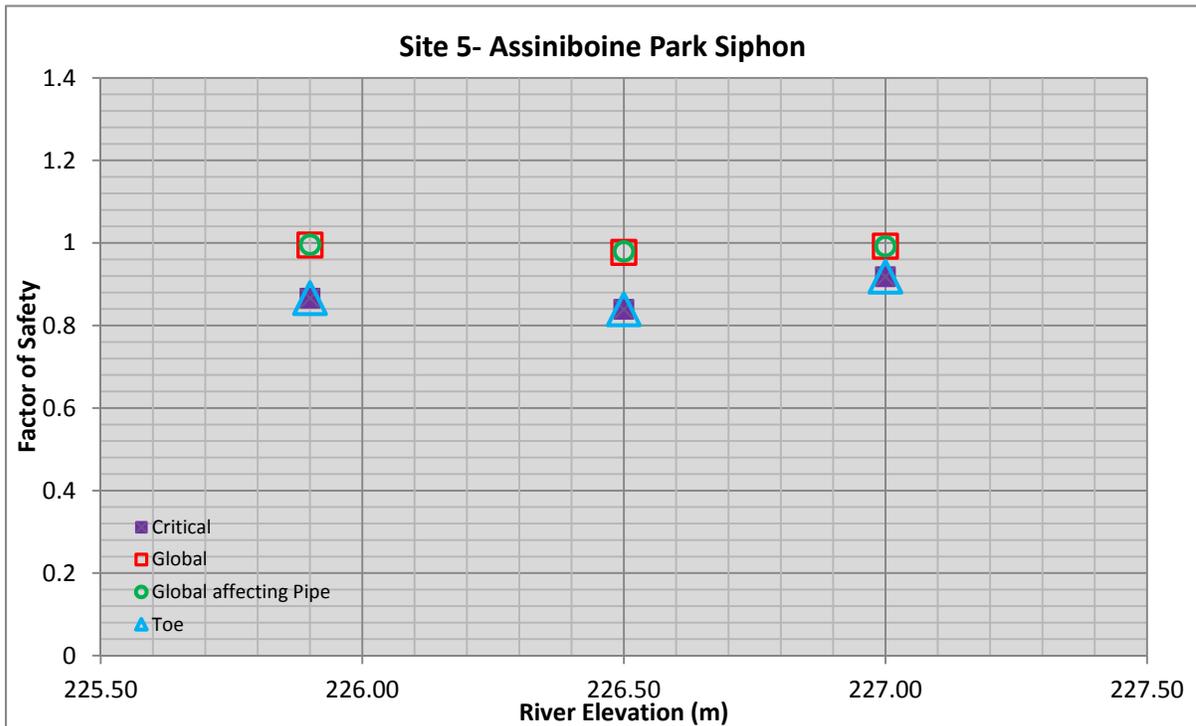
Figure 4: Slope Stability Factor of Safety Relating to the Current Condition of Site 5

The calculated FS values for the riverbank, presented in Figure 4, correlates closely to the observations made in the field which had noted the presence of a slump block near the toe of the slope. The presence of a slump block and evidences of recent movement would suggest that the riverbank has a FS close to or less than 1.0 (imminent instability).

The presented graphical results indicate the trace of the GS and GS+P theoretical slip surfaces are likely to result in global instability that engage the pipe given the depth of the impacted mass. Retrogressive failure at the toe is also further likely to reduce the overall global stability of the riverbank, as potential failure surfaces migrate upslope.

While a number of slip surfaces have FS values slightly lower than 0.8, in reality the actual FS are likely higher considering the stabilizing effect of the extensive vegetation growth. A stability output model illustrating the position of the global slip surface engaging the pipe at the lowest FS is shown in Figure 5, determined at a river elevation of 226.5 m.

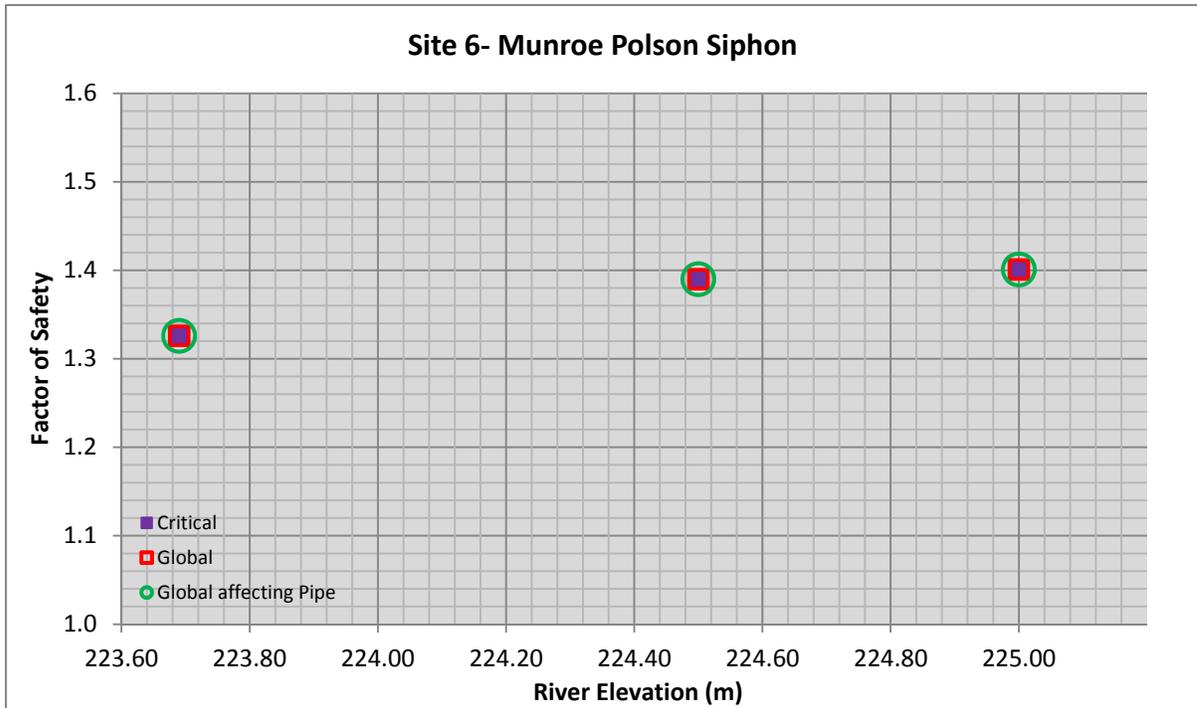
Figure 6: Slope Stability Factor of Safety Relating to the Current Condition to Site 5

The results of the slope stability analysis presented in Figure 6 indicate that the calculated FS lies typically between 1.3 to 1.4. These values are considered an acceptable level of stability. The reported FS values are for the theoretical slip surfaces which represent CS, TS, GS and GS+P.

The field inspection largely supports the results of the slope stability where there was an absence of observations relating to instability within the immediate vicinity of the pipe crossing. Nevertheless, visual inspection of adjacent properties upstream of the Right of Way (ROW) have shown significant evidence of movement which has included head scarps, trees dislocation and topsoil creep which are not present along the riverbank slope of the pipe crossing. This is believed to be related to the recent removal of tree growth allowing for surficial movement within the upper riverbank materials.

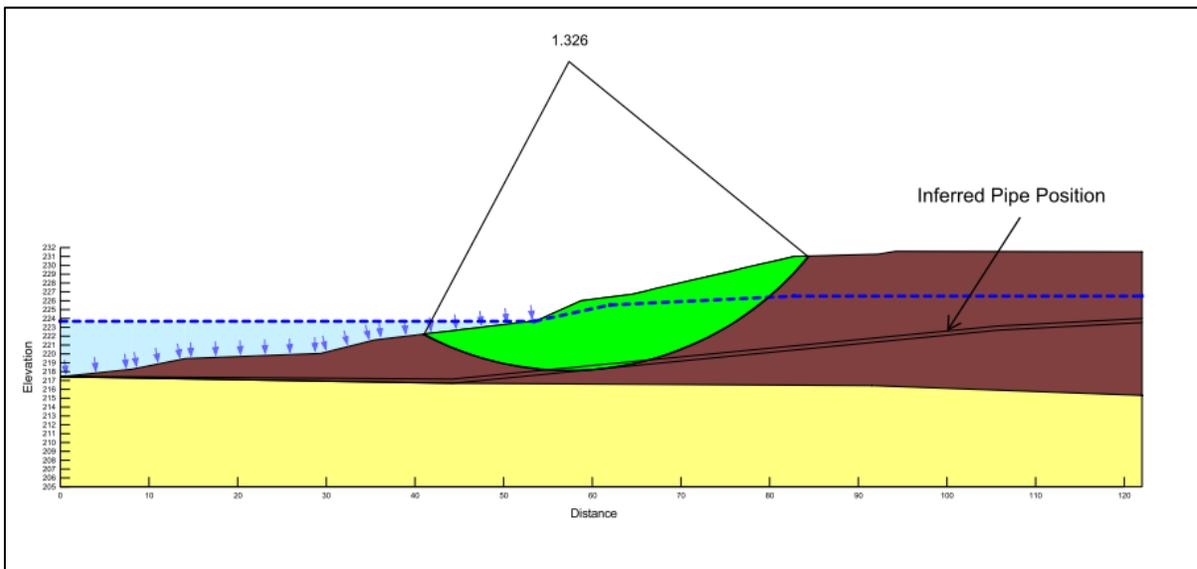
Figure 7: Munroe Polson Siphon- Global Slip Surface Engaging Pipe (GS+P)

A stability output model illustrating the position of the global slip surface engaging the pipe at the lowest FS is shown in Figure 7 determined at a river elevation of 223.69m.

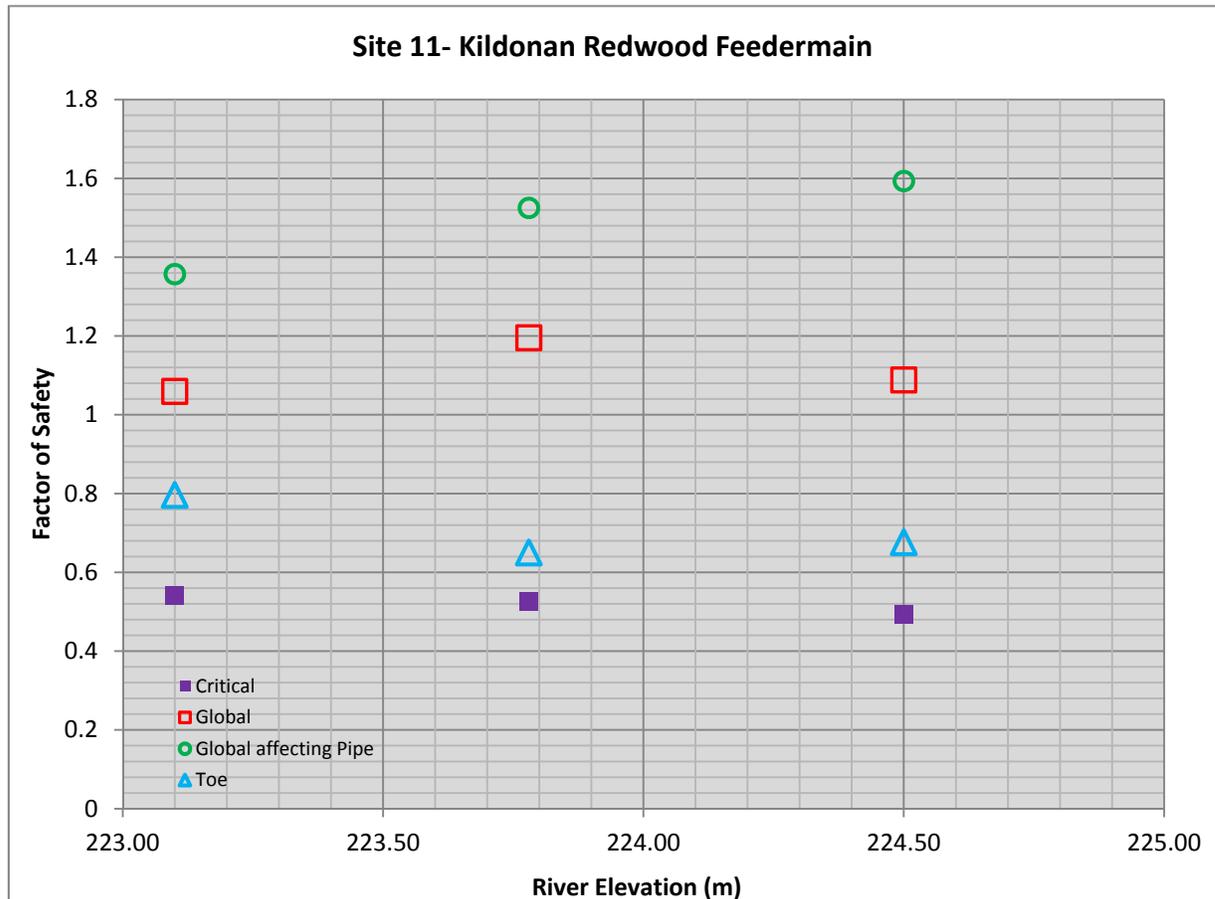
Figure 8: Slope Stability Factor of Safety Relating to the Current Conditions of Site 11

The results of the slope stability assessment appear to confirm observations made during the field inspections in regard to the overall stability of the riverbank slope. Limited or no evidence of instability along the upper and mid slope portion of the riverbank was noted, however a large percentage of observations regarding instability were concentrated at the toe of the riverbank. The calculated FS for instability at the toe of the slope has been calculated at less than 0.8, whereas the FS for global instability has been calculated at less than 0.8, whereas the FS for global instability has been calculated between 1.0 and 1.2. This is largely due to the near vertical face at the toe of the riverbank created through erosion. The calculated FS for slip surfaces engaging the pipe has been calculated between 1.3 and 1.6. The FS for critical slip surfaces largely mirror values associated with toe instability of the riverbank slope. The results of the analysis are presented graphically in Figure 8.

Reduction in overall global stability of the riverbank may occur should retrogressive failure at the toe extend further upslope and potentially engage the pipe. Placement of rock (rip-rap) and reshaping at the toe of the riverbank slope may control toe erosion, and thus reduce the potential for continued or retrogressive slips.

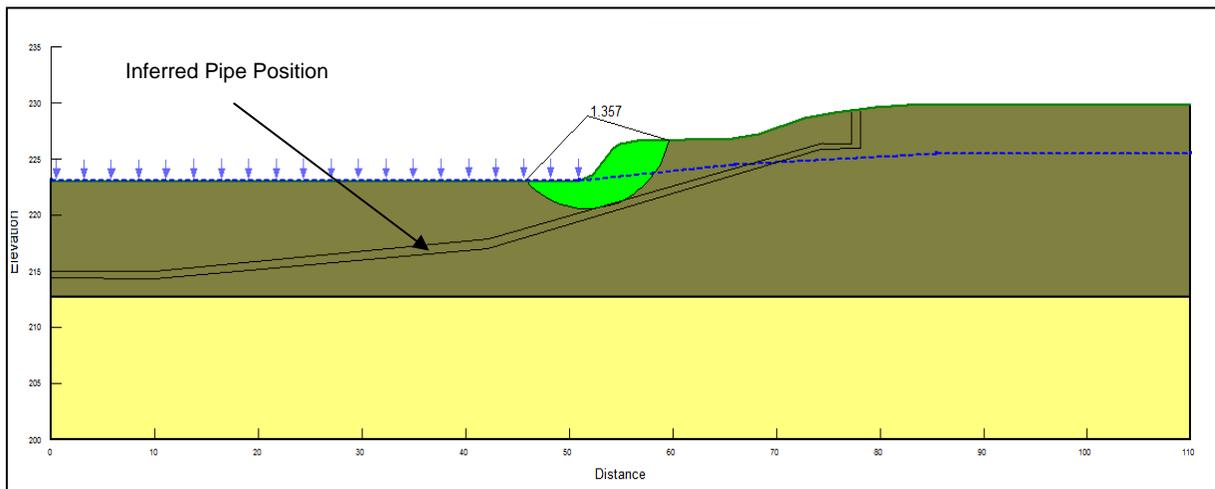
Figure 9: Site 11, Global Slip Surface Engaging the Pipe (GS+P)

A stability output model illustrating the position of the global slip surface engaging the pipe at the lowest FS is shown in Figure 9 determined at a river elevation of 223.10m.

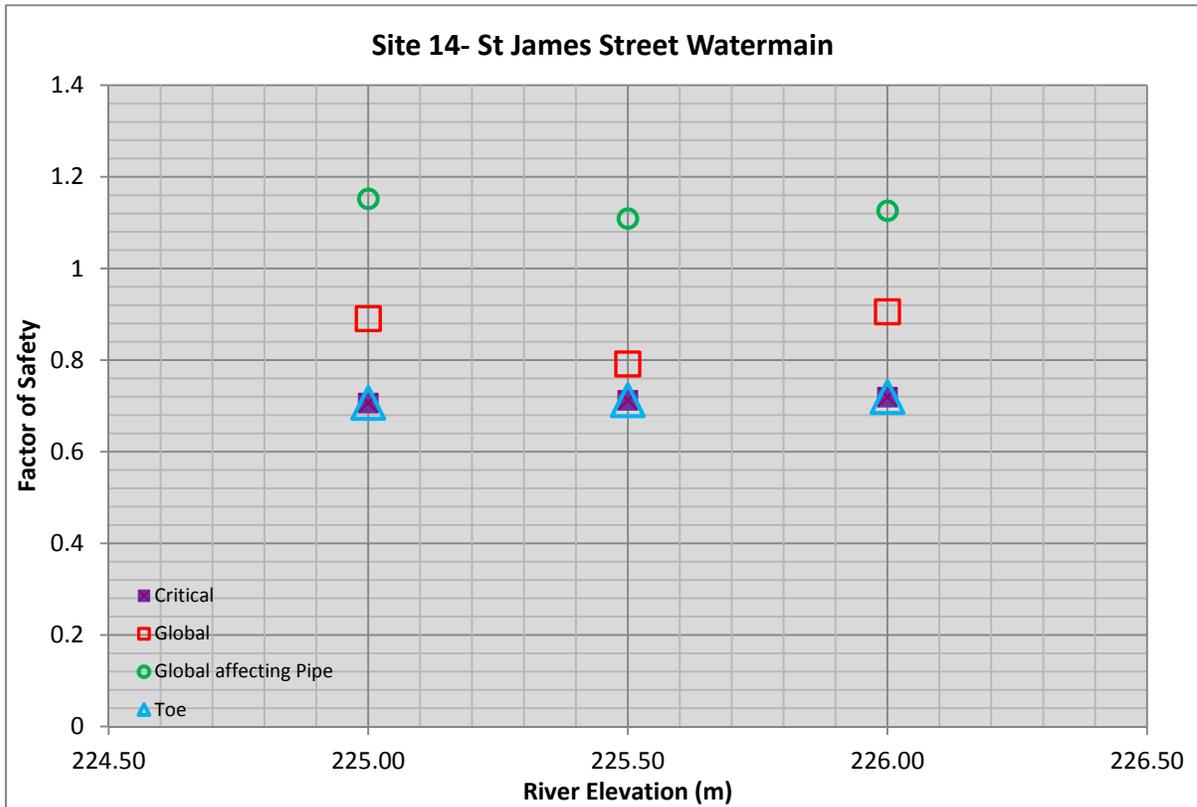
Figure 10: Slope Stability Factor of Safety Relating to the Current Conditions of Site 14

Bathymetric survey information was not available for the crossing location; therefore the channel depth and profile have been assumed based on field observations and measurements made during construction of the pipe crossing. In the absence of record drawings, these approximate field measurements were also used to locate the pipe position and invert within the slope stability models in order to assess the GS+P.

The calculated FS for the critical case and the toe case are equal, and have been calculated as less than 0.8. These failure surfaces are largely a result of the near vertical face at the toe of the riverbank. The FS for global instability has been calculated between 0.8 and 0.9, and the calculated FS for slip surfaces engaging the pipe has been calculated between 1.1 and 1.2. The results of the analysis are presented graphically in Figure 10.

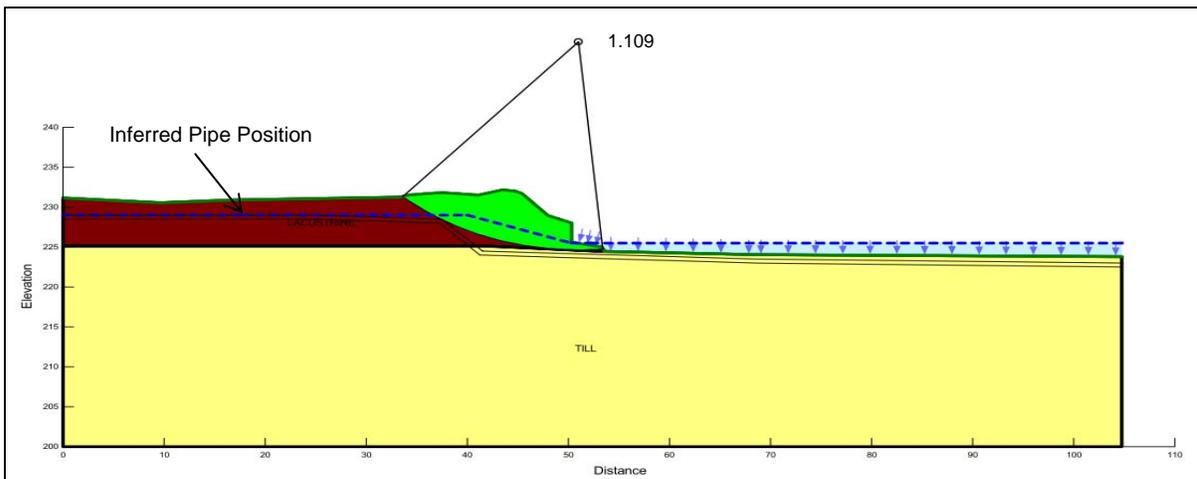
Figure 11: Site 14, Global Slip Surface Engaging the Pipe (GS+P)

A stability output model illustrating the position of the global slip surface engaging the pipe at the lowest FS is shown in Figure 11, determined at a river elevation of 225.50 m.

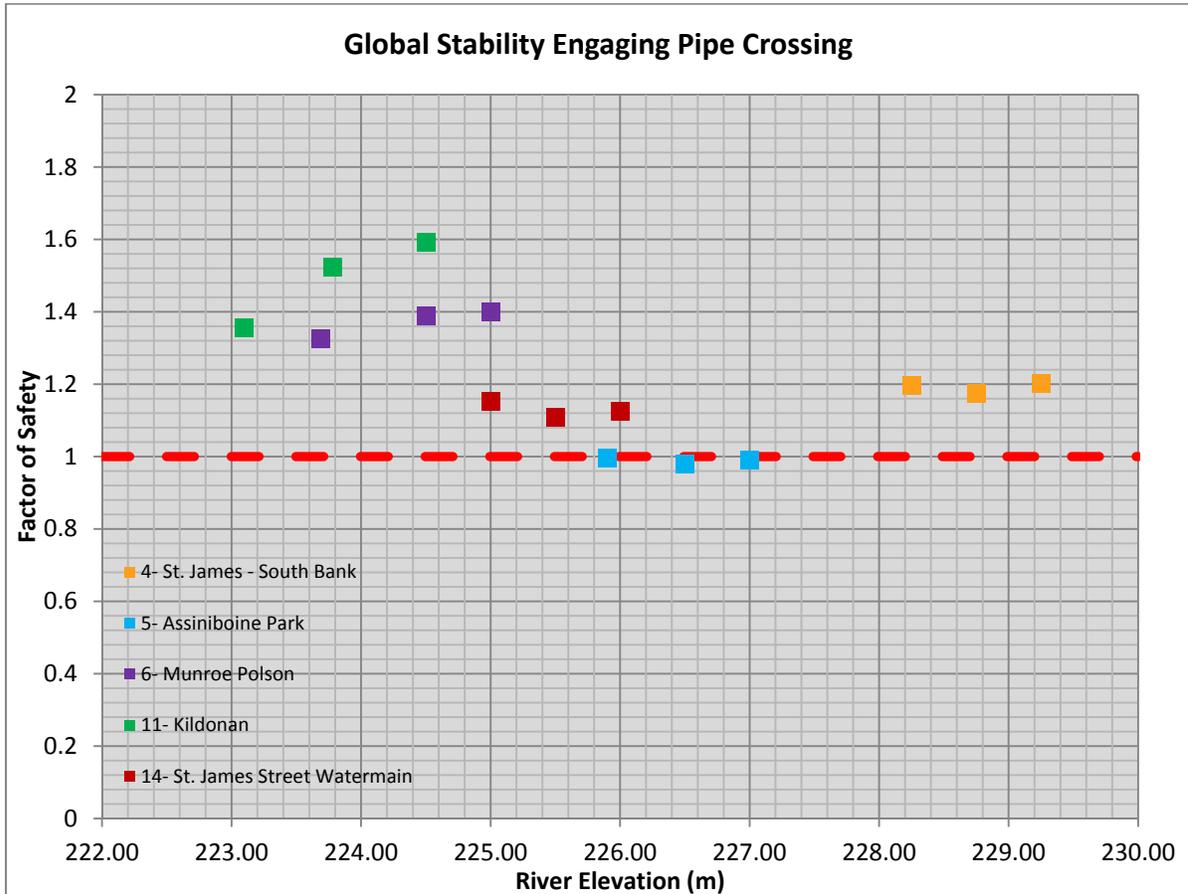
Figure 12: Global Stability Engaging Pipe Crossing

The calculated stability results from each pipe crossing discussed in previous sections has been presented graphically in Figure 12 and summarized in Table 4. Table 4 presents the sites according to a relative ranking system considering the reported site observations, slope geometries and the calculated FS for GS and GS+P slip surfaces. The relative ranking system is structured as No.1 is the relatively higher risk site and No.5 is the relatively lower risk site among the considered five sites.

Ranking	Site Location	River Elevation (m)	Global Stability	Global Stability Affecting Pipe	Comments
1	Site 14- St James Street Watermain	225.00- 226.00	0.8- 0.9	1.1- 1.2	Given the relatively low FS values, combined with an absence of accurate and detailed information about channel profile and pipe location, Site 14 should be considered a high priority.
3	Site 5- Assiniboine Park Siphon	225.90- 227.00	0.9- 1.0	0.9- 1.0	Presence of slump block near toe of slope indicating recent movement within the riverbank slope, and potential for future movement
4	Site 11- Kildonan Redwood Feedermain	223.10- 224.50	1.1- 1.2	1.4- 1.6	Extensive toe erosion noted during field inspection; however slope instability features further up slope have not been identified.
2	Site 4- St James Interceptor	227.75- 228.75	1.1- 1.2	1.1- 1.2	Oversteepened river bank slopes for given alluvial soils resulting in relative low FS values. However limited evidence of slope instability has been noted along the slope. The slope is considered to be marginally stable.

5	Site 6- Munroe Polson Siphon	221.43- 225.00	1.3- 1.4	1.3 1.4	No evidence of slope instability or movement observed directly along the slope at pipe crossing.

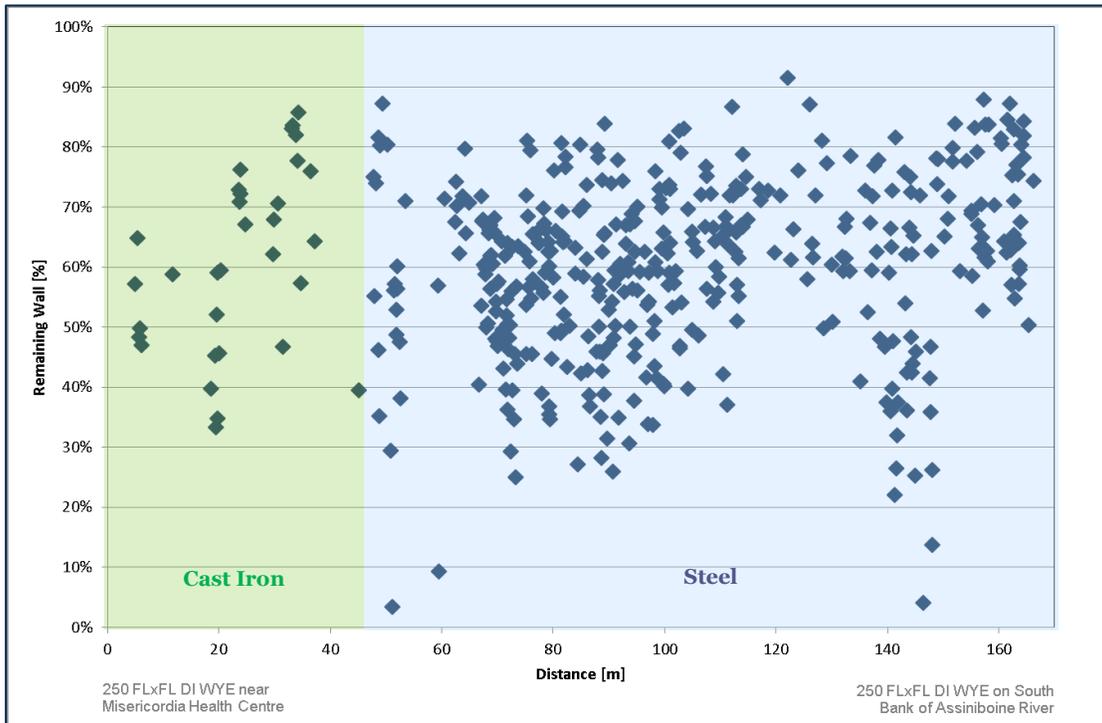
Figure 1: Distribution of wall loss with respect to remaining wall (%NWT) in pitting regions along the inspected section.

In general, the RFT analysis found the inspected section to be in “*fair to poor*” condition, with 82% of all pipes measuring less than 74% remaining wall (RW). A total of 441 localized wall loss indications were detected. Among these defects, 173 were classified as *shallow* ($\geq 65\%$ RW), 221 were *medium* (40-64% RW) and 43 were *deep* (20-39% RW). There were four defects that measured $< 20\%$ RW: 3%RW in P0150, 9%RW in P0160 and both 4%RW and 14%RW in P0300. The 4%RW defect in P0300 was verified as a through-hole during AECOM's lining of the watermain.

Figures 1 and 2 illustrate the distribution of localized wall loss along the 250mm (10in) Maryland Bridge Watermain (Assiniboine River Crossing) with respect to remaining wall and circumferential location respectively. Note that there may be some (partially) overlapping data points due to defect proximity.

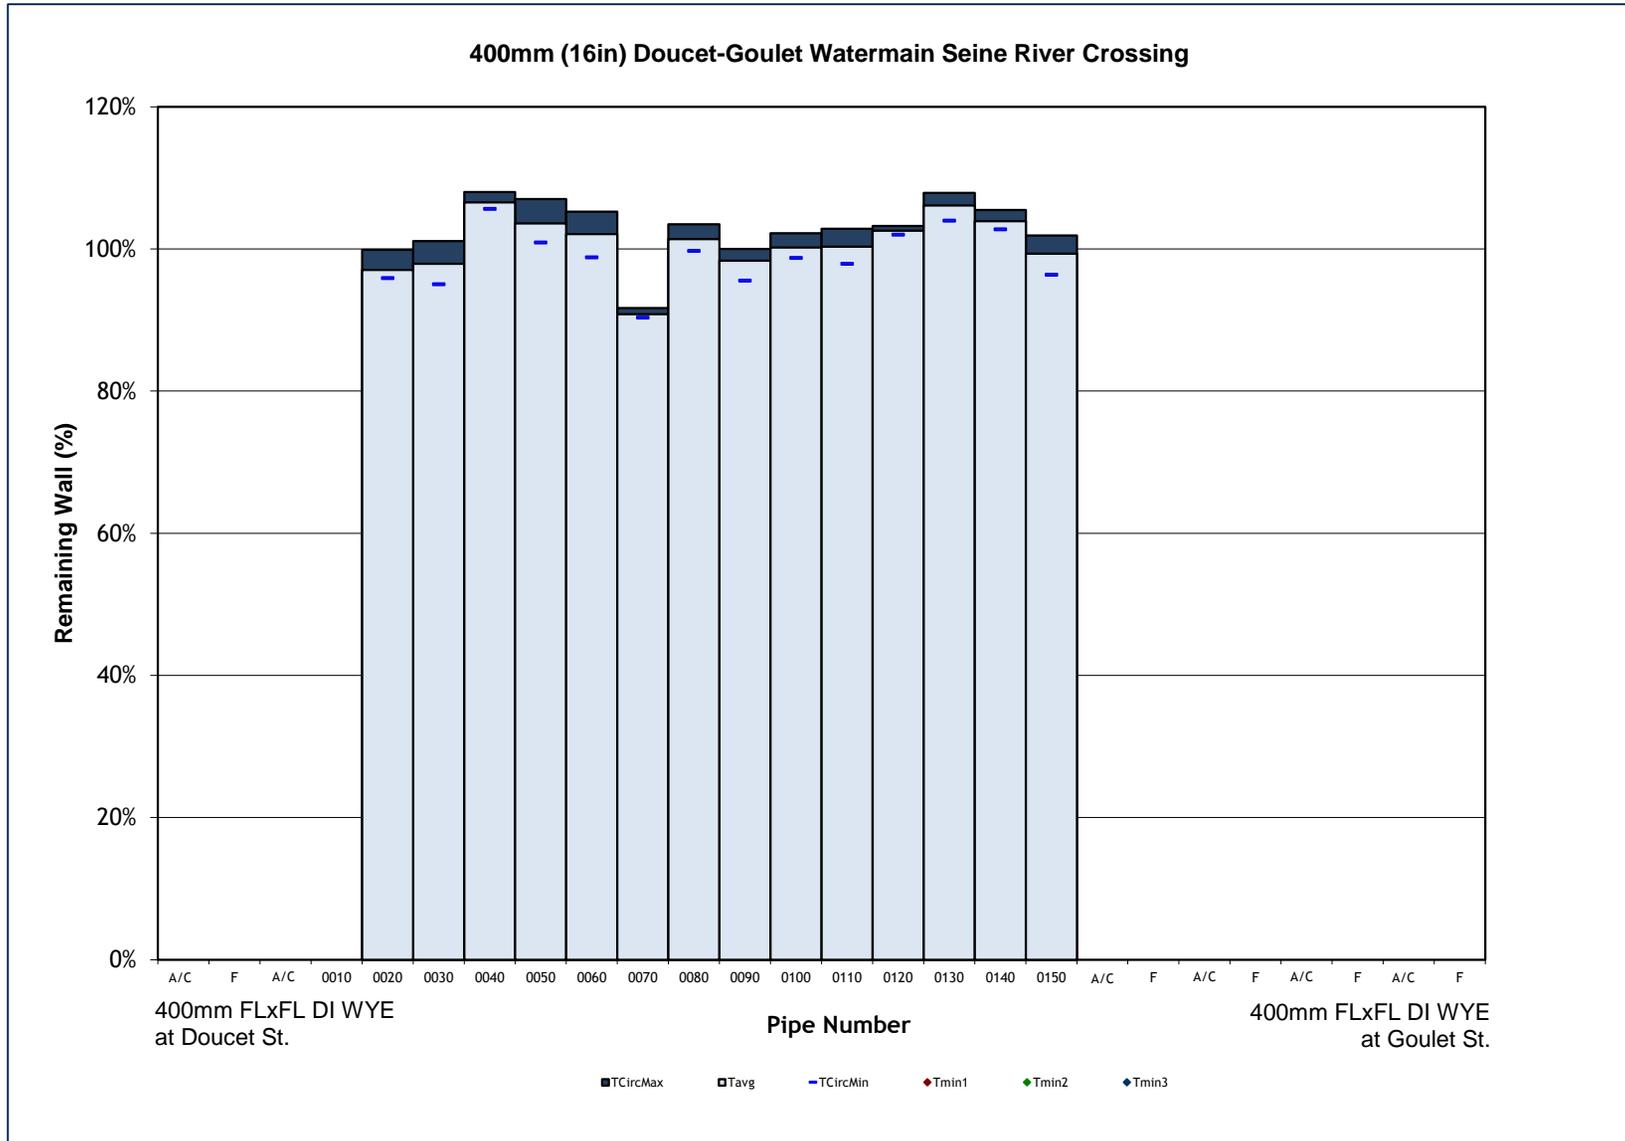
Figure 1: Structural Condition Assessment Summary – 400mm (16in) Goulet-Doucet Water Main

Table 1: Feature Indication Summary	
Inspected Length	173.82m* <small>*includes ~86.60m of asbestos cement pipe</small>
Number of Steel Pipe Sections:	15
Number of Analyzed Steel Pipe Sections:	15
Average Wall Thickness:	100%
Number of Steel pipes without localized wall loss indications:	15
Number of Steel pipes with localized wall loss indications:	0
• Number of Steel pipes in ‘good’ condition (>75% RW):	15
• Number of Steel pipes in ‘fair’ condition (50-74% RW):	0
• Number of Steel pipes in ‘poor’ condition (<50% RW):	0
Total number of wall loss indications reported:	0
Number of Regular Girth Welds:	7
Number of Flange Connections:	8
Number of Elbows:	2

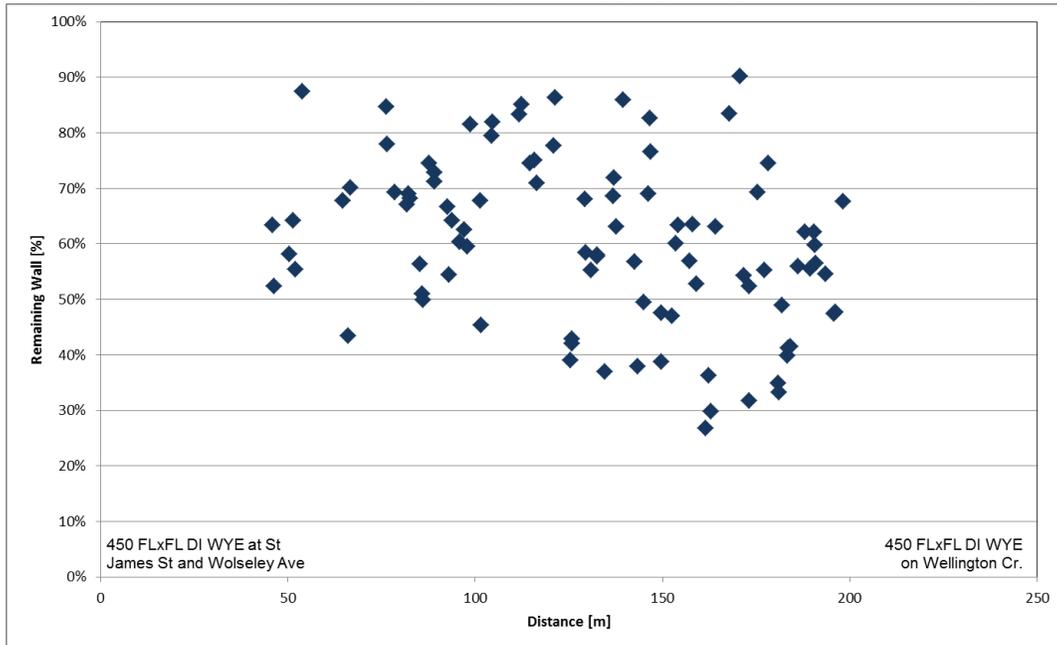
Figure 1: Distribution of wall loss with respect to remaining wall (%NWT) in pitting regions along the inspected section.

Table 1: Feature Indication Summary	
Inspected Length:	201.07m* <small>*includes ~7m of asbestos cement pipe</small>
Number of CI Pipe Sections:	59
Number of Analyzed CI Pipe Sections:	55
Average Wall Thickness:	93.7%
Thinnest circumferential pipe wall (Tcircmin):	78.8% (in Pipe 0390)
Number of CI pipes without localized wall loss indications:	19
Number of CI pipes with localized wall loss indications:	36
• Number of CI pipes in ‘good’ condition (>75% RW):	20
• Number of CI pipes in ‘fair’ condition (50-74% RW):	18
• Number of CI pipes in ‘poor’ condition (<50% RW):	12
Total number of wall loss indications reported:	165
Number of Bell and Spigot Joints:	51
Number of Elbows:	3

Figures 1 and 2 illustrate the distribution of localized wall loss along the 450mm (18in) St. James Watermain Assiniboine River Crossing with respect to remaining wall and circumferential location respectively. Note that there may be some (partially) overlapping data points due to defect proximity.

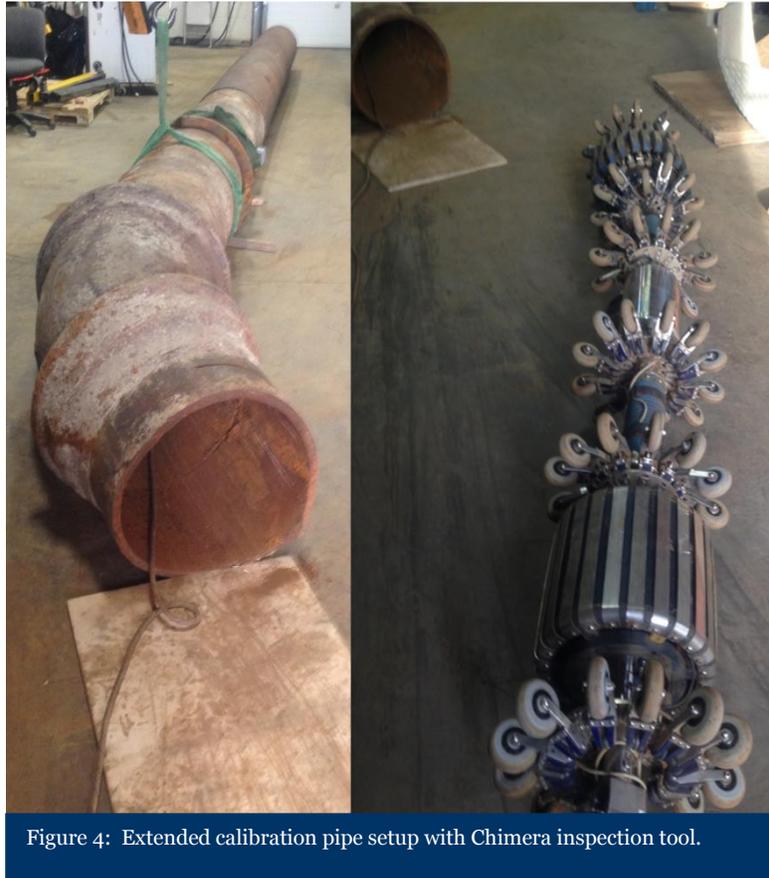
Figure 4: Extended calibration pipe setup with Chimera inspection tool.

The pipe sections appeared to be in good condition: no significant pitting was visible other than minor outer surface corrosion. There was internal tuberculation build-up, which PICA removed prior to running the Chimera tool. Due to the short usable length of the two pipe sections and the difficulty of machining cast iron pipe, a single calibration through hole was machined into the pipe, with dimensions as outlined in Table 3 below. PICA initially attempted to drill a round hole, but this proved difficult and dangerous in the thick cast iron pipe. Instead a rectangular defect was cut into the line. The RFT response to this defect is shown in Figure 5 below.

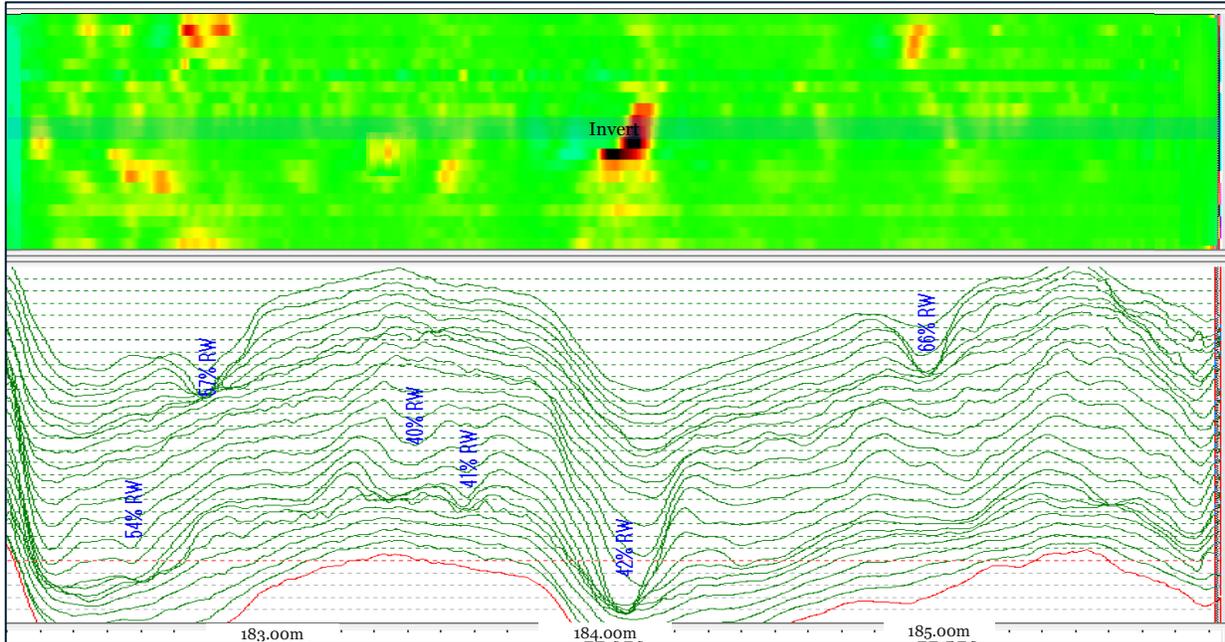
Pipe 0500: 182.16 – 185.84m (6 defects ranging between 40% and 66% RW)
