**S-MA40001409**

| Job Number: | 692-2015 | Waterway: | Bunn's Creek |
| Map Number: | 7 | Asset Location: | 671 MCIVOR AVE |
| Inspection Date: | 2015-11-13 | Surveyed By: | Darren Yarechewski |

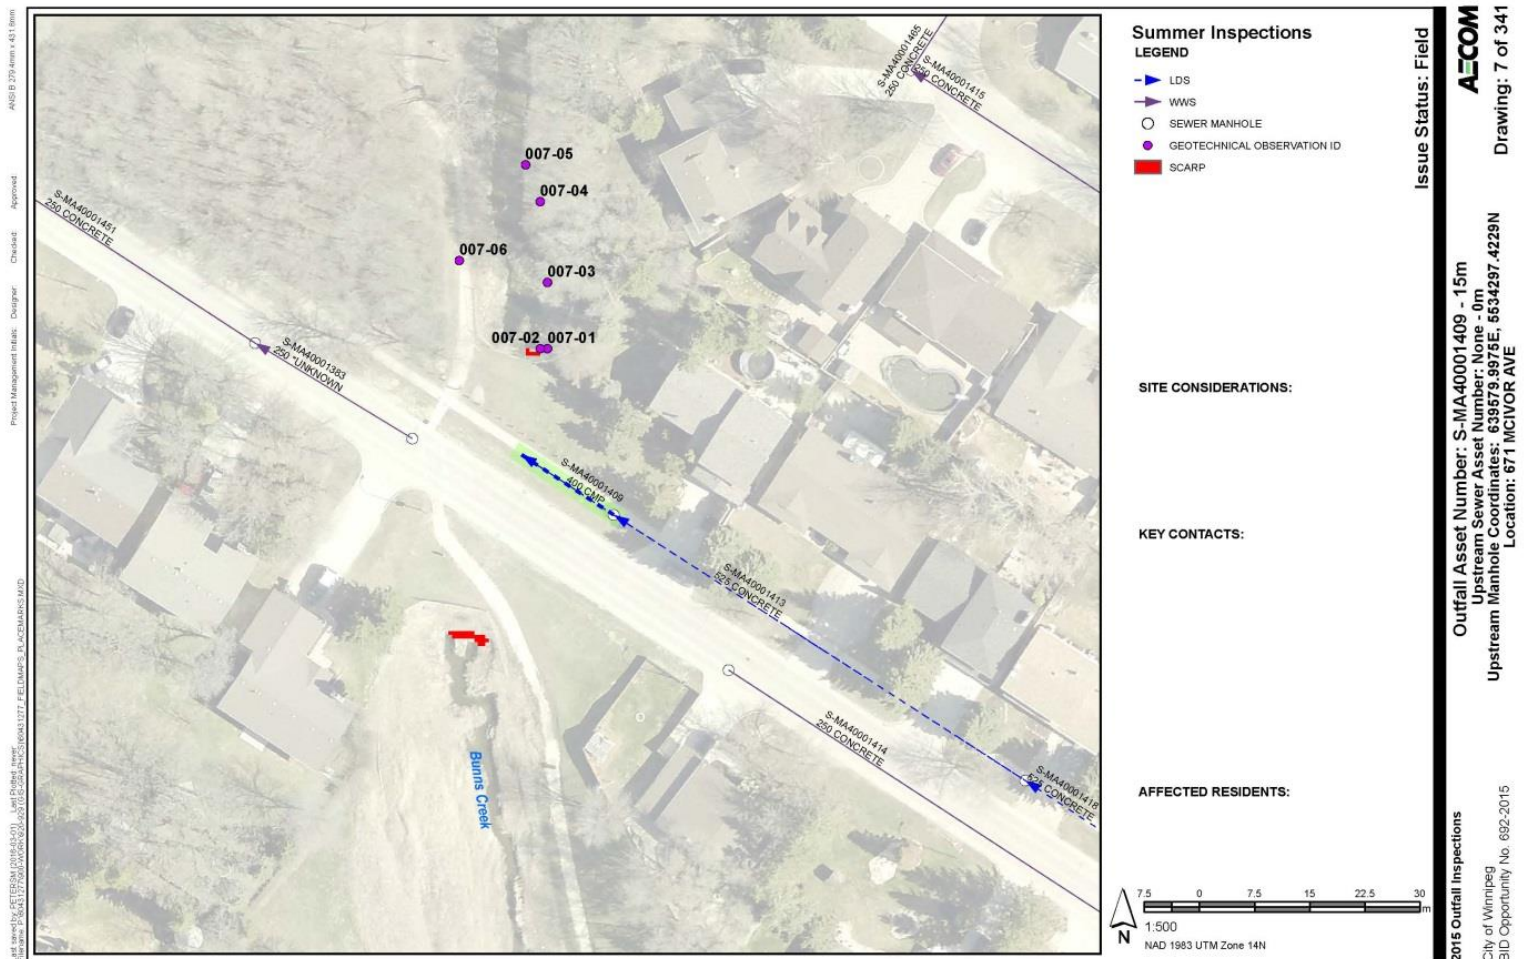
| Identified Damage: | Crushed | | |
| Slope Condition Grade: | 5 | Erosion Condition Grade: | 3 |

| Recommended Treatments: | | Erosion and Stabilization | |
