**CITY OF WINNIPEG**

**WASTEWATER LIFT STATION CONDITION ASSESSMENT PHASE II**

**Document IX: Cornish Lift Station Assessment**

Date: March 16, 2020

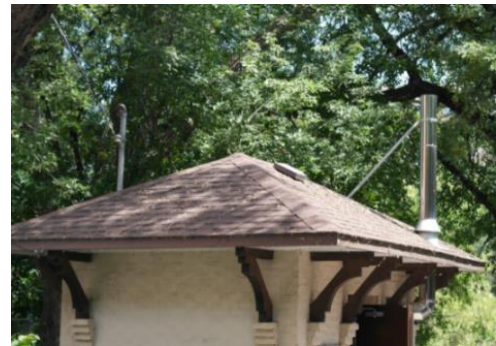
There are no gutters or downspouts. The flashings and trim are in good condition.

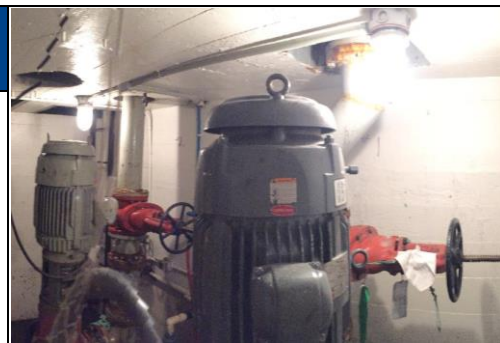
All process mechanical equipment in the lift station was installed during the major upgrades in 1987. Maintenance efforts have been carried out by the City of Winnipeg Operations and Maintenance staff including routine servicing, preventative maintenance, and building cleanup. In general, the equipment is in “Fair” operational condition. Operational staff noted that the lift station pumps frequently plug from obstructive material and the system has no way to back-flush. The pump motors frequently overheat when the room temperature is warm and the pumps have long run times.

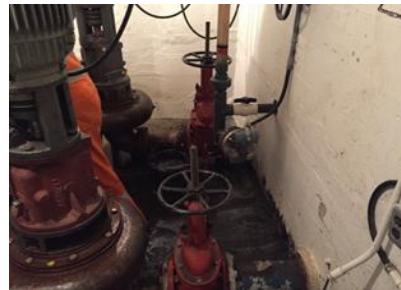
The valves were installed in 1987. The manually actuated gate valves are used for isolation of equipment for maintenance and are not regularly exercised. The check valves are critical to the operation of the lift station and are exercised regularly through operation. In general, valves are in “Fair” condition. Table 7.5 provides a summary of the condition of the valves at the Cornish Lift Station.

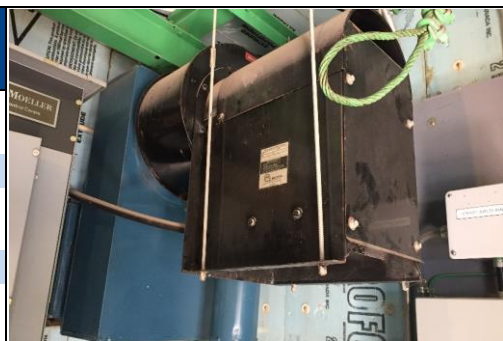
The Cornish Lift Station ventilation system includes one exhaust fan located in the main floor of the building. The ventilation system is used intermittently when the building and dry well are occupied. The exhaust fan pulls air from the dry well and comminutor chamber through separate pipes to create a negative pressure in the spaces. Fresh air is brought into the building and dry well through ducting through the building wall and roof. No major ventilation upgrades have been carried out at the lift station since the mechanical and electrical upgrades in 1987. In general, the equipment is showing signs of aging, and is in “Poor” condition. Detailed assessment forms have been appended to this report.

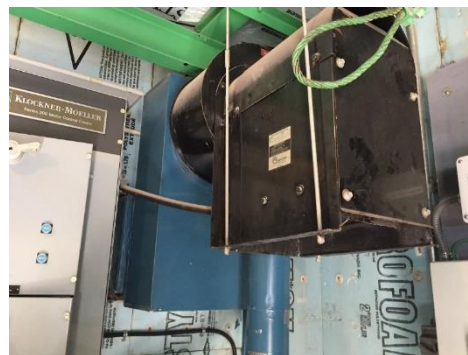
The ventilation system includes ducting for supply and exhaust in the dry well ventilation system. No concerns were noted with pressurization in the building or dry well.

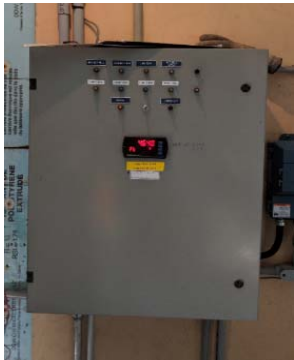
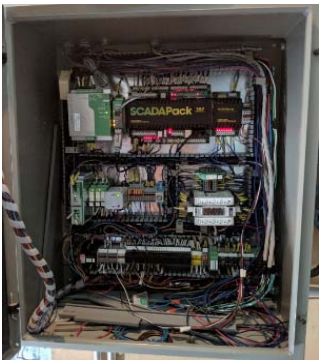
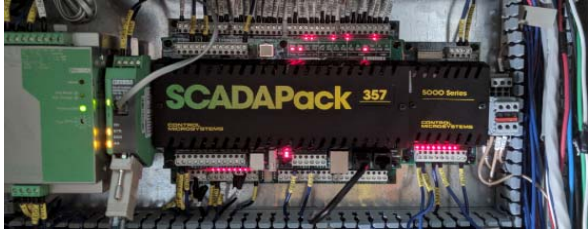
Project No.: 8400-001-00  
Tag: IC\_102\_Panel  
Facility: Cornish Lift Station  
Assessment Page 1 of 1

| SECTION | ITEM | DATA | Assessment Scores | | | | Component Age | | |
|---|---|---|---|---|---|--|---|---|---|
| | | <b>Equipment Remaining Service Life:</b><br><i>Issues for Discussion:</i><br>Rating 1 (> 90% lifecycle remain)<br>Rating 2 (> 75% lifecycle remain)<br>Rating 3 (> 50% lifecycle remain)<br>Rating 4 (> 25% lifecycle remain)<br>Rating 5 (obsolete) | 2 | 0.2 | | | | | |

| SECTION | ITEM | DATA | Assessment Scores | | | | Component Age | | |
|---|---|---|---|---|---|--|---|---|---|
| | <b>COST ESTIMATE</b><br>\$ 4,600.00 | | | | | | | | |

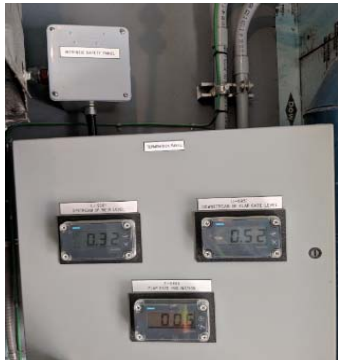
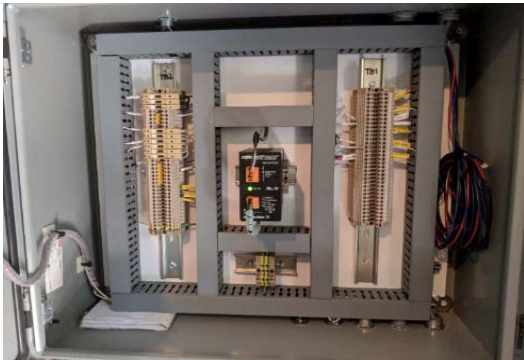
| SECTION | ITEM | DATA | Assessment Scores | | | | Component Age | | |
|---|---|---|---|---|---|--|---|---|---|
| | Current Physical Condition | <b>Equipment Visual Inspection:</b><br><i>Issues for Discussion:</i><br>Rating 1 (Like New)<br>Rating 2 (Minor Surface Corrosion)<br>Rating 3 (Surface & Internal Corrosion)<br>Rating 4 (Severe Corrosion)<br>Rating 5 (Safety Concern) | 1 | 0.1 | <b>NOTES &amp; COMMENTS:</b><br>Equipment appears to be in "Good" condition. | | | | |
| | | <b>Control Wiring Terminations Visual Inspection:</b><br><i>Issues for Discussion:</i><br>Rating 1 (Connections tight, labelled)<br>Rating 2 (Missing Labels)<br>Rating 3 (Loose / Disorganized wiring)<br>Rating 4 (Inappropriate wiring)<br>Rating 5 (Combination of above) | 1 | 0.1 | | | | | |

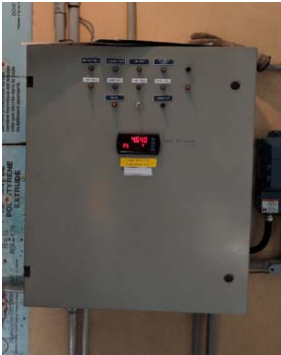
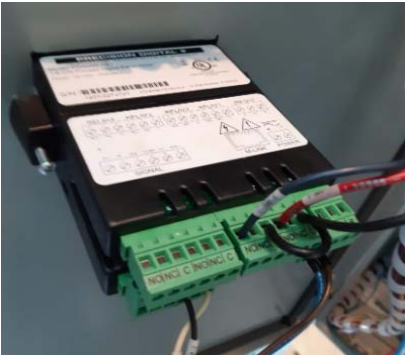
Tag: IC\_101\_Level\_Transmitter

| SECTION | ITEM | DATA | Assessment Scores | | | | AGE | | | | |
|---|---|---|---|---|---|---|---|---|---|--|--|
| | | Equipment Visual Inspection:<br><i>Issues for Discussion:</i> | Rating 1 (Like New)<br>Rating 2 (Minor Surface Corrosion)<br>Rating 3 (Surface & Internal Corrosion)<br>Rating 4 (Severe Corrosion)<br>Rating 5 (Safety Concern) | 1 | 0.1 | <b>NOTES &amp; COMMENTS:</b><br>Equipment appears to be in "Good" condition. | | | | | |
| Instrument Remaining Service Life:<br><i>Issues for Discussion:</i> | Rating 1 (> 90% lifecycle remain)<br>Rating 2 (> 75% lifecycle remain)<br>Rating 3 (> 50% lifecycle remain)<br>Rating 4 (> 25% lifecycle remain)<br>Rating 5 (obsolete) | | 3 | 0.5 | | | | | | | |

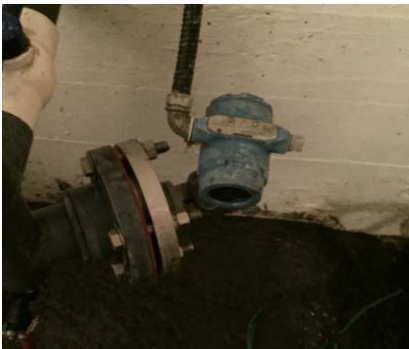
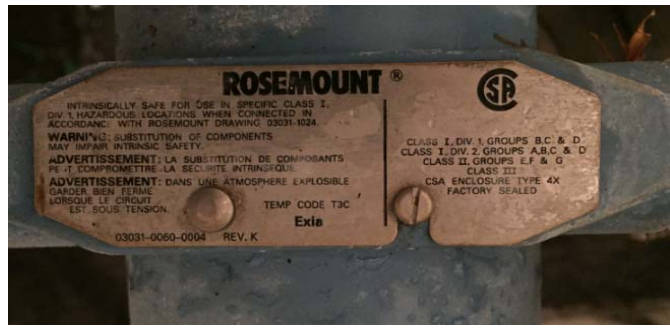
Tag: IC\_101\_Flow

| SECTION | ITEM | DATA | Assessment Scores | | | | AGE | | | |
|---|---|---|---|---|---|---|---|---|---|--|
| | Current Physical Condition | <b>Equipment Visual Inspection:</b><br><i>Issues for Discussion:</i><br>Rating 1 (Like New)<br>Rating 2 (Minor Surface Corrosion)<br>Rating 3 (Surface & Internal Corrosion)<br>Rating 4 (Severe Corrosion)<br>Rating 5 (Safety Concern) | 2 | 0.1 | <b>NOTES &amp; COMMENTS:</b><br>Equipment is starting to show signs of surface corrosion and is in "Fair" Condition. Currently no level redundancy in the case of equipment failure. | | | | | |

| SECTION | ITEM | DATA | Assessment Scores | | | | AGE | | | |
|---|---|---|---|---|---|---|---|---|---|--|
| | | | <b>COST ESTIMATE</b><br>\$ 16,800.00 | | | | | | | |

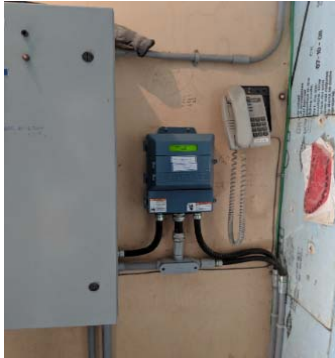
Tag: IC\_101\_FLYGT

| SECTION | ITEM | DATA | Assessment Scores | | | | AGE | | |
|---|---|---|---|---|---|---|---|---|---|
| | Current Physical Condition | Equipment Visual Inspection:<br><i>Issues for Discussion:</i> | Rating 1 (Like New)<br>Rating 2 (Minor Surface Corrosion)<br>Rating 3 (Surface & Internal Corrosion)<br>Rating 4 (Severe Corrosion)<br>Rating 5 (Safety Concern) | 1 | 0.1 | <b>NOTES &amp; COMMENTS:</b><br>Equipment appears to be in "Good" condition. | | | |

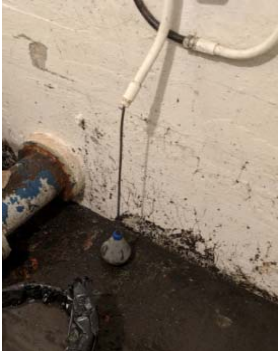
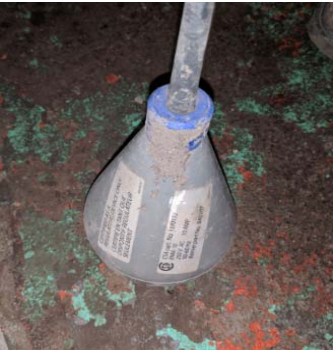
| SECTION | ITEM | DATA | Assessment Scores | | | | AGE | | |
|---|---|---|---|---|---|---|---|---|---|
| | Current Physical Condition | Equipment Visual Inspection:<br><i>Issues for Discussion:</i> | Rating 1 (Like New)<br>Rating 2 (Minor Surface Corrosion)<br>Rating 3 (Surface & Internal Corrosion)<br>Rating 4 (Severe Corrosion)<br>Rating 5 (Safety Concern) | 2 | 0.1 | <b>NOTES &amp; COMMENTS:</b><br>Equipment appears to be in "Good" condition. | | | |

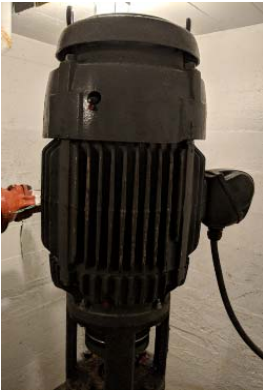
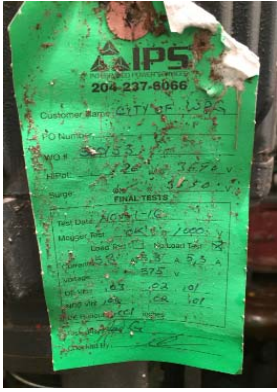
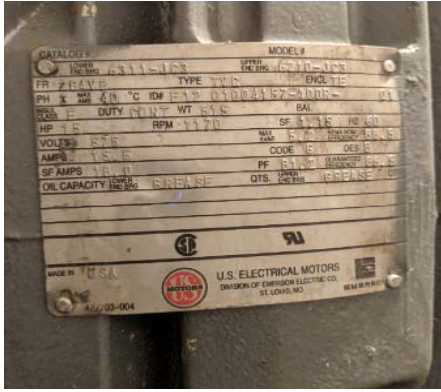
Project No.: 8400-001-00  
 Tag: E\_E102\_Motor  
 Facility: Cornish Lift Station  
 Assessment Page 1 of 1

| SECTION | ITEM | DATA | CONDITION RATING | | | | AGE | | |
|---|---|---|---|---|---|---|---|---|---|
| <b>Equipment Remaining Service Life:</b><br><i>Issues for Discussion:</i> | | Rating 1 (> 90% lifecycle remain)<br>Rating 2 (> 75% lifecycle remain)<br>Rating 3 (> 50% lifecycle remain)<br>Rating 4 (> 25% lifecycle remain)<br>Rating 5 (obsolete) | 4 | 0.25 | | | | | |

| SECTION | ITEM | DATA | CONDITION RATING | | | | AGE | | |
|---|---|---|---|---|---|---|---|---|---|
| | <b>COST ESTIMATE</b><br>\$ 12,000.00 | | | | | | | | |

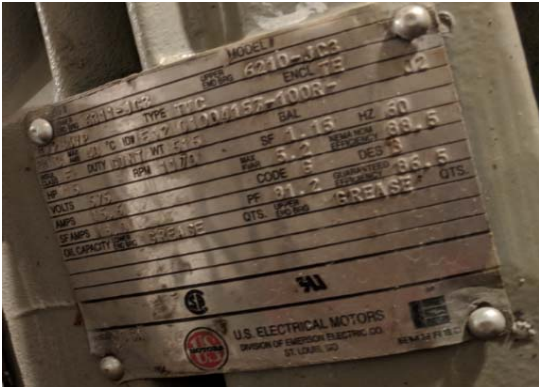
Project No.: 8400-001-00  
 Tag: E\_E103\_Motor  
 Facility: Cornish Lift Station  
 Assessment Page 1 of 1

| SECTION | ITEM | DATA | CONDITION RATING | | | | AGE | | |
|---|---|---|---|---|---|---|---|---|---|
| <b>Equipment Remaining Service Life:</b><br><i>Issues for Discussion:</i><br>Rating 1 (> 90% lifecycle remain)<br>Rating 2 (> 75% lifecycle remain)<br>Rating 3 (> 50% lifecycle remain)<br>Rating 4 (> 25% lifecycle remain)<br>Rating 5 (obsolete) | | 4 | 0.25 | | | | | | |

| SECTION | ITEM | DATA | CONDITION RATING | | | | AGE | | |
|---|---|---|---|---|---|---|---|---|---|
| | <b>COST ESTIMATE</b><br>\$ 12,000.00 | | | | | | | | |

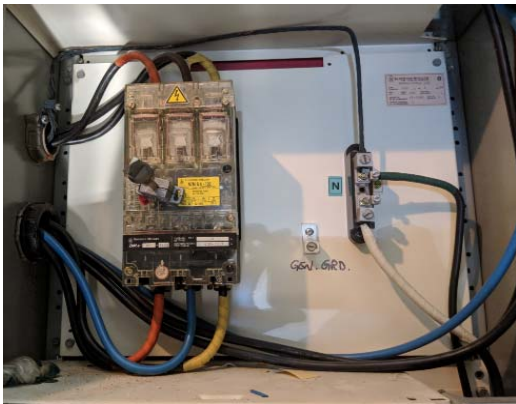
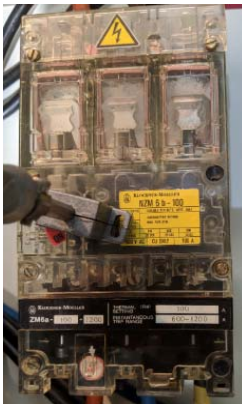
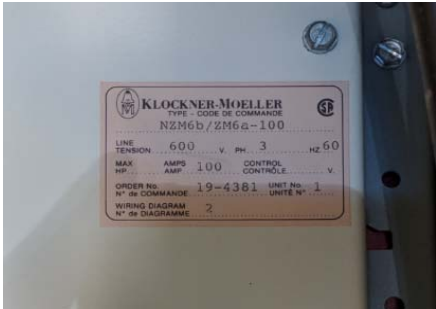
| SECTION | ITEM | DATA | CONDITION RATING | | | | AGE | | |
|---|---|---|---|---|---|--|---|---|---|
| | Current Physical Condition | <b>Equipment Visual Inspection:</b><br><i>Issues for Discussion:</i><br>Rating 1 (Like New)<br>Rating 2 (Minor Surface Corrosion)<br>Rating 3 (Surface & Internal Corrosion)<br>Rating 4 (Severe Corrosion)<br>Rating 5 (Safety Concern) | 1 | 0.1 | <b>NOTES &amp; COMMENTS:</b><br>Equipment appears to be in "Good" condition. Equipment is not rated for Zone 1 locations. Wiring along with the ground are showing signs of corrosion.<br><br><b>RECOMMENDATIONS:</b><br>Address wet well access along with ventilation requirements. | | | | |
| | | <b>Equipment Remaining Service Life:</b><br><i>Issues for Discussion:</i><br>Rating 1 (> 90% lifecycle remain)<br>Rating 2 (> 75% lifecycle remain)<br>Rating 3 (> 50% lifecycle remain)<br>Rating 4 (> 25% lifecycle remain)<br>Rating 5 (obsolete) | 3 | 0.5 | | | | | |
