ST. VITAL TWIN BRIDGE OVER THE RED RIVER REHABILITATION AND RELATED WORKS

BRIDGE REHABILITATION
PIER 2 DEFECT MAP AND SURFACE REPAIRS

CITY FILE NUMBER: B116-24-40
SHEET 126 OF 244
DRAWING NUMBER: 126

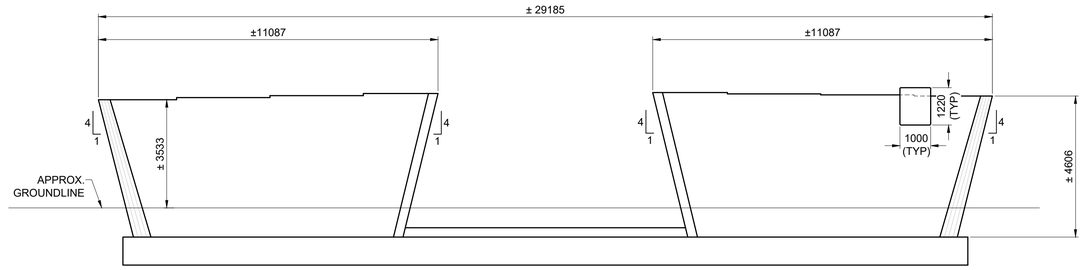
PIER 2 WEST END (1)

1. DEFECTS MAPPED JULY 2022.
2. CONTRACTOR TO UNDERTAKE DELAMINATION SURVEY WITH RESIDENT ENGINEER TO CONFIRM EXTENT OF DEFECTS.
3. MEDIUM AND WIDE CRACKS TO BE EPOXY INJECTED AS DIRECTED BY THE CONTRACT ADMINISTRATOR.
4. REPAIRS TO BE COMPLETED TO DELAMINATED, SPALLED, CRACKED, AND SCALED CONCRETE. REFER TO SHEET 139 FOR PATCH REPAIR DETAILS.
5. MEDIUM CRACKS RANGE IN WIDTH FROM 0.3 TO 1.0 mm ±
6. APPLY PENETRATING SEALER TO EXPOSED CONCRETE SURFACES AFTER COMPLETING CONCRETE REPAIRS AND MODIFICATIONS FOR BEARINGS (REFER TO SHEET 133)
