NORTH APPROACH SPAN REPAIRS

NOTE:	B.M. ELEV.	DESIGNED BY: D.N.B.			ARLING TON OVERPASS (CPR YARDS) 2010 STRUCTURAL STEEL REPAIRS	SHEET 6 OF 8
		DRAWN BY: M.R.T.				
		CHECKED BY: D.N.B.	BID OPPORTUNITY NO.: 91-2010	NORTH APPROACH SPANS	CITY DRAWING NUMBER: B106-10-06	
		APPROVED BY: D.N.B.				
		AUTHORIZED BY:				
		ORIGINAL SIGNED BY D.N. BURMEY				
	0 ISSUED FOR TENDER 23/03/10 M.T.	D.N. BURMEY BRIDGE MAINTENANCE ENGINEER				
	REVISION DATE BY

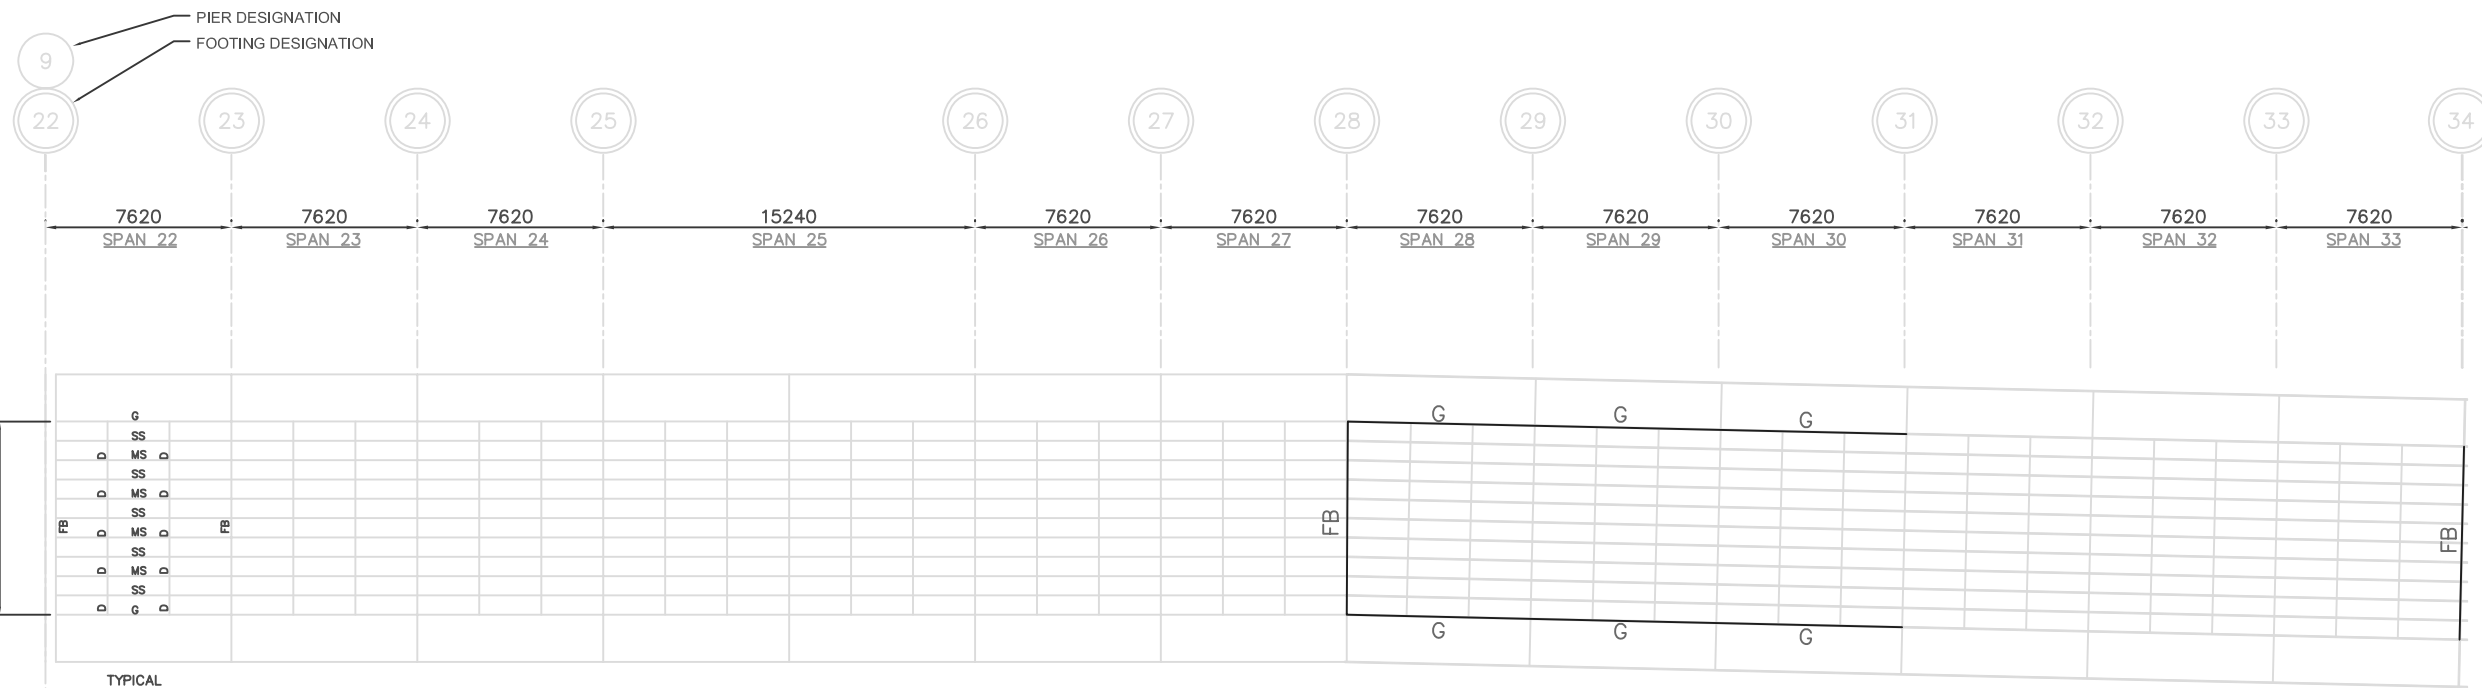
TYPICAL SPAN LAYOUT

ABBREVIATIONS:
 FB - FLOOR BEAM
 G - GIRDER
 MS - MAIN STRINGER
 SS - SECONDARY STRINGER
 D - DIAPHRAGM BEAM

ABBREVIATIONS SHOWN IN BOLD ARE MEMBERS TO BE REPAIRED/REPLACED. SEE DRAWING 7 FOR DETAILS.
