APPENDIX A – 1998 OUTFALL INSPECTIONS CONDITION AND MAINTENANCE STUDY

CITY OF WINNIPEG
OUTFALL CONDITION
AND
MAINTENANCE STUDY
FINAL REPORT //

August, 1998

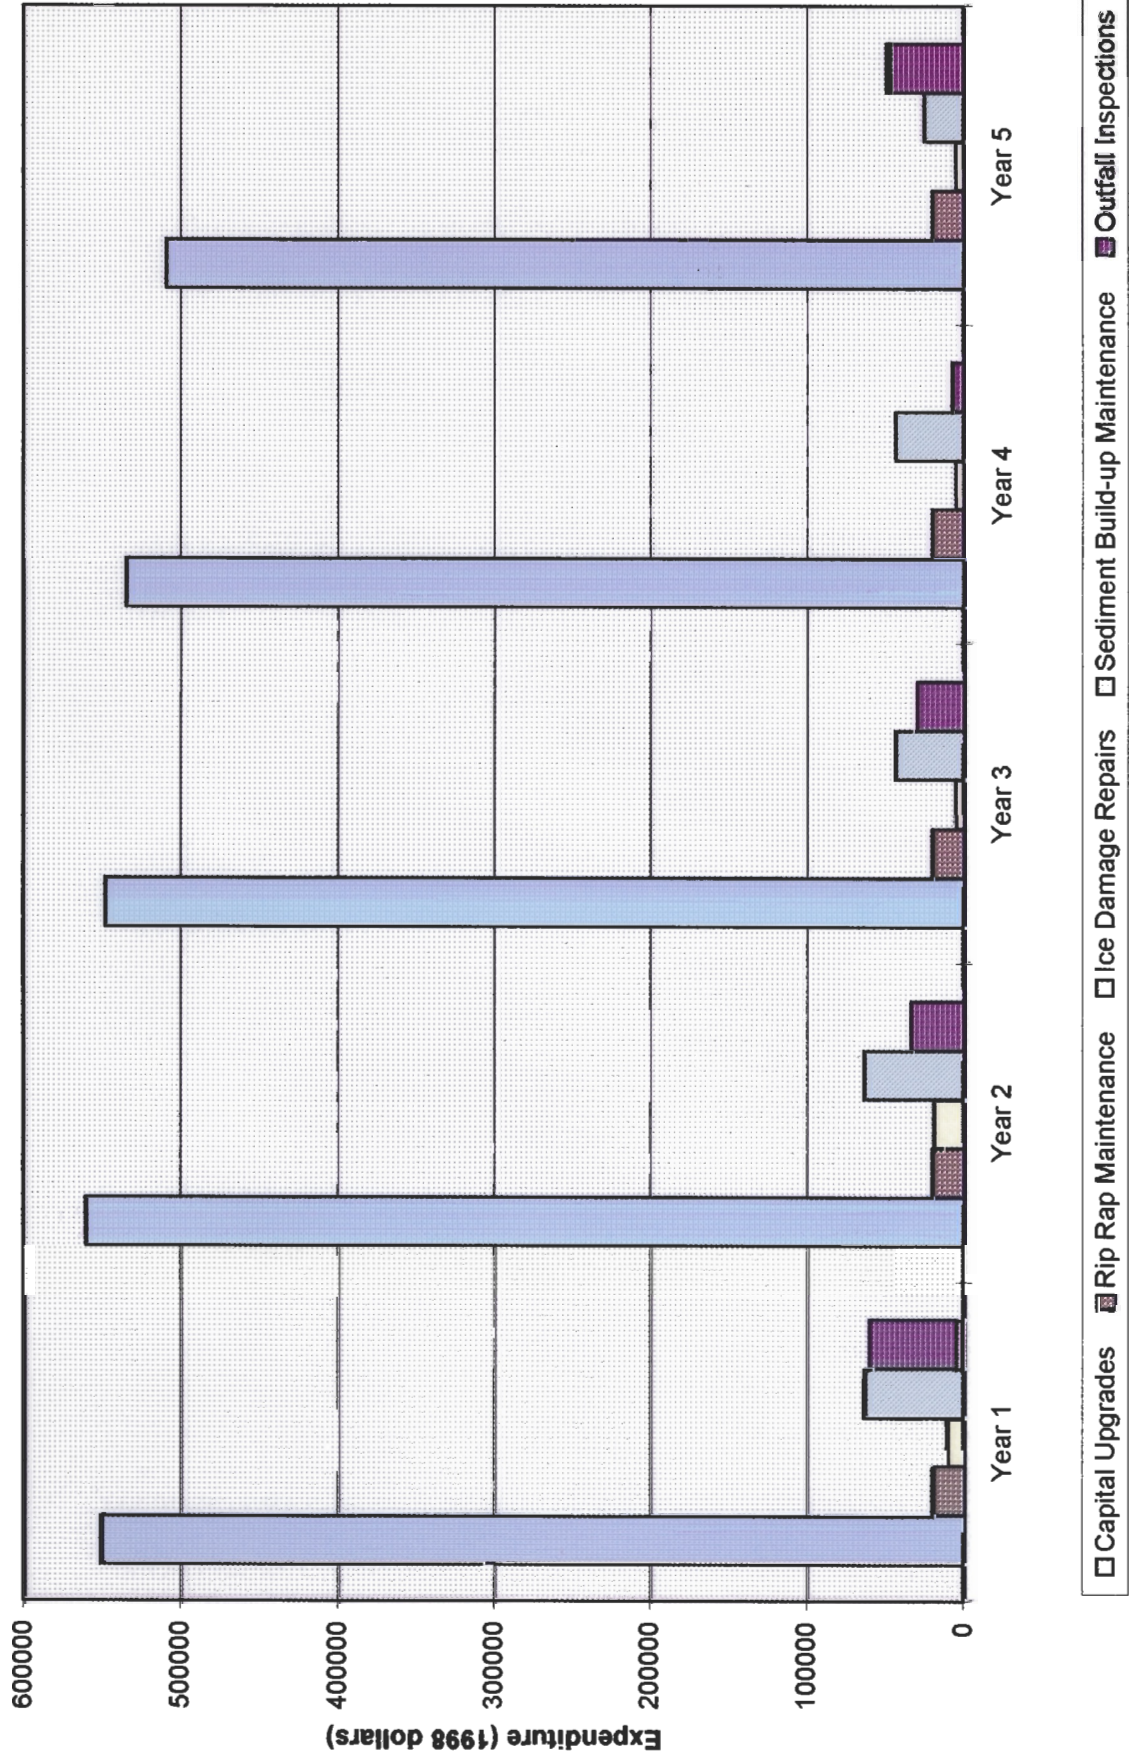
Figure 1
Recommended Outfall Budget
5 Year Plan

Figure 1, illustrates the total recommended budget plan for the next 5 years. It includes a bar chart for both required capital upgrades and O&M expenditures.

Figure 1, illustrates the total recommended budget plan for the next 5 years. It includes a bar chart for both required capital upgrades and O&M expenditures.

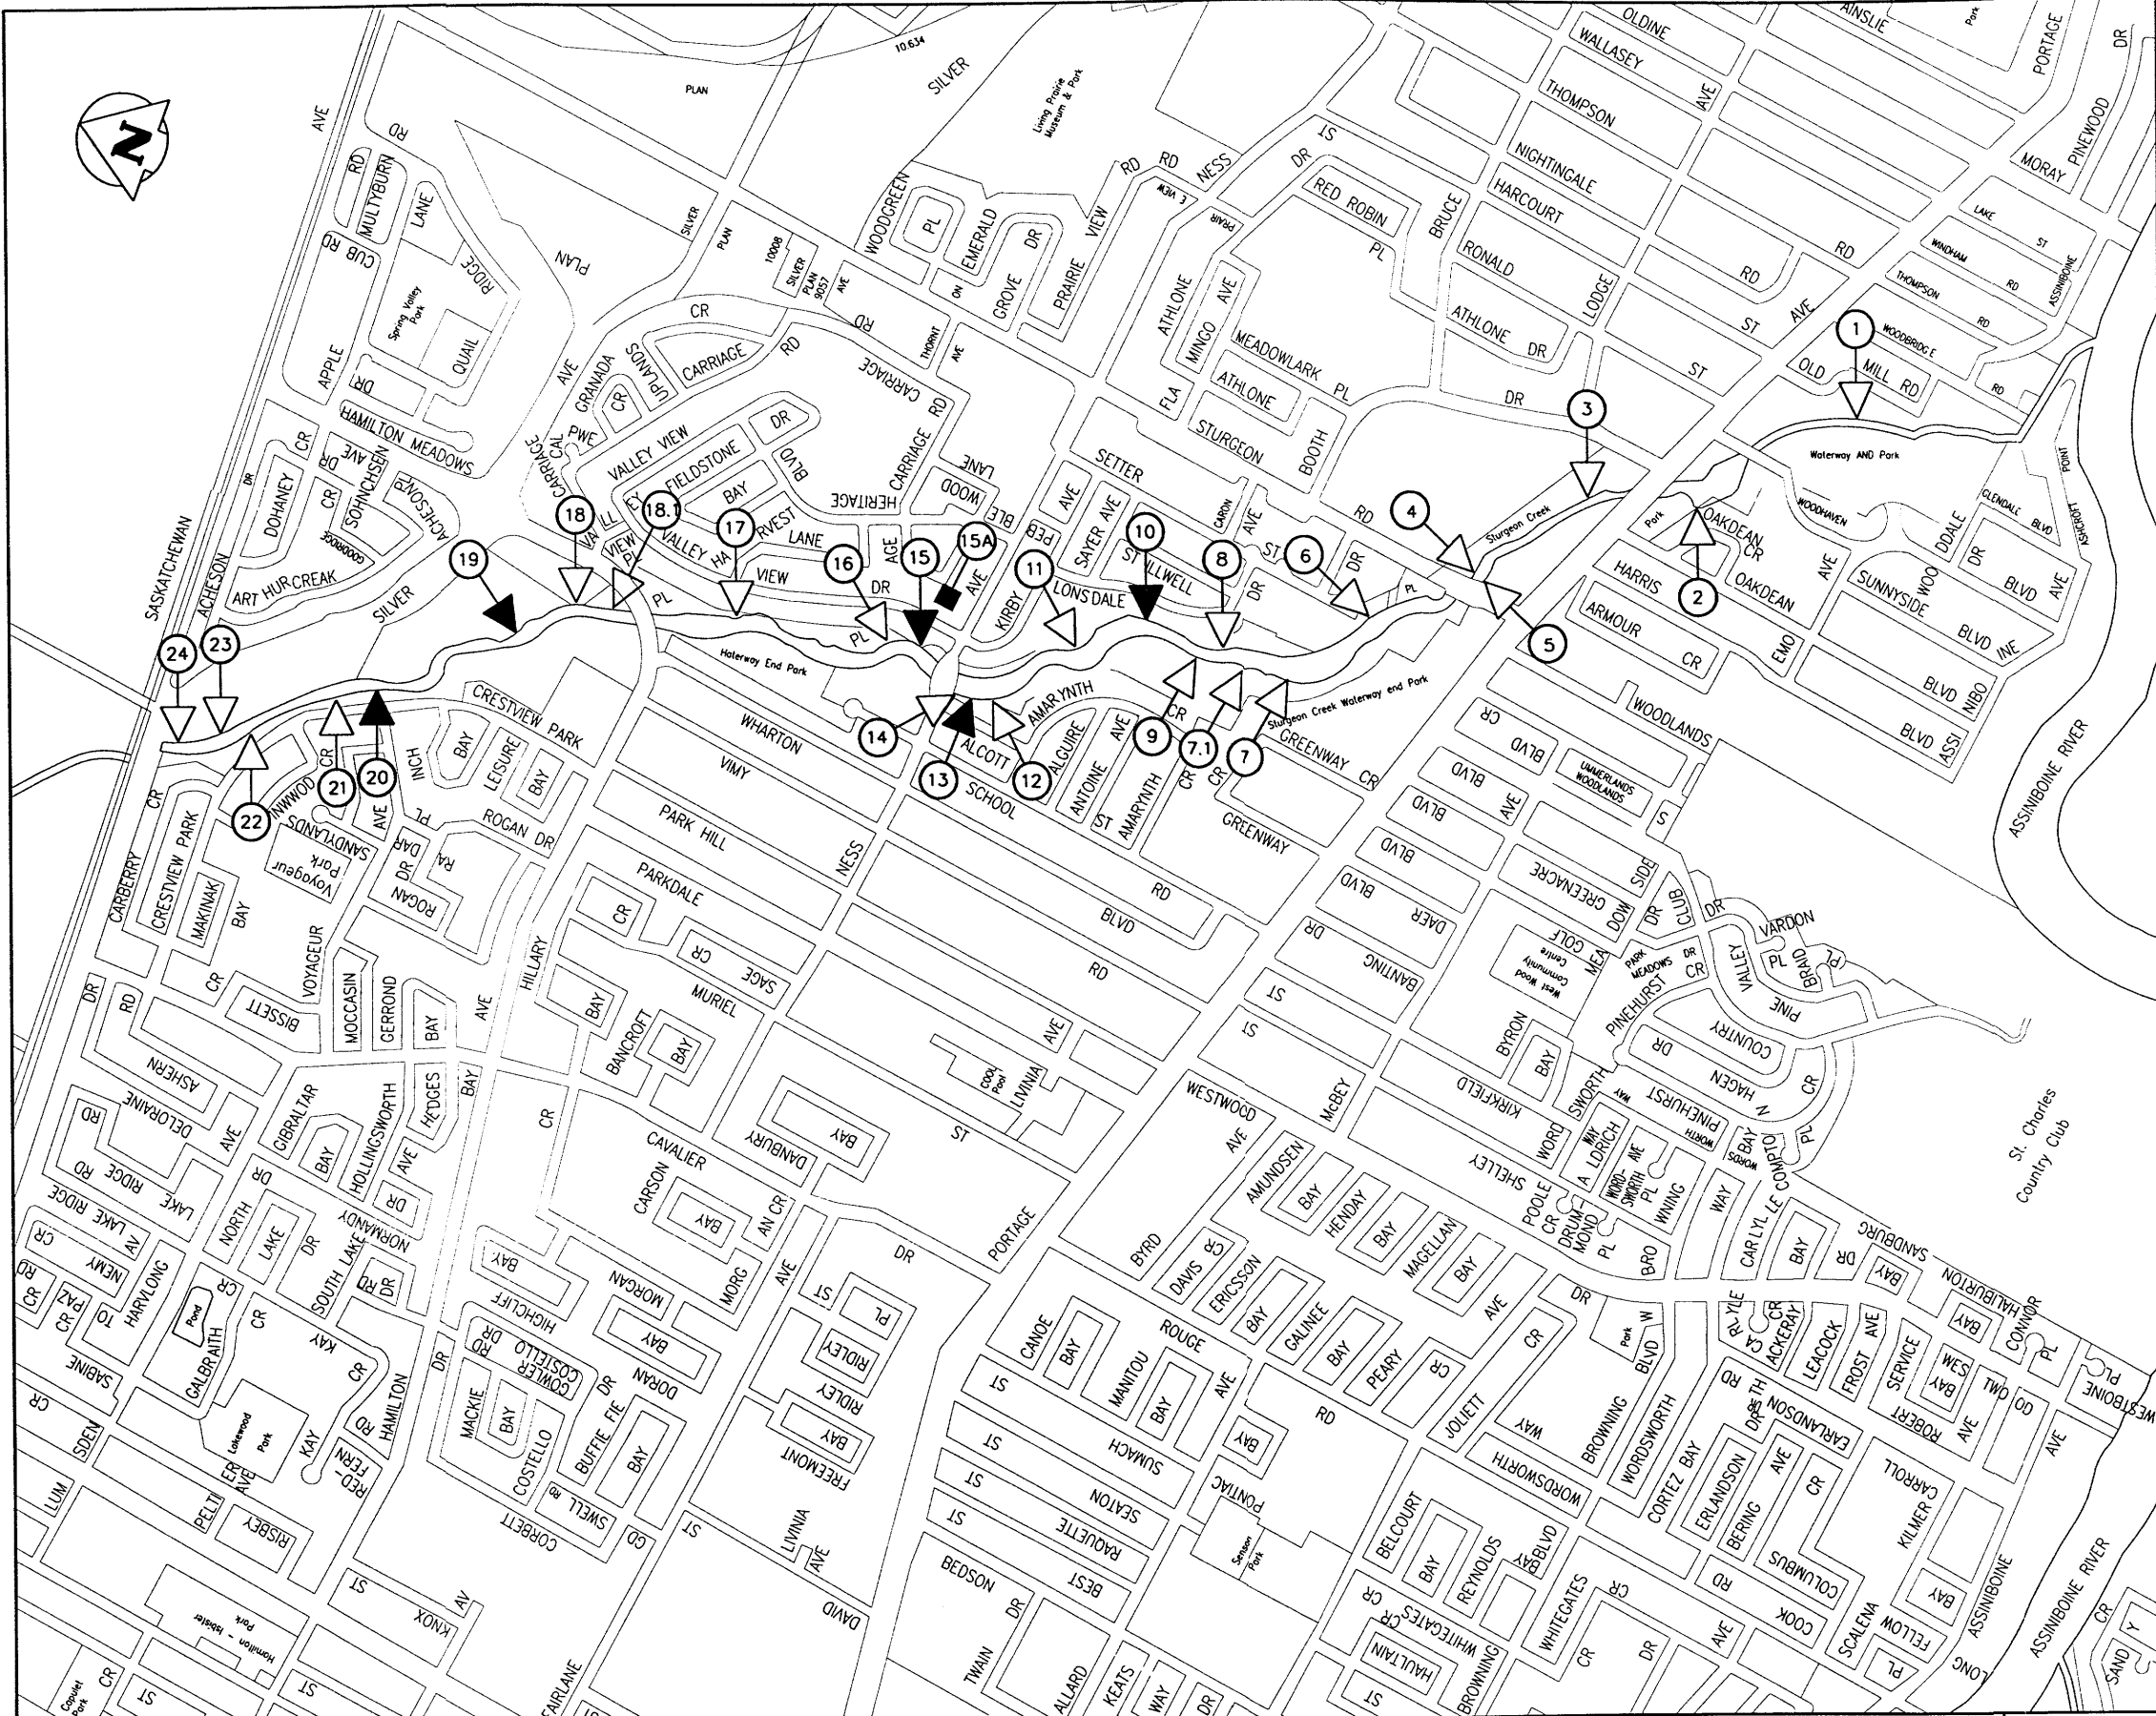
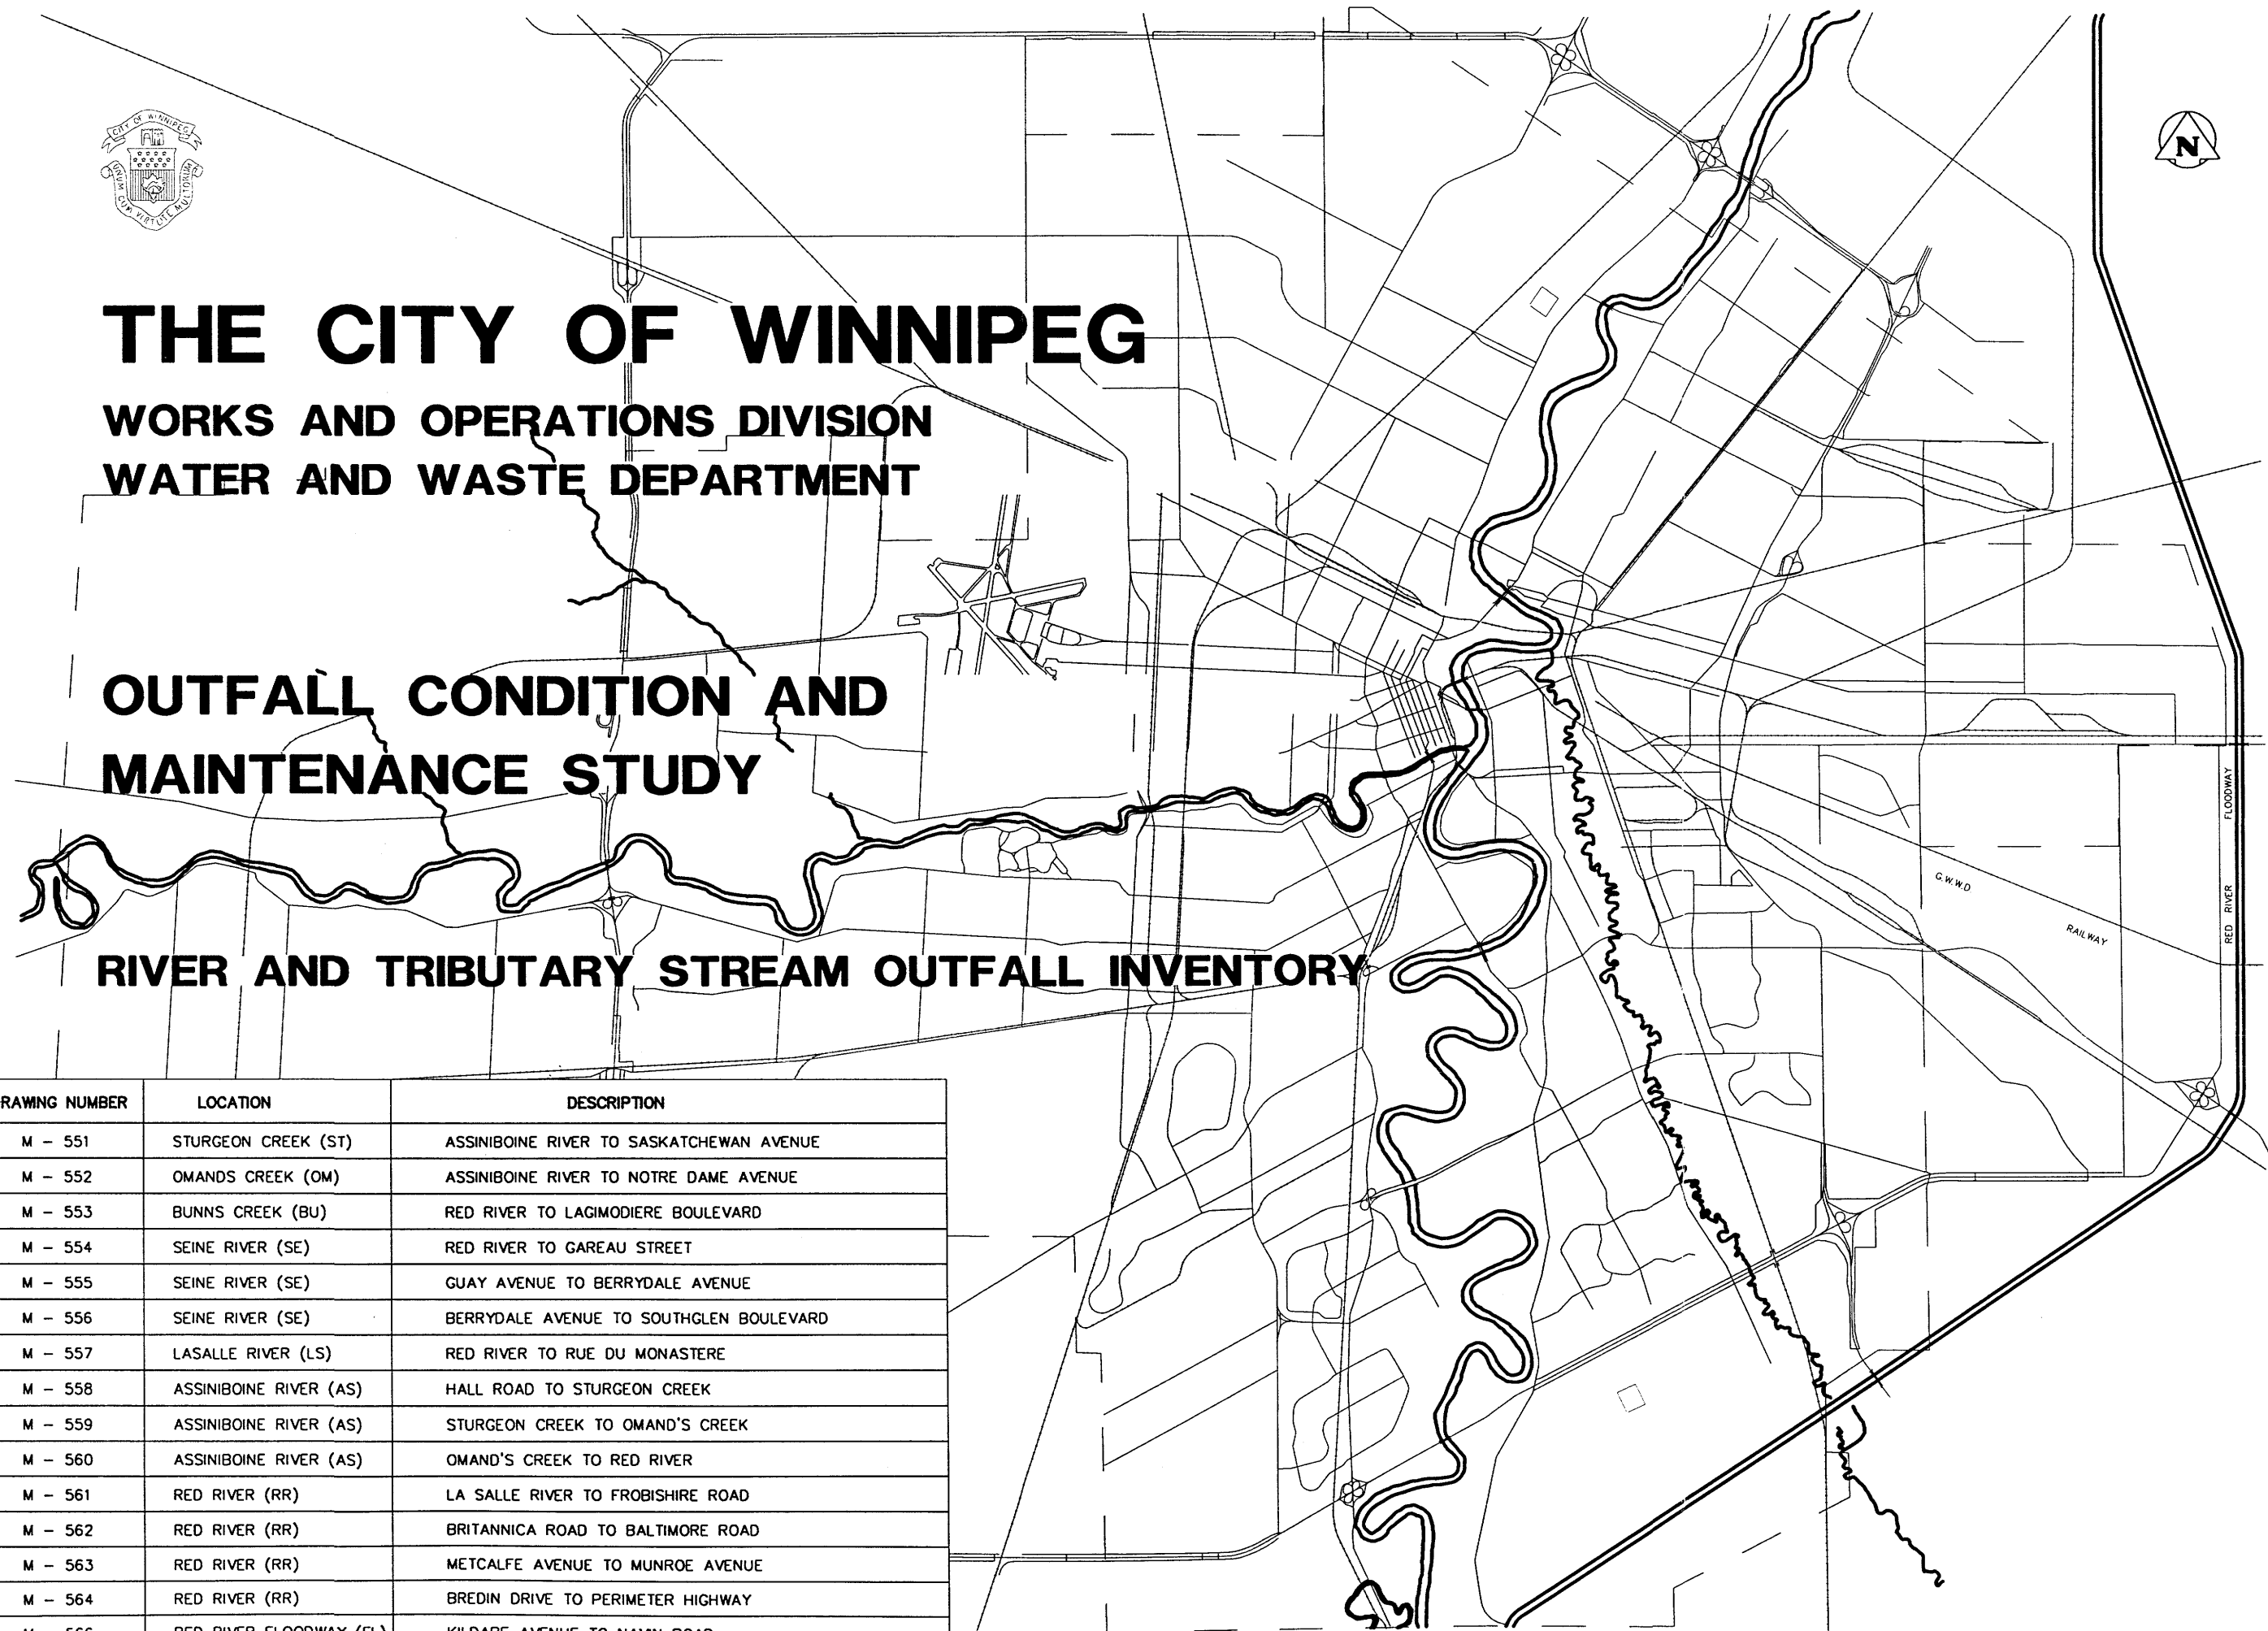
SHEET 1 OF 15
 COMPUTER FILE NAME: M-551
 CITY DRAWING NUMBER

OUTFALL ID. NO.	NAME	TYPE	SIZE
ST-1	OLD MILL RD.	LDS	400 DIA.
ST-2	OAKDEAN CRES.	LDS	300 DIA.
ST-3	BOOTH DR.	LDS	1850 DIA.
ST-4	STURGEON RD. (NORTH)	LDS	1500 DIA.
ST-5	STURGEON RD. (SOUTH)	LDS	1200 DIA.
ST-6	SETTER ST.	LDS	600 DIA.
ST-7	GREENWAY CRES. #1	LDS	600 DIA.
ST-7.1	GREENWAY CRES. #2	LDS	750 DIA.
ST-8	LONSDALE DR. #1	LDS	600 DIA.
ST-9	AMARYNTH CRES. #1	LDS	510 DIA.
ST-10	LONSDALE DR. #2	WWS	300 DIA.
ST-11	KIRBY DR.	LDS	600 DIA. & DITCH
ST-12	AMARYNTH CRES. #2	LDS	400 DIA.
ST-13	ALCOTT ST.	WWS	600 DIA.
ST-14	NESS AVE.	LDS	1900 DIA.
ST-15	VALLEYVIEW DR. #1	WWS	600 DIA.
ST-15A	HERITAGE PUMPING STATION	WWS	
ST-16	VALLEYVIEW DR. #2	LDS	1050 & 125 DIA.
ST-17	HARVEST LANE	LDS	400 DIA.
ST-18	HAMILTON AVE. #1	LDS	1500 DIA.
ST-18.1	HAMILTON AVE. #2	LDS	400 DIA.
ST-19	SILVER AVE.	WWS	525 DIA.
ST-20	VOYAGEUR AVE.	WWS	600 DIA.
ST-21	CRESTVIEW PARK DR. (RETENTION POND DRAINAGE)	LDS	1675 DIA.
ST-22	CRESTVIEW PARK DR.	LDS	750 DIA.

OUTFALL CONDITION AND MAINTENANCE STUDY
STURGEON CREEK
 ASSINIBOINE RIVER TO SASKATCHEWAN AVE.

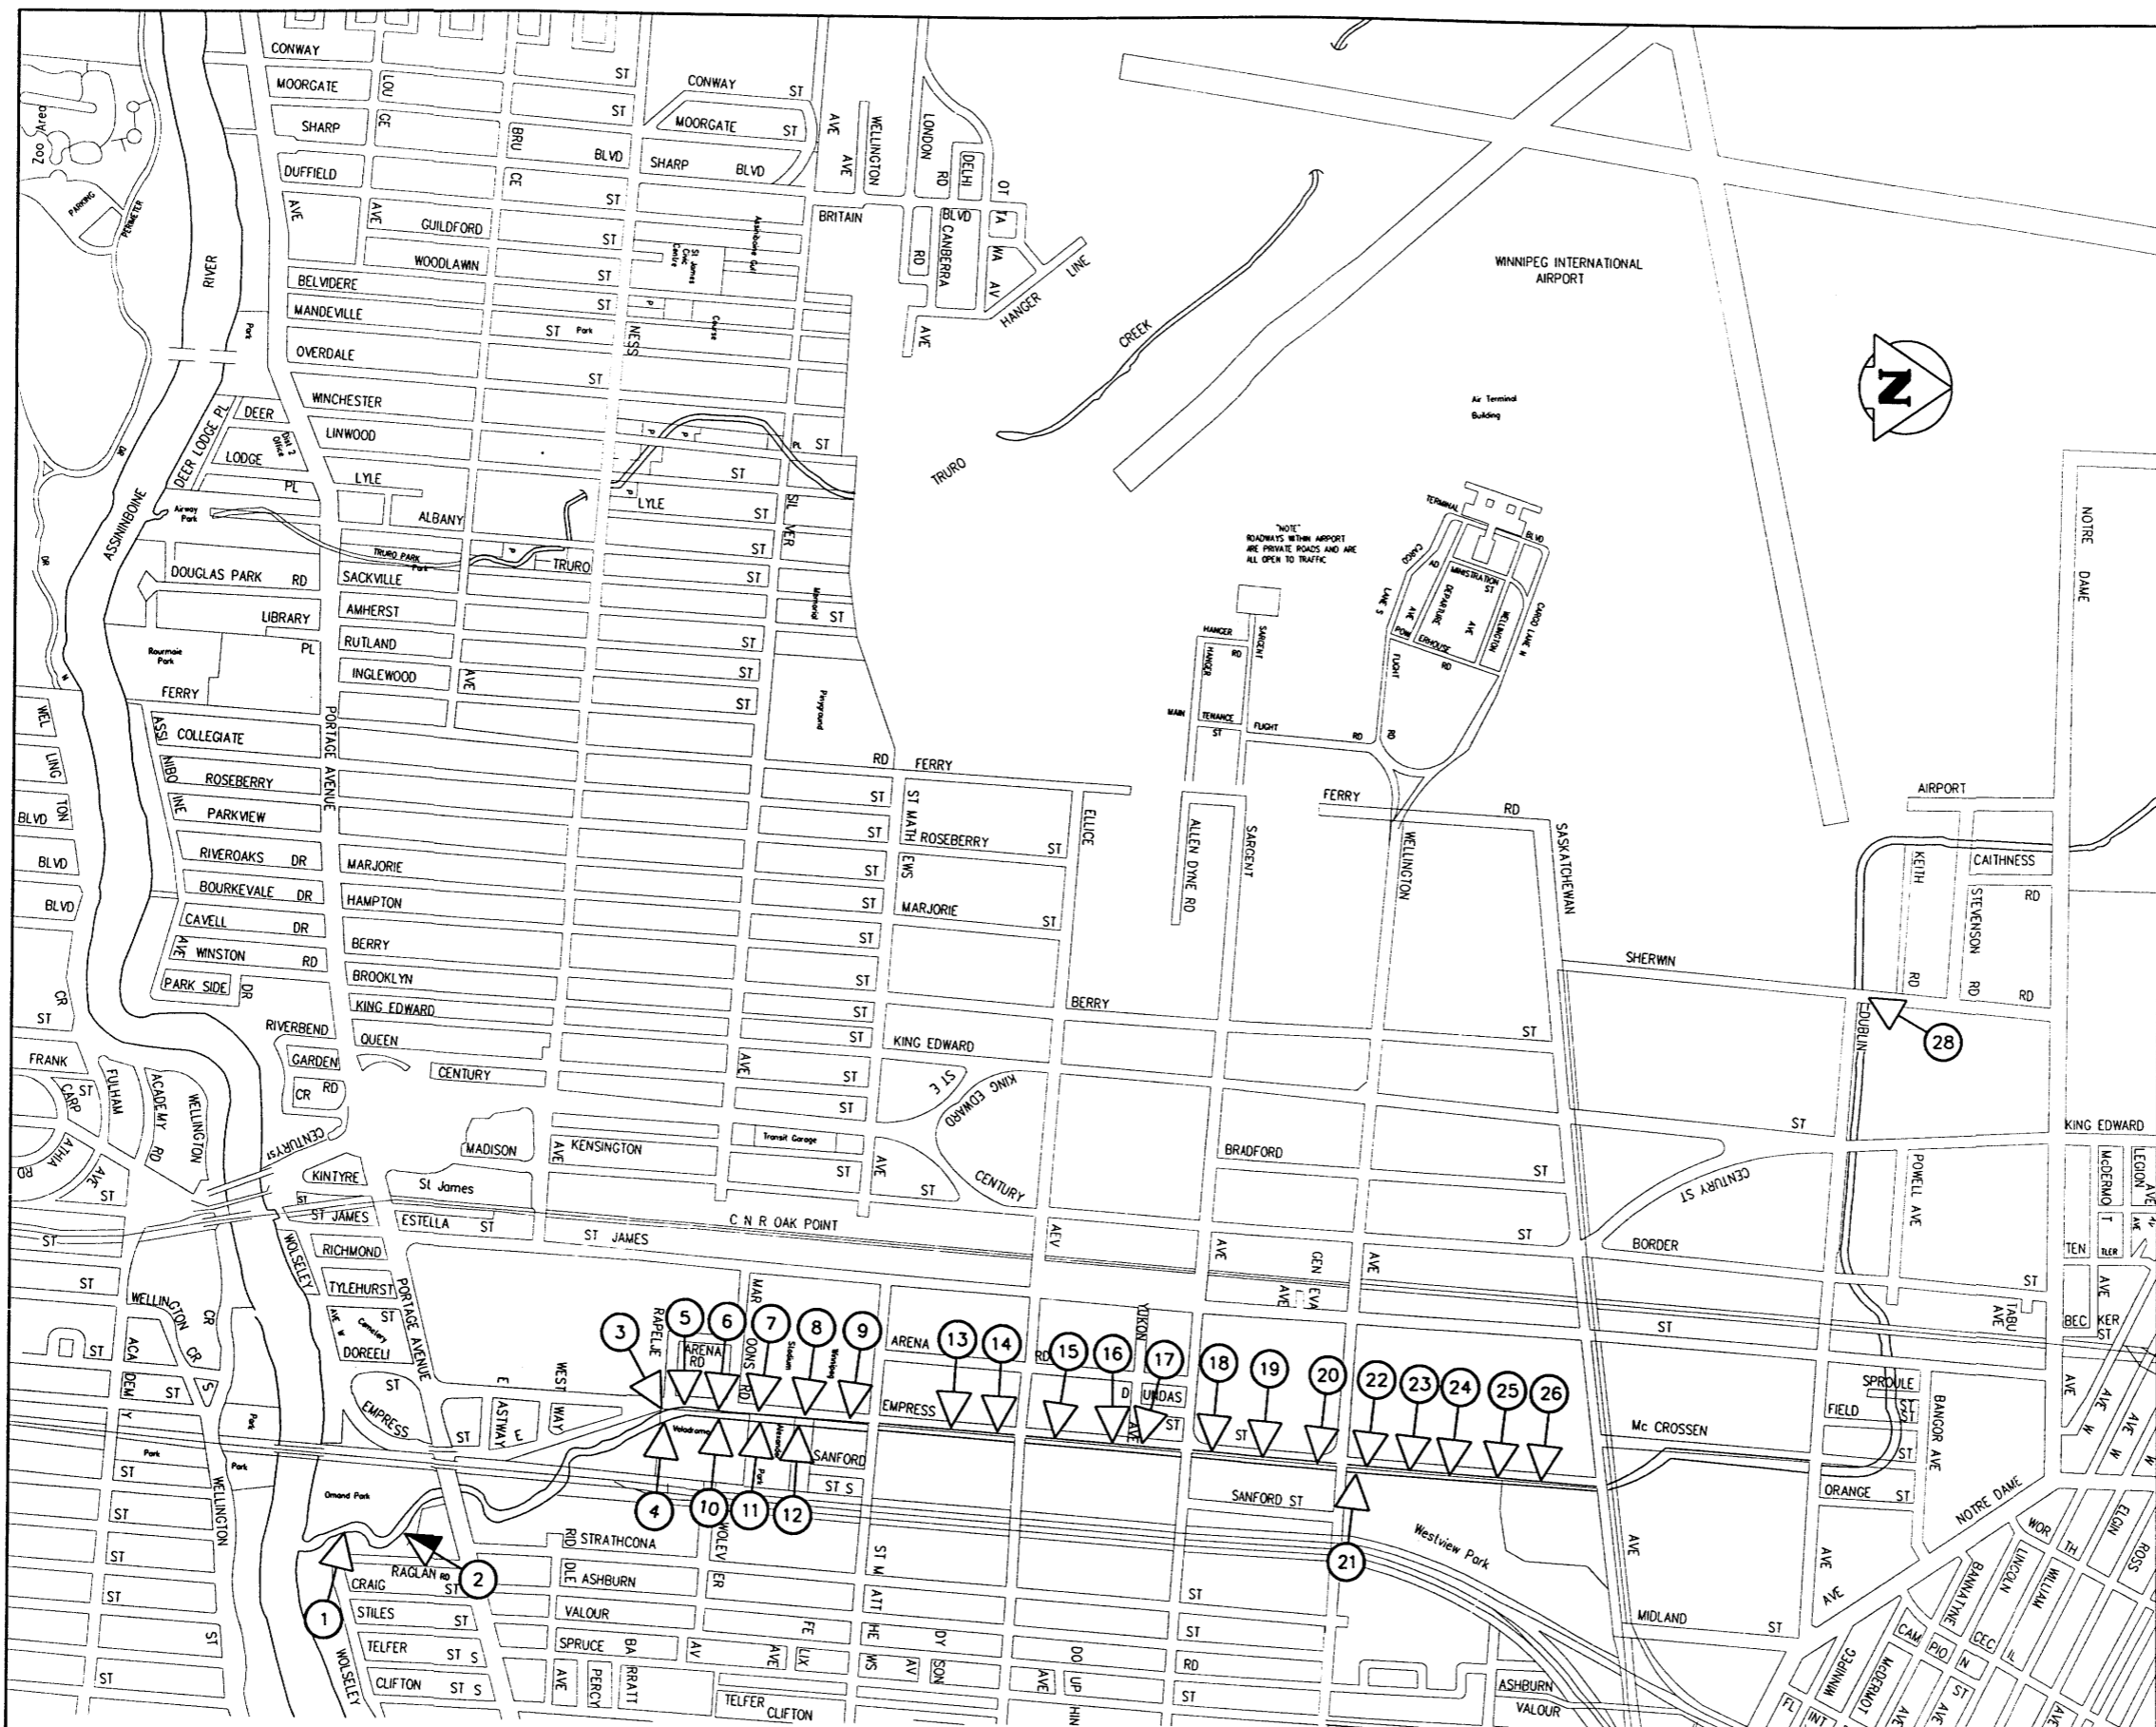
SHEET 2 OF 15
 COMPUTER FILE NAME: M-552
 CITY DRAWING NUMBER

OUTFALL ID. NO.	NAME	TYPE	SIZE
OM-1	RAGLAN RD.	LDS	400 DIA.
OM-2	CLIFTON ST. OVERFLOW	CS	2700 DIA.
OM-3	EMPRESS ST. #1	LDS	750 DIA.
OM-4	VELODROME #1	LDS	380 DIA.
OM-5	EMPRESS ST. #2	LDS	300 DIA.
OM-6	EMPRESS ST. #3	LDS	300 DIA.
OM-7	EMPRESS ST. #4	LDS	300 DIA.
OM-8	EMPRESS ST. #5	LDS	300 DIA.
OM-9	EMPRESS ST. #6	LDS	300 DIA.
OM-10	VELODROME METER PIT	LDS	100 DIA.
OM-11	VELODROME #2	LDS	300 DIA.
OM-12	EMPRESS ST. #7	LDS	300 DIA.
OM-13	EMPRESS ST. #8	LDS	300 DIA.
OM-14	EMPRESS ST. #9	LDS	300 DIA.
OM-15	EMPRESS ST. #10	LDS	300 DIA.
OM-16	EMPRESS ST. #11	LDS	300 DIA.
OM-17	EMPRESS ST. #12	LDS	300 DIA.
OM-18	EMPRESS ST. #13	LDS	300 DIA.
OM-19	EMPRESS ST. #14	LDS	300 DIA.
OM-20	WESTVIEW PARK CHANNEL	LDS	
OM-21	EMPRESS ST. #15	LDS	300 DIA.
OM-22	EMPRESS ST. #16	LDS	300 DIA.
OM-23	EMPRESS ST. #17	LDS	300 DIA.
OM-24	EMPRESS ST. #18	LDS	300 DIA.
OM-25	EMPRESS ST. #19	LDS	300 DIA.
OM-26	EMPRESS ST. #20	LDS	300 DIA.
OM-28	ABANDONED	LDS

OUTFALL CONDITION AND MAINTENANCE STUDY
OMAND'S CREEK
 ASSINIBOINE RIVER NORTH TO NOTRE DAME AVENUE

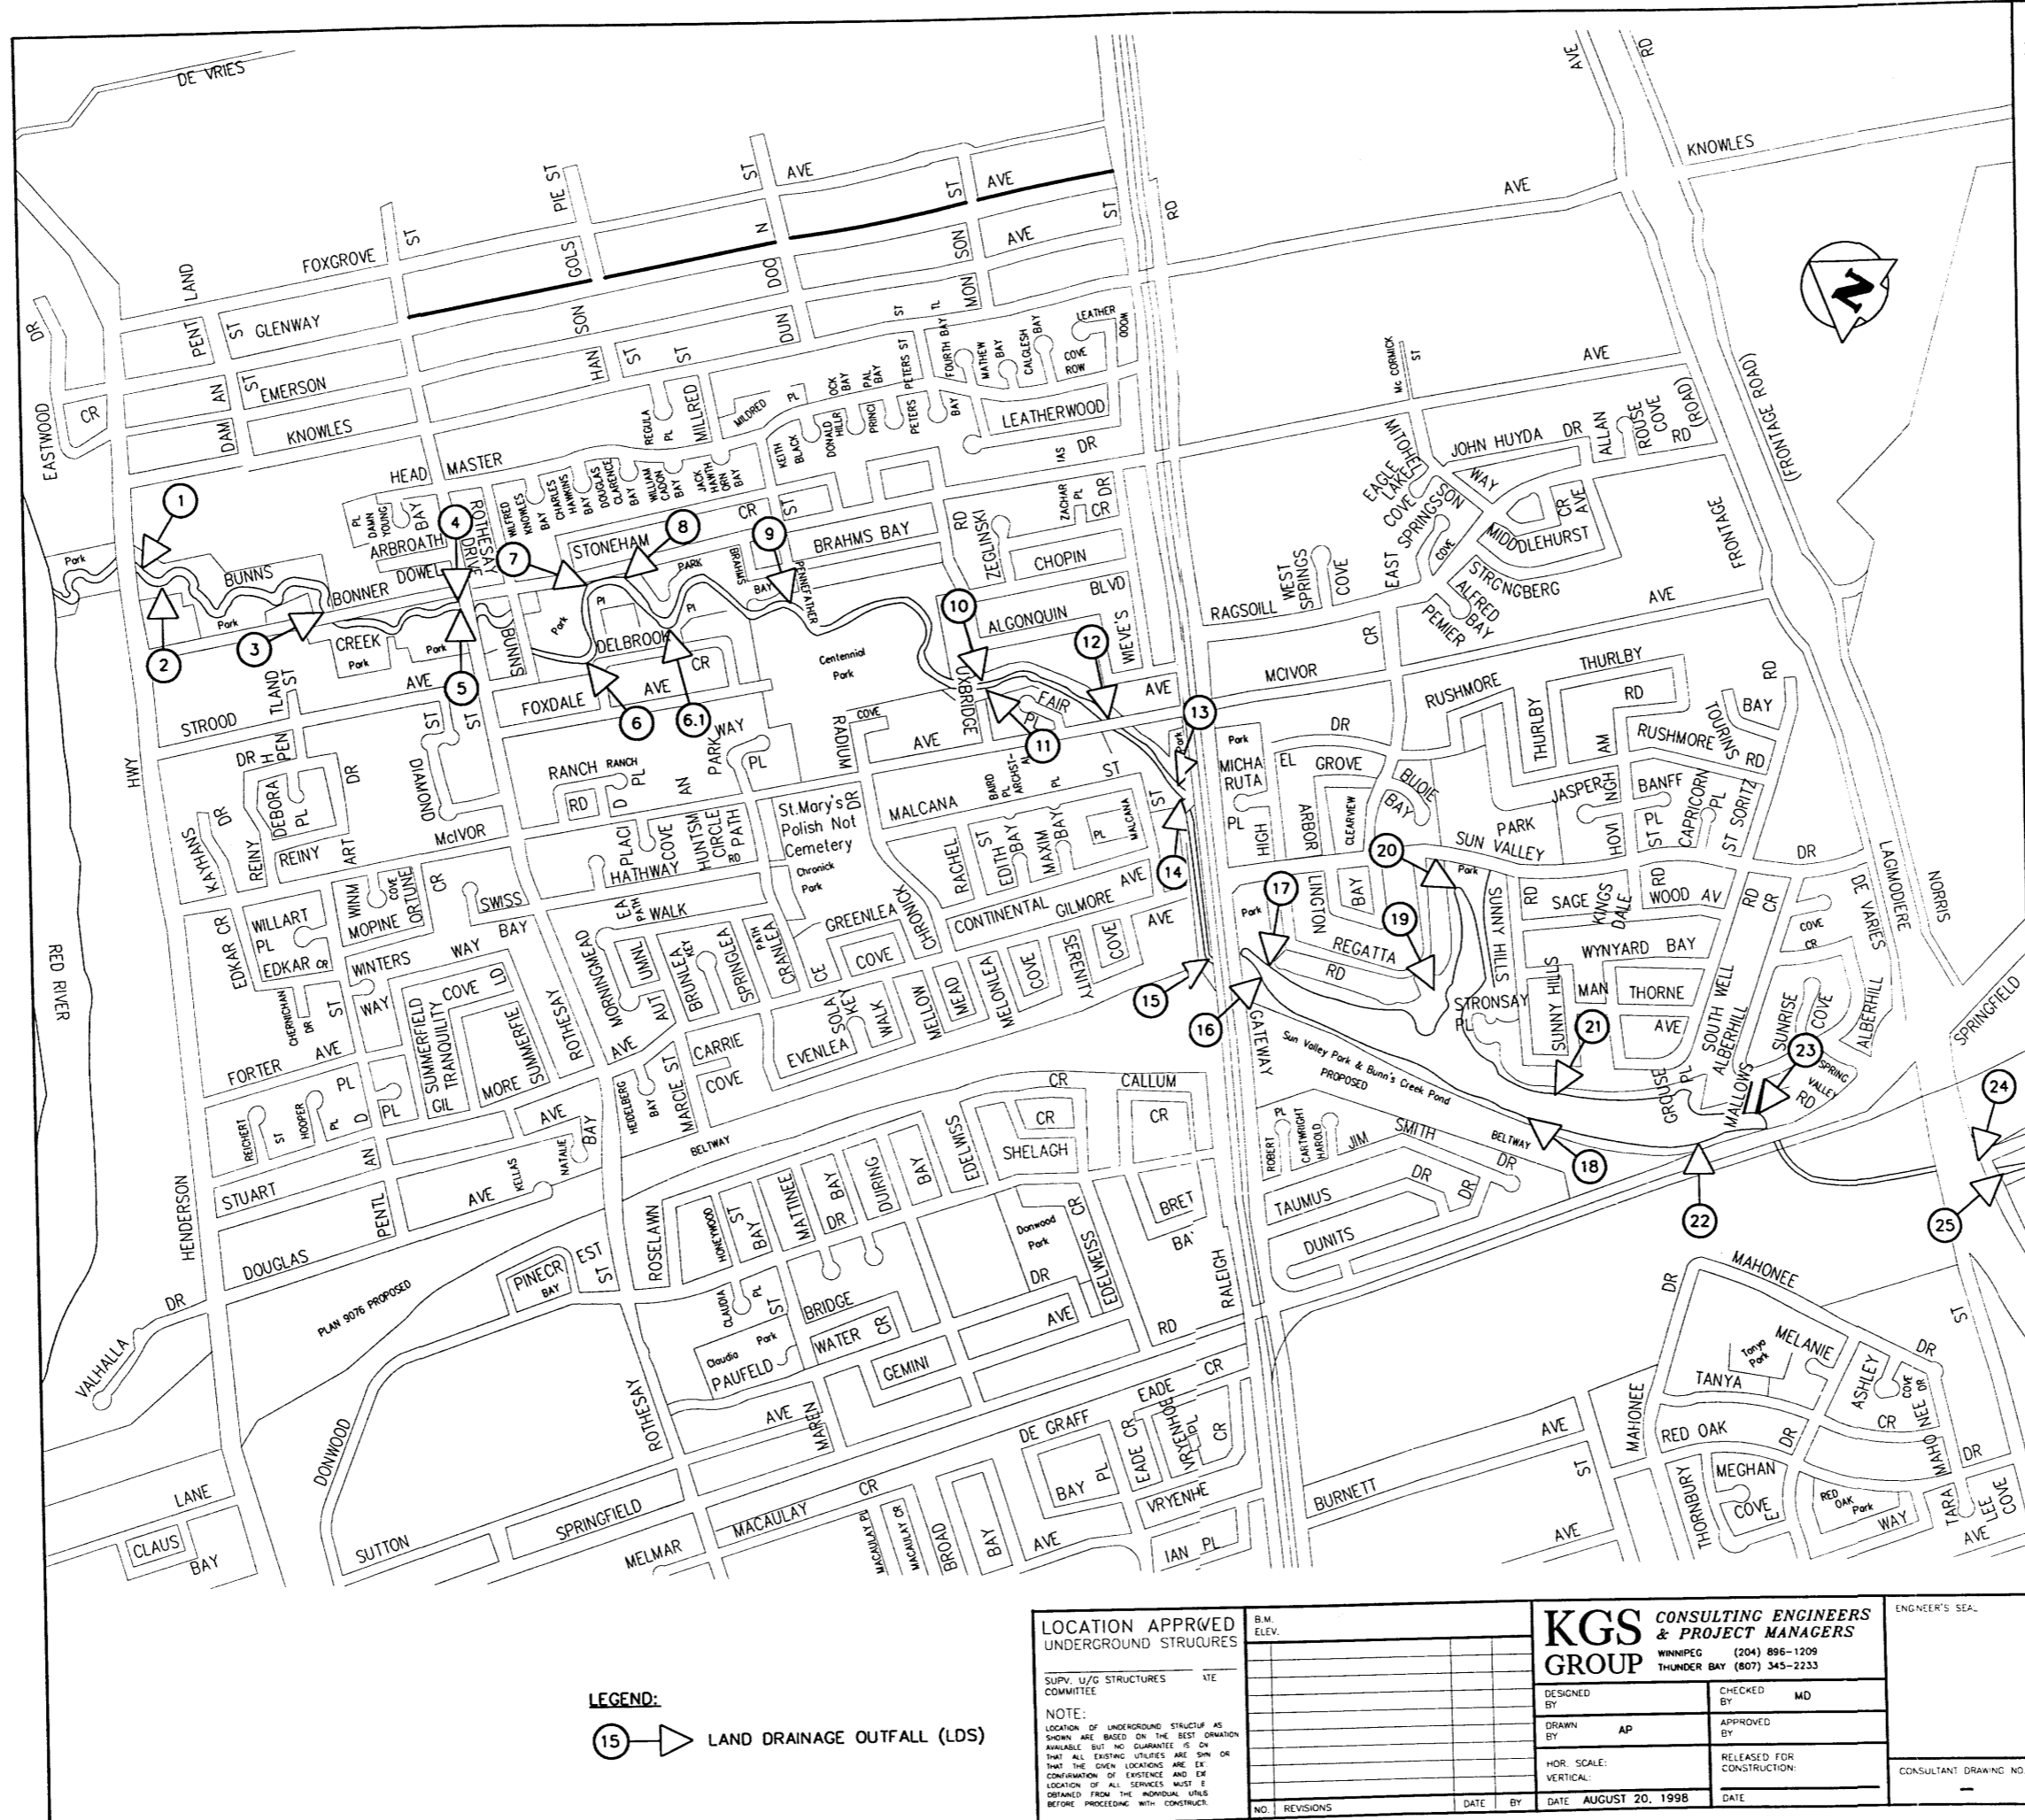
SHEET 3 OF 15
 COMPUTER FILE NAME: M-553
 CITY DRAWING NUMBER: []

OUTFALL NO.	NAME	TYPE	SIZE
BU-1	HENDERSON HWY. #1	LDS	1375 DIA.
BU-2	HENDERSON HWY. #2	LDS	1200 DIA.
BU-3	BONNER AVE. #1	LDS	525 DIA.
BU-4	ROTHESAY ST. N.	LDS	1200 DIA.
BU-5	ROTHESAY ST. S.	LDS	1200 DIA.
BU-6	DELBROOK CRES. #1	LDS	400 DIA.
BU-6.1	DELBROOK CRES. #2	LDS	600 DIA.
BU-7	BONNER AVE. #2	LDS	400 DIA.
BU-8	BONNER AVE. #3	LDS	375 DIA.
BU-9	PENNEFATHER ST.	LDS	1350 DIA.
BU-10	UXBRIDGE RD. N.	LDS	1200 DIA.
BU-11	UXBRIDGE RD. S.	LDS	900 DIA.
BU-12	McVOR AVE.	LDS	400 DIA.
BU-13	RALEIGH ST. #1	LDS	400 DIA.
BU-14	RALEIGH ST. #2	LDS	750 DIA.
BU-15	RALEIGH ST. #3	LDS	750 DIA.
BU-16	GATEWAY RD.	LDS	800 DIA.
BU-17	REGATTA RD. #1	LDS	300 DIA.
BU-18	JIM SMITH DR.	LDS	1390x975
BU-19	REGATTA RD. #2	LDS	300 DIA.
BU-20	SUN VALLEY DR.	LDS	1800 DIA.
BU-21	SUNNY HILLS RD.	LDS	725 DIA.
BU-22	WPG. HYDRO TRANSMISSION LINE	LDS	2125 DIA.
BU-23	MALLOWS WAY	LDS	900 DIA.
BU-24	KILCONA REGIONAL PARK LAKES	LDS	DITCH
BU-25	LAGMODIERE BLVD.	LDS	DITCH

OUTFALL CONDITION AND MAINTENANCE STUDY
BUNNS CREEK
 RED RIVER TO LAGMODIERE BLVD.

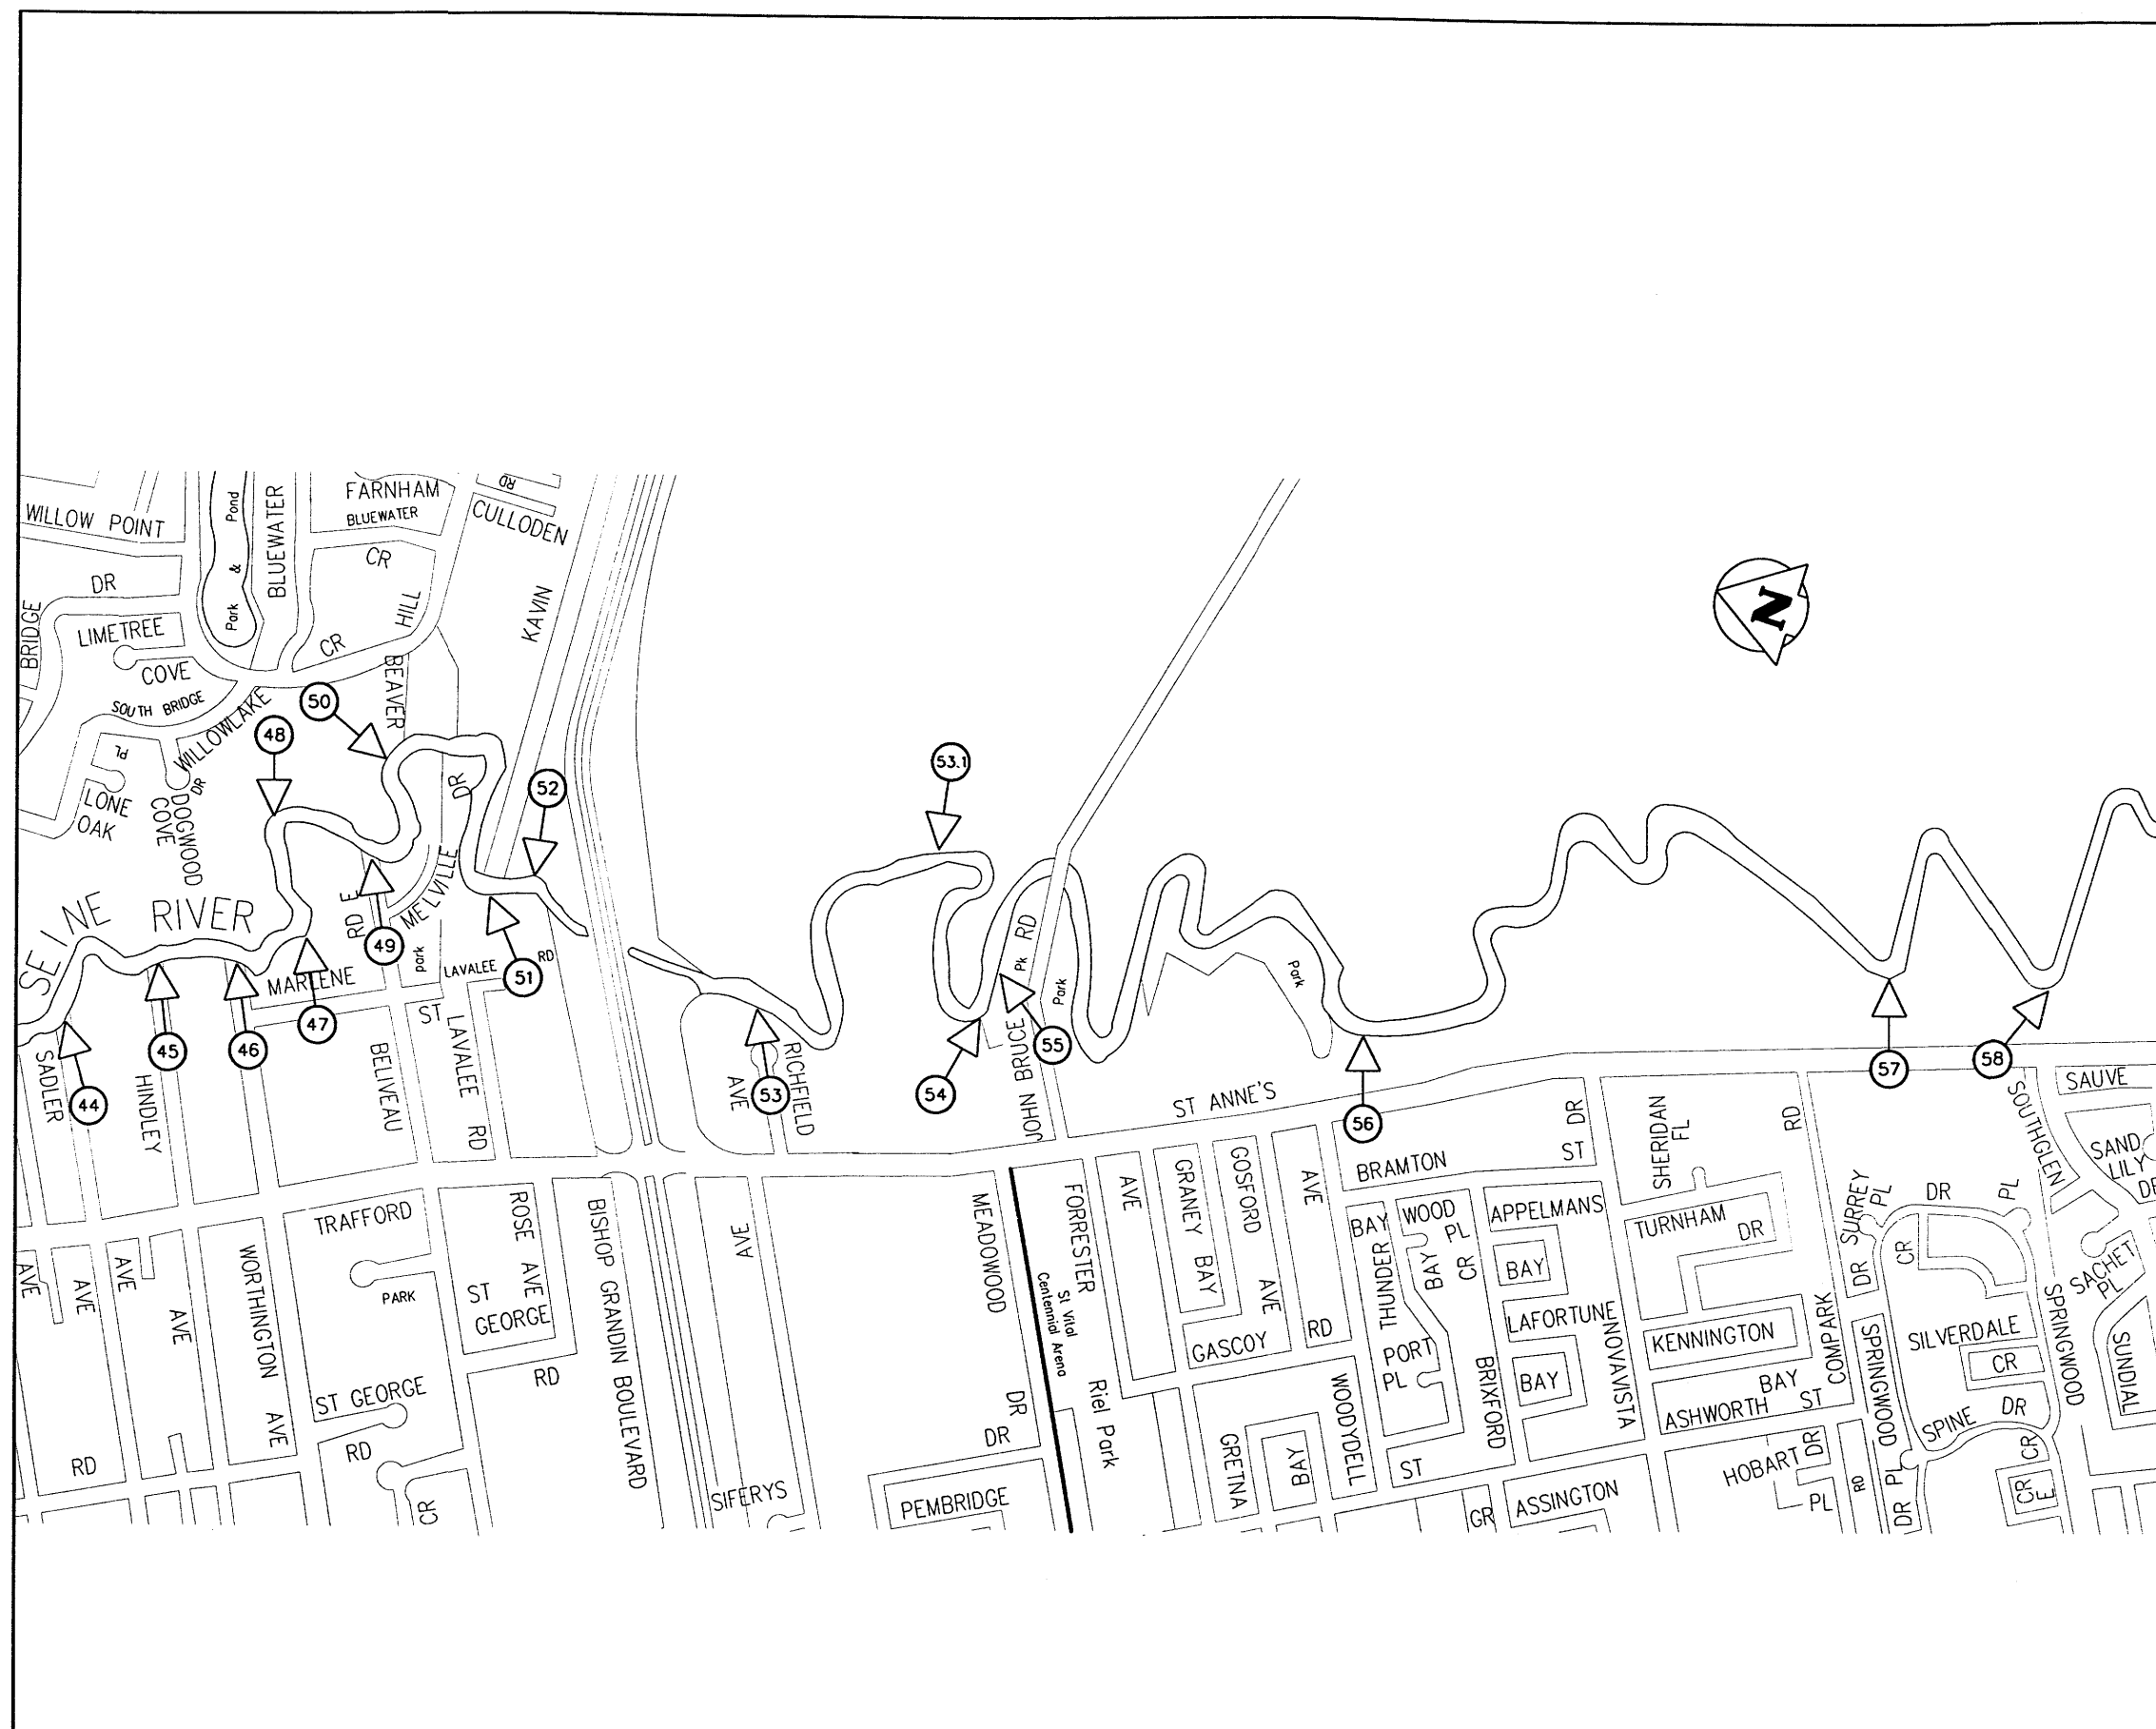
SHEET 6 OF 15
 COMPUTER FILE NAME: M-556
 CITY DRAWING NUMBER

OUTFALL ID. NO.	NAME	TYPE	SIZE
SE-44	SADLER AVE.	LDS	1050 DIA.
SE-45	HINDLEY AVE.	LDS	525 DIA.
SE-46	WORTHINGTON AVE.	LDS	750 DIA.
SE-47	MARLENE ST.	LDS	525 DIA.
SE-48	WILLOWLAKE CR.	LDS	1525 DIA.
SE-49	BELIVEAU RD.	LDS	1050 DIA.
SE-50	N. OF BEAVERHILL BLVD.	LDS	900 DIA.
SE-51	LAVALEE RD.	LDS	1200 DIA.
SE-52	BISHOP GRANDIN BLVD.	LDS	800 DIA. & DITCH
SE-53	RICHFIELD AVE.	LDS	1200 DIA.
SE-53.1	ROYALWOOD SUBDIVISION	LDS	450 DIA.
SE-54	PUBLIC LANE E. OF MEADOWWOOD DR.	LDS	1200 DIA.
SE-55	N. OF JOHN BRUCE RD.	LDS	1200 DIA.
SE-56	WOODYDELL AVE.	LDS	1200 DIA.
SE-57	COMPARK RD.	LDS	1400 DIA.
SE-58	SOUTHGLEN DR.	LDS	1600 DIA.
SE-58.1	ST. ANNES RD.	LDS	2-1600 DIA.

OUTFALL CONDITION AND MAINTENANCE STUDY
SEINE RIVER
 BERRYDALE AVE. TO SOUTHGLEN BLVD.
