APPENDIX A – 1998 OUTFALL INSPECTIONS CONDITION AND MAINTENANCE STUDY

CITY OF WINNIPEG
OUTFALL CONDITION
AND
MAINTENANCE STUDY
FINAL REPORT //

August, 1998

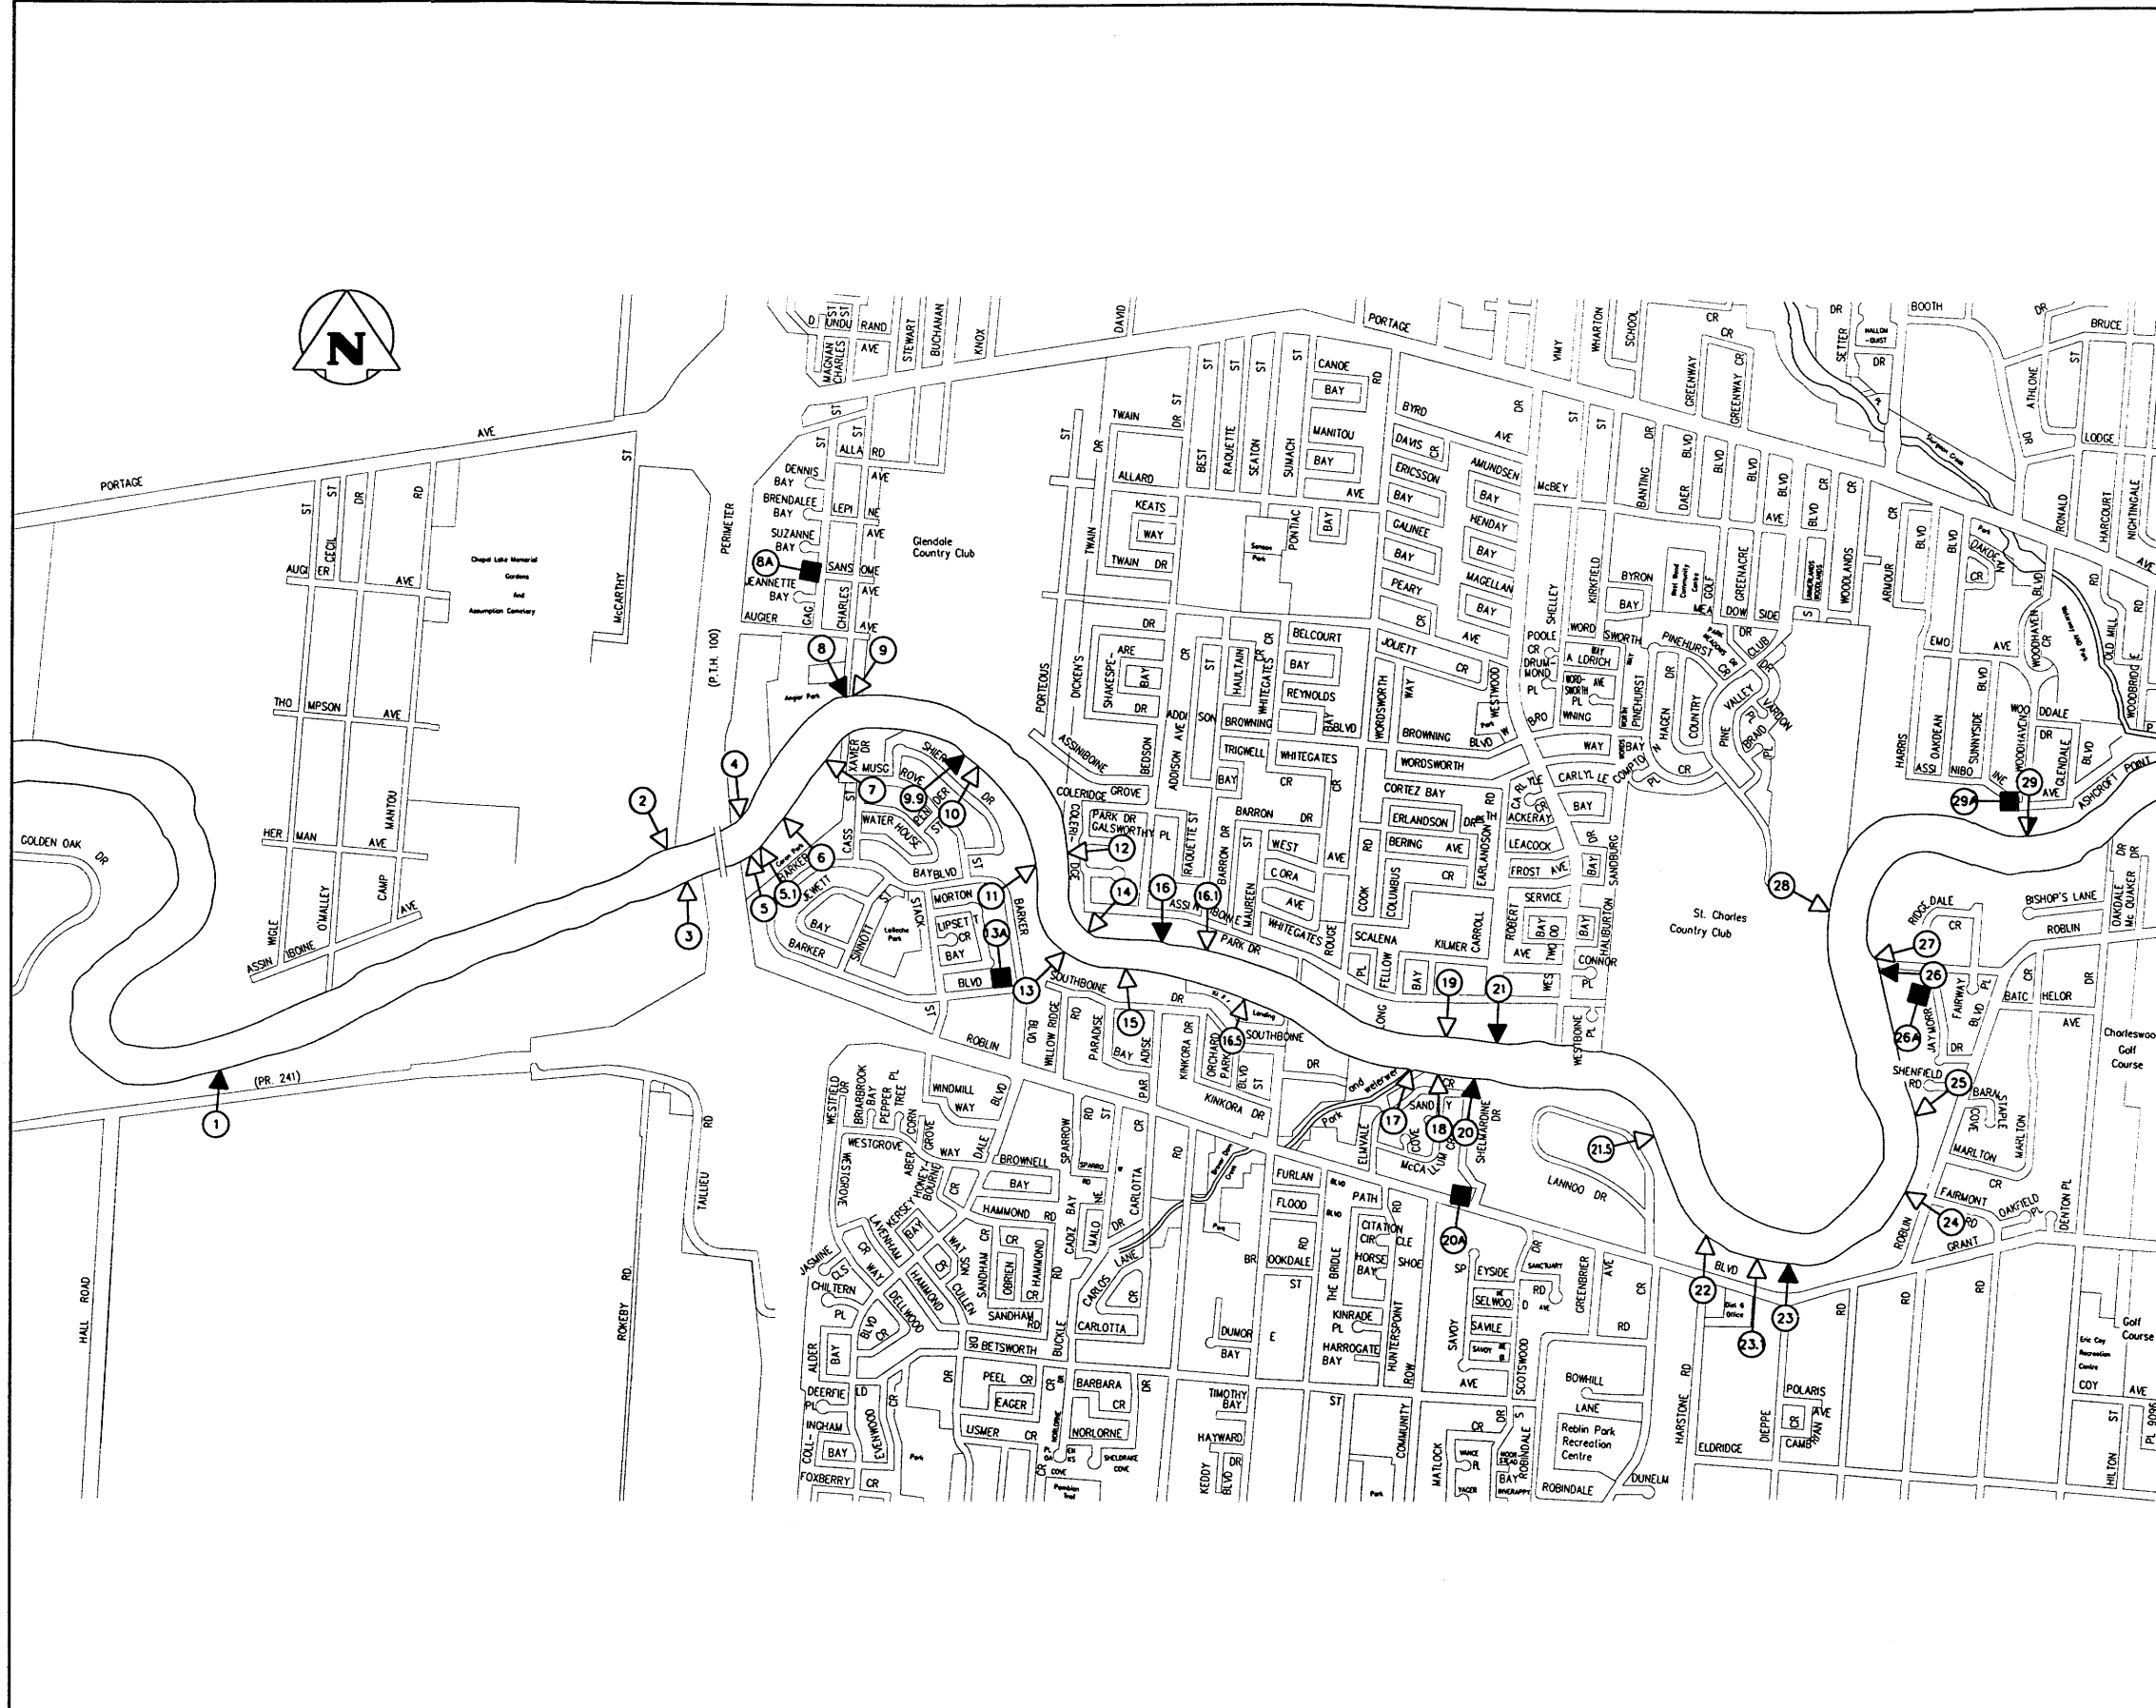
SHEET 8 OF 15

OUTFALL ID. NO.	NAME	TYPE	SIZE
AS-1	W.E.W.P.C.C. OUTFALL	TE	1500 DIA.
AS-2	P.T.H. 100 W. SIDE #1	LDS	1400 DIA.
AS-3	P.T.H. 100 W. SIDE #2	LDS	1350 DIA.
AS-4	P.T.H. 100 E. SIDE #1	LDS	800 DIA.
AS-5	P.T.H. 100 E. SIDE #2	LDS	1200 DIA.
AS-5.1	P.T.H. 100 E. SIDE #3	LDS	1500 DIA.
AS-6	BARKER SPS	LDS	150 DIA.
AS-7	CARON PARK	LDS	150 DIA.
AS-8	ST. CHARLES ST.	WWS	250 DIA.
AS-8A	ST. CHARLES ST. LIFT STATION	WWS	
AS-9	ST. CHARLES ST. #2	LDS	900 DIA.
AS-9.9	SHER DR.	WWS	250 DIA.
AS-10	PENDER ST.	LDS	900 DIA.
AS-11	BARKER BLVD.	LDS	1075 DIA.
AS-12	GALSWORTHY PL.	LDS	450 DIA.
AS-13	WILLOW RIDGE RD.	LDS	1800 DIA.
AS-13A	BARKER BLVD. LIFT STATION OVERFLOW	WWS	
AS-14	COLERIDGE PARK DR. SOUTH	LDS	450 DIA.
AS-15	PARADISE BAY	LDS	600 DIA.
AS-16	ABANDONED	WWS	450 DIA.
AS-16.1	RAQUETTE ST.	LDS	1800 DIA.
AS-16.5	ORCHARD PARK	LDS	600 DIA.
AS-17	BEAVER DAM CREEK ENTERS	LDS	
AS-18	McCALLUM CRESC.	LDS	1350 DIA.
AS-19	CARROLL RD.	LDS	1800 DIA.

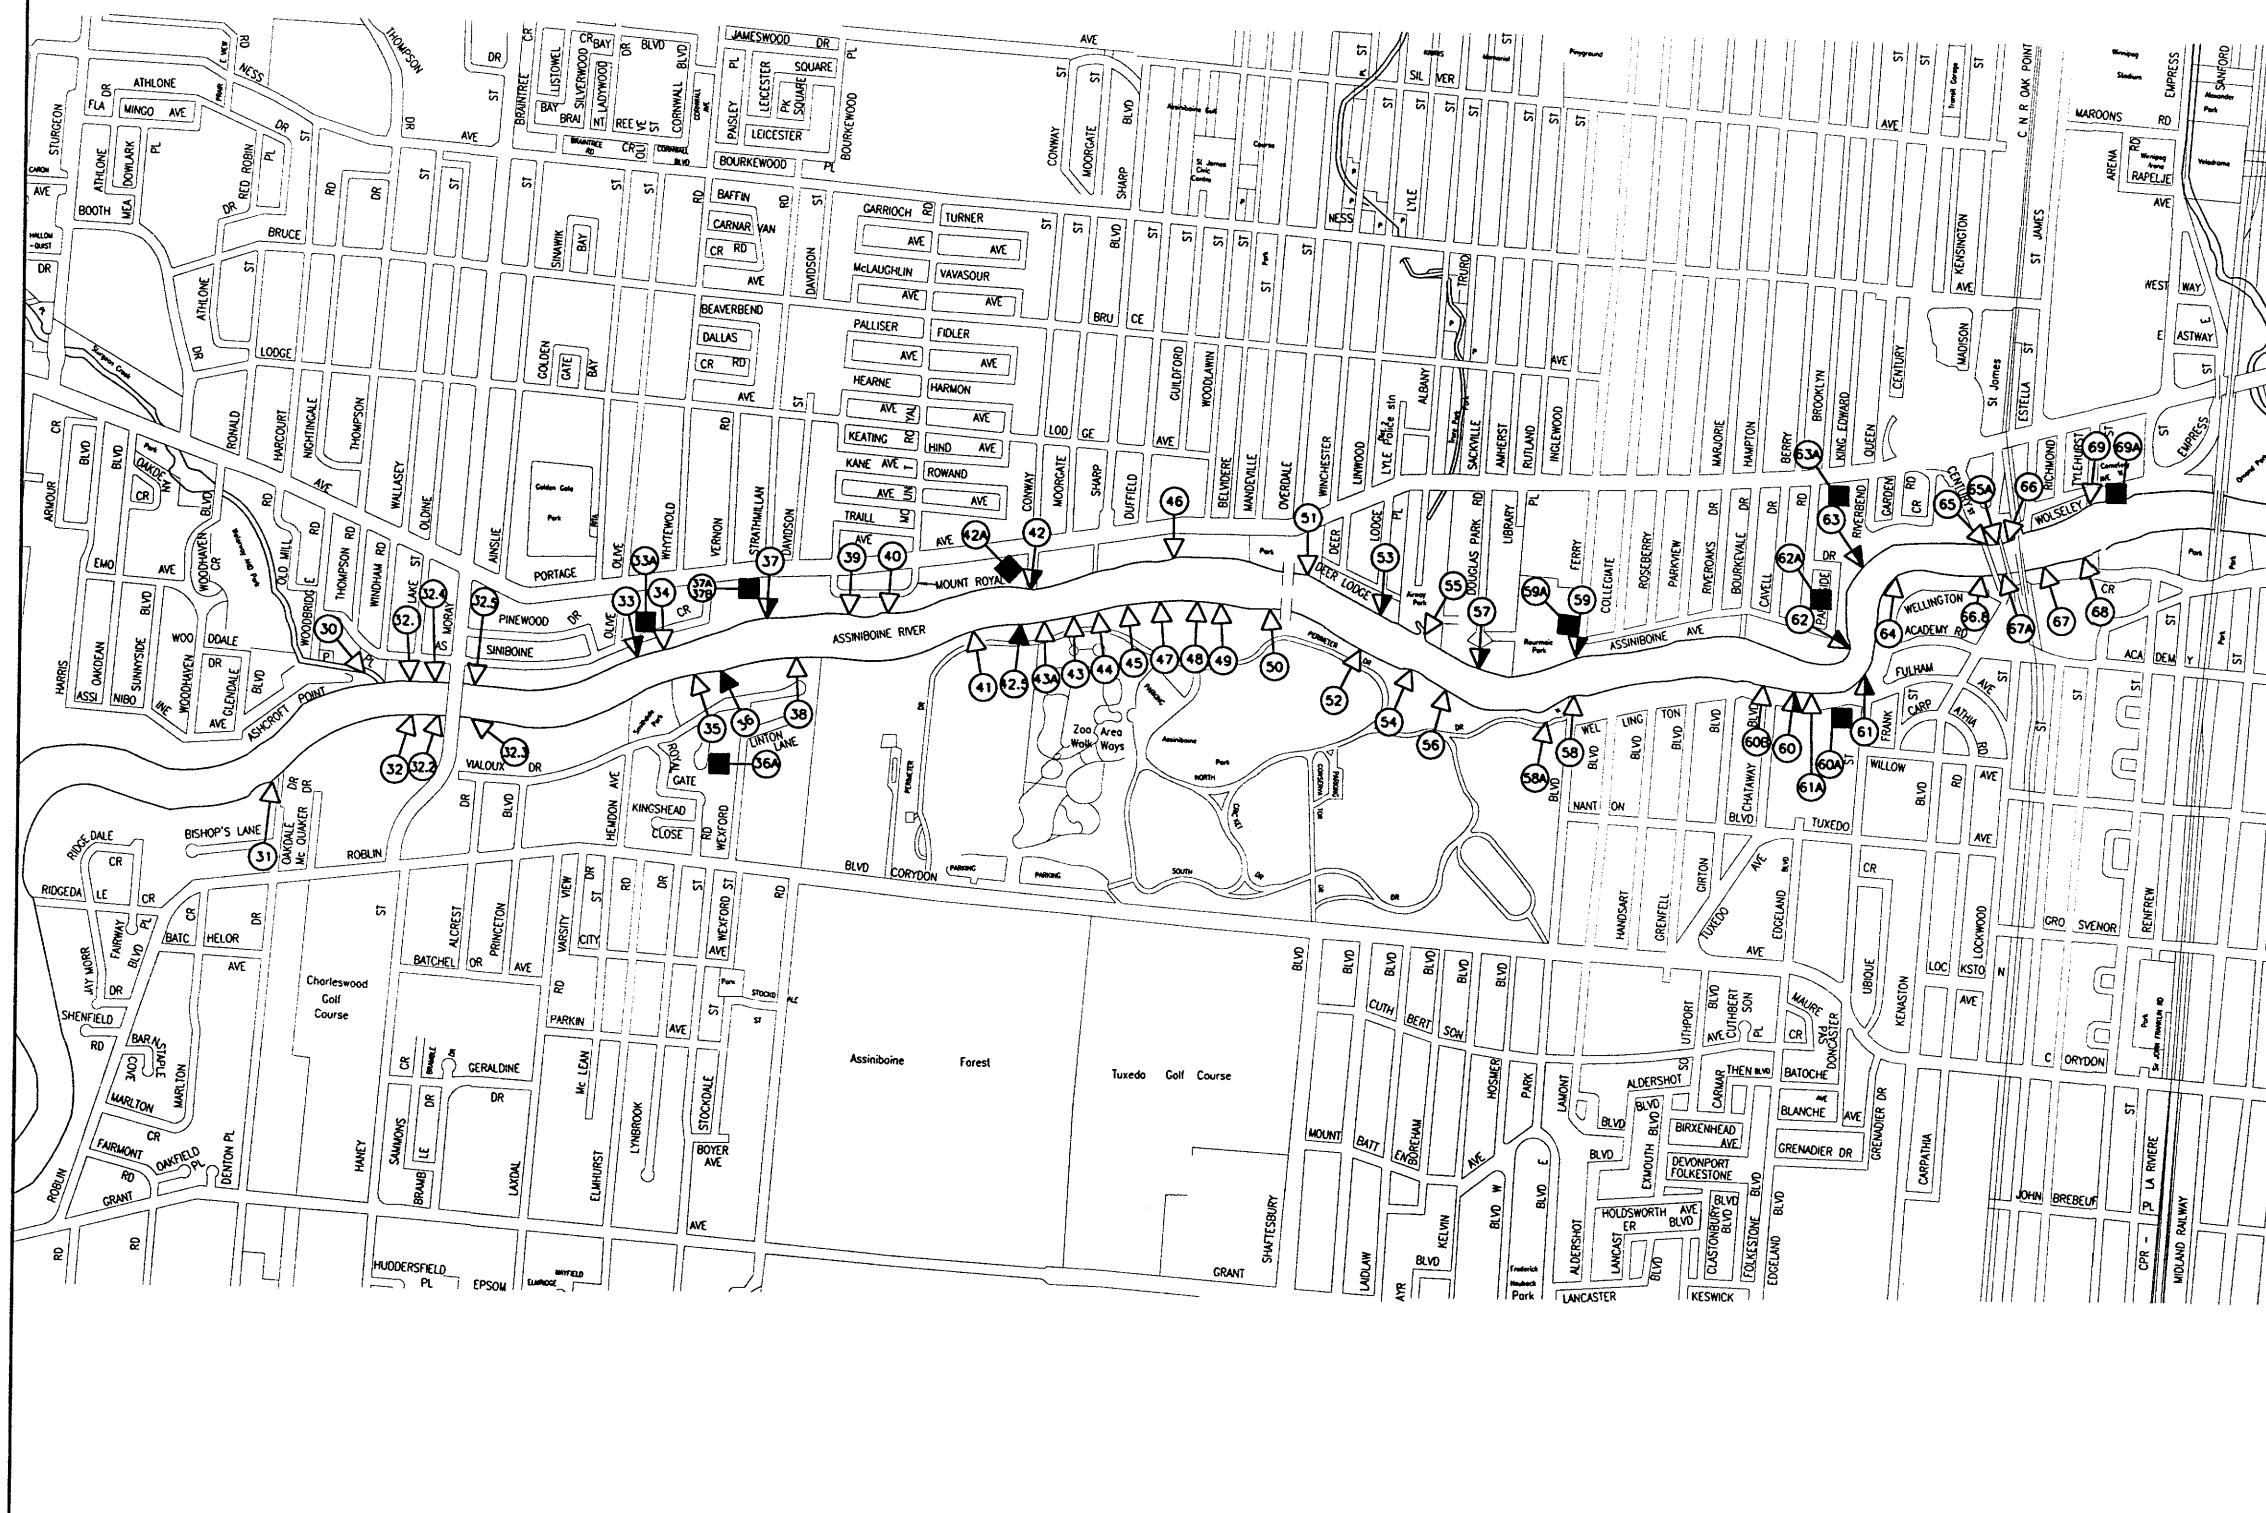
SHEET 9 OF 15
COMPUTER FILE NAME M-559
CITY DRAWING NUMBER

OUTFALL ID. NO.	NAME	TYPE	SIZE
AS-30	STURGEON CREEK ENTERS	LDS	CHANNEL
AS-31	OAKDALE DR.	LDS	600 DIA.
AS-32	MCQUAKER DR.	LDS	1050 DIA.
AS-32.1	ASSINIBOINE CRES.	LDS	300 DIA.
AS-32.2	CHARLESWOOD BRIDGE SW	LDS	250 DIA.
AS-32.3	CHARLESWOOD BRIDGE SE	LDS	250 DIA.
AS-32.4	CHARLESWOOD BRIDGE NW	LDS	250 DIA.
AS-32.5	CHARLESWOOD BRIDGE NE	LDS	250 DIA.
AS-33	OLIVE ST. #1	CS	750 DIA.
AS-33A	OLIVE ST. LIFT STATION	WWS	
AS-34	OLIVE ST. #2	LDS	2200 DIA.
AS-35	VALOUX DR.	LDS	1500 DIA.
AS-36	WEXFORD S.P.S.	CS	250 DIA.
AS-36A	WEXFORD LIFT STATION	CS	250 DIA.
AS-37	STRATHMILLAN RD.	CS	900 DIA.
AS-37A	STRATHMILLAN COMMUNATOR CHAMBER OVERFLOW	CS	
AS-37B	STRATHMILLAN GATE CHAMBER	CS	300 DIA.
AS-38	VALOUX DR. CUL-DE-SAC	LDS	750 DIA.
AS-39	MOUNT ROYAL CRES. #1	LDS	150 DIA.
AS-40	MOUNT ROYAL CRES. #2	LDS	250 DIA.
AS-41	PERIMETER DR.-ASSINIBOINE PARK #1	LDS	DITCH/DRAIN
AS-42	CONWAY CS	CS	2500 DIA.
AS-42A	CONWAY LIFT STATION	CS	
AS-42.5	PERIMETER DR.-ASSINIBOINE PARK #2	CS	300 DIA.

OUTFALL CONDITION AND MAINTENANCE STUDY
ASSINIBOINE RIVER
STURGEON CREEK TO OMAND'S CREEK

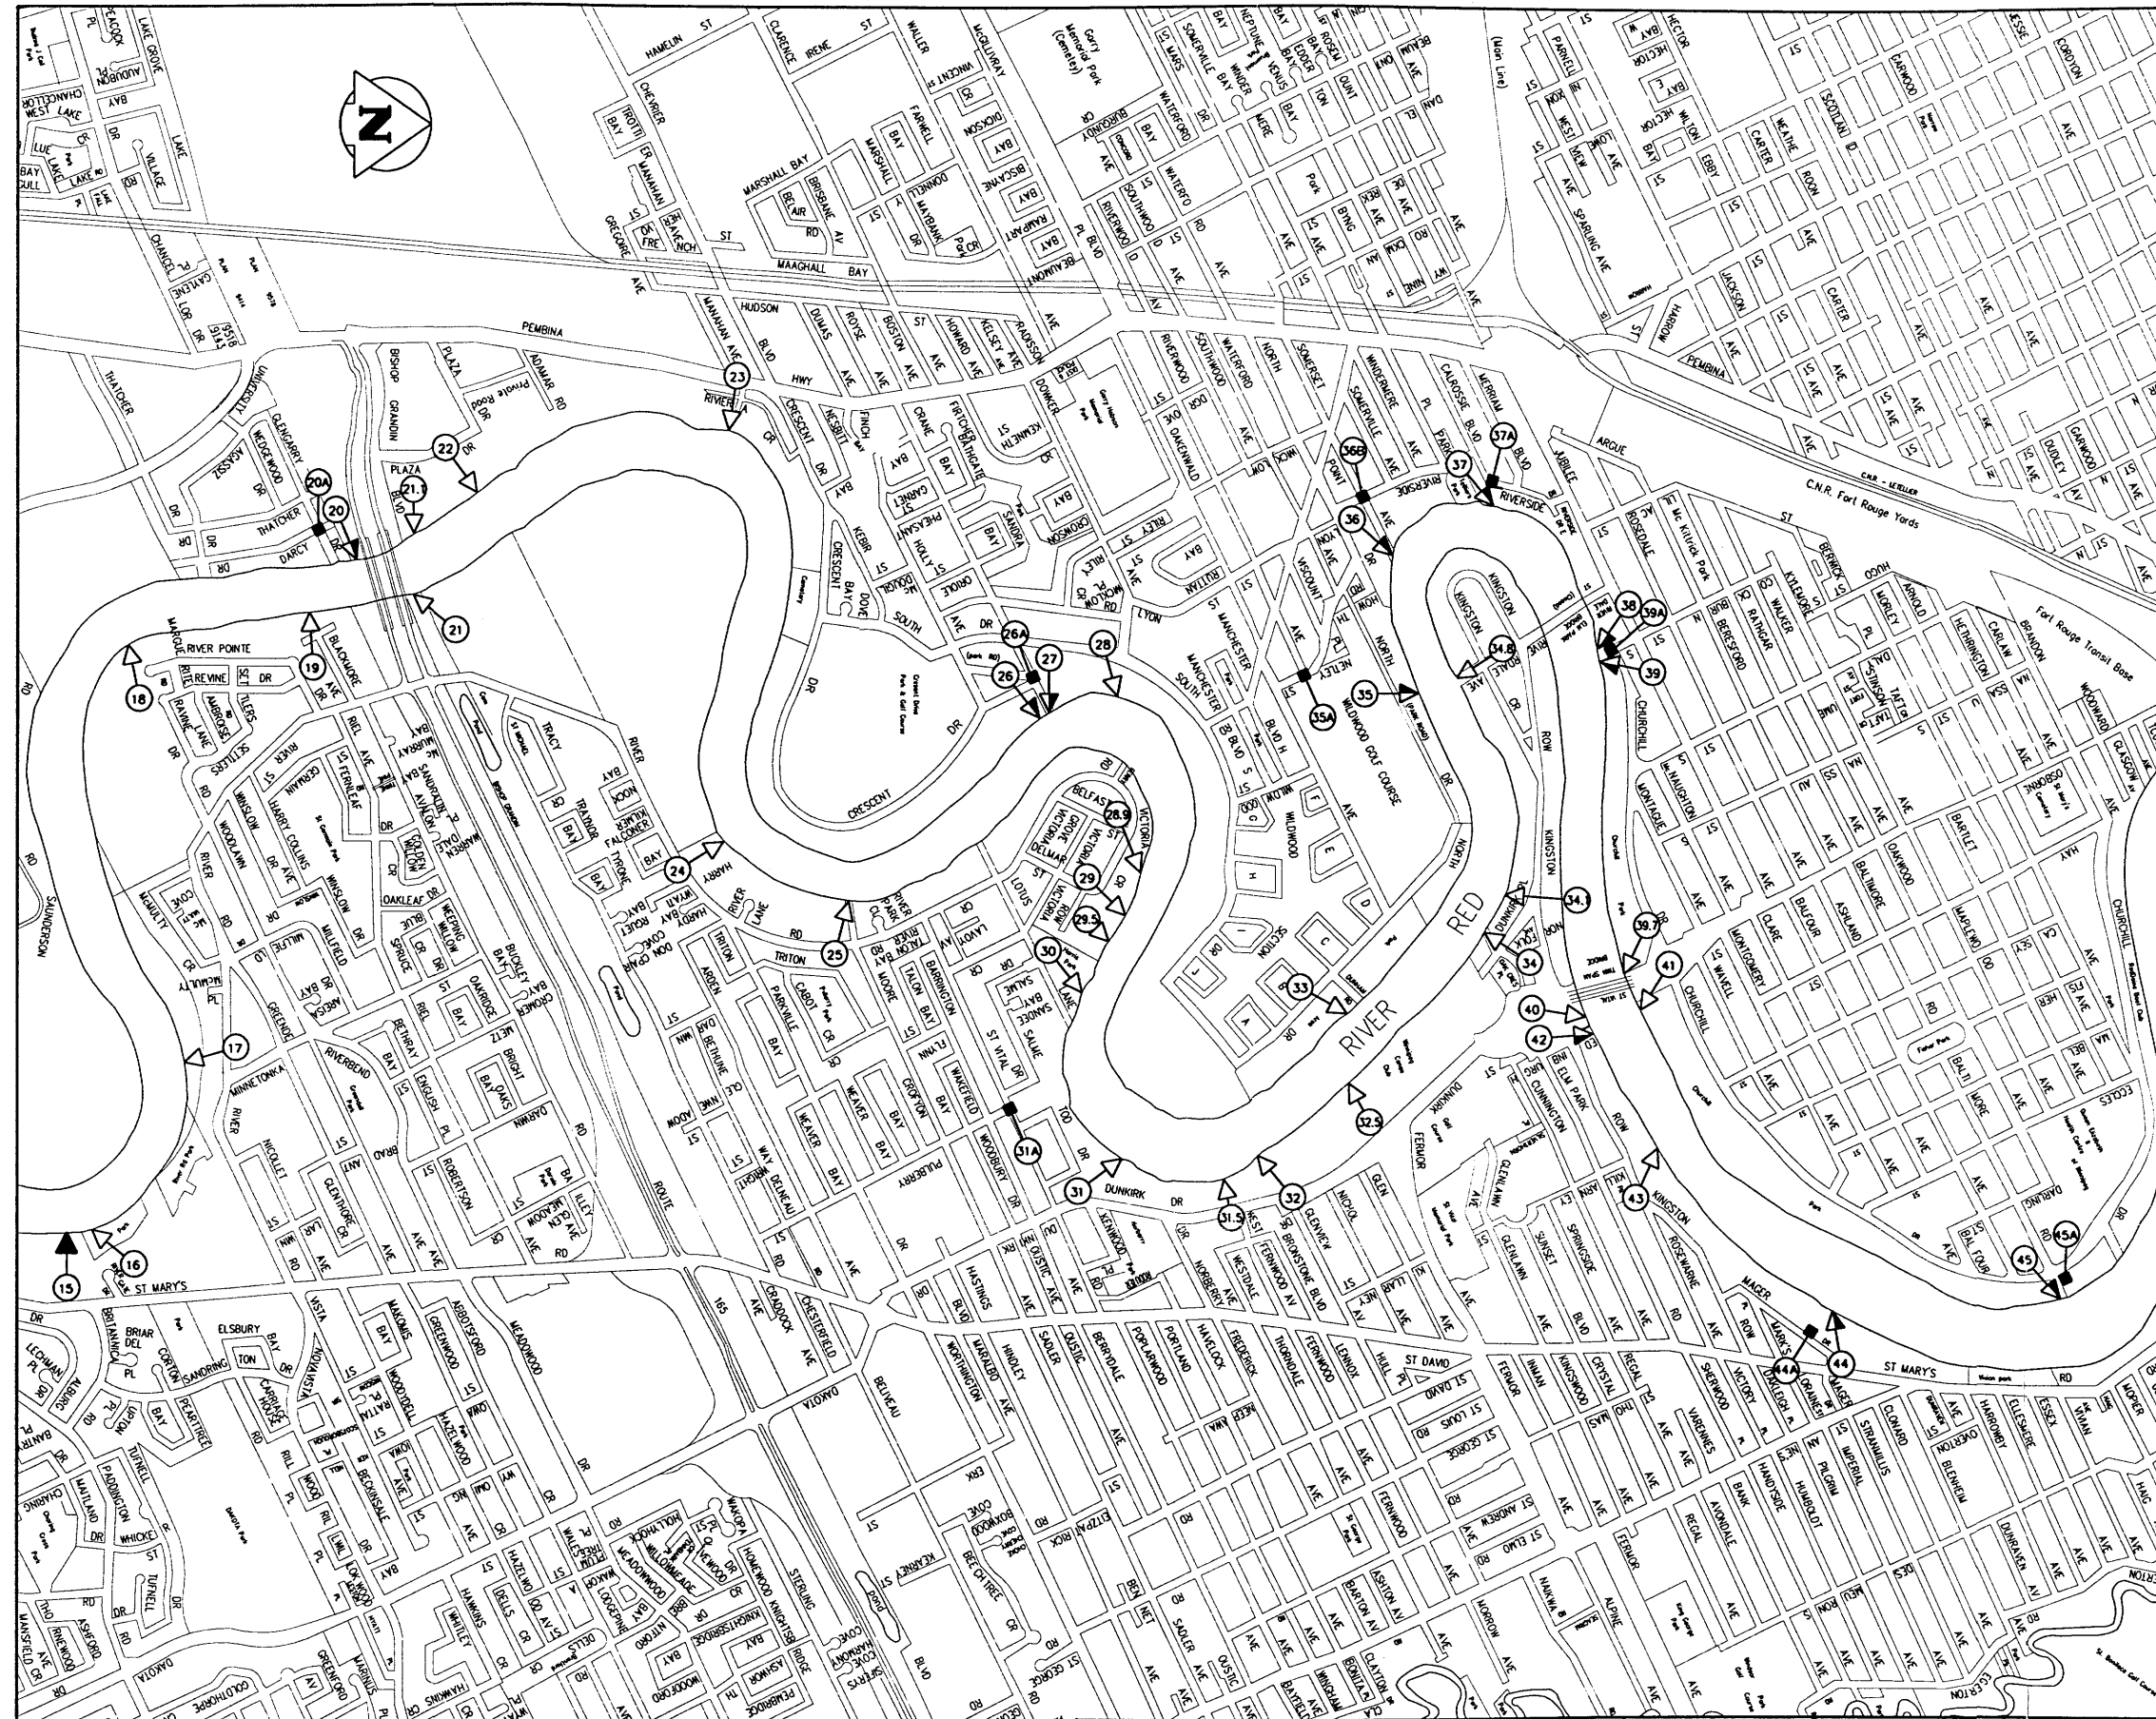
SHEET 12 OF 15
COMPUTER FILE NAME: M-562
CITY DRAWING NUMBER

OUTFALL ID. NO.	NAME	TYPE	SIZE
RR-15	RIVERGATE DR.	WWS	1350 DIA.
RR-15A	S. ST. VITAL SRB CONTROL CHAMBER		
RR-16	ST. MARY'S RD.	LDS	2280 DIA.
RR-17	MINNETONKA ST.	LDS	2100 DIA.
RR-18	RIVER POINTE PL.	LDS	1050 DIA.
RR-19	BANNING RD.	LDS	1370 DIA.
RR-20	DARCY DR.	CS	2200 DIA.
RR-20A	DARCY DR.	CS	
RR-21	BISHOP GRANDIN BLVD. #2	LDS	750 DIA.
RR-21.1	BISHOP GRANDIN BLVD. #4	LDS	750 DIA.
RR-22	PLAZA DR.	LDS	2400 DIA.
RR-23	RIVIERA CRES. OUTFALL	LDS	2000 DIA.
RR-24	FALCONER BAY	LDS	1200 DIA.
RR-25	MOORE AVE.	LDS	1100 DIA.
RR-26	CRANE AVE. #1	CS	600 DIA.
RR-26A	CRANE AVE. LIFT STATION	WWS	
RR-27	CRANE AVE. #2	CS	900 DIA.
RR-28	DOWKER AVE.	LDS	900 DIA.
RR-28.9	VICTORIA CRES. (NOT FOUND)	LDS	
RR-29	VICTORIA CRES. #2	LDS	750 DIA.
RR-29.5	VICTORIA CRES. (NOT FOUND)	LDS	
RR-30	LOTUS LANE	LDS	600 DIA.
RR-31	DUNKIRK DR.	LDS	1400 DIA.
RR-31A	PULBERRY ST. LIFT STATION	WWS	
RR-31.5	FERNWOOD AVE. (ABANDONED)	WWS	
RR-32	GLENMEW AVE.	LDS	525 DIA.

OUTFALL CONDITION AND MAINTENANCE STUDY
RED RIVER
BRITANNICA ROAD TO BALTIMORE ROAD

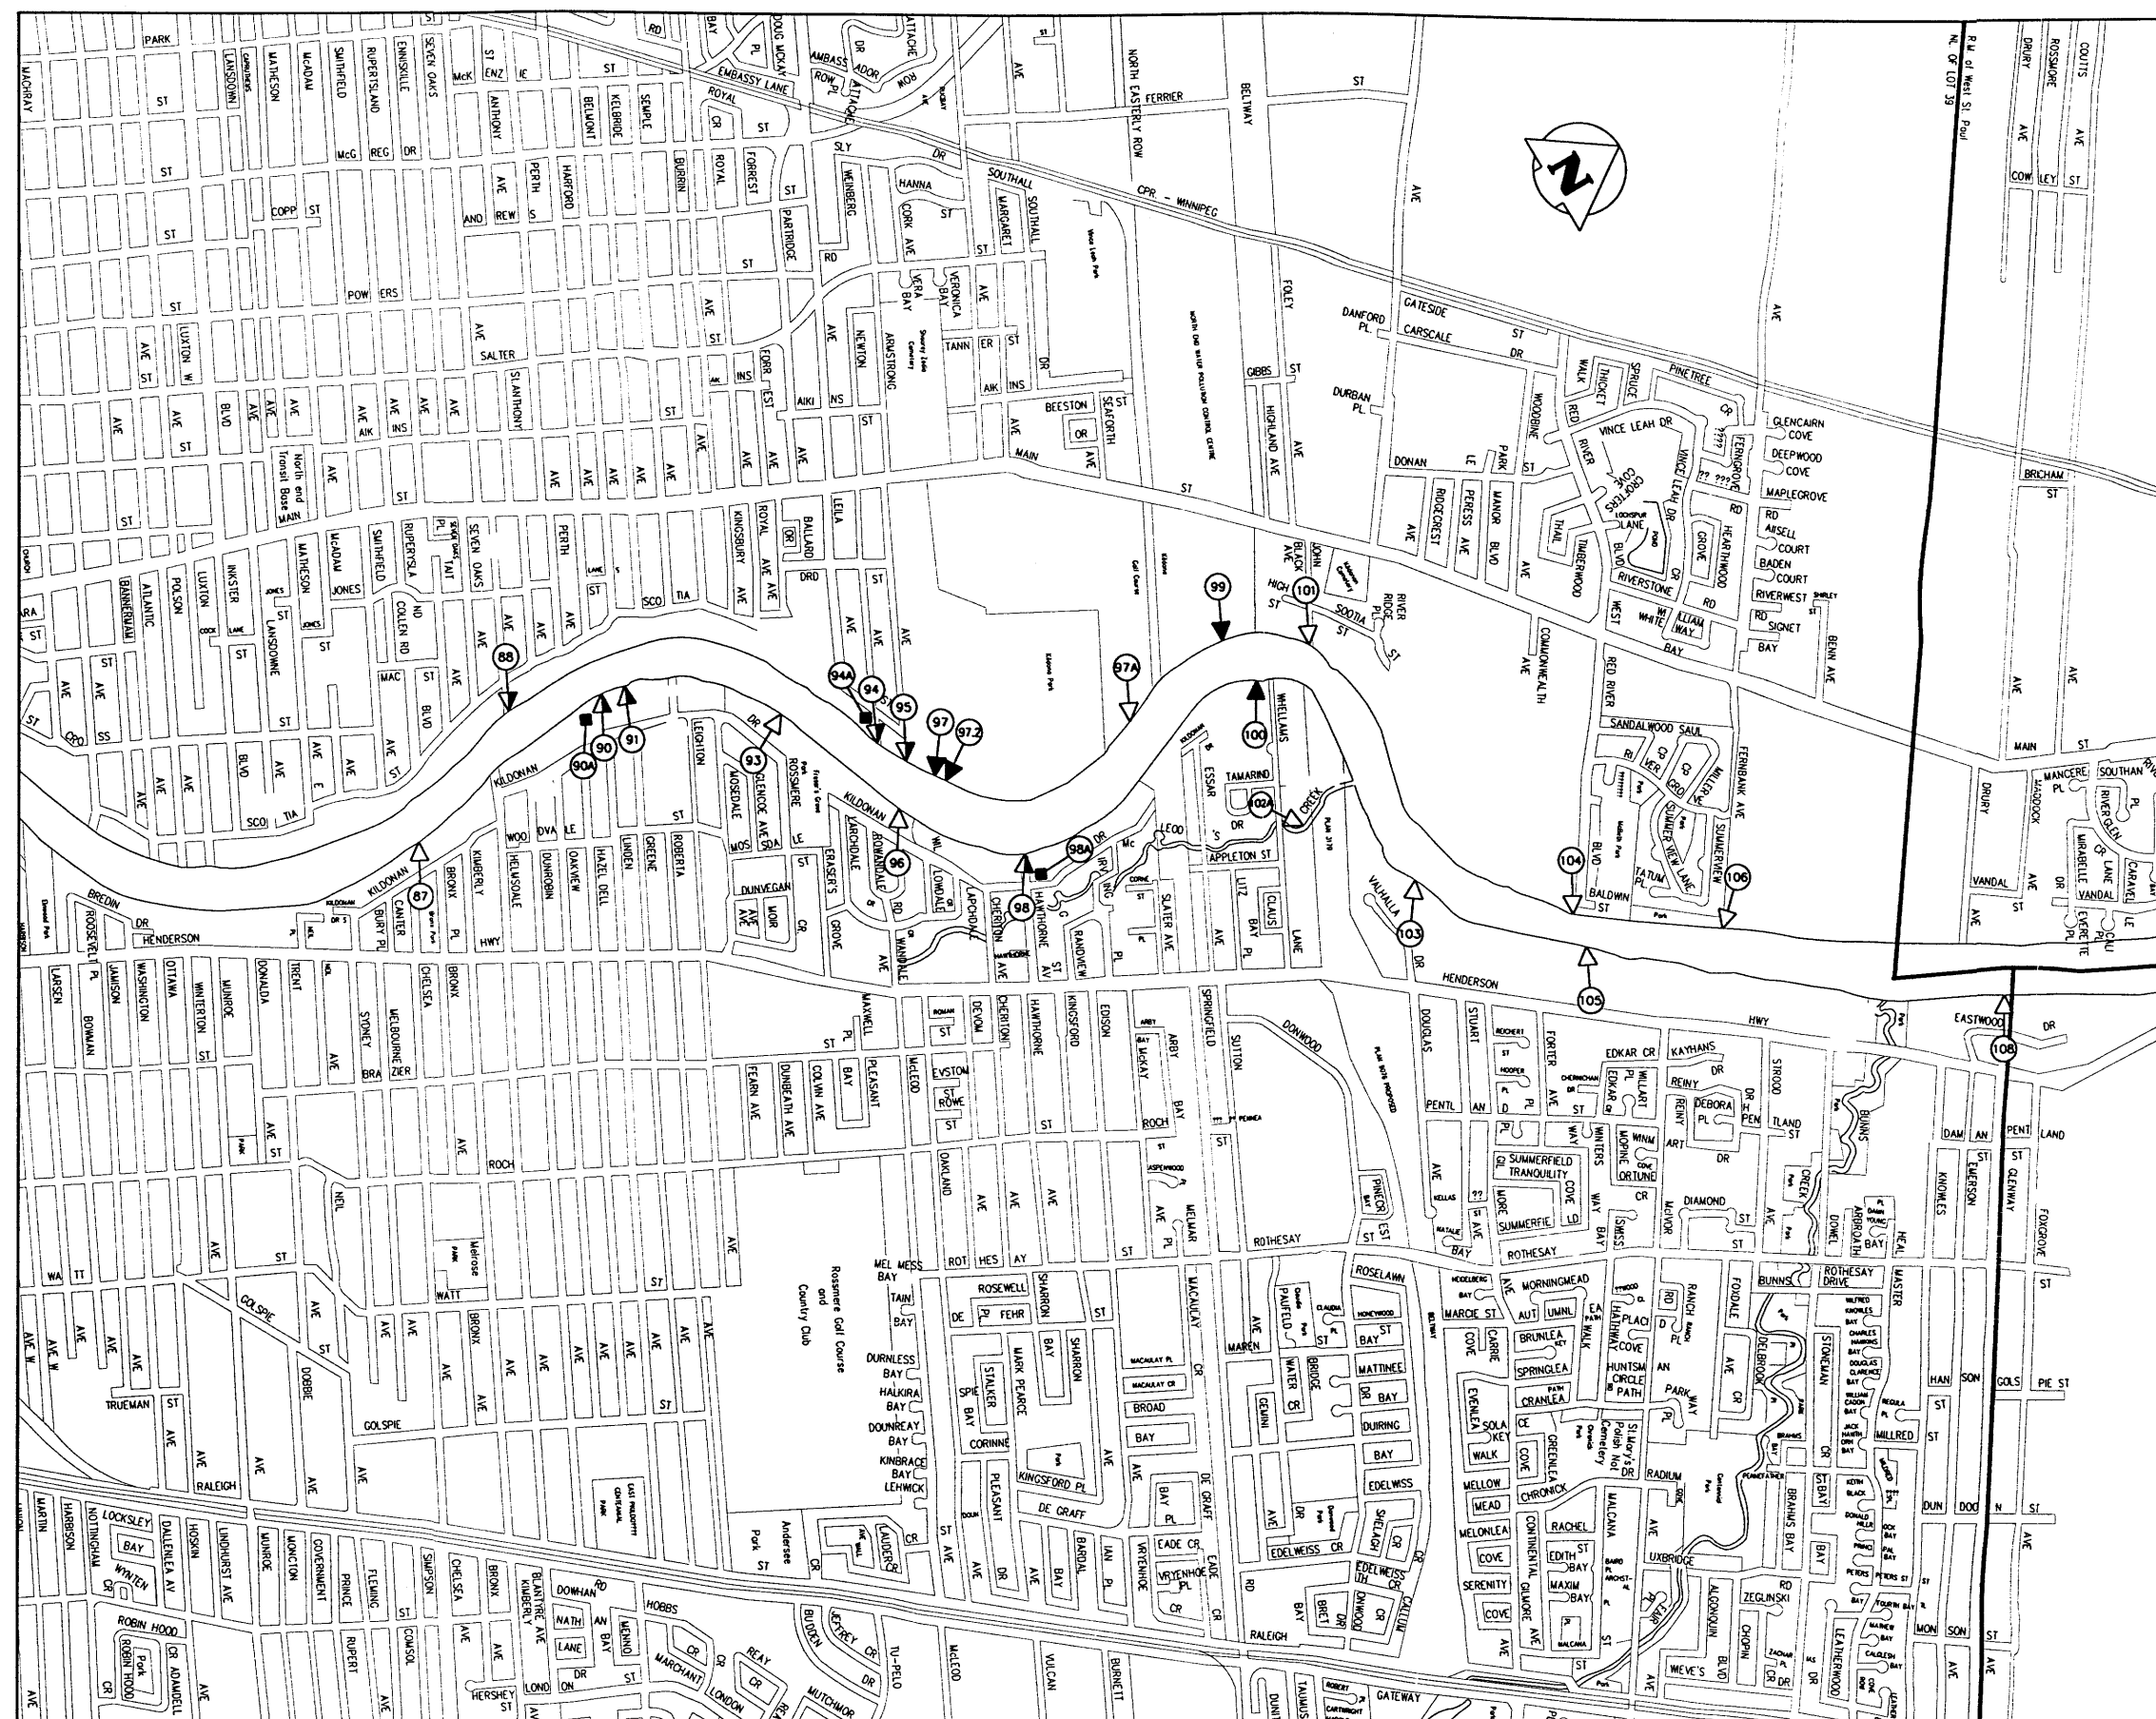
SHEET 14 OF 15
 COMPUTER FILE NAME: M-564
 CITY DRAWING NUMBER: [Blank]

OUTFALL ID. NO.	NAME	TYPE	SIZE
RR-87	CHELSEA PL.	LDS	2275 DIA.
RR-88	JEFFERSON AVE.	CS	3300 DIA.
RR-90	LINDEN AVE.	CS	1800 DIA.
RR-90A	LINDEN AVE. - LIFT STATION	CS	
RR-91	LINDEN AVE. - FPD	CS	1675 DIA.
RR-93	ROSSMERE CRES.	LDS	2900 DIA.
RR-94	NEWTON AVE.	CS	1850 DIA.
RR-94A	NEWTON AVE. - LIFT STATION	CS	
RR-95	ARMSTRONG AVE.	CS	2700 DIA.
RR-96	LARCHDALE CRES. SPS	LDS	1050 DIA.
RR-97	KILDONAN PARK #1	LDS	250 DIA.
RR-97A	BERLEN CUT-OFF (ABANDONED)	LDS	
RR-97.2	KILDONAN PARK #2	WWS	250 DIA.
RR-98	HAWTHORNE AVE.	CS	2200 DIA.
RR-98A	HAWTHORNE AVE. - LIFT STATION	CS	
RR-99	N.E.W.P.C.C. OUTFALL KILDONAN GOLF COURSE	TE	1200x3350
RR-100	WHELWAMS LANE	WWS	1200 DIA.
RR-101	JOHN BLACK AVE.	LDS	1800 DIA.
RR-102A	MCCLEOD'S CREEK	LDS	
RR-103	VALHALLA DR.	LDS	1675 DIA.
RR-104	RED RIVER BLVD.	LDS	750 DIA.
RR-105	HENDERSON HWY. (PRIVATE)	LDS	600 DIA.
RR-106	SUMMERVIEW LANE	LDS	1800 DIA.
RR-108	EASTWOOD DR.	LDS	525 DIA.

OUTFALL CONDITION AND MAINTENANCE STUDY
RED RIVER
 BREDIN DR. TO PERIMETER HWY.

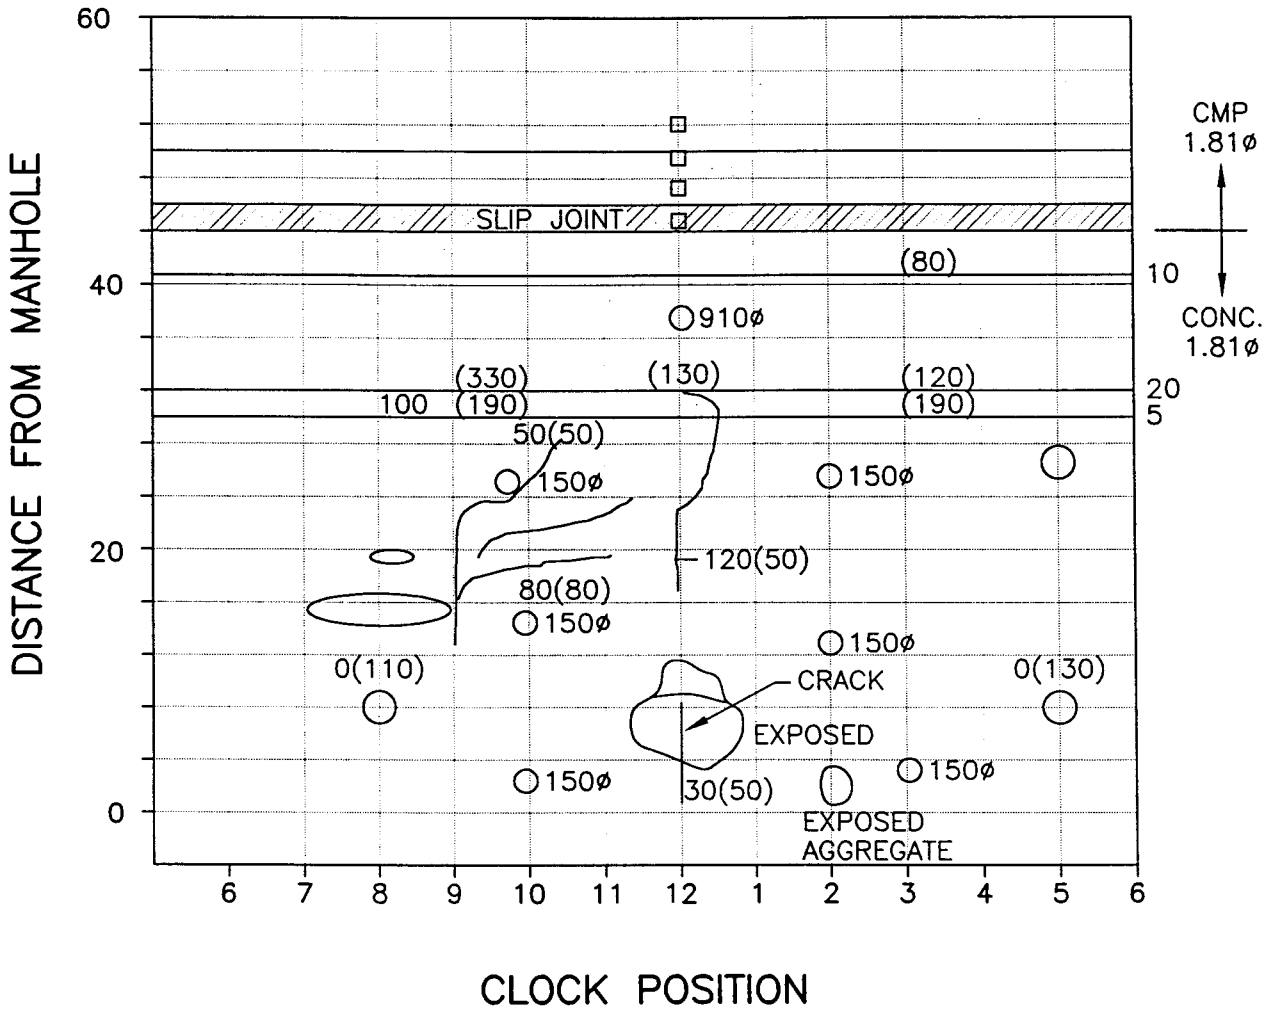
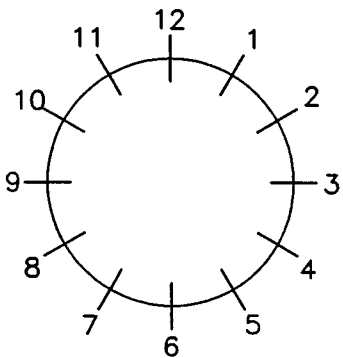
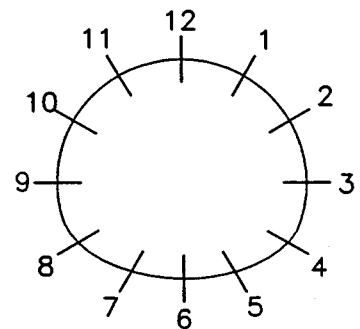
STRUCTURE CONDITION MAPPING CHART

Clock Reference Looking DOWNSTREAM

DEFECTIVE CONCRETE:	Spalling	SP	JOINTS:	Raised	JR
	Honeycomb	HC		Displaced	JD
	Erosion/Wear	EW		Spalled	SP
	Delaminated	DC			
			PIPE IDENTIFICATION:	R83

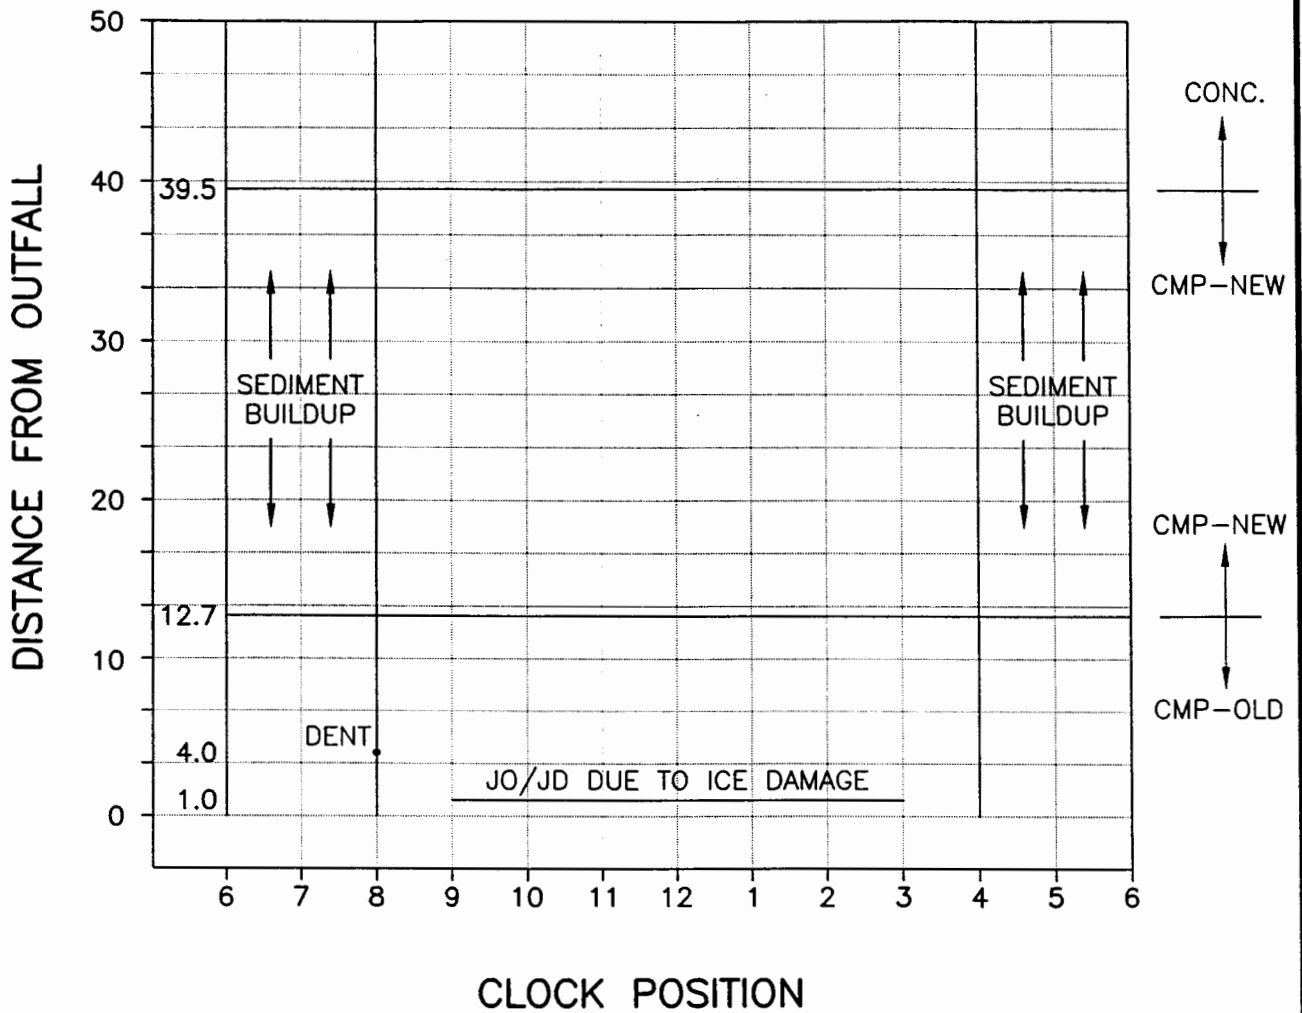
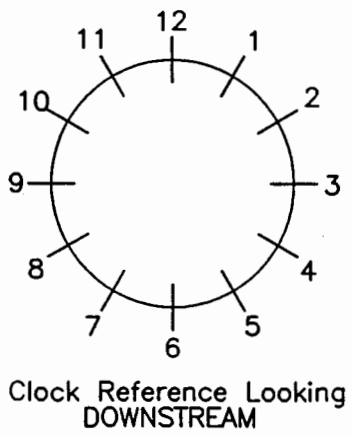
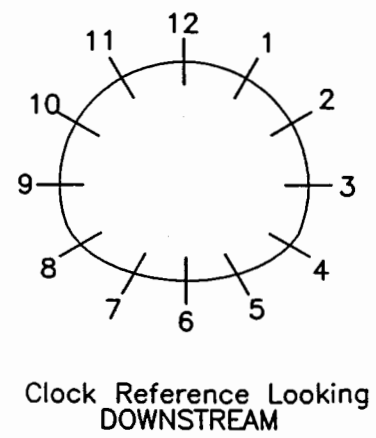
STRUCTURE CONDITION MAPPING CHART

DEFECTIVE CONCRETE: Spalling Honeycomb Erosion/Wear Delaminated	SP HC EW DC	JOINTS: Raised Displaced Spalled R87	JR JD SP
--	----------------------	---	----------------

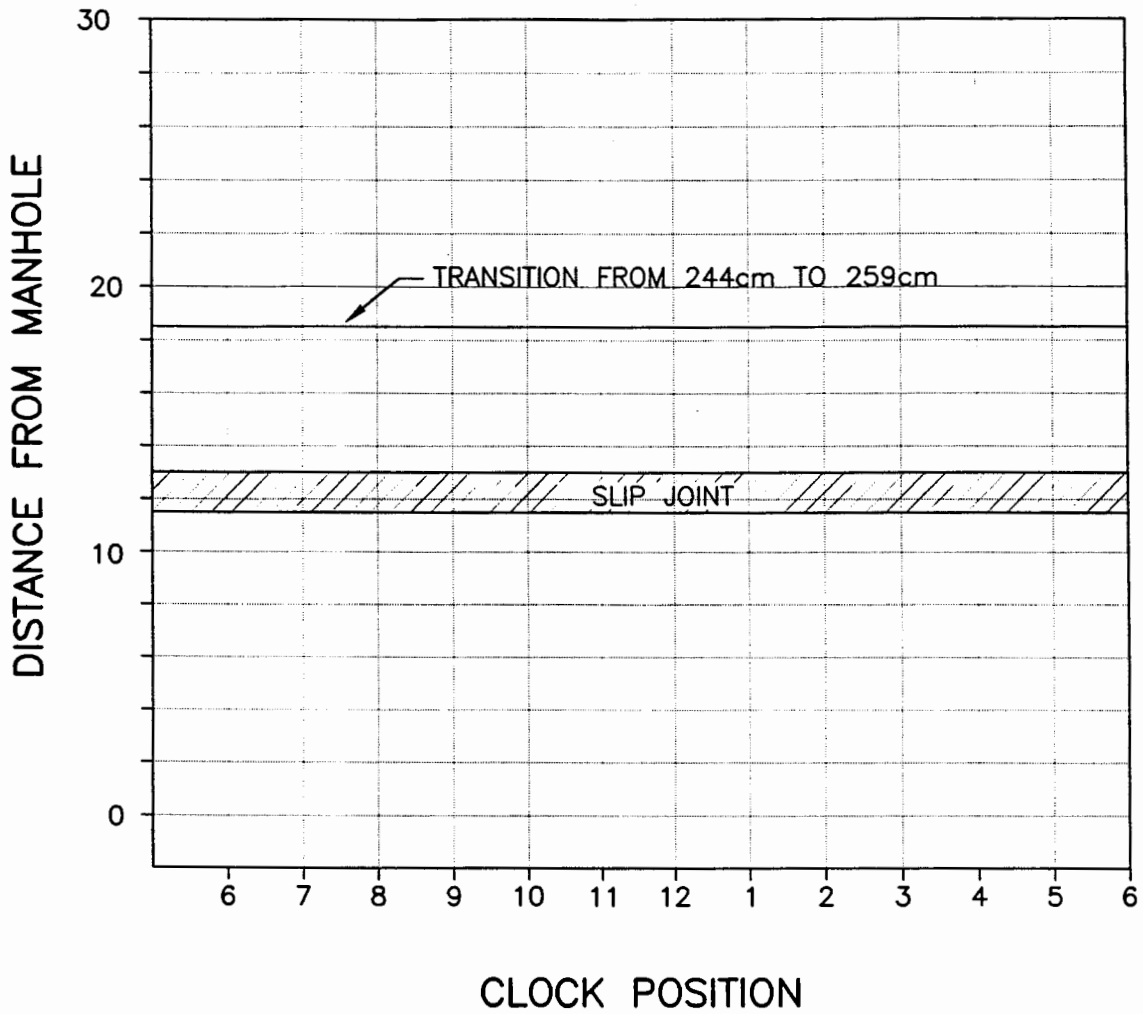
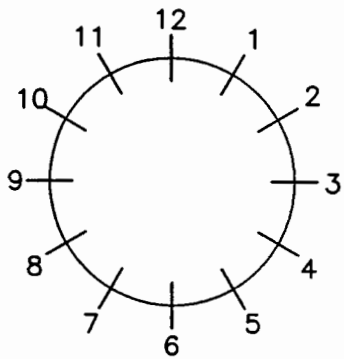
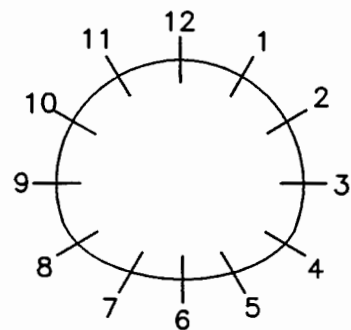
STRUCTURE CONDITION MAPPING CHART

Clock Reference Looking
DOWNSTREAM

DEFECTIVE CONCRETE: Spalling Honeycomb Erosion/Wear Delaminated	SP HC EW DC	JOINTS: Raised Displaced Spalled R84	JR JD SP
--	----------------------	---	----------------

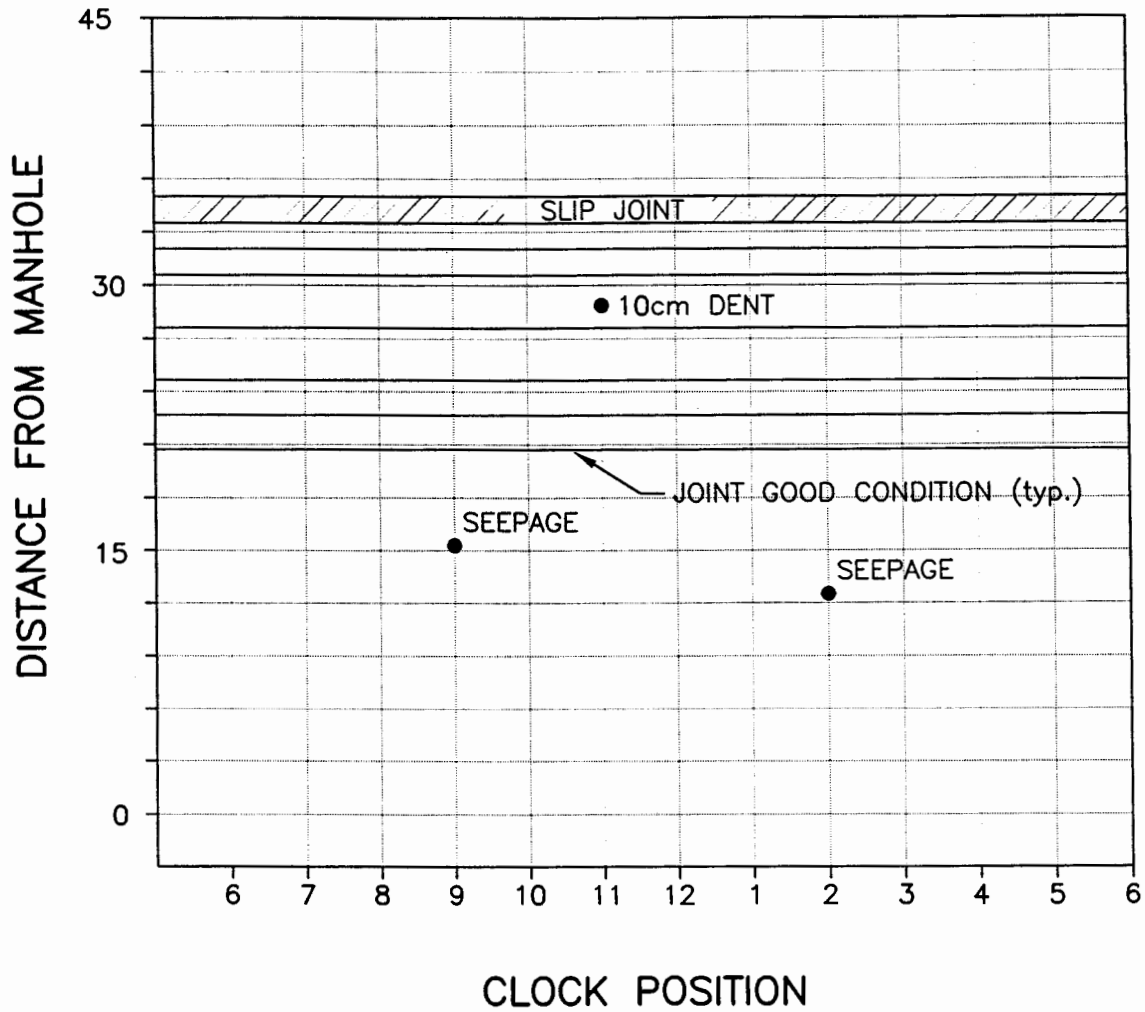
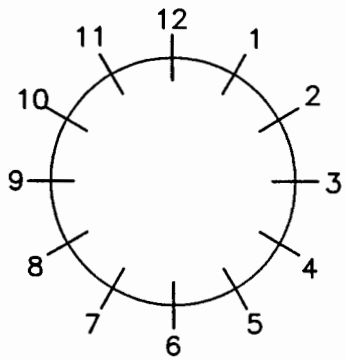
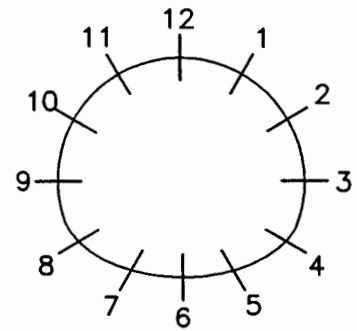
STRUCTURE CONDITION MAPPING CHART

Clock Reference Looking
DOWNSTREAM

DEFECTIVE CONCRETE:	Spalling	SP	JOINTS:	Raised	JR
	Honeycomb	HC		Displaced	JD
	Erosion/Wear	EW		Spalled	SP
	Delaminated	DC		R88	
			PIPE IDENTIFICATION:
