APPENDIX A – 1998 OUTFALL INSPECTIONS CONDITION AND MAINTENANCE STUDY

CITY OF WINNIPEG
OUTFALL CONDITION
AND
MAINTENANCE STUDY
FINAL REPORT //

August, 1998

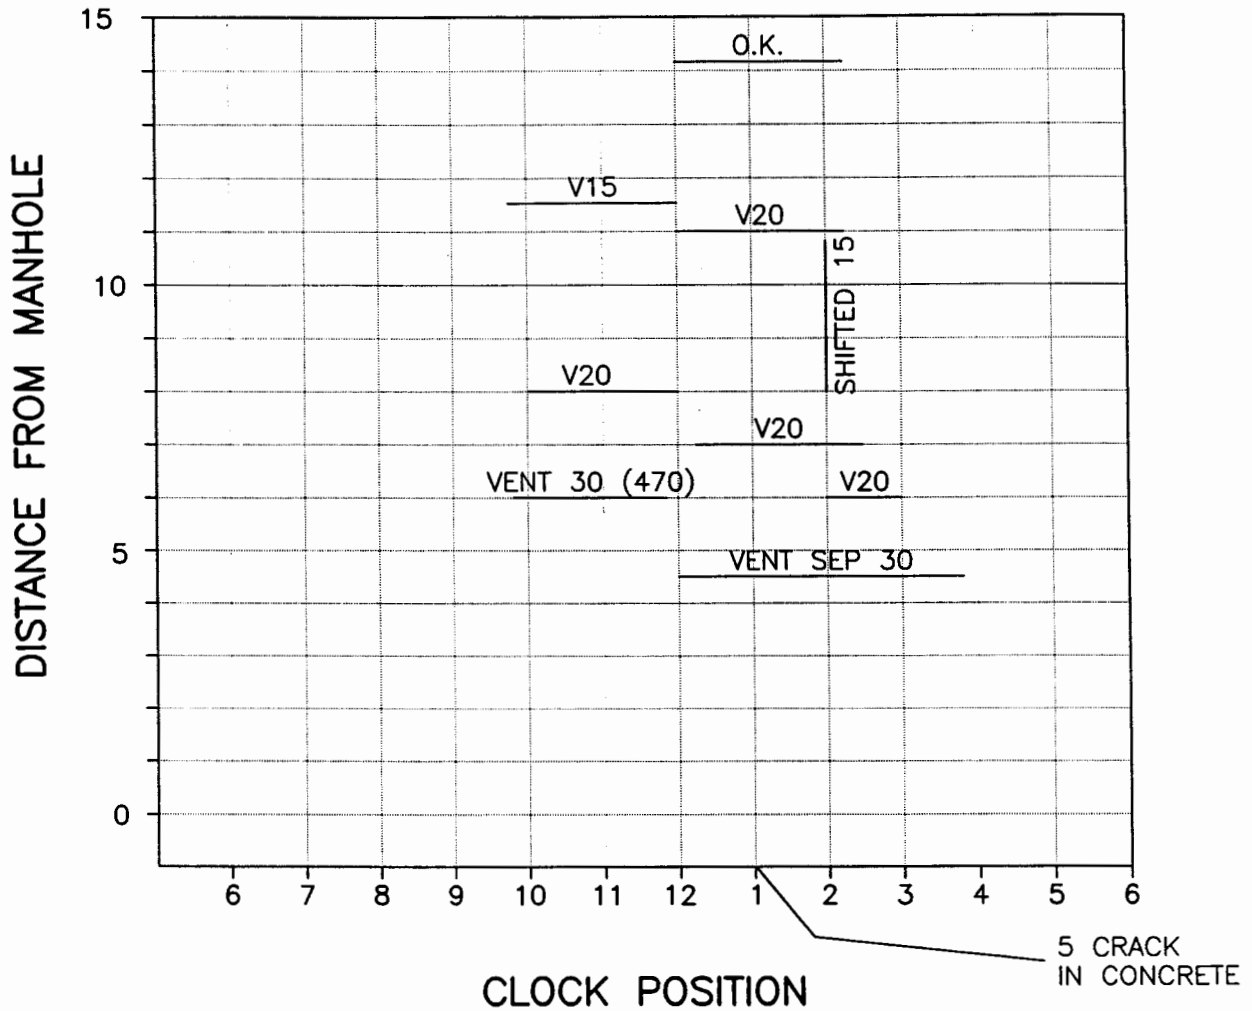
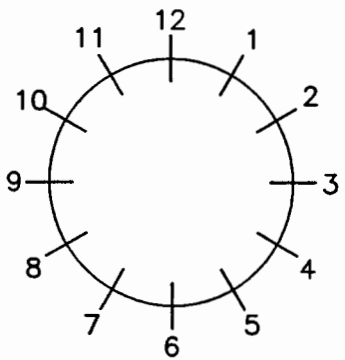
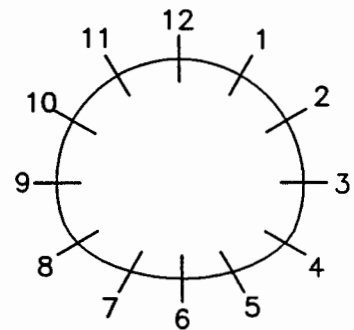
STRUCTURE CONDITION MAPPING CHART

Clock Reference Looking DOWNSTREAM

DEFECTIVE CONCRETE:	Spalling	SP	JOINTS:	Raised	JR
	Honeycomb	HC		Displaced	JD
	Erosion/Wear	EW		Spalled	SP
	Delaminated	DC			
			PIPE IDENTIFICATION:	RBB.1

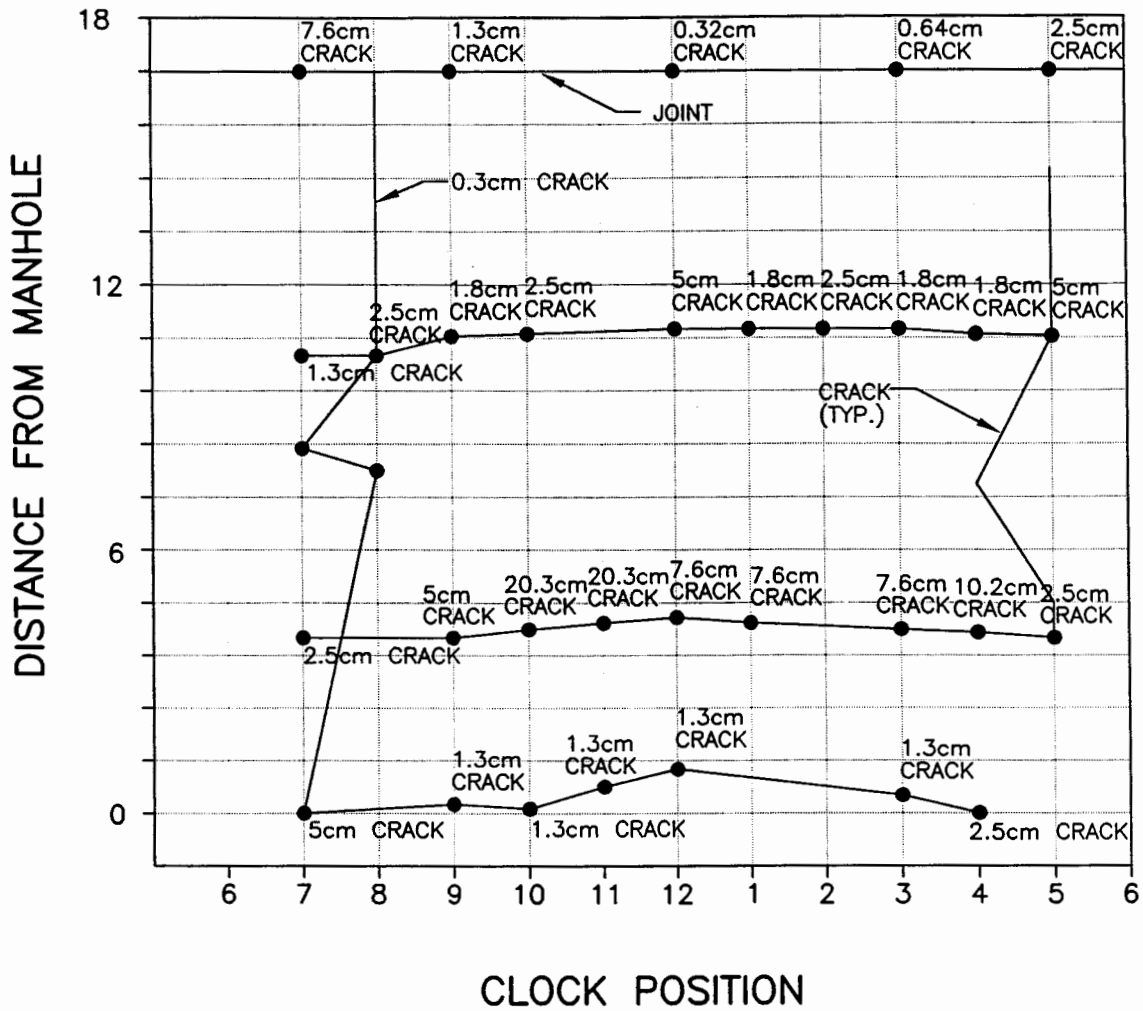
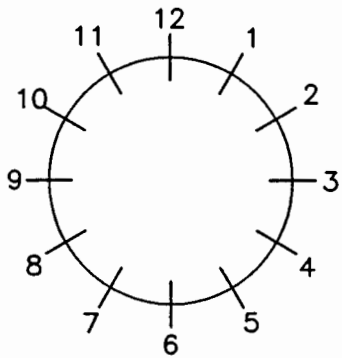
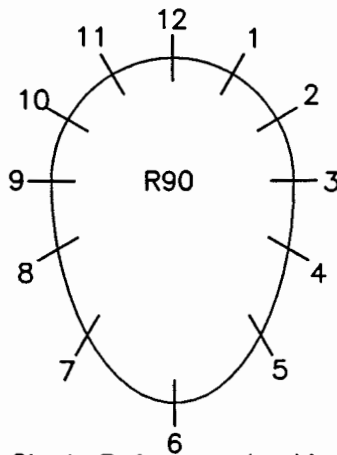
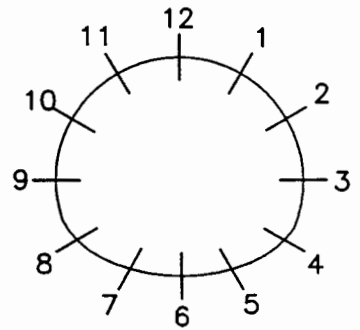
STRUCTURE CONDITION MAPPING CHART

Clock Reference Looking DOWNSTREAM

DEFECTIVE CONCRETE:	Spalling	SP	JOINTS:	Raised	JR
	Honeycomb	HC		Displaced	JD
	Erosion/Wear	EW		Spalled	SP
	Delaminated	DC			
			PIPE IDENTIFICATION:	R90

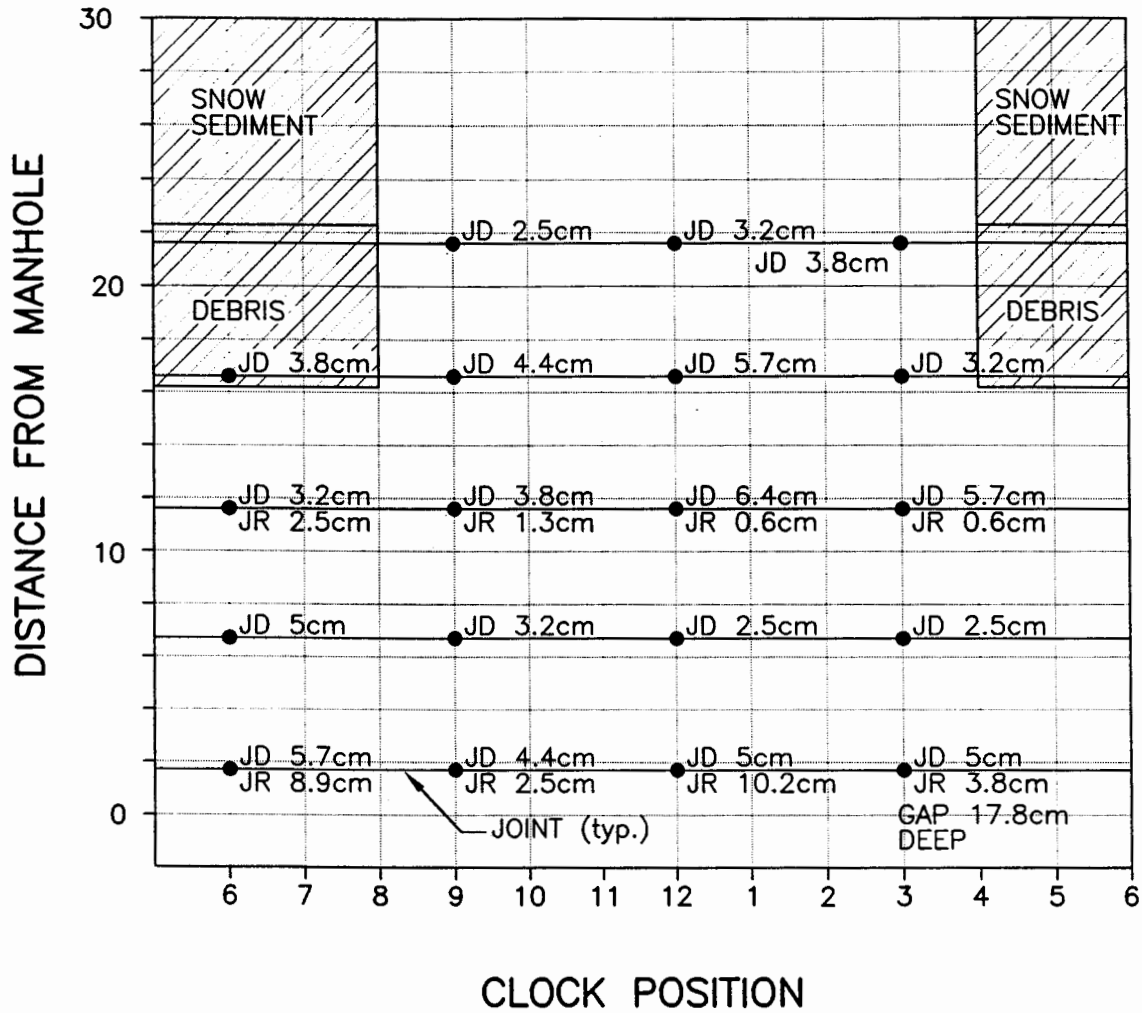
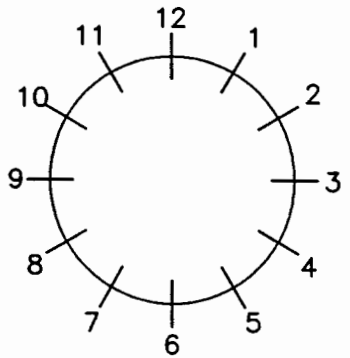
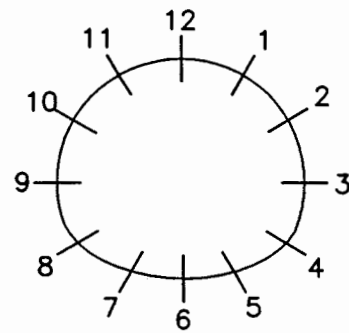
STRUCTURE CONDITION MAPPING CHART

Clock Reference Looking DOWNSTREAM

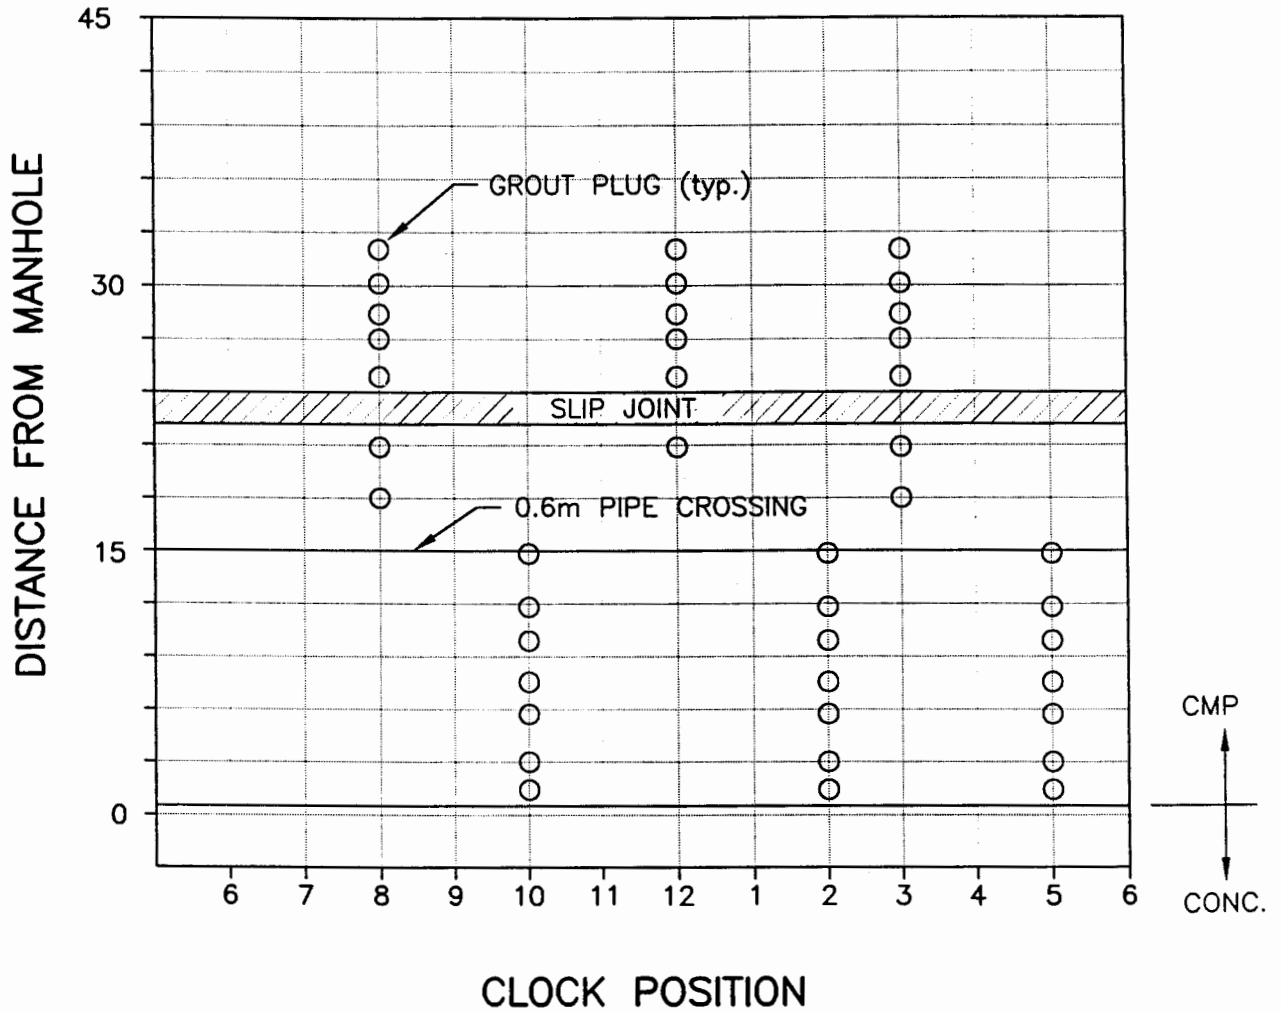
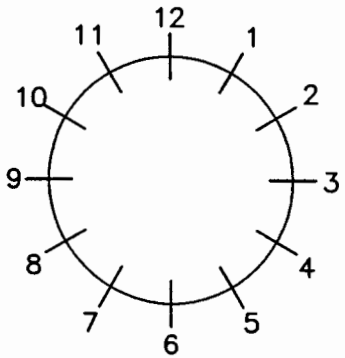
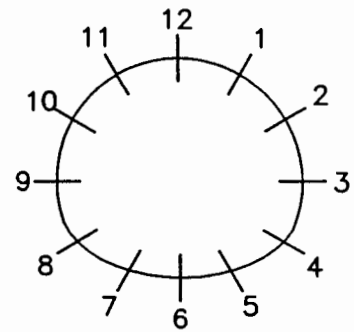
STRUCTURE CONDITION MAPPING CHART

DEFECTIVE CONCRETE:	Spalling	SP	JOINTS:	Raised	JR
	Honeycomb	HC		Displaced	JD
	Erosion/Wear	EW		Spalled	SP
	Delaminated	DC		R94	
			PIPE IDENTIFICATION:

The structure condition mapping chart represents a detailed log of all structural anomalies inside the outfall pipe. It is used to record any noted cracks, displaced joints, pipe deformations, mis-alignments, etc.

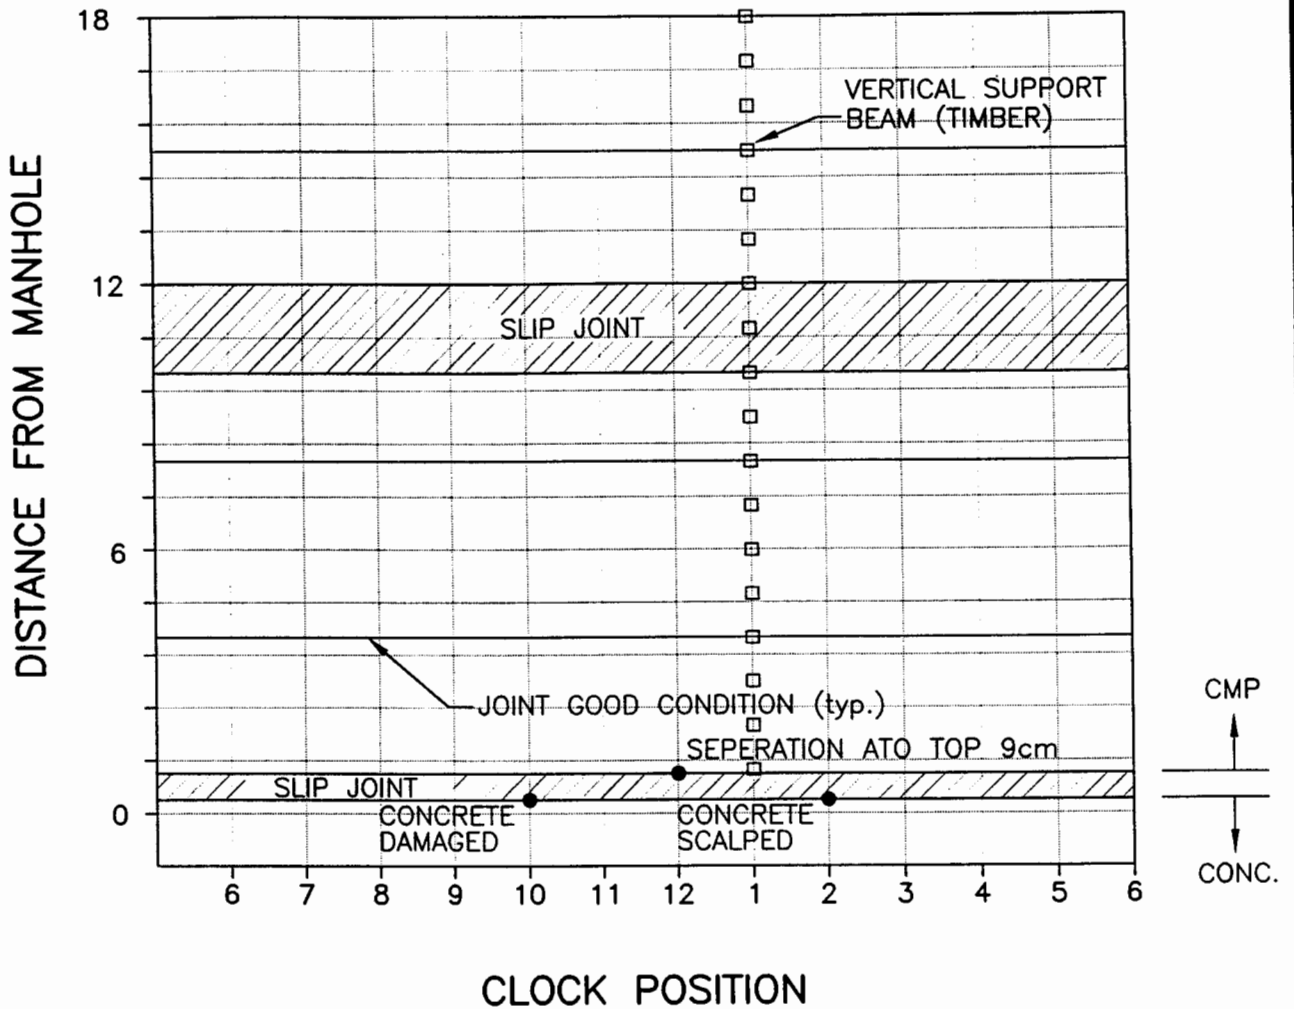
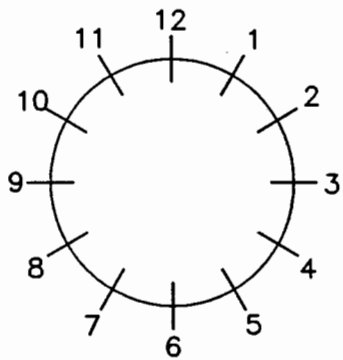
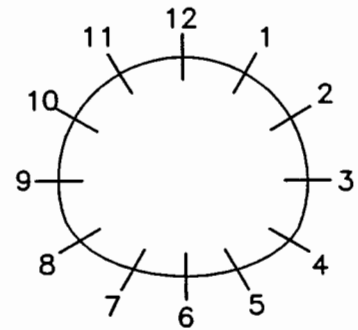
STRUCTURE CONDITION MAPPING CHART

DEFECTIVE CONCRETE:	Spalling	SP	JOINTS:	Raised	JR
	Honeycomb	HC		Displaced	JD
	Erosion/Wear	EW		Spalled	SP
	Delaminated	DC		PIPE IDENTIFICATION:	R95

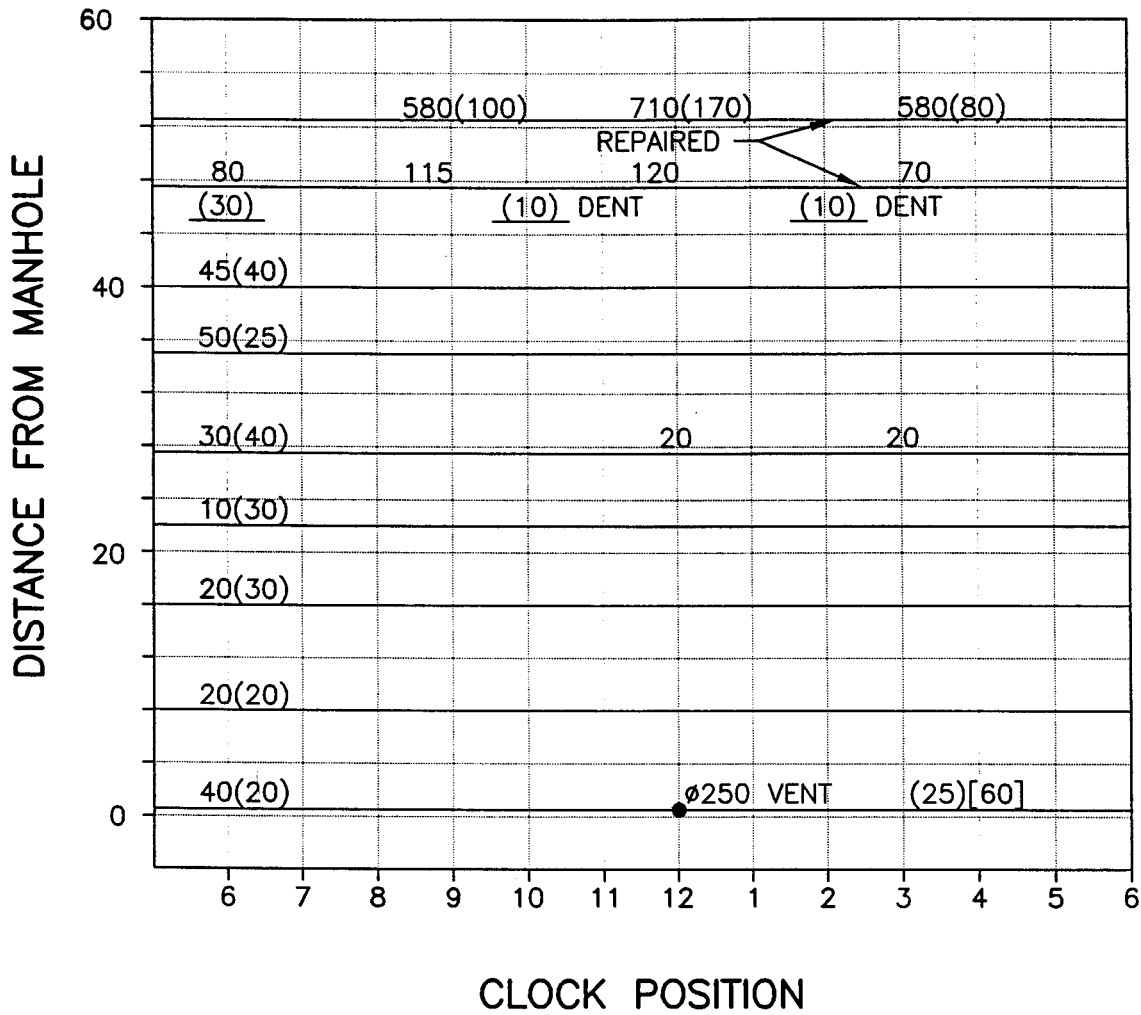
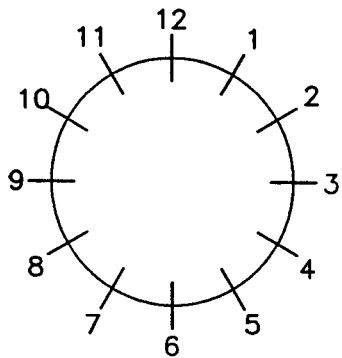
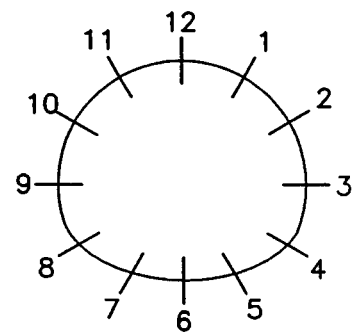
STRUCTURE CONDITION MAPPING CHART

DEFECTIVE CONCRETE: Spalling Honeycomb Erosion/Wear Delaminated	SP HC EW DC	JOINTS: Raised Displaced Spalled R98	JR JD SP
--	----------------------	---	----------------

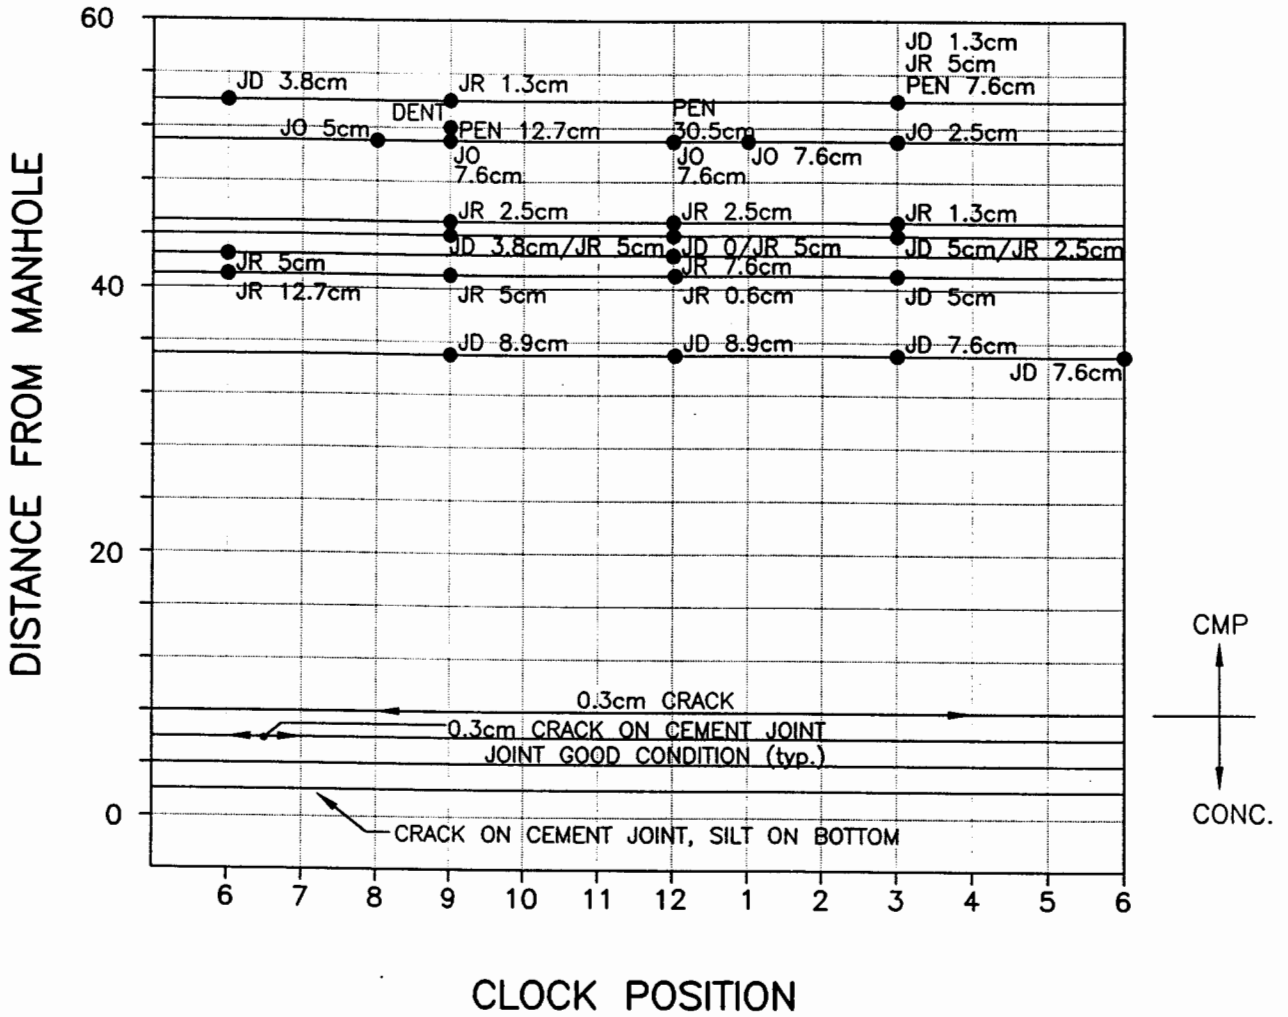
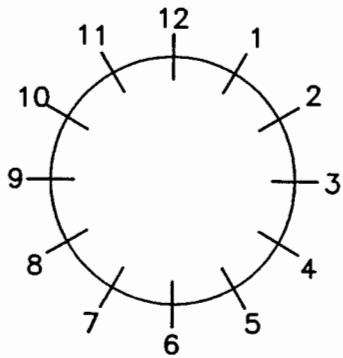
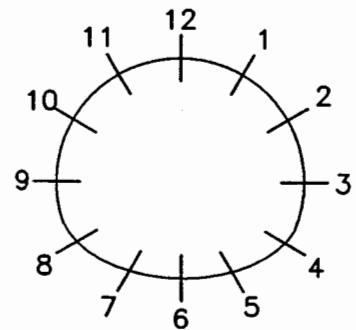
STRUCTURE CONDITION MAPPING CHART

DEFECTIVE CONCRETE:	Spalling	SP	PIPE IDENTIFICATION:	Raised	JR
	Honeycomb	HC		Displaced	JD
	Erosion/Wear	EW		Spalled	SP
	Delaminated	DC		R103

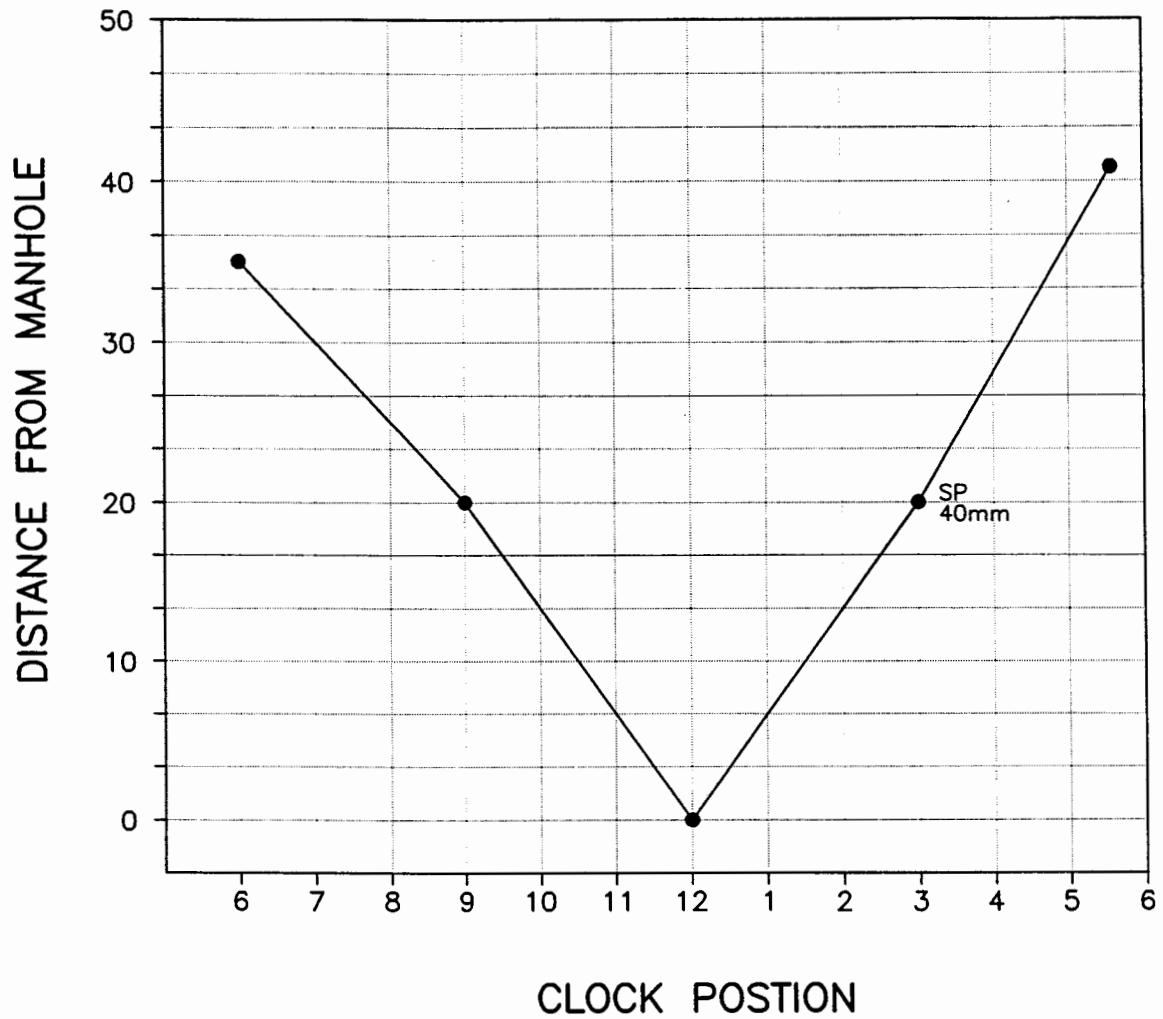
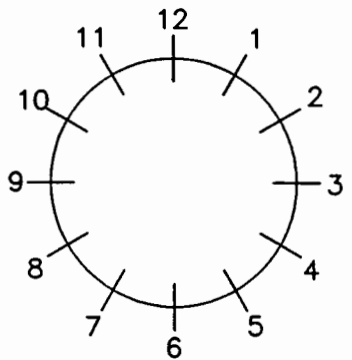
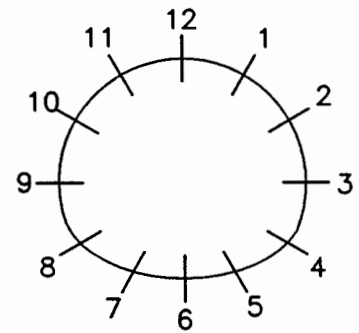
STRUCTURE CONDITION MAPPING CHART

DEFECTIVE CONCRETE: Spalling Honeycomb Erosion/Wear Delaminated	SP HC EW DC	JOINTS: Open Displaced Spalled A1	JO JD SP
		PIPE IDENTIFICATION:

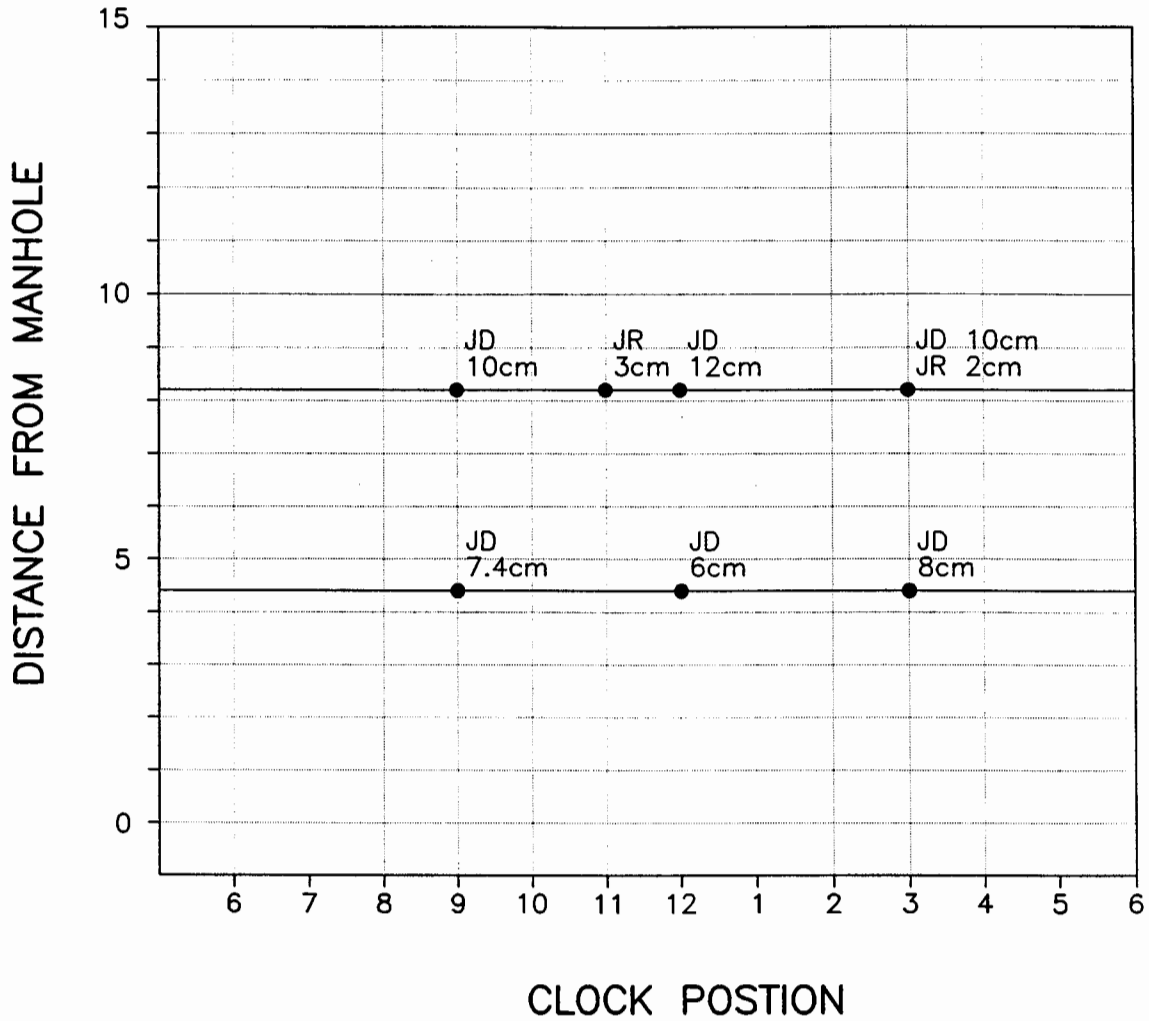
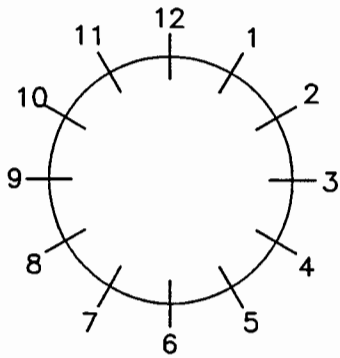
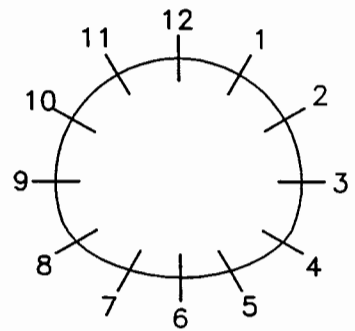
STRUCTURE CONDITION MAPPING CHART

DEFECTIVE CONCRETE: Spalling Honeycomb Erosion/Wear Delaminated	SP HC EW DC	JOINTS: Open Displaced Raised PIPE IDENTIFICATION: A2	JO JD JR
--	----------------------	--	----------------

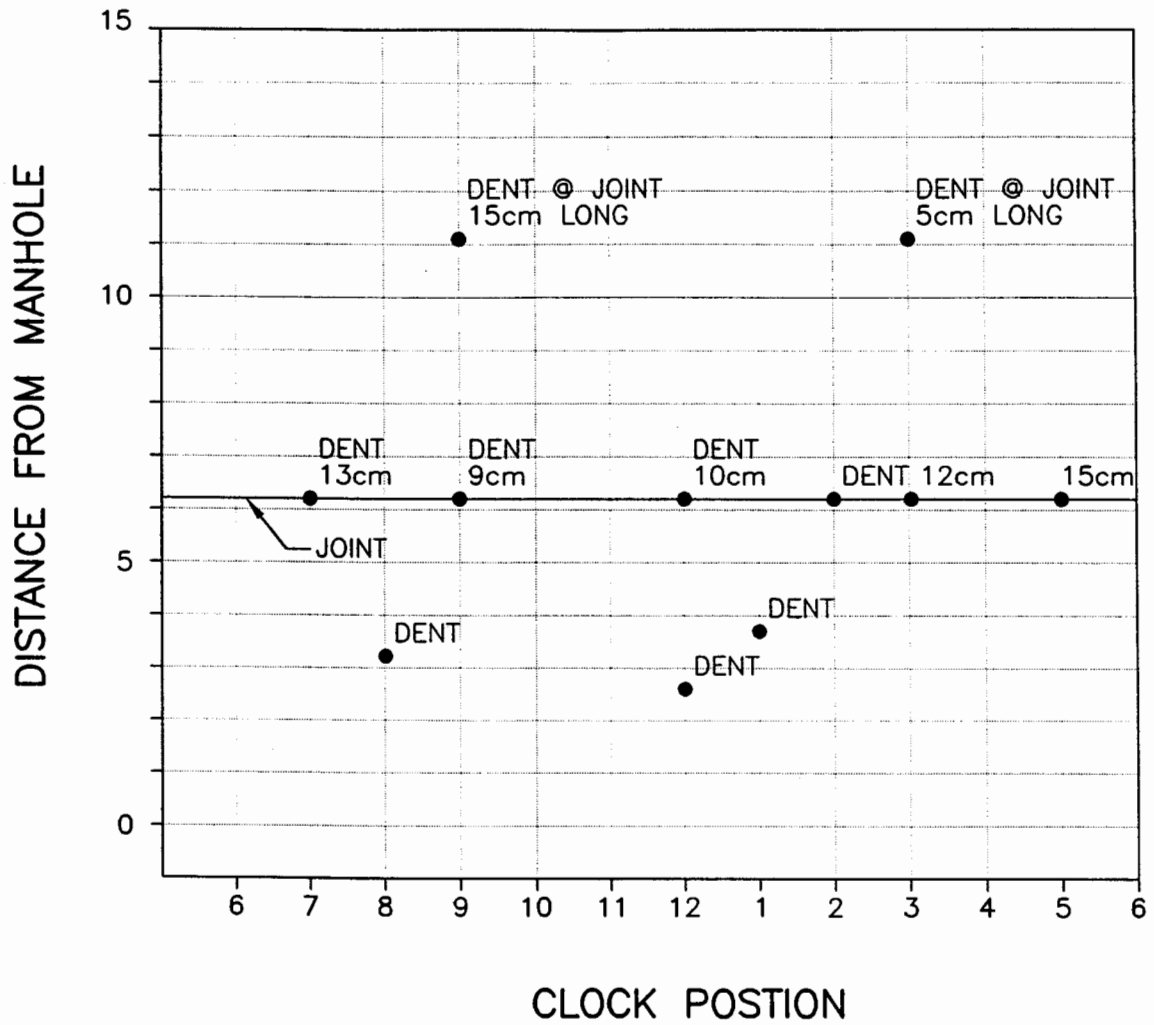
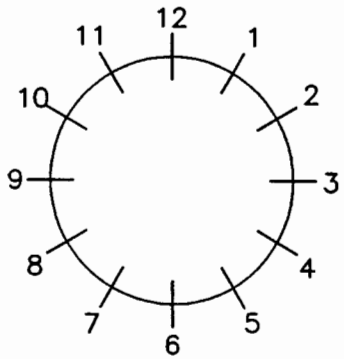
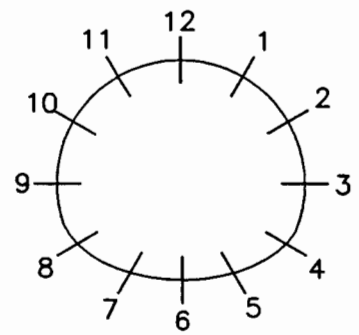
STRUCTURE CONDITION MAPPING CHART

DEFECTIVE CONCRETE: Spalling Honeycomb Erosion/Wear Delaminated	SP HC EW DC	JOINTS: Open Displaced Raised A3 ₁	JO JD JR
--	----------------------	--	----------------

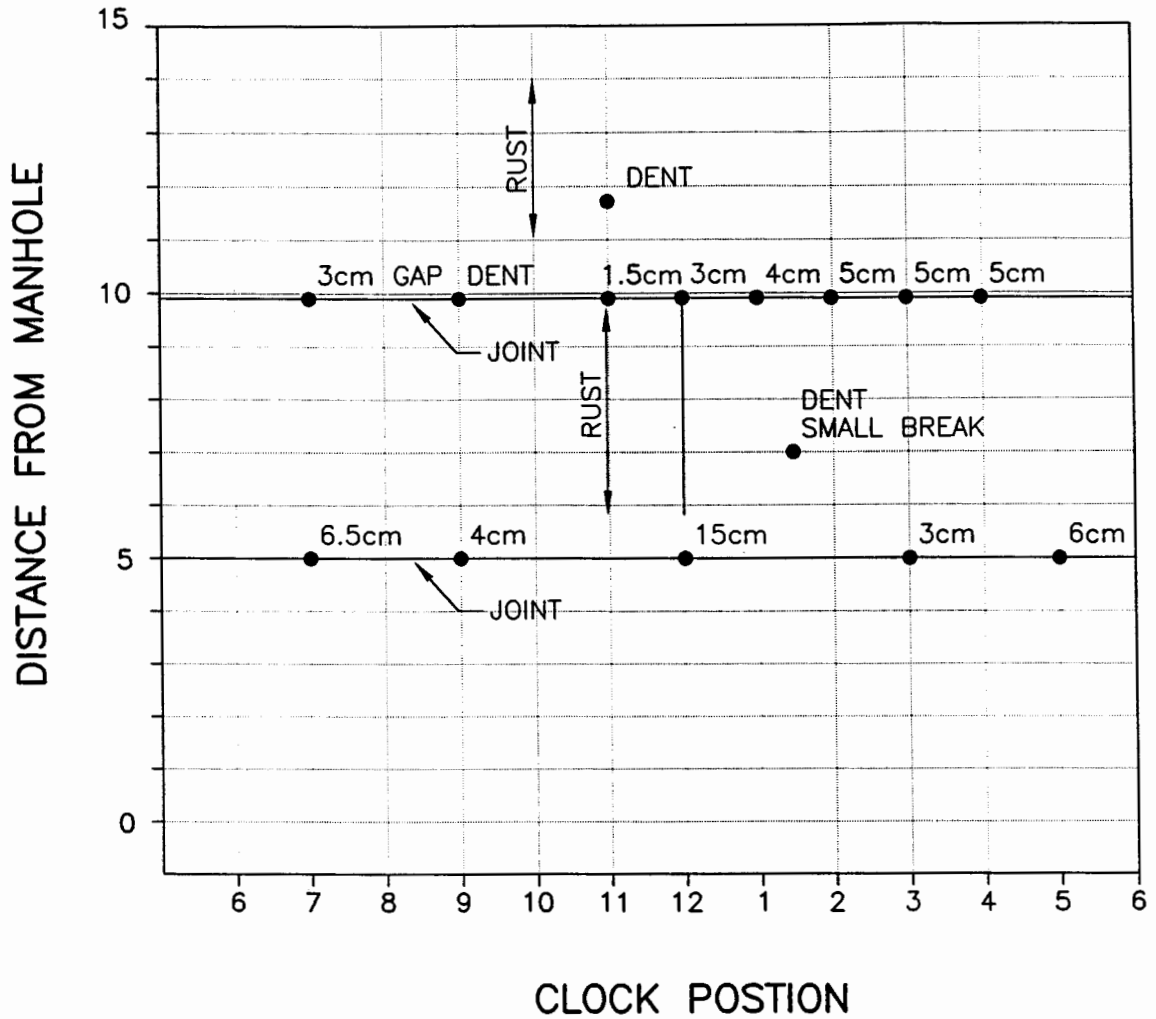
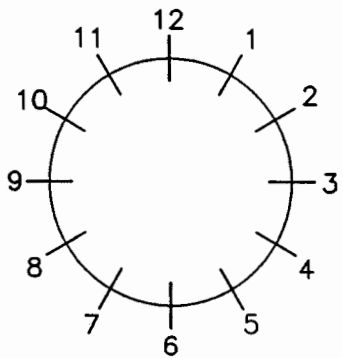
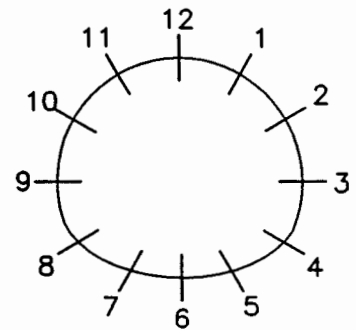
STRUCTURE CONDITION MAPPING CHART

DEFECTIVE CONCRETE: Spalling Honeycomb Erosion/Wear Delaminated	SP HC EW DC	JOINTS: Open Displaced Raised A32	JO JD JR
		PIPE IDENTIFICATION:

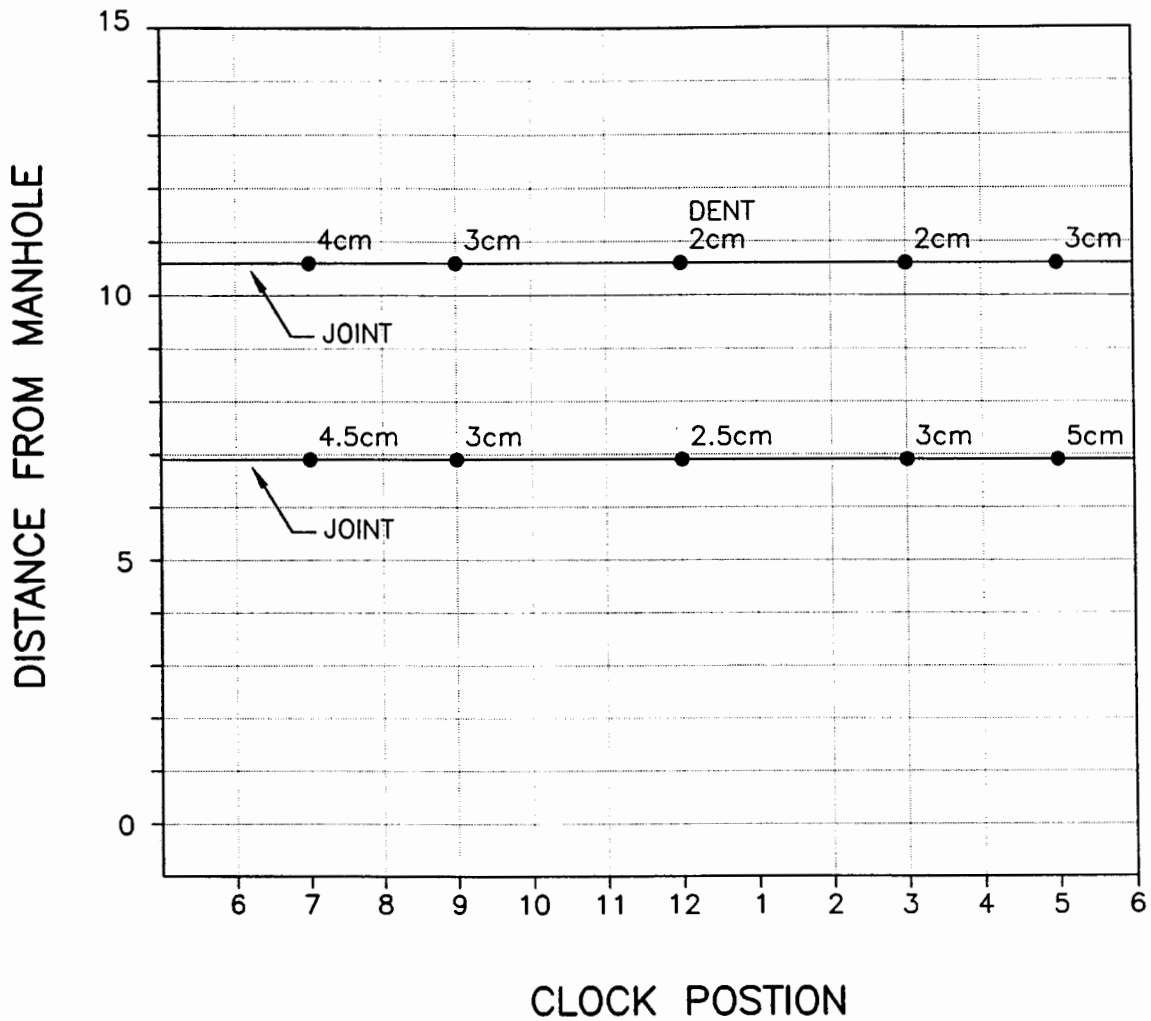
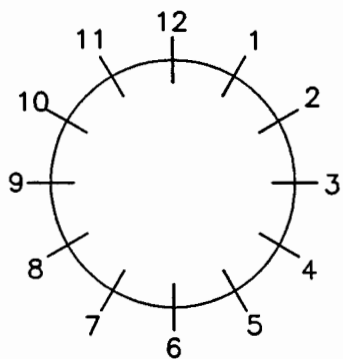
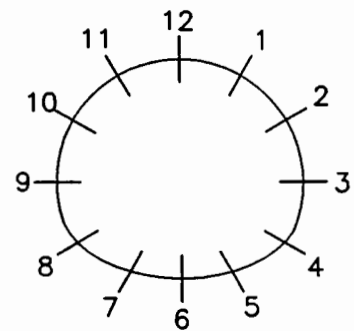
STRUCTURE CONDITION MAPPING CHART

DEFECTIVE CONCRETE:	Spalling	SP	JOINTS:	Open	JO
	Honeycomb	HC		Displaced	JD
	Erosion/Wear	EW		Raised	JR
	Delaminated	DC			
			PIPE IDENTIFICATION:	A5 ₁

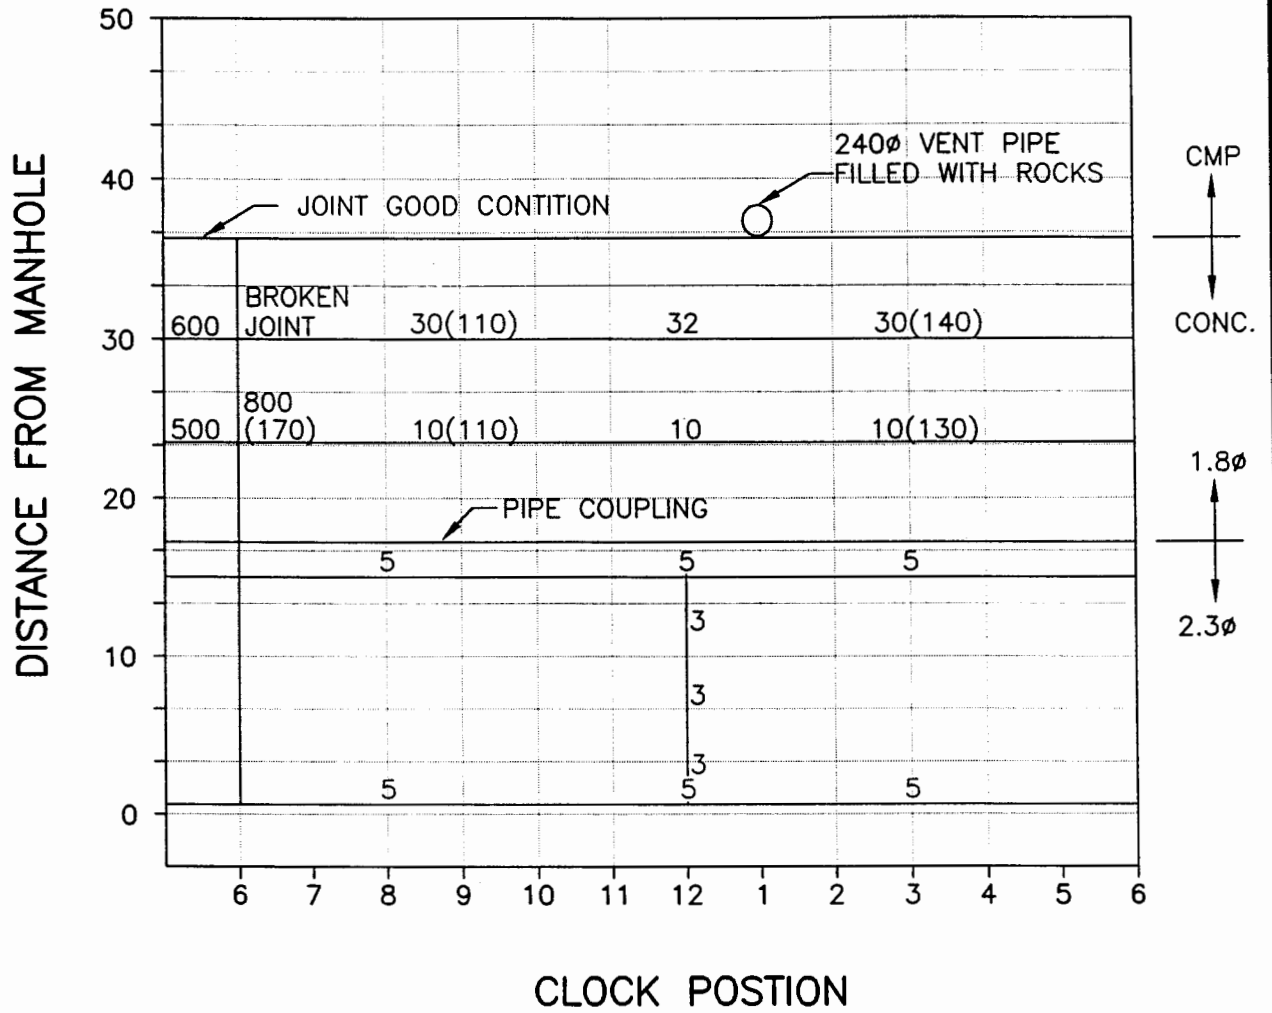
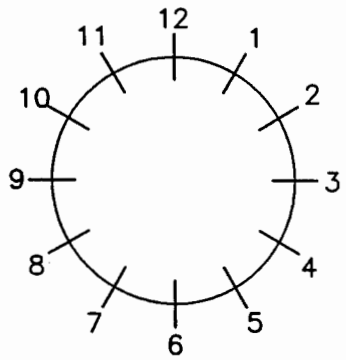
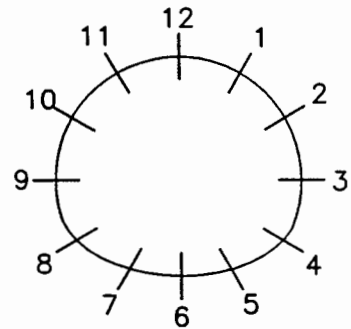
STRUCTURE CONDITION MAPPING CHART

DEFECTIVE CONCRETE:	Spalling	SP	JOINTS:	Open	JO
	Honeycomb	HC		Displaced	JD
	Erosion/Wear	EW		Spalled	SP
	Delaminated	DC			
			PIPE IDENTIFICATION:	A10

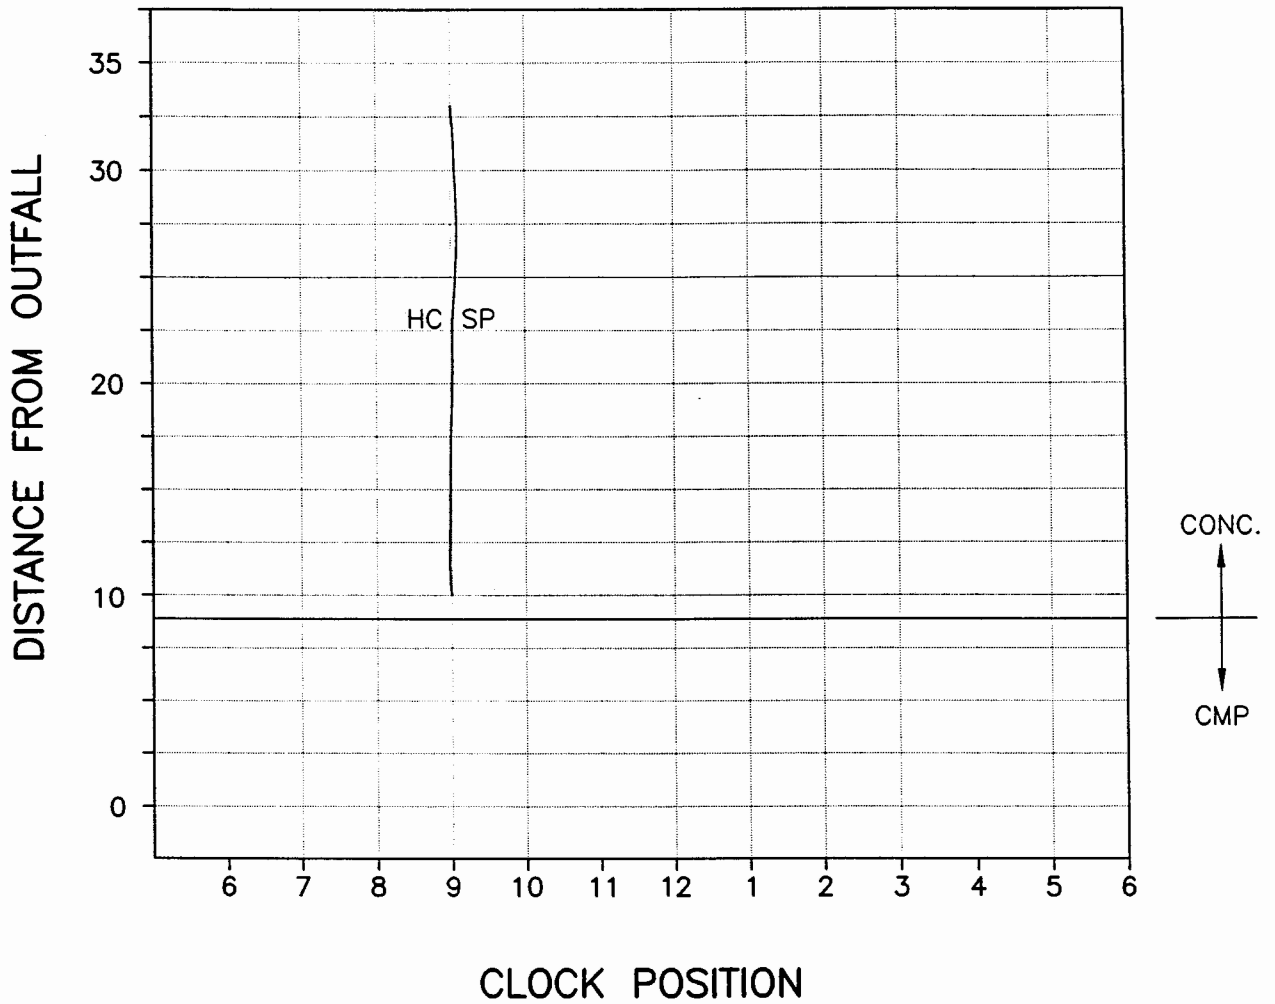
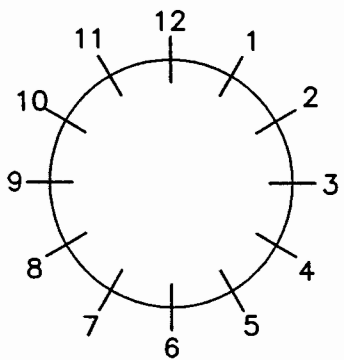
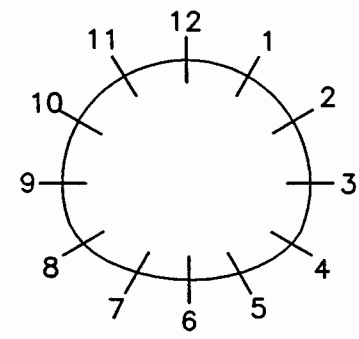
STRUCTURE CONDITION MAPPING CHART

DEFECTIVE CONCRETE: Spalling Honeycomb Erosion/Wear Delaminated	SP HC EW DC	JOINTS: Raised Displaced Spalled	JR JD SP PIPE IDENTIFICATION: A16.1
--	----------------------	--	---

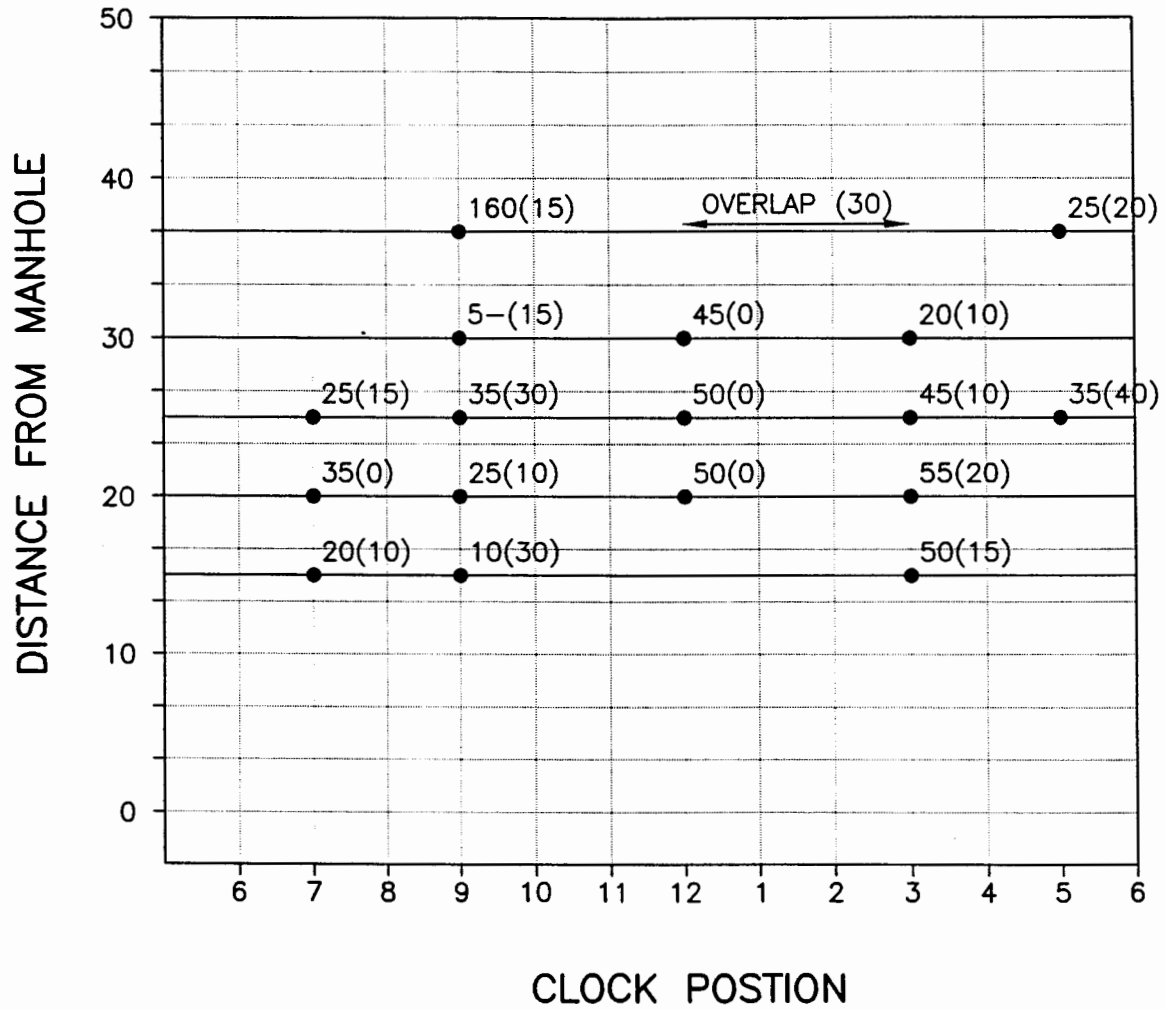
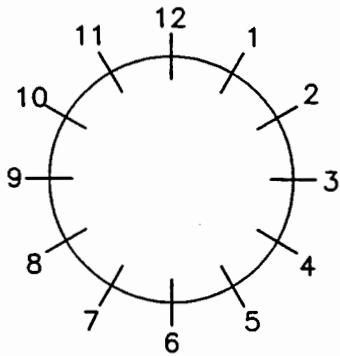
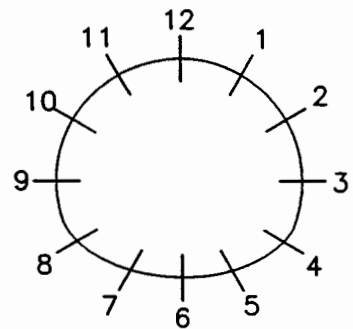
STRUCTURE CONDITION MAPPING CHART

DEFECTIVE CONCRETE: Spalling Honeycomb Erosion/Wear Delaminated	SP HC EW DC	JOINTS: Open Displaced Spalled A18 PIPE IDENTIFICATION:	JO JD SP
--	----------------------	--	----------------
