APPENDIX A – 1998 OUTFALL INSPECTIONS CONDITION AND MAINTENANCE STUDY

CITY OF WINNIPEG
OUTFALL CONDITION
AND
MAINTENANCE STUDY
FINAL REPORT //

August, 1998

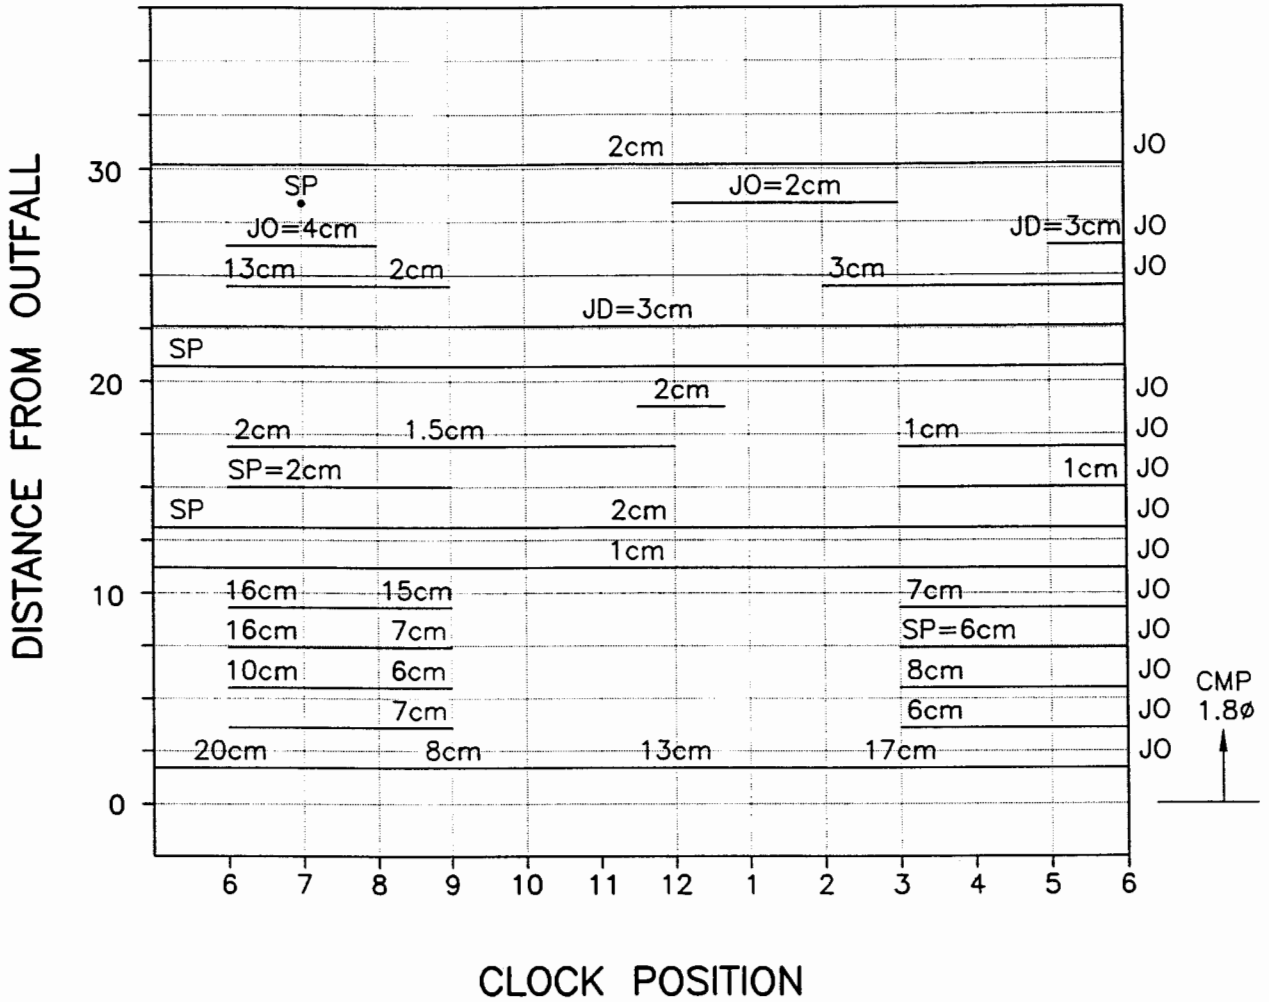
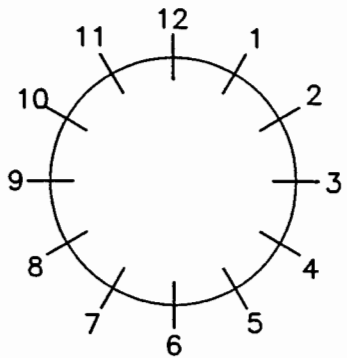
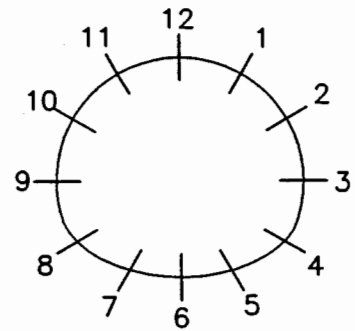
STRUCTURE CONDITION MAPPING CHART

DEFECTIVE CONCRETE:	Spalling	SP	JOINTS:	Raised	JR
	Honeycomb	HC		Displaced	JD
	Erosion/Wear	EW		Spalled	SP
	Delaminated	DC			
			PIPE IDENTIFICATION:	A19

The structure condition mapping chart represents a detailed log of all structural anomalies inside the outfall pipe. It is used to record any noted cracks, displaced joints, pipe deformations, mis-alignments, etc.

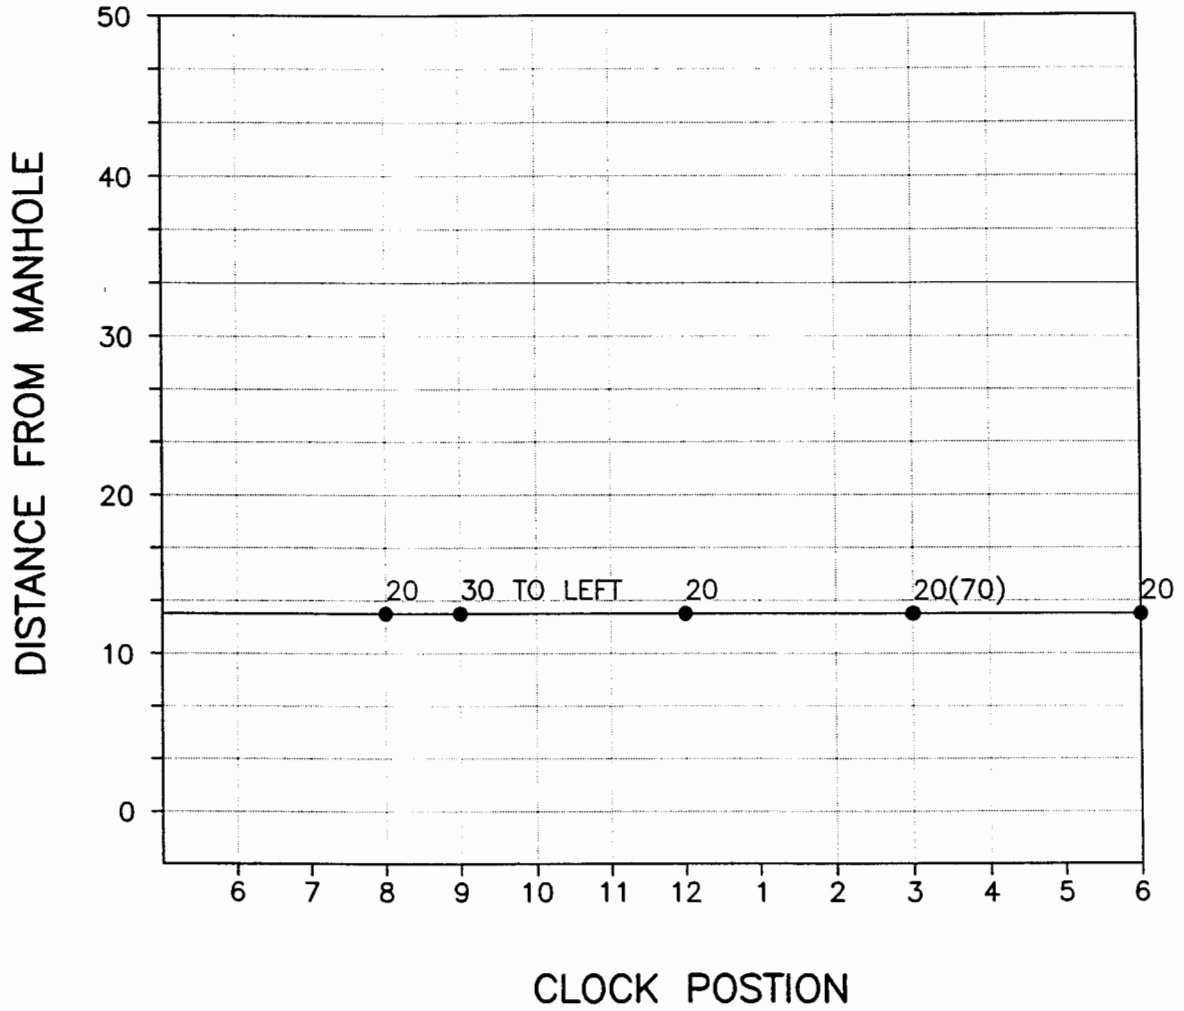
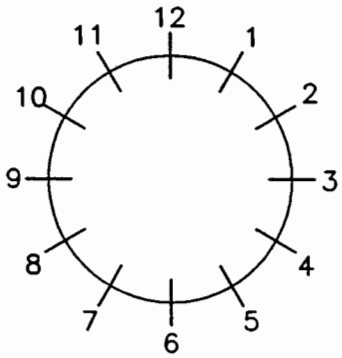
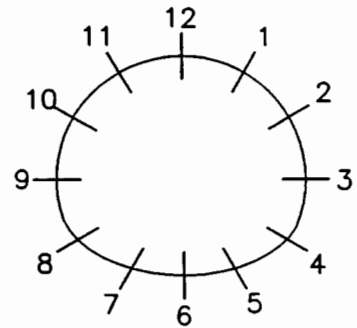
STRUCTURE CONDITION MAPPING CHART

DEFECTIVE CONCRETE: Spalling Honeycomb Erosion/Wear Delaminated	SP HC EW DC	JOINTS: Open Displaced Spalled A35	JO JD SP
--	----------------------	---	----------------

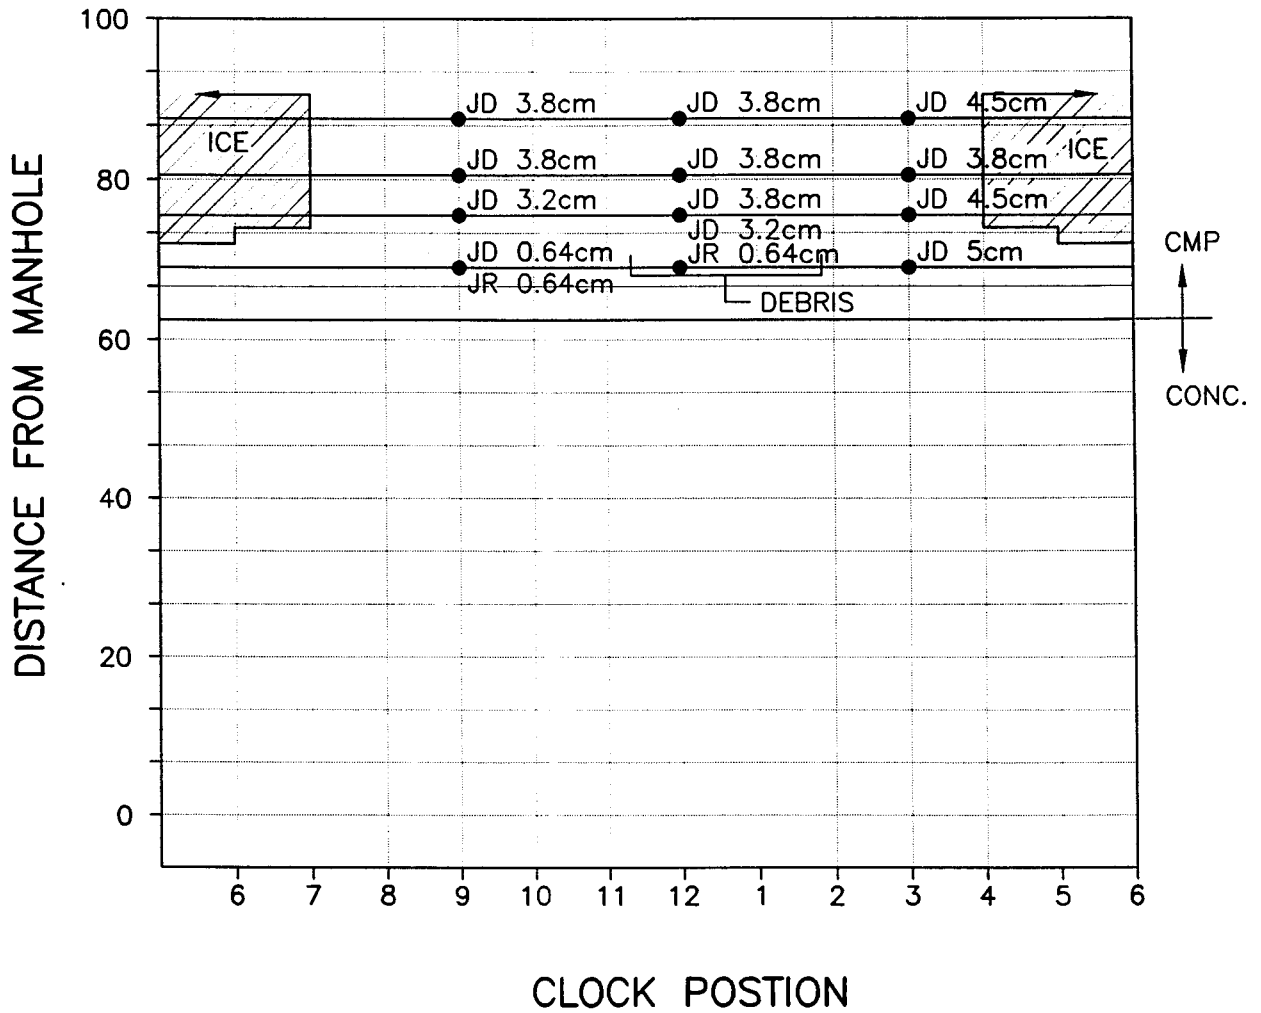
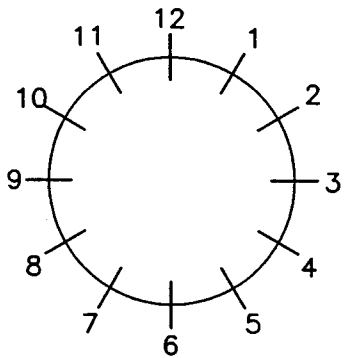
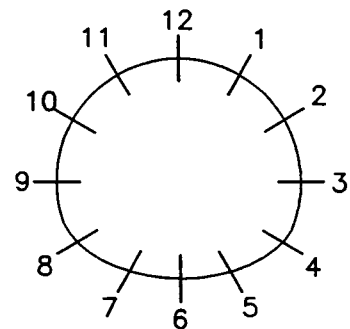
STRUCTURE CONDITION MAPPING CHART

DEFECTIVE CONCRETE:	Spalling	SP	JOINTS:	Open	JO
	Honeycomb	HC		Displaced	JD
	Erosion/Wear	EW		Spalled	SP
	Delaminated	DC			
			PIPE IDENTIFICATION:	A42

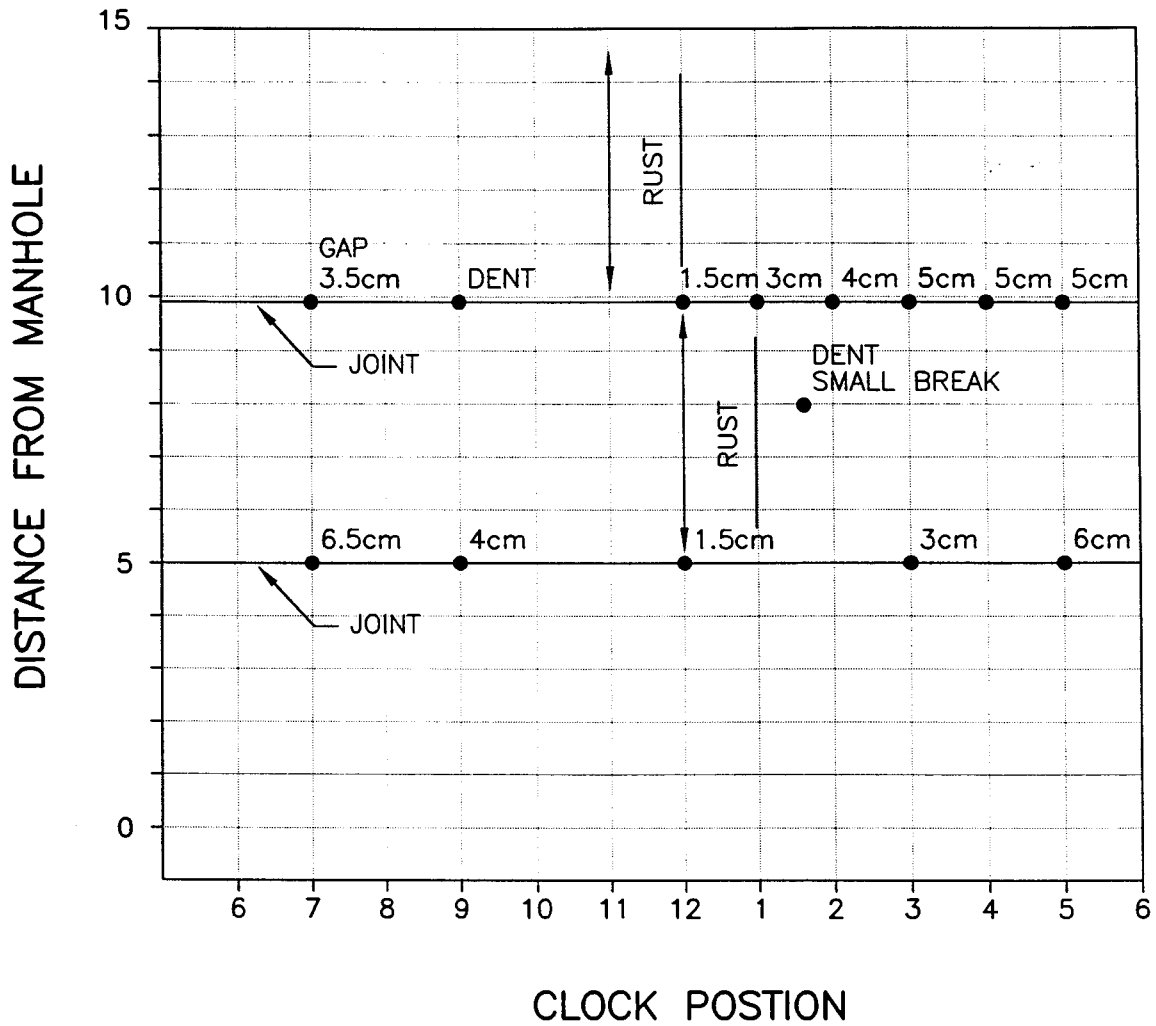
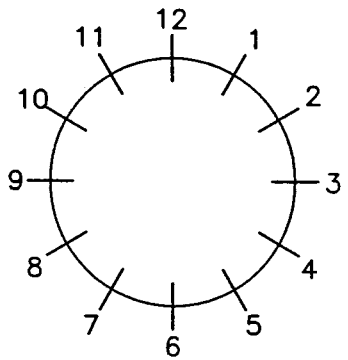
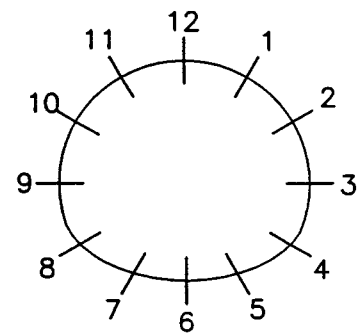
STRUCTURE CONDITION MAPPING CHART

DEFECTIVE CONCRETE: Spalling Honeycomb Erosion/Wear Delaminated	SP HC EW DC	JOINTS: Open Displaced Raised A52	JO JD JR
--	----------------------	--	----------------

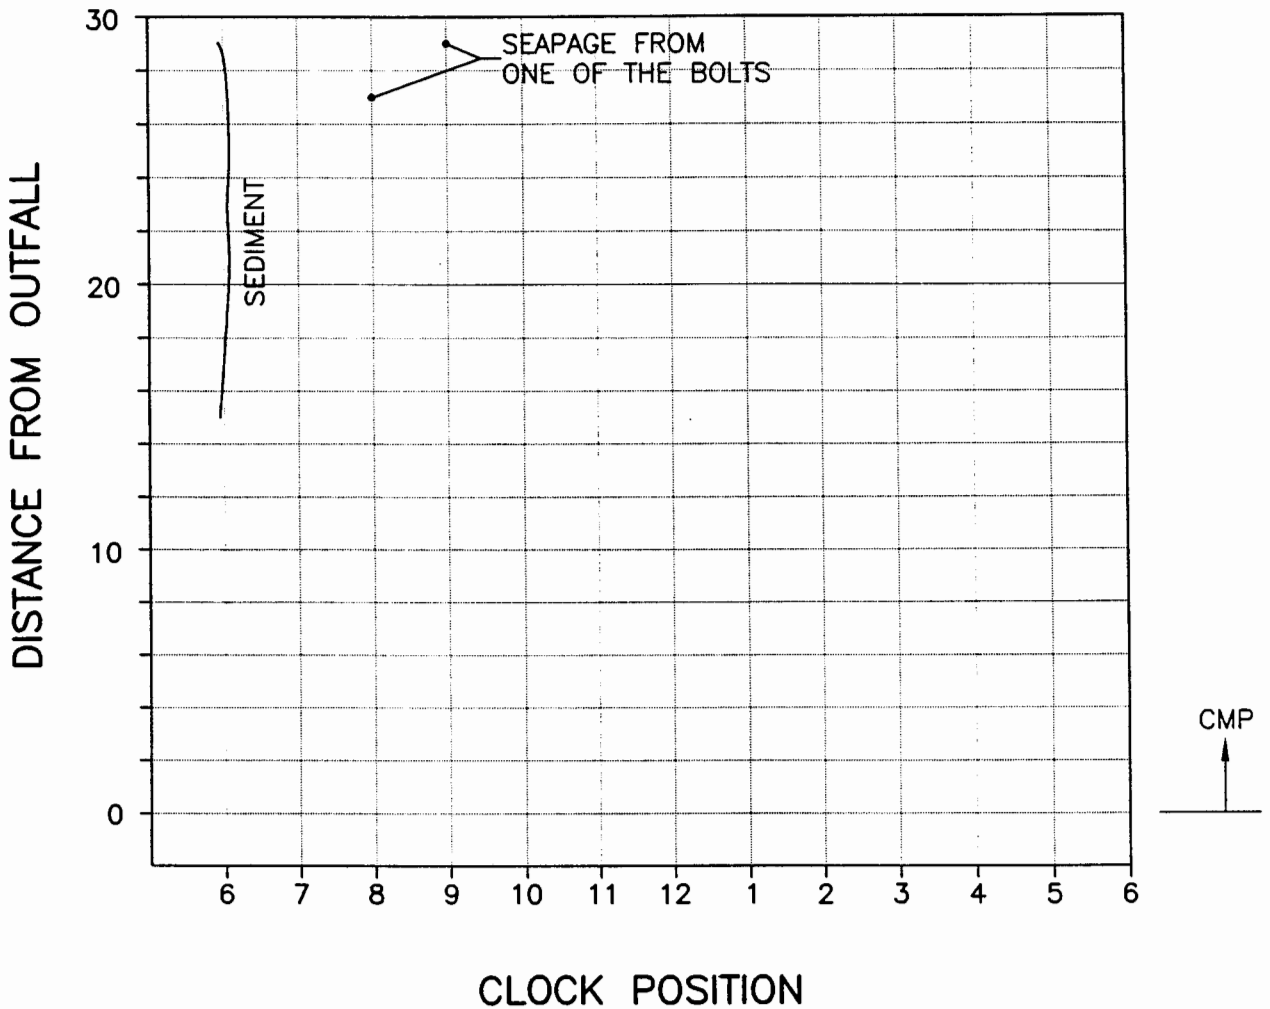
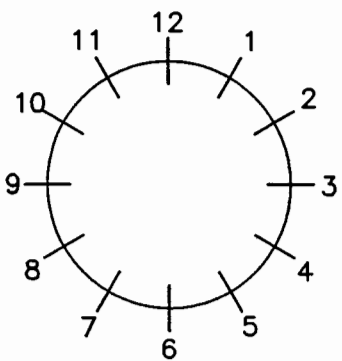
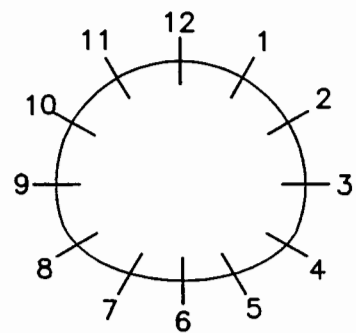
STRUCTURE CONDITION MAPPING CHART

DEFECTIVE CONCRETE: Spalling Honeycomb Erosion/Wear Delaminated	SP HC EW DC	JOINTS: Raised Displaced Spalled A58	JR JD SP
		PIPE IDENTIFICATION:

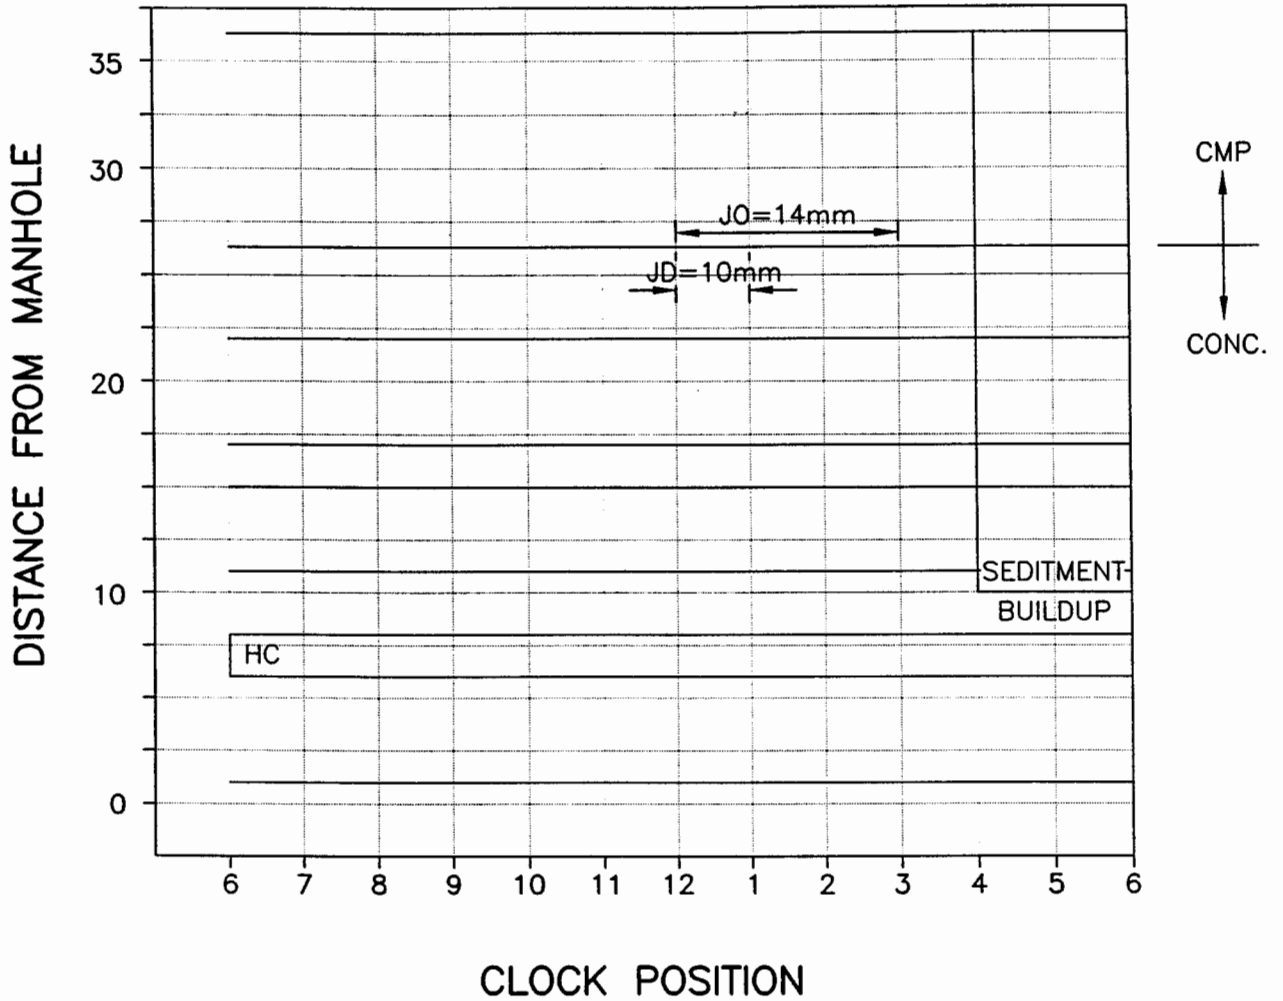
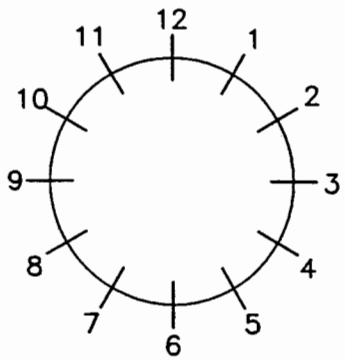
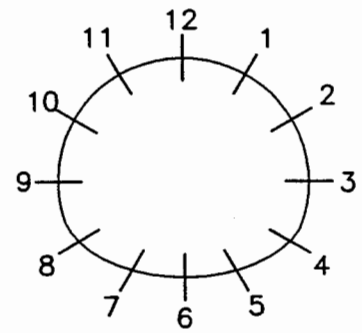
STRUCTURE CONDITION MAPPING CHART

DEFECTIVE CONCRETE: Spalling Honeycomb Erosion/Wear Delaminated	SP HC EW DC	JOINTS: Raised Displaced Spalled A63	JR JD SP
--	----------------------	---	----------------

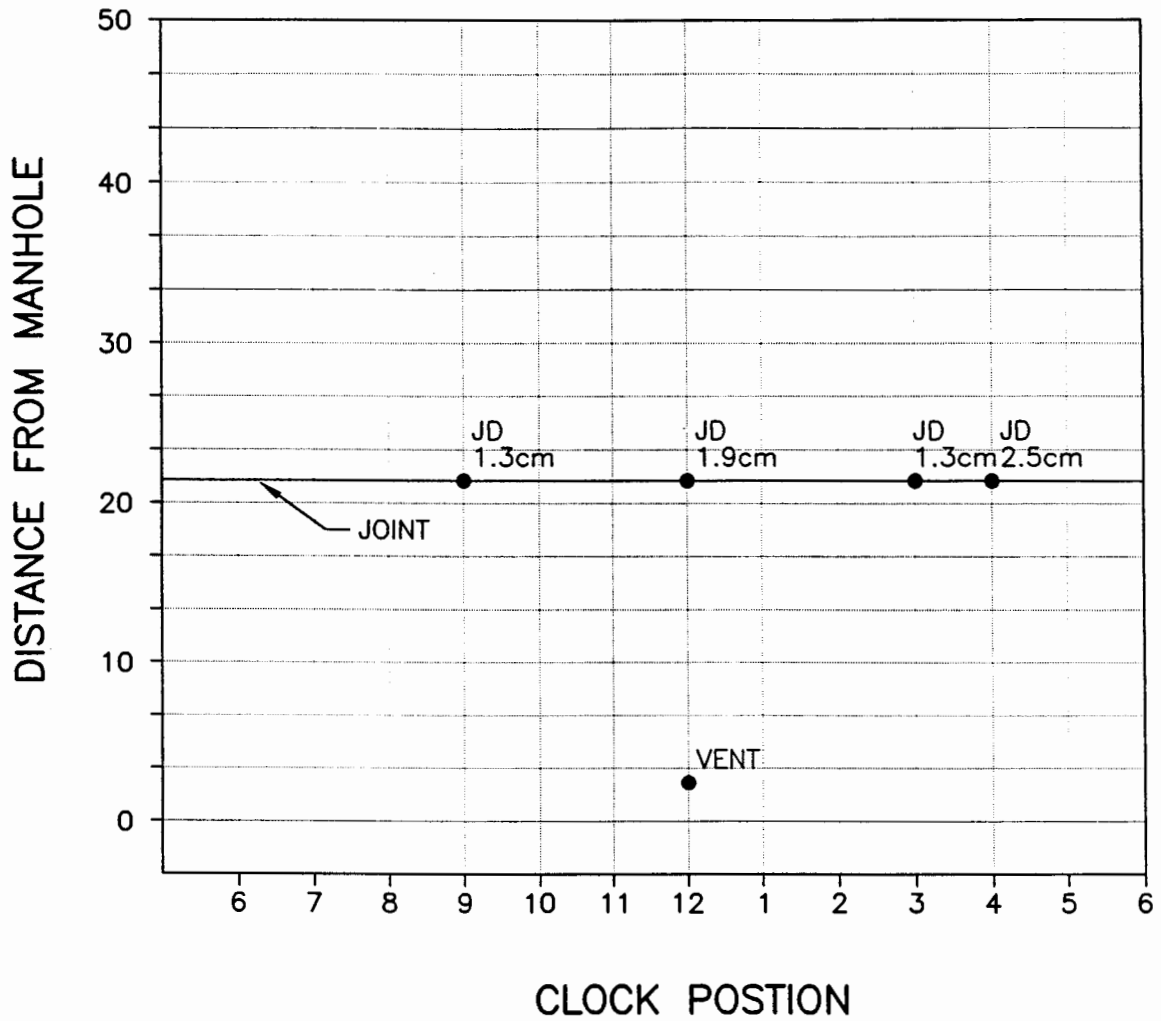
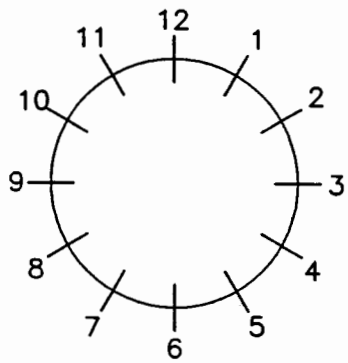
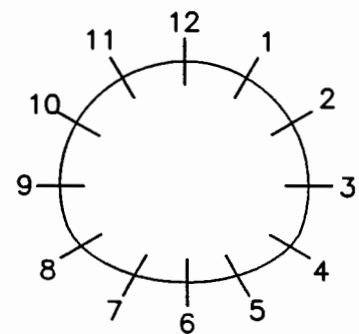
STRUCTURE CONDITION MAPPING CHART

DEFECTIVE CONCRETE: Spalling Honeycomb Erosion/Wear Delaminated	SP HC EW DC	JOINTS: Open Displaced Spalled	JO JD SP
PIPE IDENTIFICATION:		A69

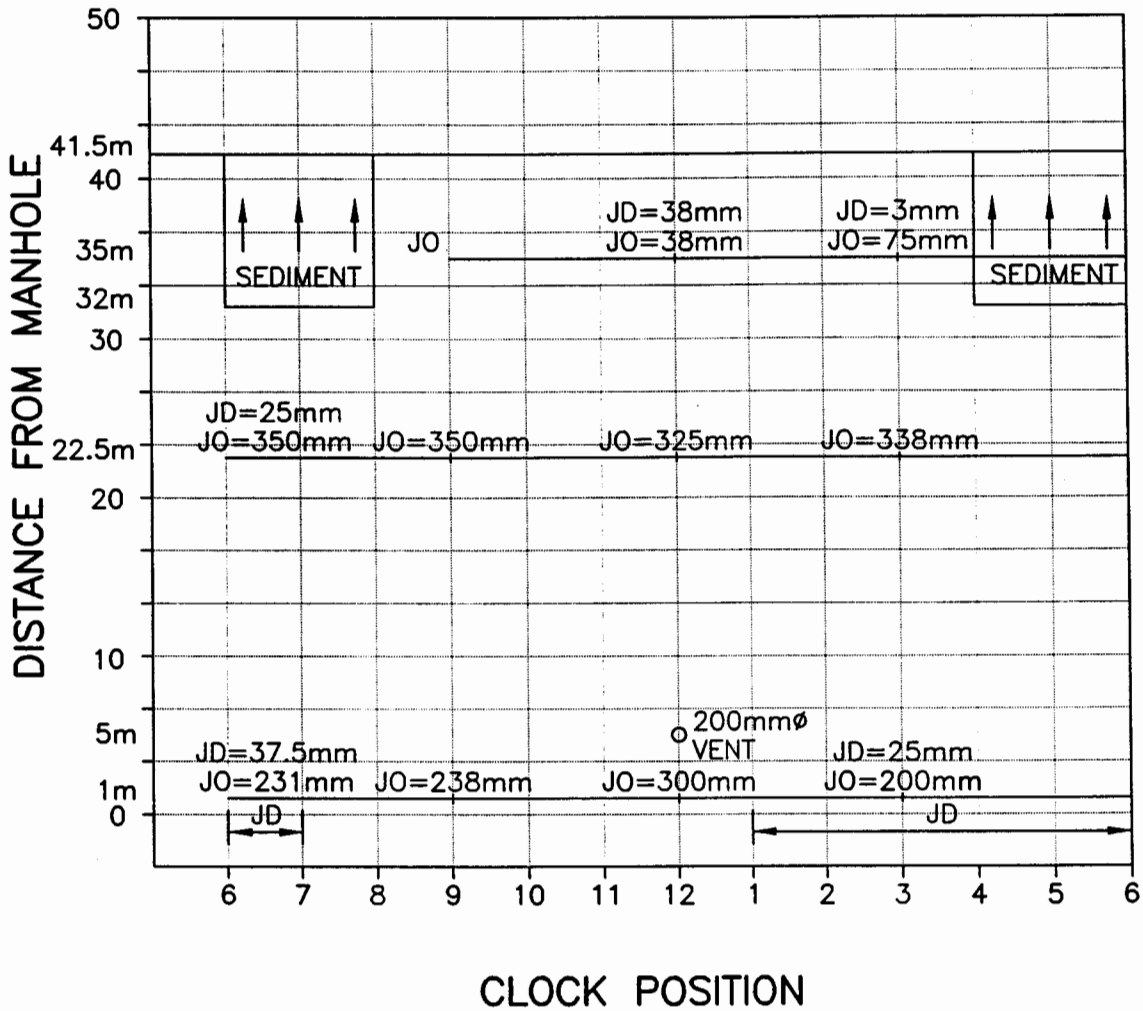
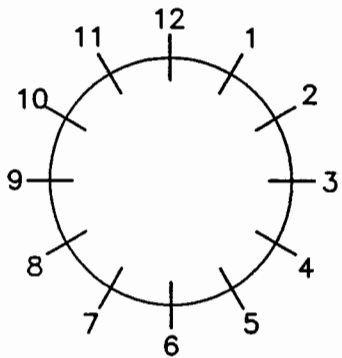
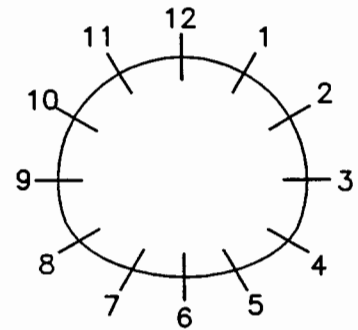
STRUCTURE CONDITION MAPPING CHART

CMP 2.1m ϕ

DEFECTIVE CONCRETE: Spalling Honeycomb Erosion/Wear Delaminated	SP HC EW DC	JOINTS: Raised Displaced Spalled A74	JR JD SP
--	----------------------	---	----------------

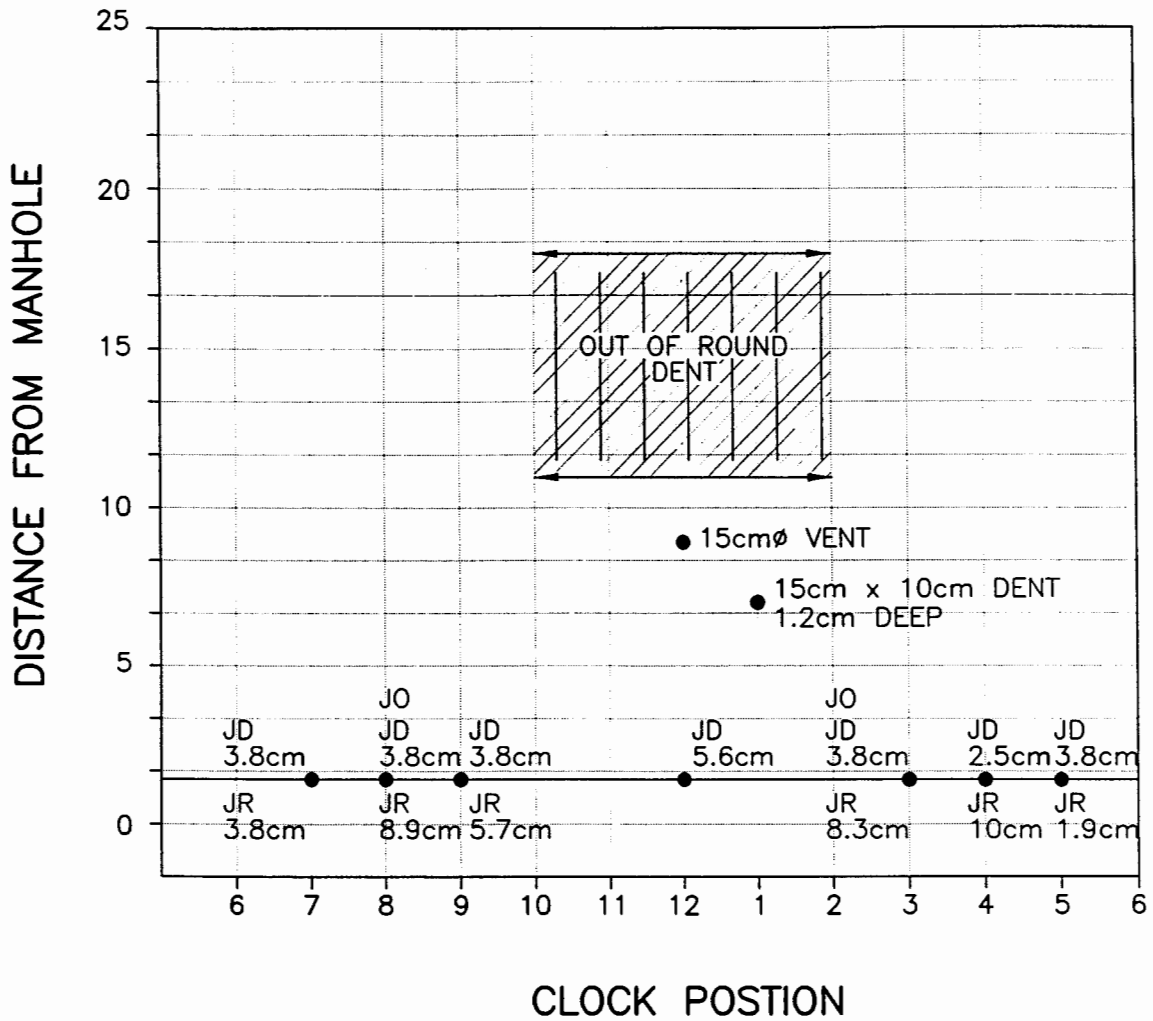
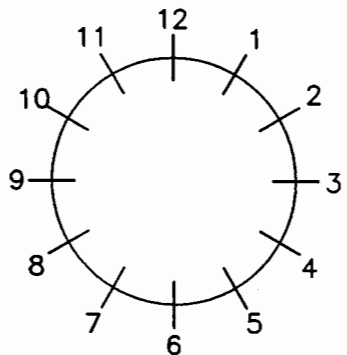
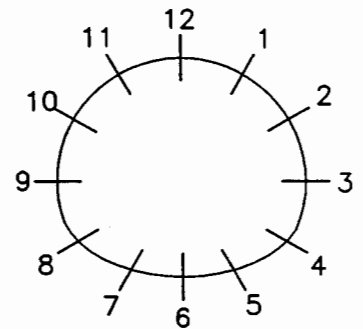
STRUCTURE CONDITION MAPPING CHART

DEFECTIVE CONCRETE:	Spalling	SP	JOINTS:	Open	JO
	Honeycomb	HC		Displaced	JD
	Erosion/Wear	EW		Raised	JR
	Delaminated	DC			
			PIPE IDENTIFICATION:	A75

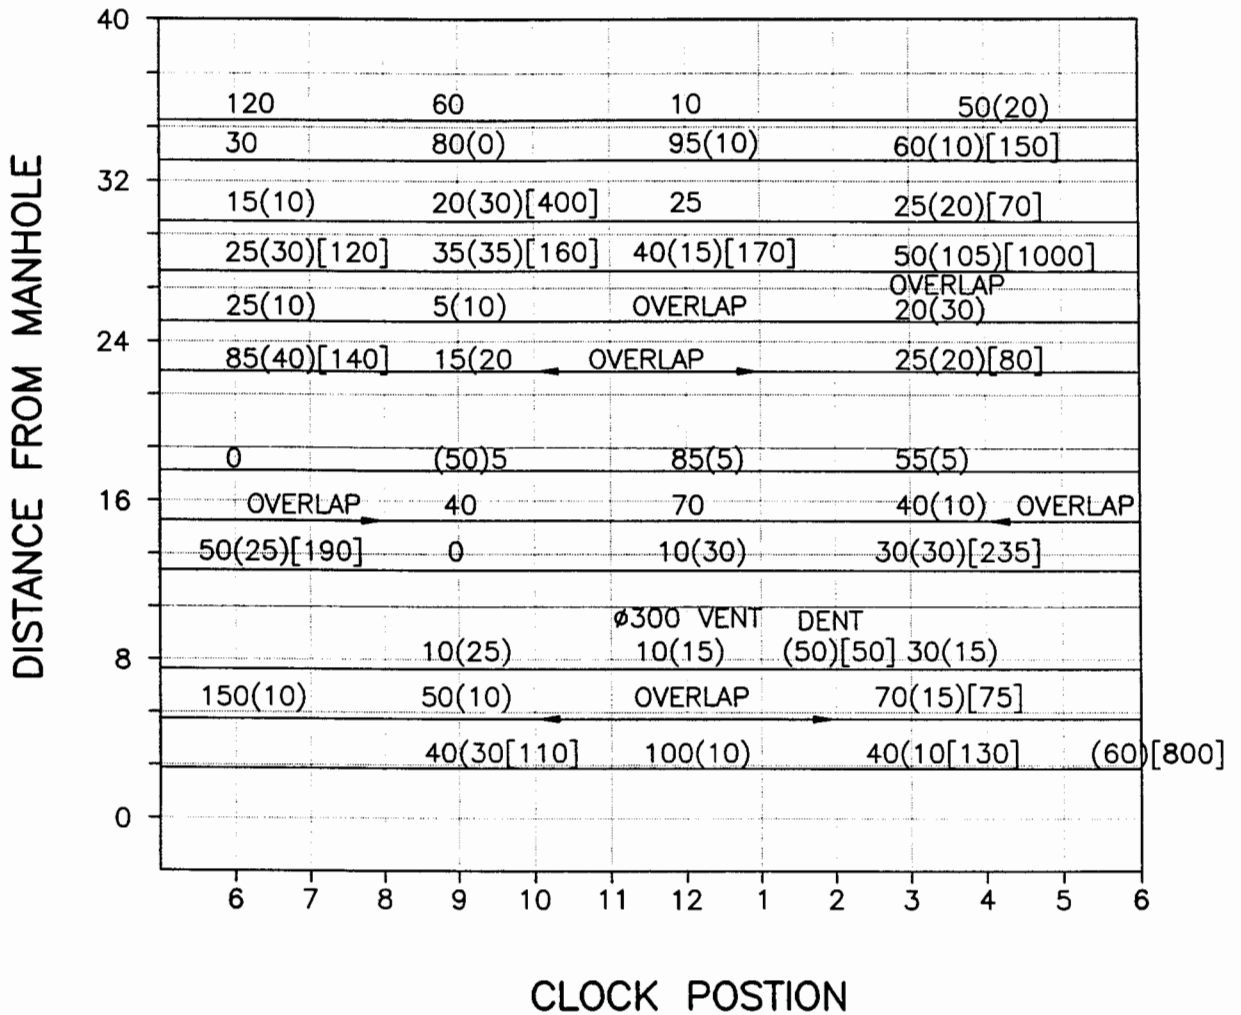
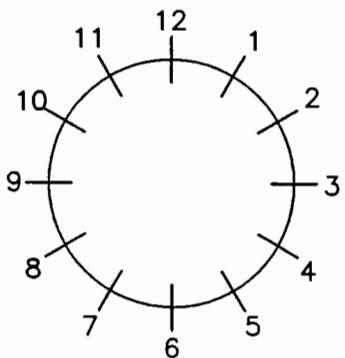
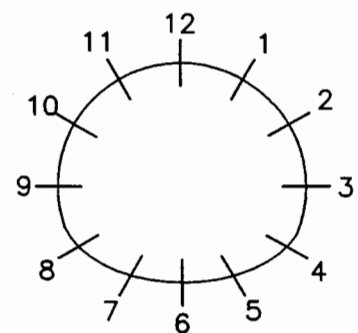
STRUCTURE CONDITION MAPPING CHART

DEFECTIVE CONCRETE:	Spalling	SP	JOINTS:	Open	JO
	Honeycomb	HC		Displaced	JD
	Erosion/Wear	EW		Spalled	SP
	Delaminated	DC			
			PIPE IDENTIFICATION:	A-76

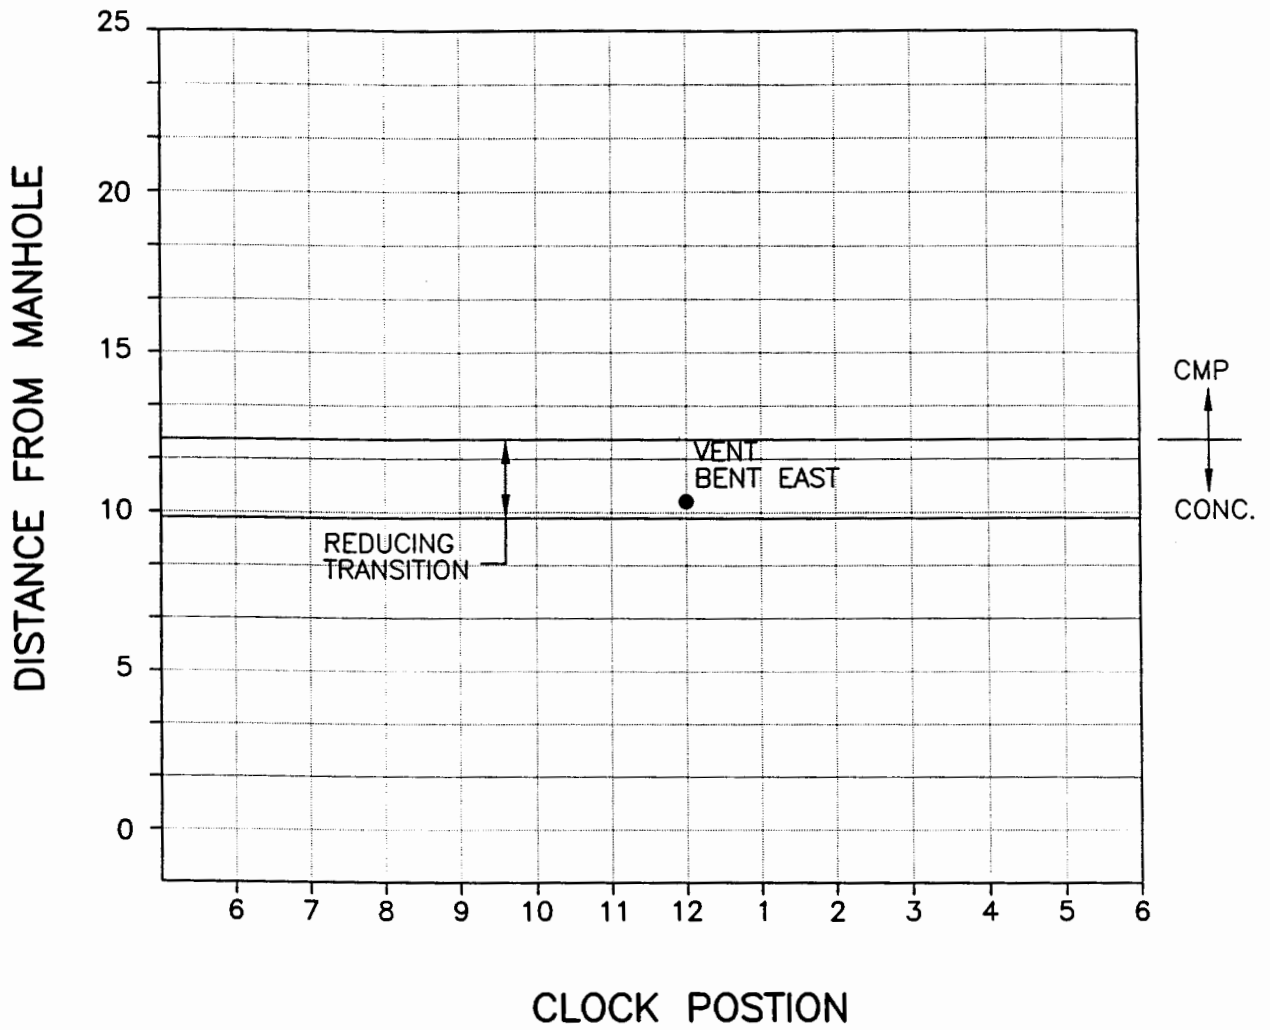
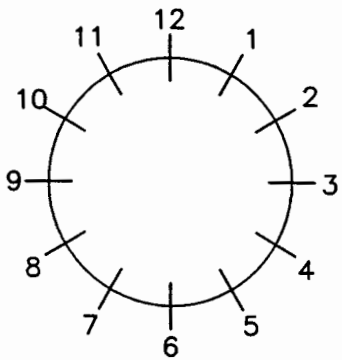
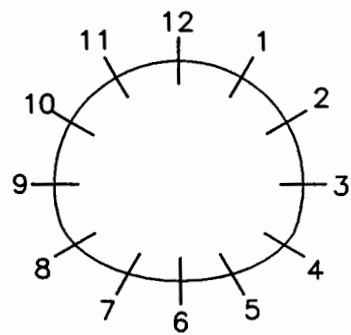
STRUCTURE CONDITION MAPPING CHART

DEFECTIVE CONCRETE:	Spalling	SP	JOINTS:	Open	JO
	Honeycomb	HC		Displaced	JD
	Erosion/Wear	EW		Raised	JR
	Delaminated	DC			
			PIPE IDENTIFICATION:	A80

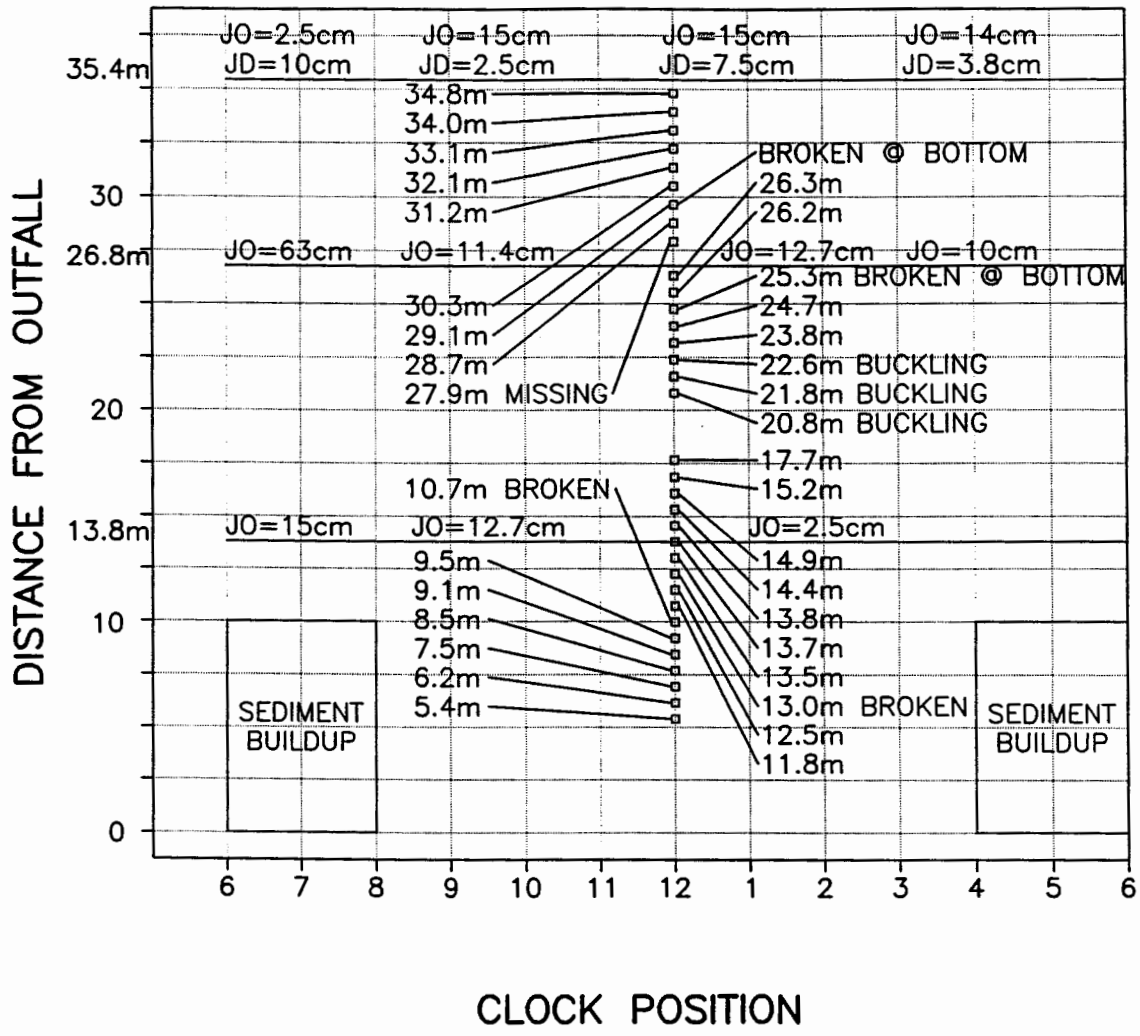
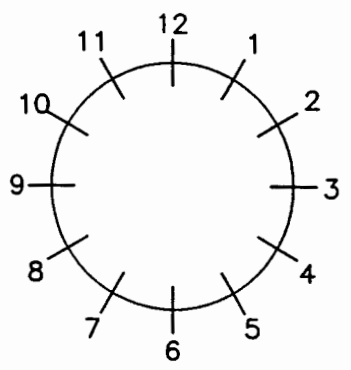
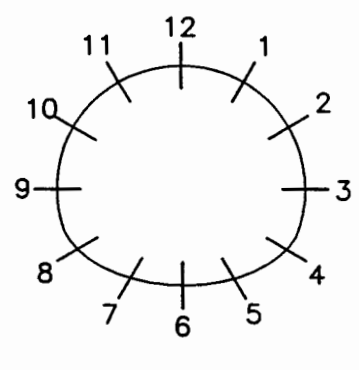
STRUCTURE CONDITION MAPPING CHART

CMP 2.1m ø

□ 11.8m - WOOD BRACE AND DISTANCE FROM OUTLET

DEFECTIVE CONCRETE:	Spalling	SP	PIPE IDENTIFICATION:	Raised	JR
	Honeycomb	HC		Displaced	JD
	Erosion/Wear	EW		Spalled	SP
	Delaminated	DC		A81

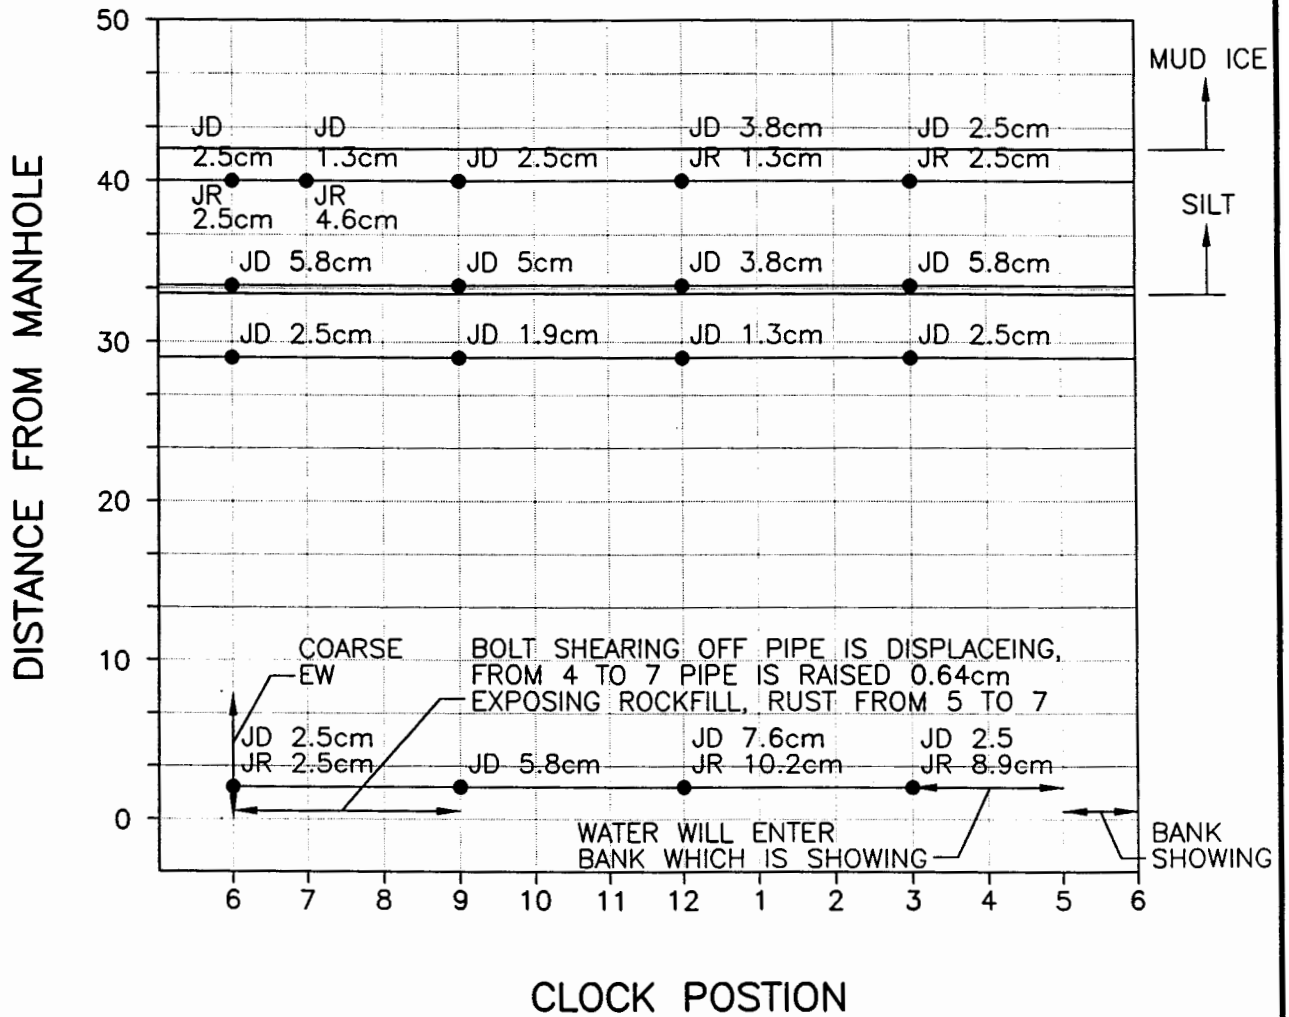
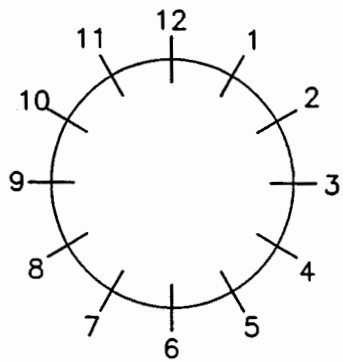
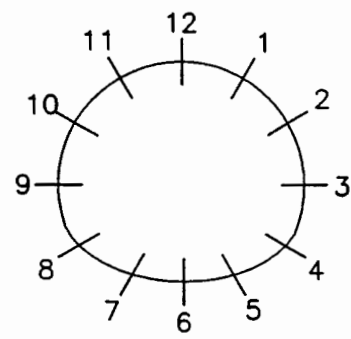
STRUCTURE CONDITION MAPPING CHART

DEFECTIVE CONCRETE:	Spalling	SP	PIPE IDENTIFICATION:	Open	JO
	Honeycomb	HC		Displaced	JD
	Erosion/Wear	EW		Spalled	SP
	Delaminated	DC		A86

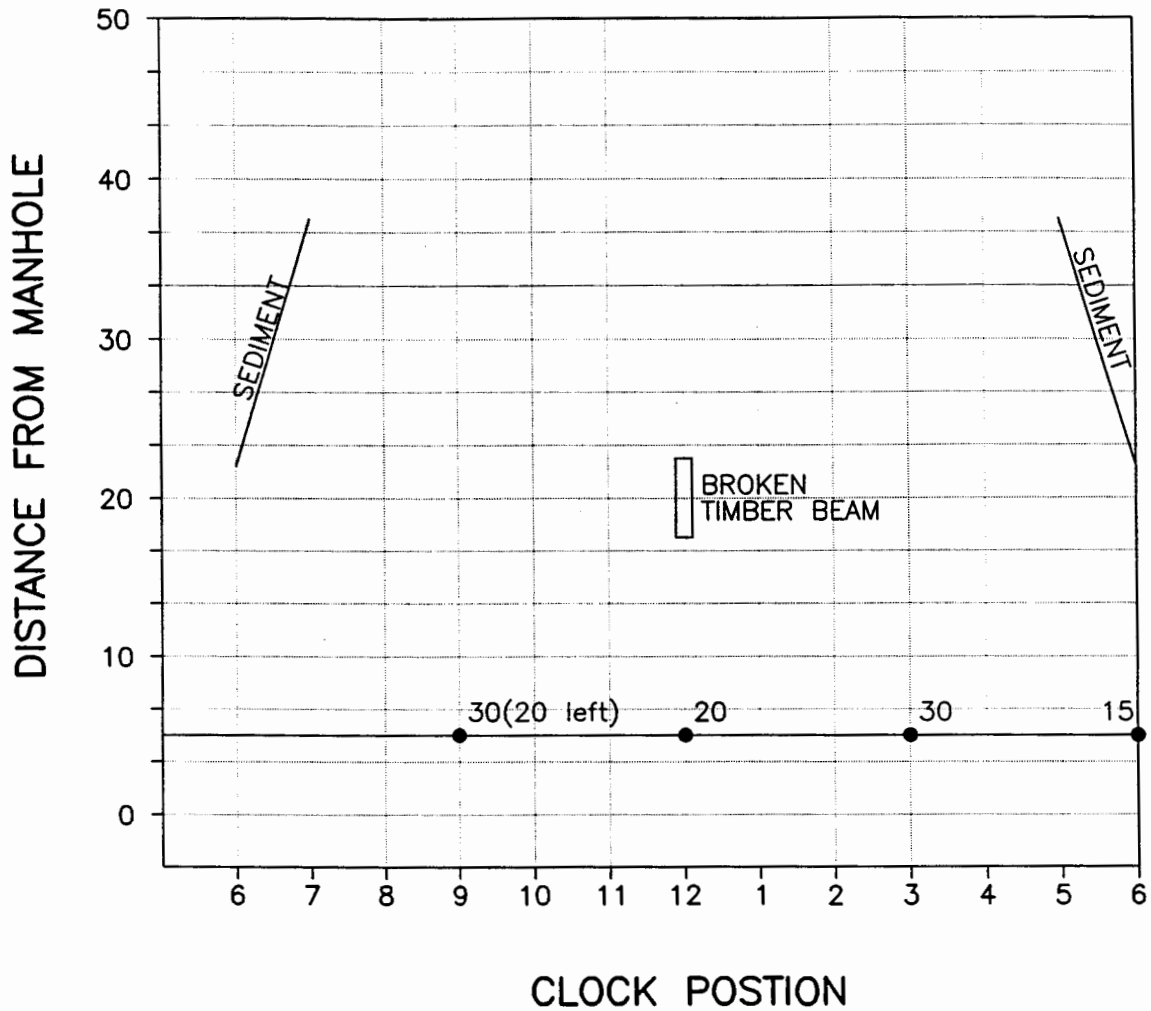
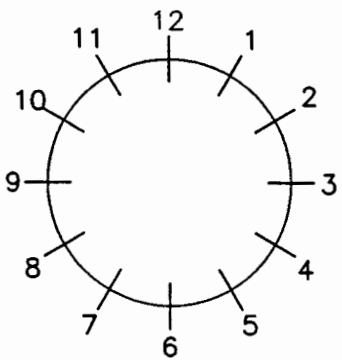
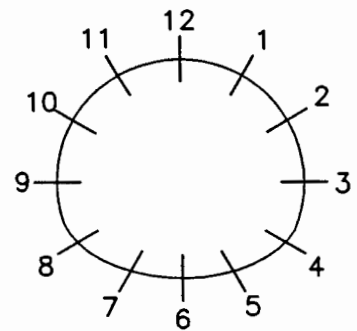
STRUCTURE CONDITION MAPPING CHART

DEFECTIVE CONCRETE:	Spalling	SP	JOINTS:	Open	JO
	Honeycomb	HC		Displaced	JD
	Erosion/Wear	EW		Spalled	SP
	Delaminated	DC			
			PIPE IDENTIFICATION:	AB7

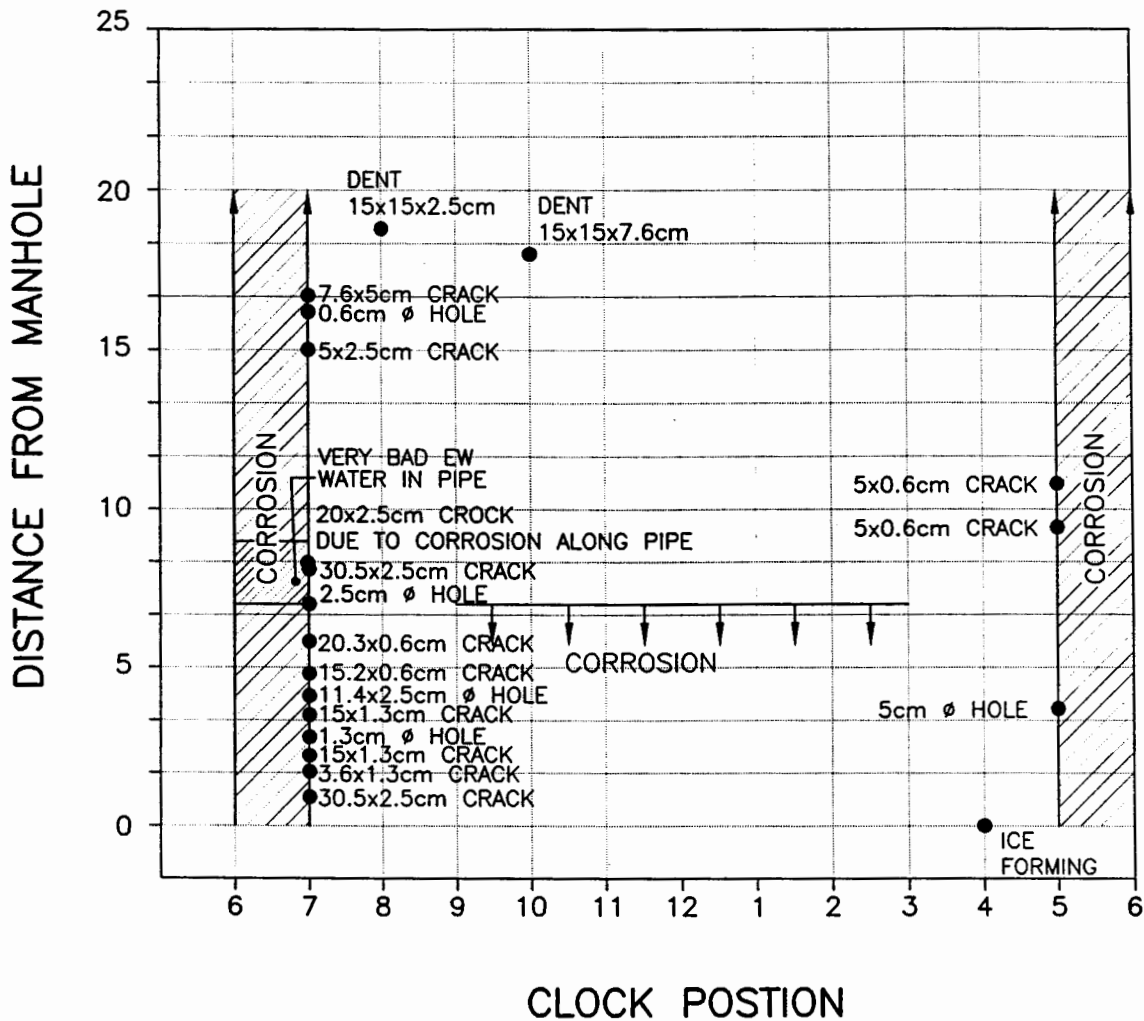
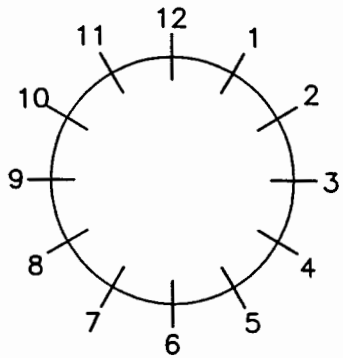
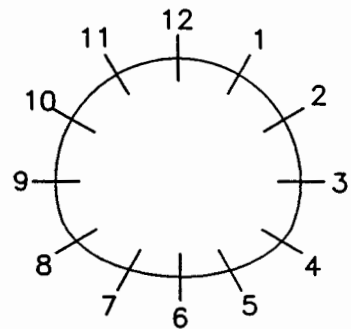
DEFECTIVE CONCRETE:	Spalling	SP	JOINTS:	Open	JO
	Honeycomb	HC		Displaced	JD
	Erosion/Wear	EW		Raised	JR
	Delaminated	DC			
			PIPE IDENTIFICATION:	ABB

STRUCTURE CONDITION MAPPING CHART

Clock Reference Looking DOWNSTREAM
