APPENDIX A – 1998 OUTFALL INSPECTIONS CONDITION AND MAINTENANCE STUDY

CITY OF WINNIPEG
OUTFALL CONDITION
AND
MAINTENANCE STUDY
FINAL REPORT //

August, 1998

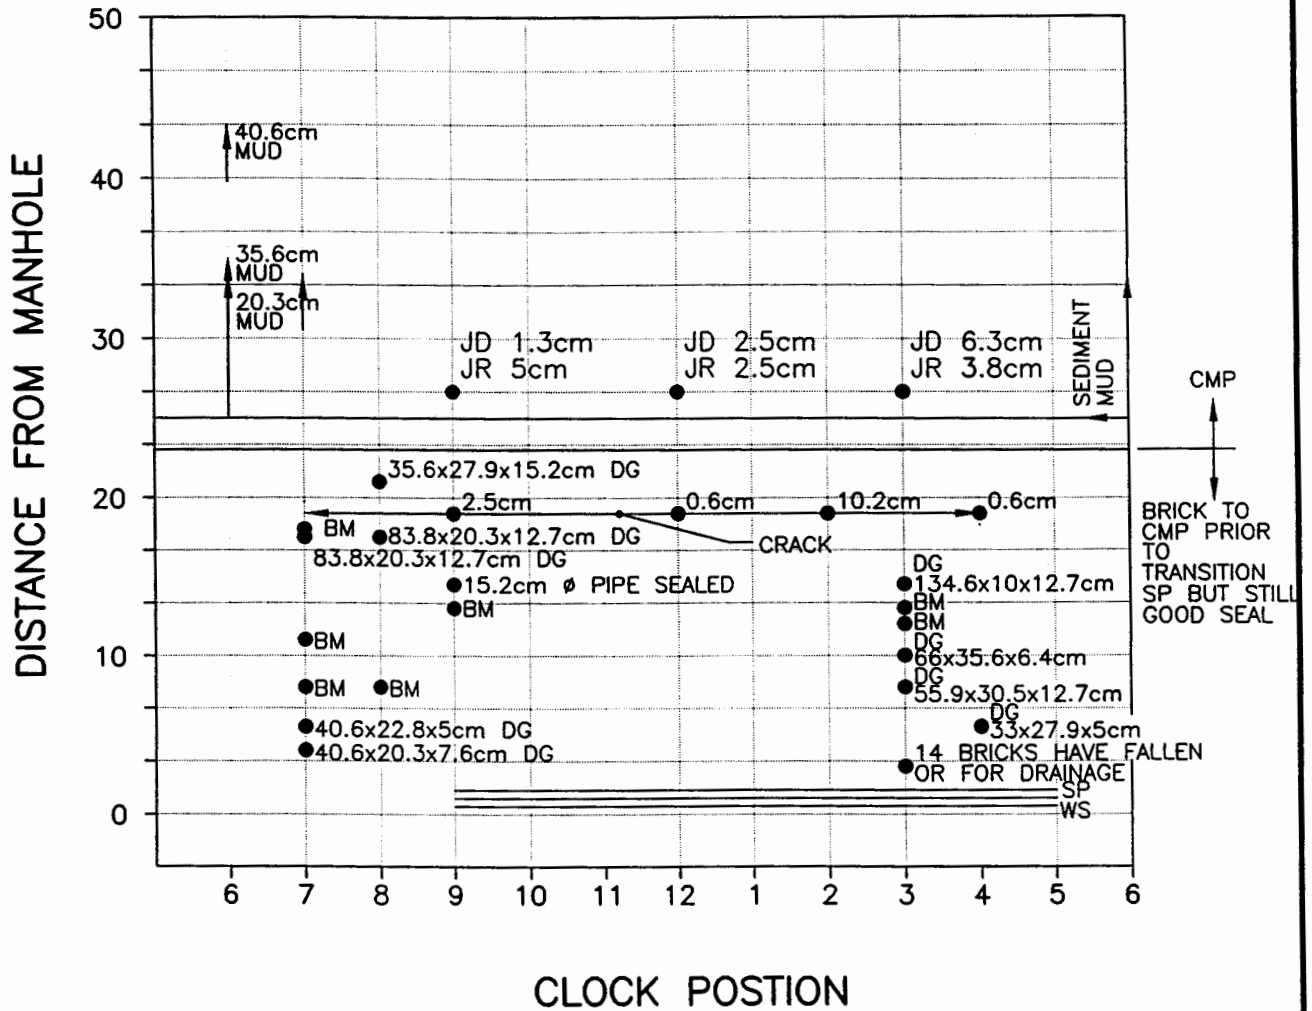
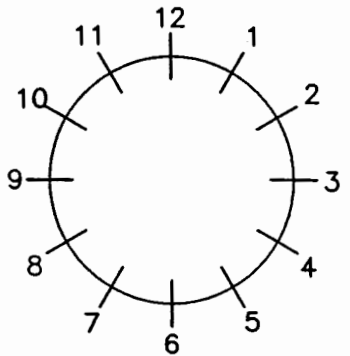
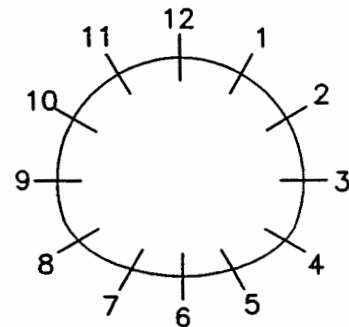
DEFECTIVE CONCRETE:		Spalling	SP	JOINTS:	Raised	JR
DG	DEEP GAP	Honeycomb	HC	Displaced	JD	
BM	BRICK MISSING	Erosion/Wear	EW	Spalled	SP	
WS	WATER SEEPAGE	Delaminated	DC	PIPE IDENTIFICATION:	A90

STRUCTURE CONDITION MAPPING CHART

Clock Reference Looking DOWNSTREAM

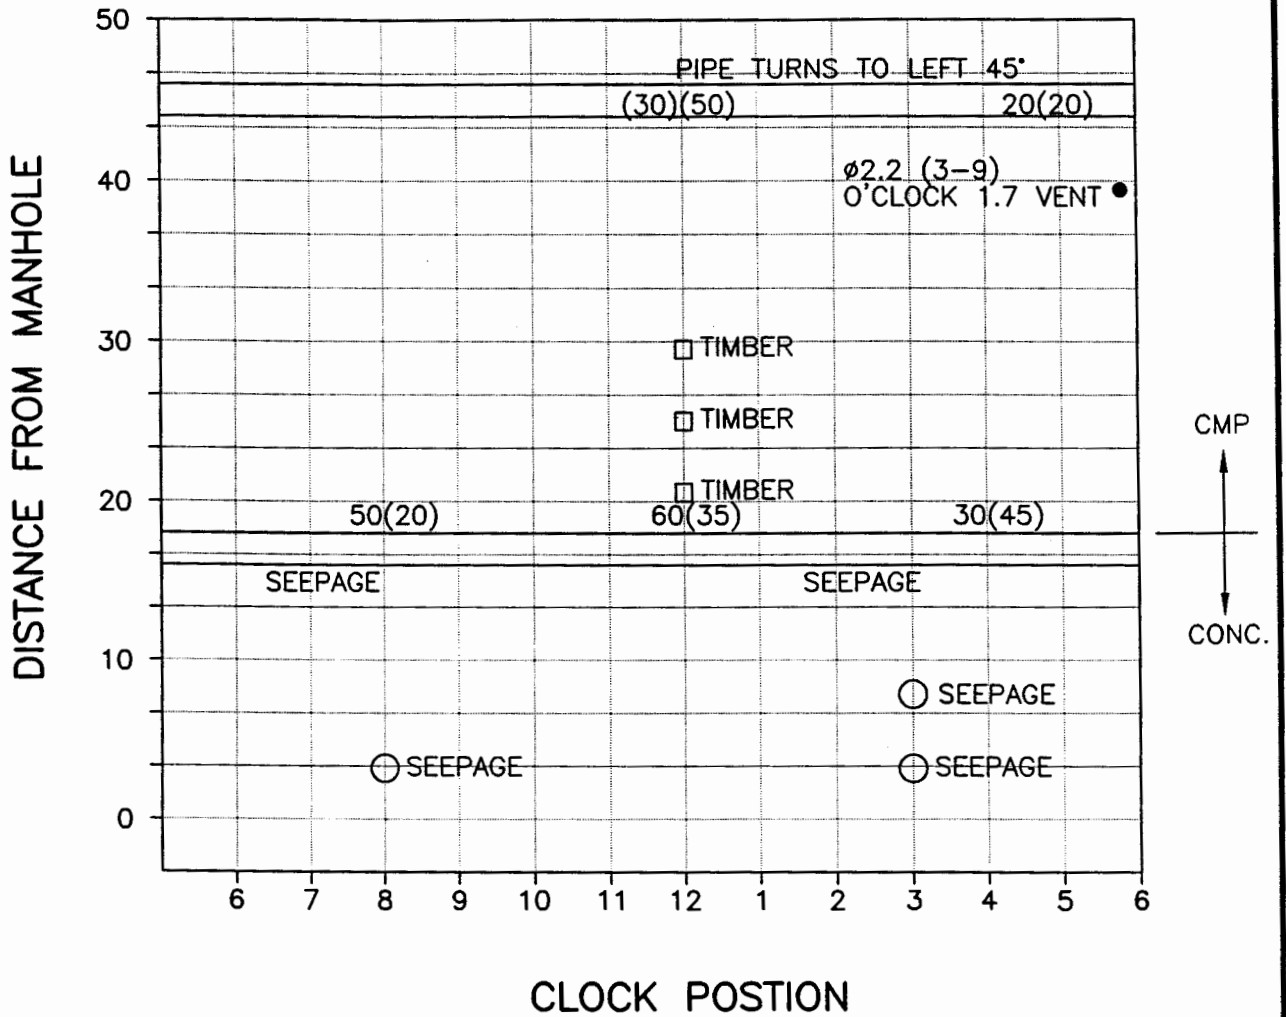
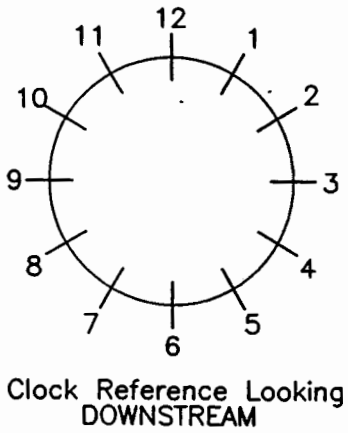
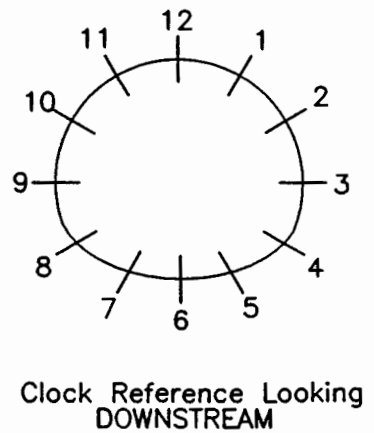
DEFECTIVE CONCRETE: Spalling Honeycomb Erosion/Wear Delaminated	SP HC EW DC	JOINTS: Open Displaced Spalled A94	JO JD SP
--	----------------------	---	----------------

STRUCTURE CONDITION MAPPING CHART

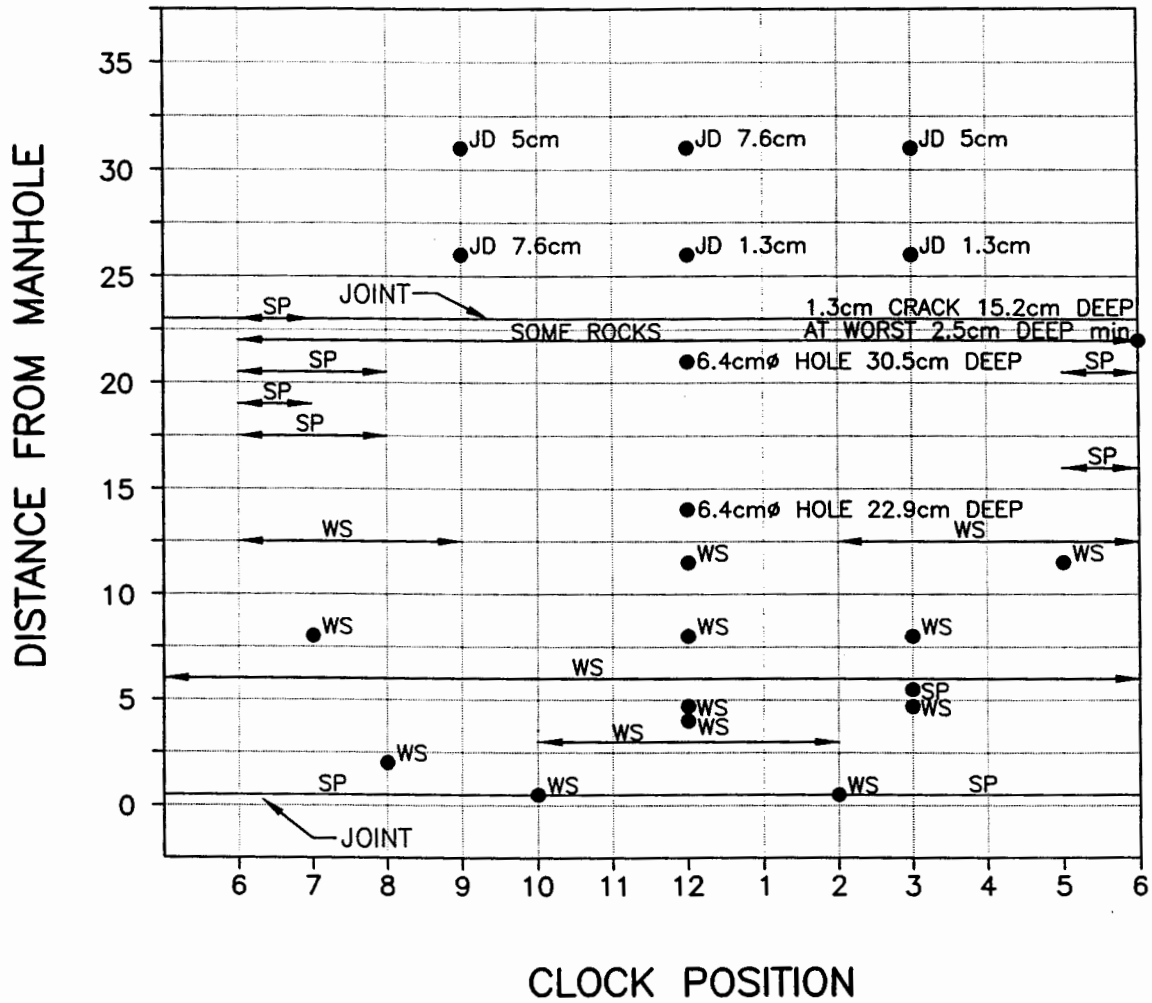
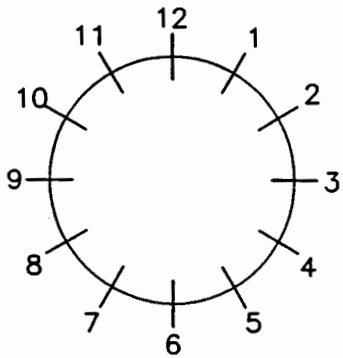
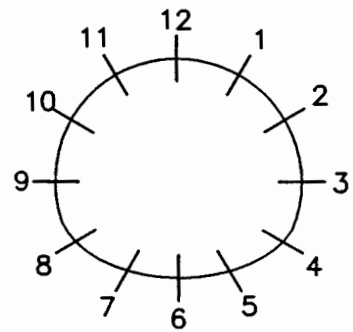
DEFECTIVE CONCRETE:	Spalling	SP	PIPE IDENTIFICATION:	Open	JO
	Honeycomb	HC		Displaced	JD
	Erosion/Wear	EW		Spalled	SP
	Delaminated	DC		A95

STRUCTURE CONDITION MAPPING CHART

Clock Reference Looking DOWNSTREAM

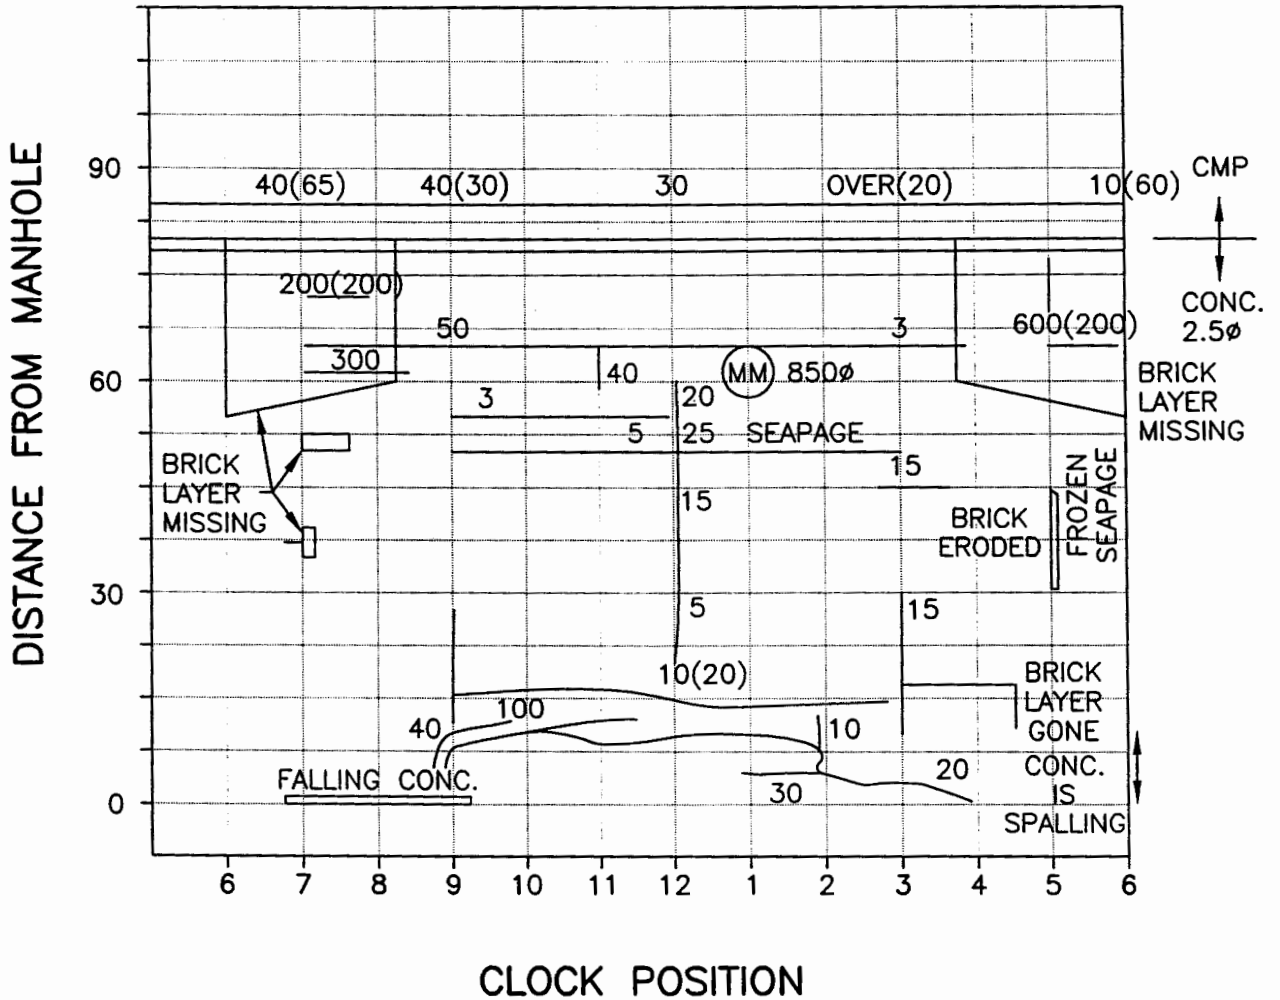
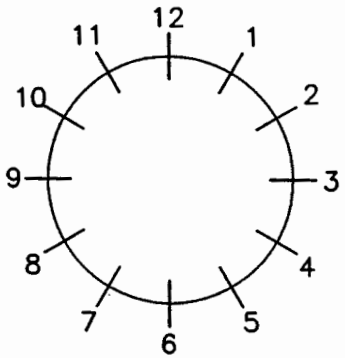
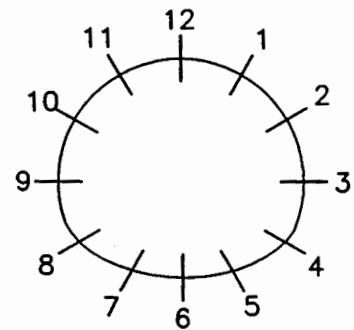
DEFECTIVE CONCRETE: Spalling Honeycomb Erosion/Wear Delaminated	SP HC EW DC	JOINTS: Raised Displaced Spalled SE1	JR JD SP
--	----------------------	---	----------------

STRUCTURE CONDITION MAPPING CHART

Clock Reference Looking DOWNSTREAM

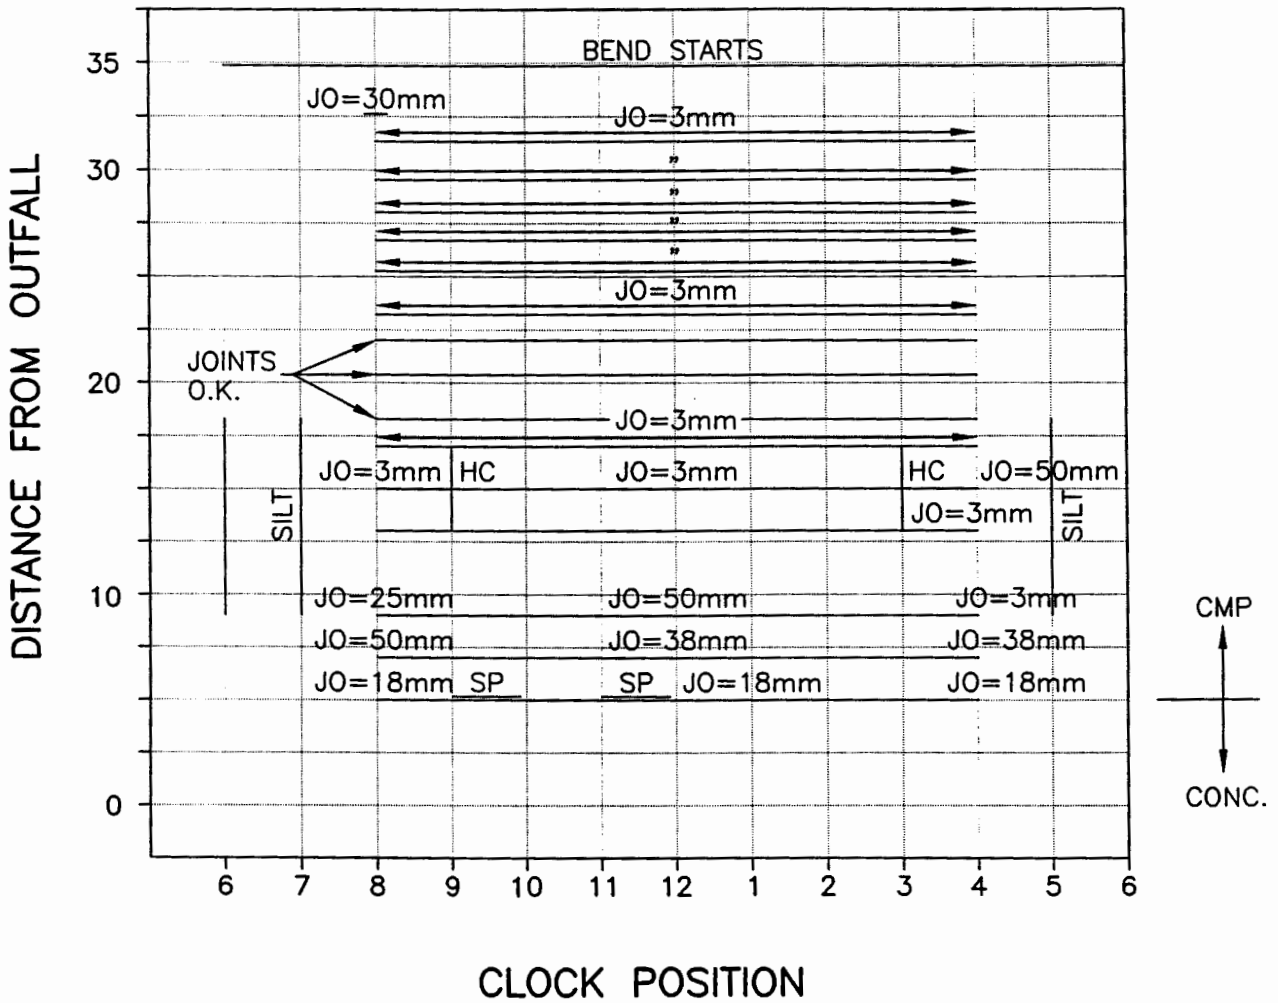
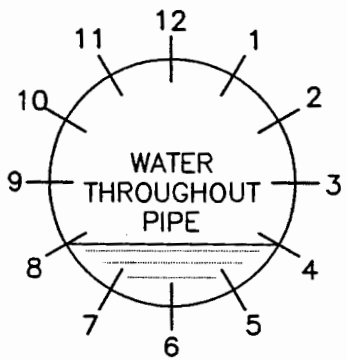
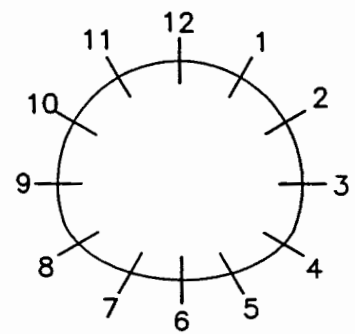
DEFECTIVE CONCRETE: Spalling Honeycomb Erosion/Wear Delaminated	SP HC EW DC	JOINTS: Raised Displaced Spalled SE34	JR JD SP
--	----------------------	--	----------------

STRUCTURE CONDITION MAPPING CHART

Clock Reference Looking
DOWNSTREAM

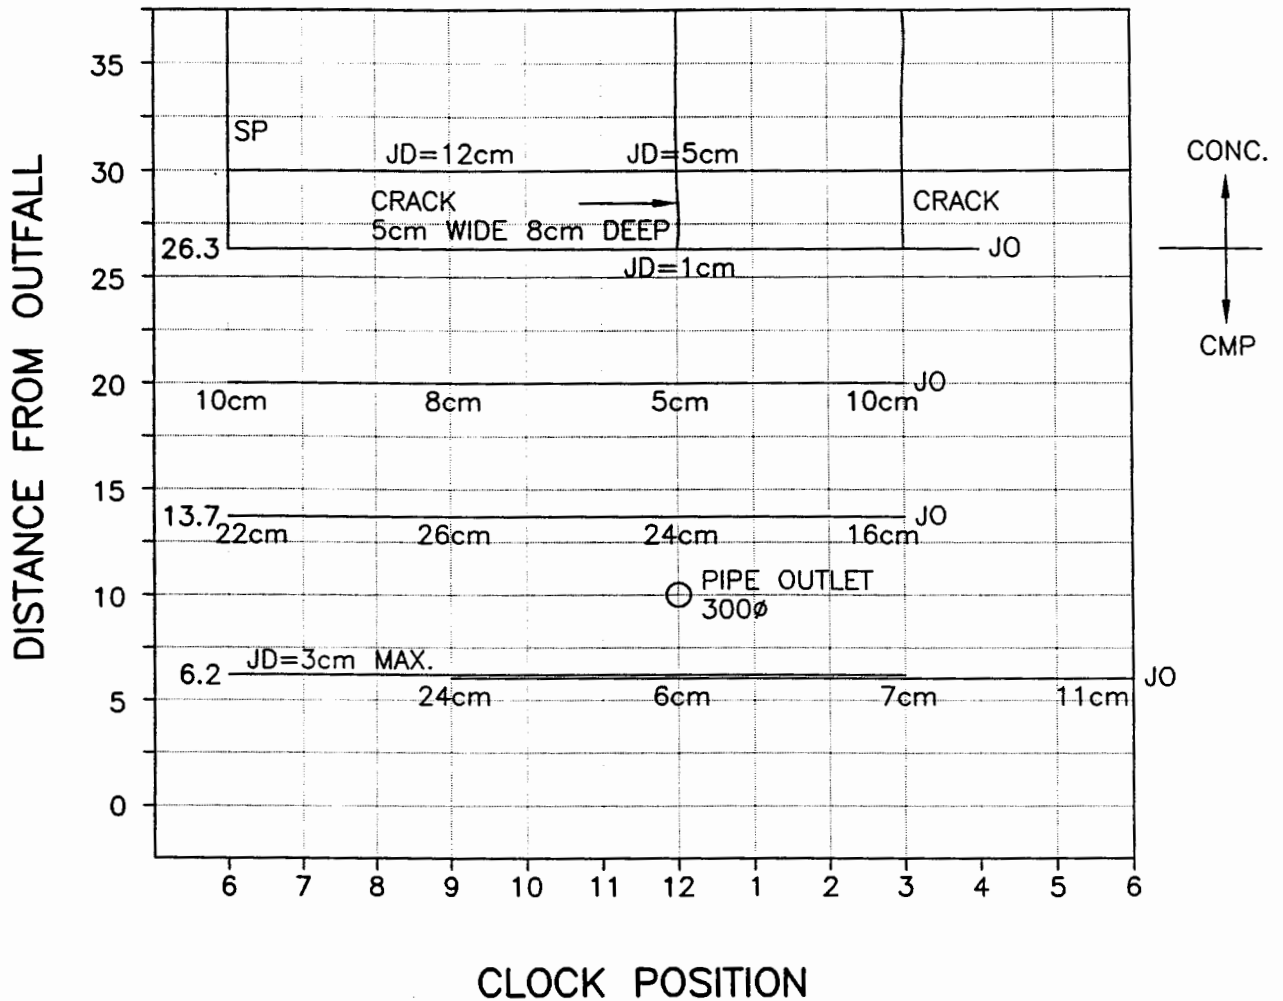
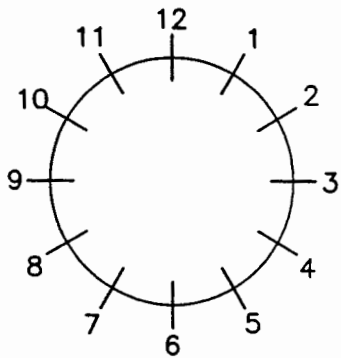
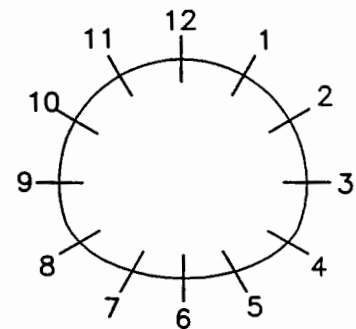
DEFECTIVE CONCRETE:	Spalling	SP	PIPE IDENTIFICATION:	Raised	JR
	Honeycomb	HC		Displaced	JD
	Erosion/Wear	EW		Spalled	SP
	Delaminated	DC		ST3

STRUCTURE CONDITION MAPPING CHART

Clock Reference Looking DOWNSTREAM

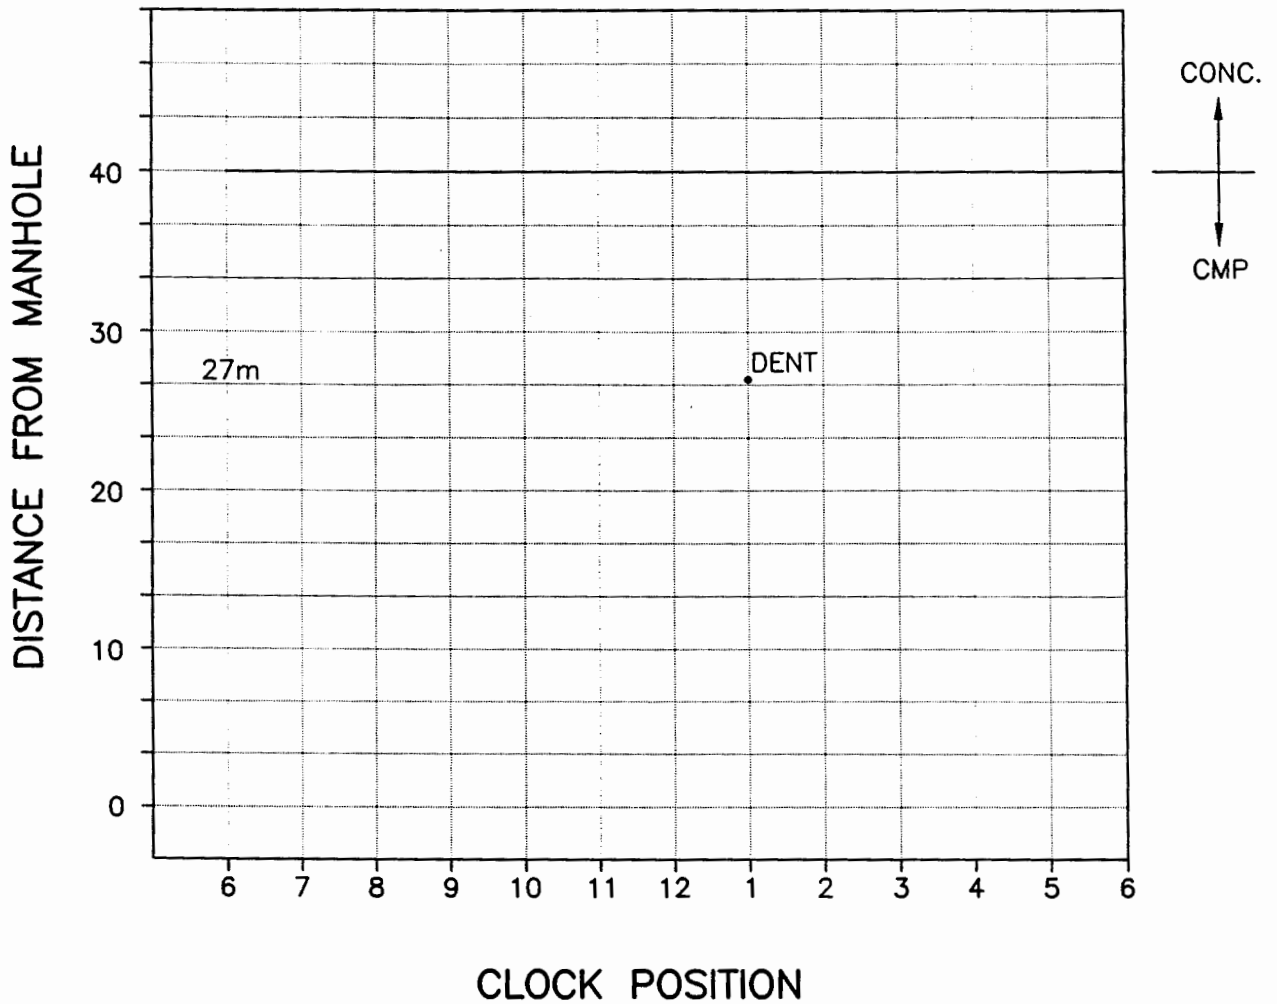
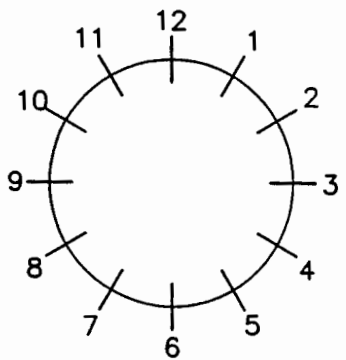
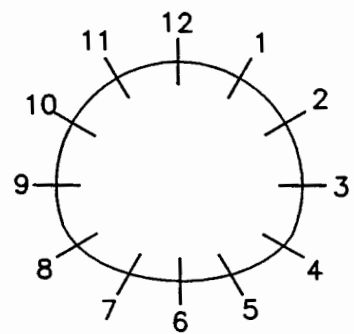
DEFECTIVE CONCRETE: Spalling Honeycomb Erosion/Wear Delaminated	SP HC EW DC	JOINTS: Raised Displaced Spalled ST18	JR JD SP
--	----------------------	--	----------------

STRUCTURE CONDITION MAPPING CHART

Clock Reference Looking DOWNSTREAM

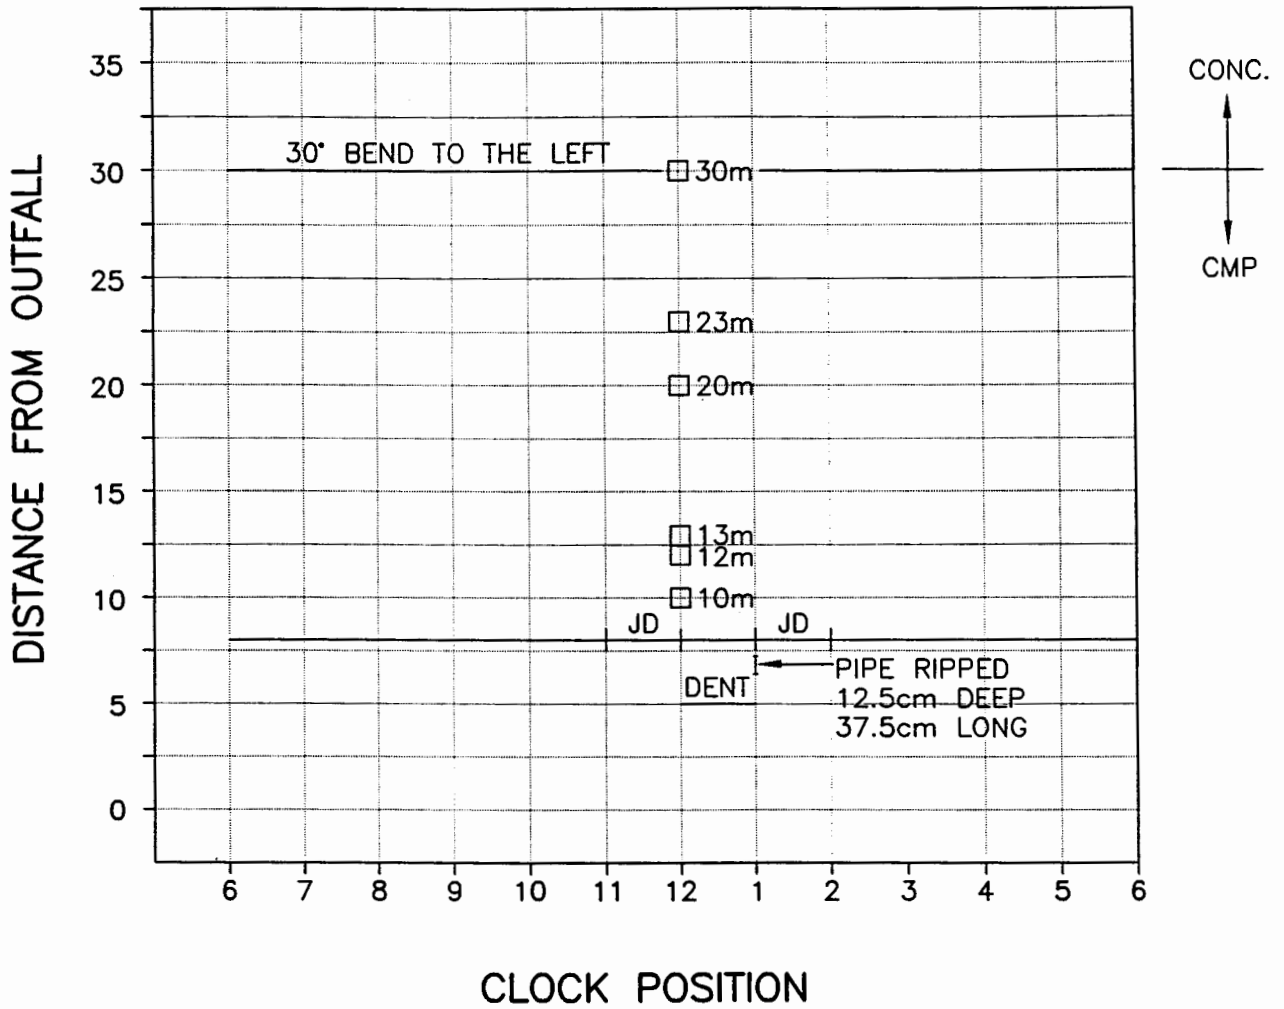
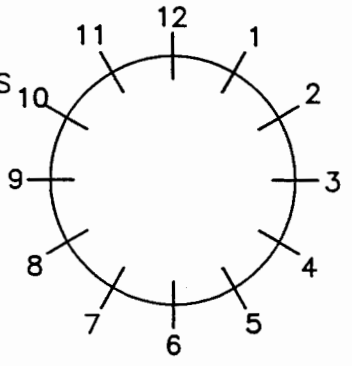
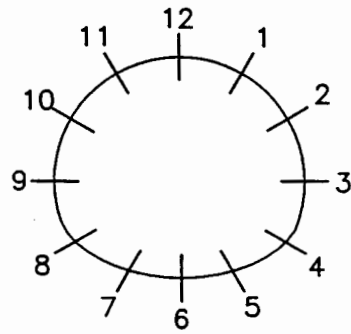
DEFECTIVE CONCRETE:	Spalling Honeycomb Erosion/Wear Delaminated	SP HC EW DC	JOINTS:	Raised Displaced Spalled	JR JD SP
			PIPE IDENTIFICATION:	ST21

STRUCTURE CONDITION MAPPING CHART

□ 4"x4" WOOD BRACES

Clock Reference Looking DOWNSTREAM

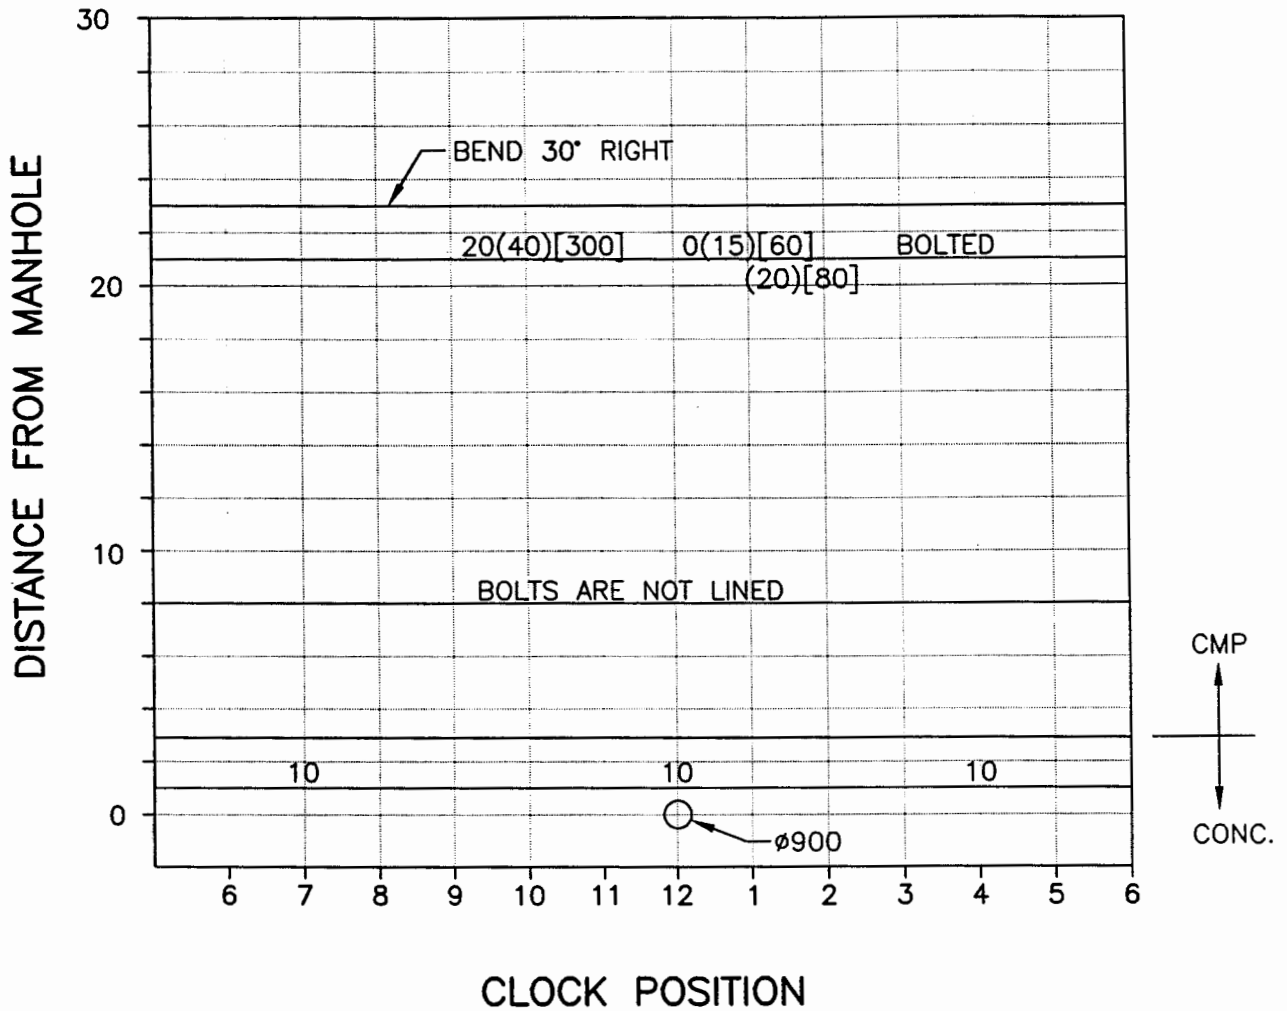
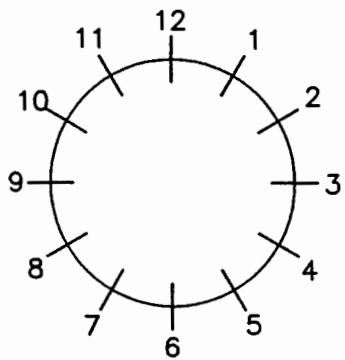
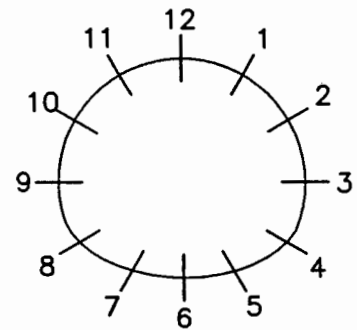
DEFECTIVE CONCRETE: Spalling Honeycomb Erosion/Wear Delaminated	SP HC EW DC	JOINTS: Raised Displaced Spalled BU1	JR JD SP
--	----------------------	---	----------------

STRUCTURE CONDITION MAPPING CHART

Clock Reference Looking DOWNSTREAM

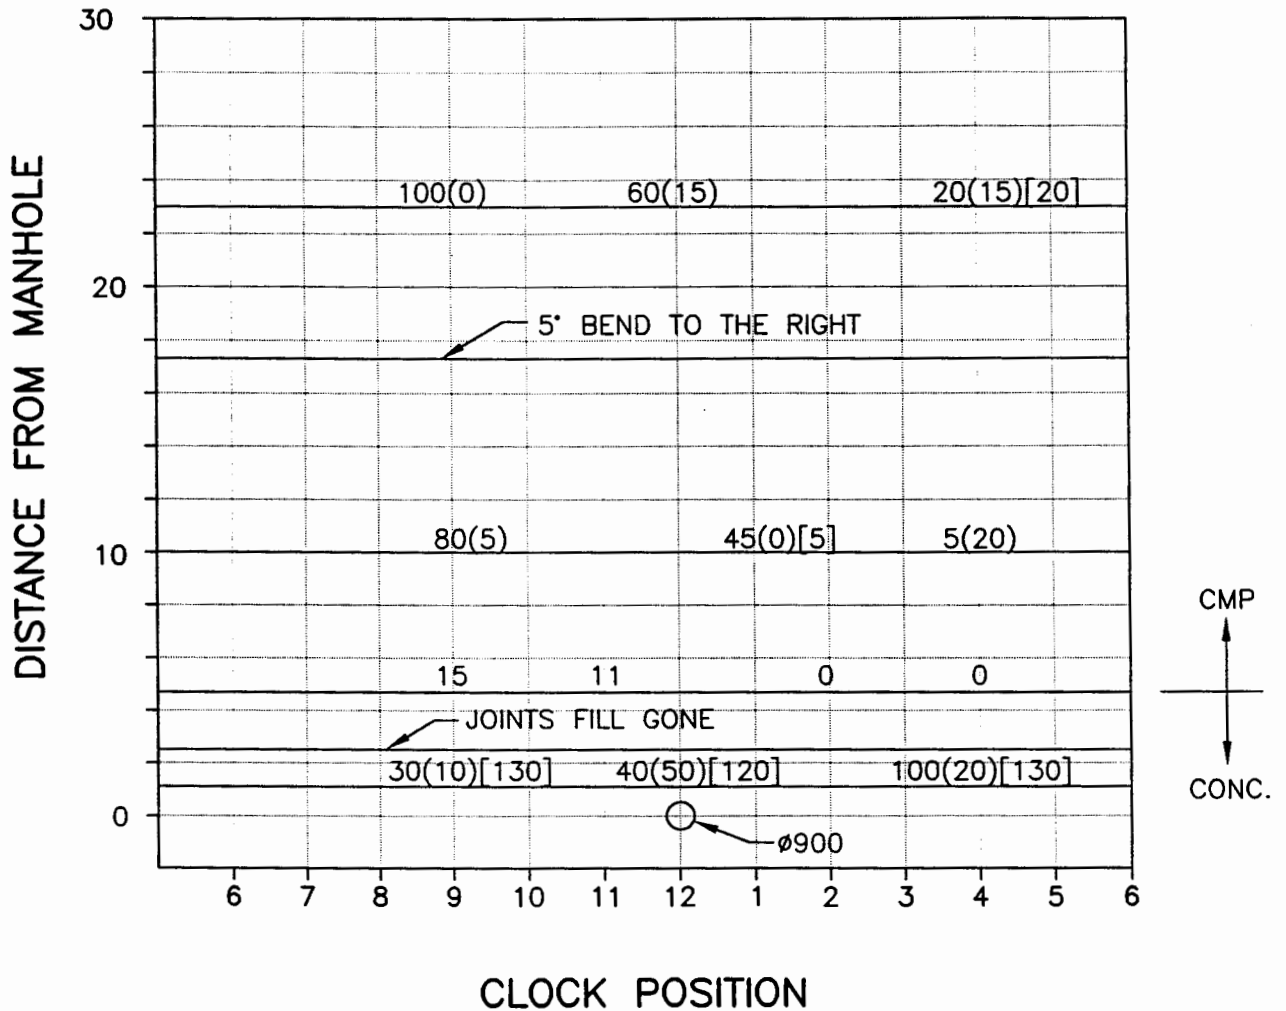
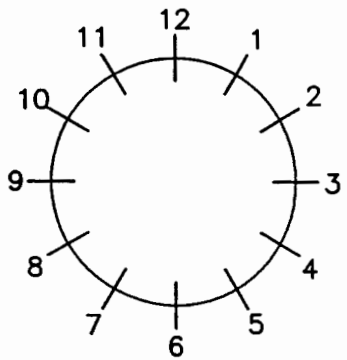
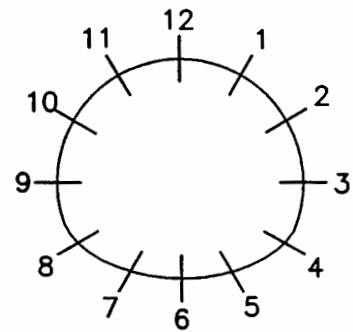
DEFECTIVE CONCRETE:	Spalling	SP	JOINTS:	Raised	JR
	Honeycomb	HC		Displaced	JD
	Erosion/Wear	EW		Spalled	SP
	Delaminated	DC		BU2	
			PIPE IDENTIFICATION:

STRUCTURE CONDITION MAPPING CHART

Clock Reference Looking DOWNSTREAM

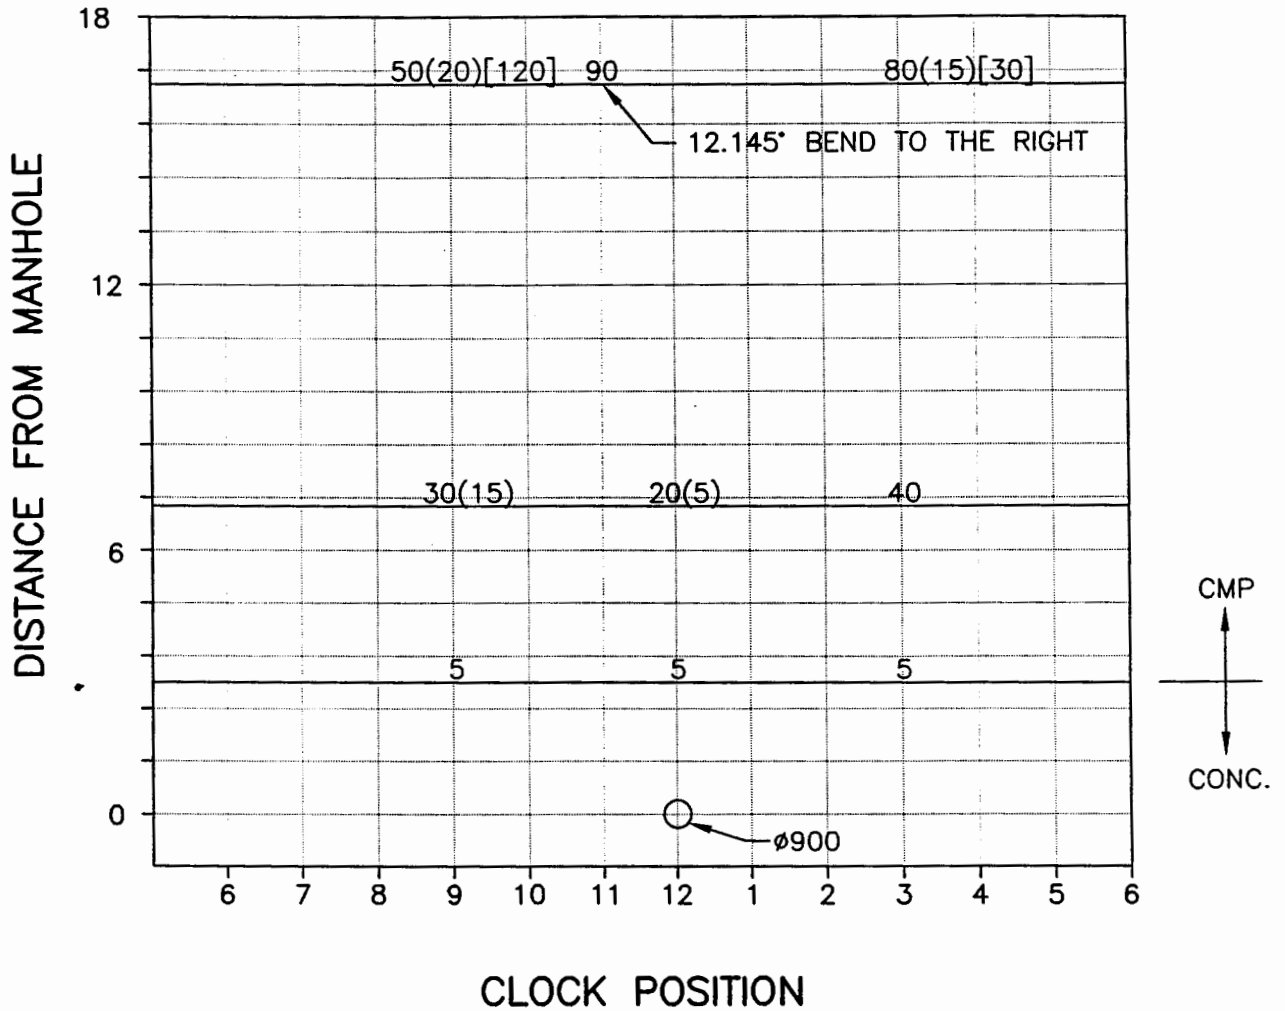
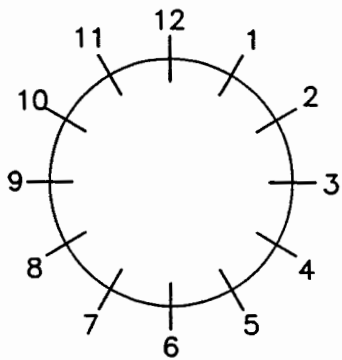
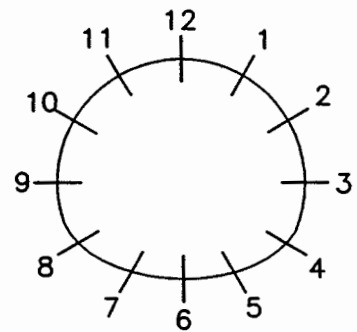
DEFECTIVE CONCRETE: Spalling Honeycomb Erosion/Wear Delaminated	SP HC EW DC	JOINTS: Raised Displaced Spalled BU10	JR JD SP
--	----------------------	--	----------------

STRUCTURE CONDITION MAPPING CHART

Clock Reference Looking
DOWNSTREAM

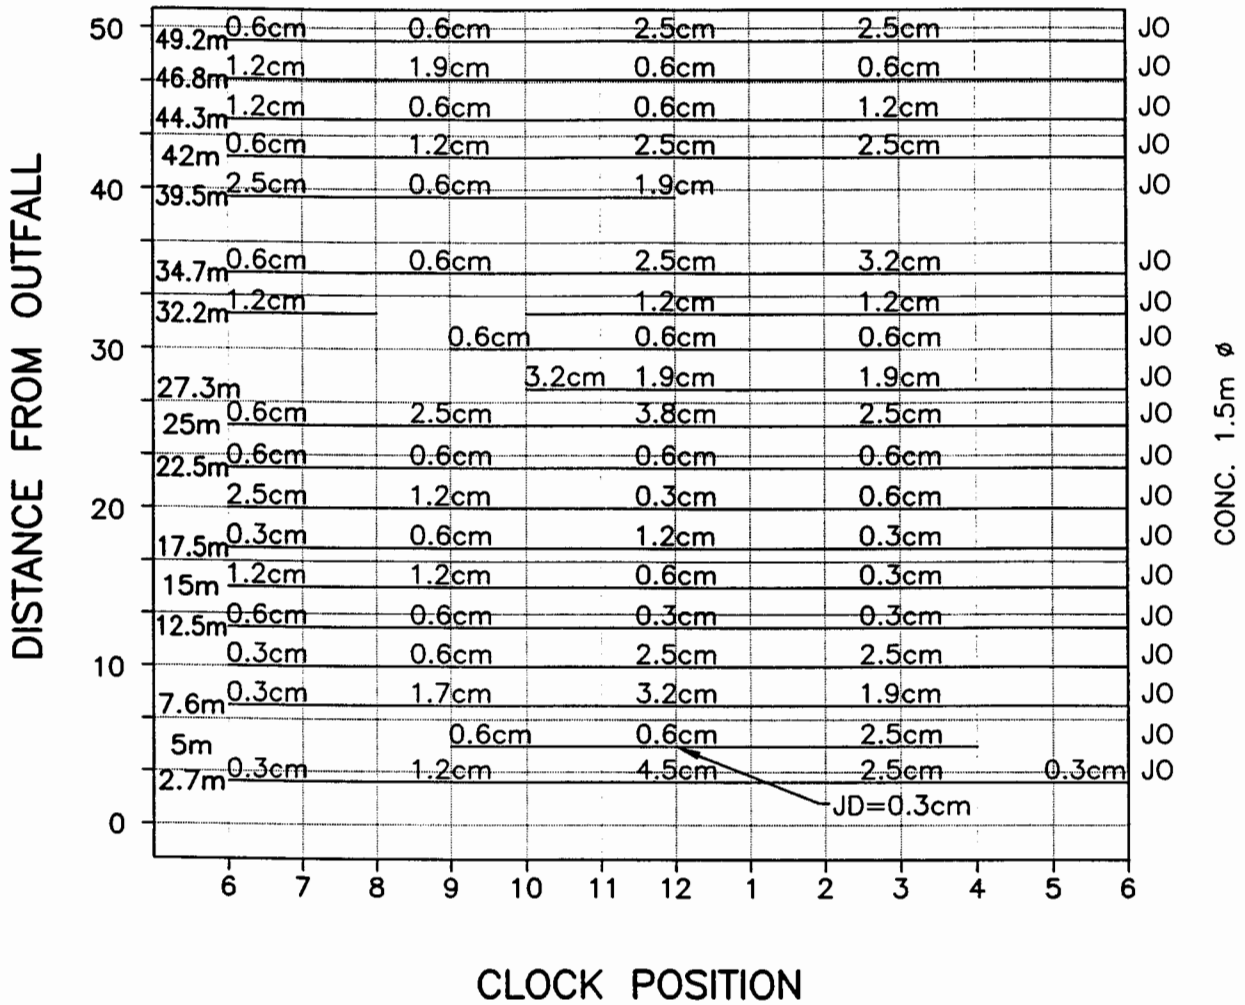
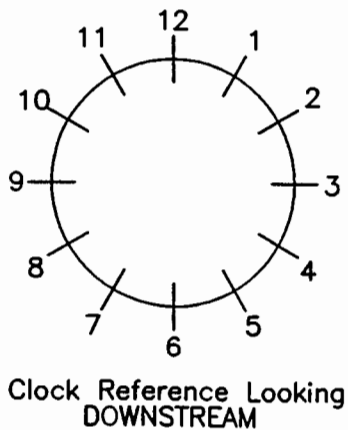
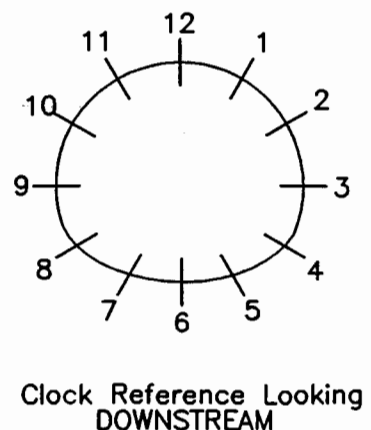
DEFECTIVE CONCRETE:	Spalling	SP	JOINTS:	Raised	JR
	Honeycomb	HC		Displaced	JD
	Erosion/Wear	EW		Spalled	SP
	Delaminated	DC			
			PIPE IDENTIFICATION:	FL1

STRUCTURE CONDITION MAPPING CHART

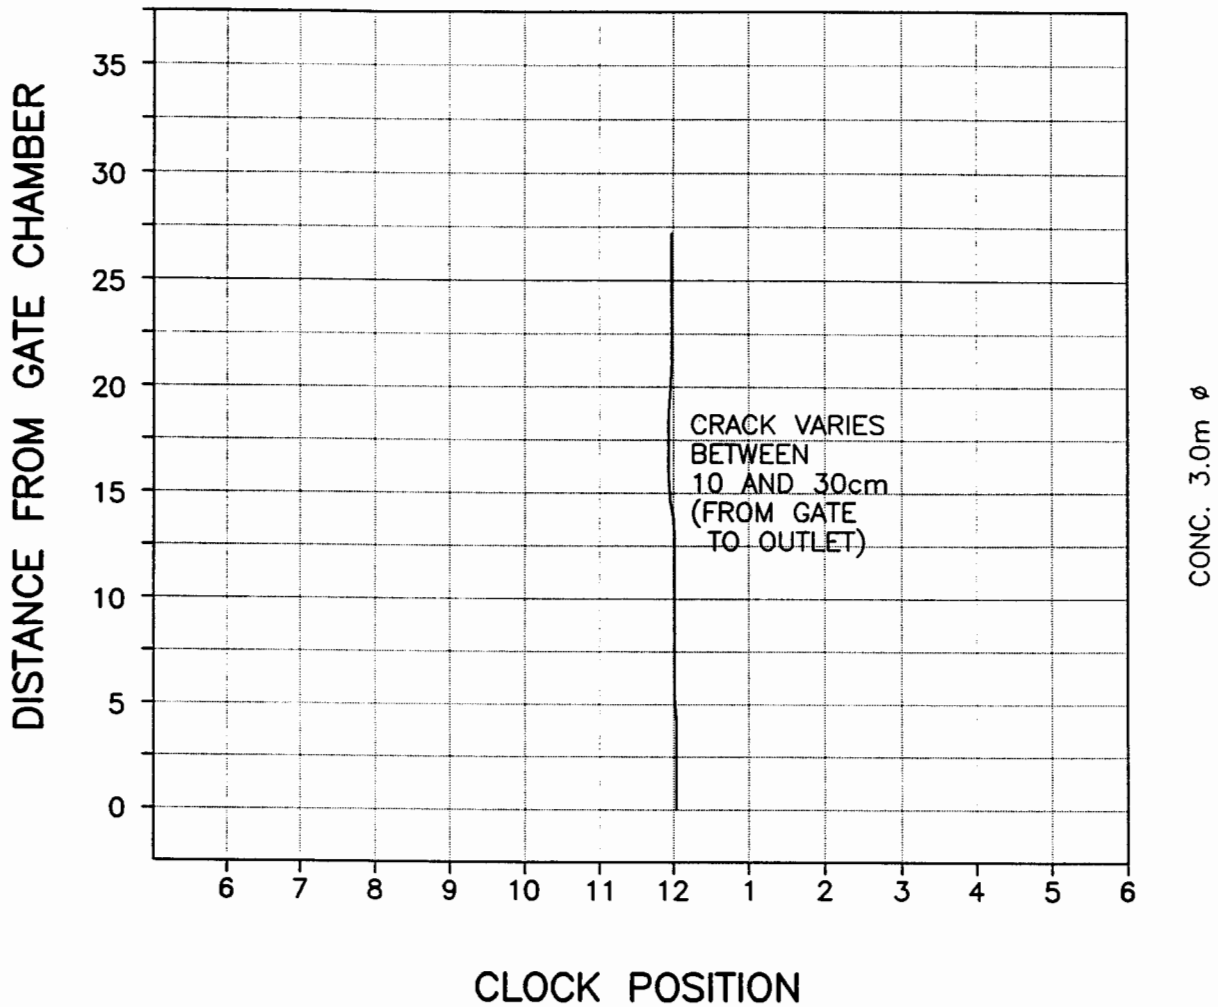
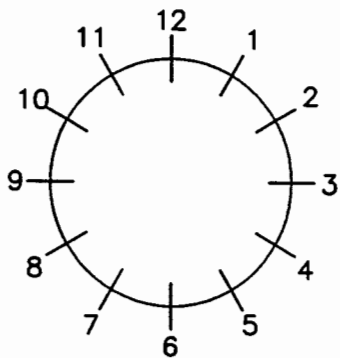
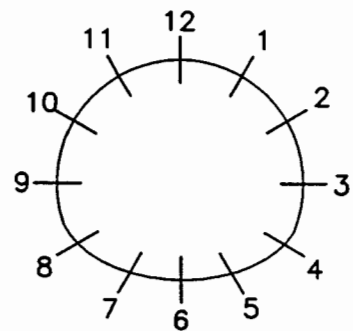
STRUCTURE CONDITION MAPPING CHART

Clock Reference Looking
DOWNSTREAM

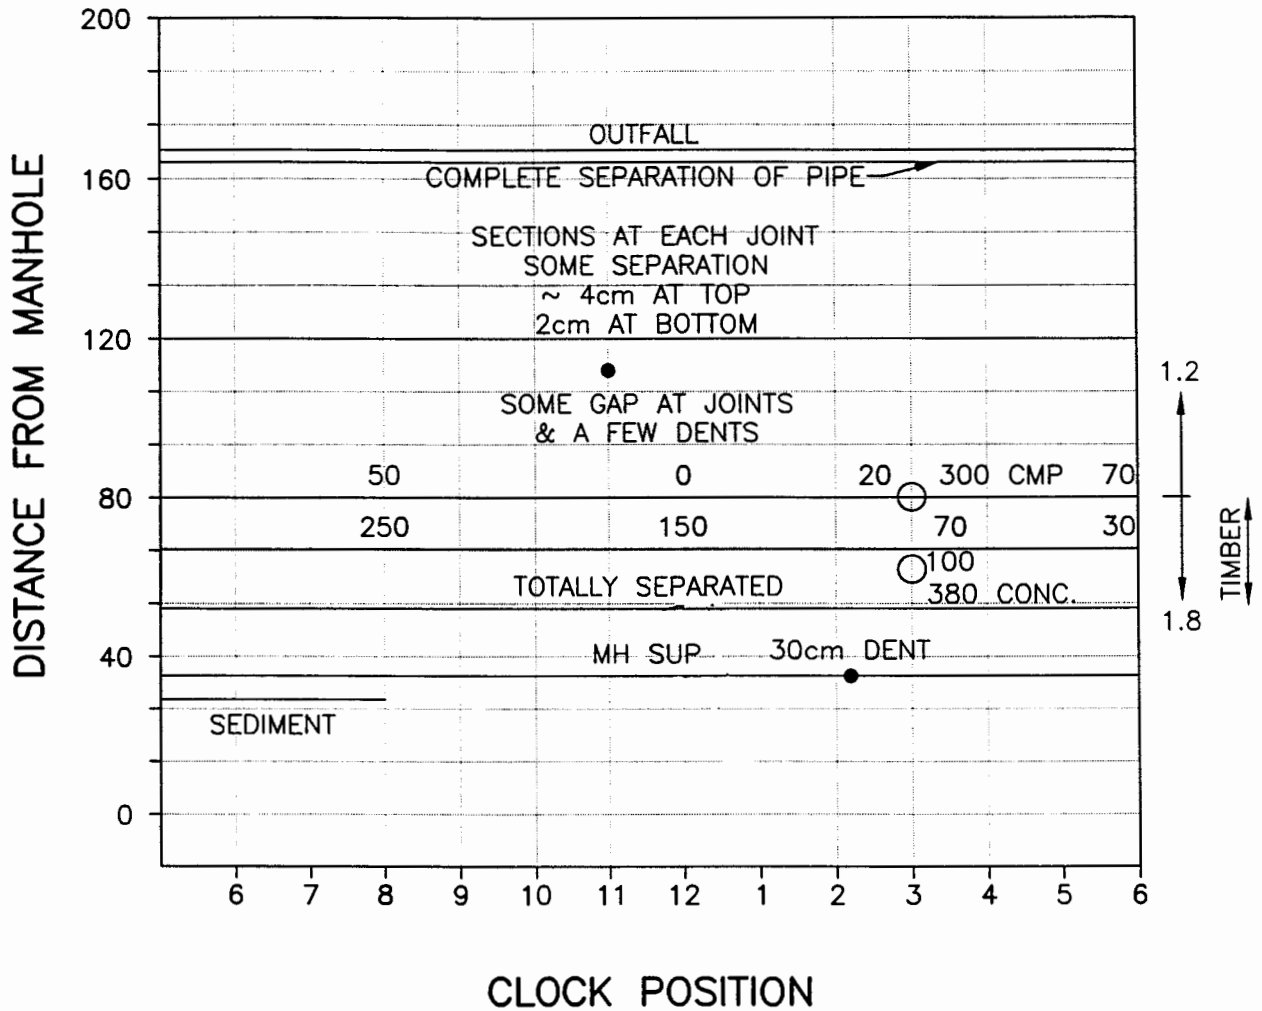
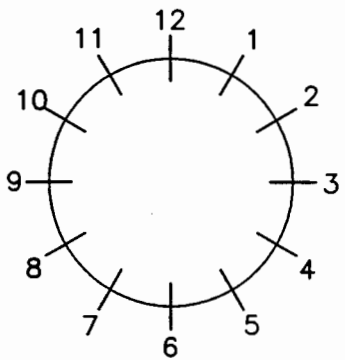
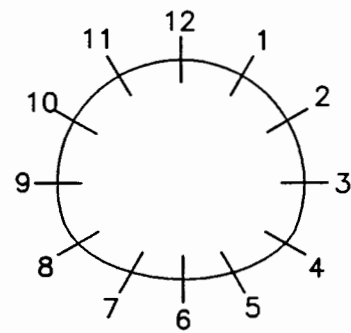
STRUCTURE CONDITION MAPPING CHART

Clock Reference Looking DOWNSTREAM
