APPENDIX A – 1998 OUTFALL INSPECTIONS CONDITION AND MAINTENANCE STUDY

CITY OF WINNIPEG
OUTFALL CONDITION
AND
MAINTENANCE STUDY
FINAL REPORT //

August, 1998

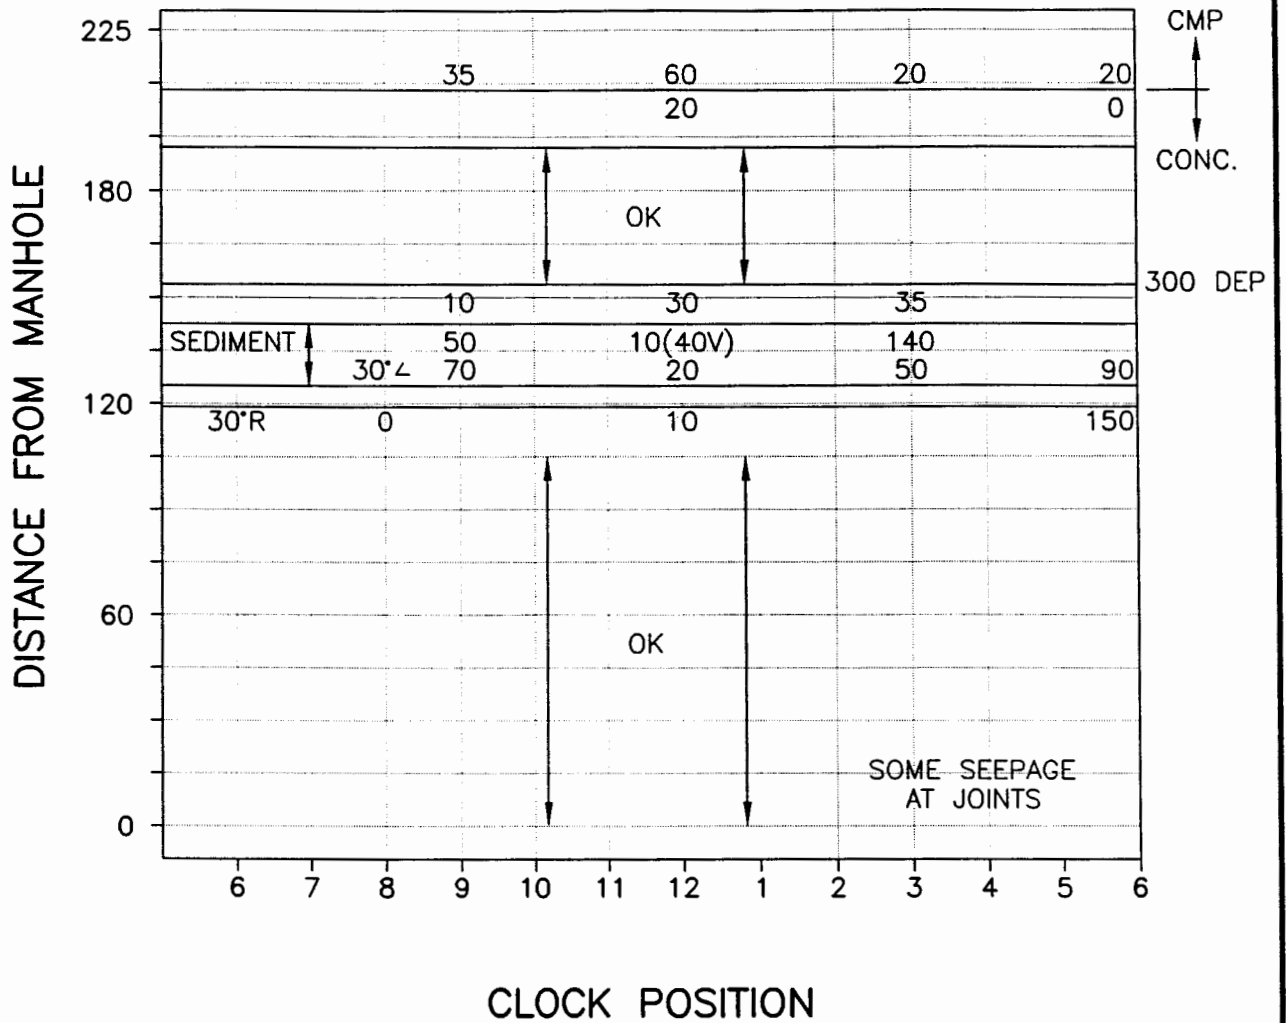
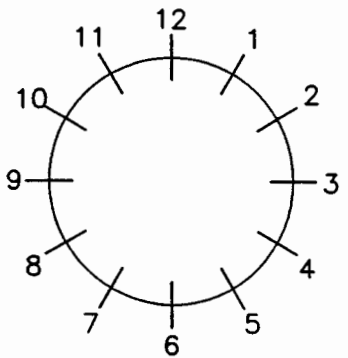
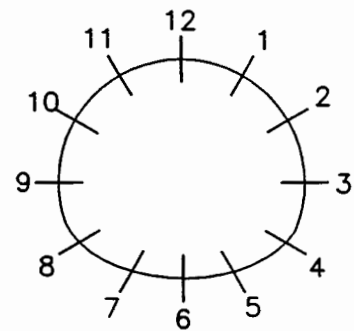
STRUCTURE CONDITION MAPPING CHART

Clock Reference Looking DOWNSTREAM

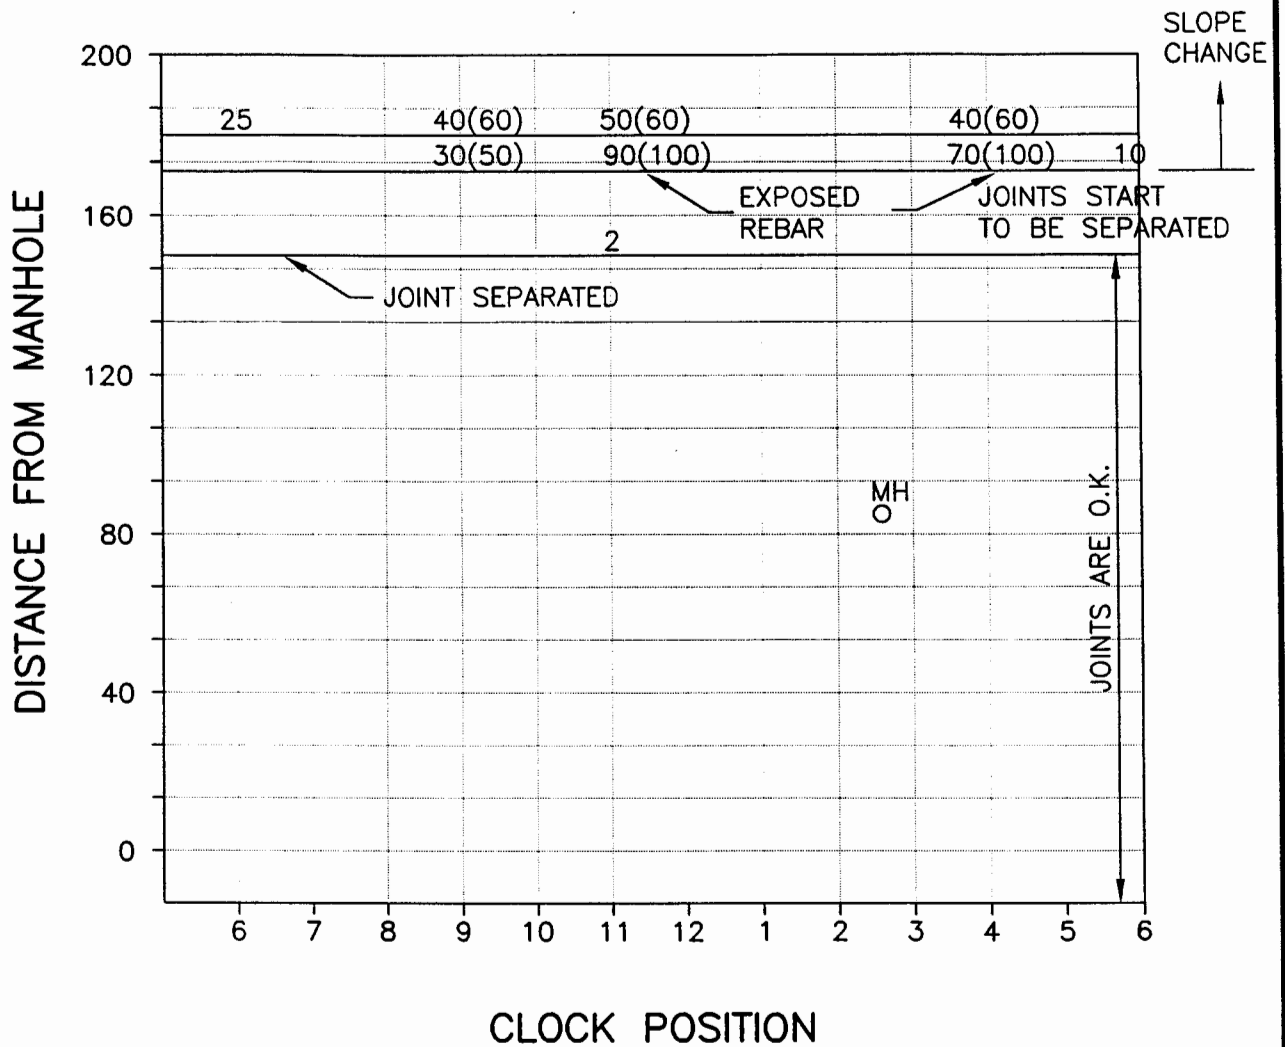
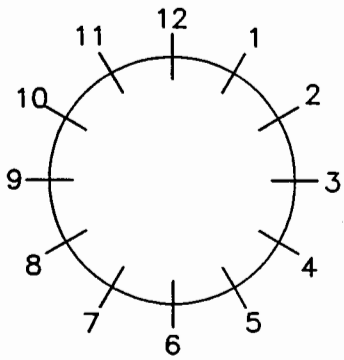
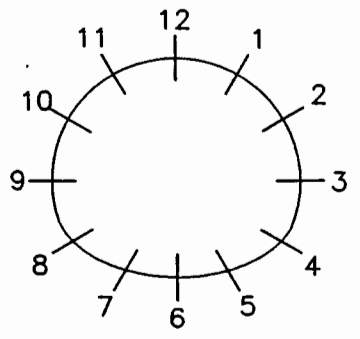
STRUCTURE CONDITION MAPPING CHART

Clock Reference Looking DOWNSTREAM

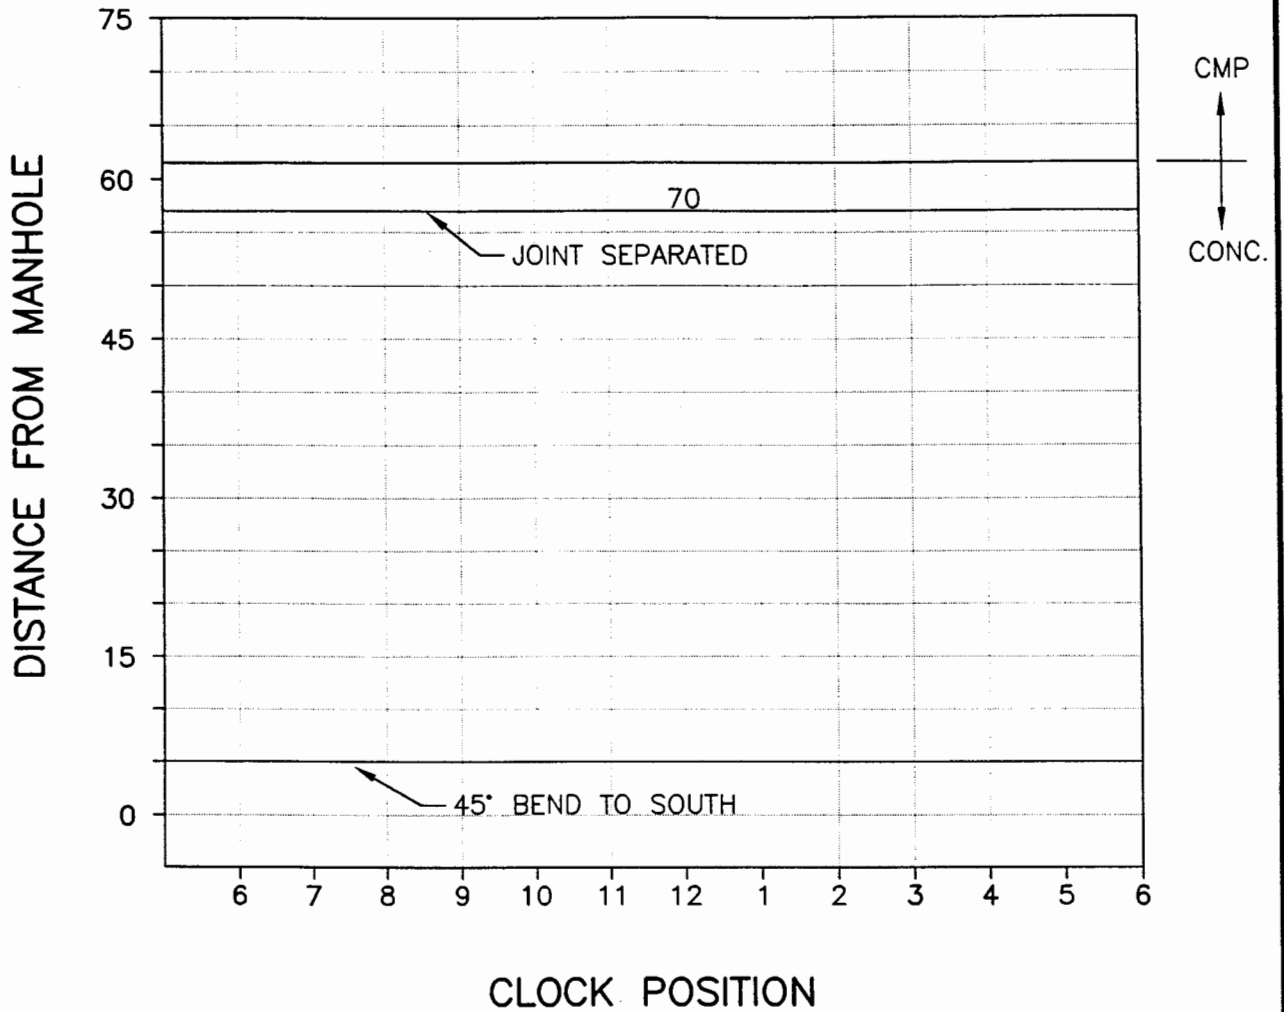
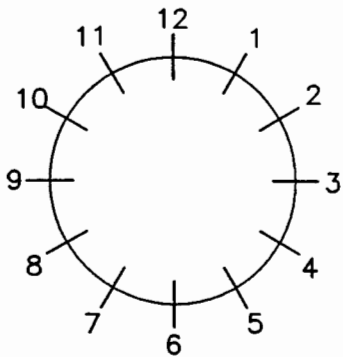
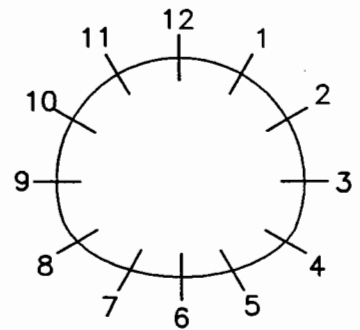
STRUCTURE CONDITION MAPPING CHART

Clock Reference Looking DOWNSTREAM

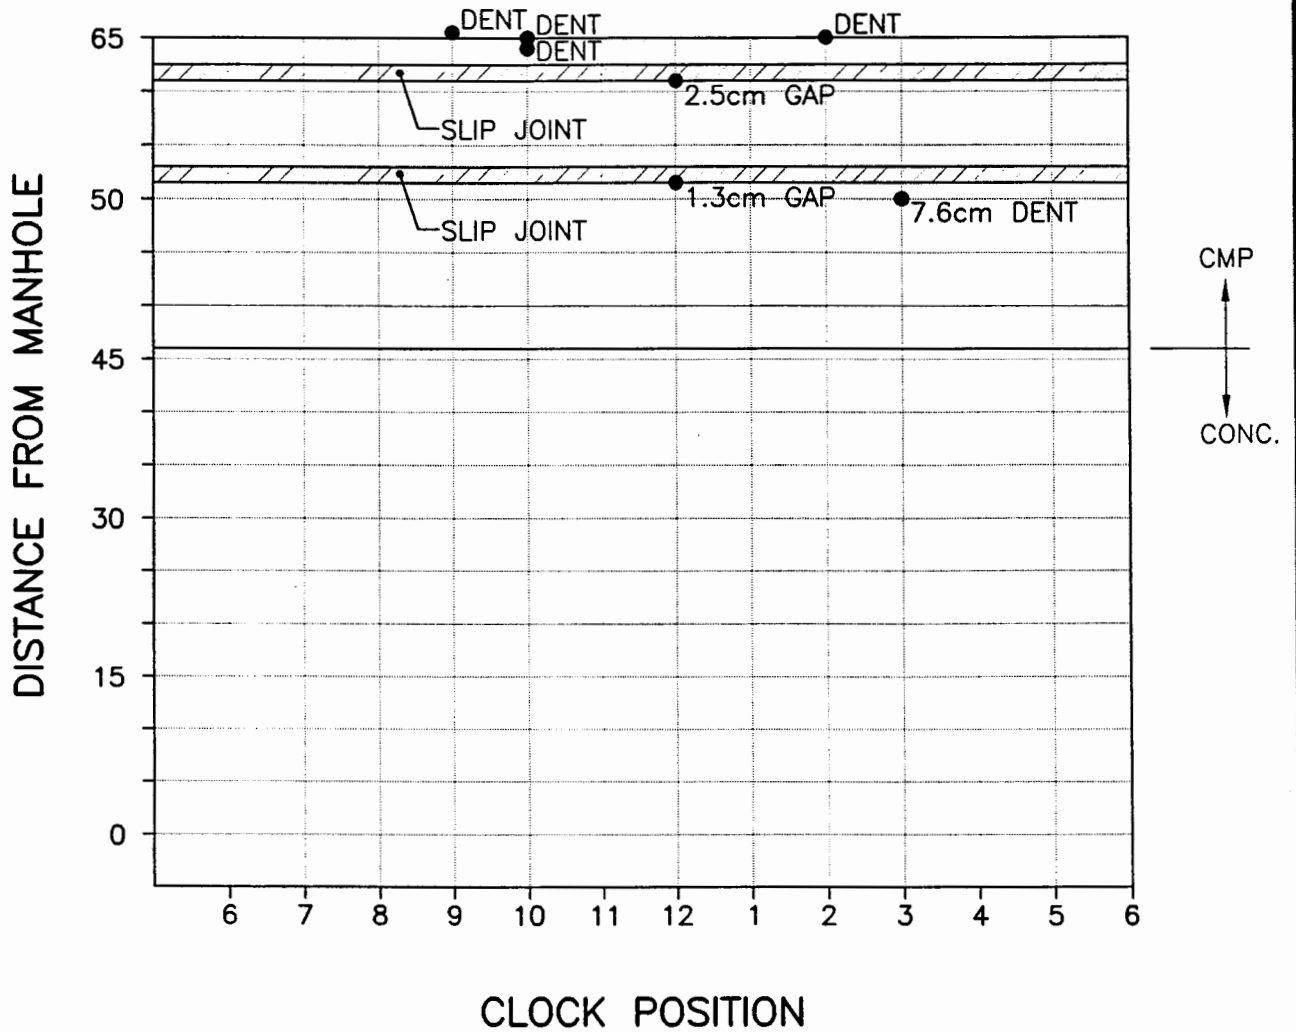
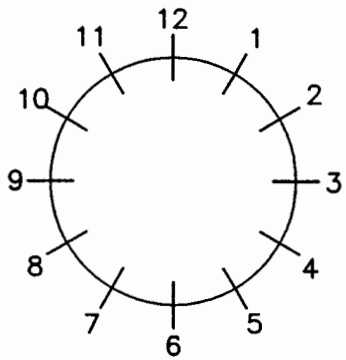
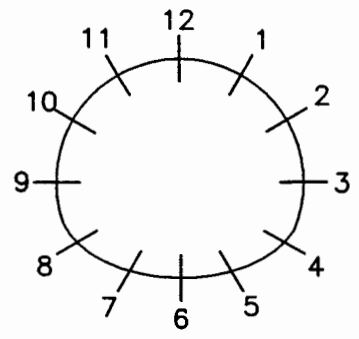
STRUCTURE CONDITION MAPPING CHART

Clock Reference Looking DOWNSTREAM

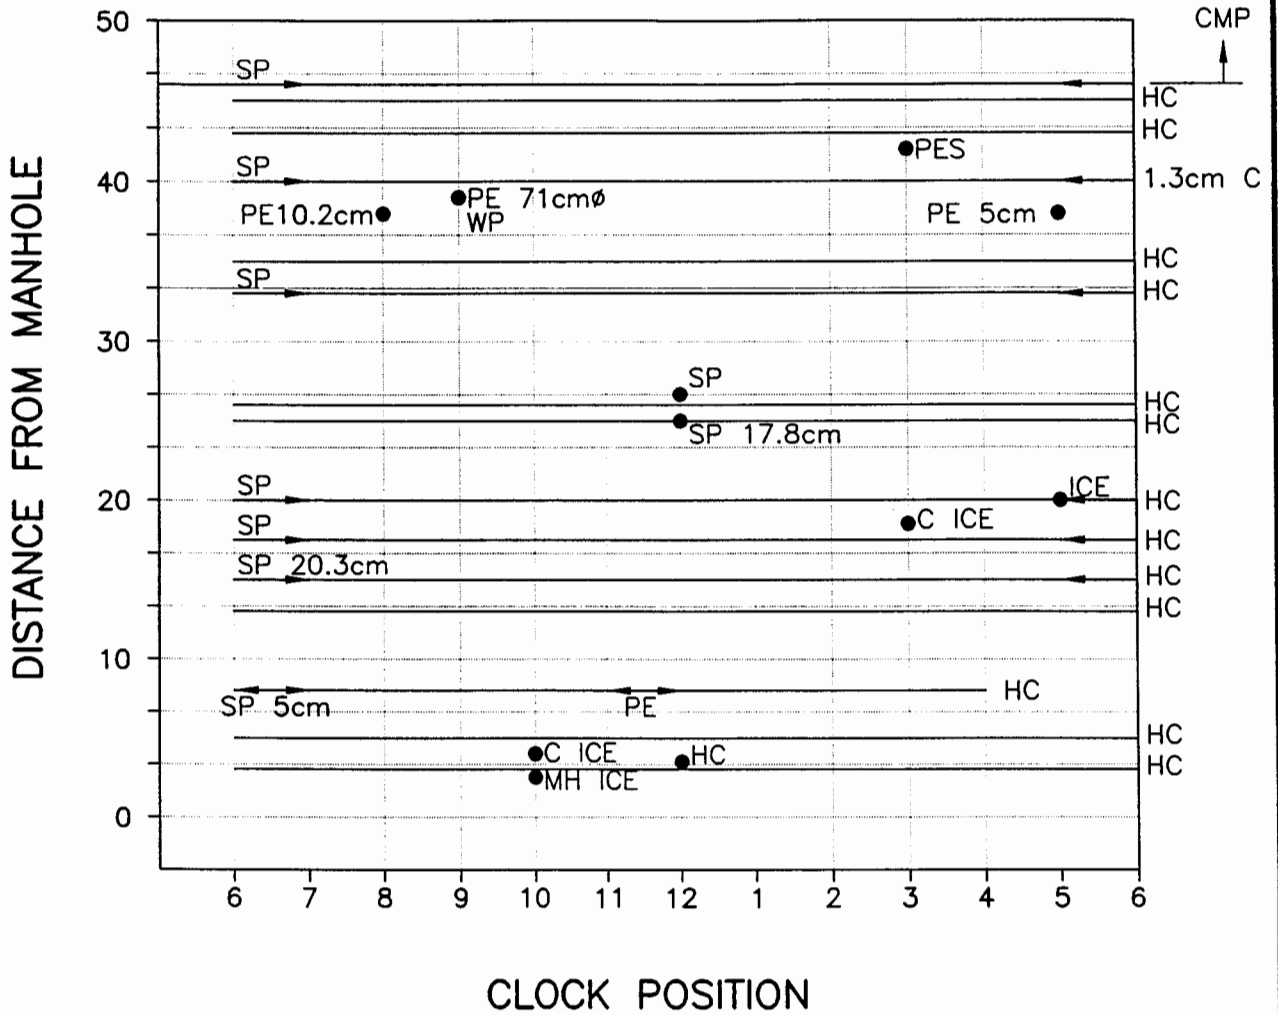
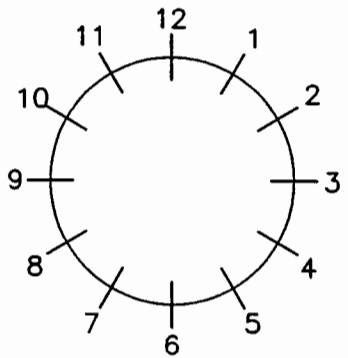
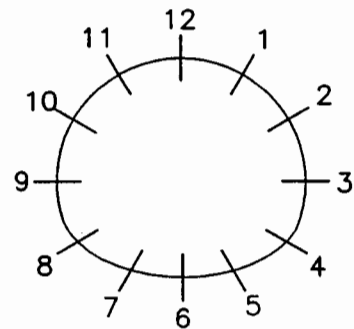
STRUCTURE CONDITION MAPPING CHART

Clock Reference Looking DOWNSTREAM

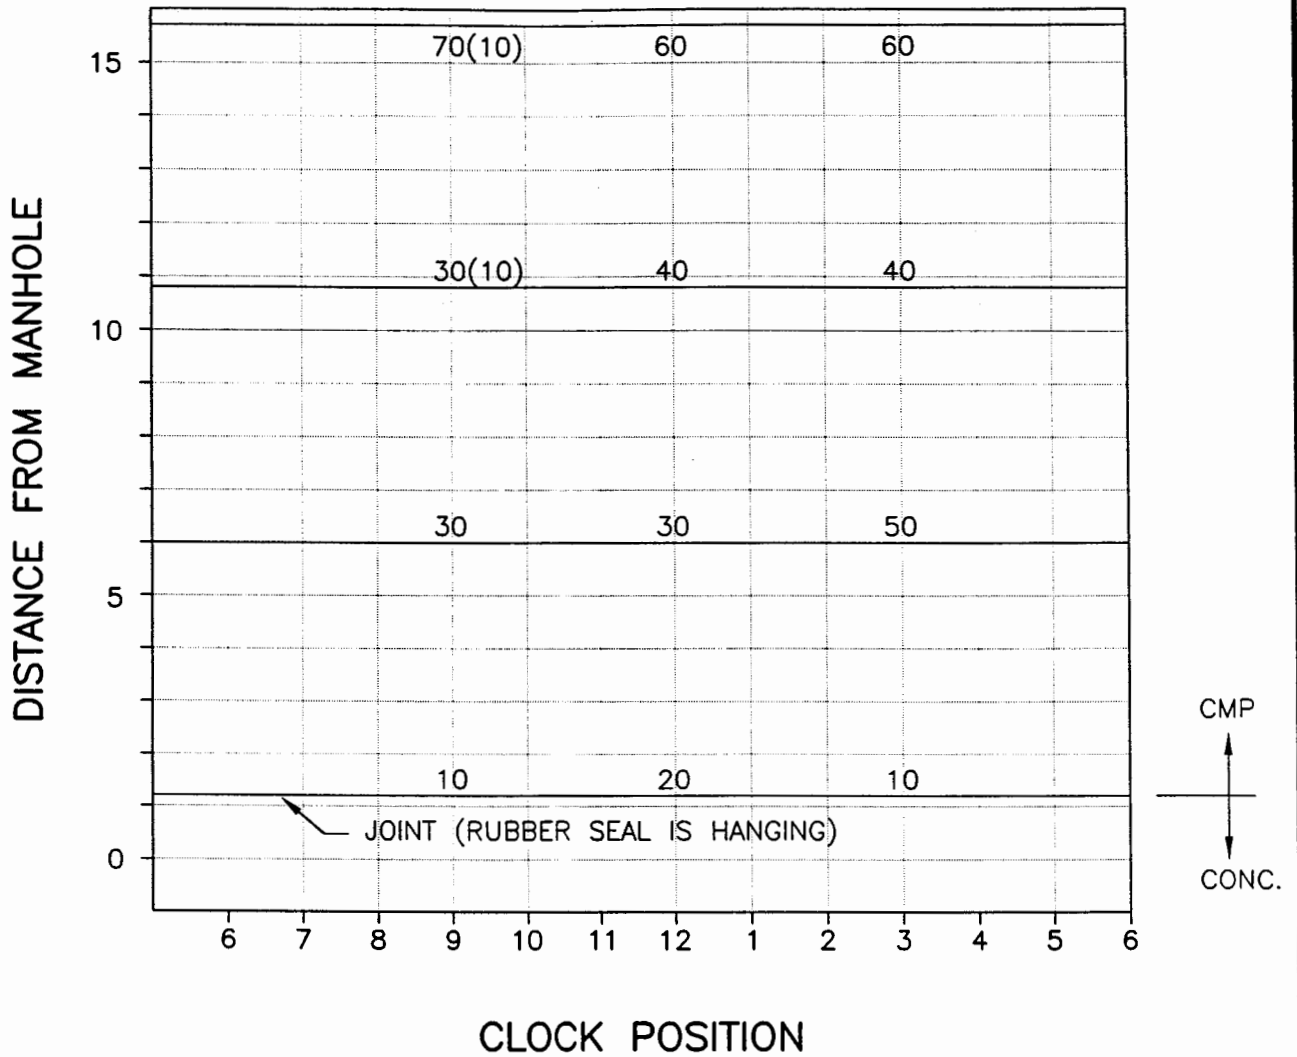
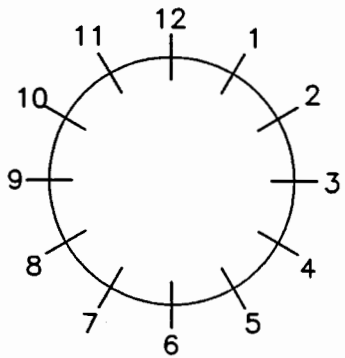
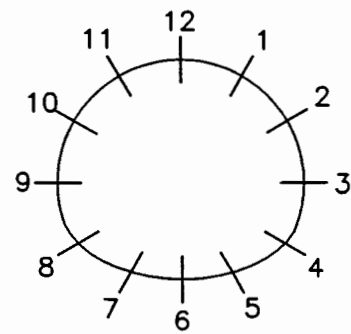
STRUCTURE CONDITION MAPPING CHART

Clock Reference Looking DOWNSTREAM

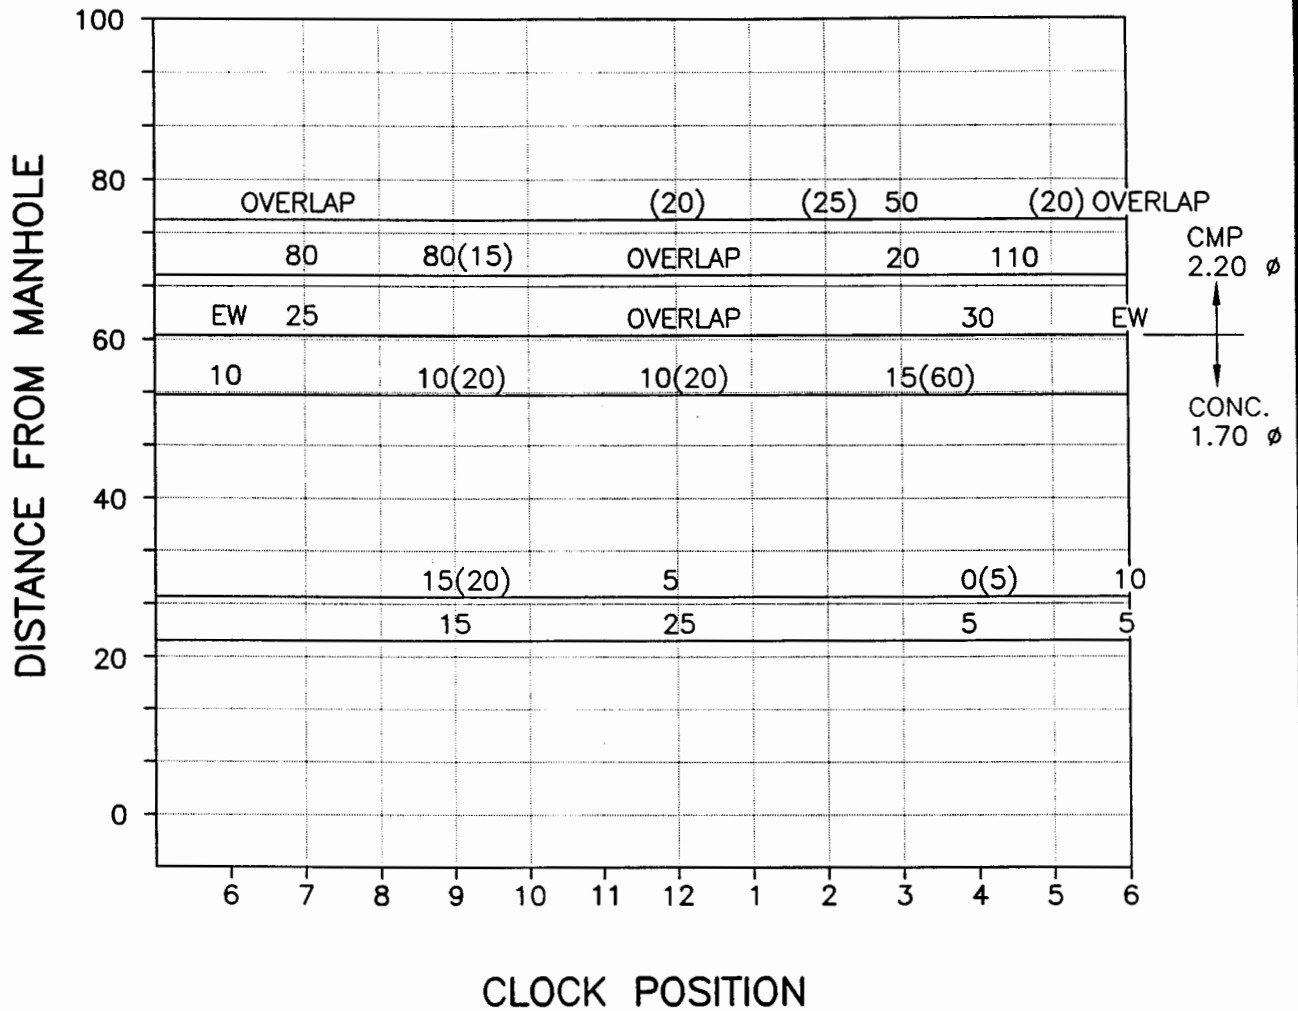
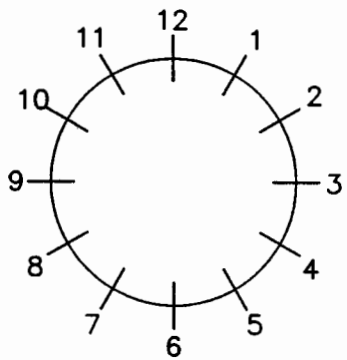
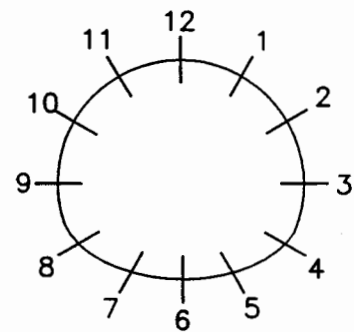
STRUCTURE CONDITION MAPPING CHART

Clock Reference Looking DOWNSTREAM

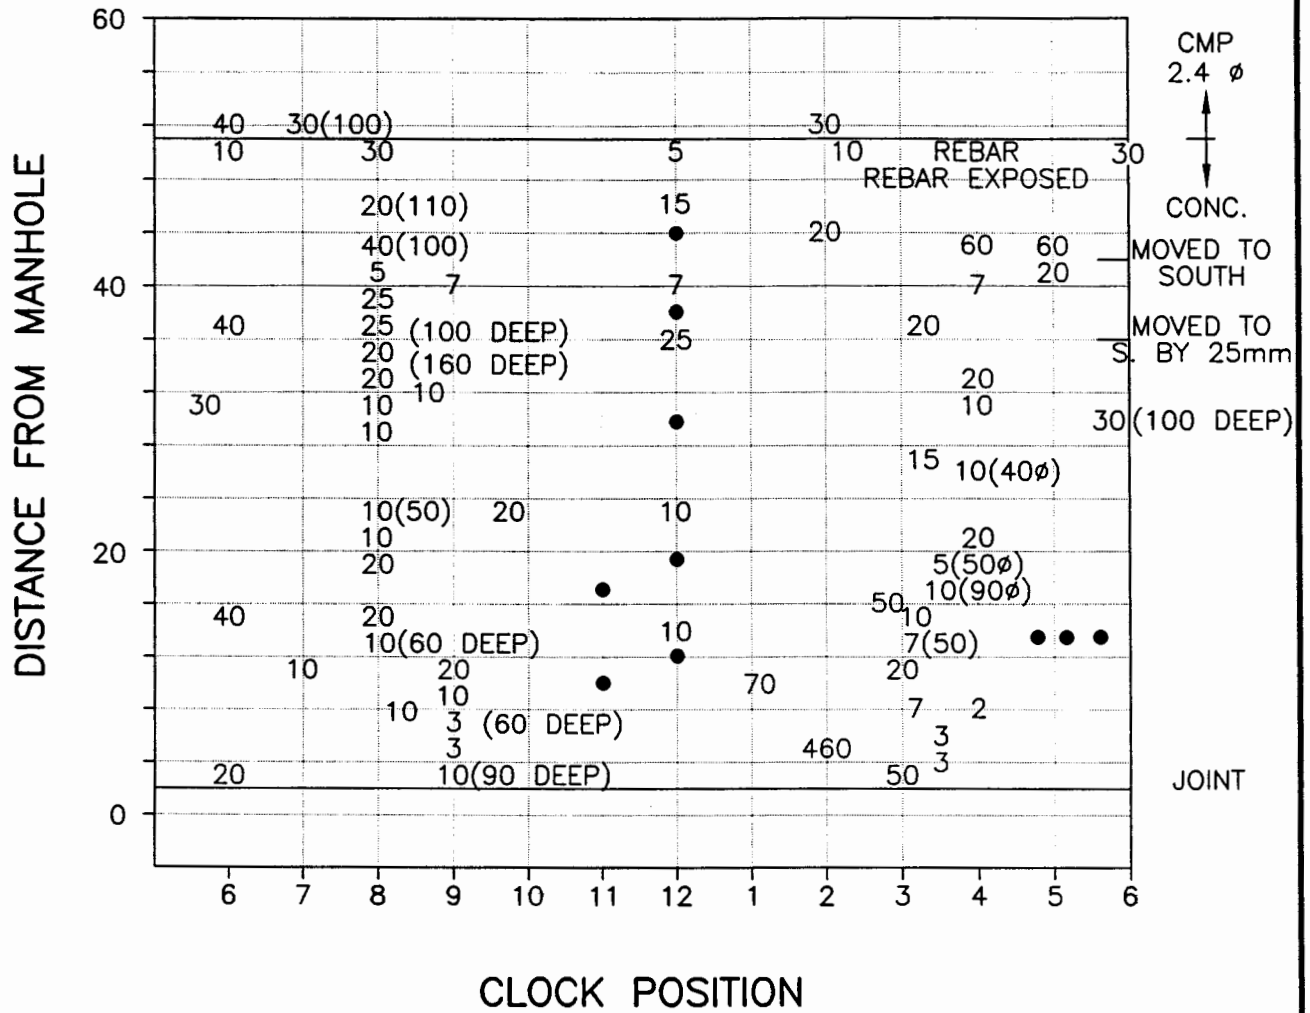
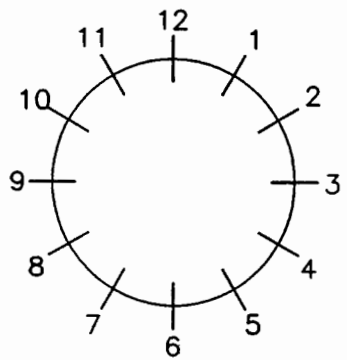
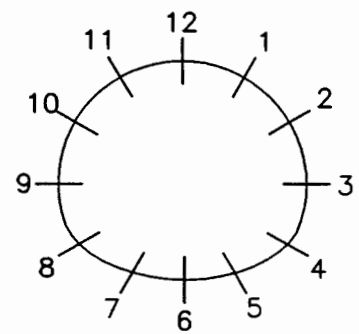
STRUCTURE CONDITION MAPPING CHART

Clock Reference Looking DOWNSTREAM

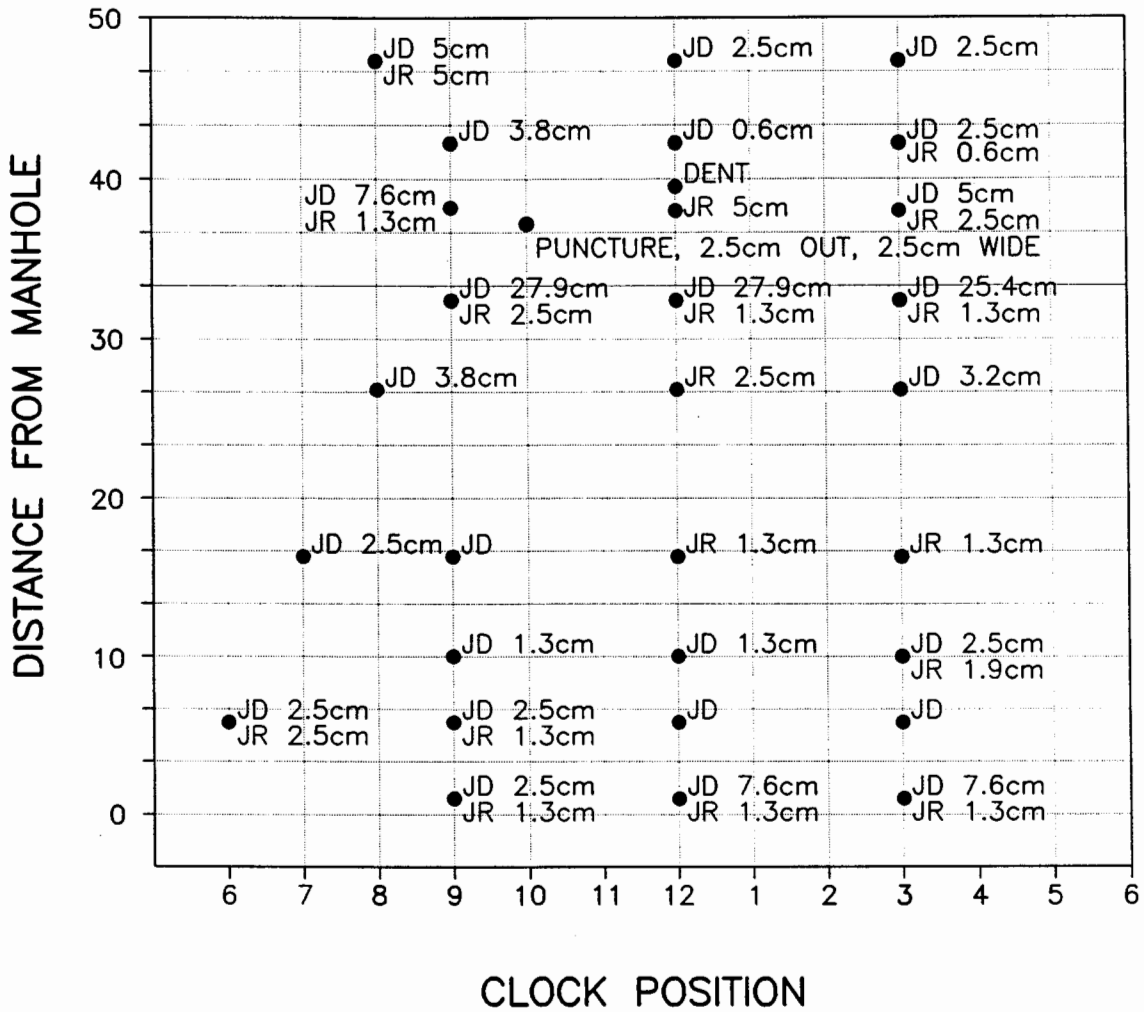
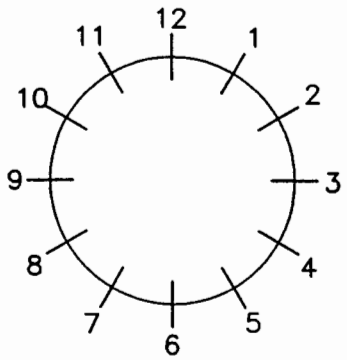
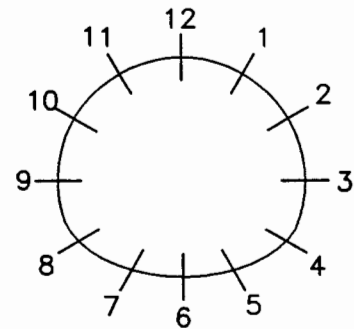
STRUCTURE CONDITION MAPPING CHART

Clock Reference Looking DOWNSTREAM

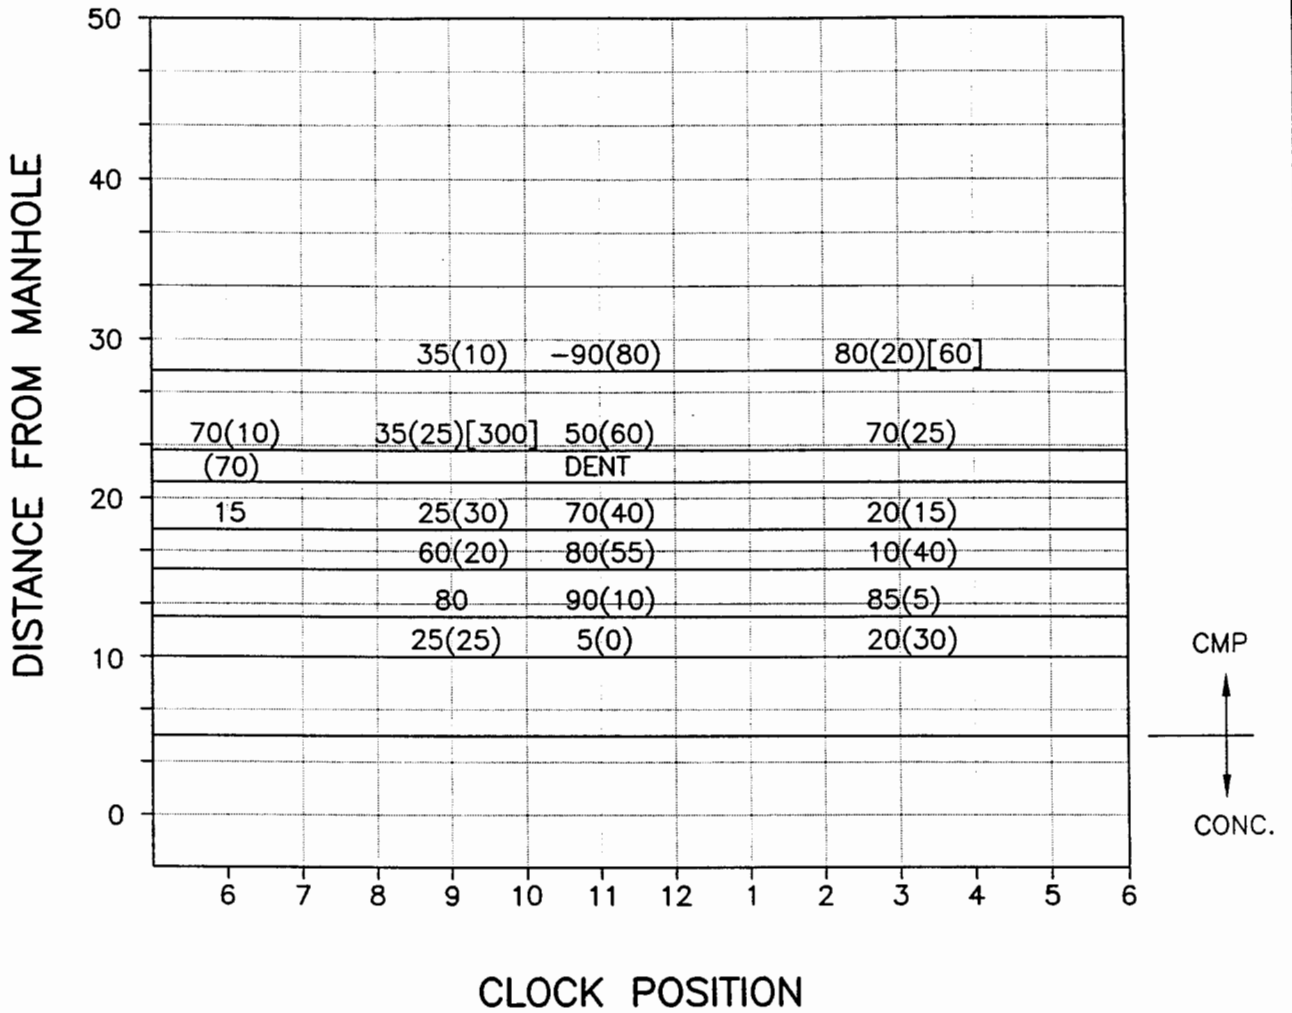
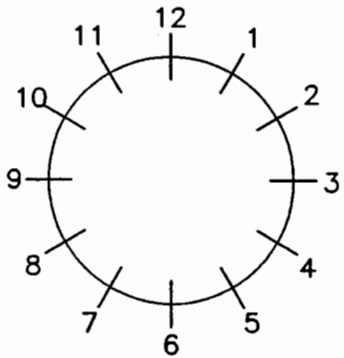
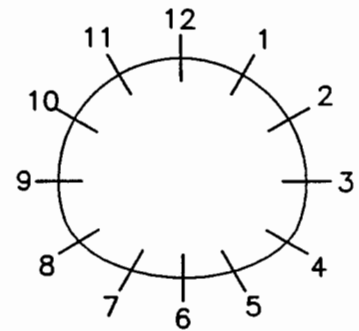
STRUCTURE CONDITION MAPPING CHART

Clock Reference Looking DOWNSTREAM

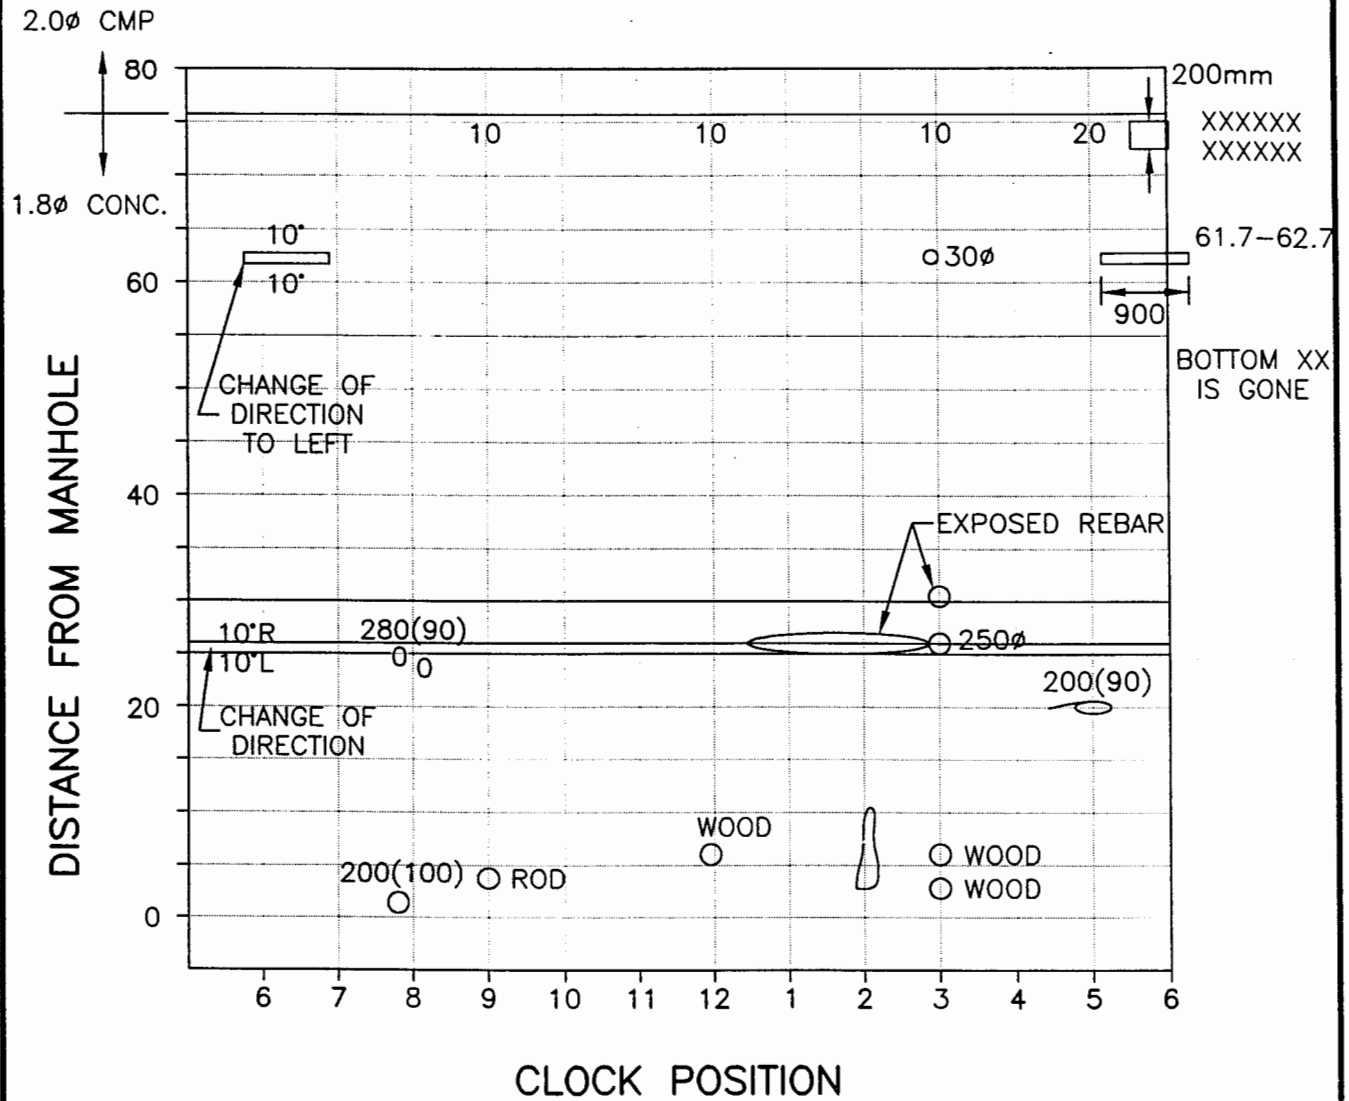
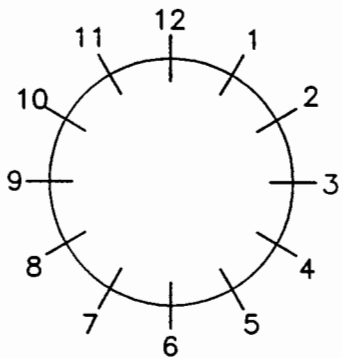
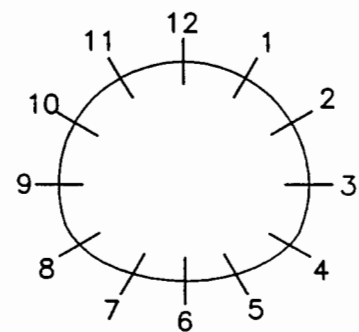
STRUCTURE CONDITION MAPPING CHART

Clock Reference Looking DOWNSTREAM

DEFECTIVE CONCRETE: Spalling Honeycomb Erosion/Wear Delaminated	SP HC EW DC	JOINTS: Raised Displaced Spalled R36	JR JD SP
--	----------------------	---	----------------

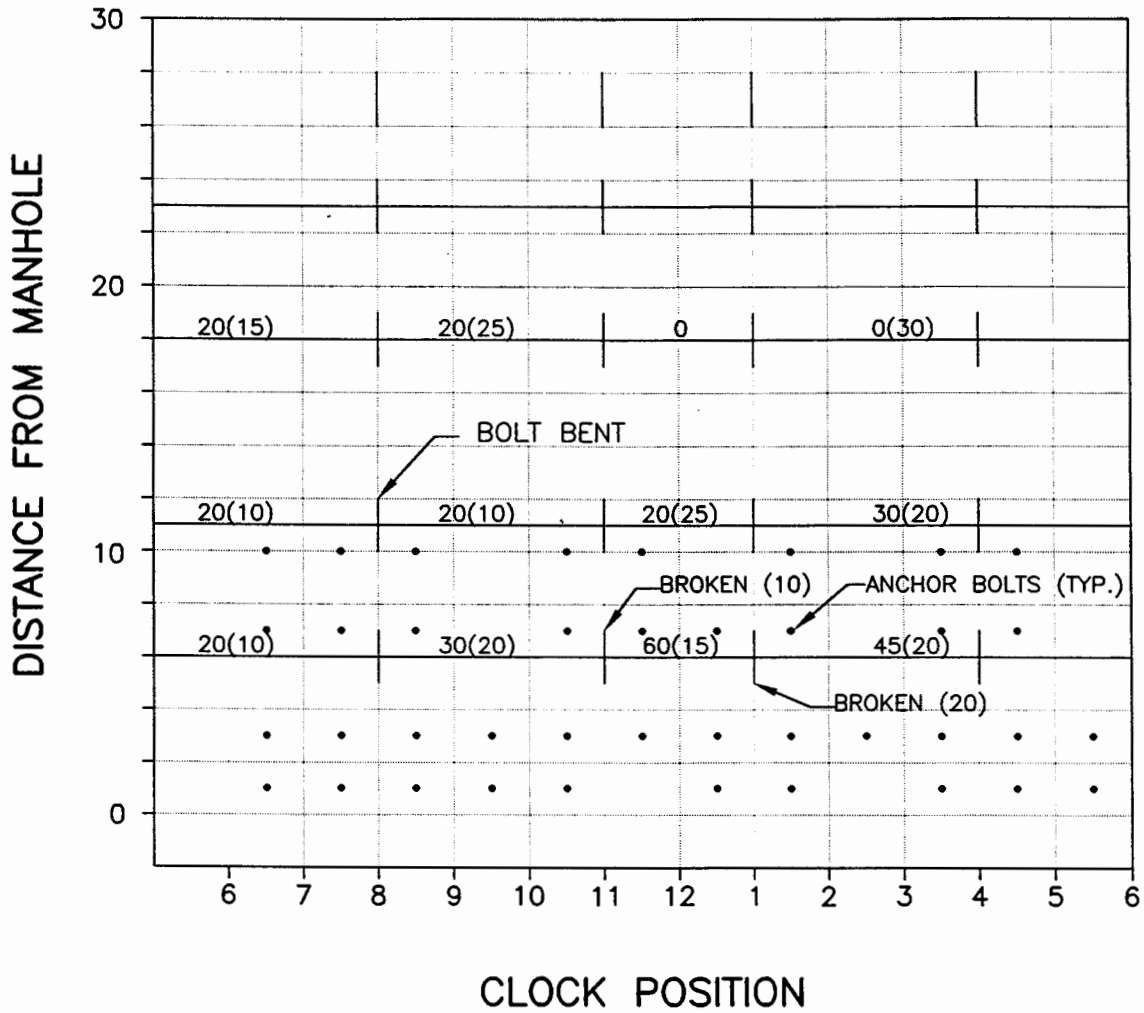
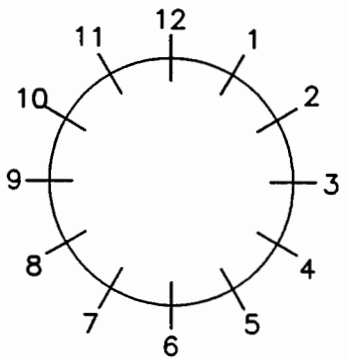
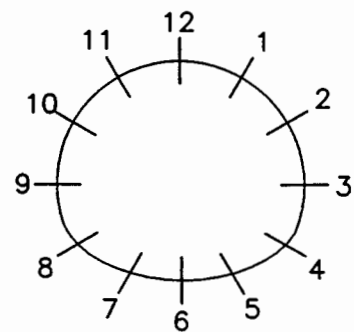
STRUCTURE CONDITION MAPPING CHART

Clock Reference Looking
DOWNSTREAM

DEFECTIVE CONCRETE: • ANCHOR BOLT	Spalling Honeycomb Erosion/Wear Delaminated	SP HC EW DC	JOINTS: Raised Displaced Spalled R38	JR JD SP
---	--	----------------------	---	----------------

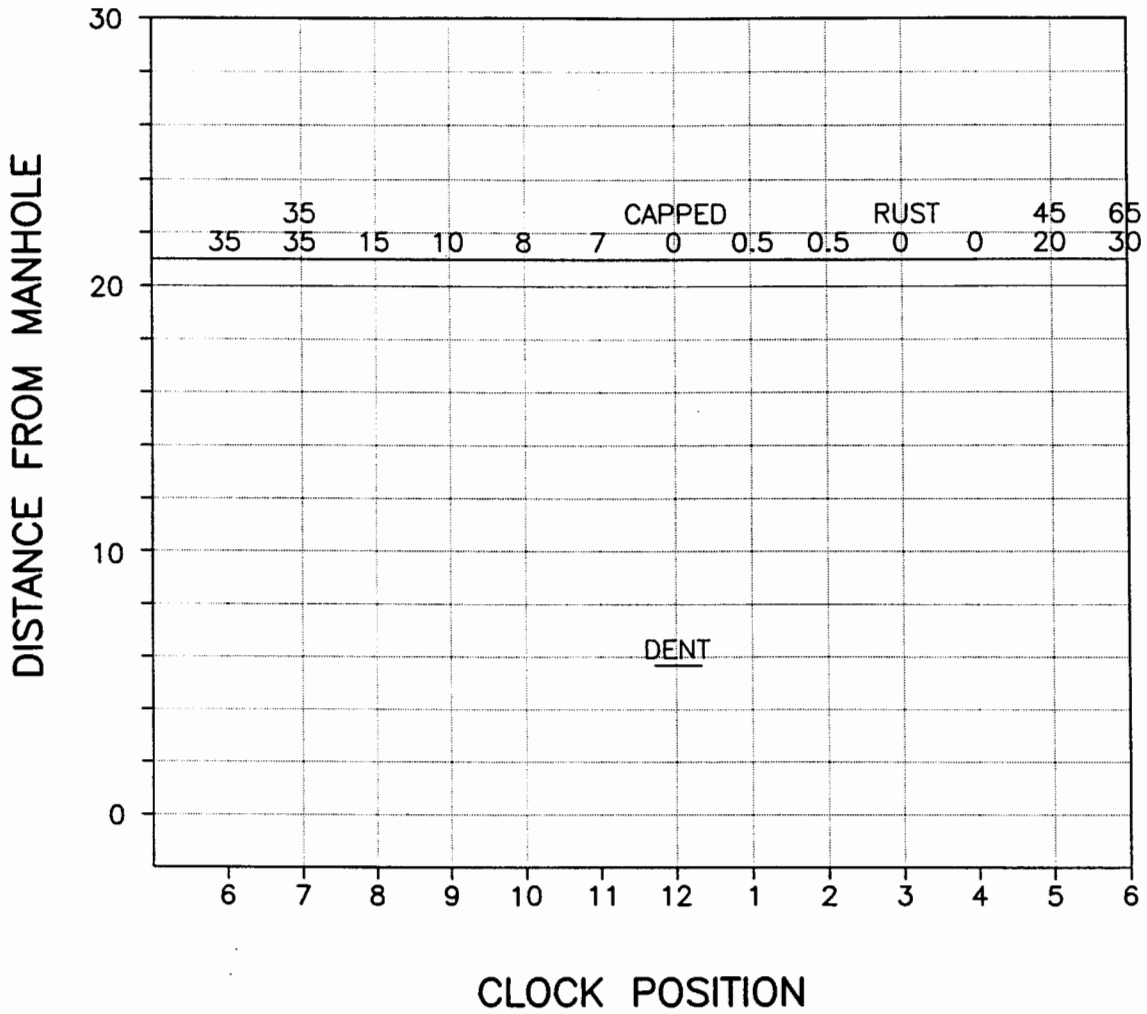
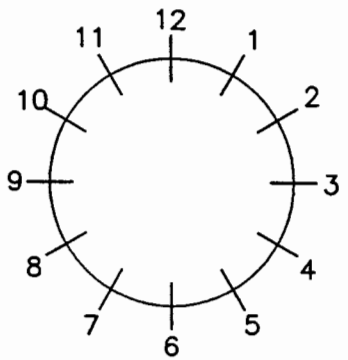
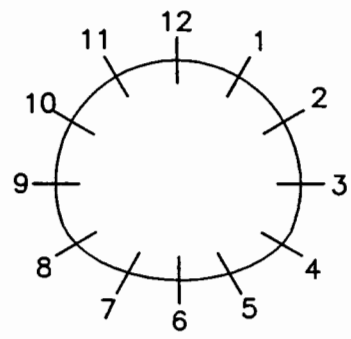
STRUCTURE CONDITION MAPPING CHART

Clock Reference Looking
DOWNSTREAM

DEFECTIVE CONCRETE: Spalling Honeycomb Erosion/Wear Delaminated	SP HC EW DC	JOINTS: Raised Displaced Spalled R39	JR JD SP
--	----------------------	---	----------------

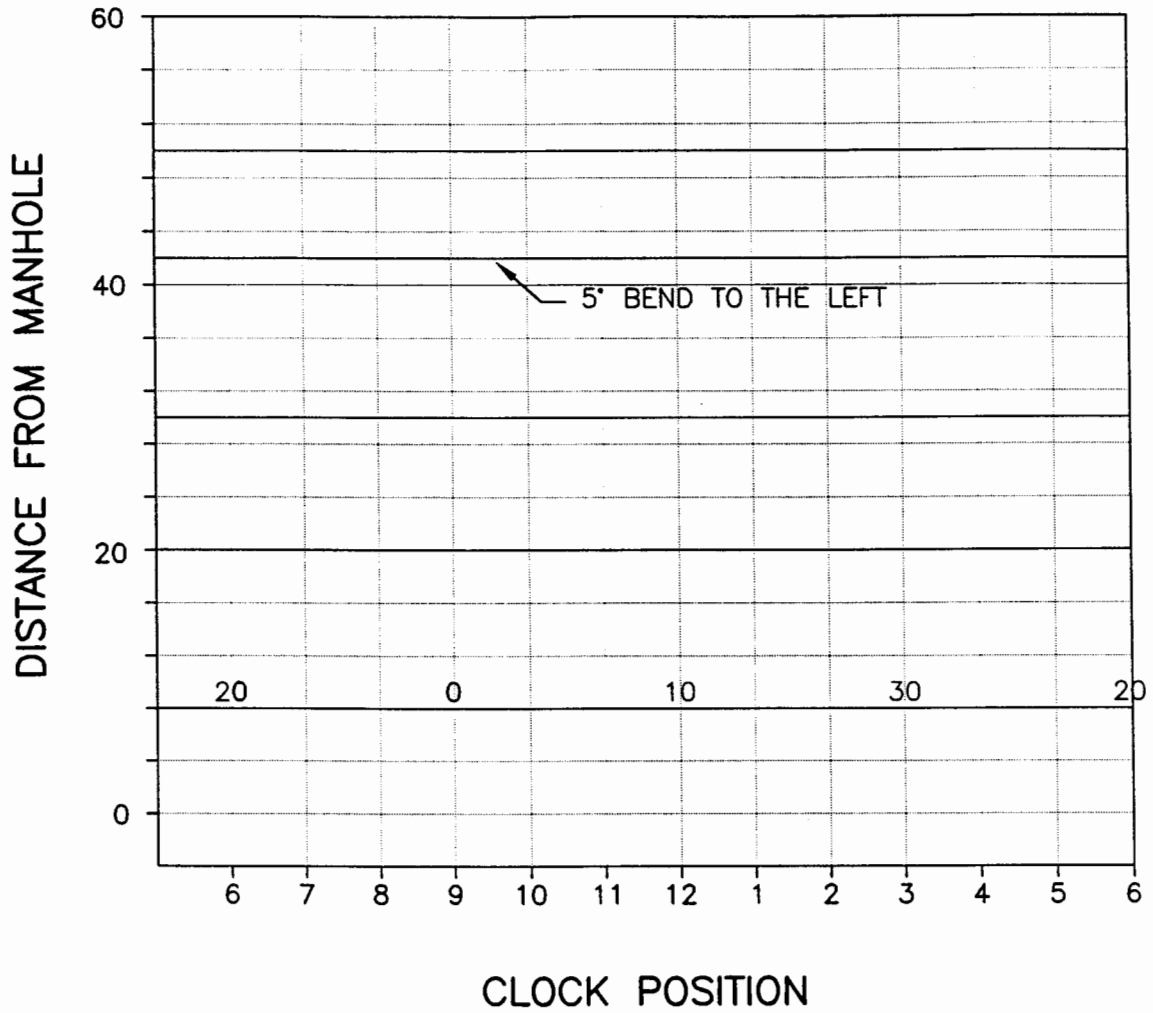
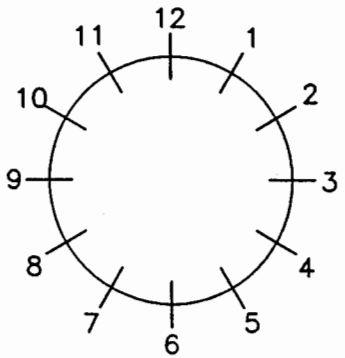
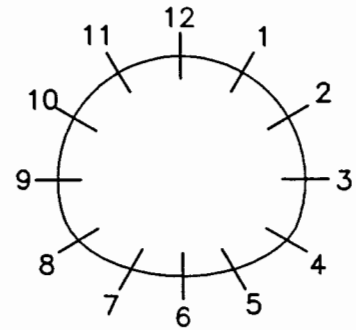
STRUCTURE CONDITION MAPPING CHART

Clock Reference Looking
DOWNSTREAM

DEFECTIVE CONCRETE: Spalling Honeycomb Erosion/Wear Delaminated	SP HC EW DC	JOINTS: Raised Displaced Spalled R43	JR JD SP
--	----------------------	---	----------------
