APPENDIX A – 1998 OUTFALL INSPECTIONS CONDITION AND MAINTENANCE STUDY

CITY OF WINNIPEG
OUTFALL CONDITION
AND
MAINTENANCE STUDY
FINAL REPORT //

August, 1998

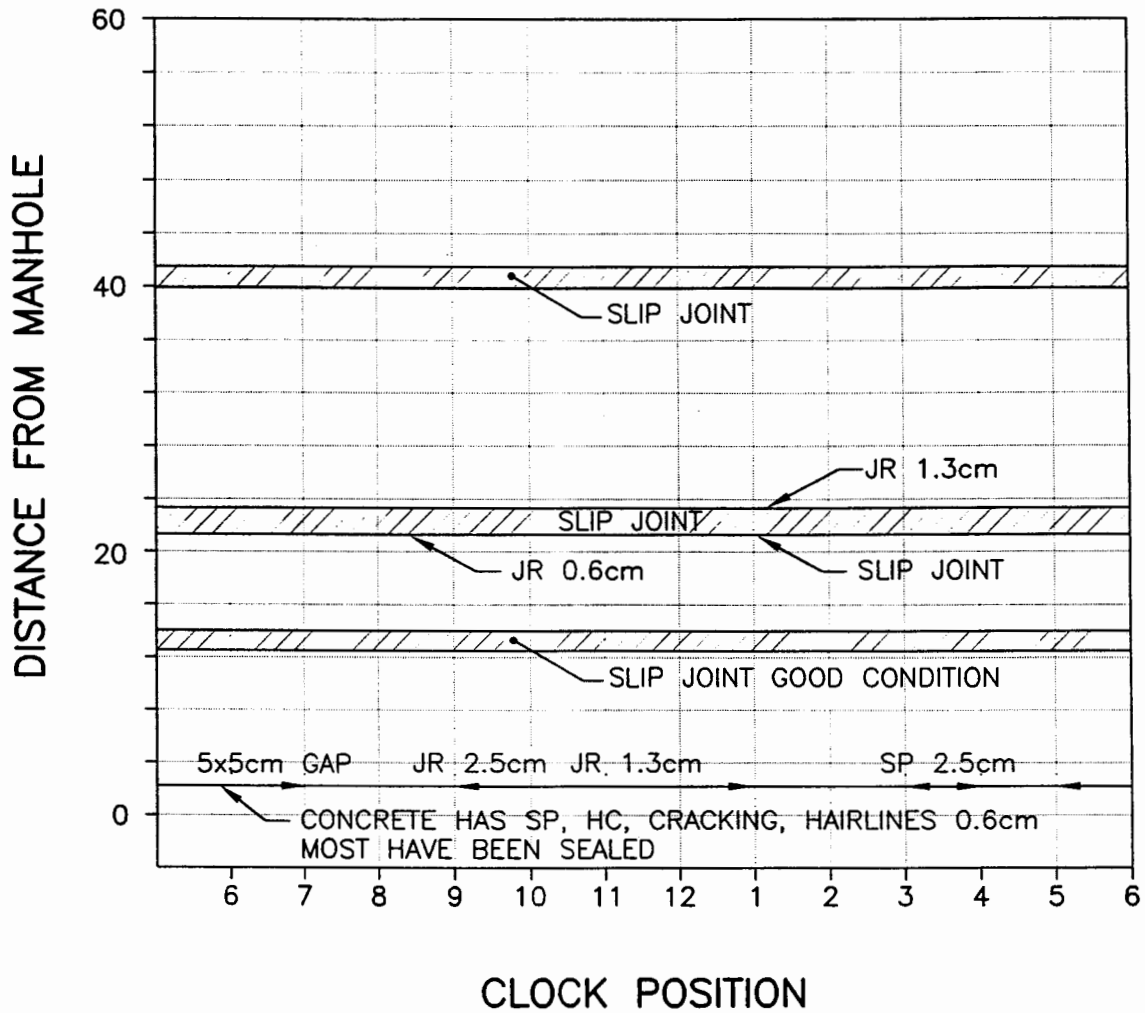
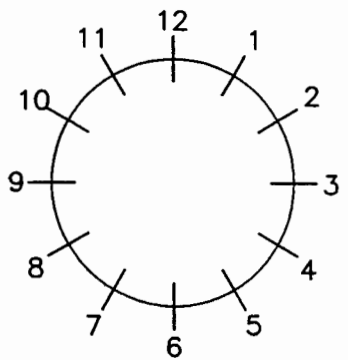
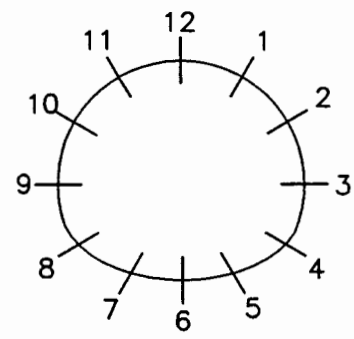
STRUCTURE CONDITION MAPPING CHART

Clock Reference Looking DOWNSTREAM

DEFECTIVE CONCRETE: Spalling Honeycomb Erosion/Wear Delaminated	SP HC EW DC	JOINTS: Raised Displaced Spalled R44	JR JD SP
--	----------------------	---	----------------

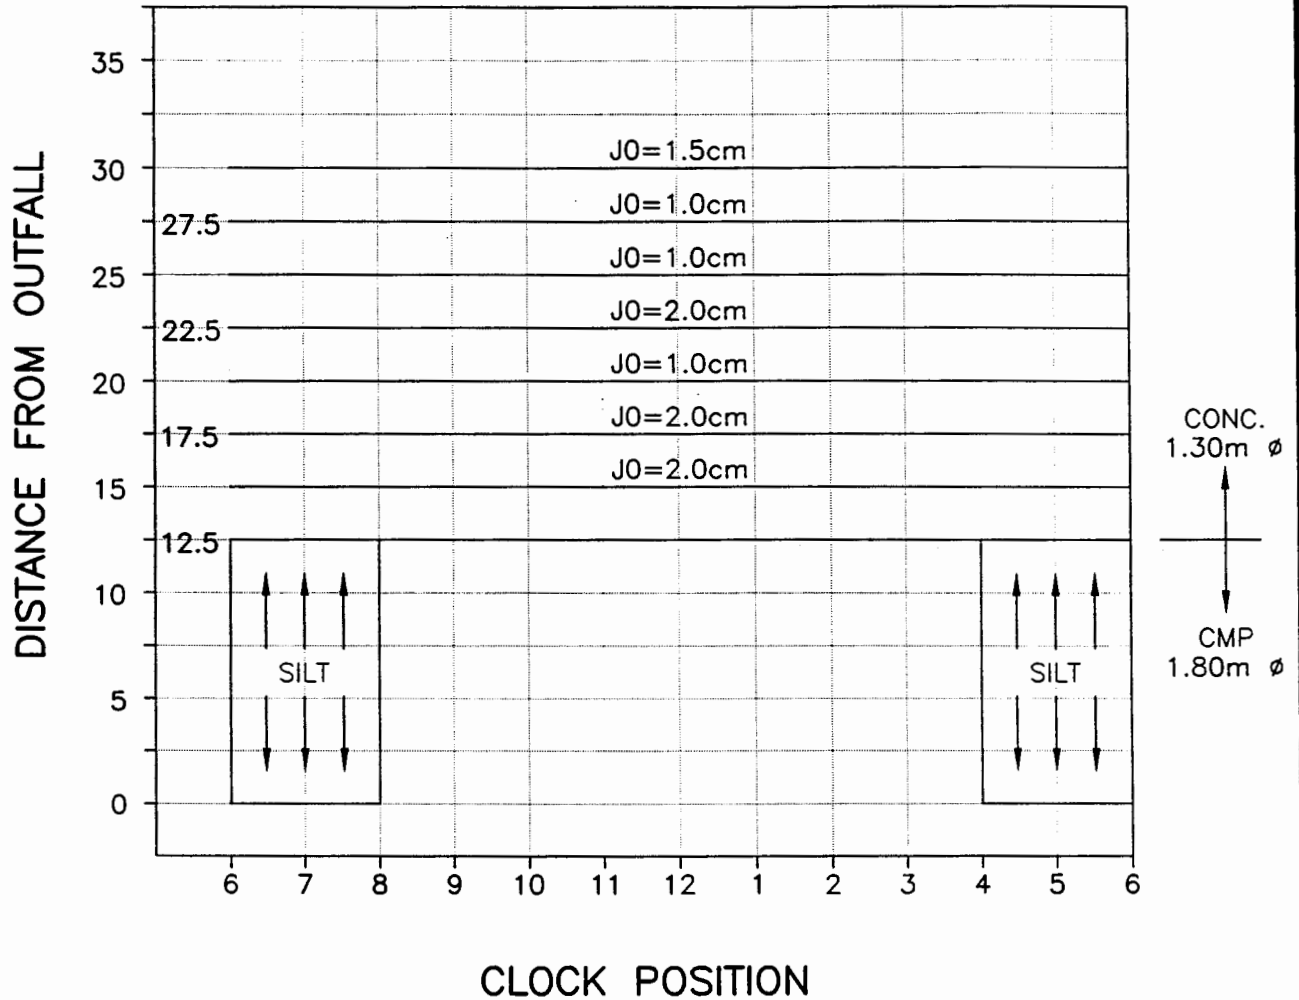
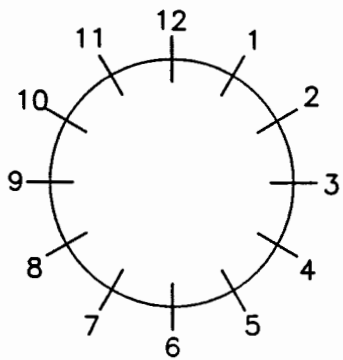
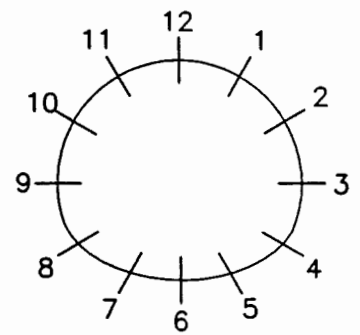
STRUCTURE CONDITION MAPPING CHART

Clock Reference Looking DOWNSTREAM

DEFECTIVE CONCRETE:	Spalling	SP	PIPE IDENTIFICATION:	Raised	JR
	Honeycomb	HC		Displaced	JD
	Erosion/Wear	EW		Spalled	SP
	Delaminated	DC		R45

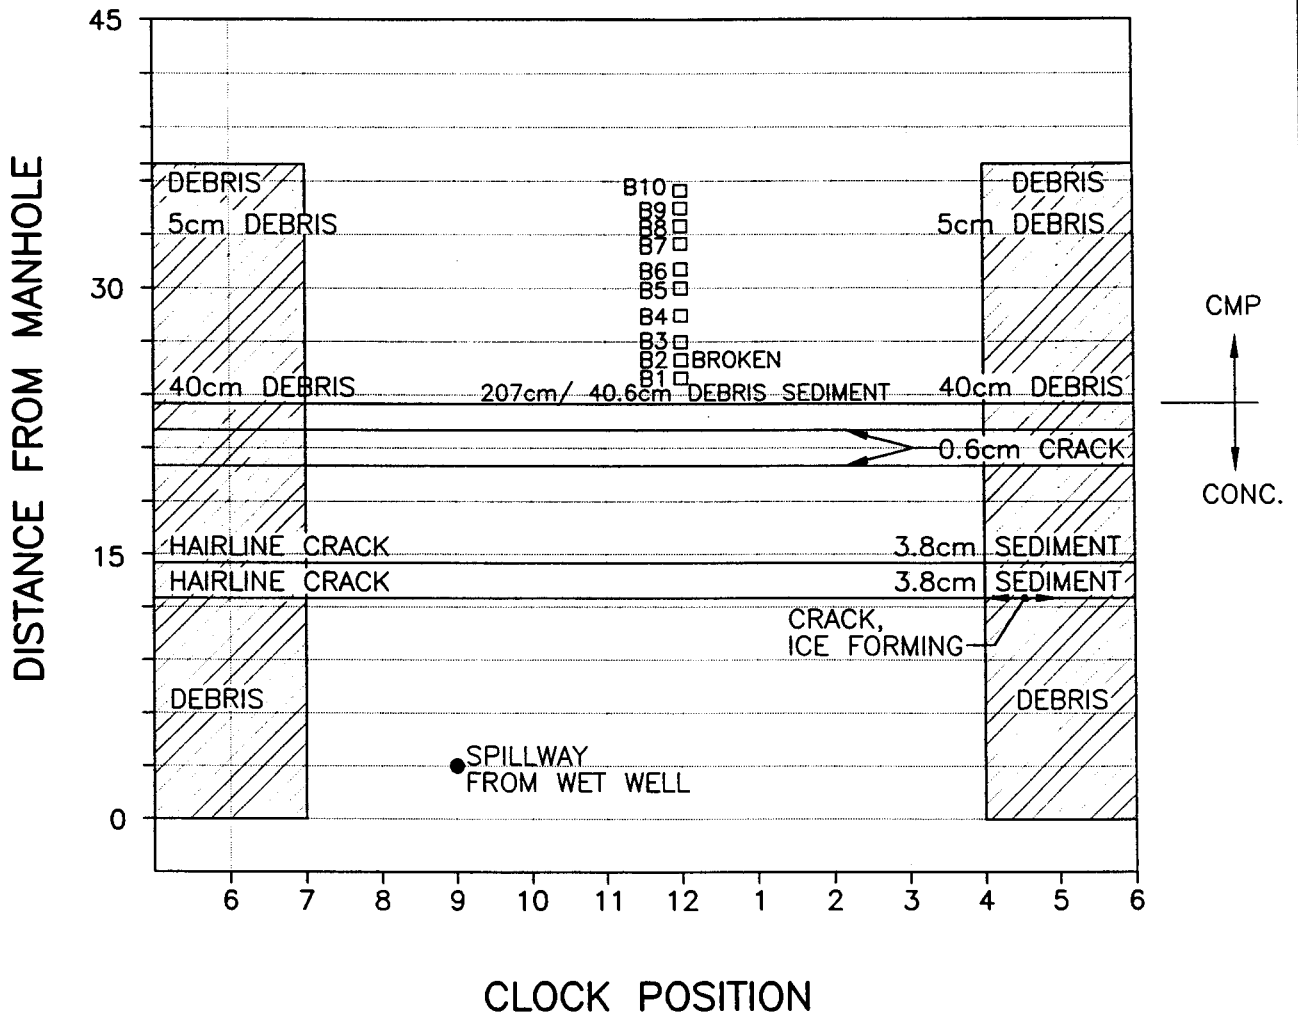
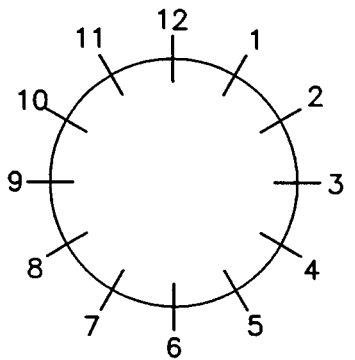
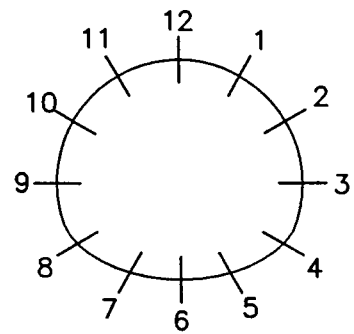
STRUCTURE CONDITION MAPPING CHART

Clock Reference Looking DOWNSTREAM

DEFECTIVE CONCRETE:	Spalling	SP	JOINTS:	Raised	JR
	B10 □ VERTICAL SUPPORT BEAM	Honeycomb		HC	Displaced
	Erosion/Wear	EW		Spalled	SP
	Delaminated	DC	PIPE IDENTIFICATION:	R46

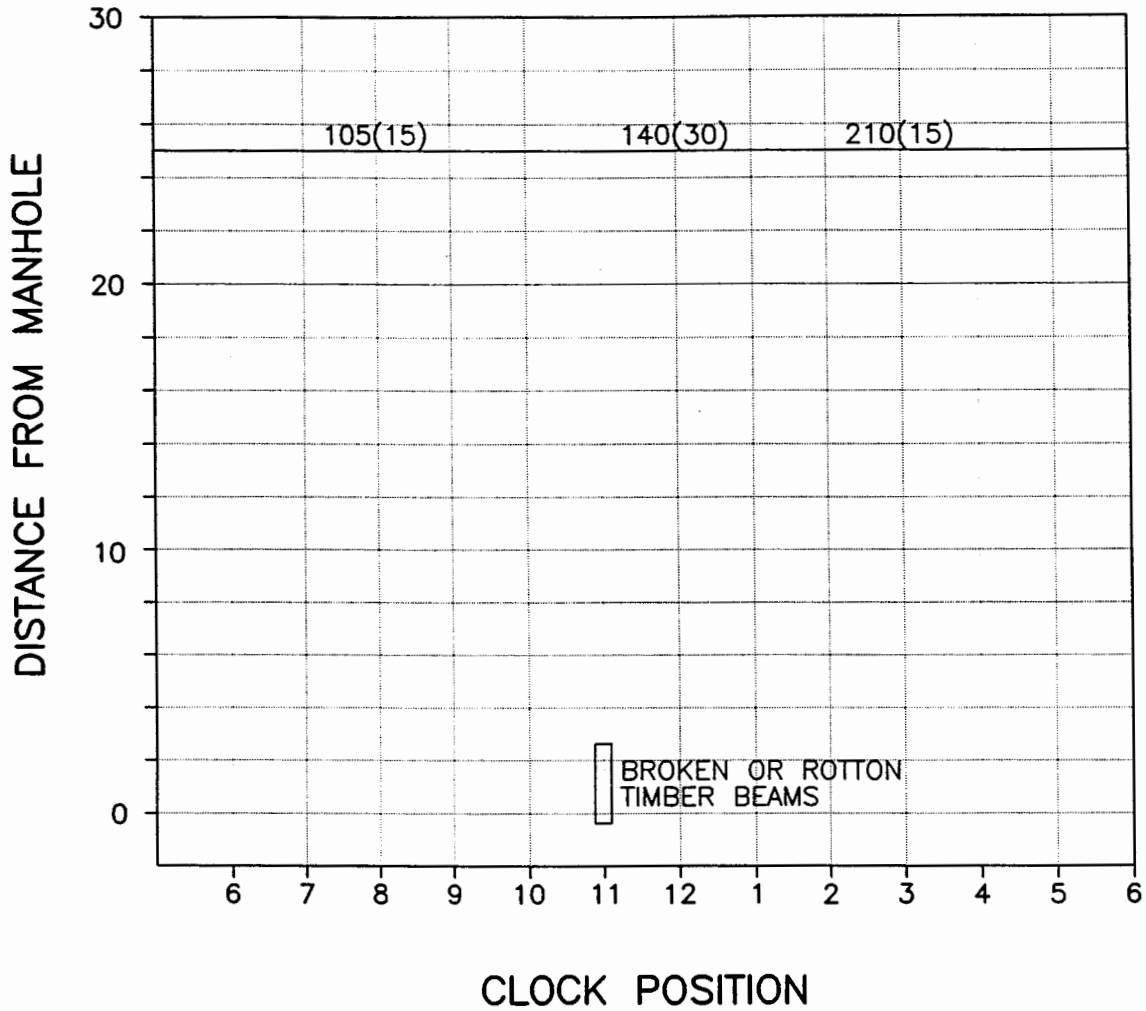
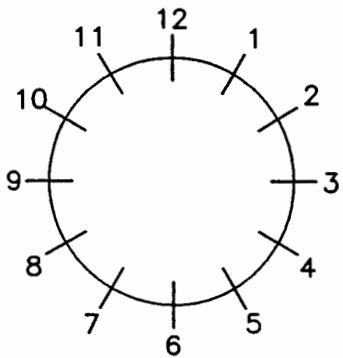
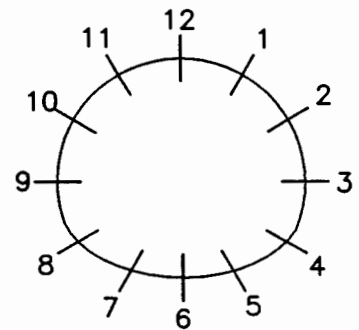
STRUCTURE CONDITION MAPPING CHART

Clock Reference Looking
DOWNSTREAM

DEFECTIVE CONCRETE:	Spalling Honeycomb Erosion/Wear Delaminated	SP HC EW DC	JOINTS:	Raised Displaced Spalled R48	JR JD SP
			PIPE IDENTIFICATION:

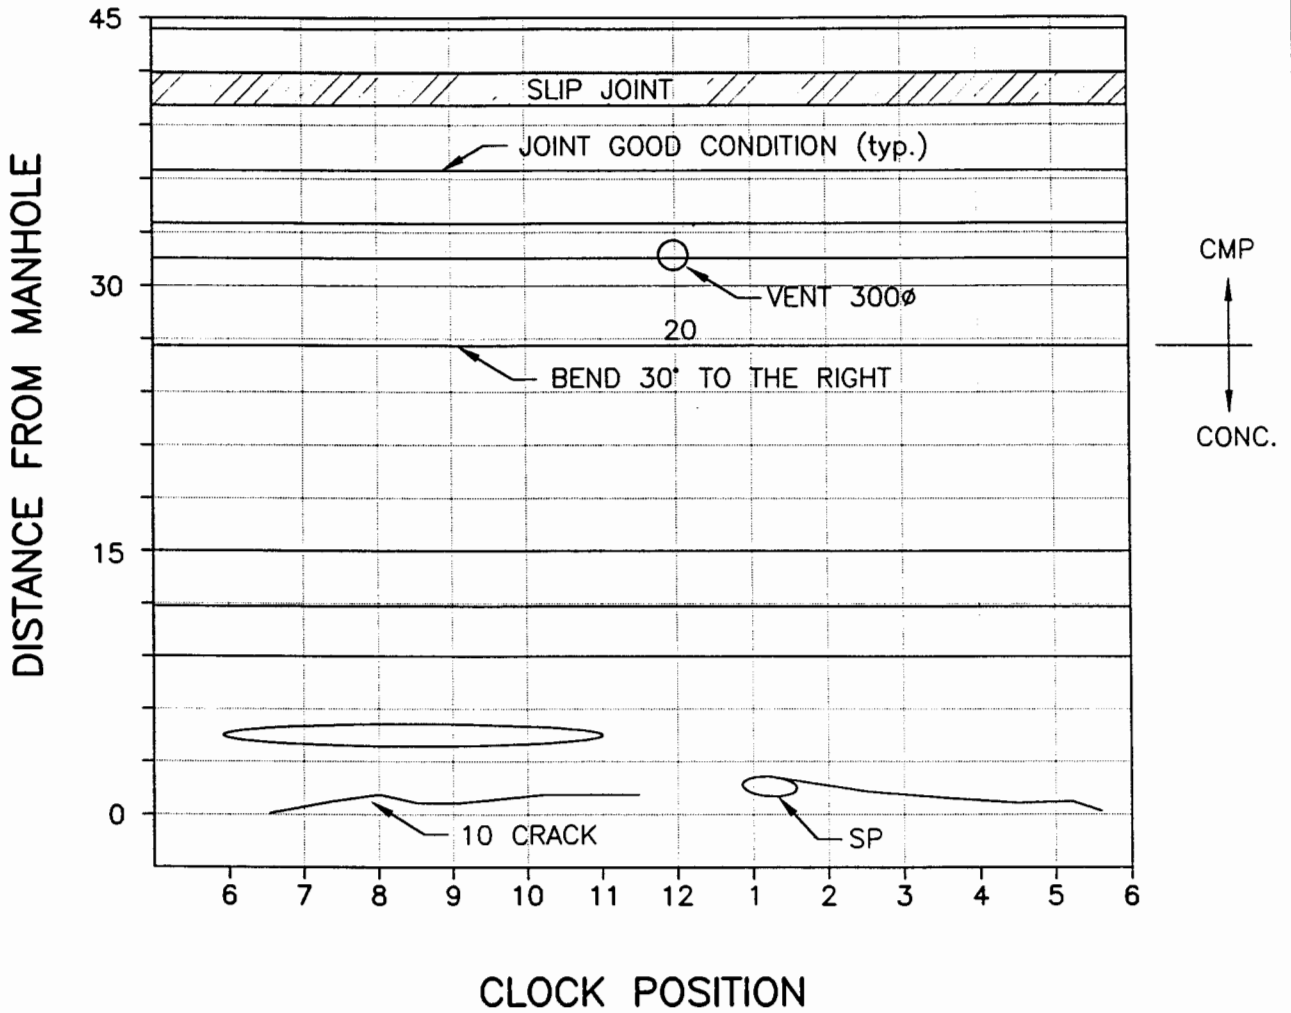
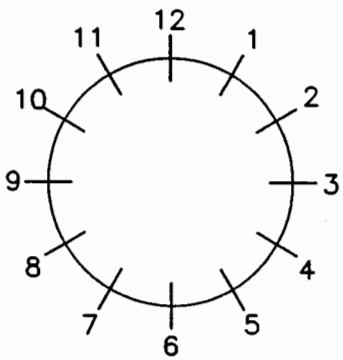
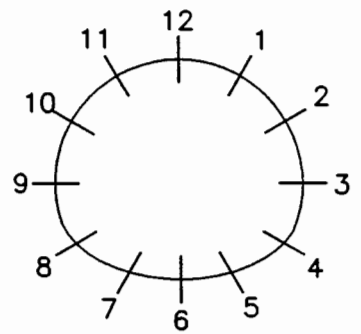
STRUCTURE CONDITION MAPPING CHART

Clock Reference Looking DOWNSTREAM

DEFECTIVE CONCRETE:	Spalling	SP	JOINTS:	Raised	JR
	Honeycomb	HC		Displaced	JD
	Erosion/Wear	EW		Spalled	SP
	Delaminated	DC			
			PIPE IDENTIFICATION:	R49

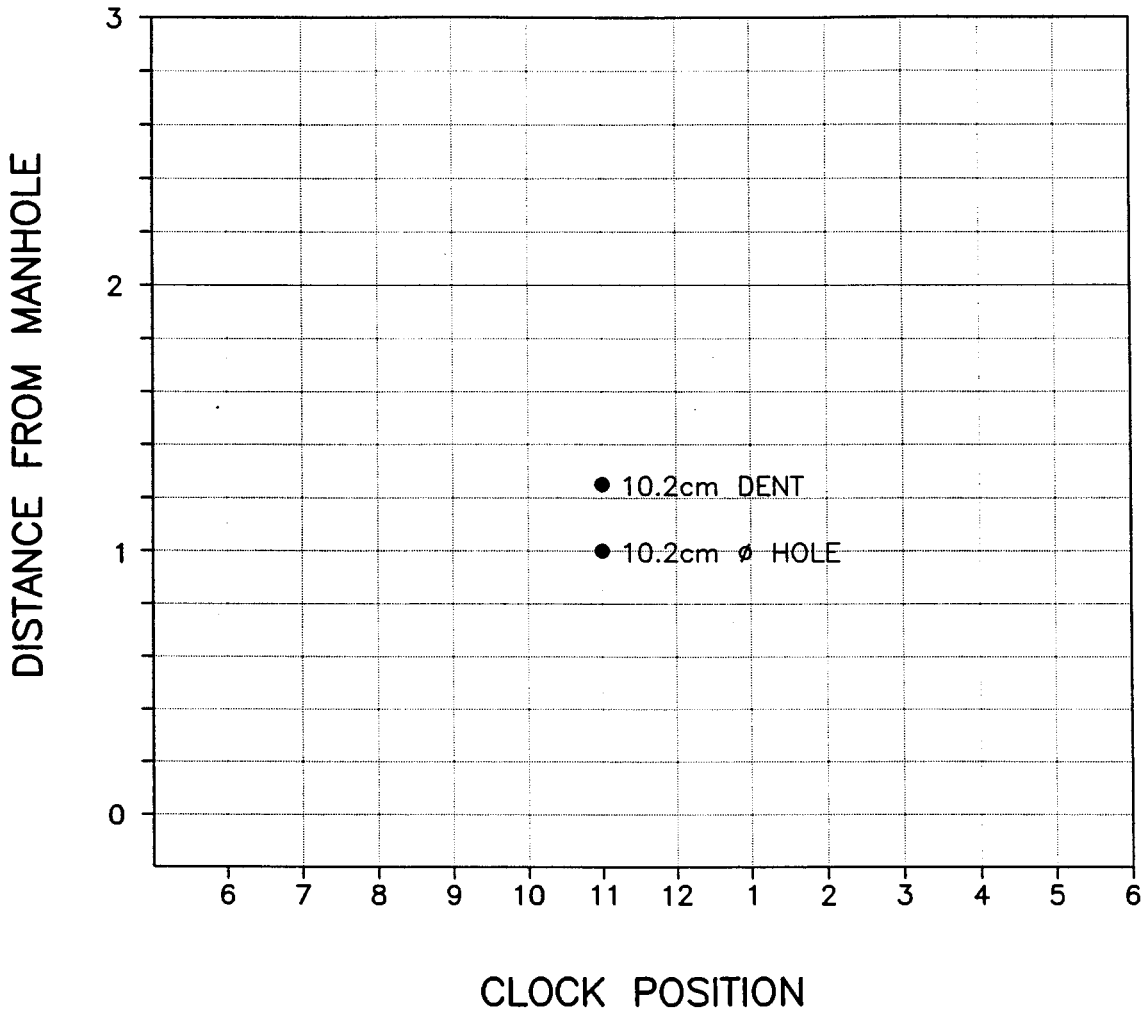
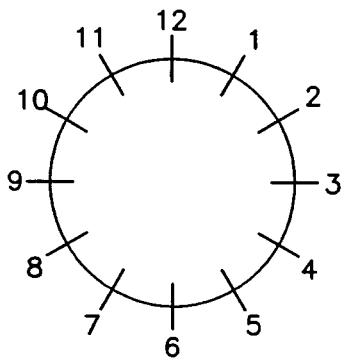
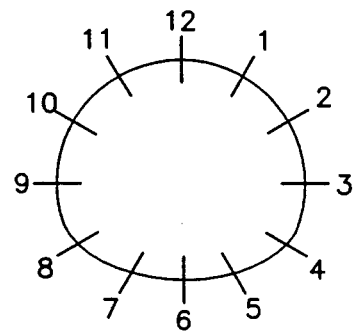
STRUCTURE CONDITION MAPPING CHART

Clock Reference Looking
DOWNSTREAM

DEFECTIVE CONCRETE: Spalling Honeycomb Erosion/Wear Delaminated	SP HC EW DC	JOINTS: Raised Displaced Spalled R51	JR JD SP
--	----------------------	---	----------------

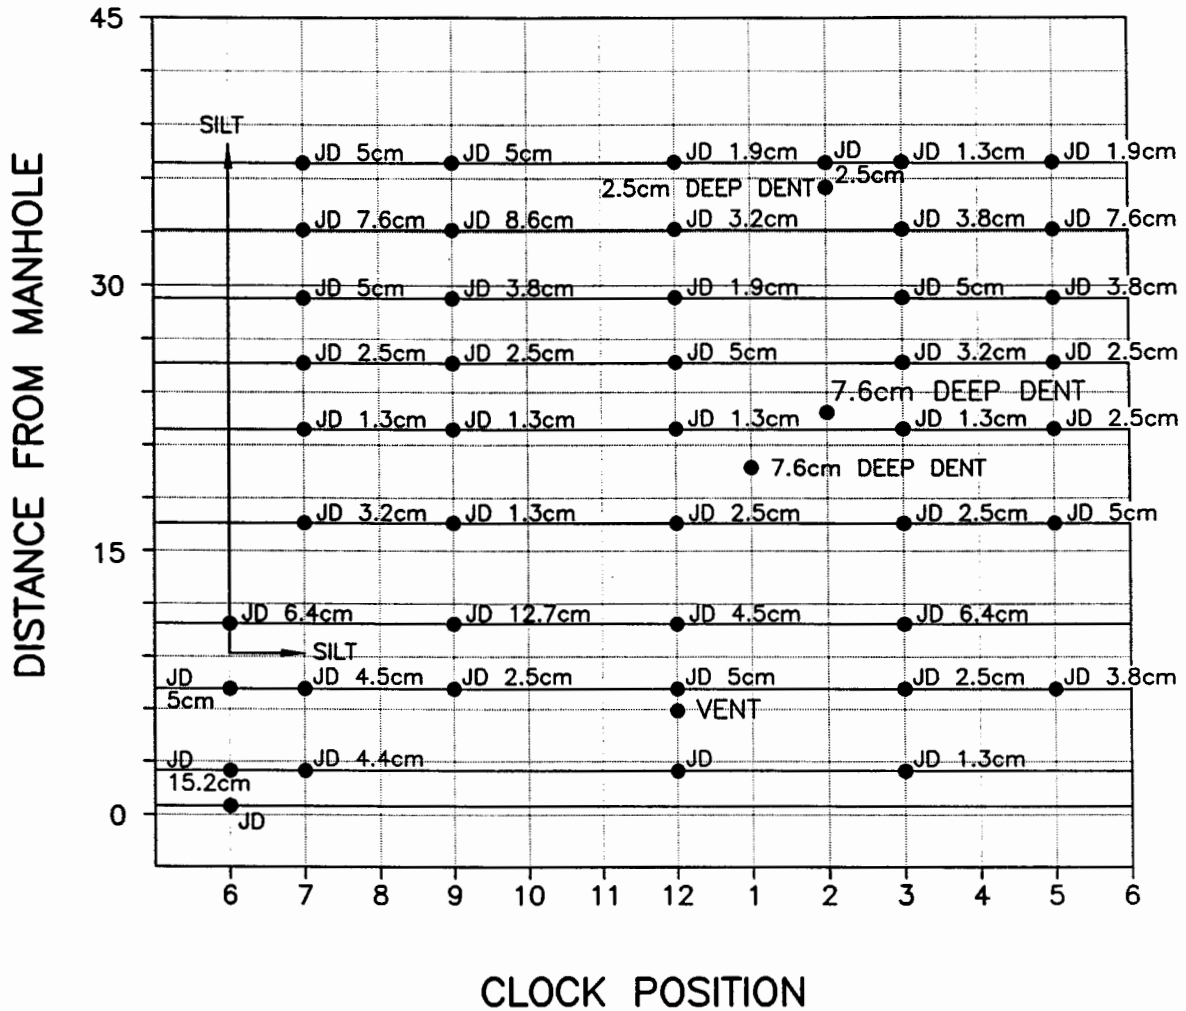
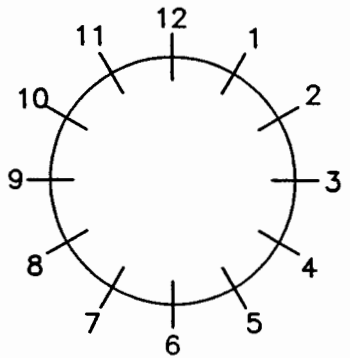
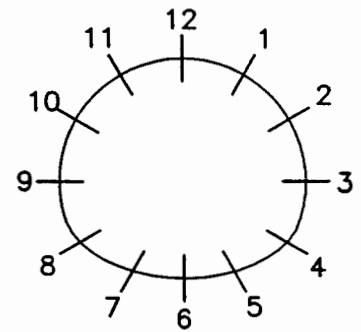
STRUCTURE CONDITION MAPPING CHART

Clock Reference Looking DOWNSTREAM

DEFECTIVE CONCRETE: Spalling Honeycomb Erosion/Wear Delaminated	SP HC EW DC	JOINTS: Raised Displaced Spalled R52	JR JD SP
--	----------------------	---	----------------

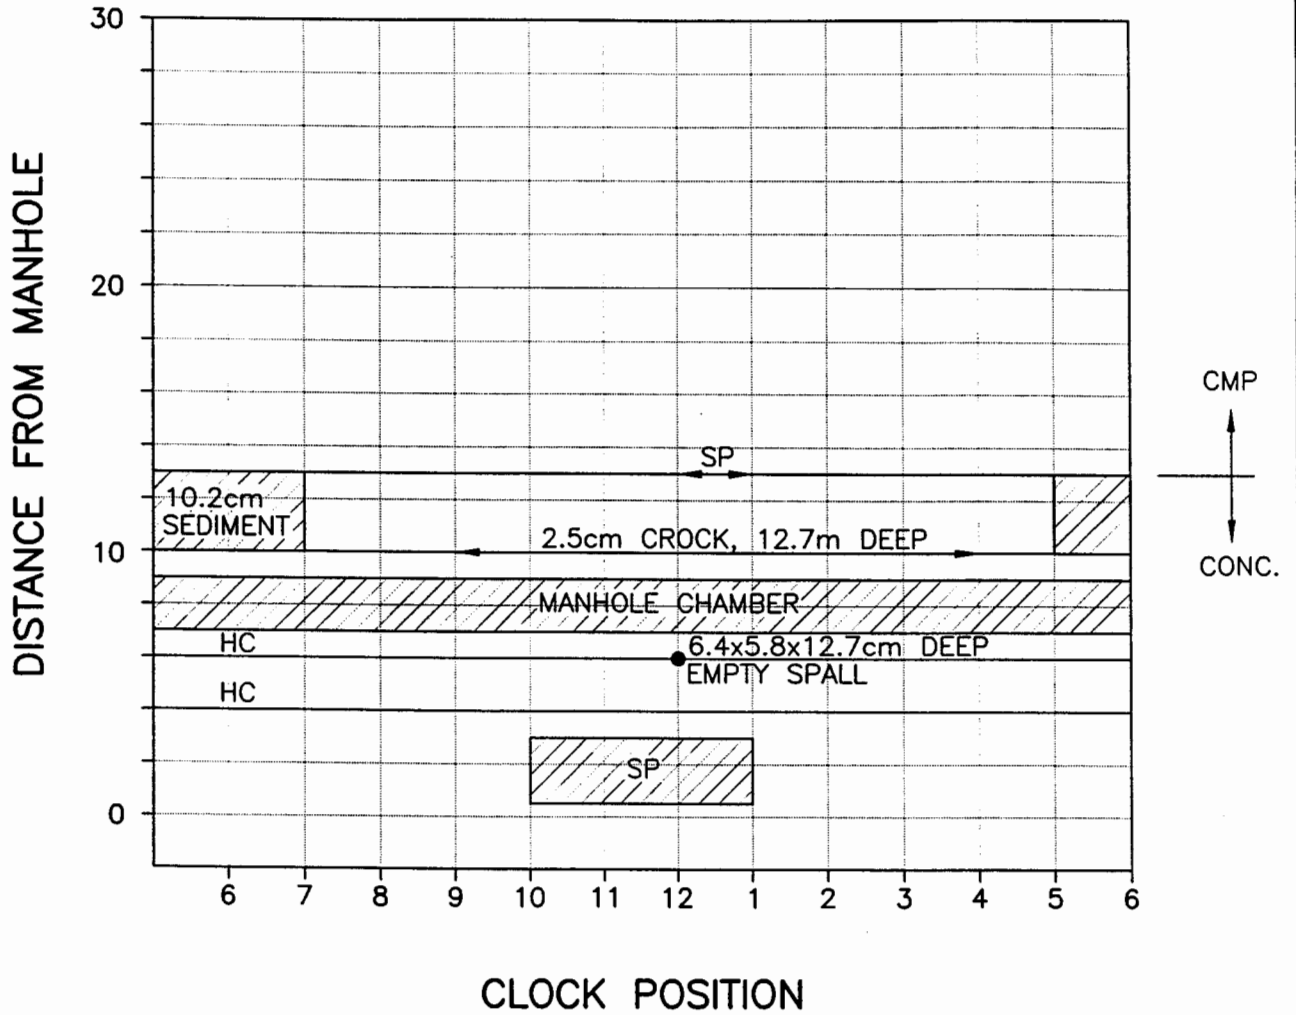
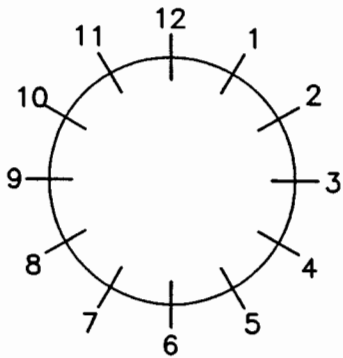
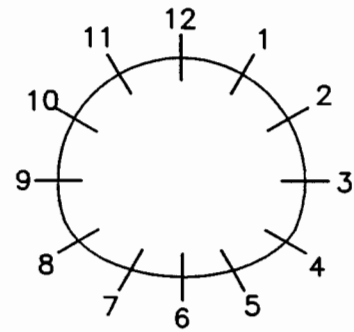
STRUCTURE CONDITION MAPPING CHART

Clock Reference Looking DOWNSTREAM

DEFECTIVE CONCRETE:	Spalling	SP	JOINTS:	Raised	JR
	Honeycomb	HC		Displaced	JD
	Erosion/Wear	EW		Spalled	SP
	Delaminated	DC		PIPE IDENTIFICATION:	R54

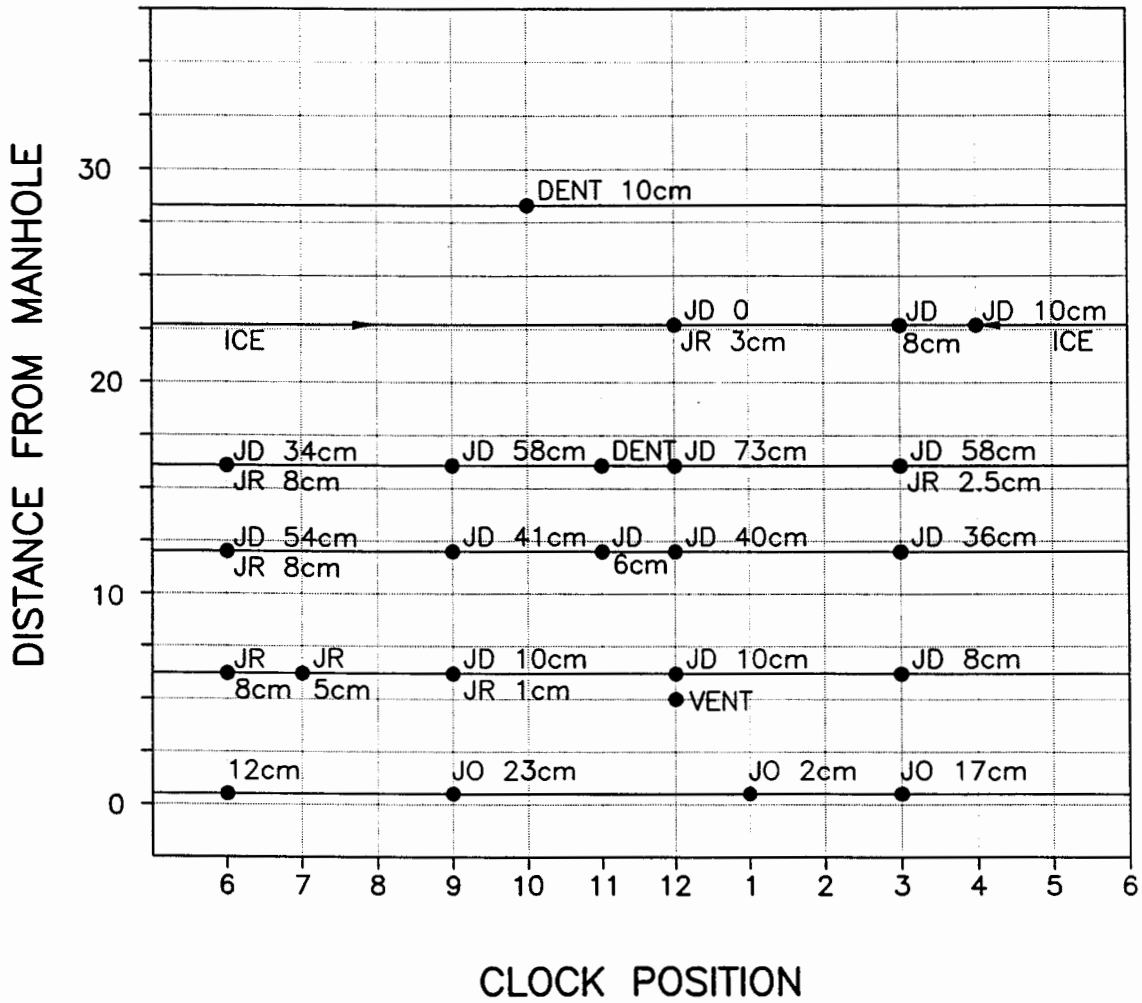
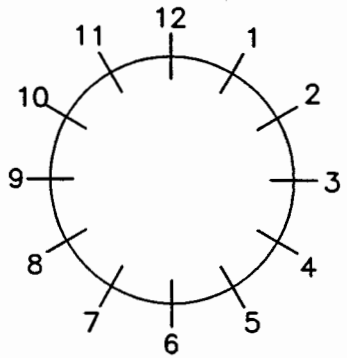
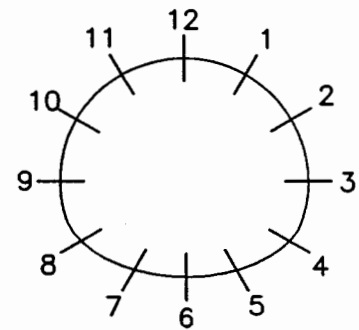
STRUCTURE CONDITION MAPPING CHART

Clock Reference Looking DOWNSTREAM

DEFECTIVE CONCRETE: Spalling Honeycomb Erosion/Wear Delaminated	SP HC EW DC	JOINTS: Raised Displaced Spalled R55	JR JD SP
--	----------------------	---	----------------

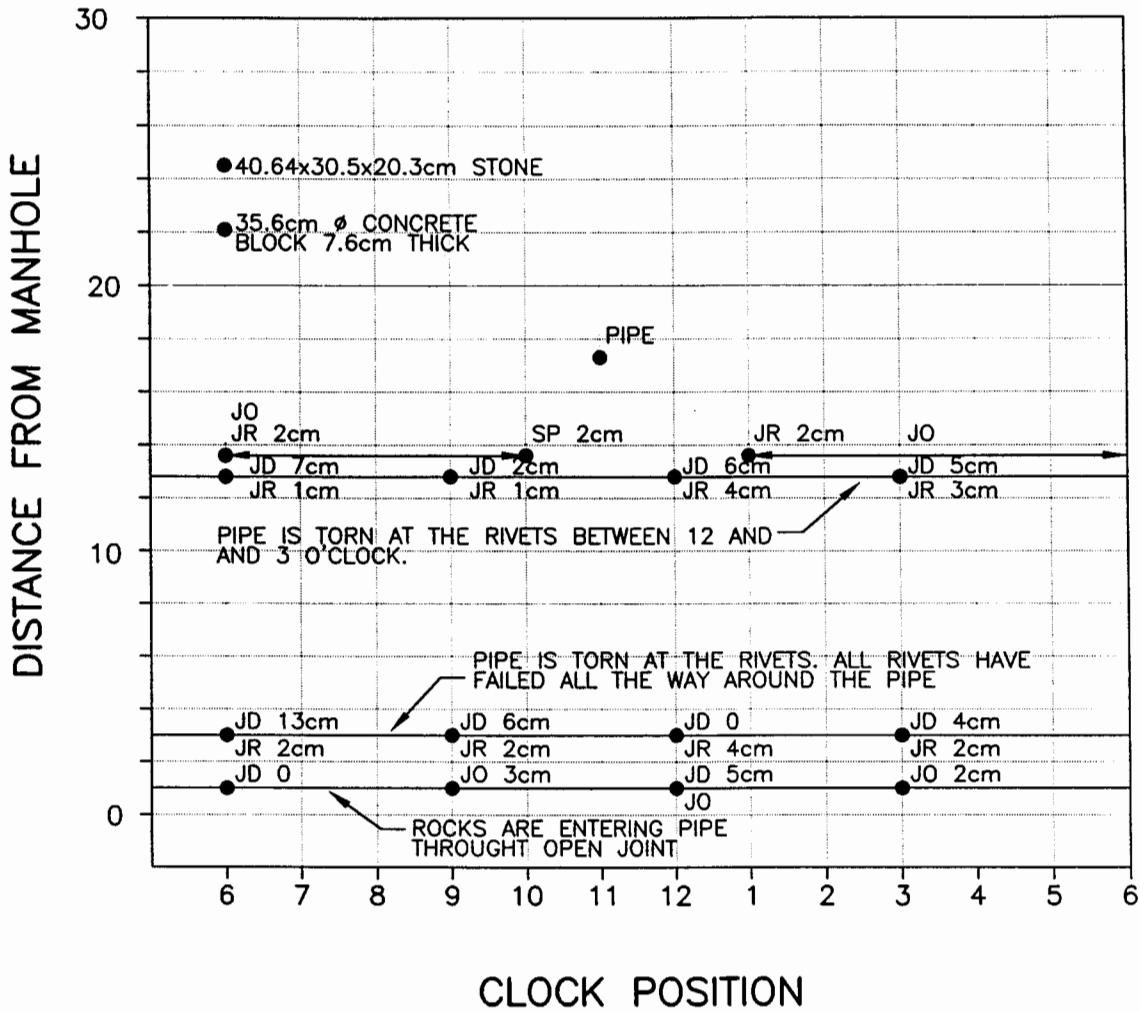
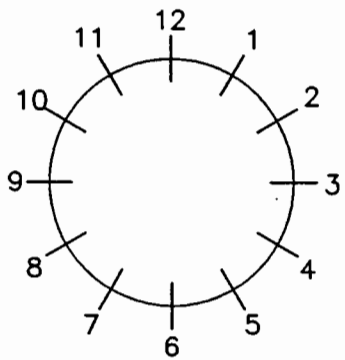
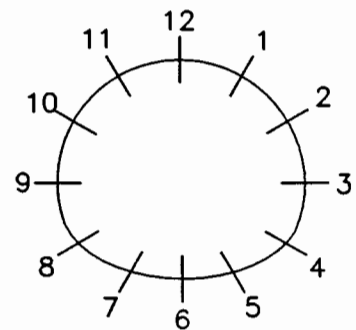
Clock Reference Looking DOWNSTREAM

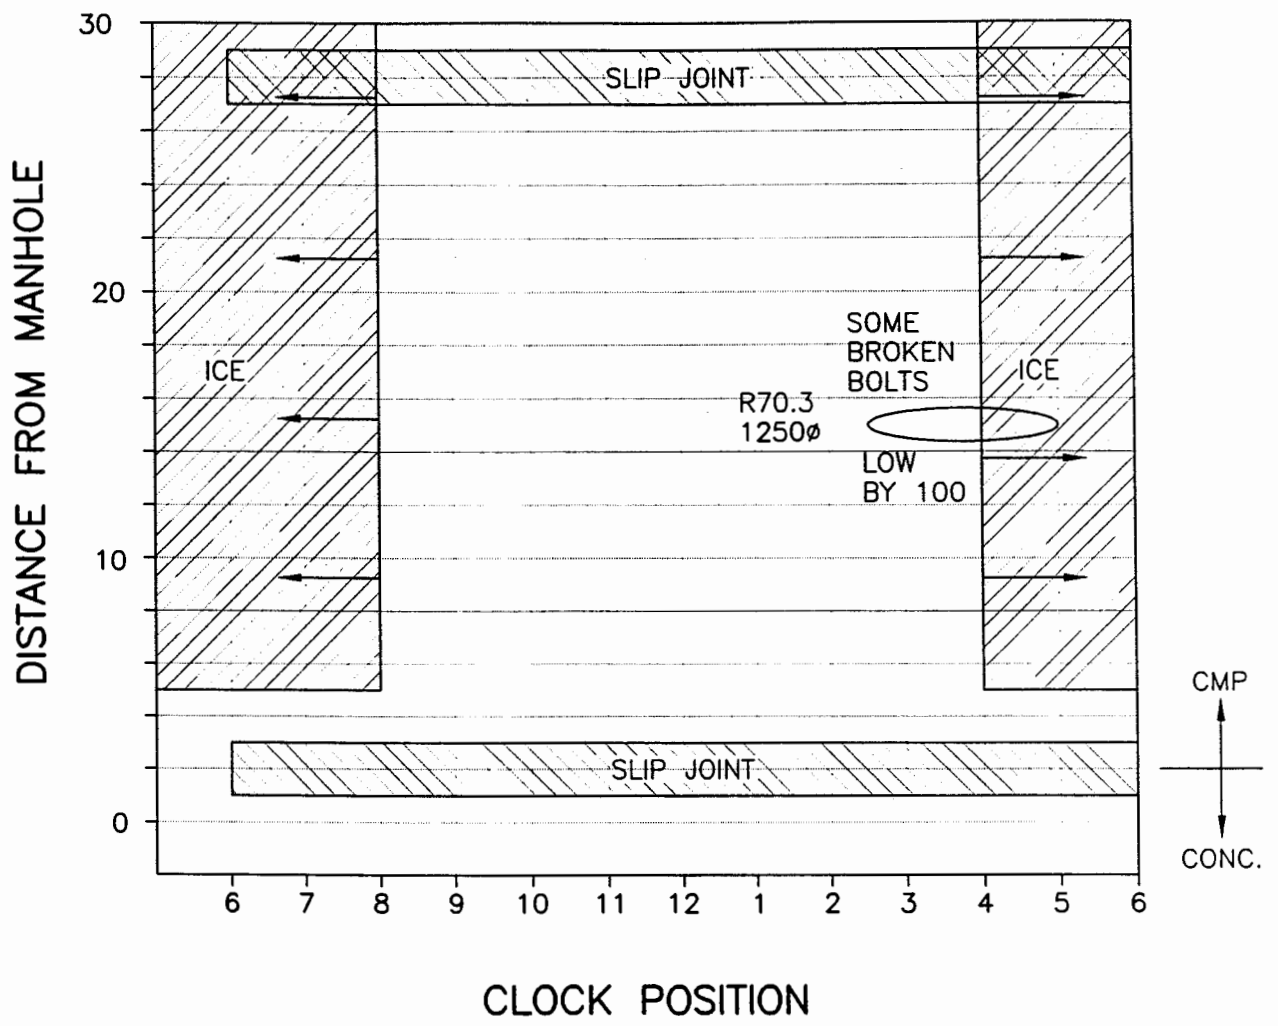
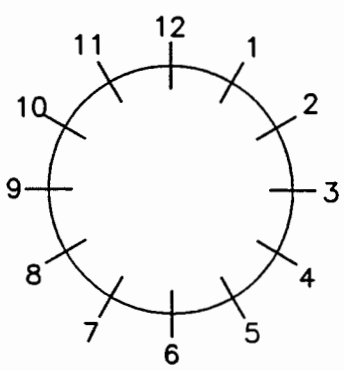
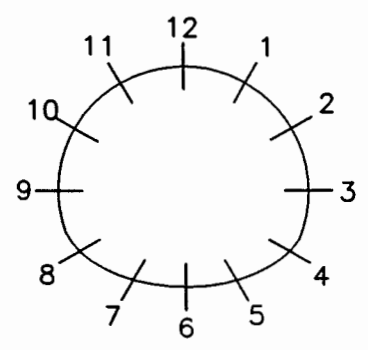
STRUCTURE CONDITION MAPPING CHART

Clock Reference Looking DOWNSTREAM

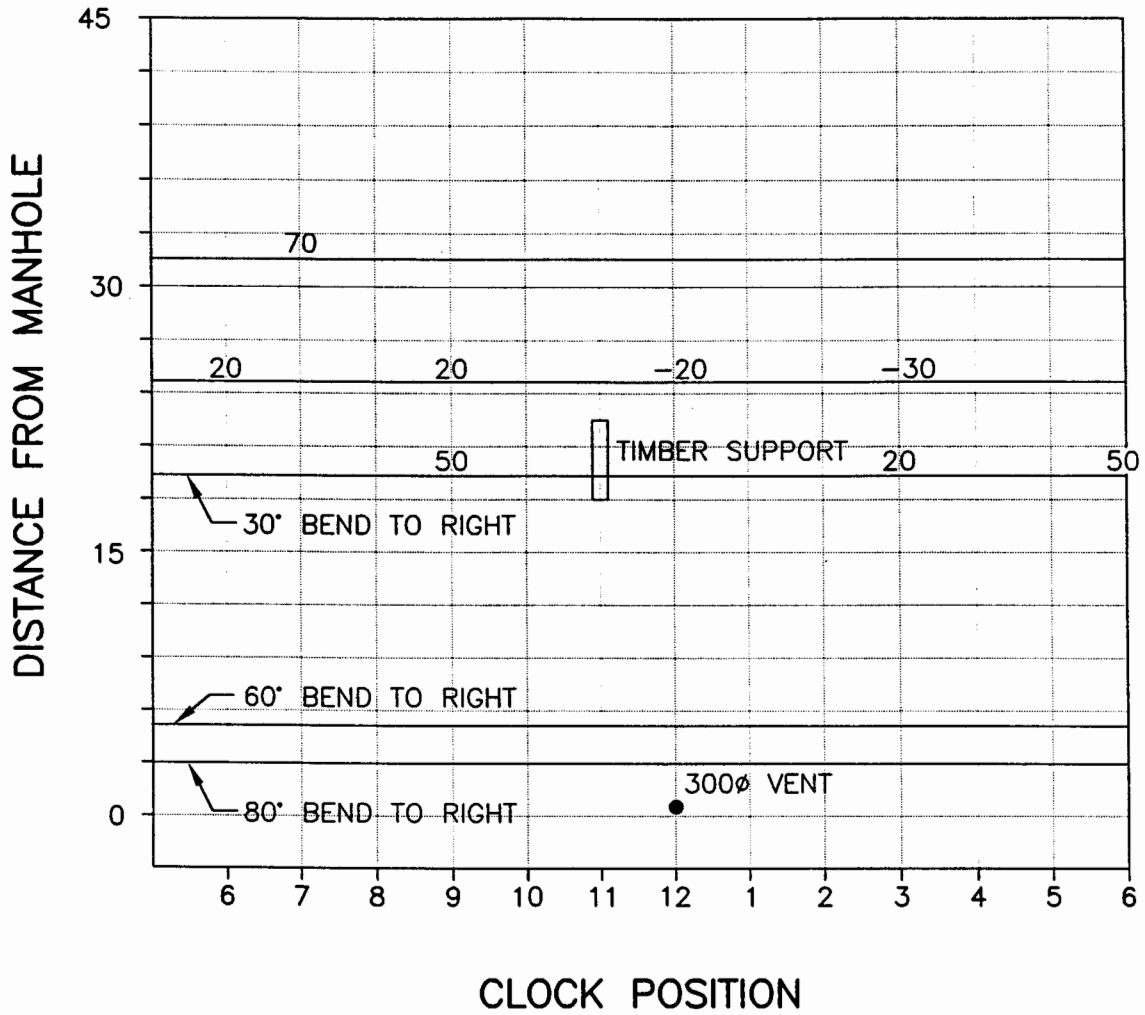
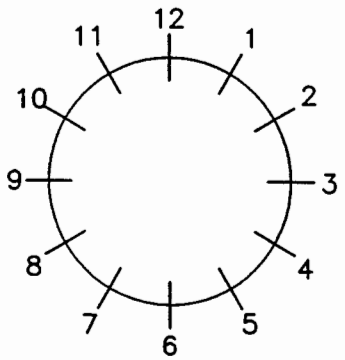
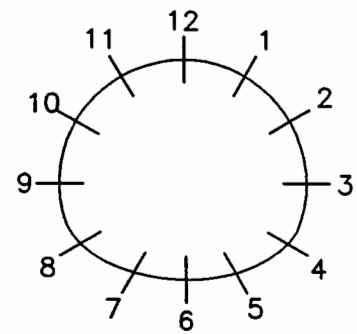
STRUCTURE CONDITION MAPPING CHART

Clock Reference Looking DOWNSTREAM

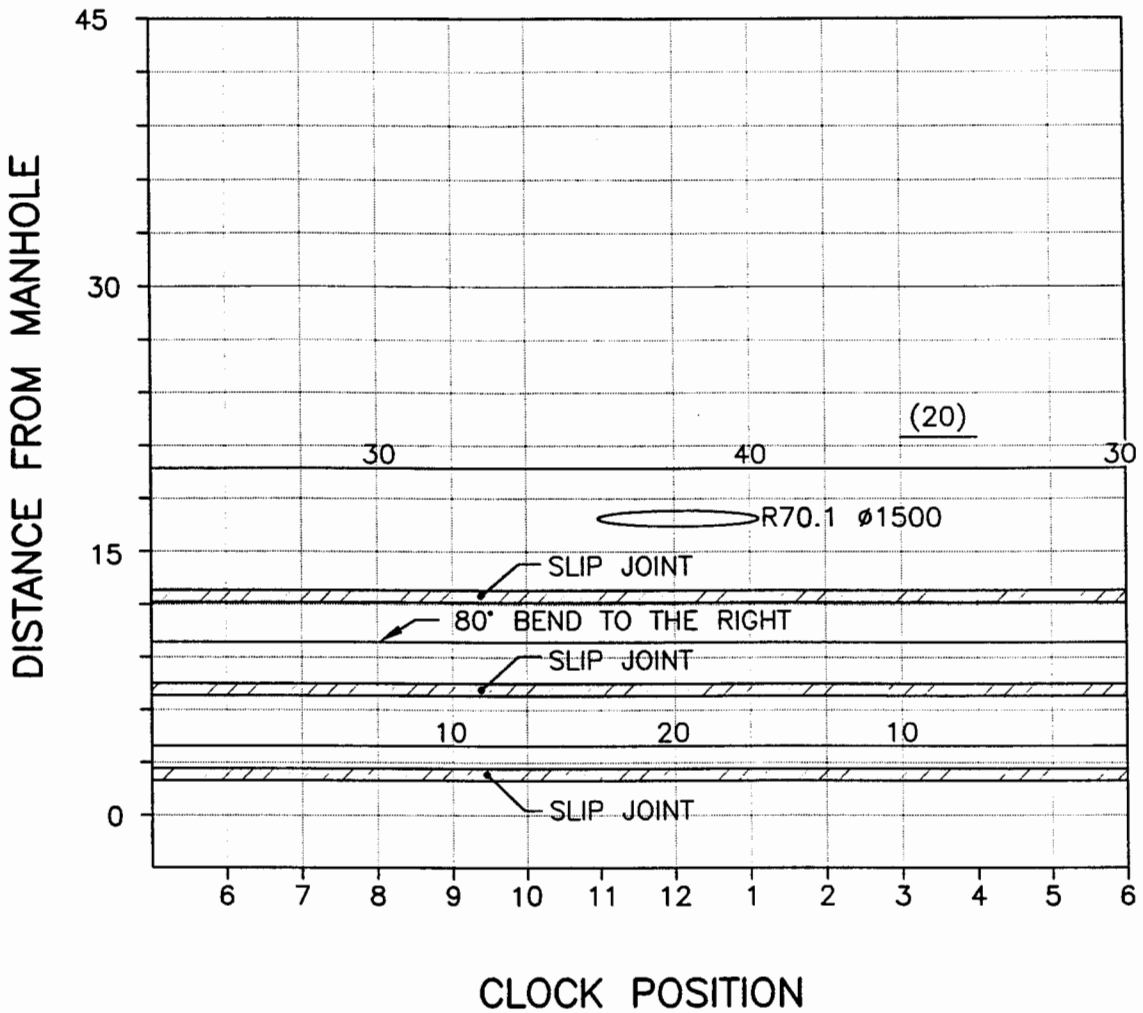
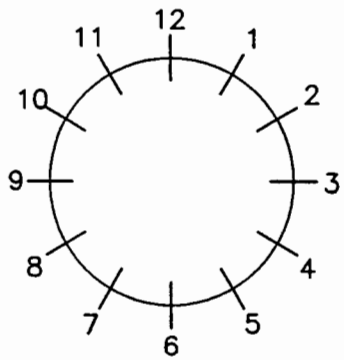
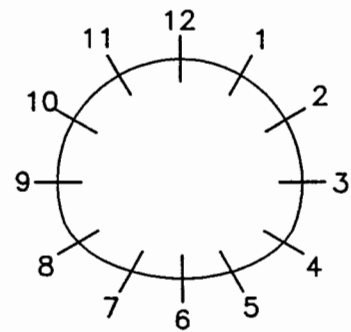
STRUCTURE CONDITION MAPPING CHART

Clock Reference Looking DOWNSTREAM

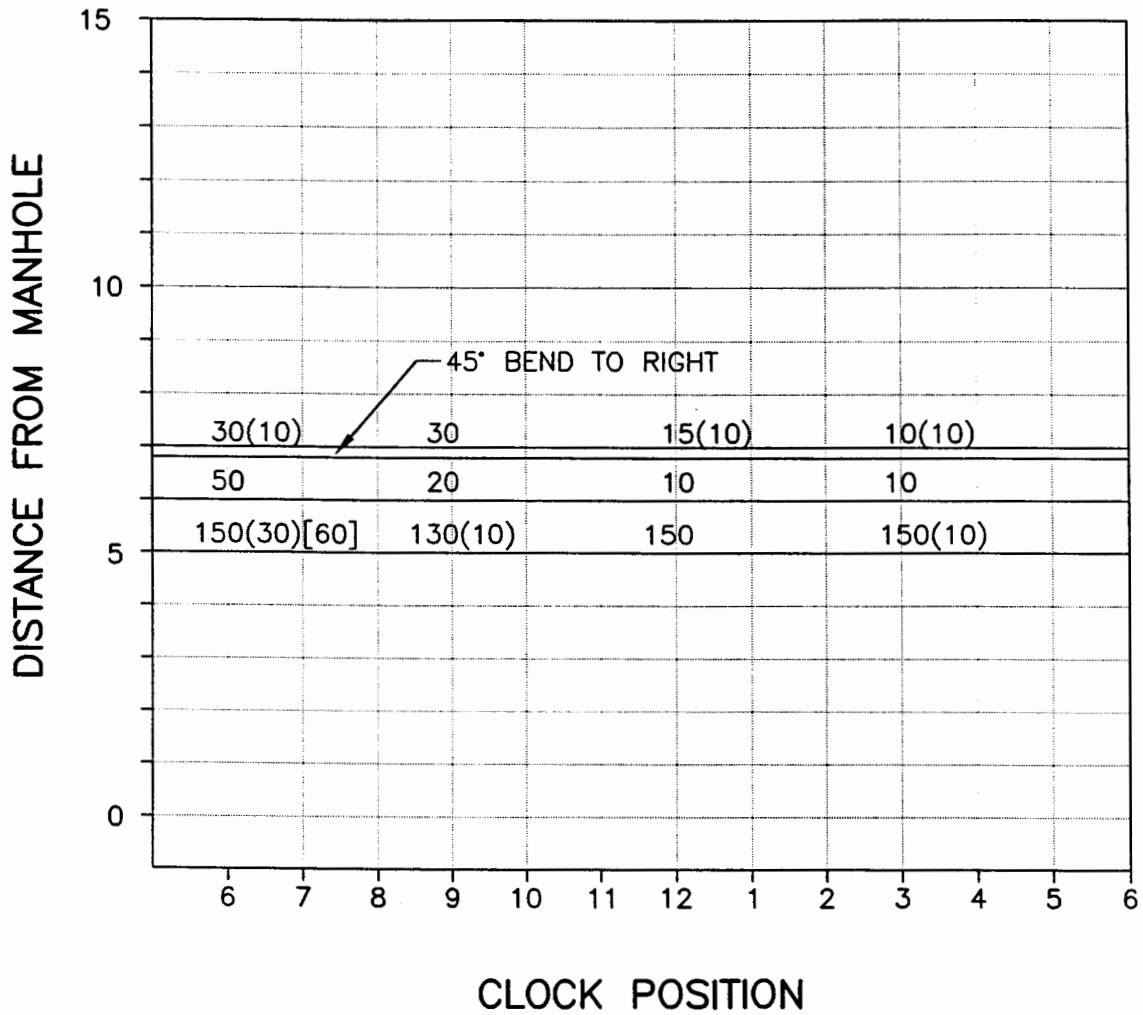
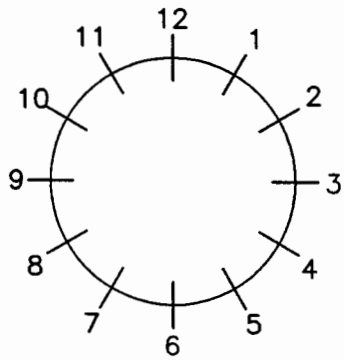
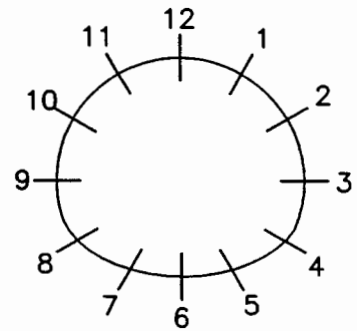
STRUCTURE CONDITION MAPPING CHART

Clock Reference Looking DOWNSTREAM

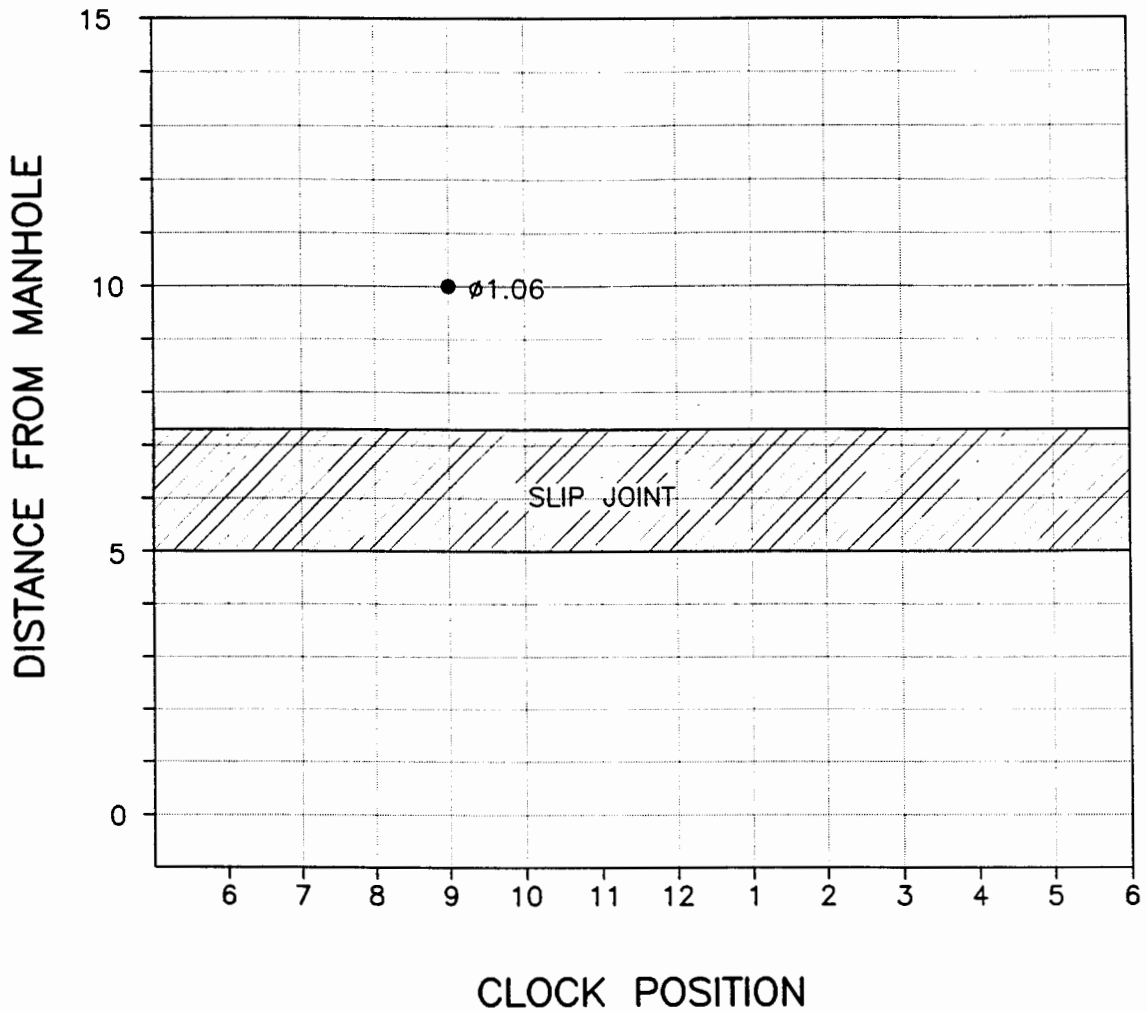
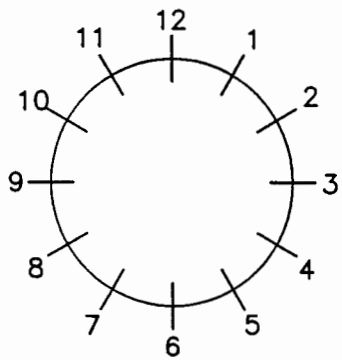
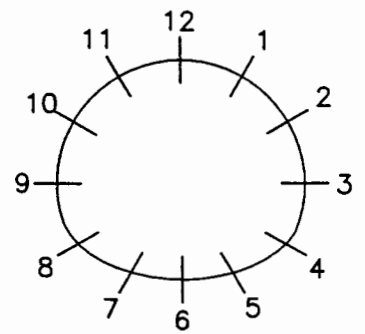
STRUCTURE CONDITION MAPPING CHART

Clock Reference Looking DOWNSTREAM
