APPENDIX A – 1998 OUTFALL INSPECTIONS CONDITION AND MAINTENANCE STUDY

CITY OF WINNIPEG
OUTFALL CONDITION
AND
MAINTENANCE STUDY
FINAL REPORT //

August, 1998

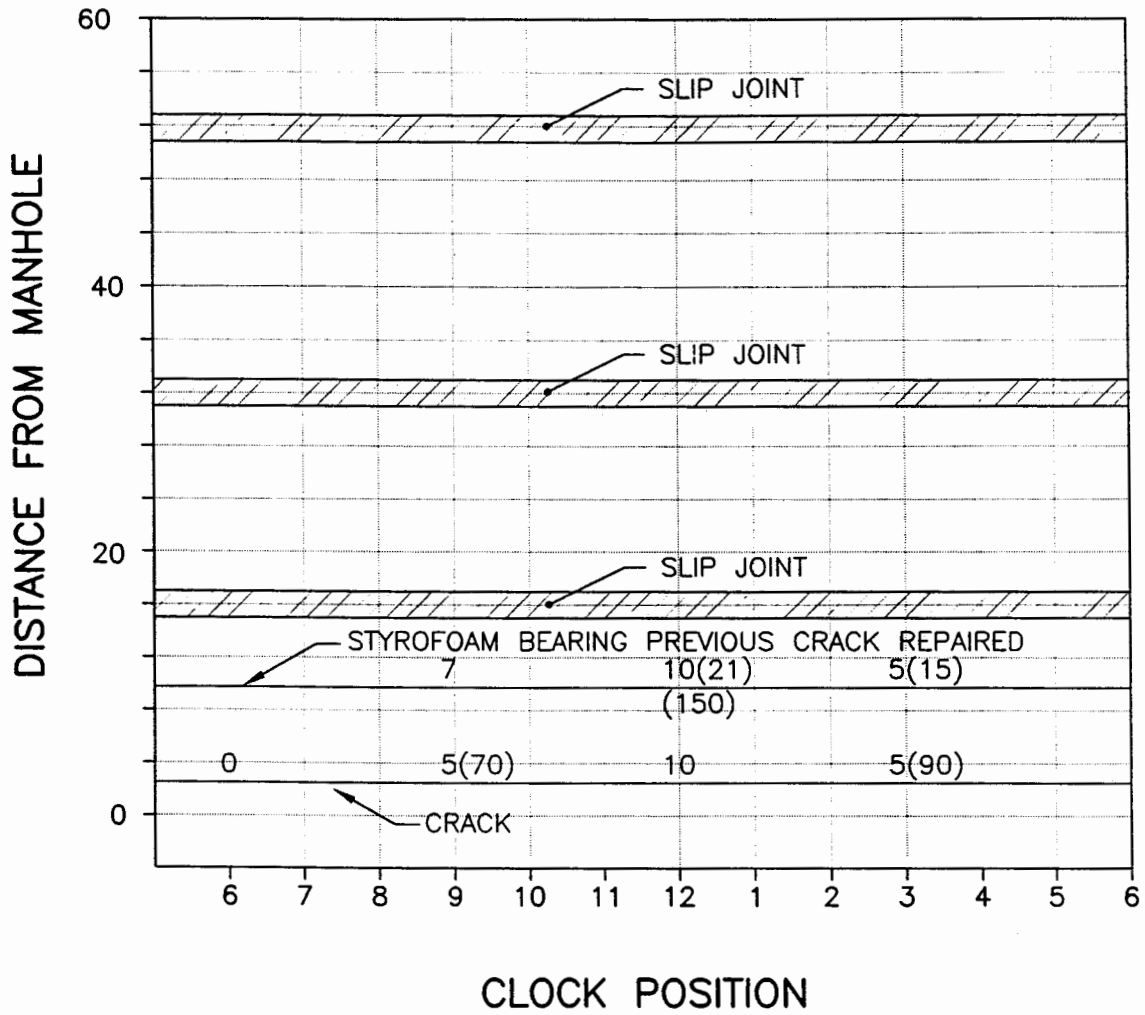
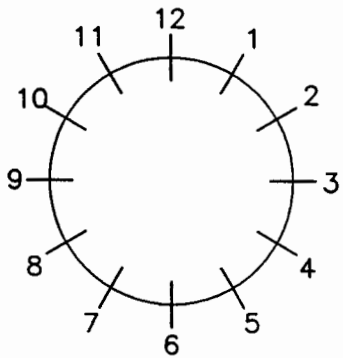
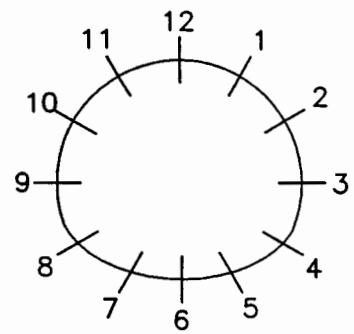
STRUCTURE CONDITION MAPPING CHART

Clock Reference Looking
DOWNSTREAM

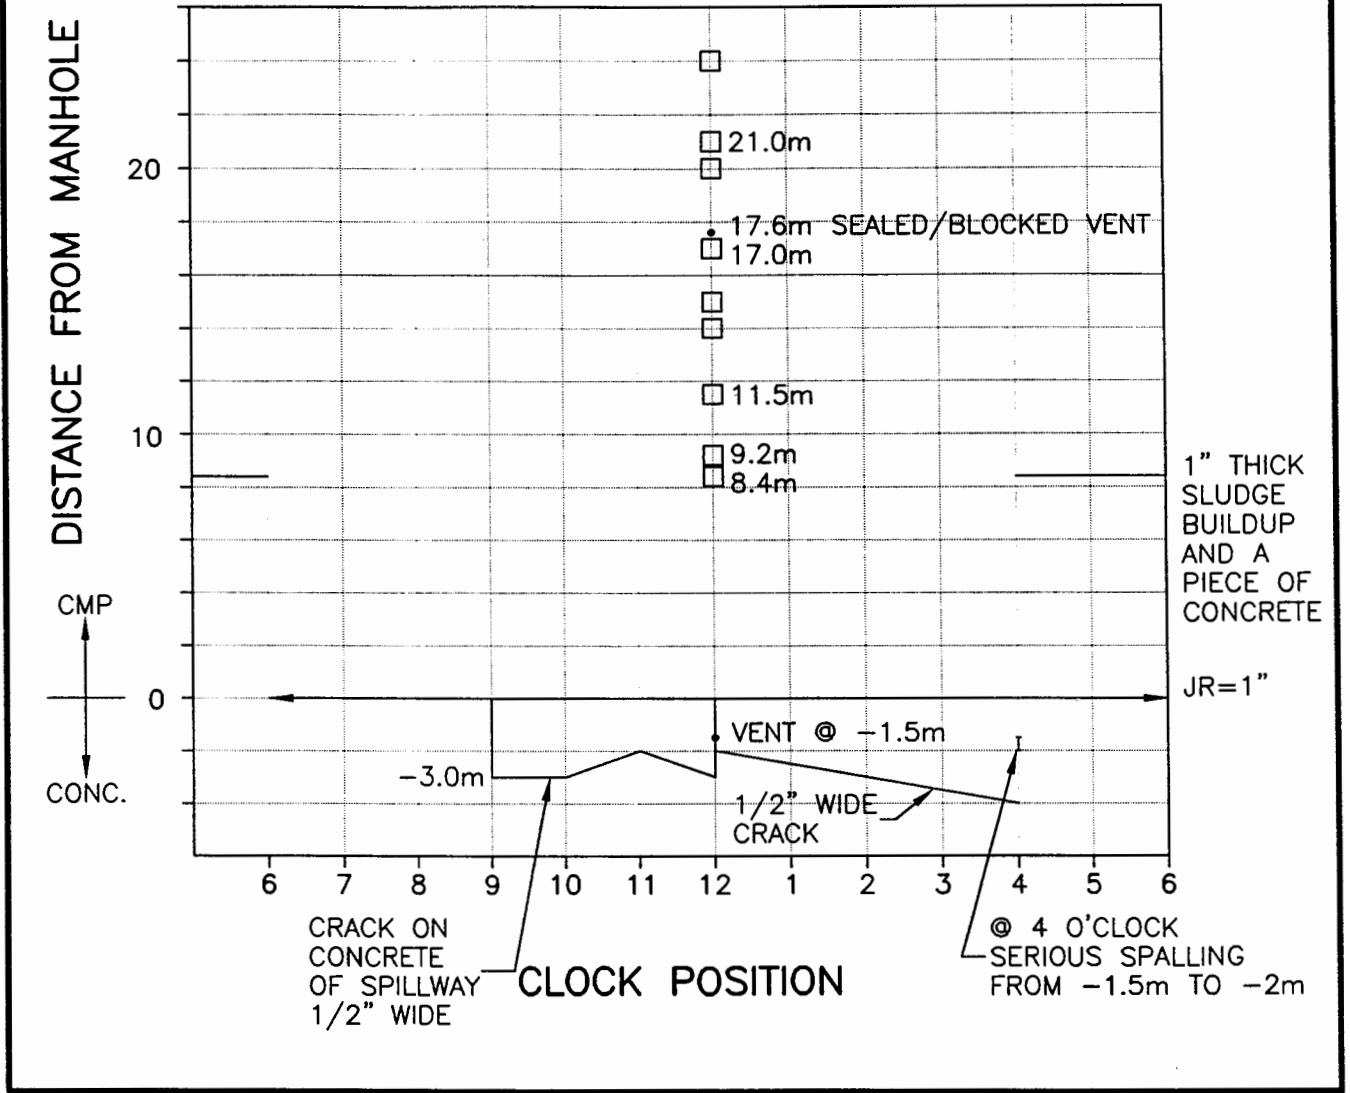
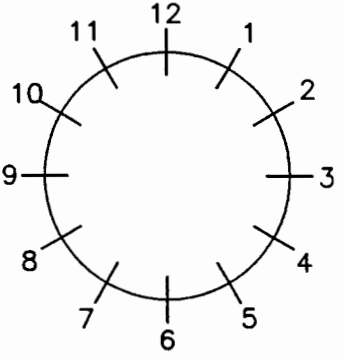
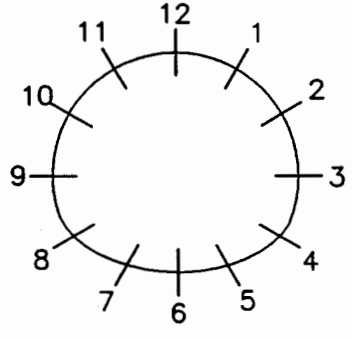
STRUCTURE CONDITION MAPPING CHART

□ 4"x4" WOOD BRACES

Clock Reference Looking DOWNSTREAM

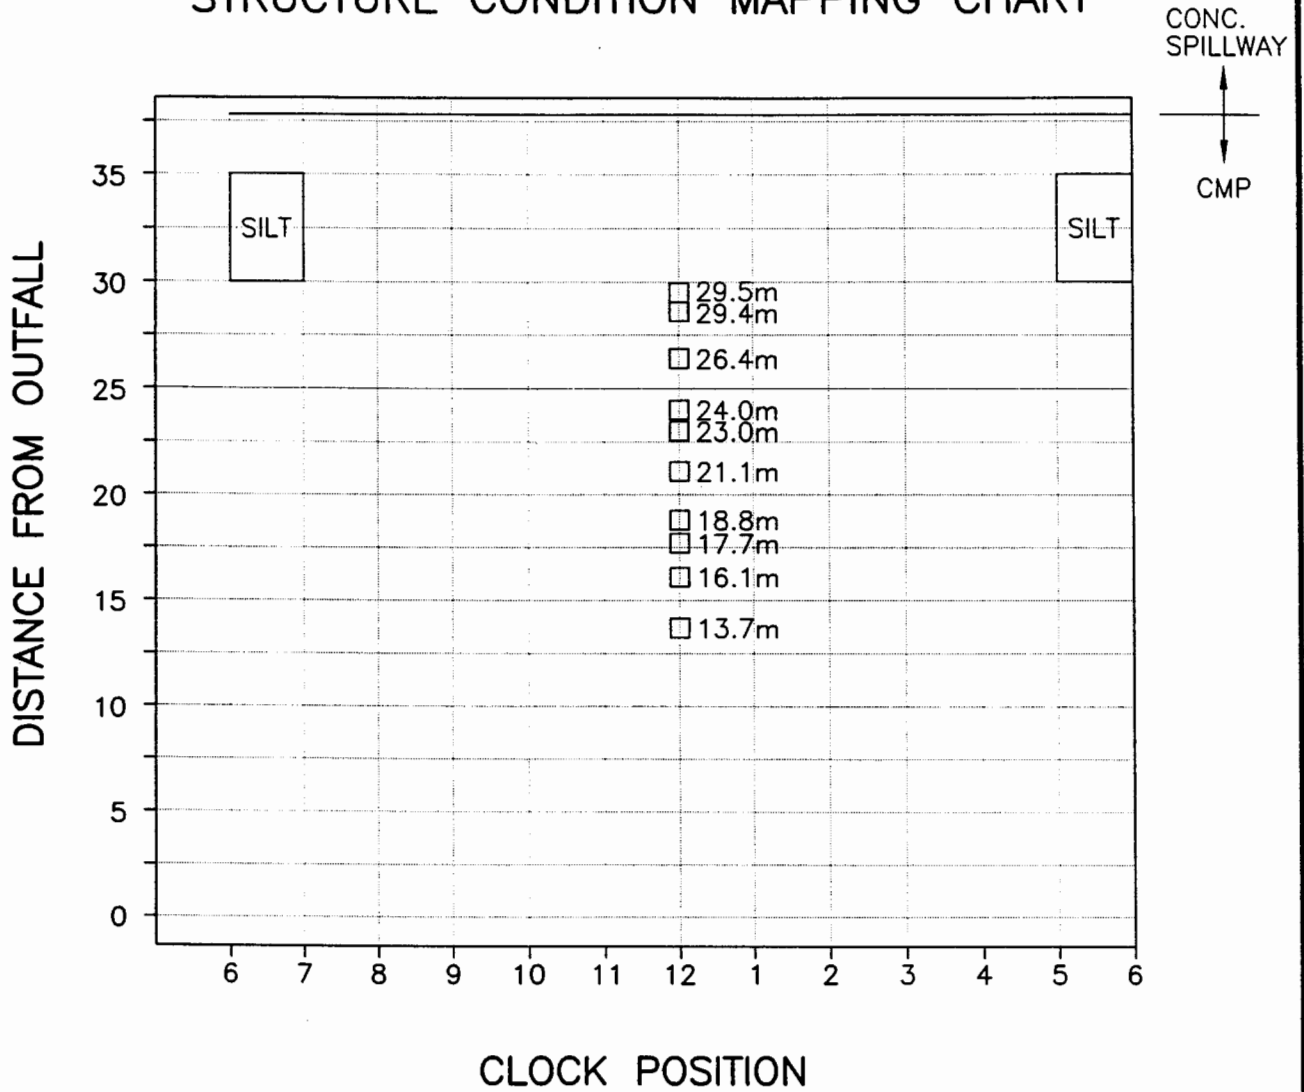
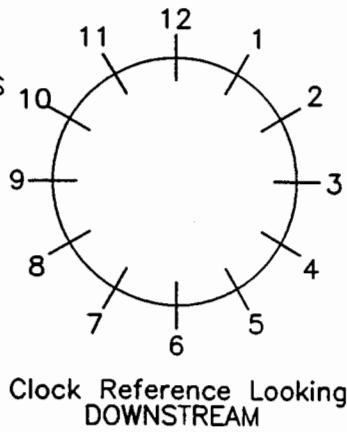
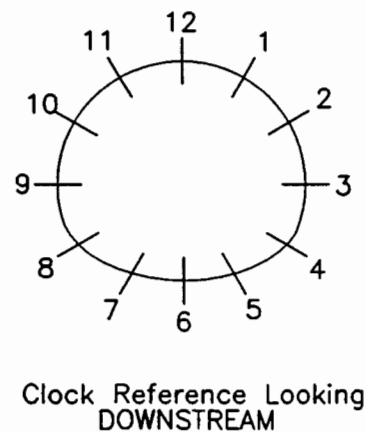
STRUCTURE CONDITION MAPPING CHART

□ 4"x4" WOOD BRACES

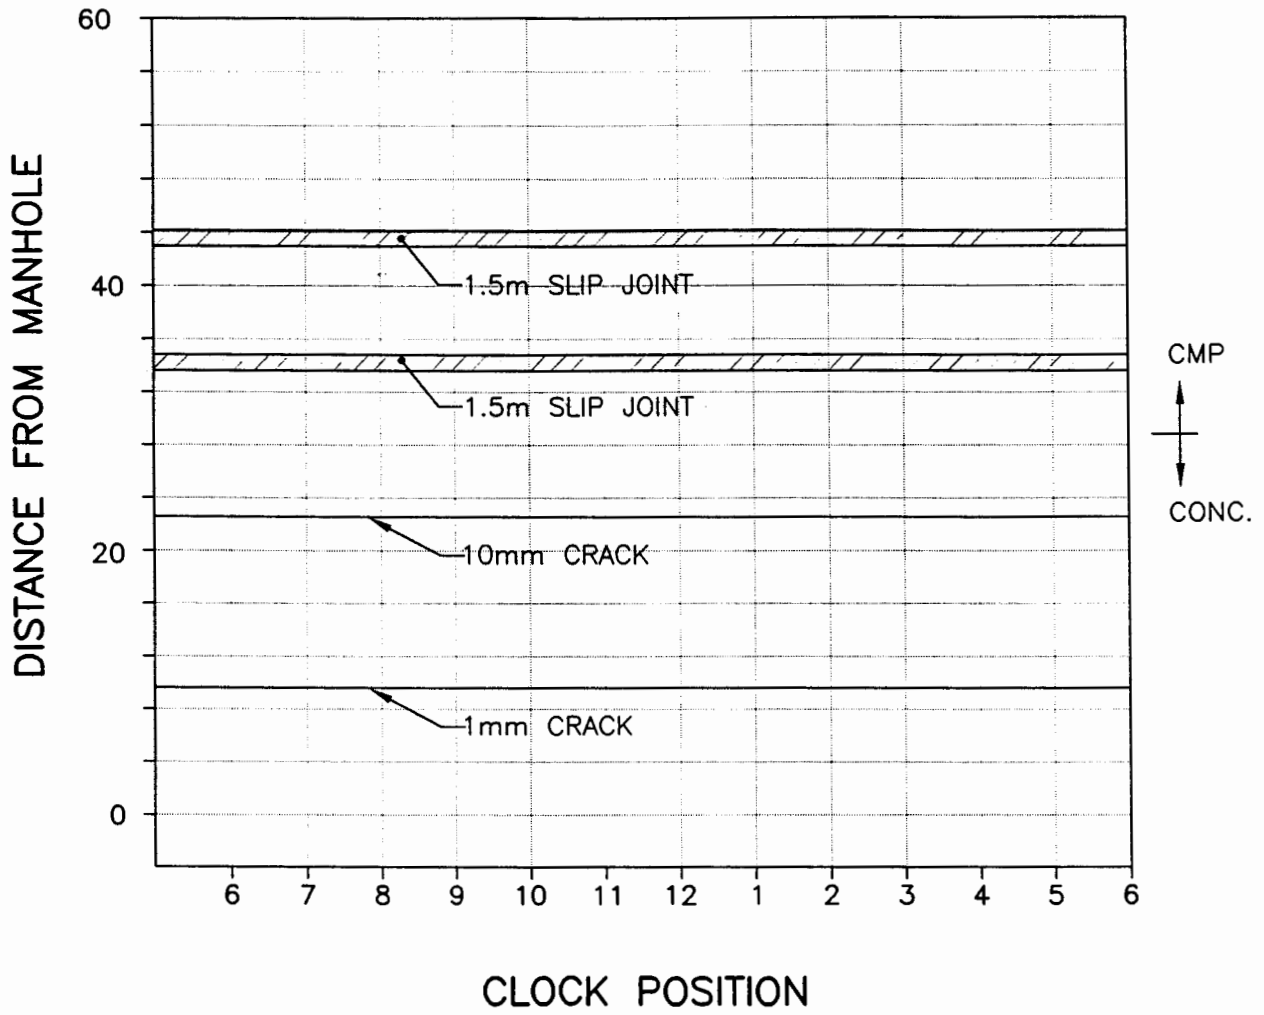
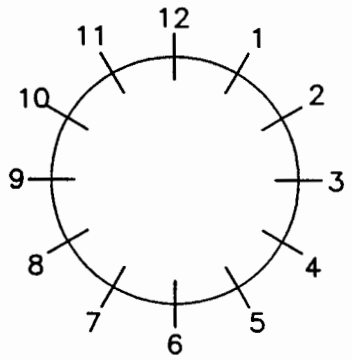
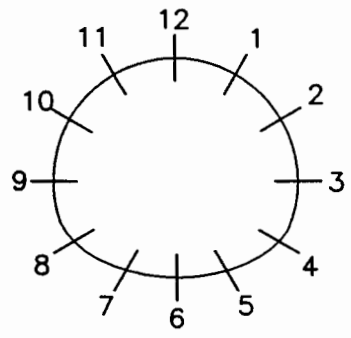
STRUCTURE CONDITION MAPPING CHART

Clock Reference Looking DOWNSTREAM

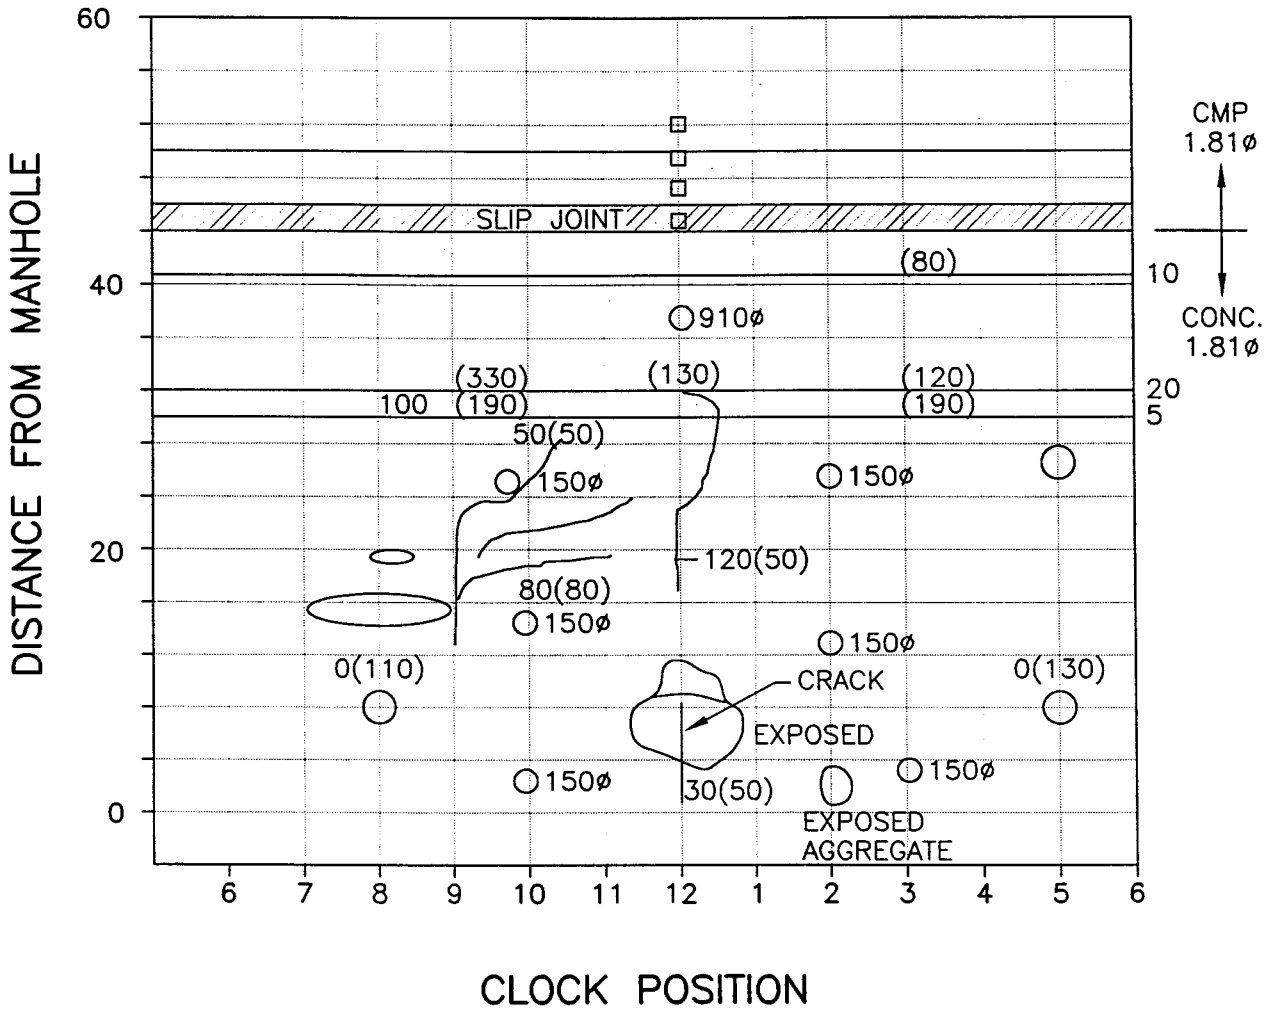
STRUCTURE CONDITION MAPPING CHART

RED RIVER

Clock Reference Looking DOWNSTREAM

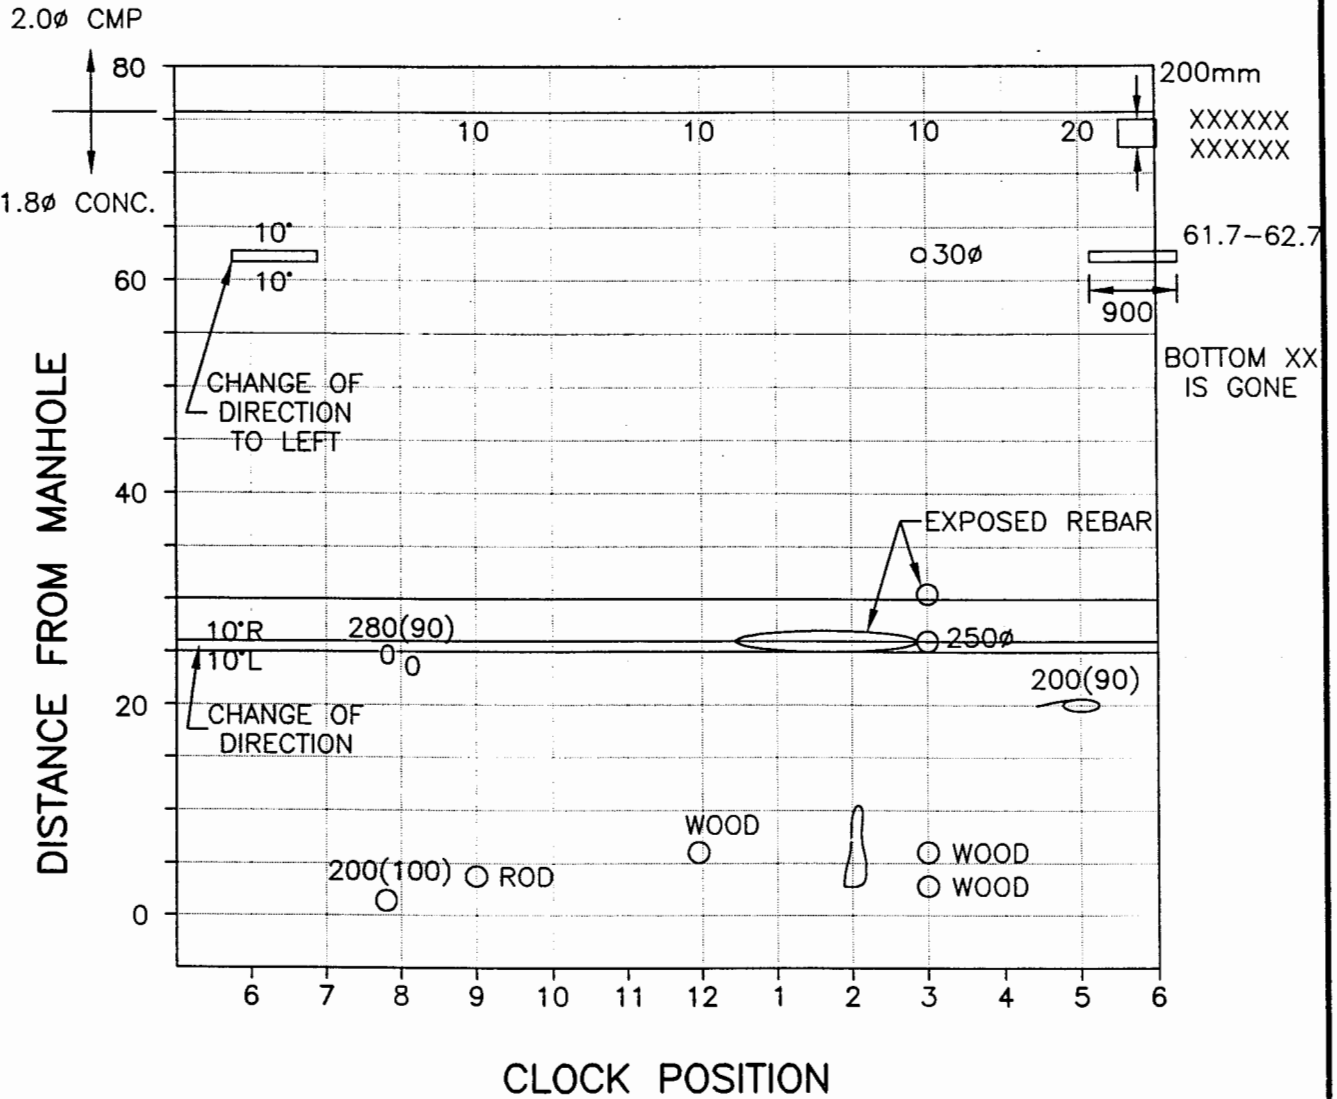
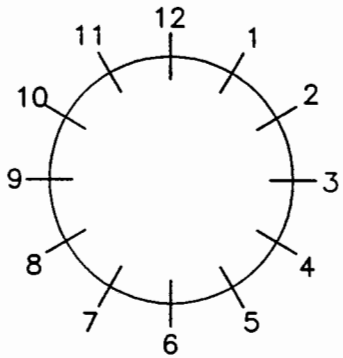
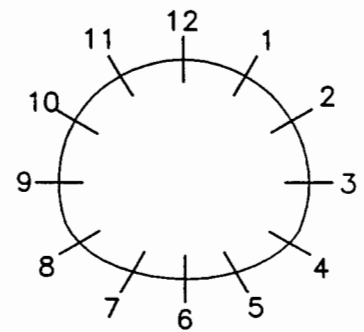
STRUCTURE CONDITION MAPPING CHART

Clock Reference Looking DOWNSTREAM

DEFECTIVE CONCRETE:	Spalling	SP	JOINTS:	Raised	JR
	Honeycomb	HC		Displaced	JD
	Erosion/Wear	EW		Spalled	SP
	Delaminated	DC	PIPE IDENTIFICATION:	R36

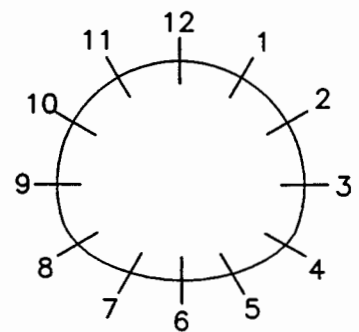
STRUCTURE CONDITION MAPPING CHART

DEFECTIVE CONCRETE: • ANCHOR BOLT	Spalling Honeycomb Erosion/Wear Delaminated	SP HC EW DC	JOINTS: Raised Displaced Spalled R38	JR JD SP
---	--	----------------------	---	----------------

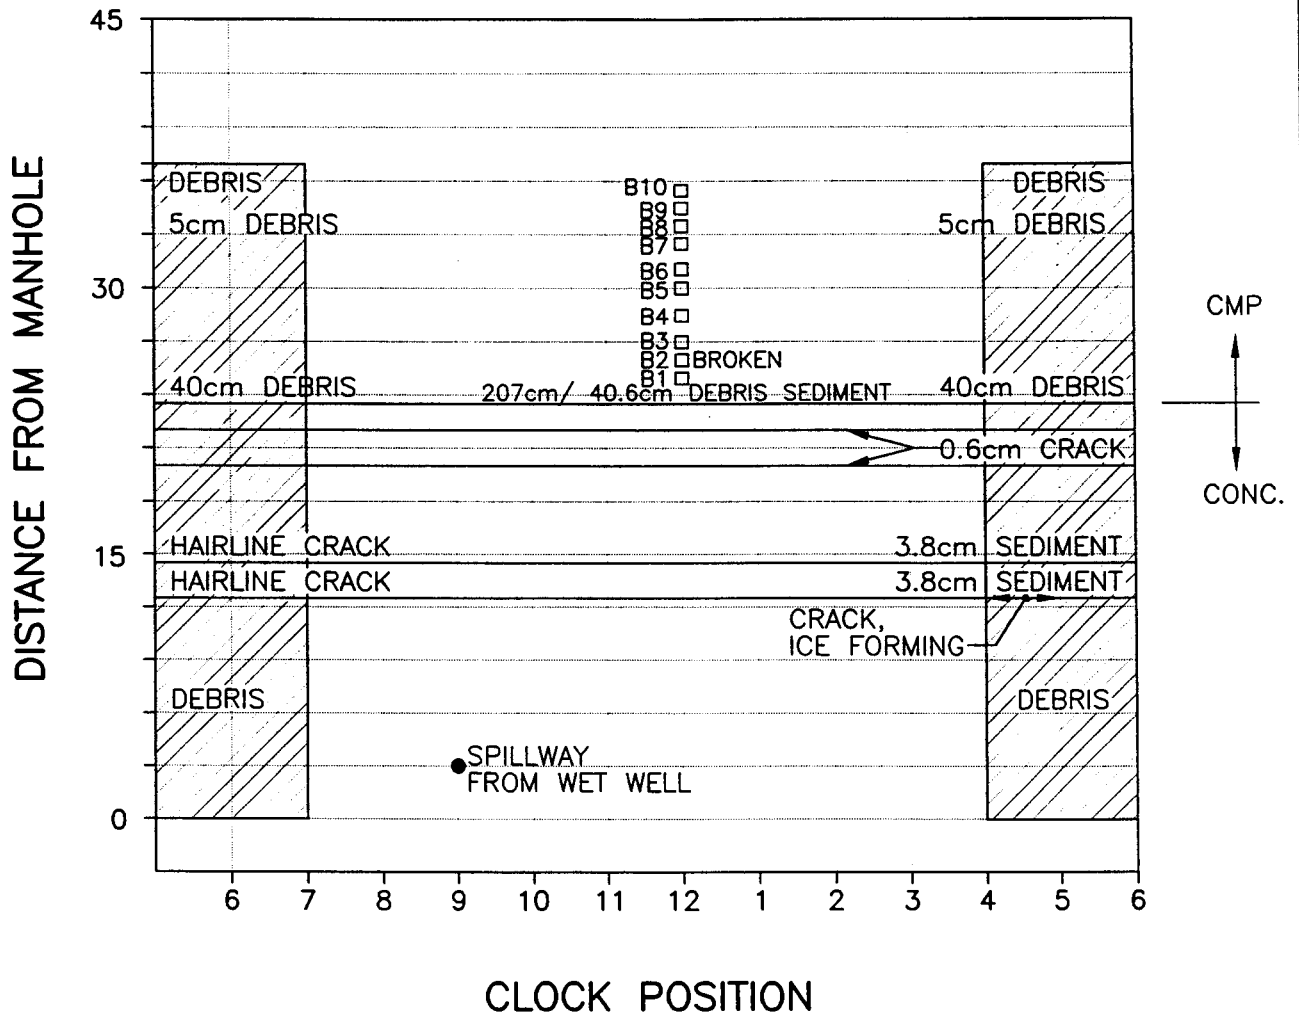
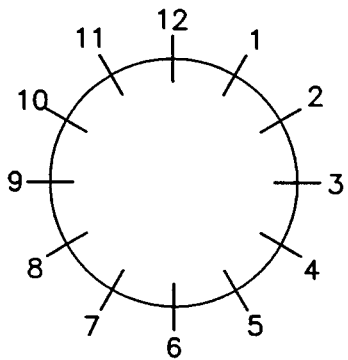
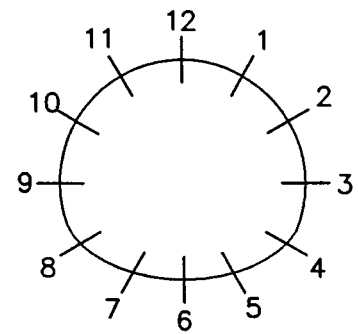
STRUCTURE CONDITION MAPPING CHART

Clock Reference Looking DOWNSTREAM

DEFECTIVE CONCRETE:	Spalling	SP	JOINTS:	Raised	JR
	Honeycomb	HC		Displaced	JD
B10 □ VERTICAL SUPPORT BEAM	Erosion/Wear	EW		Spalled	SP
	Delaminated	DC	PIPE IDENTIFICATION:	R46

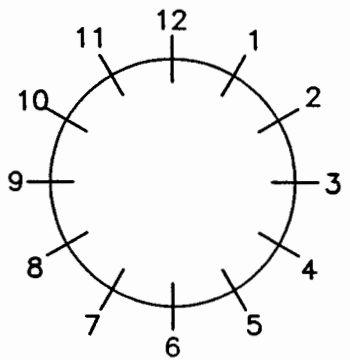
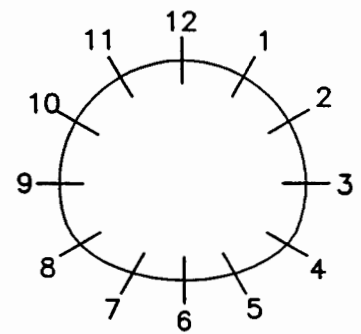
STRUCTURE CONDITION MAPPING CHART

Clock Reference Looking DOWNSTREAM

DEFECTIVE CONCRETE: Spalling Honeycomb Erosion/Wear Delaminated	SP HC EW DC	JOINTS: Raised Displaced Spalled R52	JR JD SP
--	----------------------	---	----------------

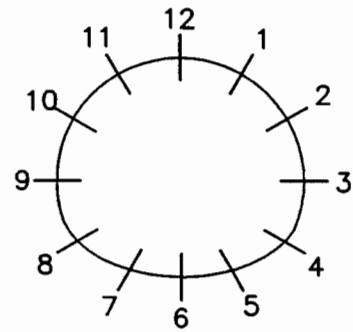
STRUCTURE CONDITION MAPPING CHART

Clock Reference Looking DOWNSTREAM

DEFECTIVE CONCRETE: Spalling Honeycomb Erosion/Wear Delaminated	SP HC EW DC	JOINTS: Raised Displaced Spalled R54 PIPE IDENTIFICATION:	JR JD SP
--	----------------------	--	----------------

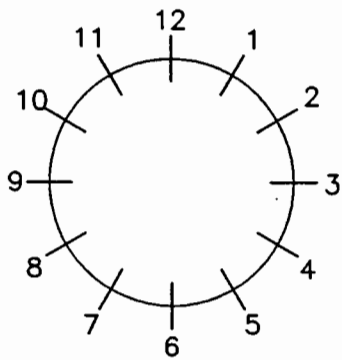
STRUCTURE CONDITION MAPPING CHART

Clock Reference Looking DOWNSTREAM

DEFECTIVE CONCRETE:	Spalling	SP	JOINTS:	Raised	JR
	Honeycomb	HC		Displaced	JD
	Erosion/Wear	EW		Spalled	SP
	Delaminated	DC		R58	
			PIPE IDENTIFICATION:

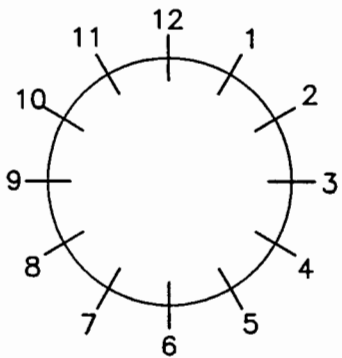
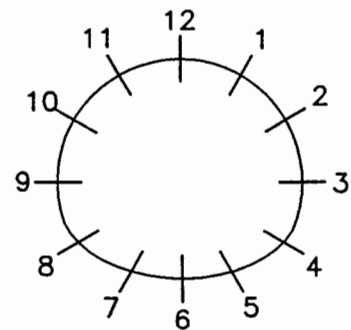
STRUCTURE CONDITION MAPPING CHART

Clock Reference Looking
DOWNSTREAM

DEFECTIVE CONCRETE: Spalling Honeycomb Erosion/Wear Delaminated	SP HC EW DC	JOINTS: Raised Displaced Spalled R70.2	JR JD SP
--	----------------------	---	----------------

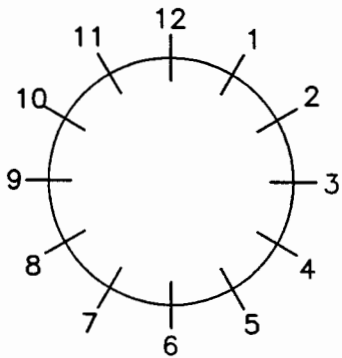
STRUCTURE CONDITION MAPPING CHART

Clock Reference Looking DOWNSTREAM

DEFECTIVE CONCRETE: Spalling Honeycomb Erosion/Wear Delaminated	SP HC EW DC	JOINTS: Raised Displaced Spalled R71	JR JD SP
--	----------------------	---	----------------

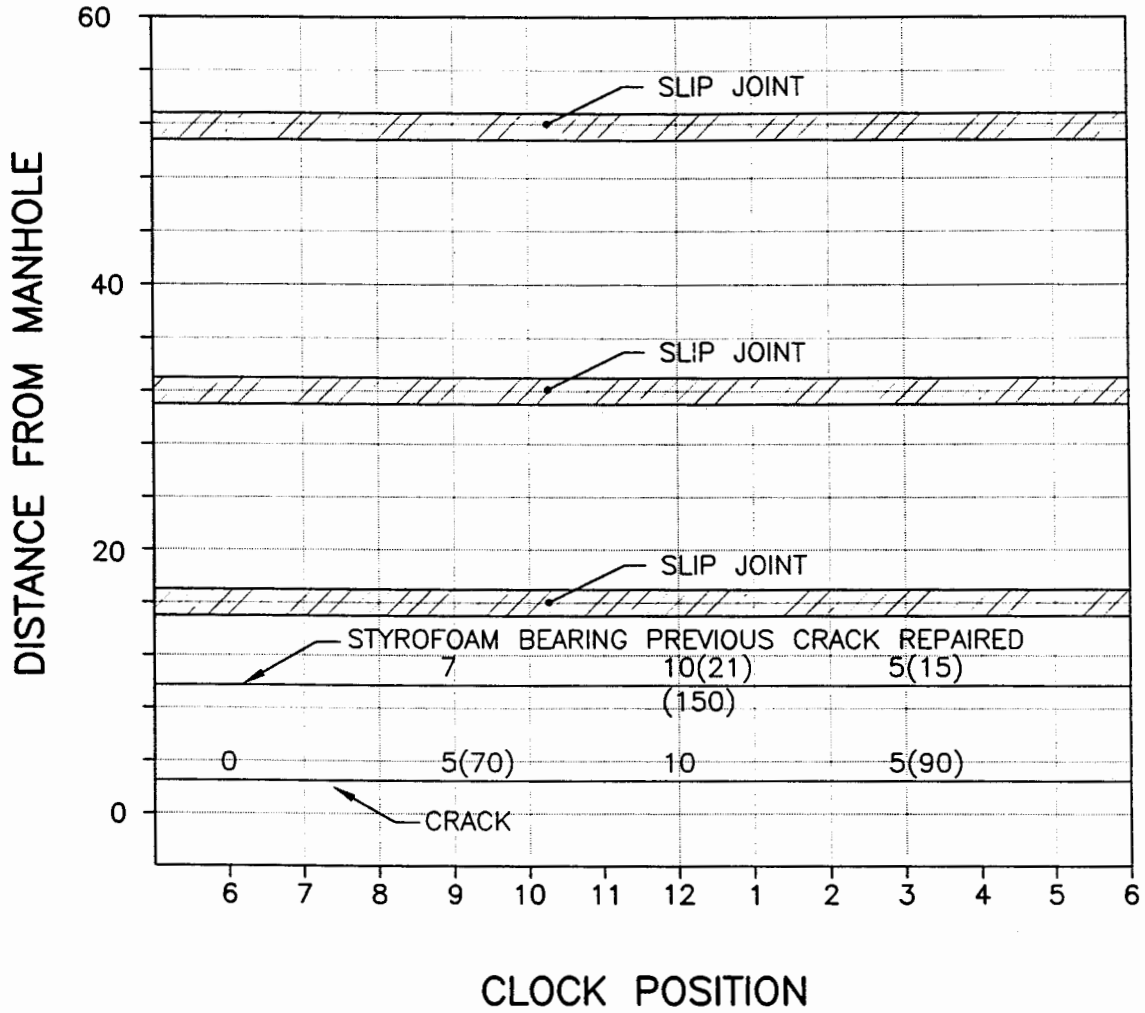
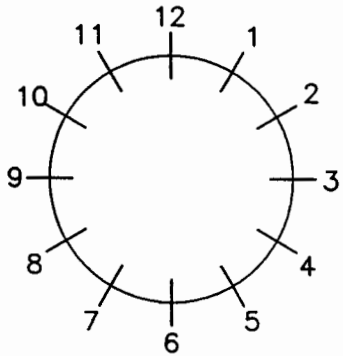
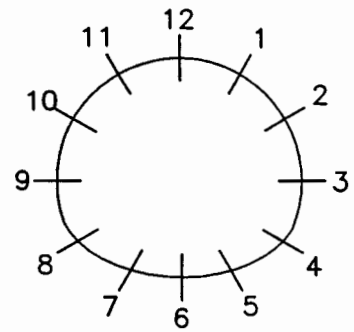
STRUCTURE CONDITION MAPPING CHART

Clock Reference Looking DOWNSTREAM

DEFECTIVE CONCRETE:	Spalling	SP	JOINTS:	Raised	JR
	Honeycomb	HC		Displaced	JD
	Erosion/Wear	EW		Spalled	SP
	Delaminated	DC		PIPE IDENTIFICATION:	R74

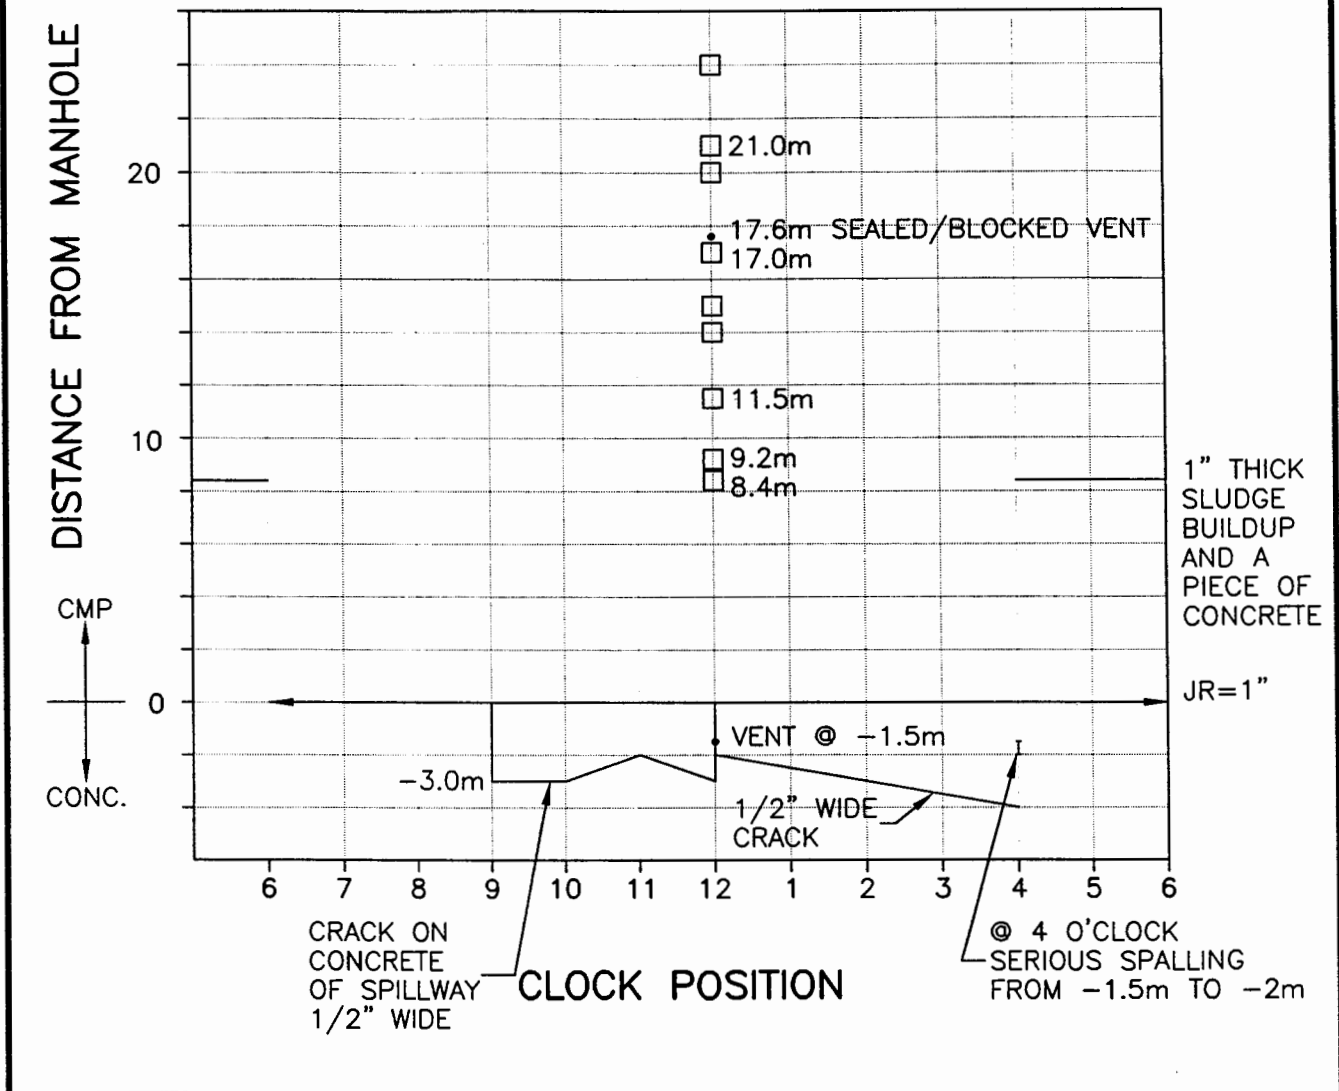
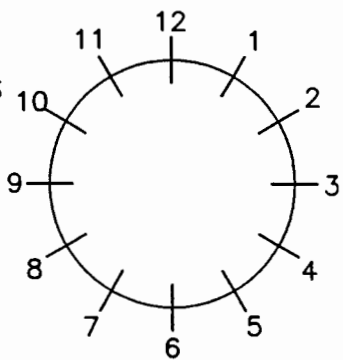
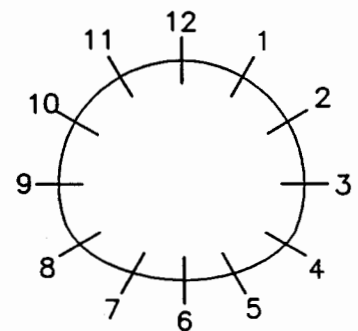
STRUCTURE CONDITION MAPPING CHART

□ 4"x4" WOOD BRACES

DEFECTIVE CONCRETE:	Spalling Honeycomb Erosion/Wear Delaminated	SP HC EW DC	JOINTS:	Raised Displaced Spalled R79	JR JD SP
			PIPE IDENTIFICATION:
