# **GEOTECHNICAL REPORT**

## **19-C-10 Erin Street Pavement Renewal**

**RE: Sub-Surface Investigation Report for  
19-C-10 Erin Pavement Renewal**

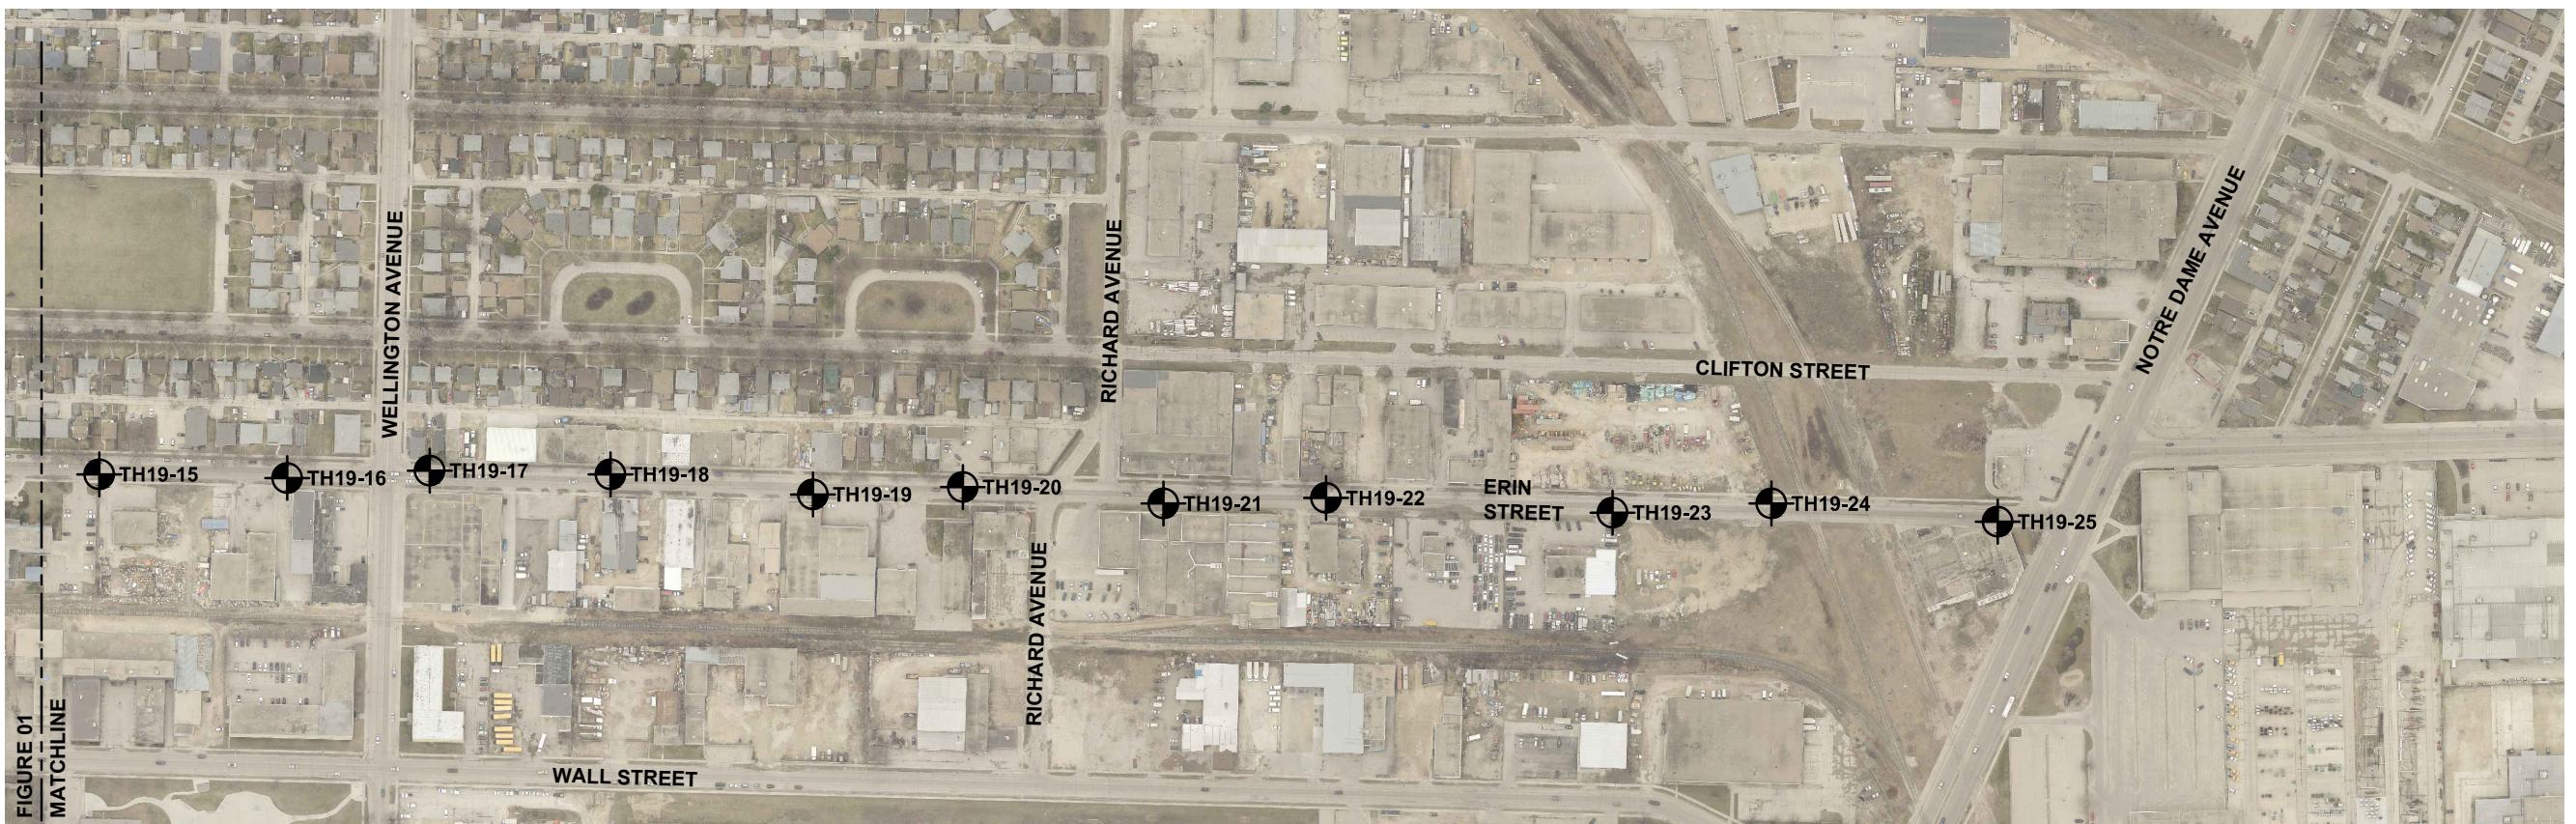
**FIGURE 01**

FIGURE 01  
MATCHLINE

Figure 01 Test Hole Location Plan – Erin Street

The investigation included coring of pavement followed by drilling of test holes at 25 locations. TREK Geotechnical and Morrison Hershfield selected the investigation locations as shown on Figure 01 and Figure 02 (attached). The road investigation was conducted between September 26, 2019 and October 2, 2019. The pavement structure (asphalt and/or concrete) was cored by Harsimran Singh of TREK Geotechnical Inc. (TREK) using a portable coring press equipped with a hollow 150 mm diameter diamond core drill bit. Twenty-five test holes were drilled to a depth of 3.0 m below road surface by Maple Leaf Drilling Ltd. using a truck mounted drill rig equipped with 125 mm diameter solid stem augers. The sub-surface conditions were observed during drilling and visually classified by Bryan Hiebert of TREK. Other pertinent information such as groundwater and drilling conditions were also recorded during the drilling investigation. Disturbed (auger cuttings) samples and bulk samples retrieved during the sub-surface investigation were transported to TREK's material testing laboratory for further testing. Core samples were also retrieved and logged at TREK's material testing laboratory.

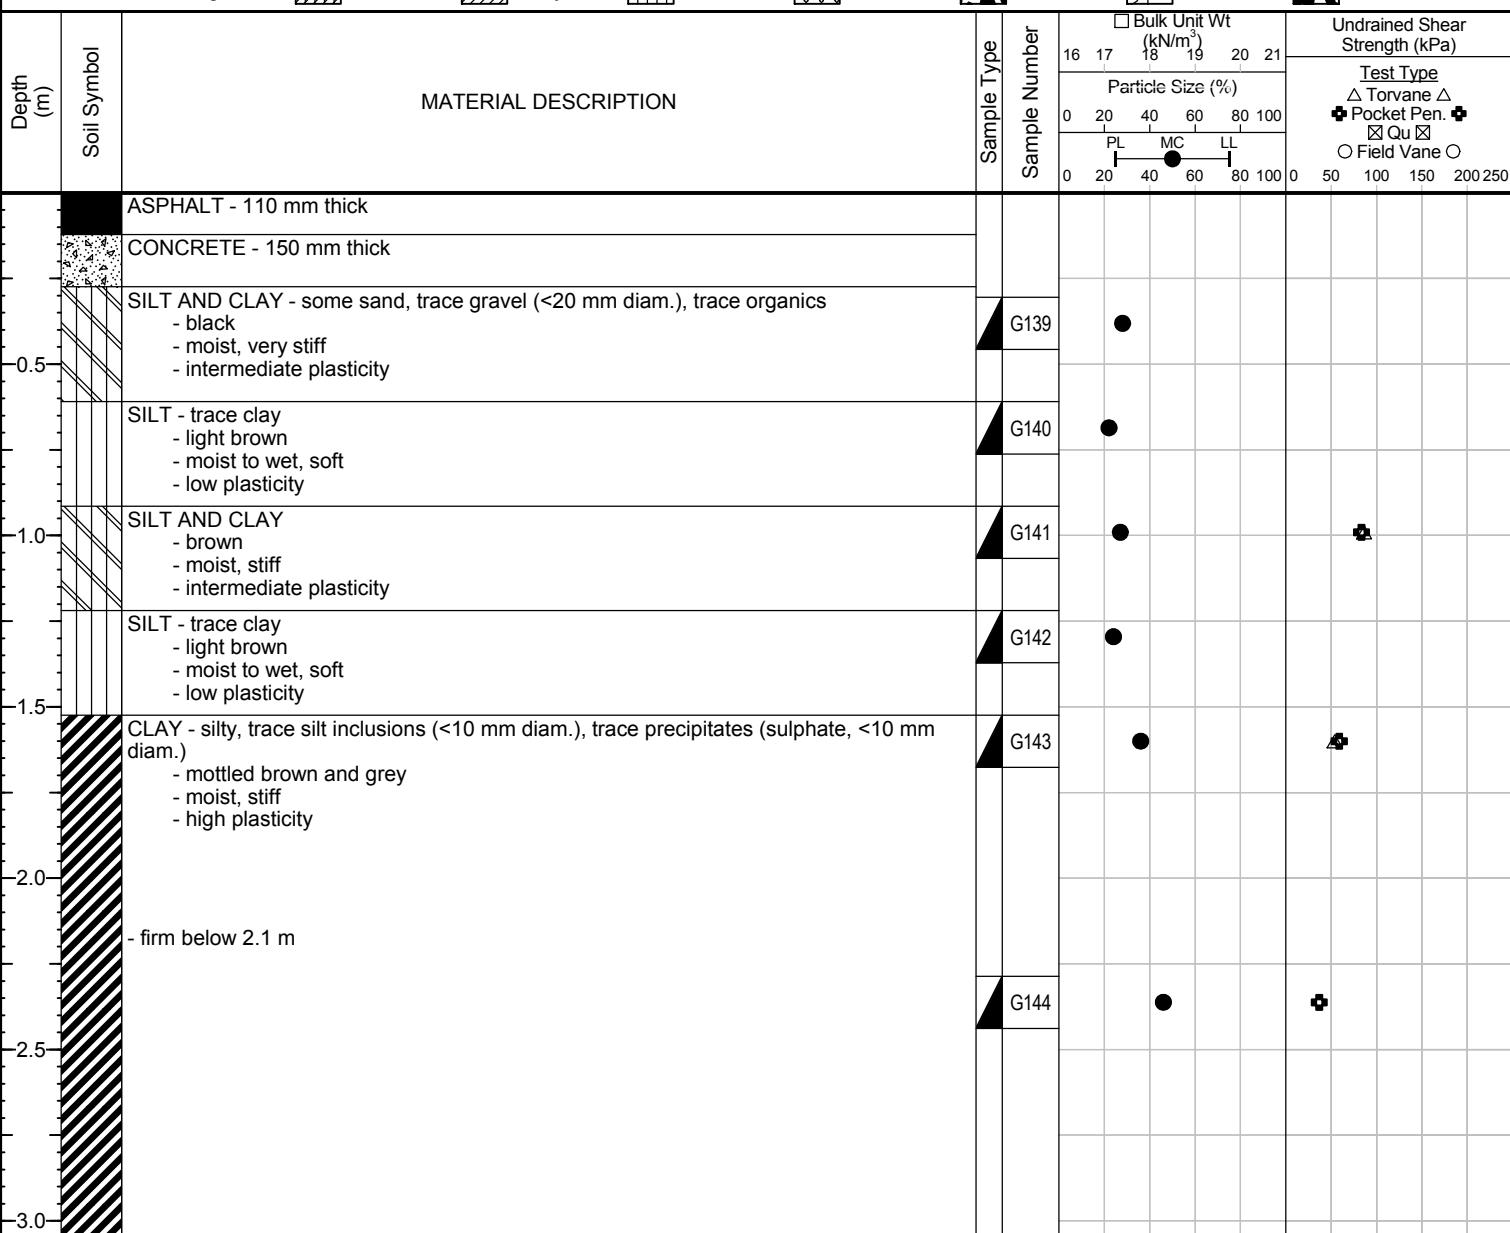
END OF TEST HOLE AT 3.0 m IN CLAY

- 1) No seepage observed. Sloughing in silt layer observed from 1.2 to 1.5 m.
- 2) Test hole open to 1.4 m immediately after drilling.
- 3) Test hole backfilled with auger cuttings, granular fill and cold patch asphalt.
- 4) Test hole located in East curb lane, 45 m North and 4.2 m West of fire hydrant at Erin Street and Wolver Ave intersection.

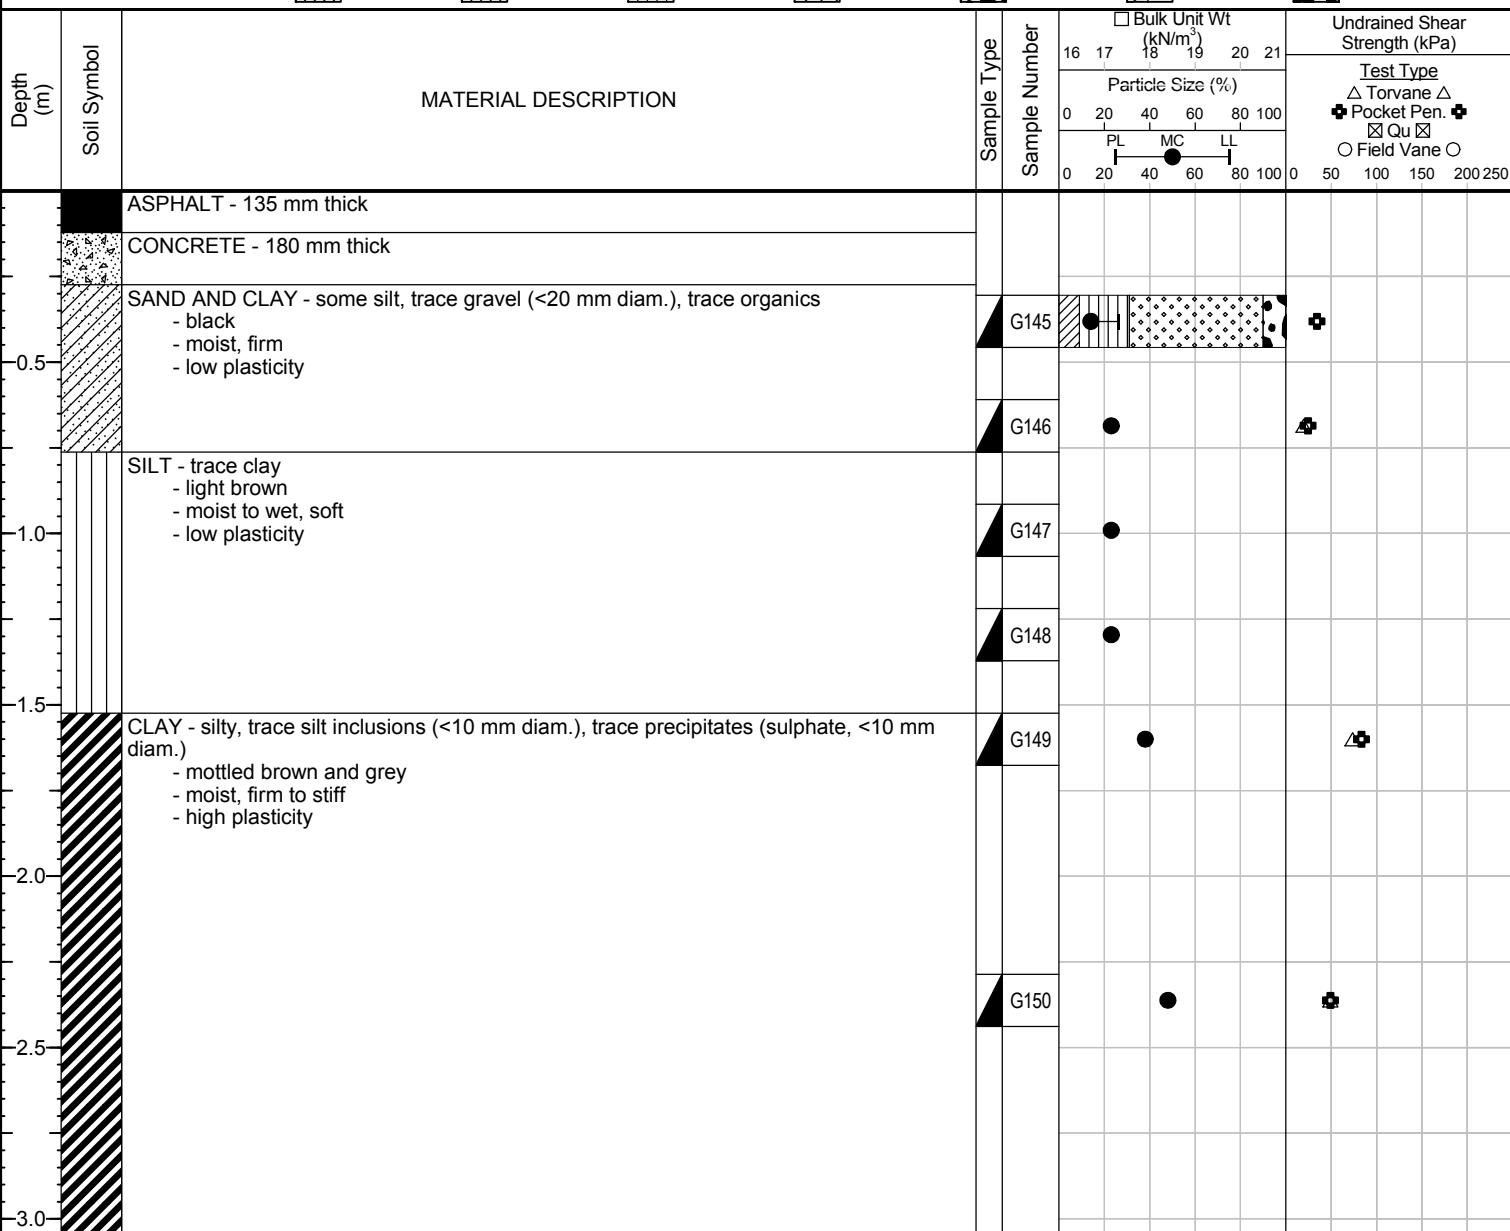
- 1) No seepage observed. Sloughing in silt layer observed from 0.7 to 1.5 m.  
2) Test hole open to 1.5 m immediately after drilling.  
3) Test hole backfilled with auger cuttings, granular fill and cold patch asphalt.  
4) Test hole located in Median lane, 49.5 m North and 8 m West of fire hydrant at 777 Erin Street.

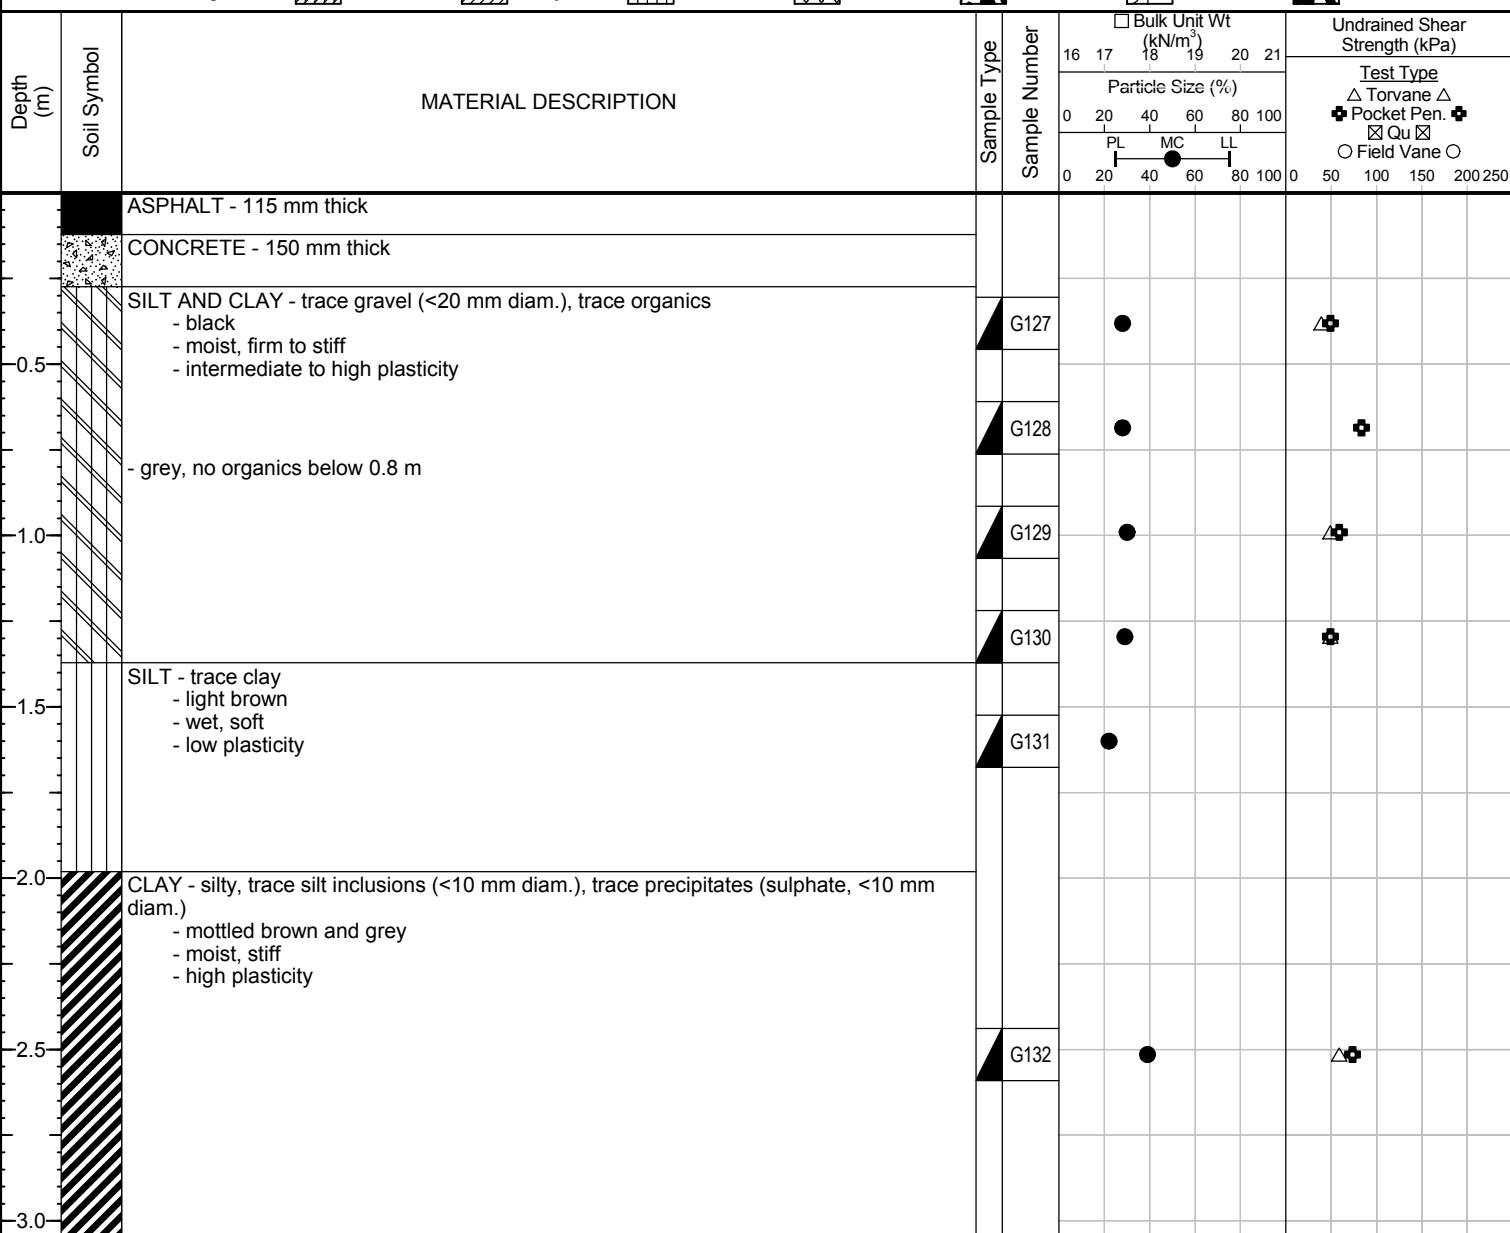
- 1) No seepage observed. Sloughing in silt layer observed from 1.3 to 1.9 m.  
2) Test hole open to 1.2 m immediately after drilling.  
3) Test hole backfilled with auger cuttings, granular fill and cold patch asphalt.  
4) Test hole located between Median and West curb lane, 22 m South and 9 m West of fire hydrant at 803 Erin Street.

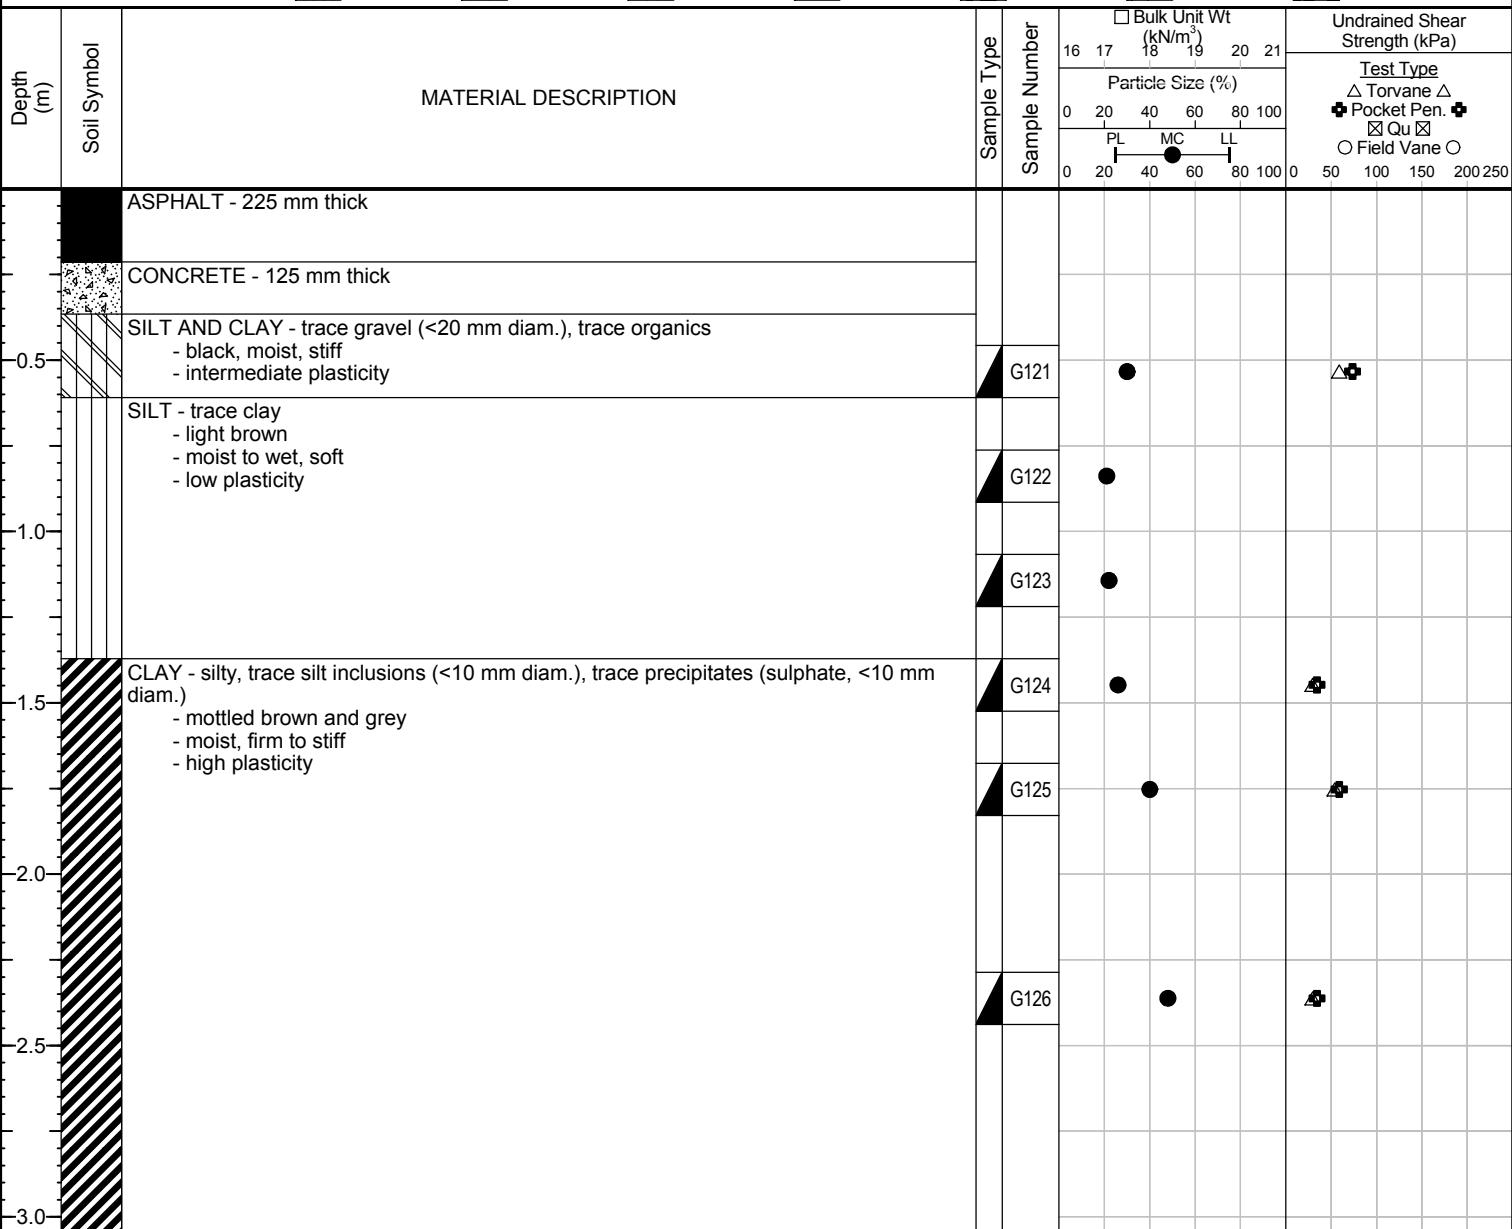
- 1) No seepage observed. Sloughing in silt layer observed from 0.6 to 1.3 m.  
2) Test hole open to 1.5 m immediately after drilling.  
3) Test hole backfilled with auger cuttings, granular fill and cold patch asphalt.  
4) Test hole located in East curb lane, 10 m South and 3 m West of fire hydrant at Erin Street and St. Matthews Ave intersection.

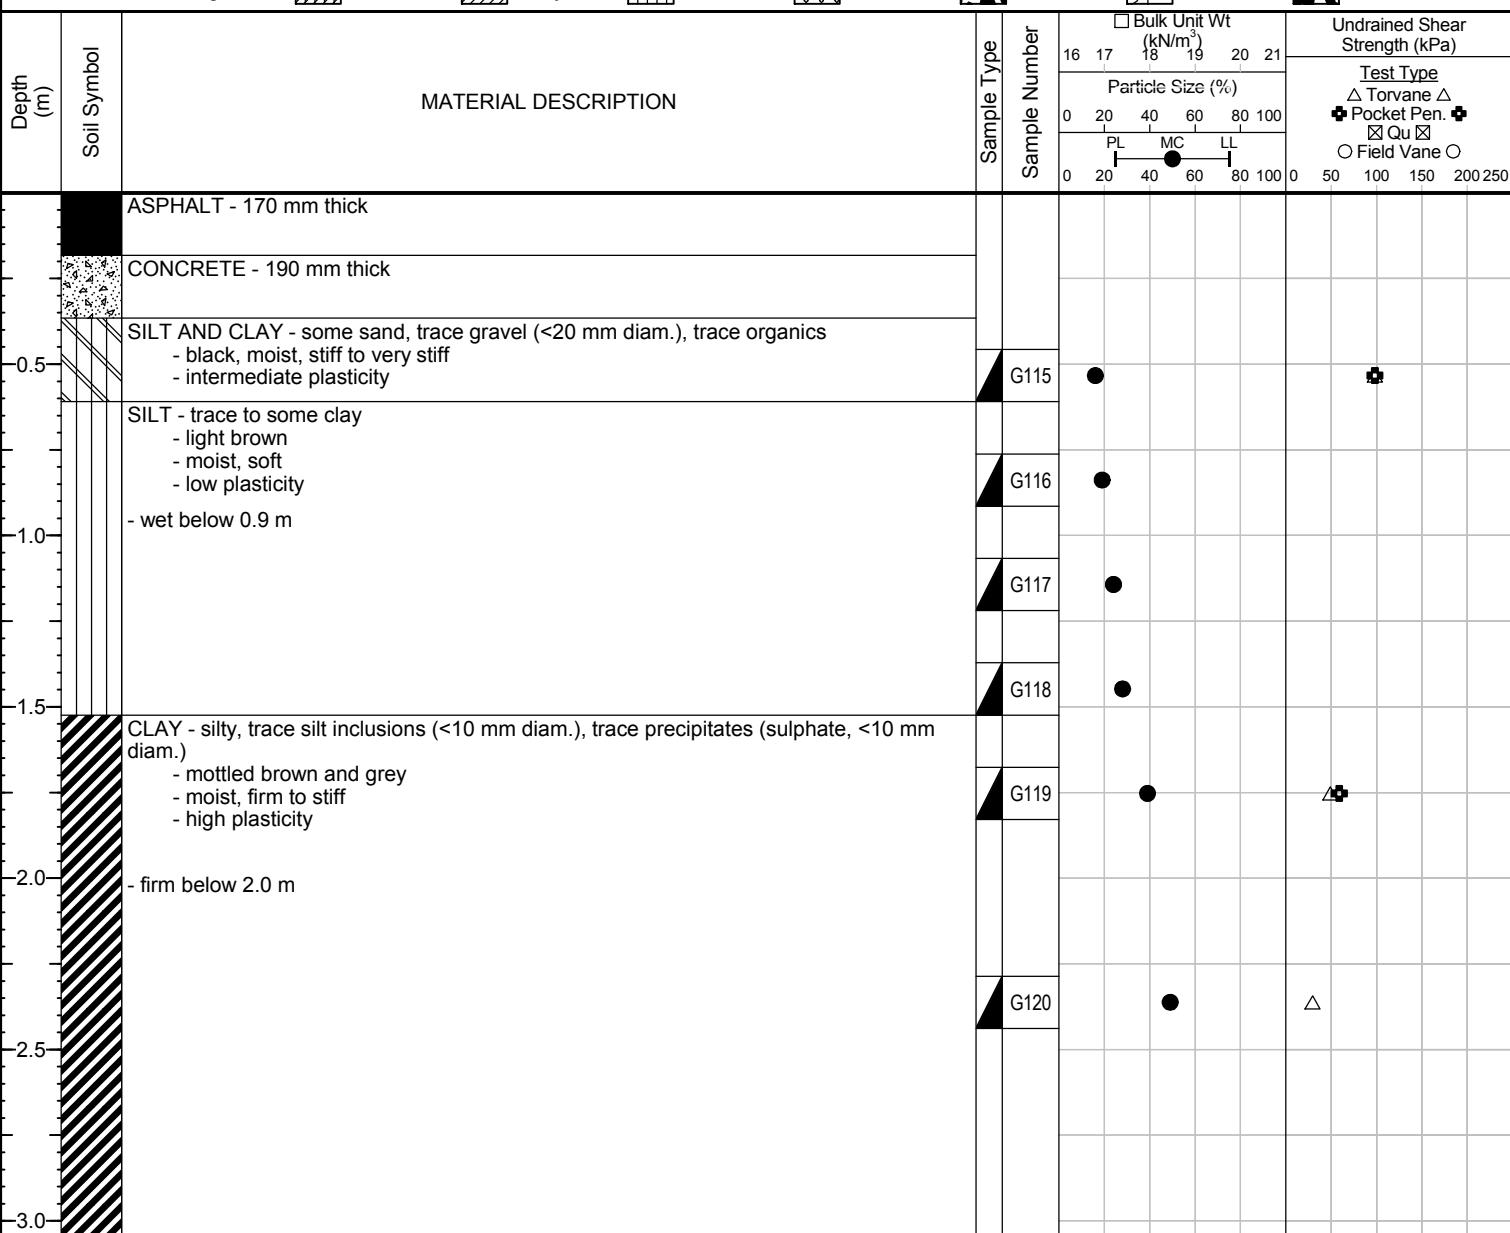
- 1) No seepage observed. Sloughing in silt layer observed from 0.6 to 1.5 m.  
2) Test hole open to 1.5 m immediately after drilling.  
3) Test hole backfilled with auger cuttings, granular fill and cold patch asphalt.  
4) Test hole located in East curb lane, 11 m South and 3.1 m West of fire hydrant at 889 Erin Street.

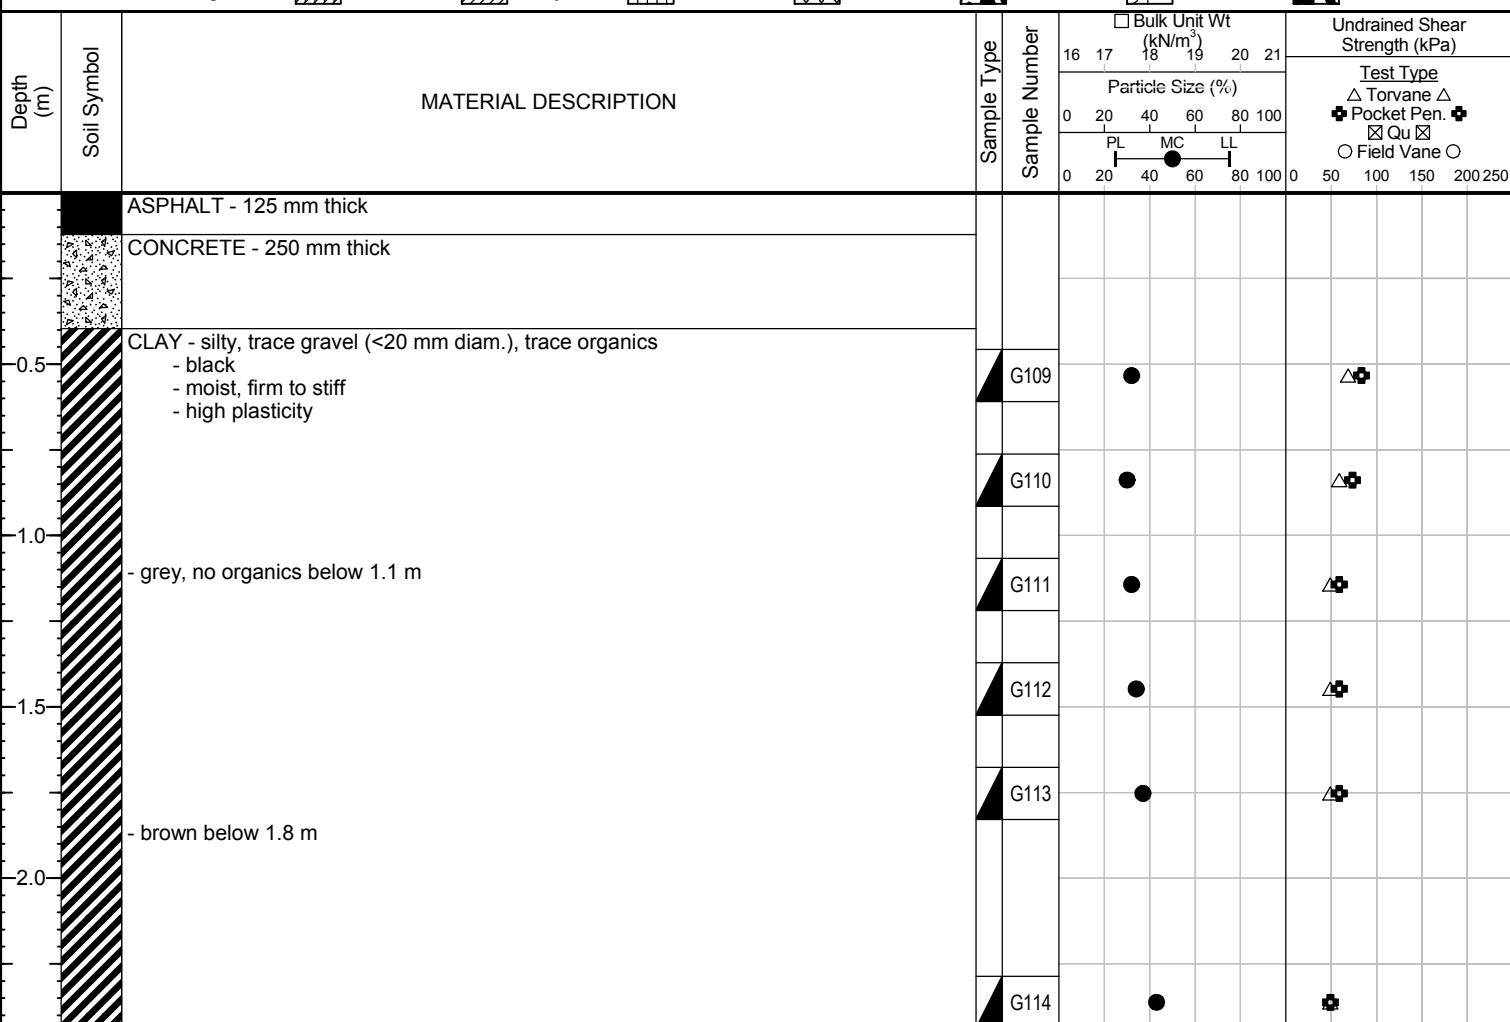
END OF TEST HOLE AT 2.4 m IN CLAY

- 1) No seepage or sloughing observed.
- 2) Test hole open to 2.4 m immediately after drilling.
- 3) Test hole backfilled with auger cuttings, granular fill and cold patch asphalt.
- 4) Test hole located in West curb lane, 15 m North and 9 m West of fire hydrant at 889 Erin Street.

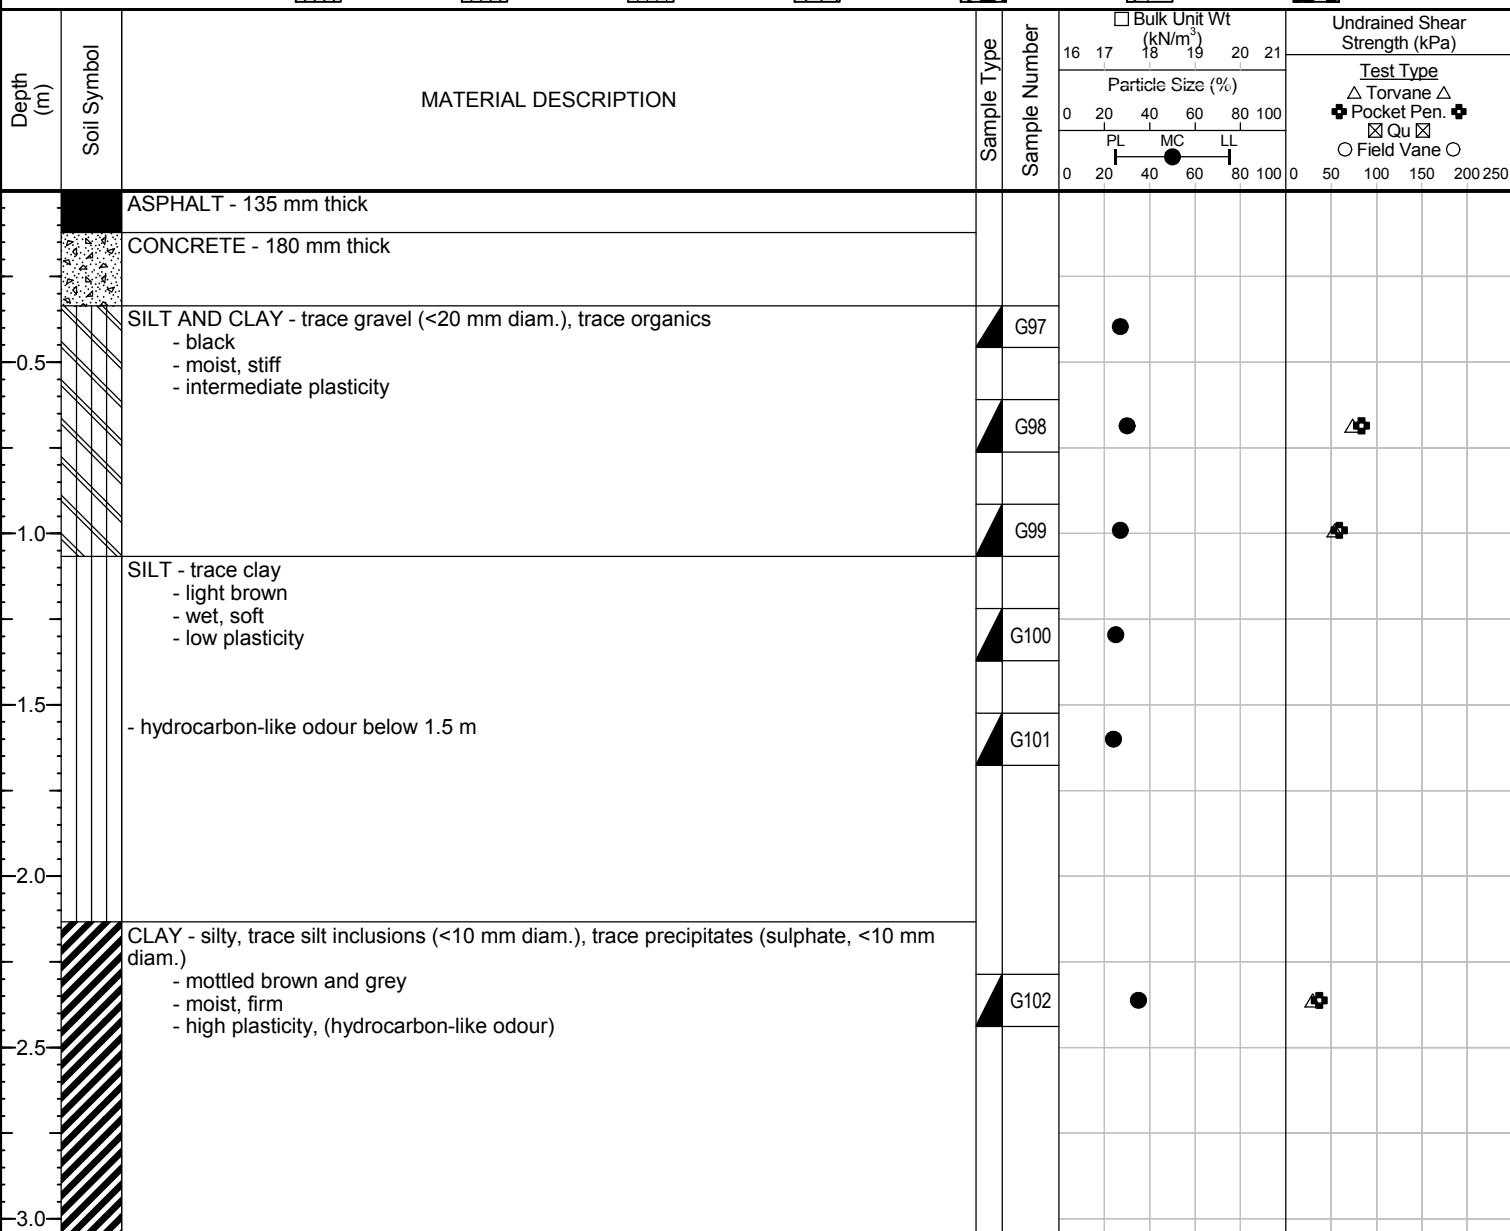
- 1) No seepage observed. Sloughing in silt layer observed from 1.1 to 2.1 m.
- 2) Test hole open to 1.5 m immediately after drilling.
- 3) Test hole backfilled with auger cuttings, granular fill and cold patch asphalt.
- 4) Test hole located in West curb lane, 39 m South and 9.2 m West of fire hydrant at 996 Erin Street.

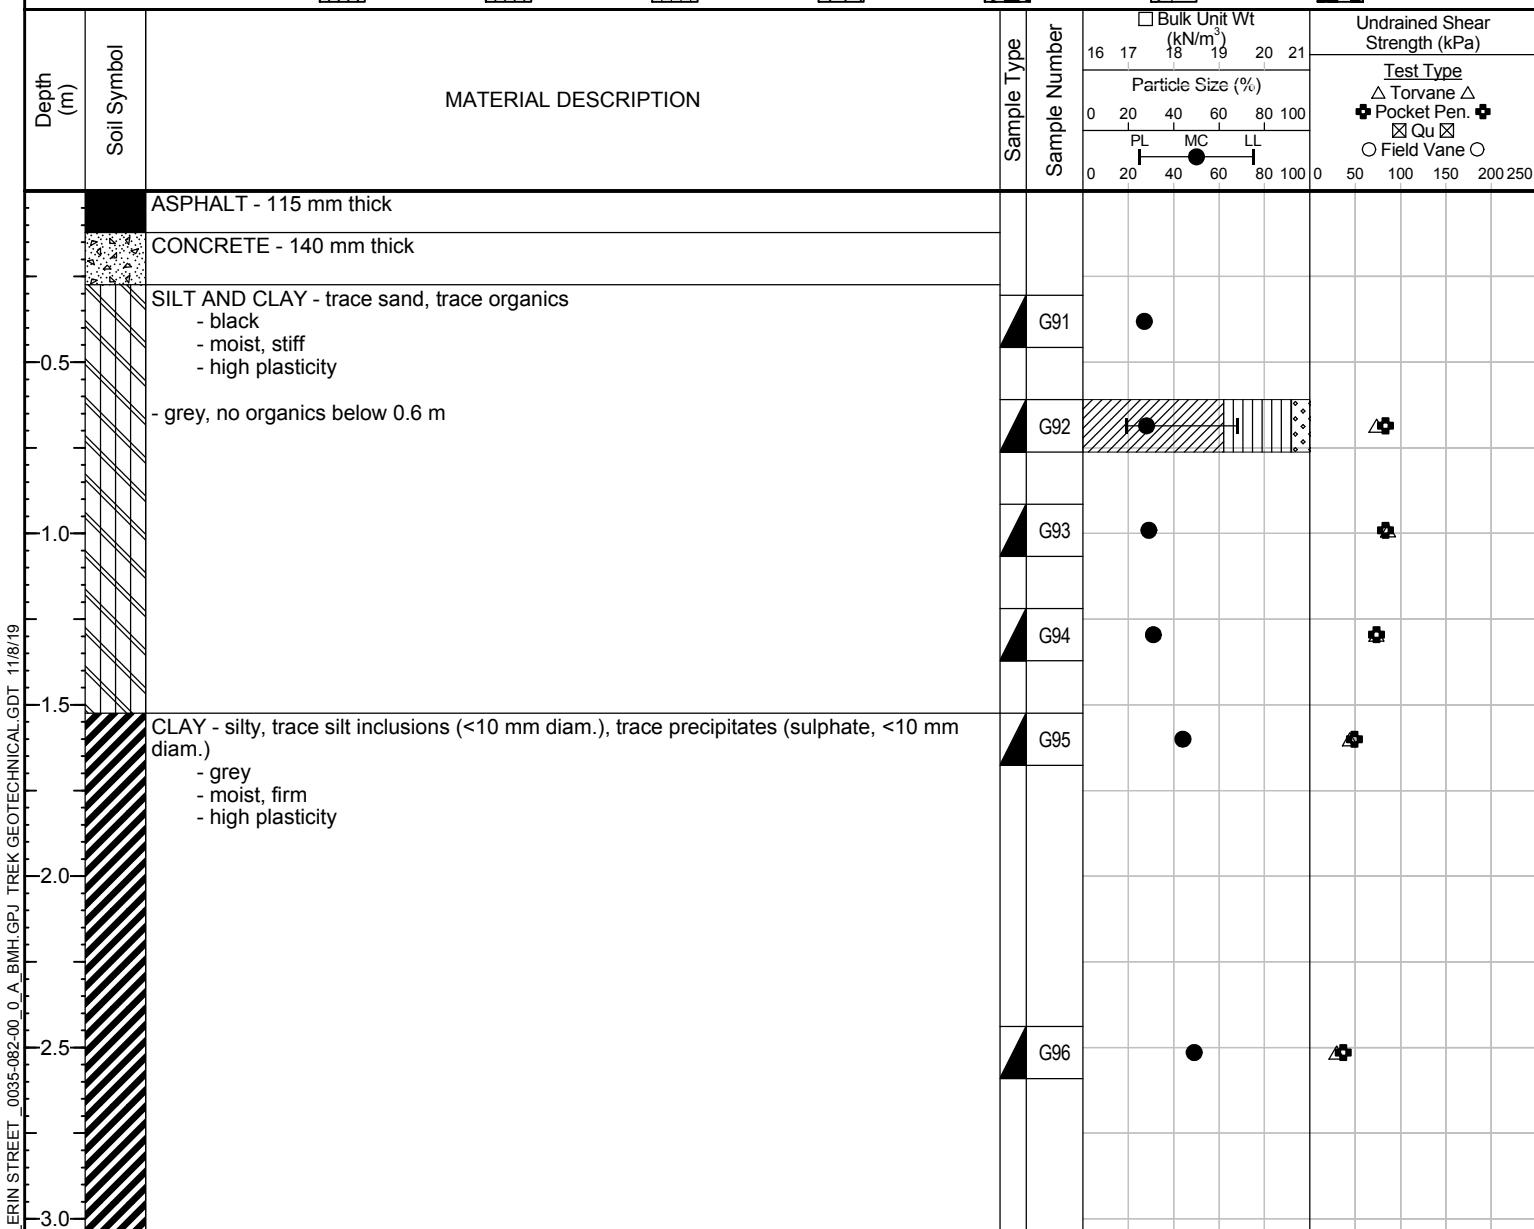
END OF TEST HOLE AT 3.0 m IN CLAY

- 1) No seepage or sloughing observed.
- 2) Test hole open to 3.0 m immediately after drilling.
- 3) Test hole backfilled with auger cuttings, granular fill and cold patch asphalt.
- 4) Bulk sample taken from 0.3 to 1.5 m for CBR testing.
- 5) Test hole located in West curb lane, 11 m South and 9 m West of fire hydrant at 1020 Erin Street.

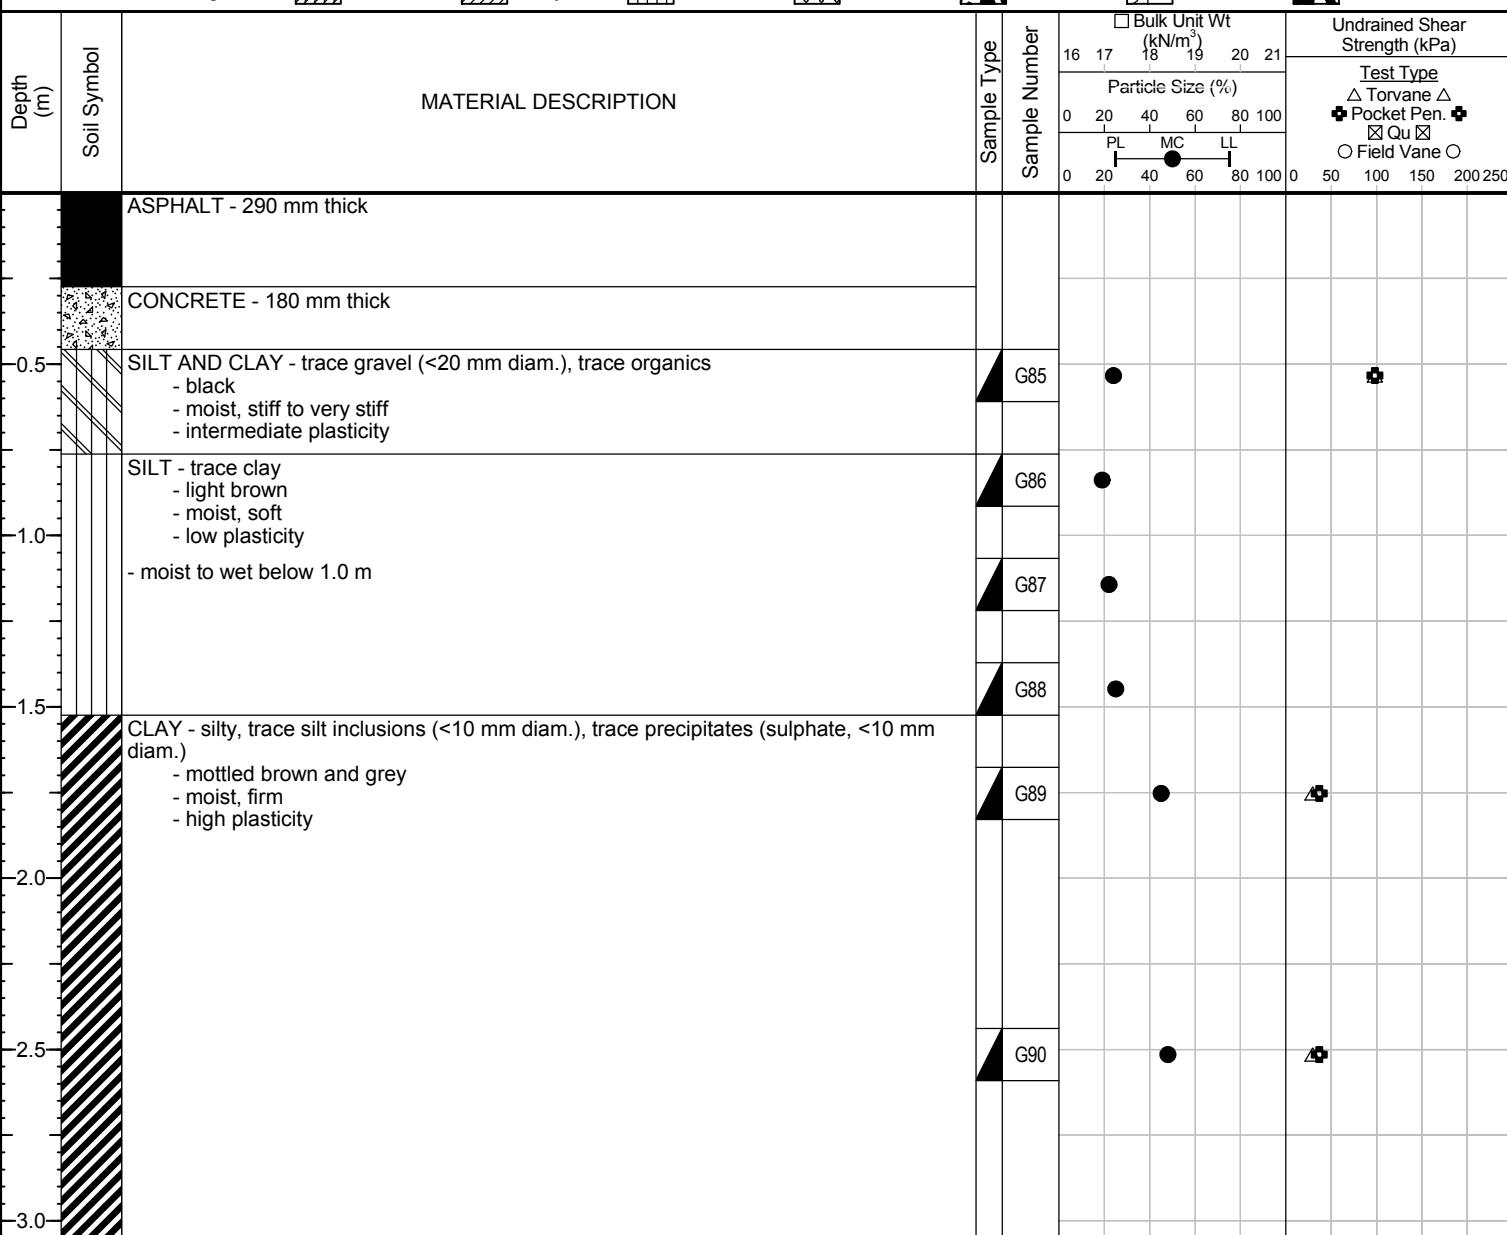
- 1) No seepage observed. Sloughing in silt layer observed from 0.7 to 1.5 m.
- 2) Test hole open to 1.4 m immediately after drilling.
- 3) Test hole backfilled with auger cuttings, granular fill and cold patch asphalt.
- 4) Test hole located in East curb lane, 25.5 m South and 2.8 m West of fire hydrant at 1052 Erin Street.

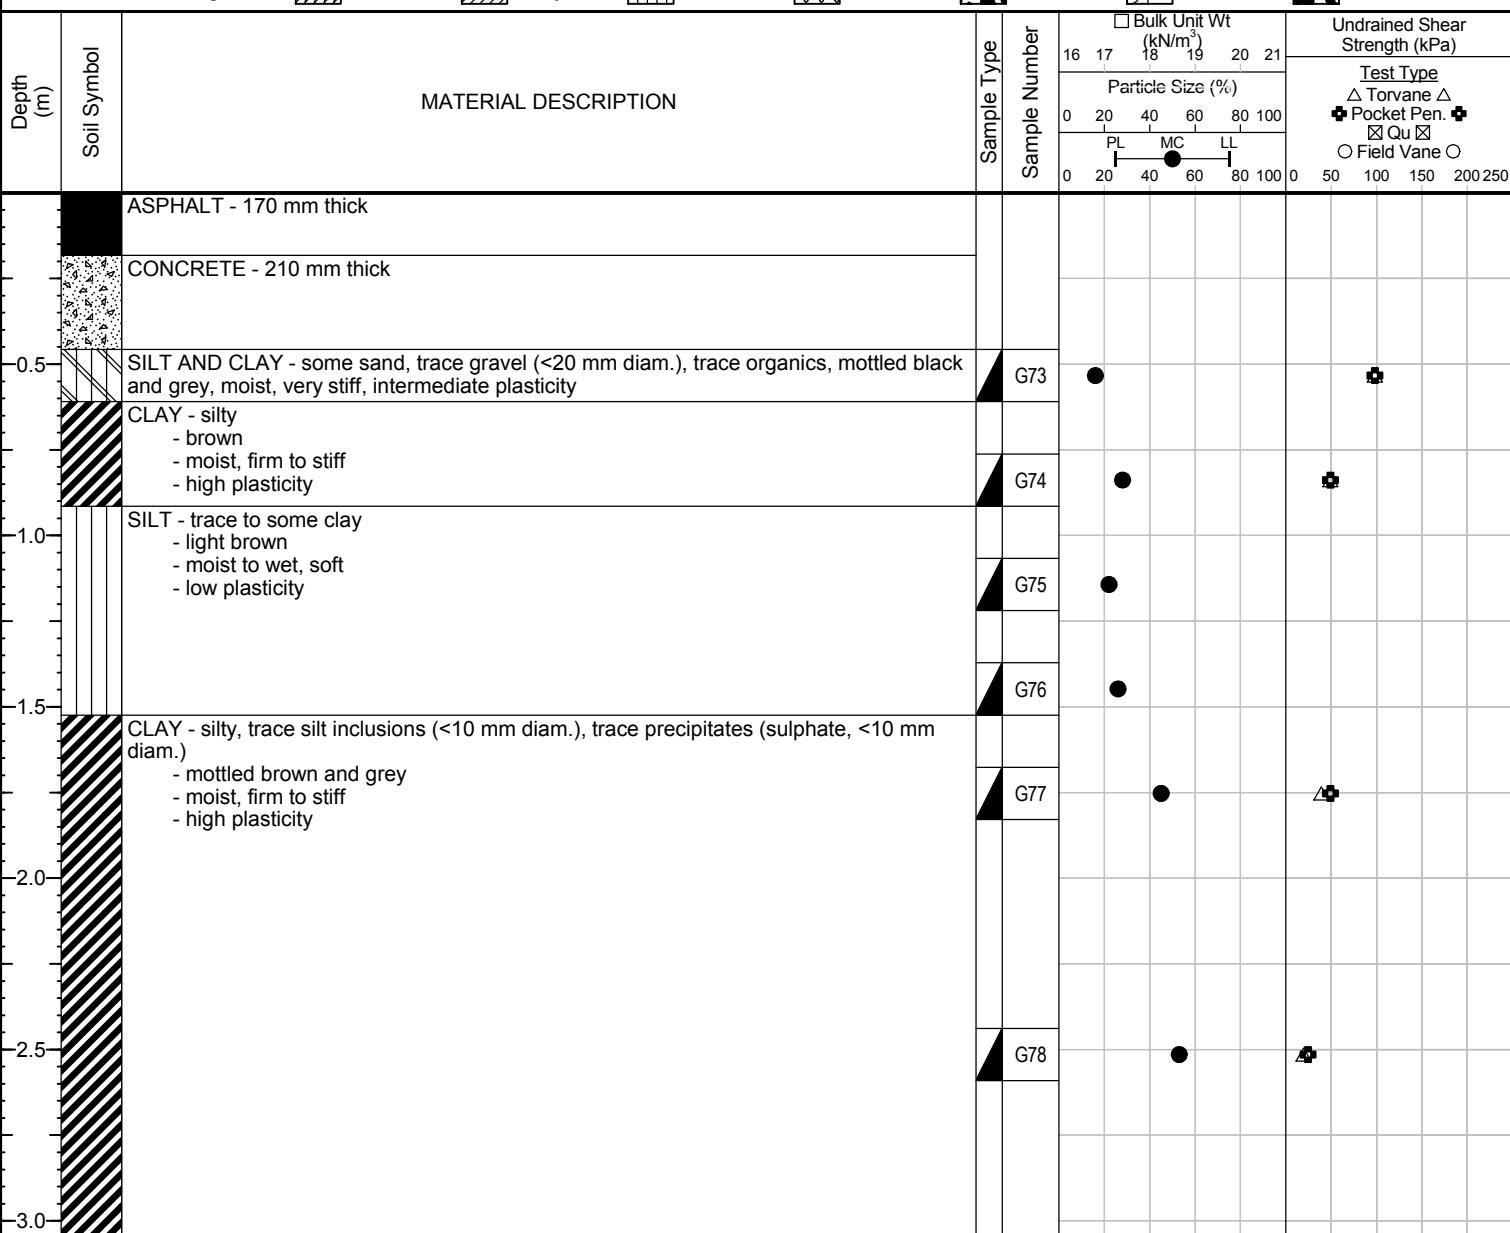
- END OF TEST HOLE AT 3.0 m IN CLAY  
1) No seepage or sloughing observed.  
2) Test hole open to 3.0 m immediately after drilling.  
3) Test hole backfilled with auger cuttings, granular fill and cold patch asphalt.  
4) Test hole located in East curb lane, 28 m North and 3 m West of fire hydrant at Northeast of Erin Street and Sargent Ave intersection.
