# **GEOTECHNICAL REPORT**

## **19-C-10 Erin Street Pavement Renewal**

**RE: Sub-Surface Investigation Report for  
19-C-10 Erin Pavement Renewal**

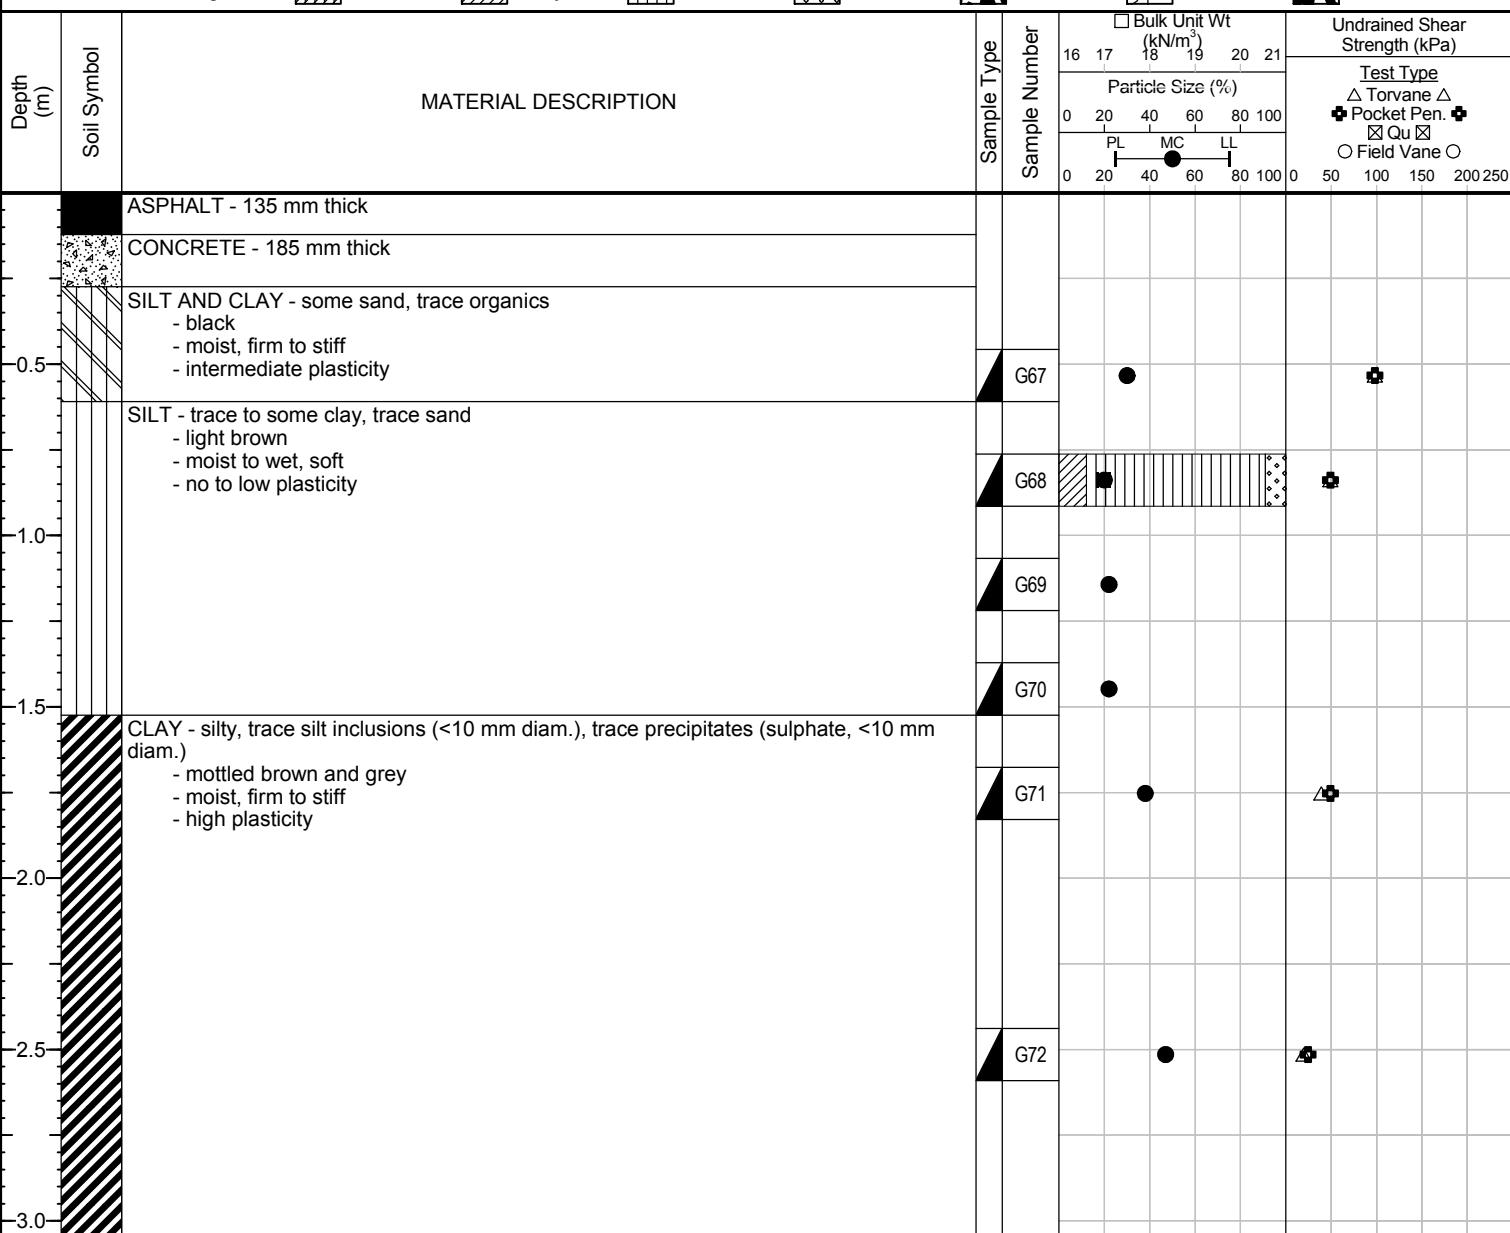
END OF TEST HOLE AT 3.0 m IN CLAY

- 1) No seepage or sloughing observed.
- 2) Test hole open to 3.0 m immediately after drilling.
- 3) Test hole backfilled with auger cuttings, granular fill and cold patch asphalt.
- 4) Test hole located between Median and West curb lane, 0.2 m North and 8 m West of fire hydrant at 1310 Erin Street.

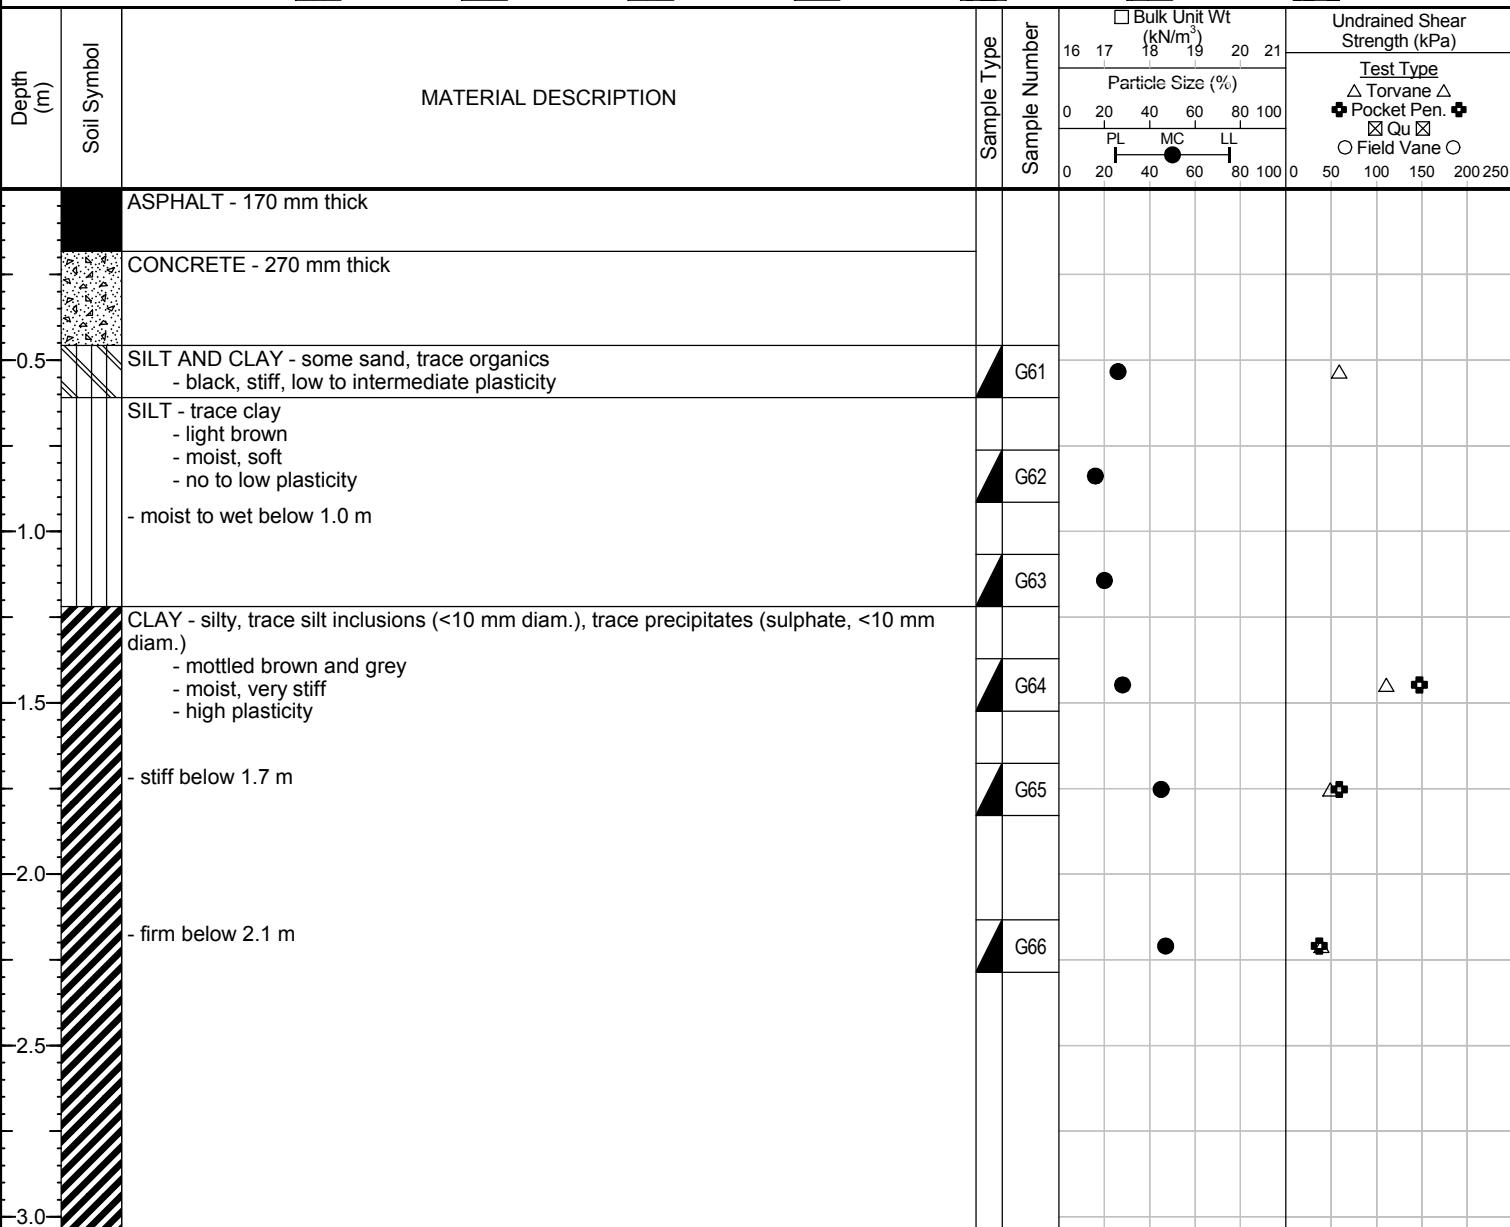
- 1) No seepage or sloughing observed.  
2) Test hole open to 2.7 m immediately after drilling.  
3) Test hole backfilled with auger cuttings, granular fill and cold patch asphalt.  
4) Test hole located in East curb lane, 32 m North and 3.2 m West of fire hydrant at 1330 Erin Street.

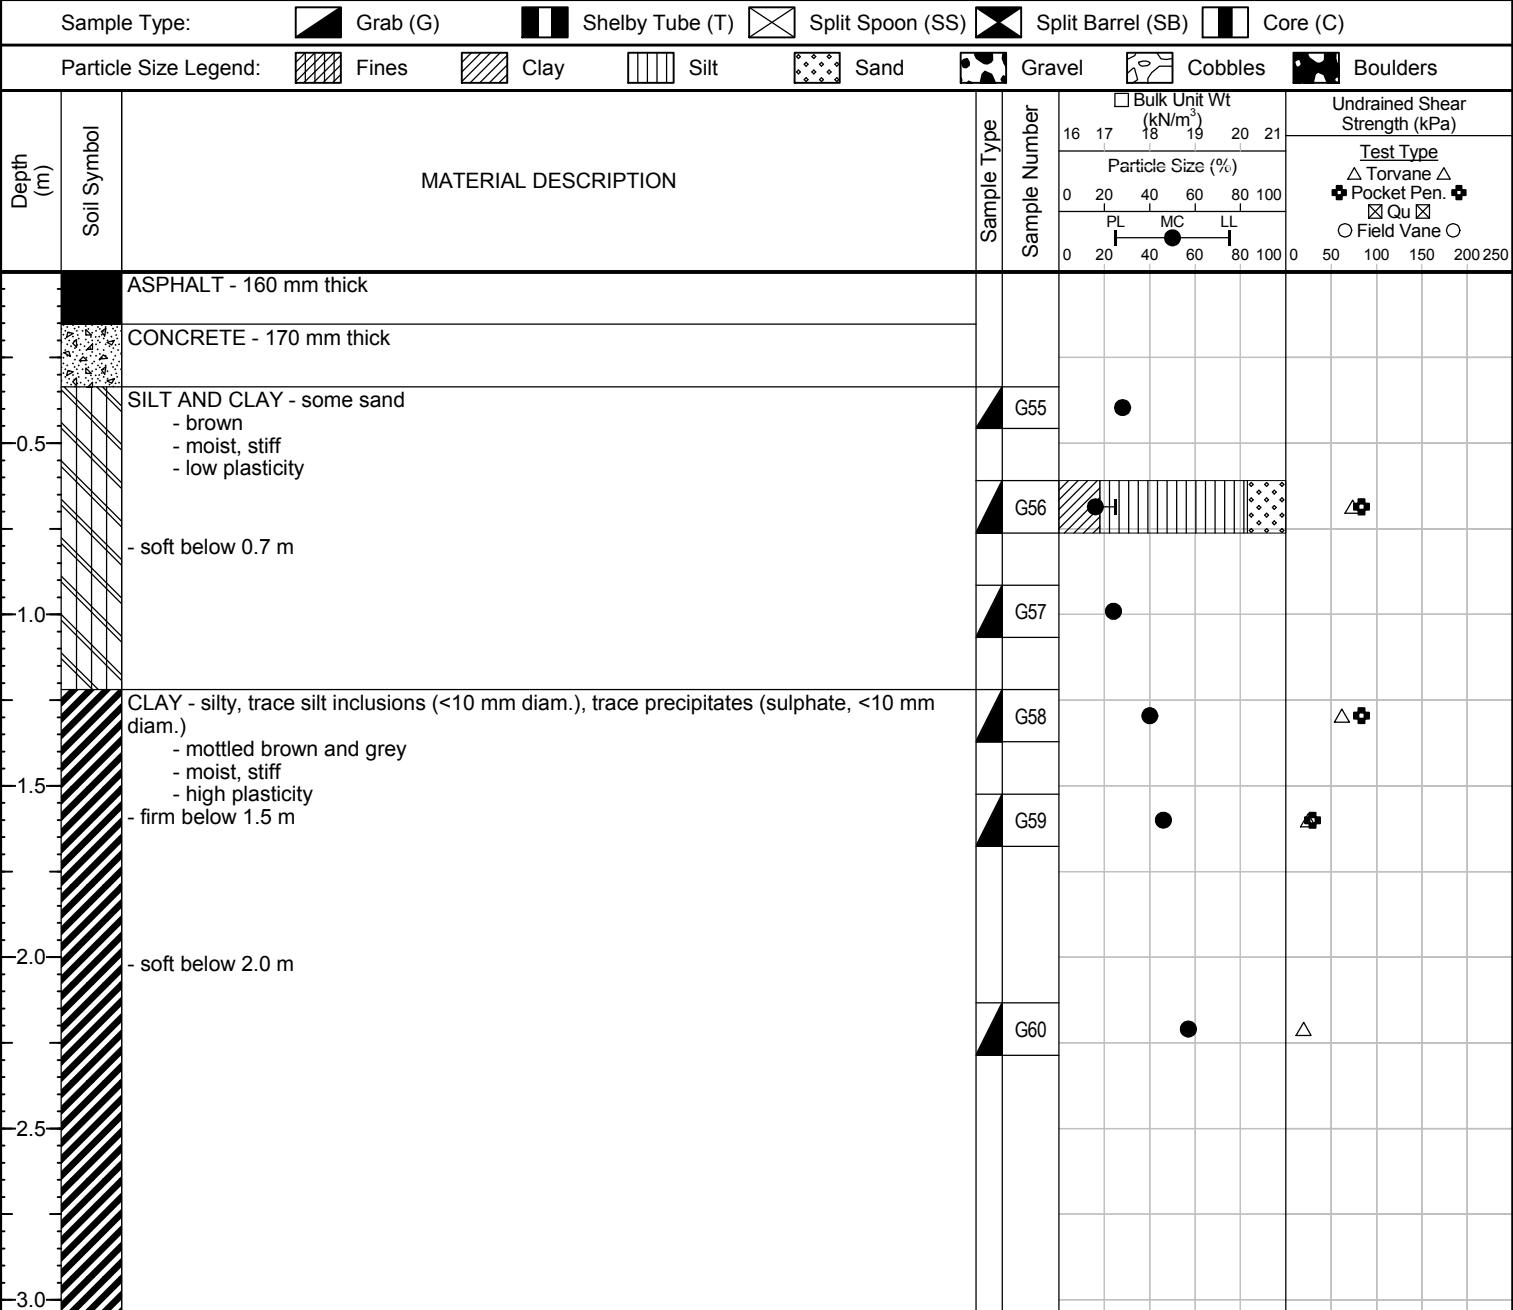
**Client:** Morrison Hershfield  
**Project Name:** 19-C-10 Erin Street Pavement Renewal  
**Contractor:** Maple Leaf Drilling Ltd.  
**Method:** 125 mm Solid Stem Auger, CME55 Truck Mount

**Project Number:** 0035-082-00-401  
**Location:** UTM N-5529122, E-630424  
**Ground Elevation:** Top of Pavement  
**Date Drilled:** October 1, 2019

- 1) No seepage observed. Sloughing in silt layer observed from 0.7 to 1.2 m.  
 2) Test hole open to 1.8 m immediately after drilling.  
 3) Test hole backfilled with auger cuttings, granular fill and cold patch asphalt.  
 4) Test hole located in East curb lane, 46 m South and 3.2 m West of fire hydrant at Southeast of Erin Street and Wellington Ave intersection.

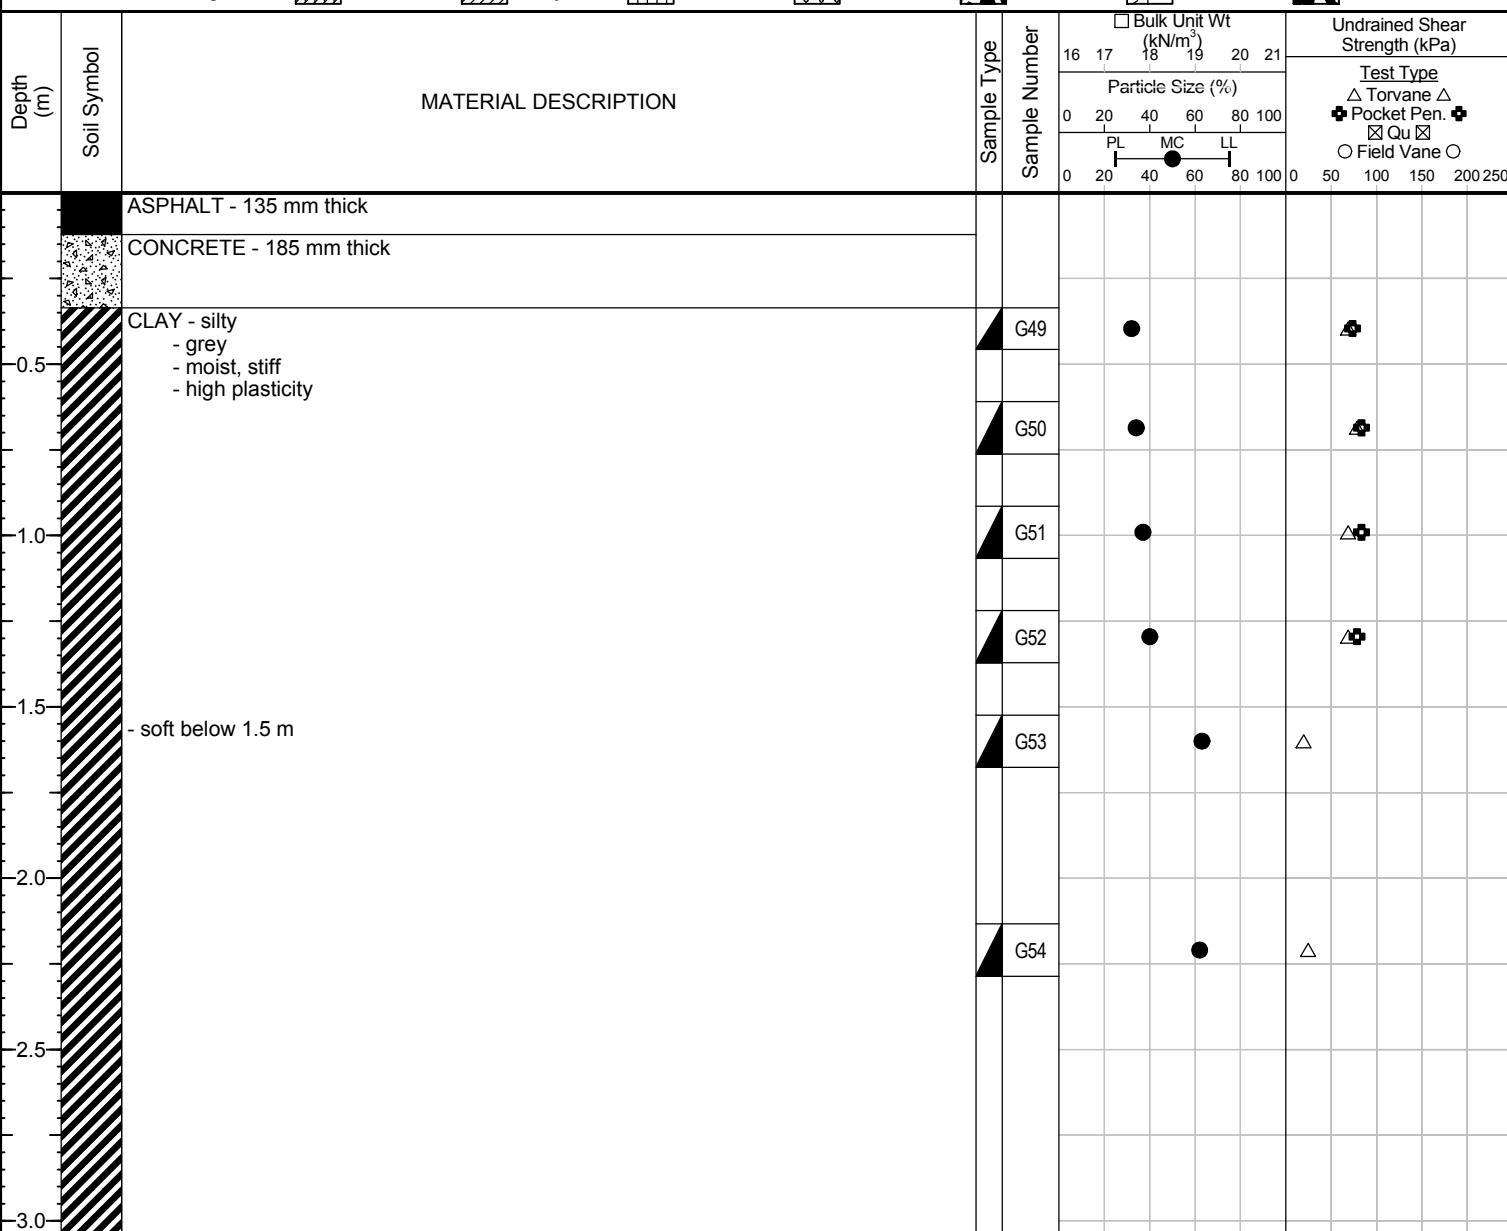
- 1) No seepage or sloughing observed.  
2) Test hole open to 3.0 m immediately after drilling.  
3) Test hole backfilled with auger cuttings, granular fill and cold patch asphalt.  
4) Test hole located in West curb lane, 9 m North and 9 m West of fire hydrant at Northeast of Erin Street and Wellington Ave intersection.

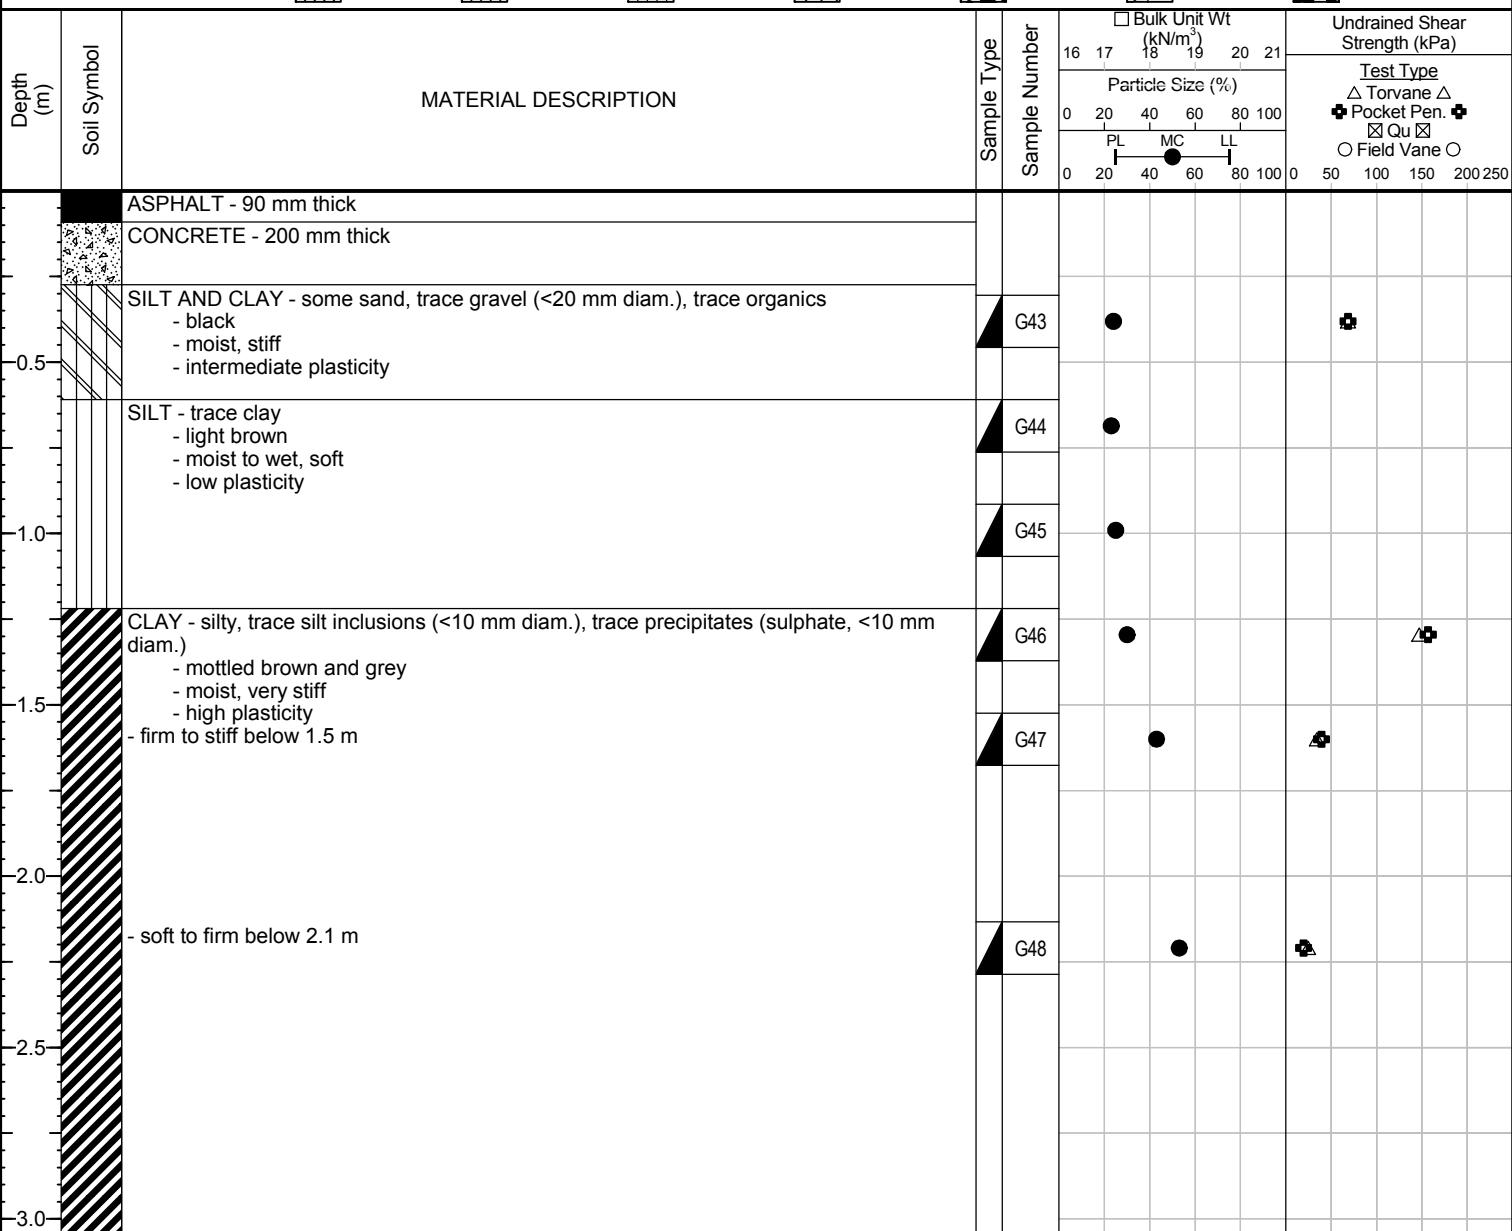
- 1) No seepage observed. Sloughing in silt layer observed from 0.6 to 1.2 m.  
2) Test hole open to 2.1 m immediately after drilling.  
3) Test hole backfilled with auger cuttings, granular fill and cold patch asphalt.  
4) Test hole located in West curb lane, 26 m North and 7.5 m West of fire hydrant at 1407 Erin Street.

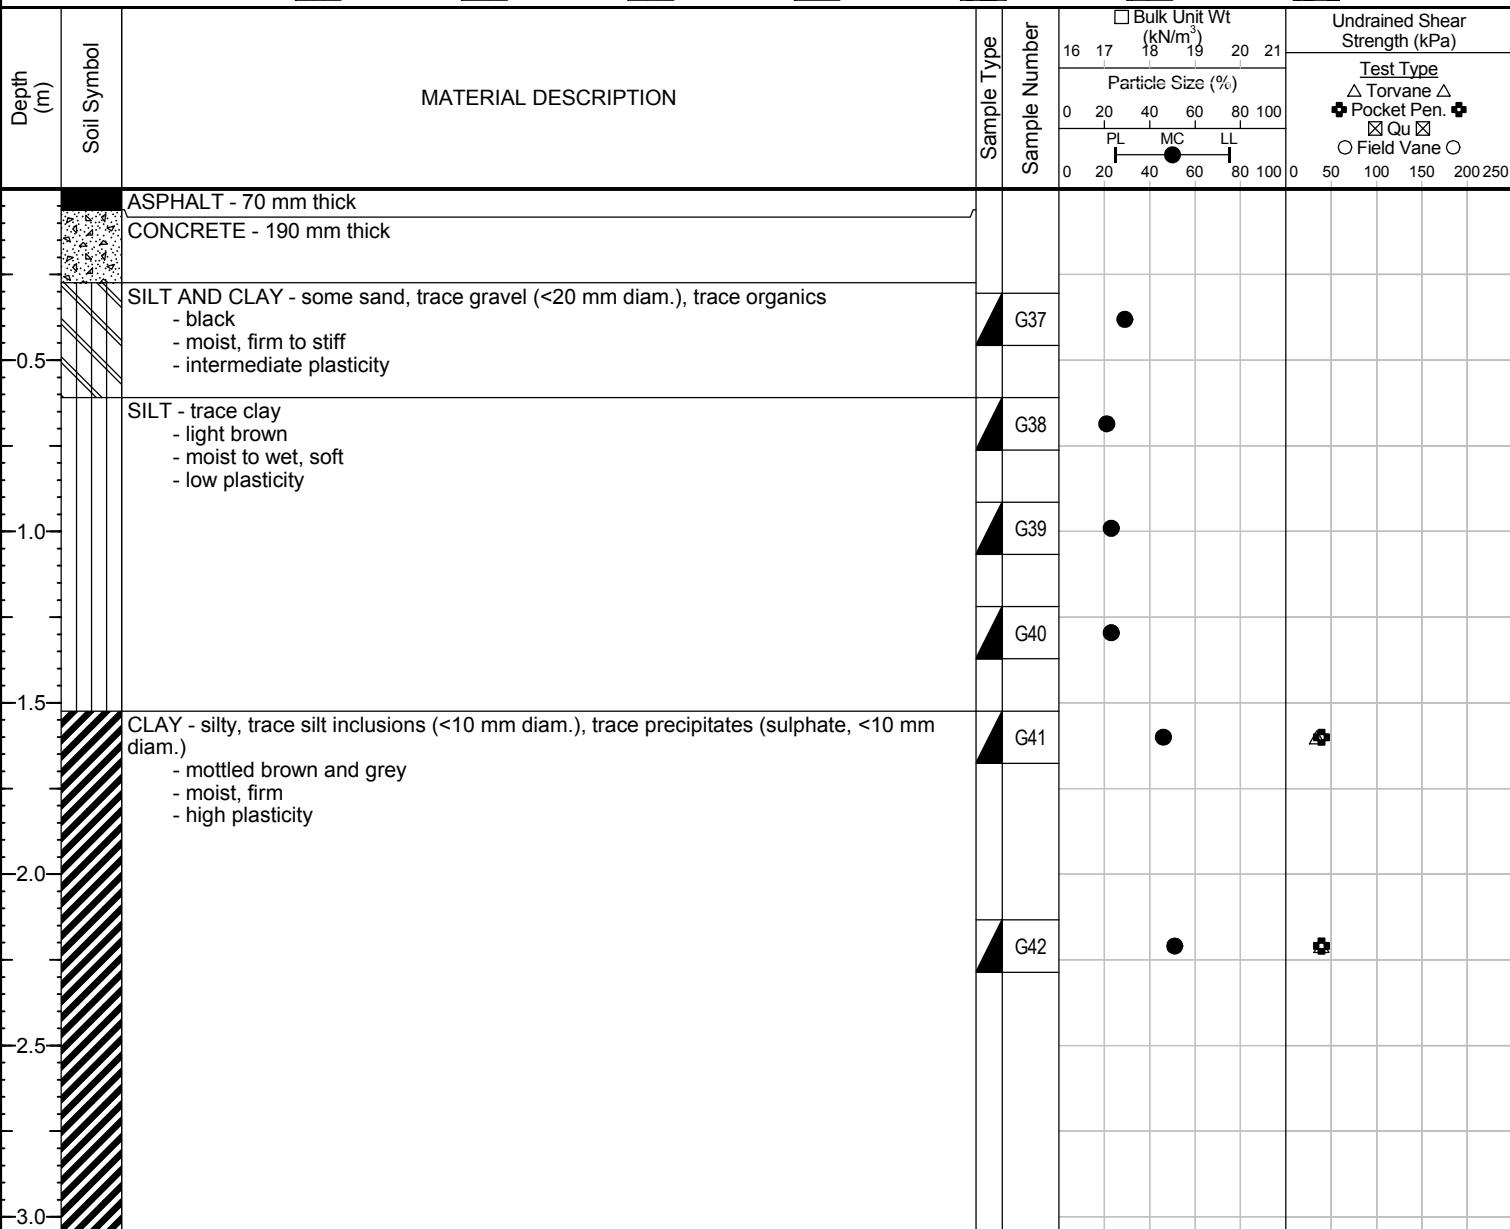
- 2) No seepage or sloughing observed.  
1) Test hole open to 3.0 m immediately after drilling.  
3) Test hole backfilled with auger cuttings, granular fill and cold patch asphalt.  
4) Test hole located in East curb lane, 43 m North and 3 m West of fire hydrant at 1445 Erin Street.

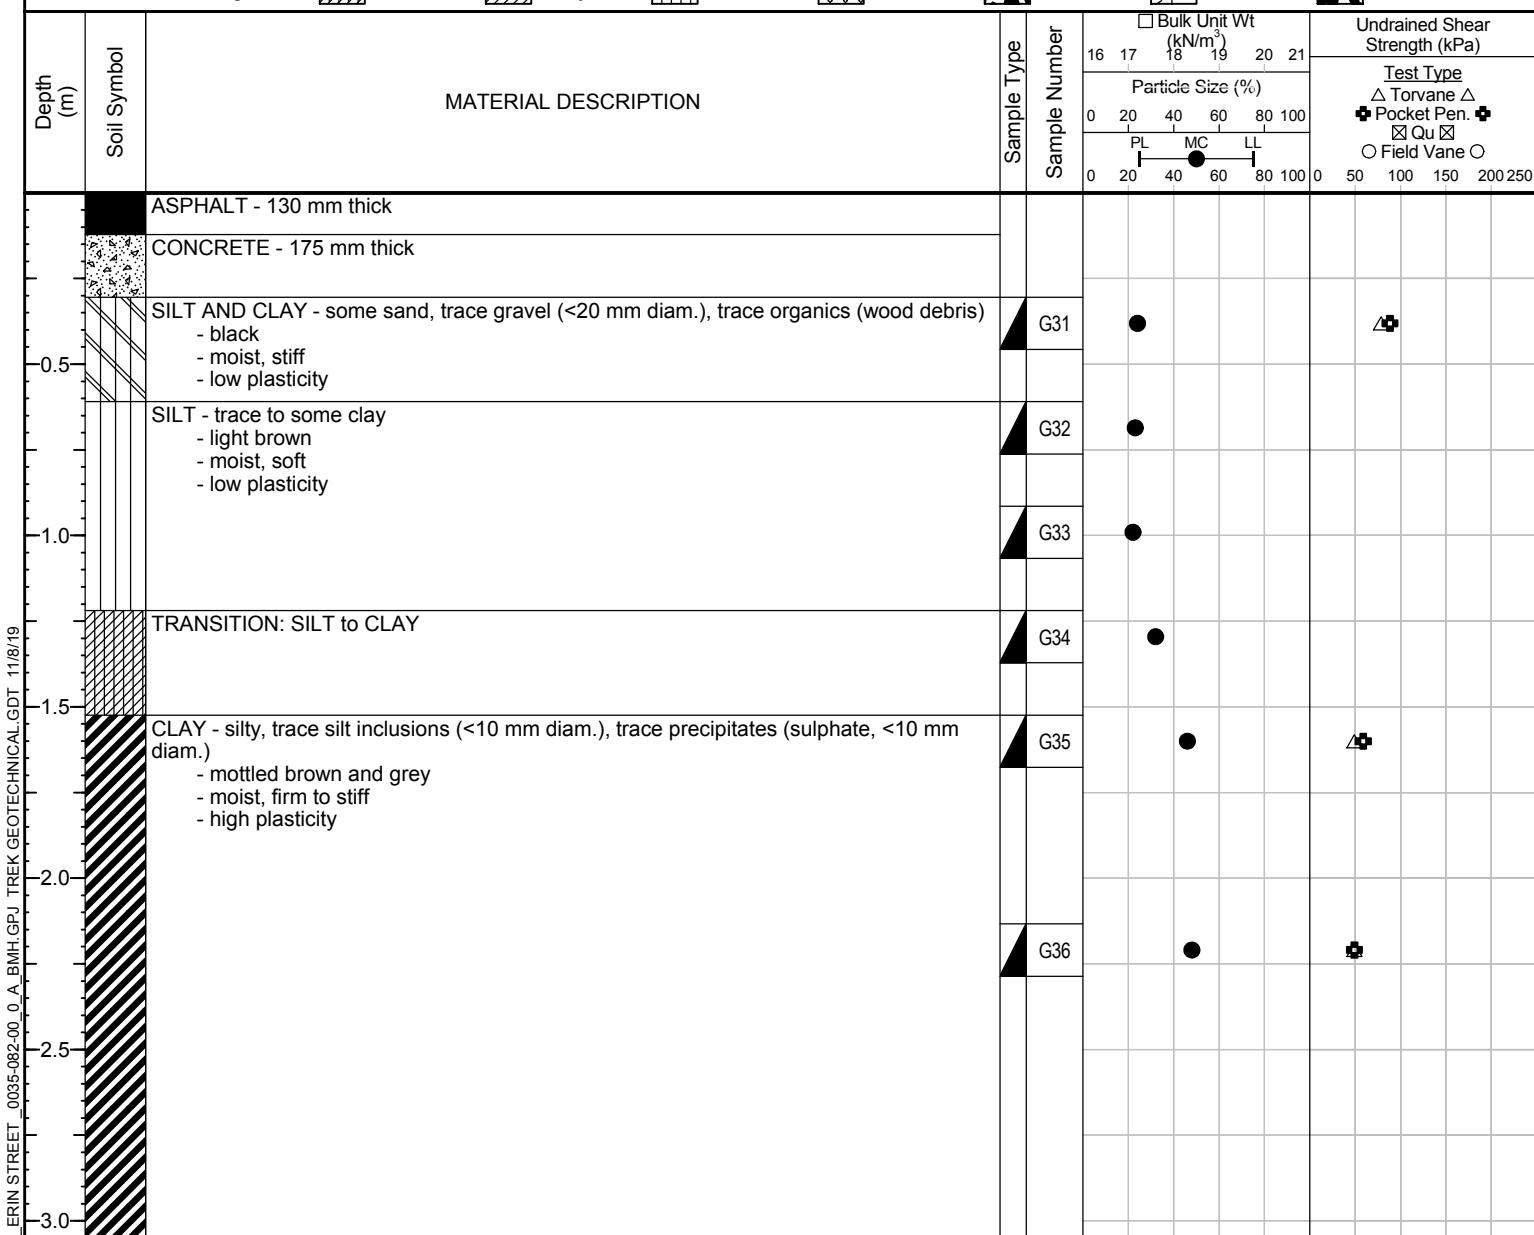
- 1) No seepage observed. Sloughing in silt layer observed from 0.7 to 1.5 m.  
2) Test hole open to 0.9 m immediately after drilling.  
3) Test hole backfilled with auger cuttings, granular fill and cold patch asphalt.  
4) Test hole located between Median and West curb lane, 40 m North and 7.4 m West of fire hydrant at 1474 Erin Street.

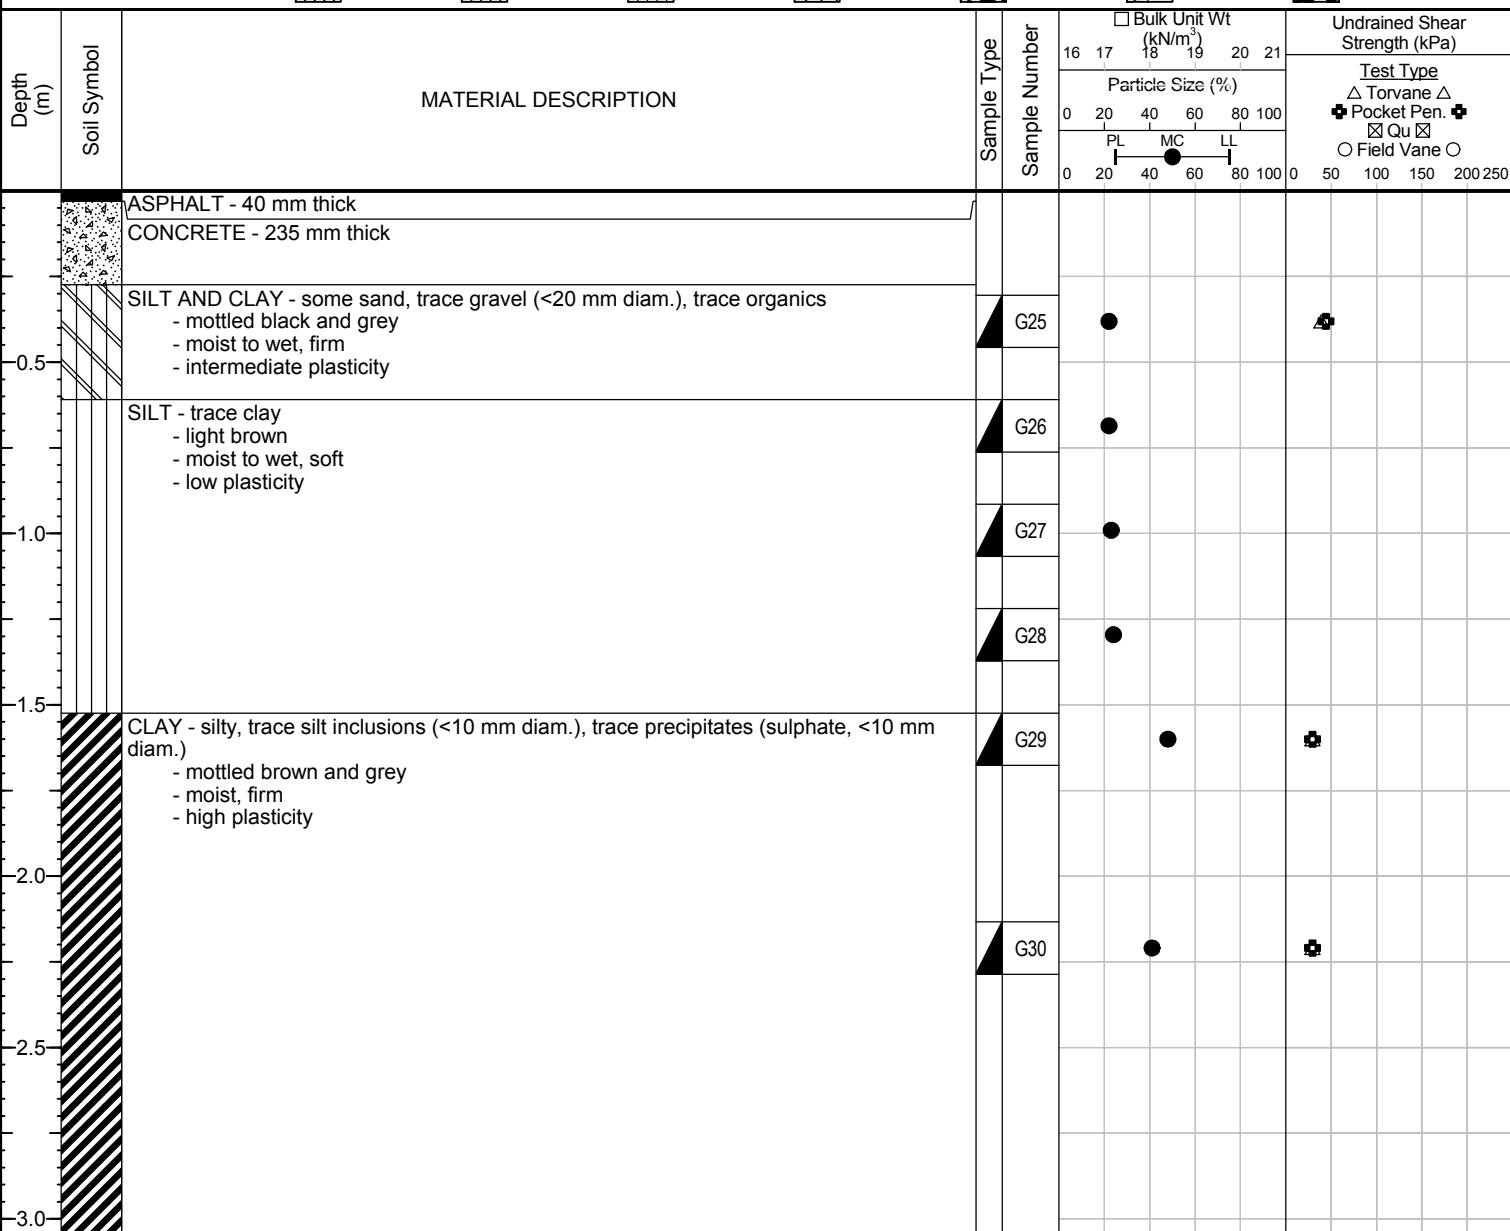
- 1) No seepage observed. Sloughing in silt layer observed from 0.7 to 1.5 m.
- 2) Test hole open to 1.5 m immediately after drilling.
- 3) Test hole backfilled with auger cuttings, granular fill and cold patch asphalt.
- 4) Test hole located in East curb lane, 50 m North and 3 m West of fire hydrant at Erin Street and Richard Ave intersection.

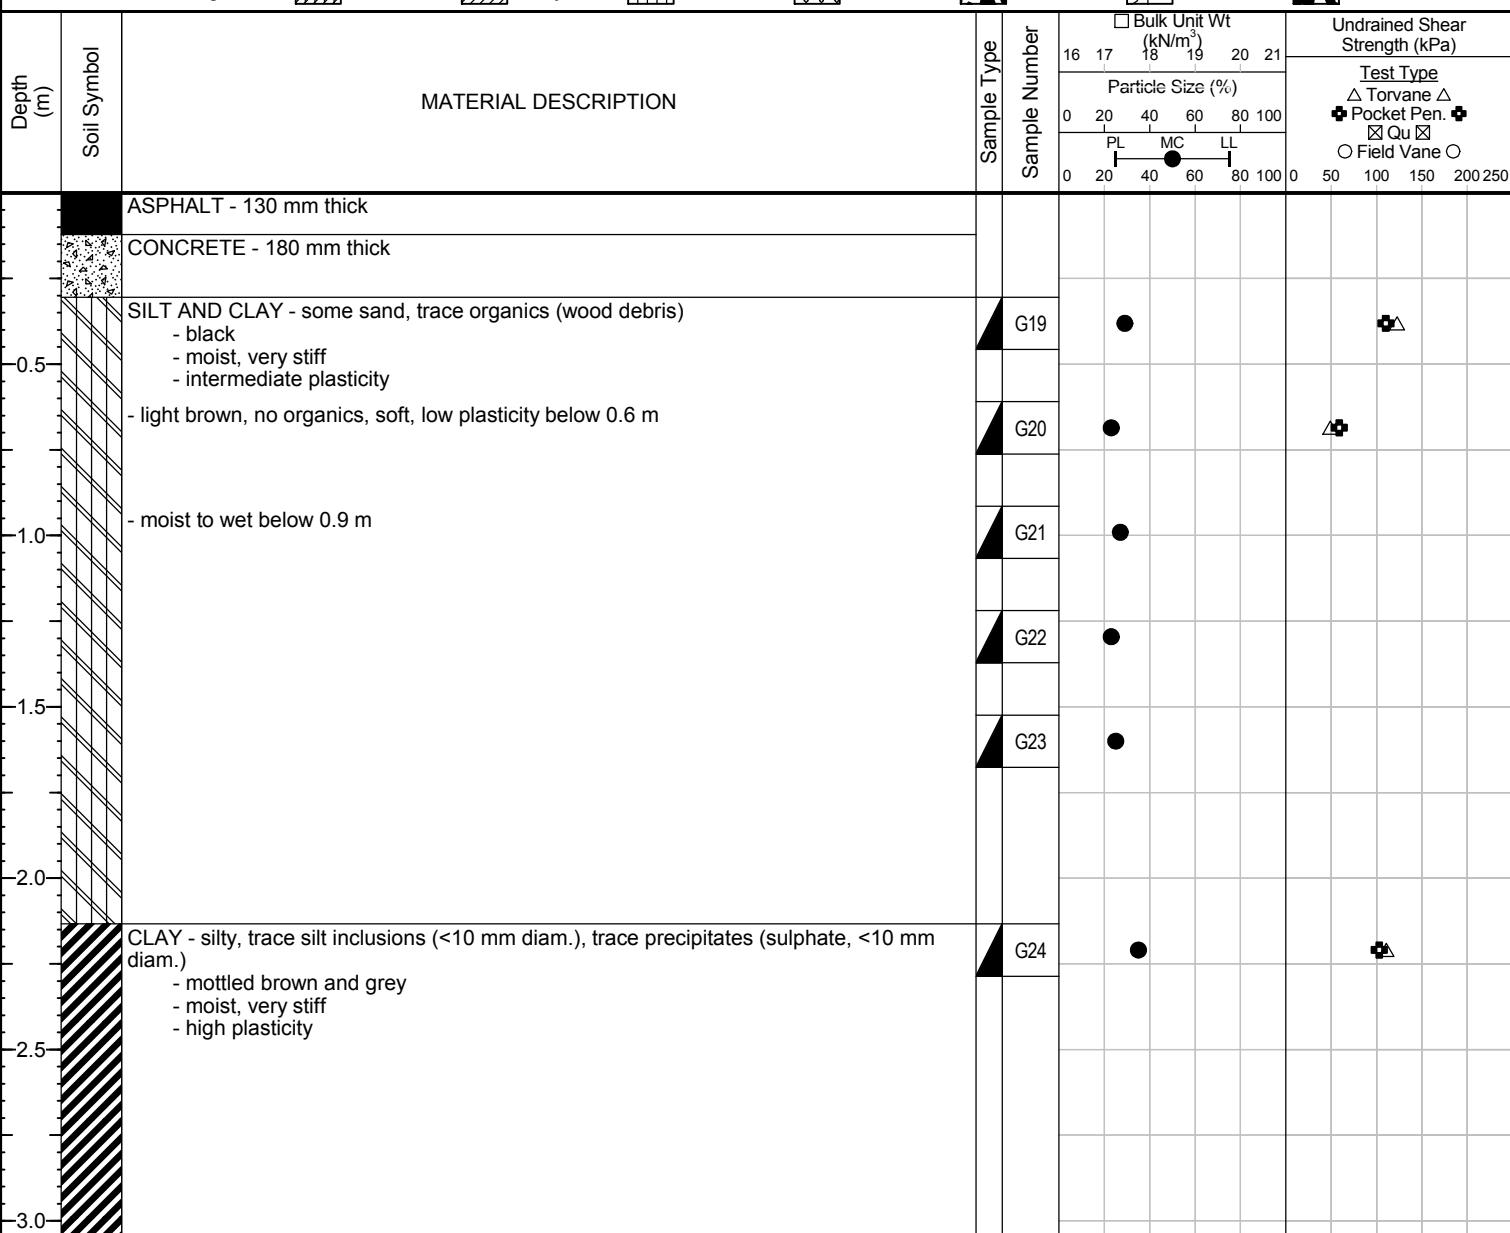
- 1) No seepage observed. Sloughing in silt layer observed from 0.7 to 2.1 m.
- 2) Test hole open to 1.8 m immediately after drilling.
- 3) Test hole backfilled with auger cuttings, granular fill and cold patch asphalt.
- 4) Bulk sample taken from 0.6 to 1.5 m for CBR testing.
- 5) Test hole located at intersection of Median and West curb lane, 7 m North and 10 m East of at 1560 Erin Street.

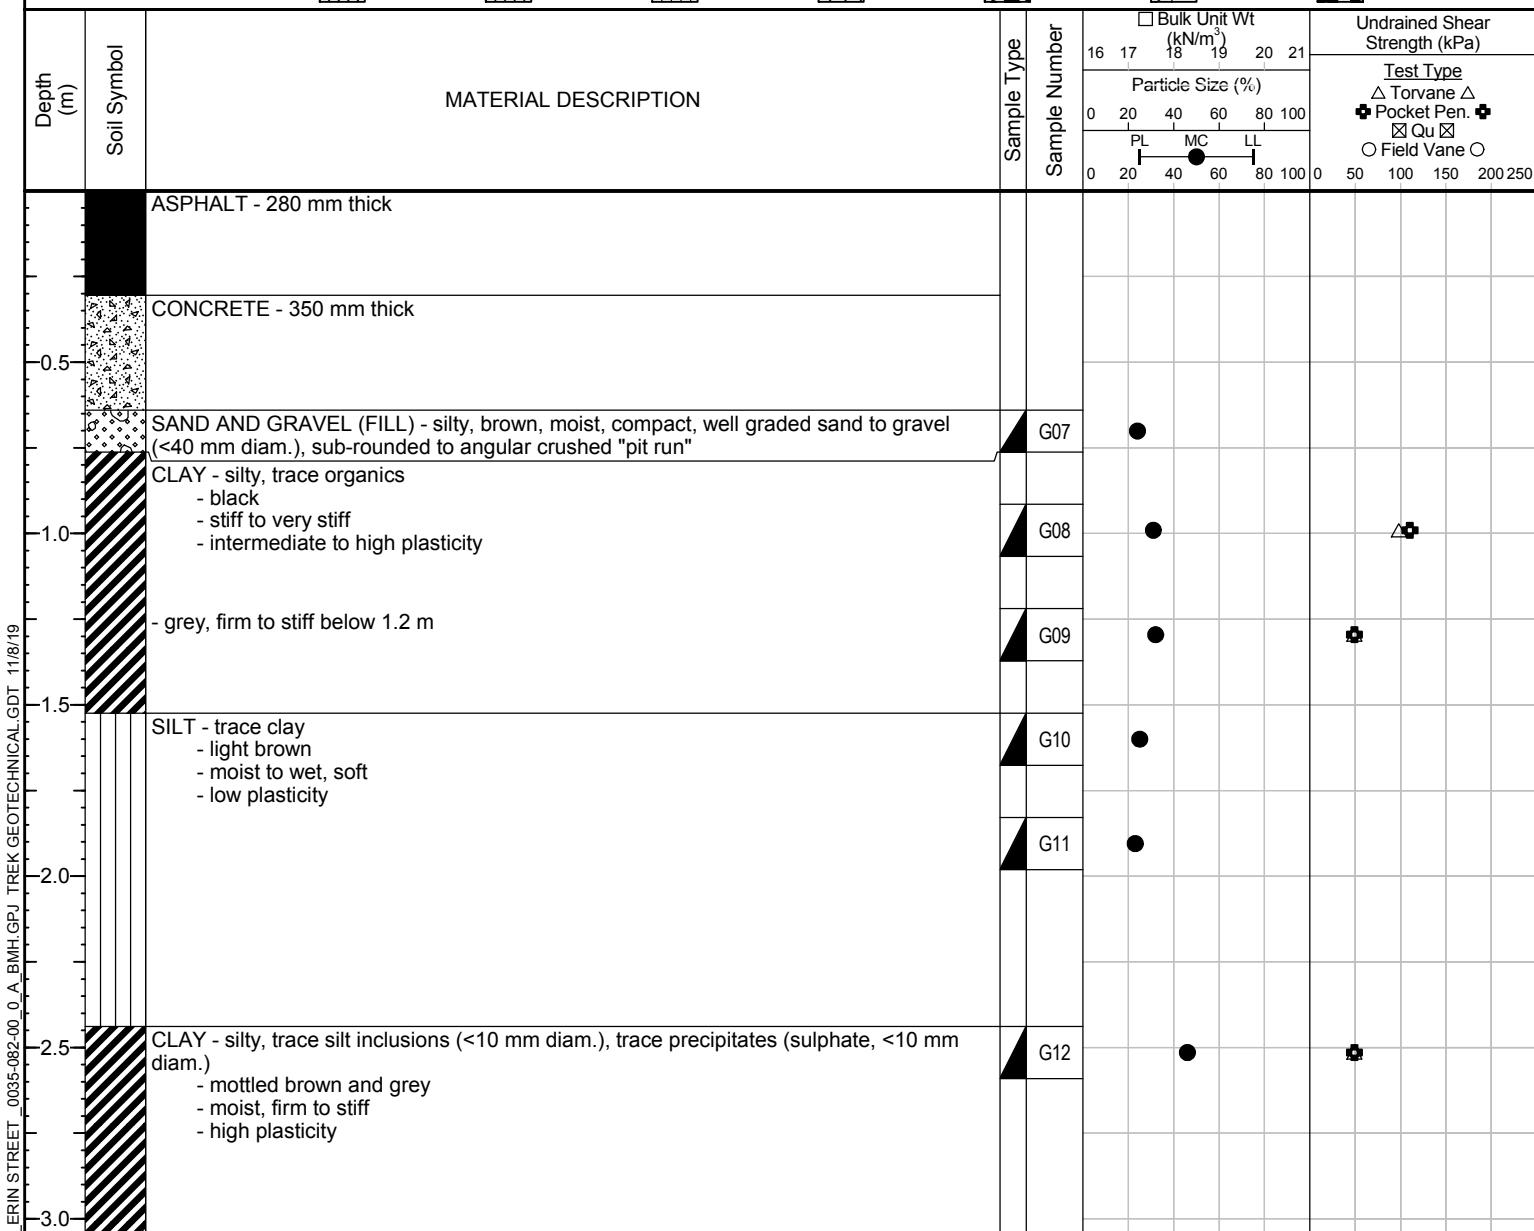
- 1) No seepage observed. Sloughing in silt layer observed from 1.5 to 2.4 m.  
2) Test hole open to 1.8 m immediately after drilling.  
3) Test hole backfilled with auger cuttings, granular fill and cold patch asphalt.  
4) Test hole located in West curb lane, 2.5 m South and 10 m West of fire hydrant at South of Railway crossing of Erin Street.

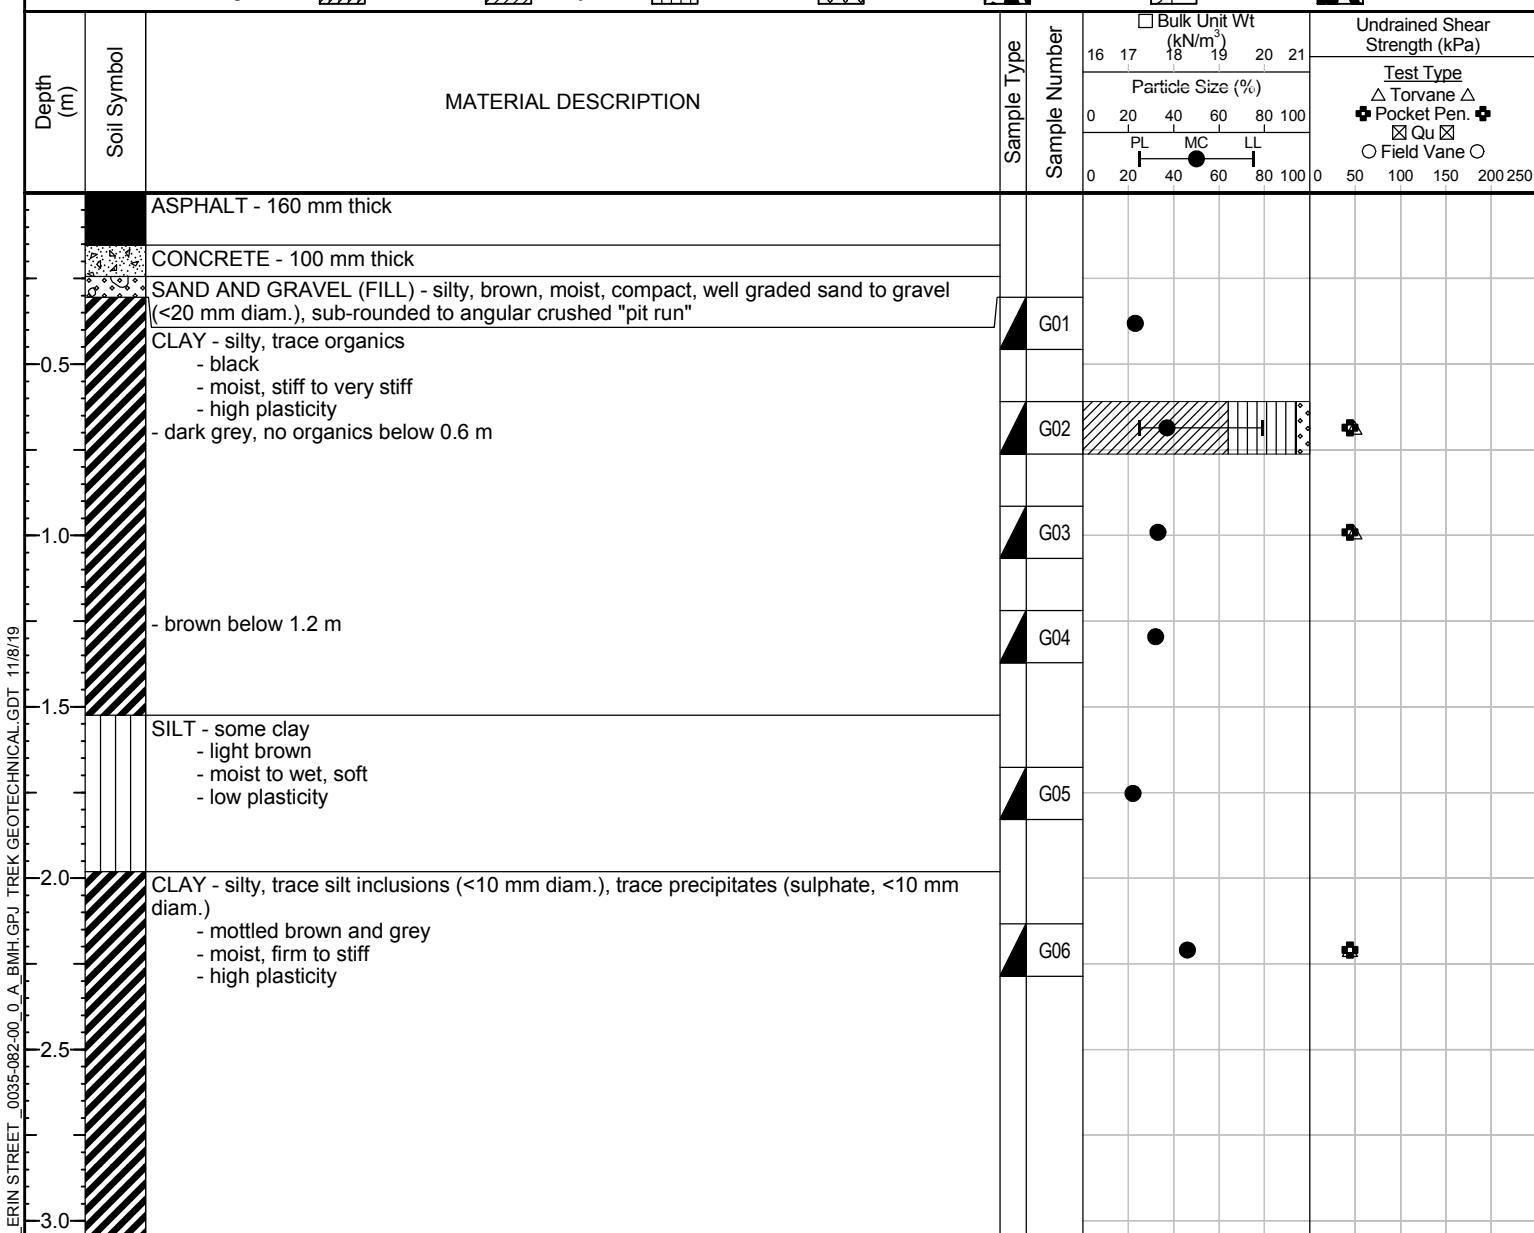
- 1) No seepage observed. Sloughing in silt layer observed from 1.2 to 2.0 m.  
2) Test hole open to 1.7 m immediately after drilling.  
3) Test hole backfilled with auger cuttings, granular fill and cold patch asphalt.  
4) Test hole located in East curb lane, 25 m South and 3.5 m East of fire hydrant at intersection of Notre Dame Ave and Erin Street intersection.

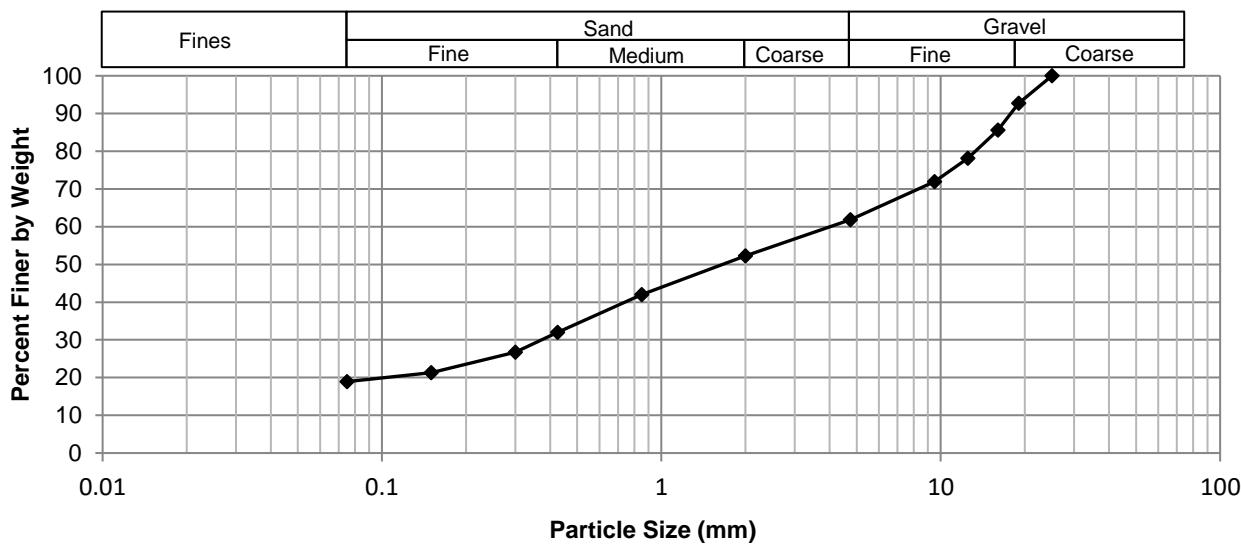
### Particle Size Distribution Curve

<b>Gravel %</b>	38.2
<b>Sand %</b>	42.9
<b>Fines %</b>	18.9

Sieve Opening (mm)	Percent Passing	Specification (Min - Max)
25.0	100	-
19.0	93	-
16.0	86	-
12.5	78	-
9.5	72	-
4.75	62	-
2.00	52	-
0.85	42	-
0.425	32	-
0.300	27	-
0.150	21	-
0.075	19	-
