# **GEOTECHNICAL REPORT**

## **19-C-10 Erin Street Pavement Renewal**

**RE: Sub-Surface Investigation Report for  
19-C-10 Erin Pavement Renewal**

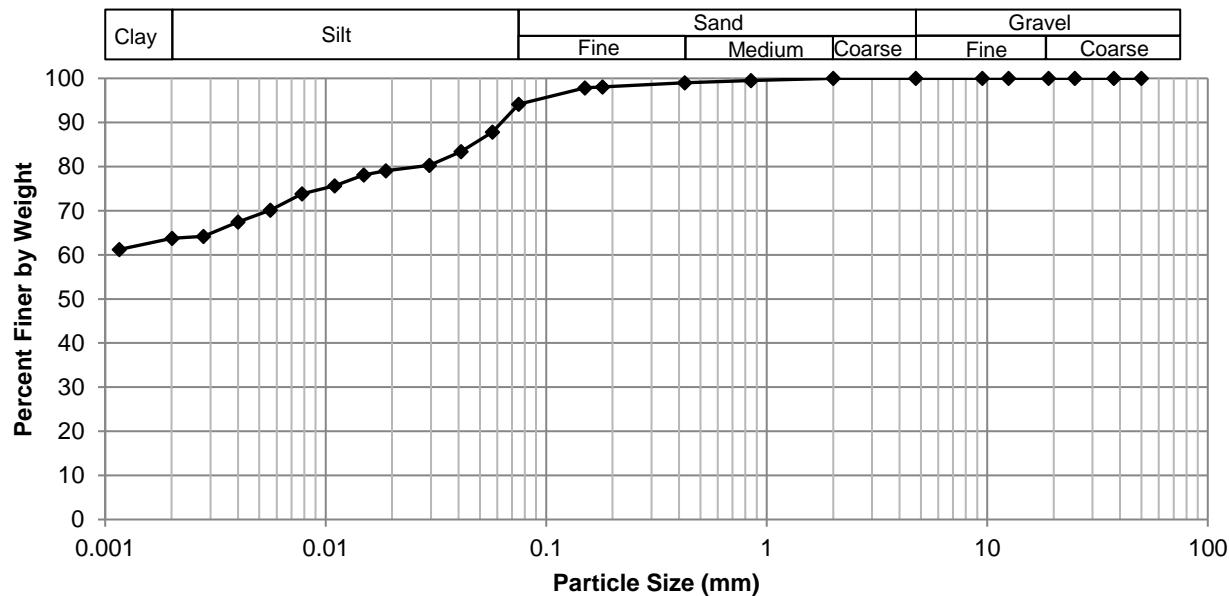
### Particle Size Distribution Curve

<b>Gravel</b>	0.0%
<b>Sand</b>	5.9%
<b>Silt</b>	30.4%
<b>Clay</b>	63.7%

Gravel		Sand		Silt and Clay	
Particle Size (mm)	Percent Passing	Particle Size (mm)	Percent Passing	Particle Size (mm)	Percent Passing
50.0	100.00	4.75	100.00	0.0750	94.12
37.5	100.00	2.00	100.00	0.0570	87.82
25.0	100.00	0.850	99.51	0.0412	83.44
19.0	100.00	0.425	99.02	0.0295	80.31
12.5	100.00	0.180	98.05	0.0188	79.06
9.50	100.00	0.150	97.83	0.0149	78.12
4.75	100.00	0.075	94.12	0.0110	75.68
				0.0078	73.86
				0.0056	70.16
				0.0040	67.46
				0.0028	64.18
				0.0020	63.72
				0.0012	61.20

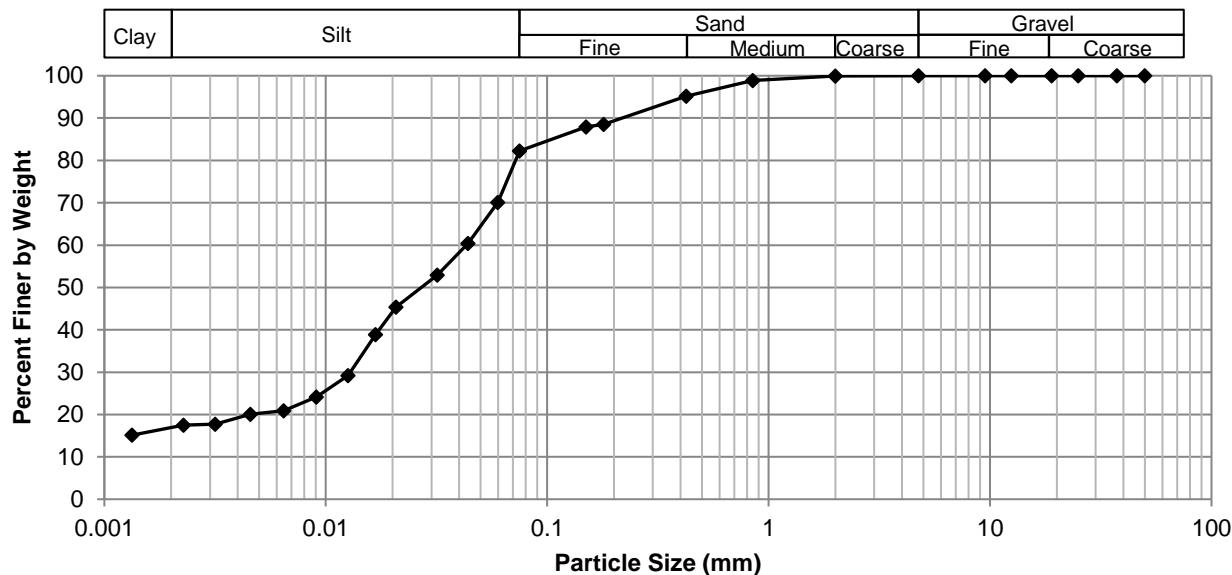
### Particle Size Distribution Curve

<b>Gravel</b>	0.0%
<b>Sand</b>	17.8%
<b>Silt</b>	65.5%
<b>Clay</b>	16.8%

<b>Gravel</b>		<b>Sand</b>		<b>Silt and Clay</b>	
<b>Particle Size (mm)</b>	<b>Percent Passing</b>	<b>Particle Size (mm)</b>	<b>Percent Passing</b>	<b>Particle Size (mm)</b>	<b>Percent Passing</b>
50.0	100.00	4.75	100.00	0.0750	82.23
37.5	100.00	2.00	99.91	0.0598	70.09
25.0	100.00	0.850	98.87	0.0440	60.41
19.0	100.00	0.425	95.16	0.0319	52.91
12.5	100.00	0.180	88.56	0.0207	45.42
9.50	100.00	0.150	87.89	0.0168	38.86
4.75	100.00	0.075	82.23	0.0126	29.17
				0.0091	24.17
				0.0065	20.87
				0.0046	20.06
				0.0032	17.76
				0.0023	17.46
				0.0013	15.13

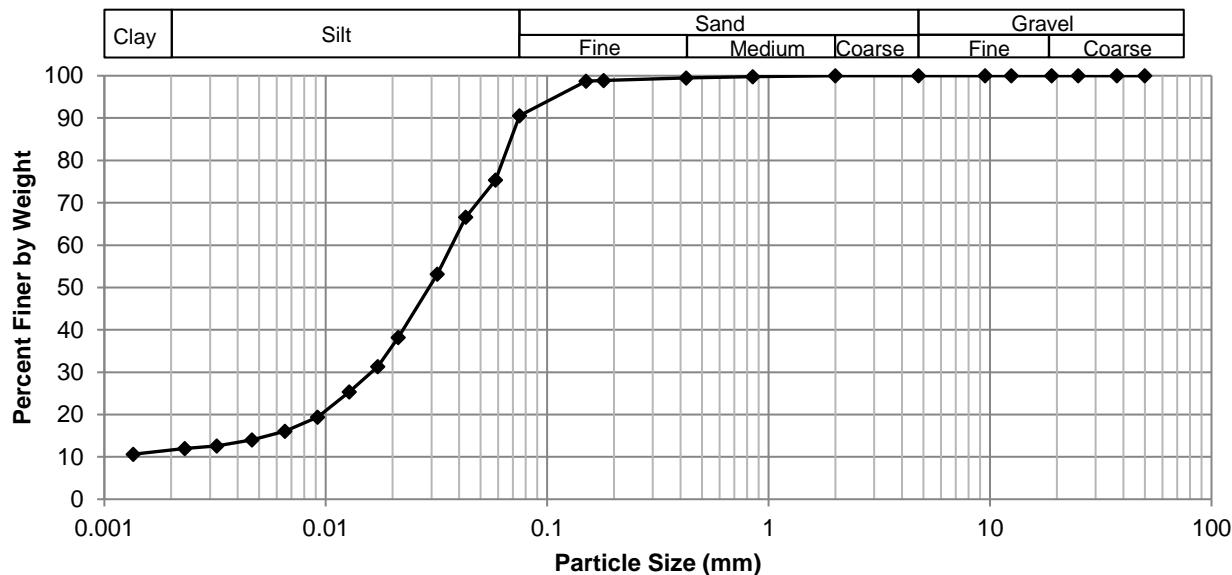
### Particle Size Distribution Curve

<b>Gravel</b>	0.0%
<b>Sand</b>	9.5%
<b>Silt</b>	79.0%
<b>Clay</b>	11.5%

<b>Gravel</b>		<b>Sand</b>		<b>Silt and Clay</b>	
<b>Particle Size (mm)</b>	<b>Percent Passing</b>	<b>Particle Size (mm)</b>	<b>Percent Passing</b>	<b>Particle Size (mm)</b>	<b>Percent Passing</b>
50.0	100.00	4.75	100.00	0.0750	90.54
37.5	100.00	2.00	100.00	0.0585	75.38
25.0	100.00	0.850	99.82	0.0429	66.63
19.0	100.00	0.425	99.47	0.0319	53.18
12.5	100.00	0.180	98.89	0.0212	38.18
9.50	100.00	0.150	98.75	0.0172	31.30
4.75	100.00	0.075	90.54	0.0128	25.36
				0.0092	19.42
				0.0065	16.09
				0.0046	14.01
				0.0032	12.61
				0.0023	11.95
				0.0014	10.62

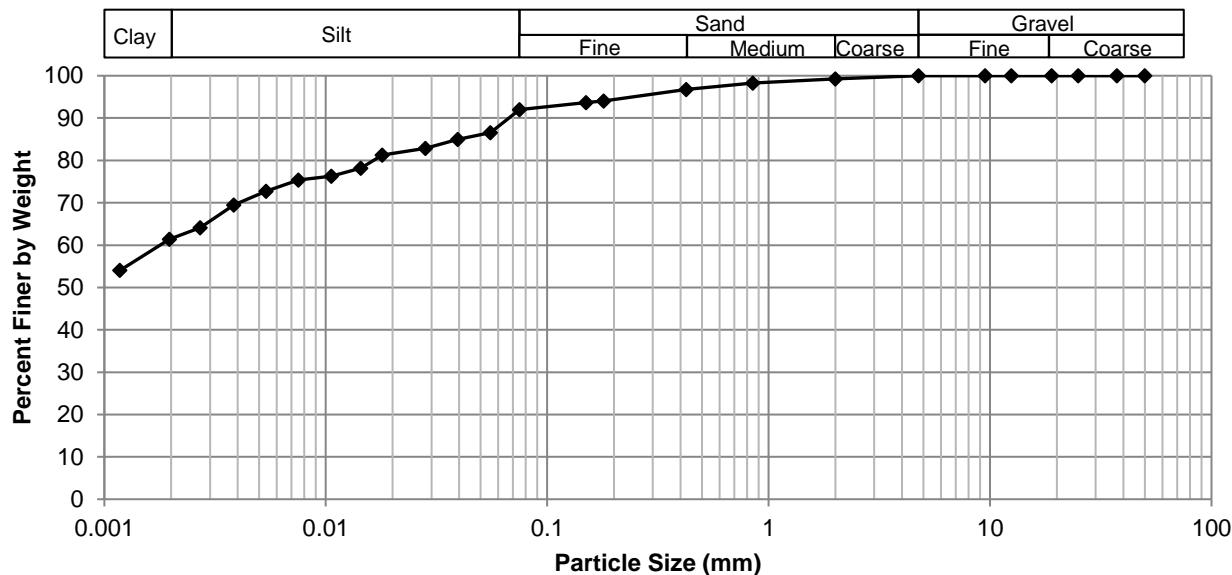
### Particle Size Distribution Curve

<b>Gravel</b>	0.0%
<b>Sand</b>	8.0%
<b>Silt</b>	30.5%
<b>Clay</b>	61.5%

Gravel		Sand		Silt and Clay	
Particle Size (mm)	Percent Passing	Particle Size (mm)	Percent Passing	Particle Size (mm)	Percent Passing
50.0	100.00	4.75	100.00	0.0750	92.02
37.5	100.00	2.00	99.22	0.0555	86.56
25.0	100.00	0.850	98.30	0.0395	85.01
19.0	100.00	0.425	96.74	0.0282	82.83
12.5	100.00	0.180	94.04	0.0180	81.28
9.50	100.00	0.150	93.70	0.0144	78.18
4.75	100.00	0.075	92.02	0.0106	76.32
				0.0075	75.39
				0.0054	72.74
				0.0038	69.48
				0.0027	64.12
				0.0020	61.38
				0.0012	54.04

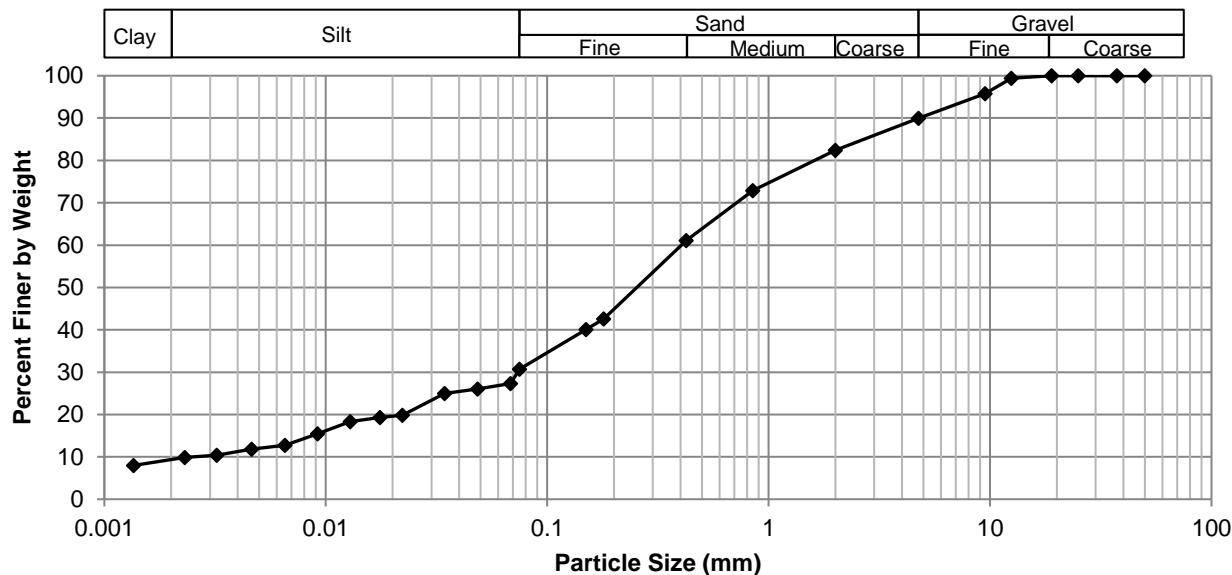
### Particle Size Distribution Curve

<b>Gravel</b>	10.1%
<b>Sand</b>	59.3%
<b>Silt</b>	21.5%
<b>Clay</b>	9.2%

<b>Gravel</b>		<b>Sand</b>		<b>Silt and Clay</b>	
<b>Particle Size (mm)</b>	<b>Percent Passing</b>	<b>Particle Size (mm)</b>	<b>Percent Passing</b>	<b>Particle Size (mm)</b>	<b>Percent Passing</b>
50.0	100.00	4.75	89.95	0.0750	30.69
37.5	100.00	2.00	82.40	0.0683	27.33
25.0	100.00	0.850	72.86	0.0485	26.05
19.0	100.00	0.425	61.13	0.0344	25.01
12.5	99.43	0.180	42.57	0.0222	19.86
9.50	95.79	0.150	40.11	0.0176	19.35
4.75	89.95	0.075	30.69	0.0129	18.32
				0.0092	15.48
				0.0066	12.74
				0.0046	11.80
				0.0032	10.39
				0.0023	9.84
				0.0014	7.98

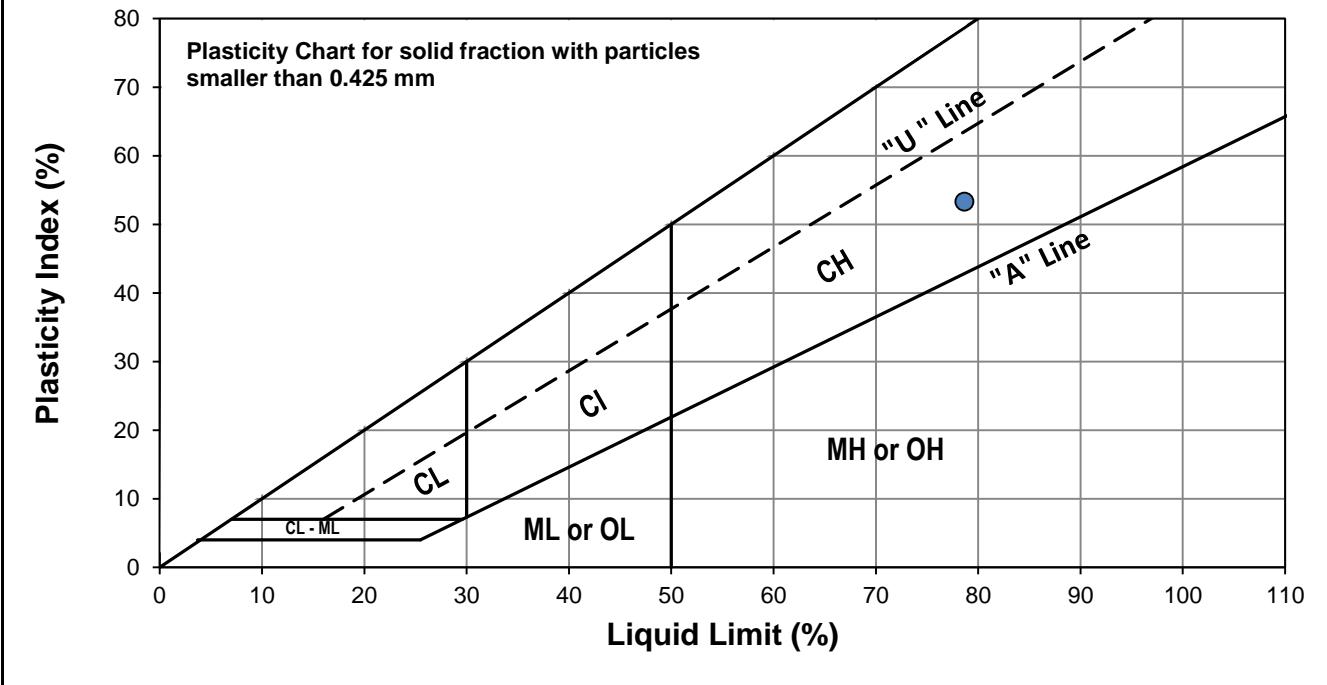
#### Liquid Limit

Trial #	1	2	3		
Number of Blows (N)	18	27	32		
Mass Wet Soil + Tare (g)	23.623	22.278	23.114		
Mass Dry Soil + Tare (g)	19.398	18.704	19.251		
Mass Tare (g)	14.183	14.123	14.234		
Mass Water (g)	4.225	3.574	3.863		
Mass Dry Soil (g)	5.215	4.581	5.017		
Moisture Content (%)	81.016	78.018	76.998

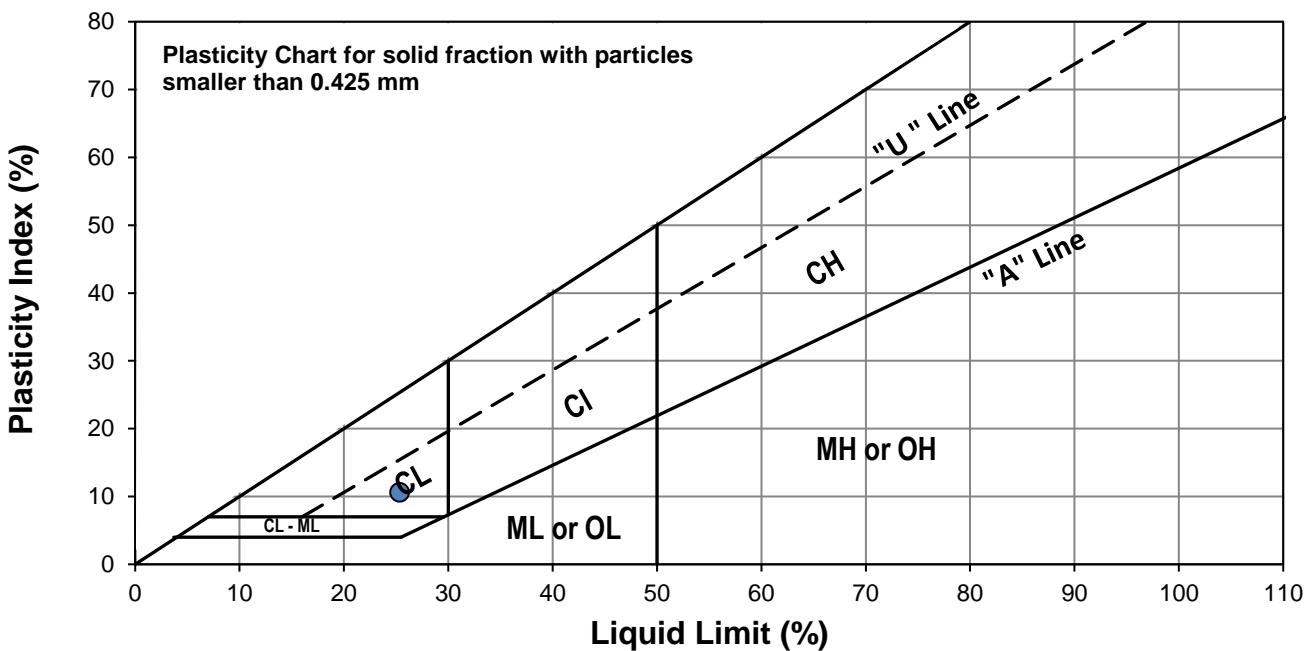
#### Liquid Limit

Trial #	1	2	3		
<b>Number of Blows (N)</b>	19	25	35		
<b>Mass Wet Soil + Tare (g)</b>	21.235	24.018	25.137		
<b>Mass Dry Soil + Tare (g)</b>	19.788	22.010	22.983		
<b>Mass Tare (g)</b>	14.215	14.128	14.143		
<b>Mass Water (g)</b>	1.447	2.008	2.154		
<b>Mass Dry Soil (g)</b>	5.573	7.882	8.840		
<b>Moisture Content (%)</b>	25.964	25.476	24.367

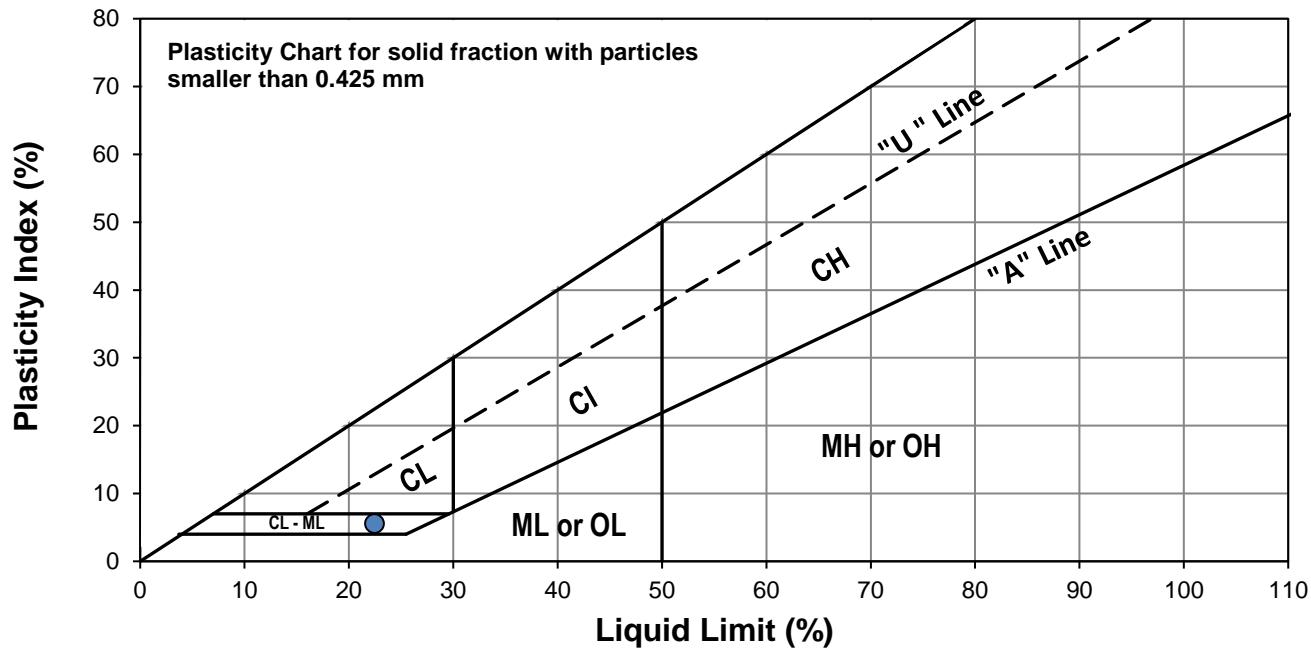
#### Liquid Limit

Trial #	1	2	3		
Number of Blows (N)	15	20	34		
Mass Wet Soil + Tare (g)	24.084	25.470	23.094		
Mass Dry Soil + Tare (g)	22.234	23.364	21.522		
Mass Tare (g)	14.317	14.112	14.350		
Mass Water (g)	1.850	2.106	1.572		
Mass Dry Soil (g)	7.917	9.252	7.172		
Moisture Content (%)	23.367	22.763	21.919

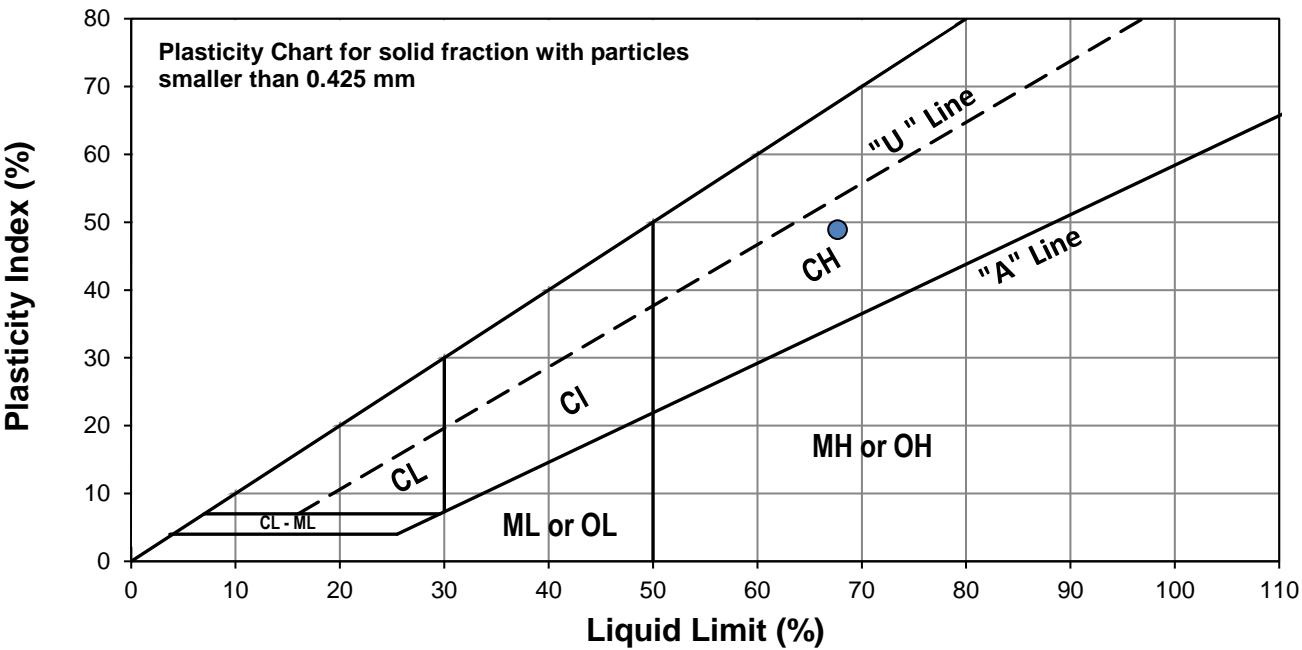
#### Liquid Limit

Trial #	1	2	3		
Number of Blows (N)	16	20	33		
Mass Wet Soil + Tare (g)	23.611	22.440	22.380		
Mass Dry Soil + Tare (g)	19.623	18.976	19.104		
Mass Tare (g)	13.977	13.968	14.129		
Mass Water (g)	3.988	3.464	3.276		
Mass Dry Soil (g)	5.646	5.008	4.975		
Moisture Content (%)	70.634	69.169	65.849

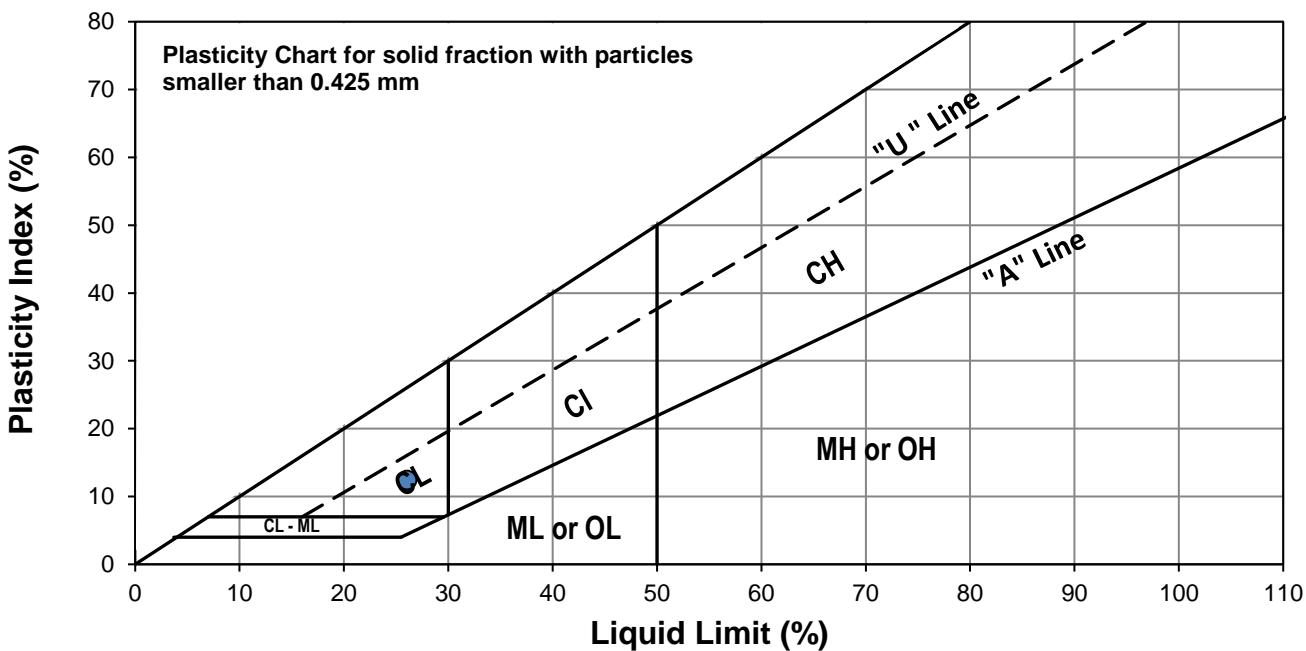
#### Liquid Limit

Trial #	1	2	3		
<b>Number of Blows (N)</b>	15	27	33		
<b>Mass Wet Soil + Tare (g)</b>	27.079	25.985	25.443		
<b>Mass Dry Soil + Tare (g)</b>	24.273	23.551	23.116		
<b>Mass Tare (g)</b>	14.131	14.123	13.872		
<b>Mass Water (g)</b>	2.806	2.434	2.327		
<b>Mass Dry Soil (g)</b>	10.142	9.428	9.244		
<b>Moisture Content (%)</b>	27.667	25.817	25.173

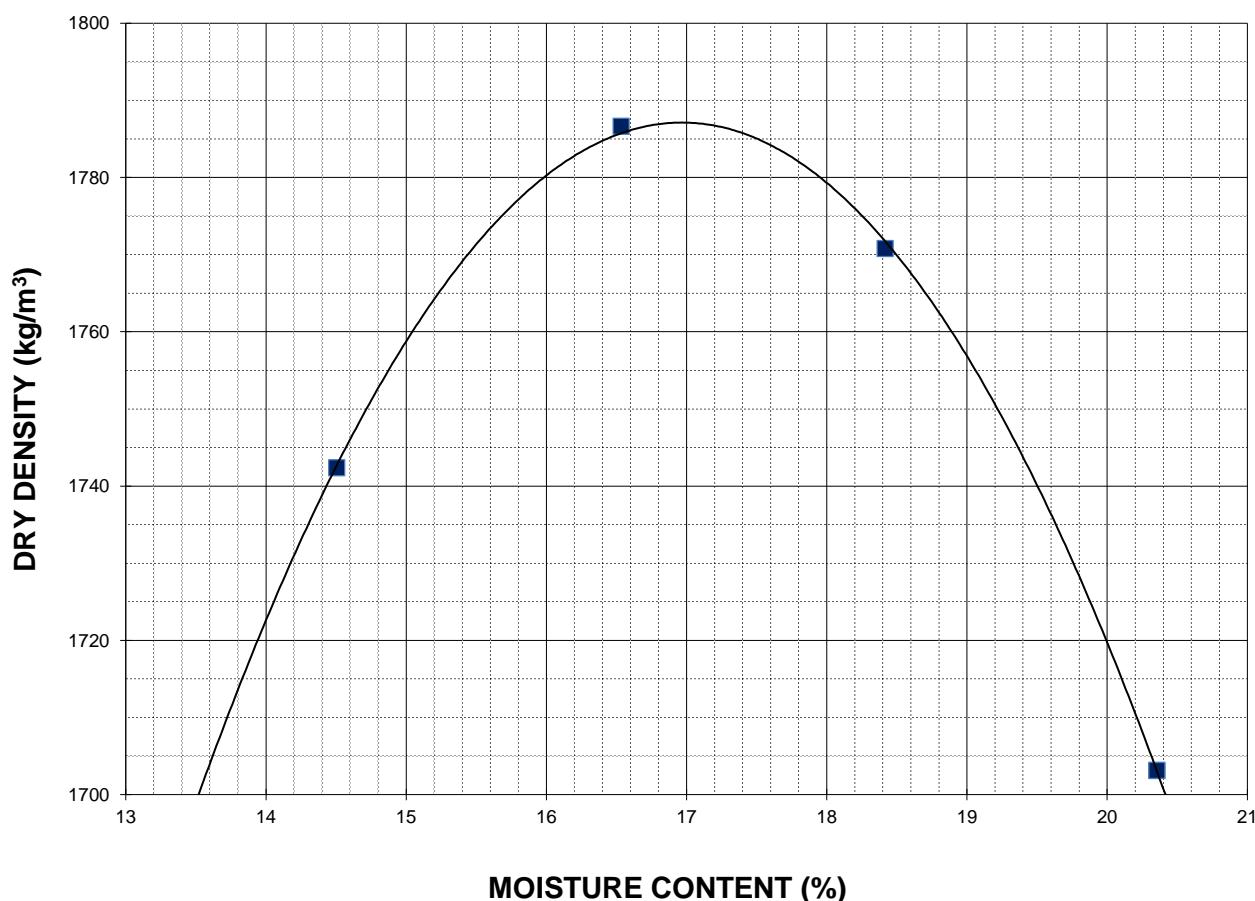
**Maximum Dry Density (kg/m<sup>3</sup>)** 1787  
**Optimum Moisture (%)** 17.0

Trial Number	1	2	3	4	
<b>Wet Density (kg/m<sup>3</sup>)</b>	1995	2082	2097	2050	
<b>Dry Density (kg/m<sup>3</sup>)</b>	1742	1787	1771	1703	
<b>Moisture Content (%)</b>	14.5	16.5	18.4	20.4

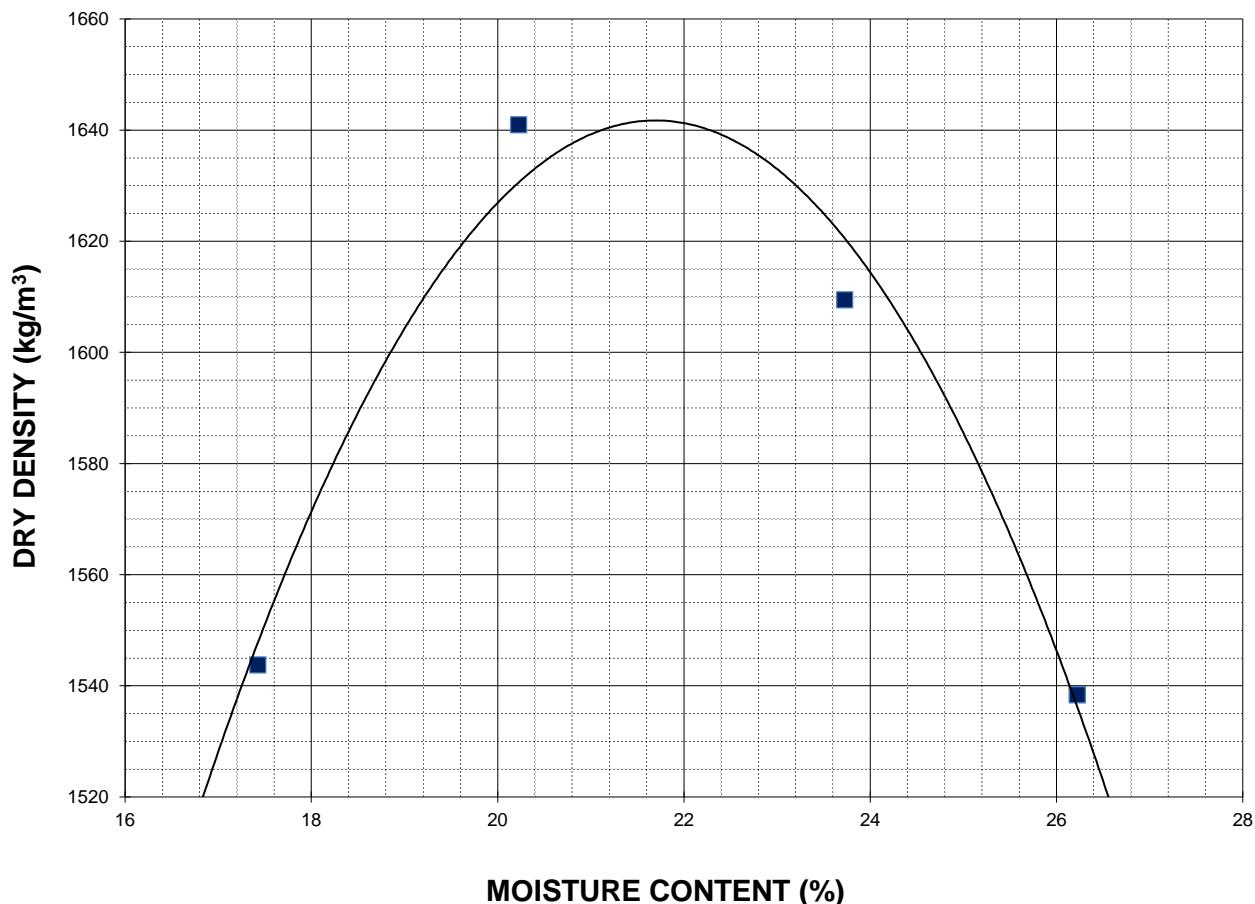
Maximum Dry Density (kg/m<sup>3</sup>) 1642  
Optimum Moisture (%) 21.7

Trial Number	1	2	3	4	
Wet Density (kg/m <sup>3</sup> )	1813	1973	1991	1942	
Dry Density (kg/m <sup>3</sup> )	1544	1641	1609	1538	
Moisture Content (%)	17.4	20.2	23.7	26.2

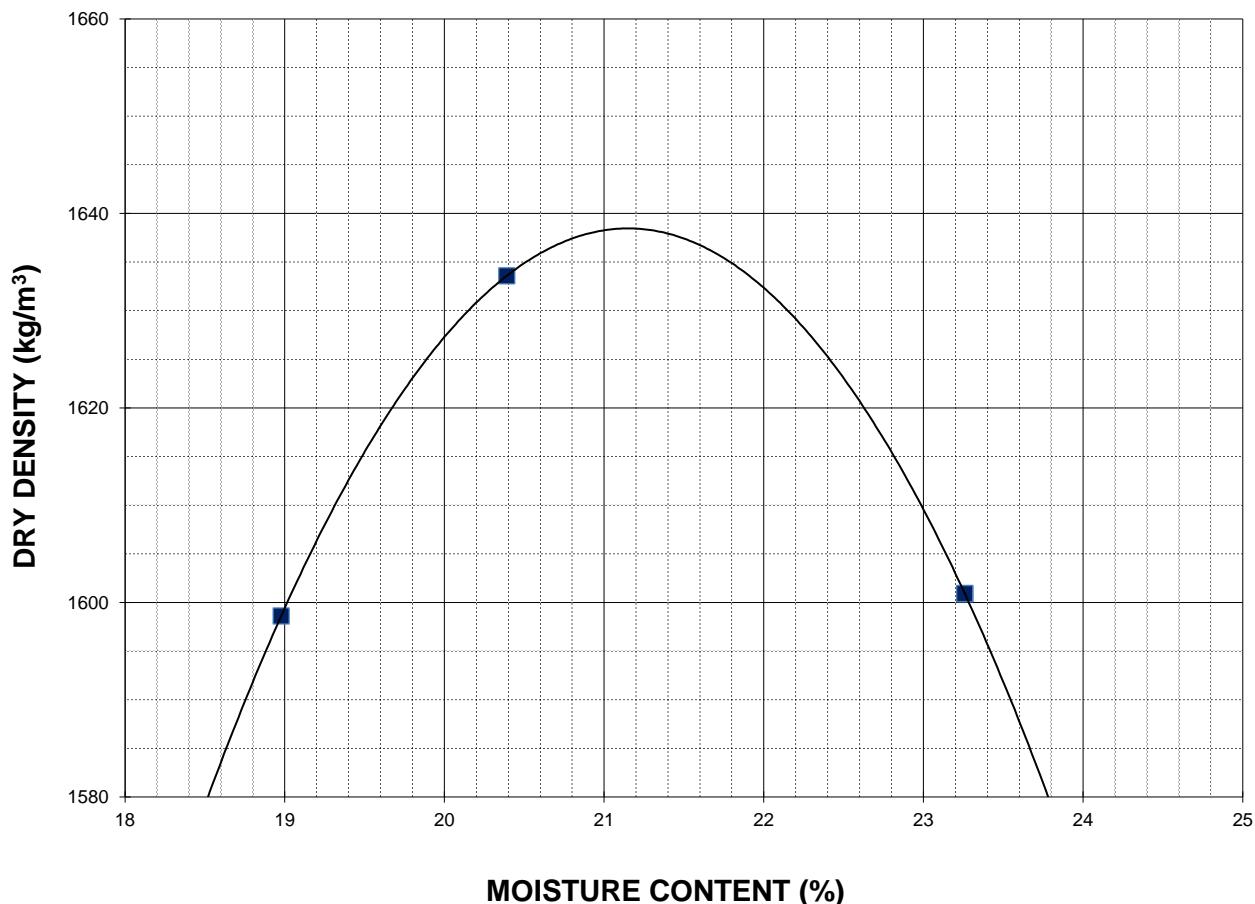
Maximum Dry Density (kg/m<sup>3</sup>) 1638  
Optimum Moisture (%) 21.1

Trial Number	1	2	3		
Wet Density (kg/m <sup>3</sup> )	1902	1967	1973		
Dry Density (kg/m <sup>3</sup> )	1599	1634	1601		
Moisture Content (%)	19.0	20.4	23.3

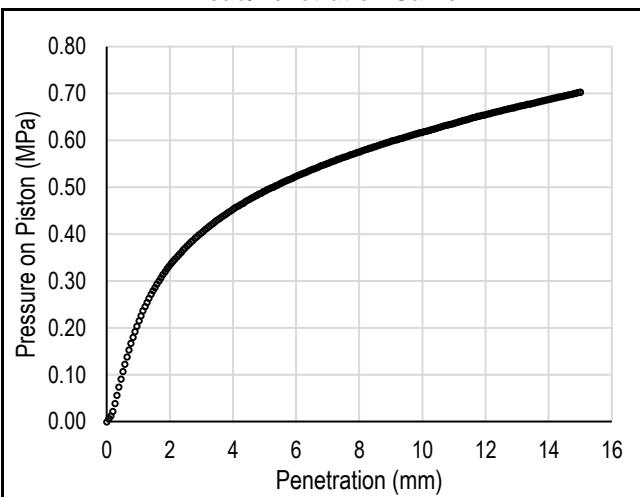
### Load/Penetration Curve

Dry Density	1702 kg/m <sup>3</sup>
Initial Moisture Content	17.0 %
Relative Density	95.3 % SPMDD

Surcharge	4.54 kg
Swell	0.2 %
Moisture Content in top 25 mm	19.6 %
Immersion Period	69 h

Penetration (mm)	Measured Pressure (MPa)	Corrected Pressure (MPa)
0.64	0.14	0.14
1.27	0.25	0.25
1.91	0.33	0.33
2.54	0.38	0.38
3.18	0.41	0.41
3.81	0.45	0.45
4.45	0.47	0.47
5.08	0.50	0.50
7.62	0.57	0.57
10.16	0.62	0.62
12.70	0.67	0.67

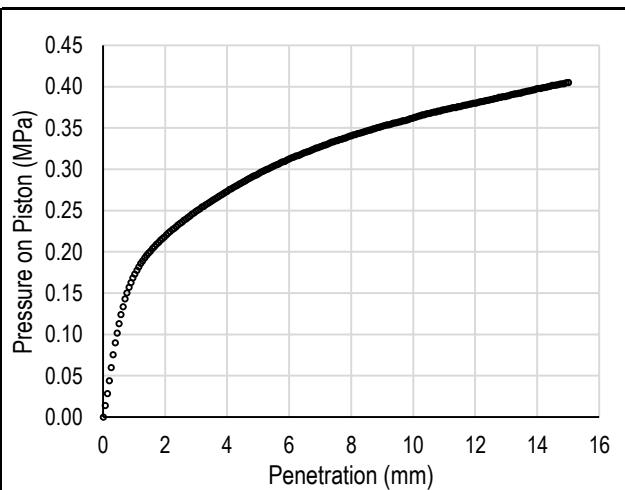
### Load/Penetration Curve

Dry Density                            1551 kg/m<sup>3</sup>  
Initial Moisture Content            23.4 %  
Relative Density                      94.4 % SPMDD

Surcharge                              4.54 kg  
Swell                                    0.7 %  
Moisture Content in top 25 mm    27.7 %  
Immersion Period                    92 h

Penetration (mm)	Measured Pressure (MPa)	Corrected Pressure (MPa)
0.64	0.13	0.13
1.27	0.19	0.19
1.91	0.22	0.22
2.54	0.24	0.24
3.18	0.25	0.25
3.81	0.27	0.27
4.45	0.28	0.28
5.08	0.30	0.30
7.62	0.34	0.34
10.16	0.36	0.36
12.70	0.39	0.39

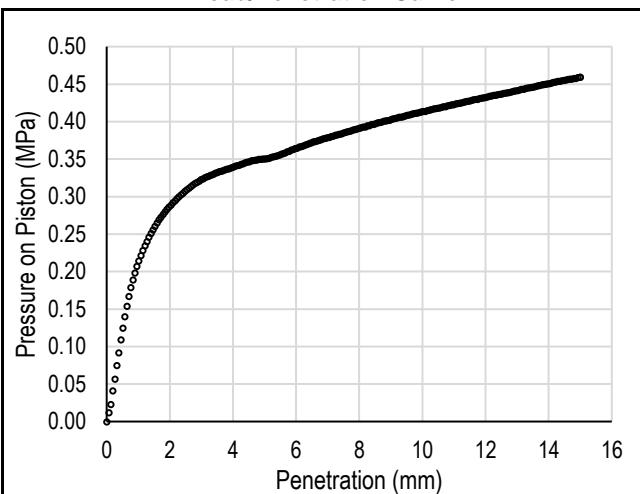
### Load/Penetration Curve

Dry Density	1545 kg/m <sup>3</sup>
Initial Moisture Content	24.5 %
Relative Density	94.3 % SPMDD

Surcharge	4.54 kg
Swell	0.5 %
Moisture Content in top 25 mm	29.0 %
Immersion Period	96 h

Penetration (mm)	Measured Pressure (MPa)	Corrected Pressure (MPa)
0.64	0.15	0.15
1.27	0.24	0.24
1.91	0.28	0.28
2.54	0.31	0.31
3.18	0.33	0.33
3.81	0.34	0.34
4.45	0.35	0.35
5.08	0.35	0.35
7.62	0.39	0.39
10.16	0.42	0.42
12.70	0.44	0.44

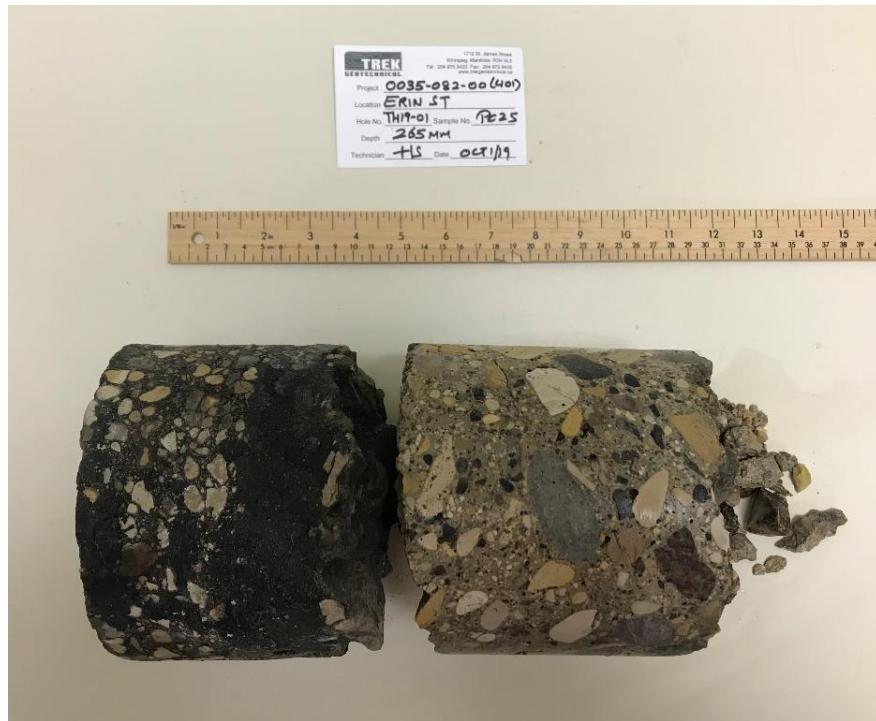
Photo 1: Pavement Core Sample at Test Hole TH19-01

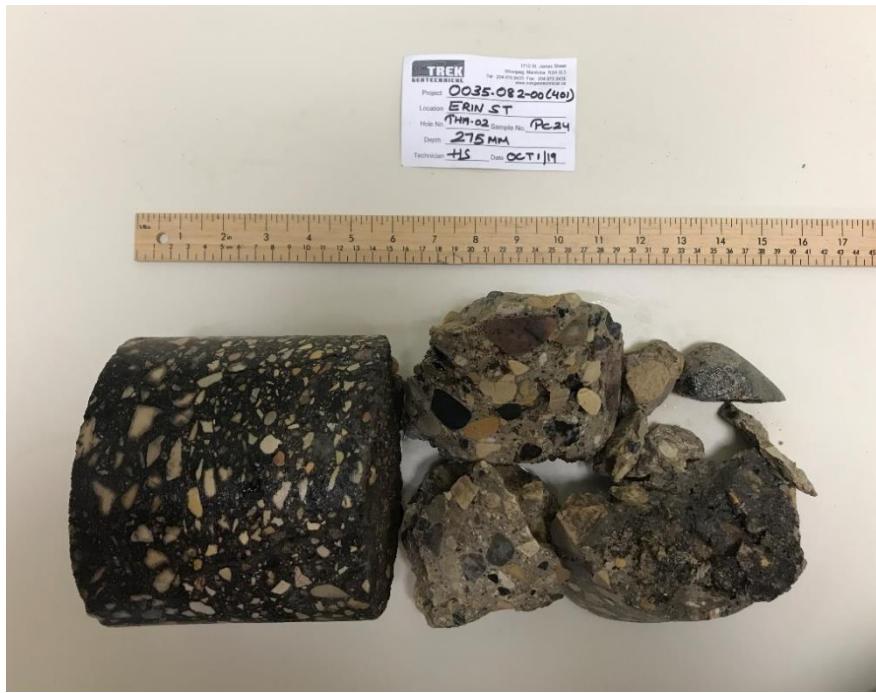
Photo 2: Pavement Core Sample at Test Hole TH19-02

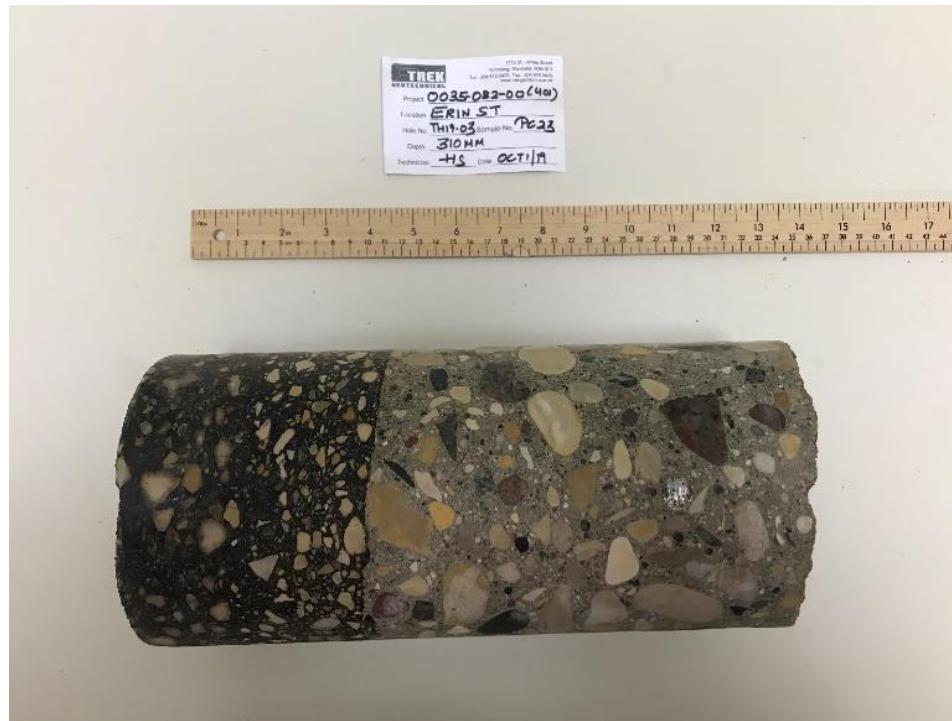
Photo 3: Pavement Core Sample at Test Hole TH19-03

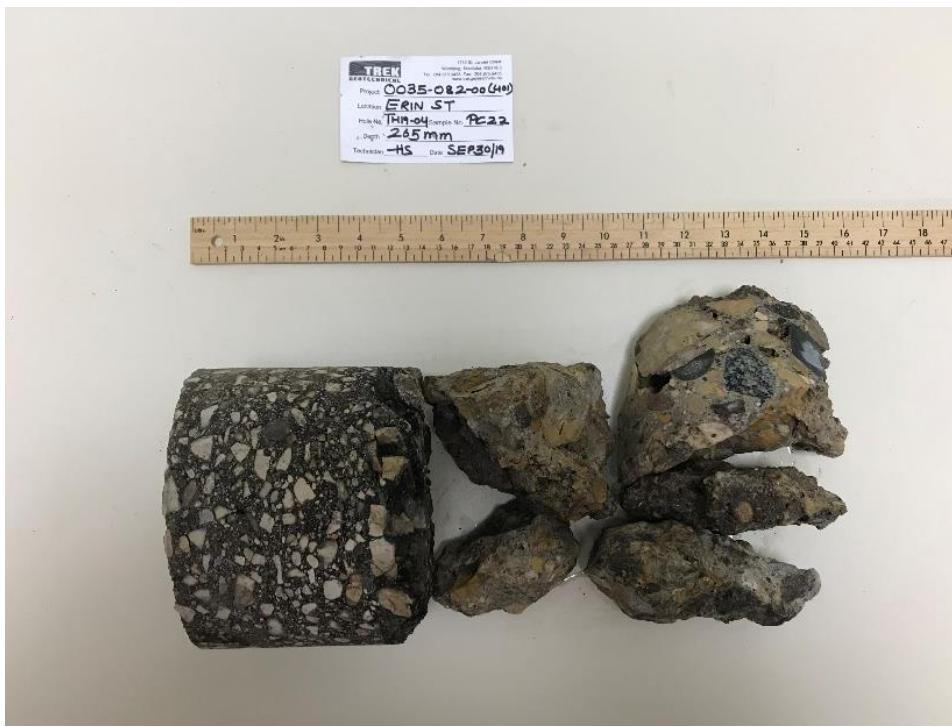
Photo 4: Pavement Core Sample at Test Hole TH19-04

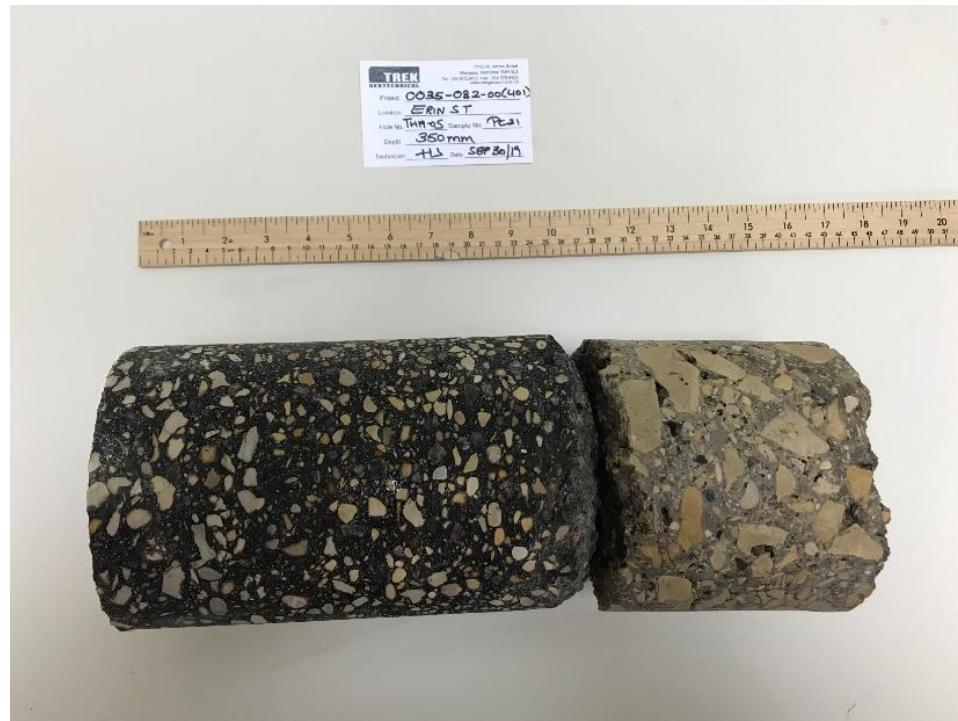
Photo 5: Pavement Core Sample at Test Hole TH19-05

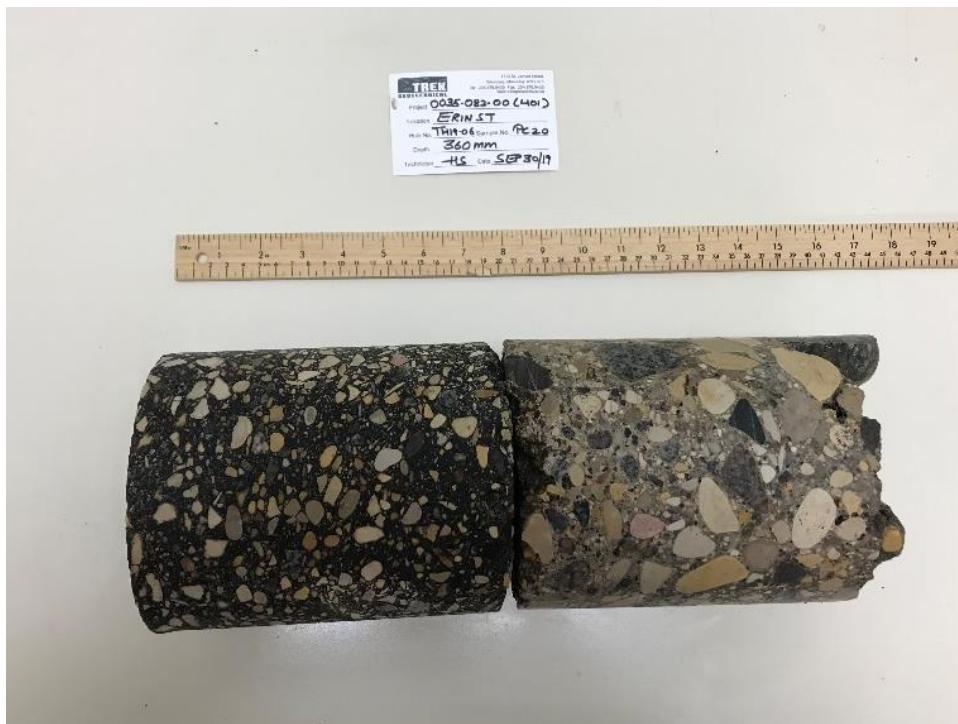
Photo 6: Pavement Core Sample at Test Hole TH19-06

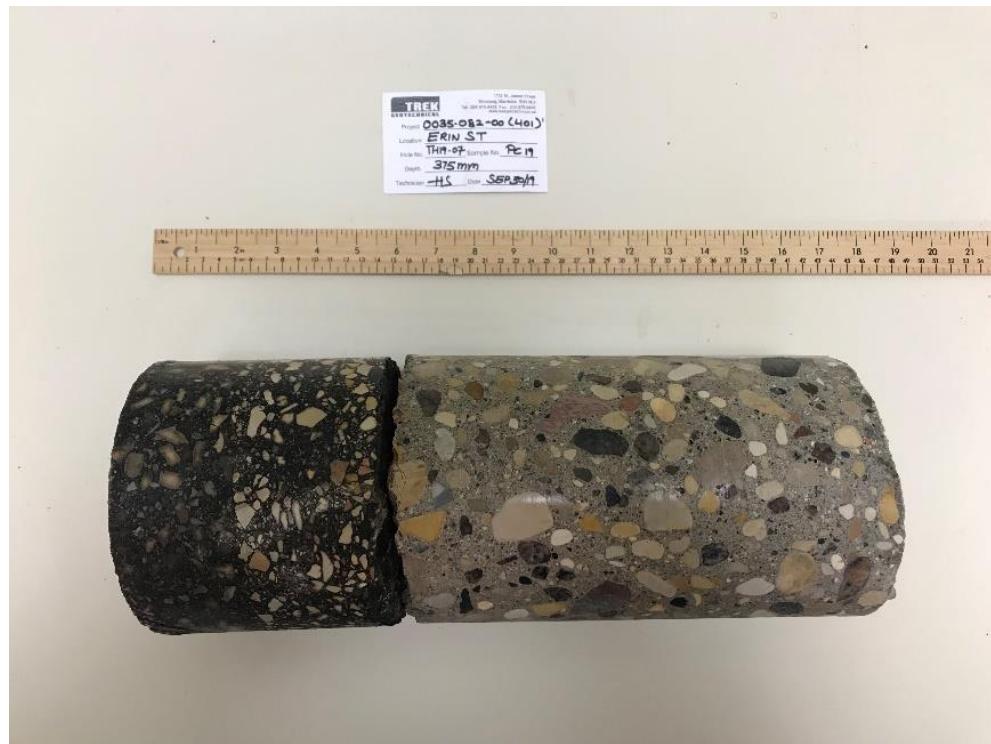
Photo 7: Pavement Core Sample at Test Hole TH19-07

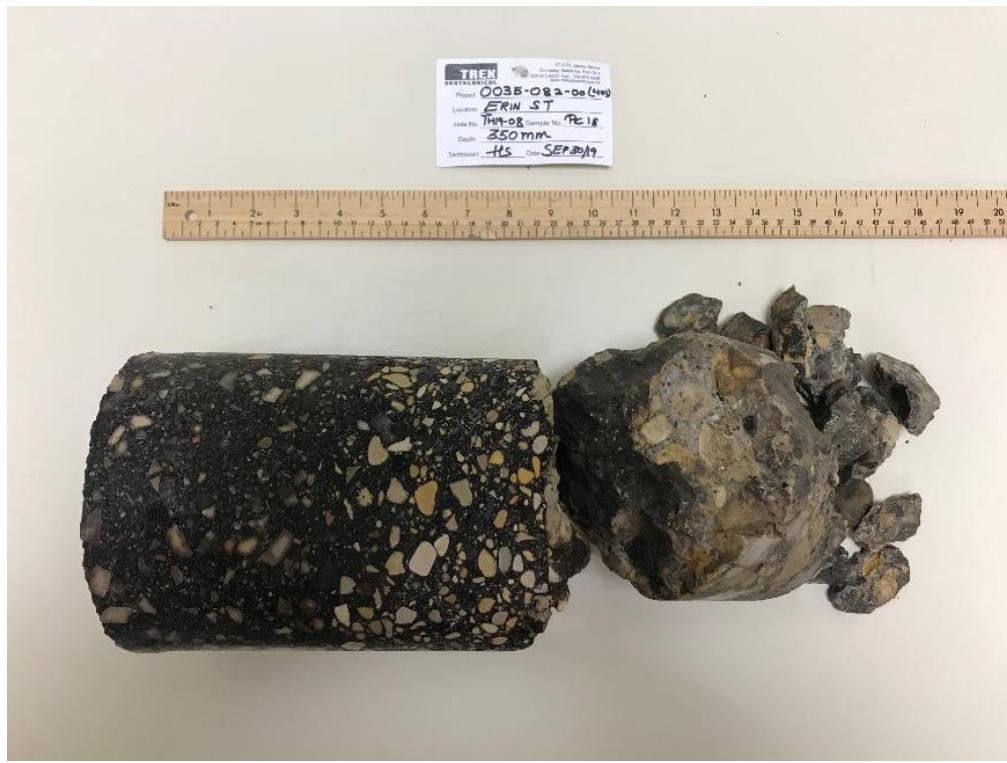
Photo 8: Pavement Core Sample at Test Hole TH19-08

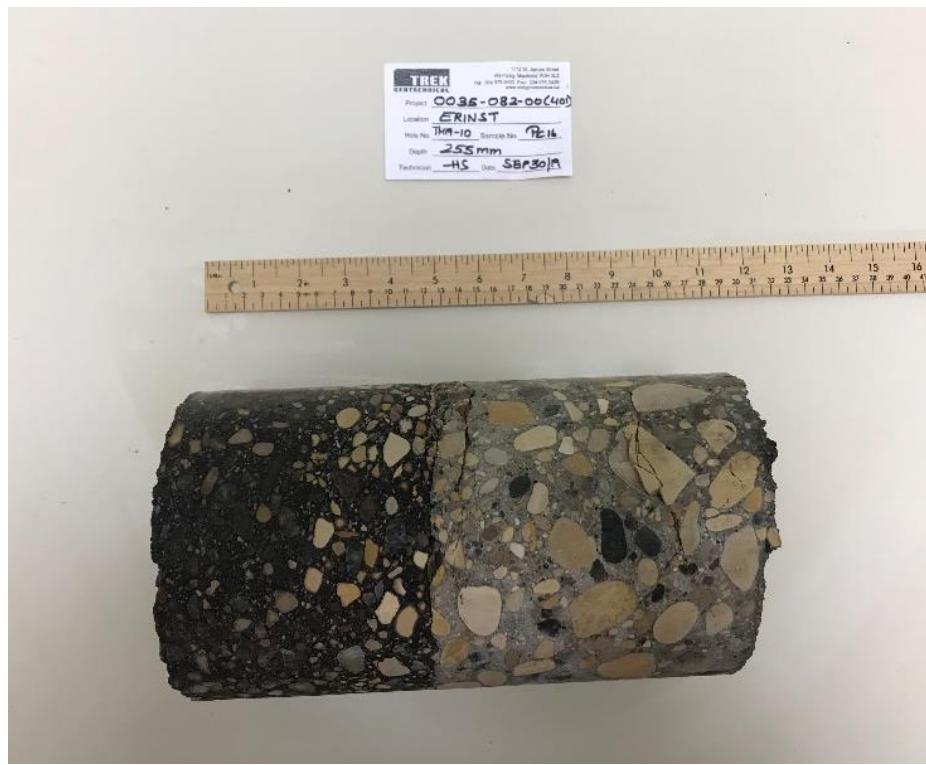
Photo 10: Pavement Core Sample at Test Hole TH19-10

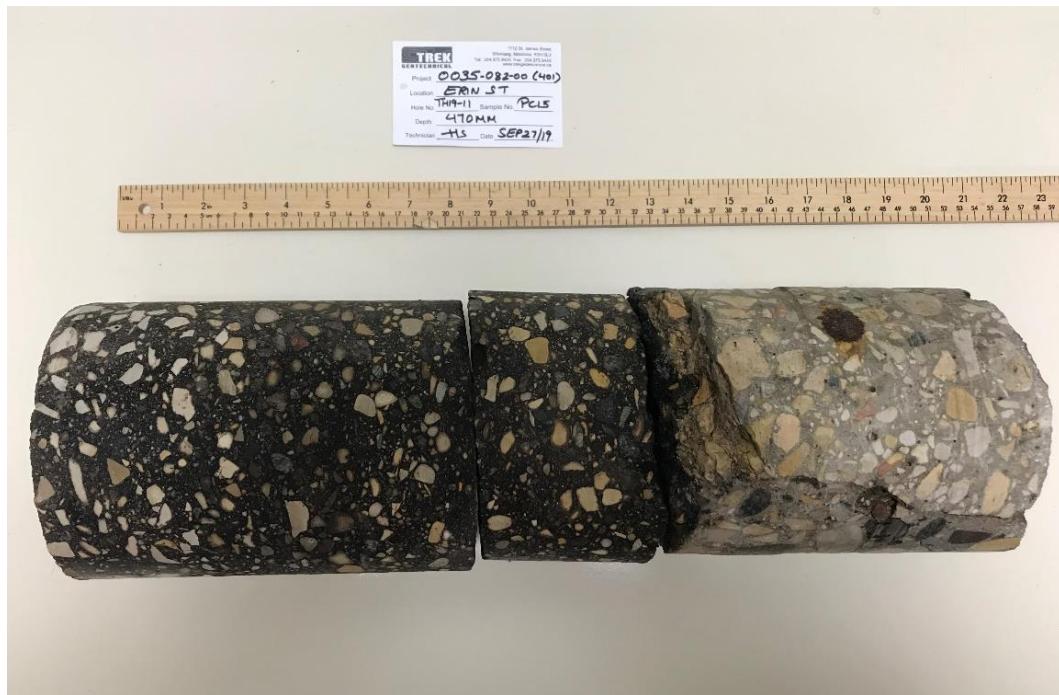
Photo 11: Pavement Core Sample at Test Hole TH19-11

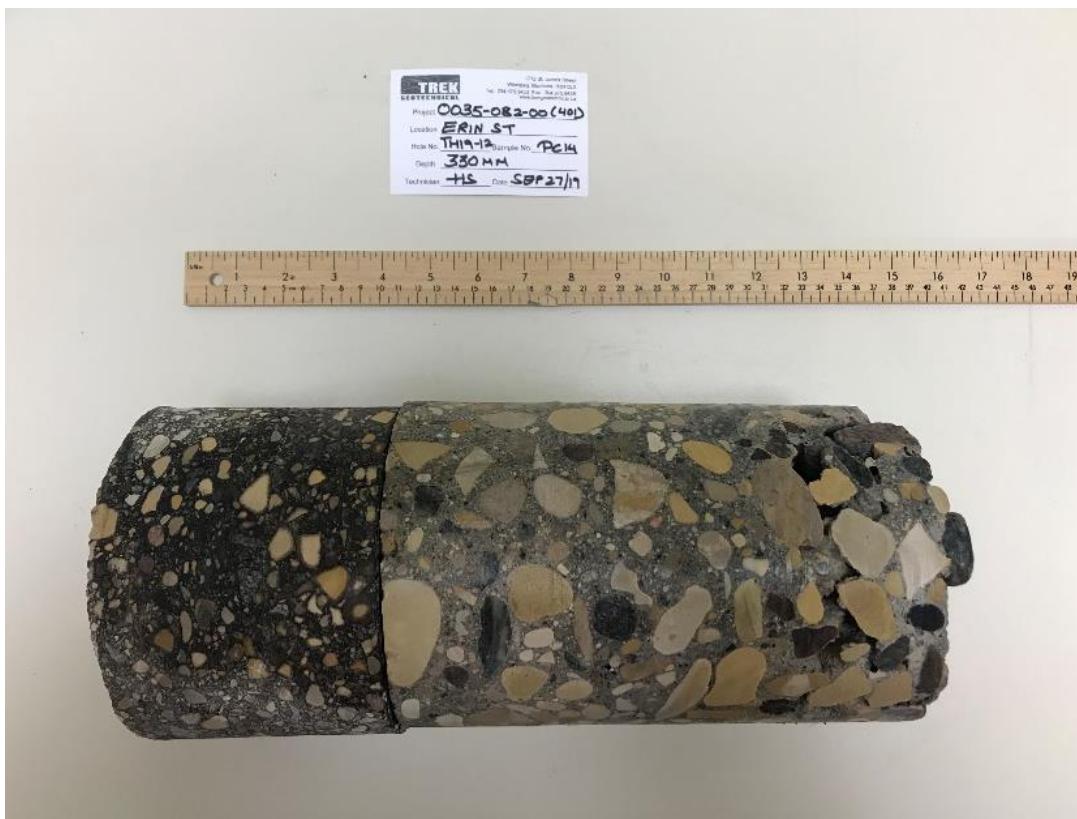
Photo 12: Pavement Core Sample at Test Hole TH19-12

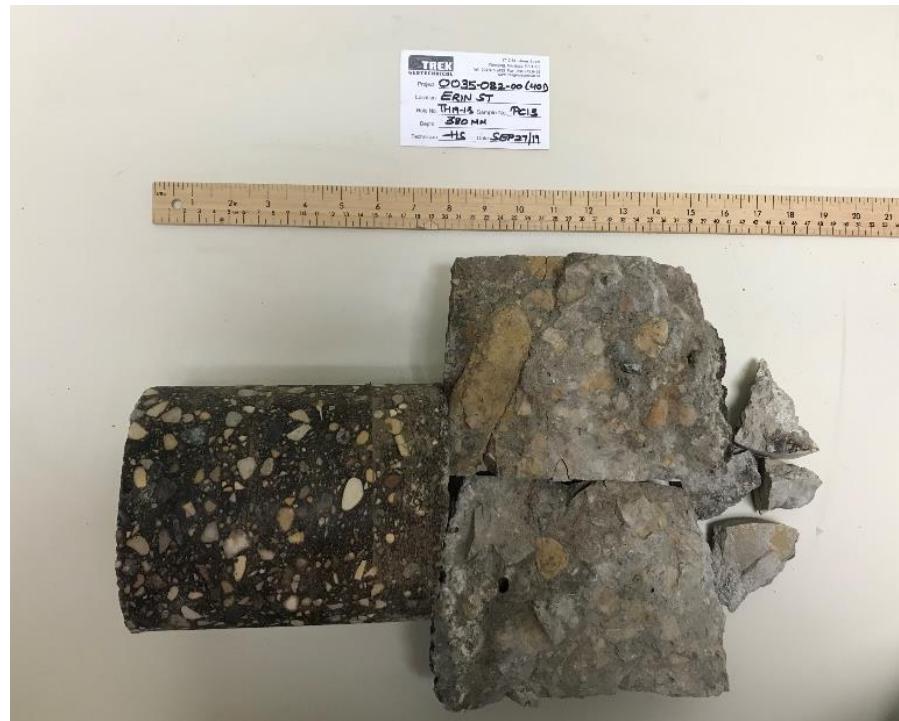
Photo 13: Pavement Core Sample at Test Hole TH19-13
