# **GEOTECHNICAL REPORT**

## **19-C-10 Erin Street Pavement Renewal**

**RE: Sub-Surface Investigation Report for  
19-C-10 Erin Pavement Renewal**

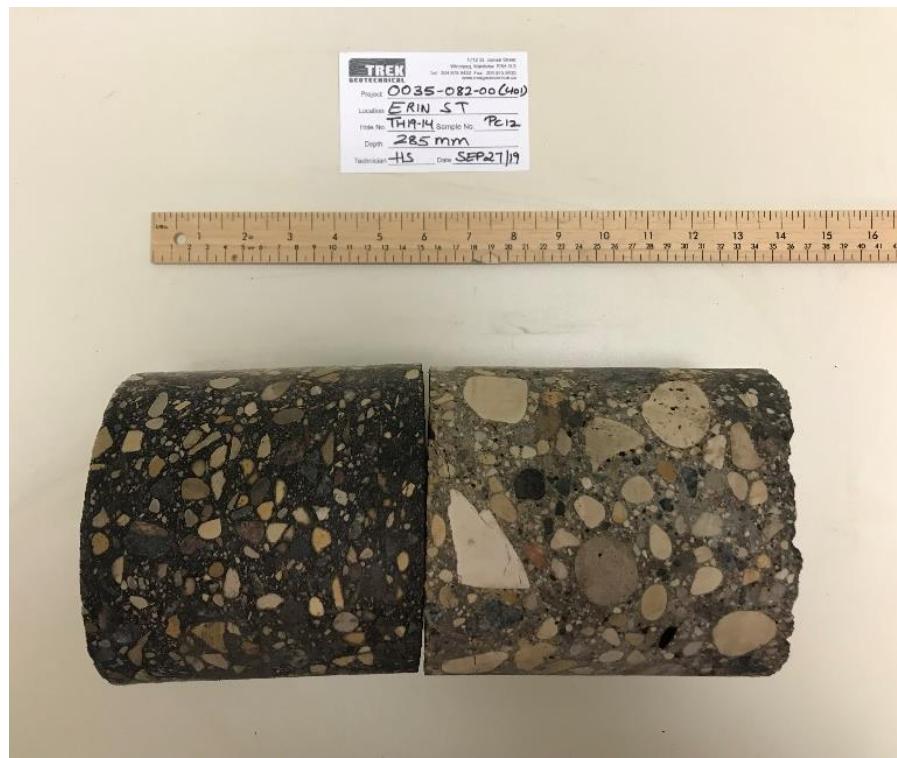
Photo 14: Pavement Core Sample at Test Hole TH19-14

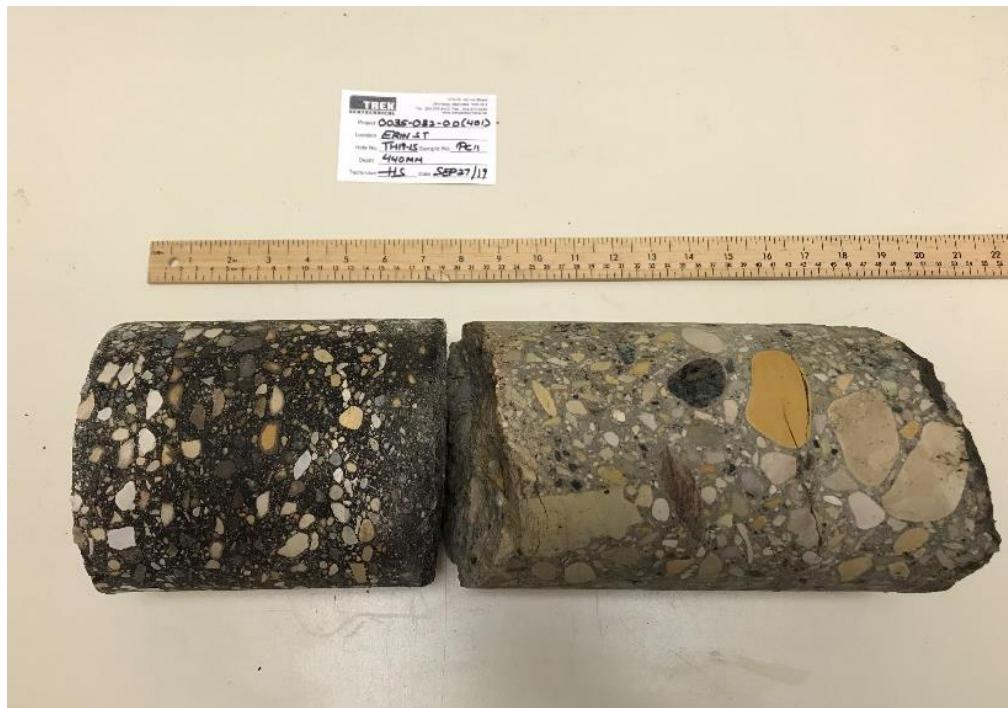
Photo 15: Pavement Core Sample at Test Hole TH19-15

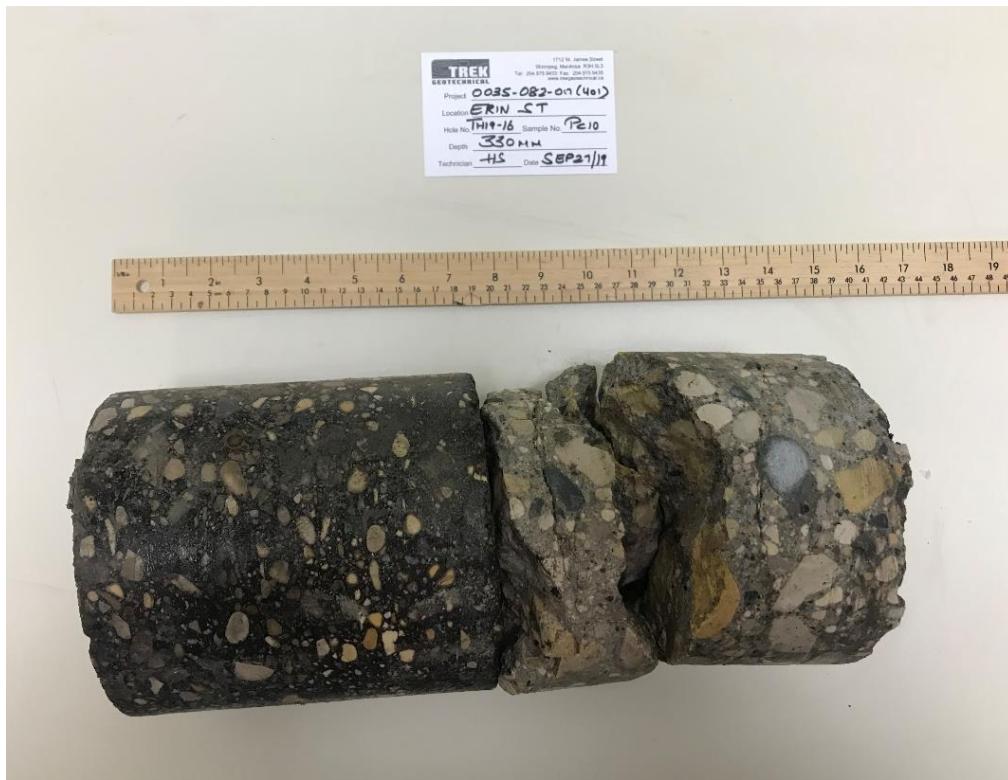
Photo 16: Pavement Core Sample at Test Hole TH19-16

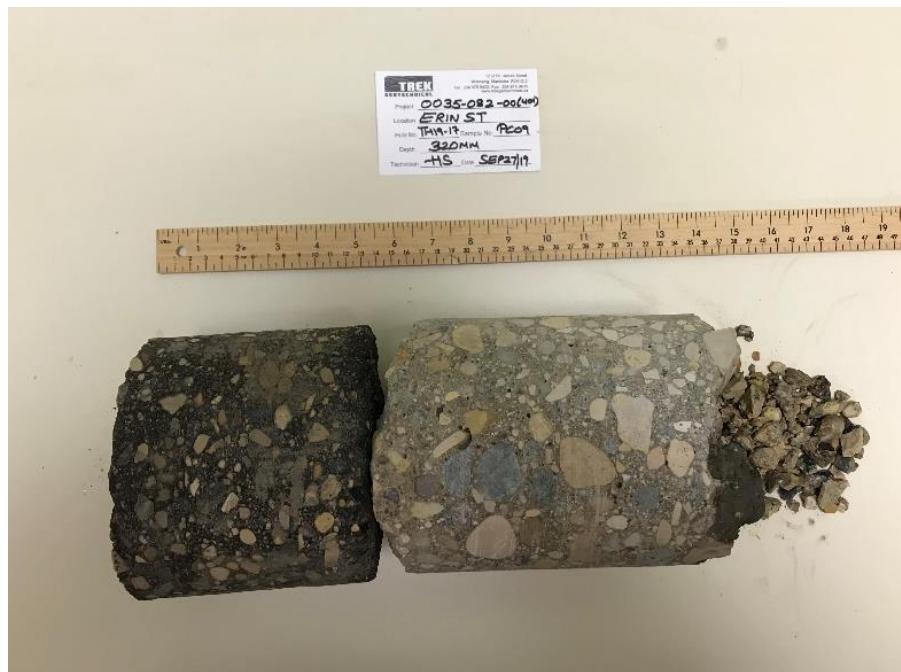
Photo 17: Pavement Core Sample at Test Hole TH19-17

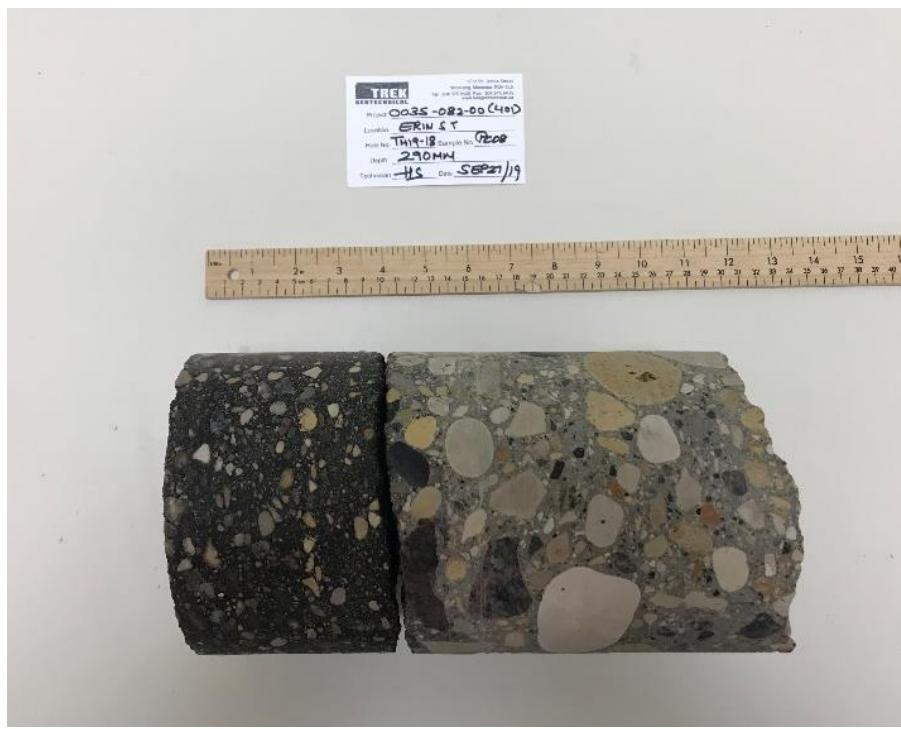
Photo 18: Pavement Core Sample at Test Hole TH19-18

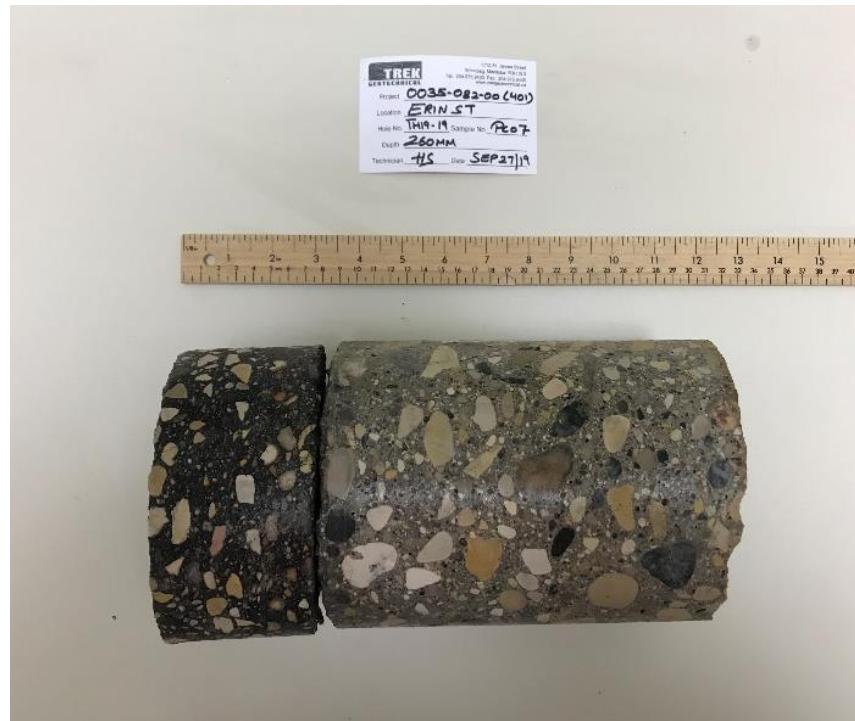
Photo 19: Pavement Core Sample at Test Hole TH18-19

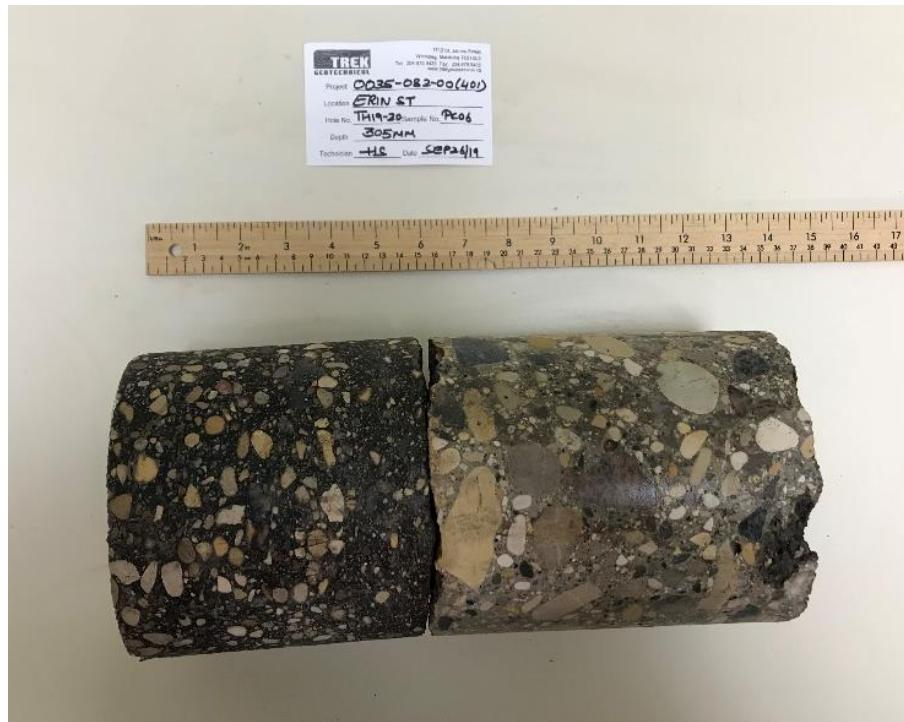
Photo 20: Pavement Core Sample at Test Hole TH19-20

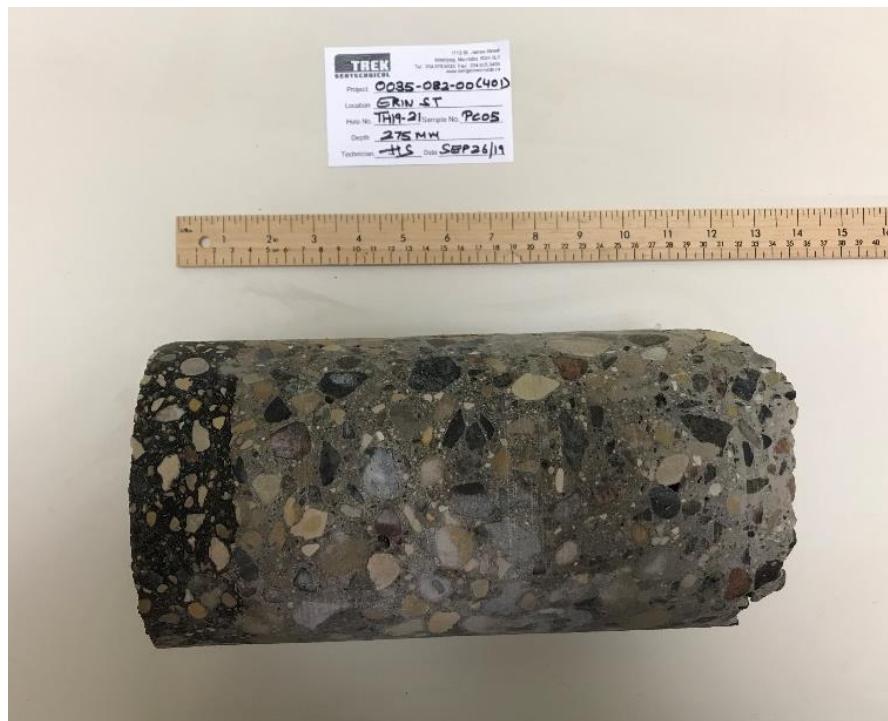
Photo 21: Pavement Core Sample at Test Hole TH19-21

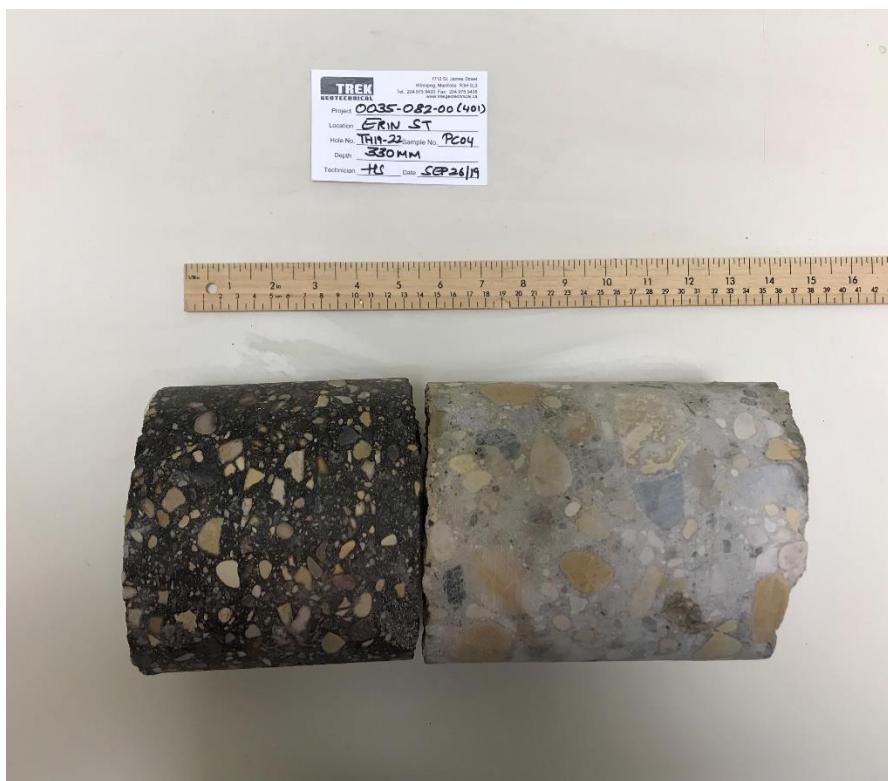
Photo 22: Pavement Core Sample at Test Hole TH19-22

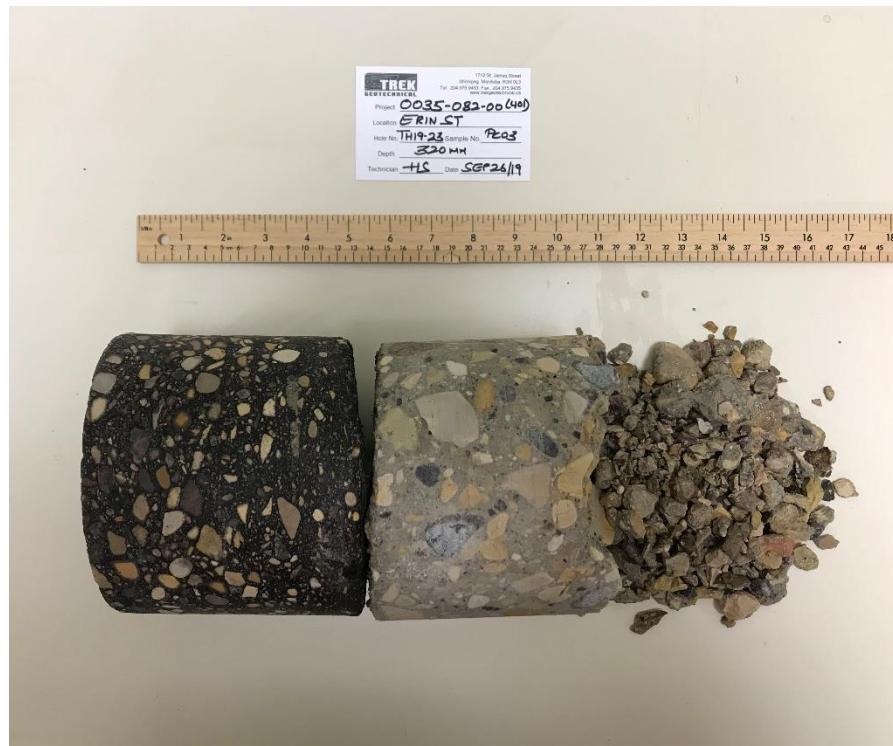
Photo 23: Pavement Core Sample at Test Hole TH19-23

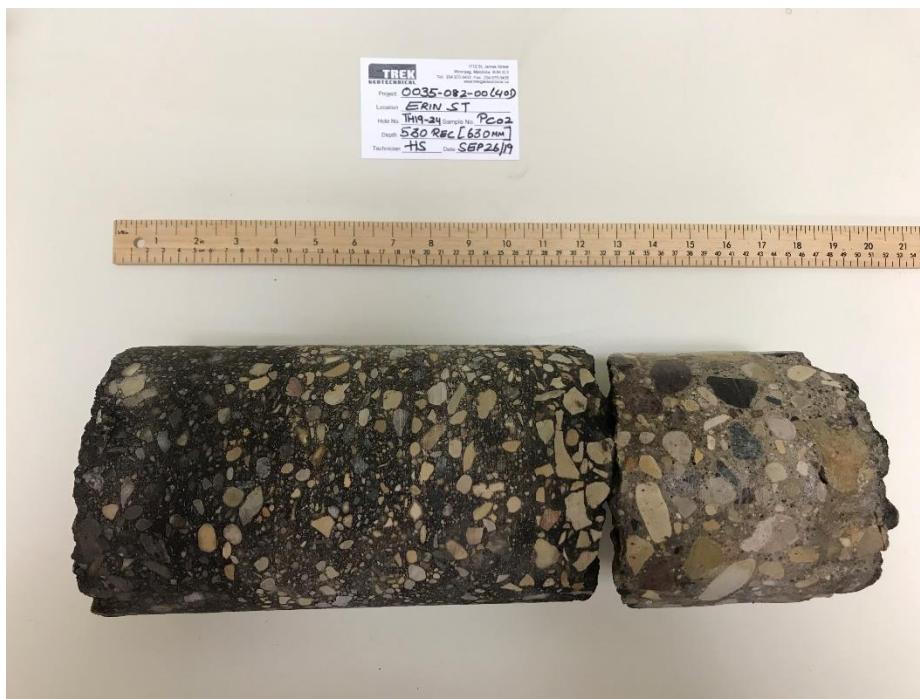
Photo 24: Pavement Core Sample at Test Hole TH19-24

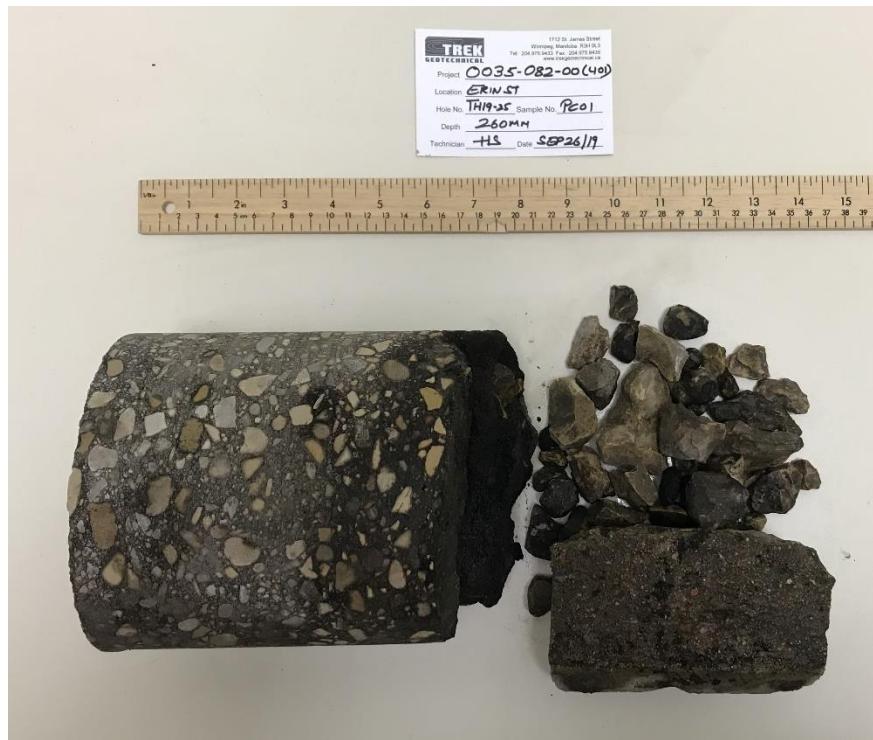
Photo 25: Pavement Core Sample at Test Hole TH19-25
