Pinchin Environmental Asbestos Laboratory Certificate of Analysis

Project Name:	City of Winnipeg, Administration Bldg. North End Water Pollution Control Centre, 2230 Main St., Winnipeg, MB 68112		
Project No.:	68112		
Prepared For:	L. Cruz / J. Combe	Date Received:	May 16, 2011
Lab Reference No.:	b80899	Date Analyzed:	May 25, 2011
Analyst(s):	N. Barinque	# Samples submitted:	5
		# Phases analyzed:	5

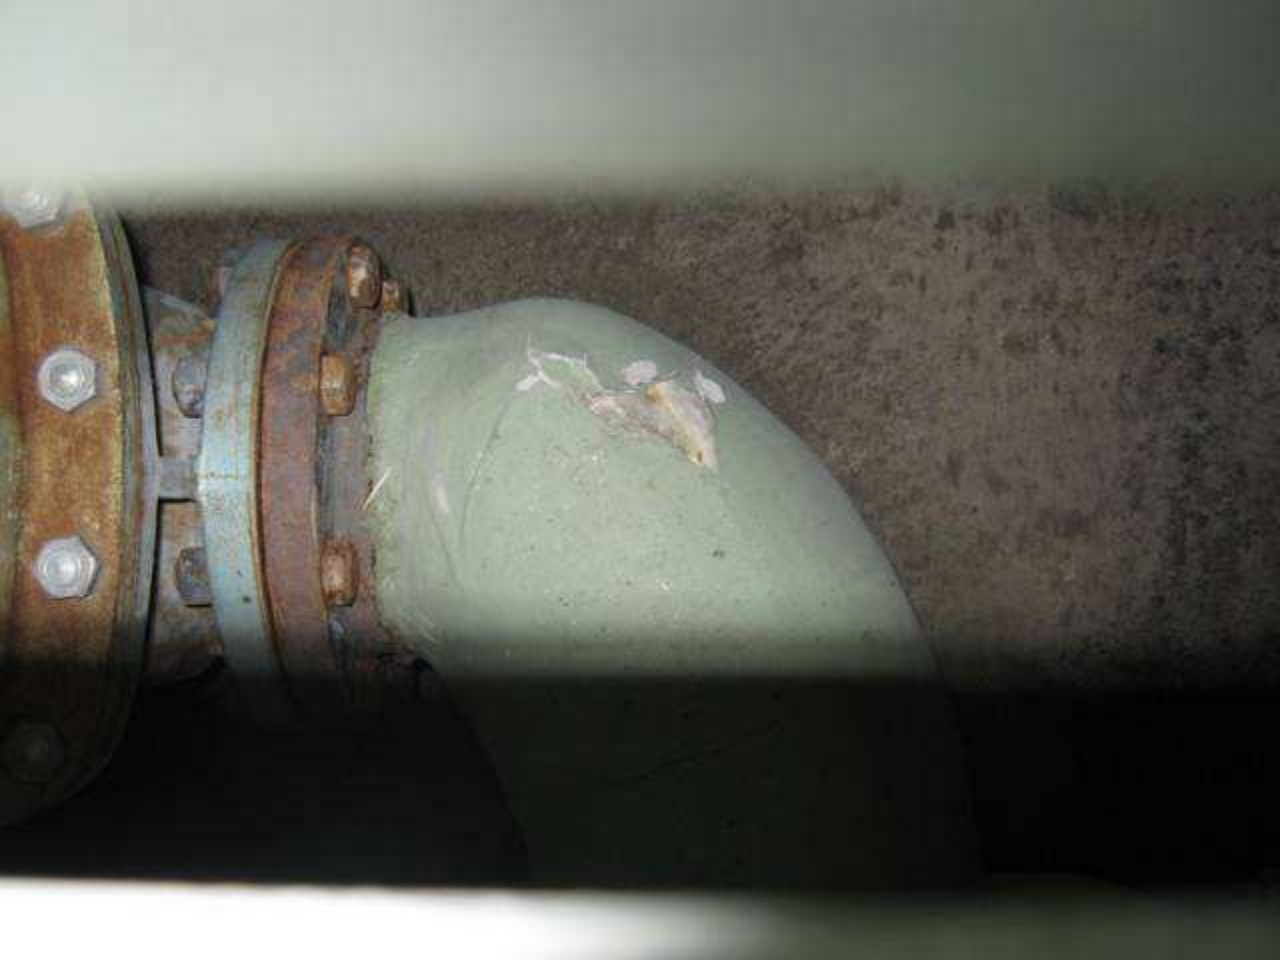
A photograph of a utility room corner. A green pipe runs horizontally across the top and bottom of the frame. A yellow label is attached to the vertical section of the pipe on the right side. A light fixture is mounted on the wall, and a grey electrical box is visible in the top left corner. The wall is off-white and shows some signs of wear.

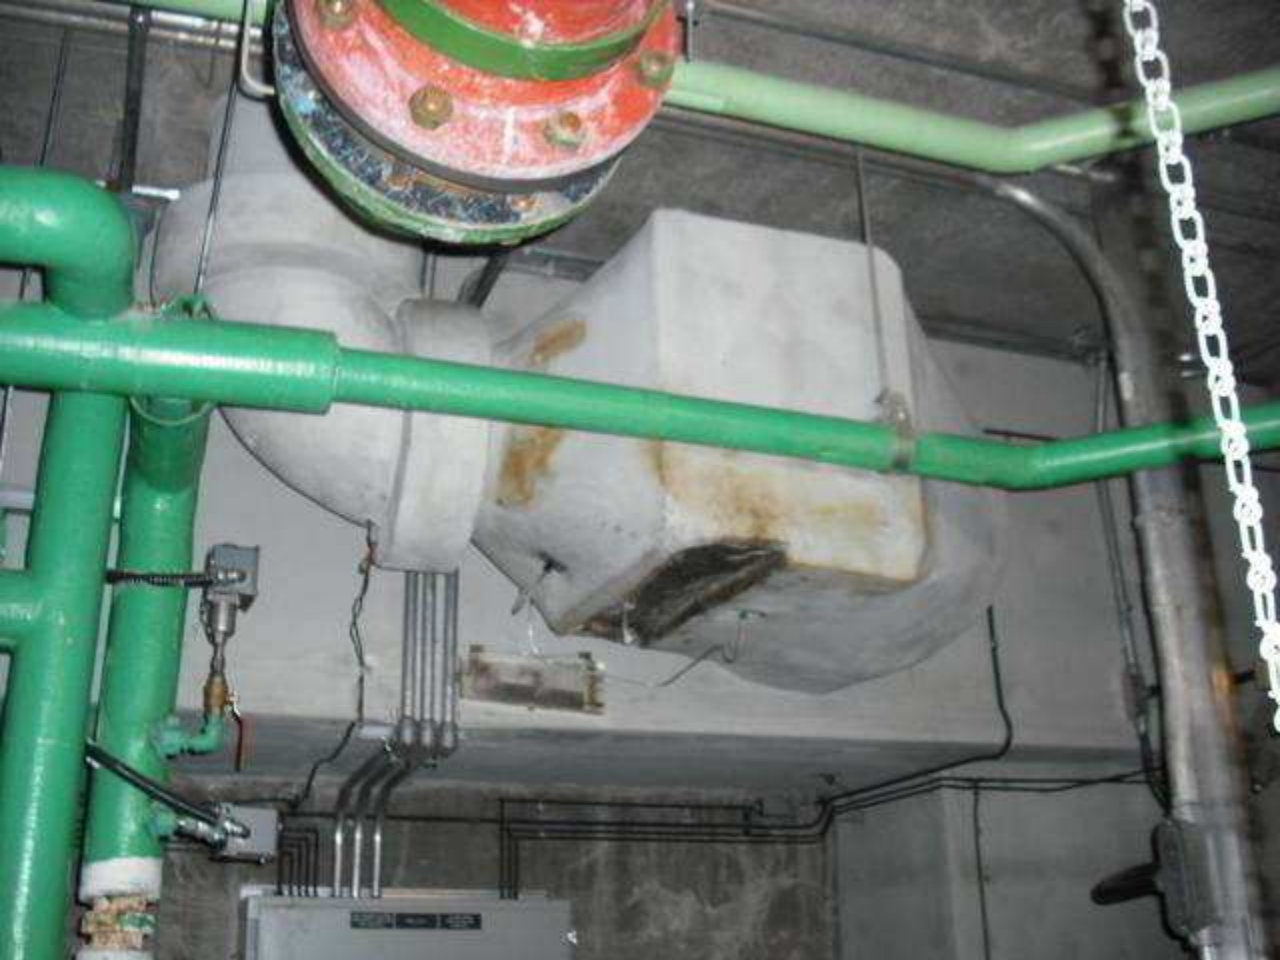
The image shows a dense network of industrial pipes. A large, horizontal white pipe runs across the middle of the frame. Attached to it is a yellow rectangular warning label with black text. Above and to the right of this pipe, there are several large green pipes with complex fittings and elbows. In the background, there are more pipes, some of which are white and appear to be wrapped in a protective material. A metal chain hangs vertically from the right side of the white pipe. The overall environment is industrial and somewhat cluttered.

CAUTION
ASBESTOS PRESENT
AT FITTINGS

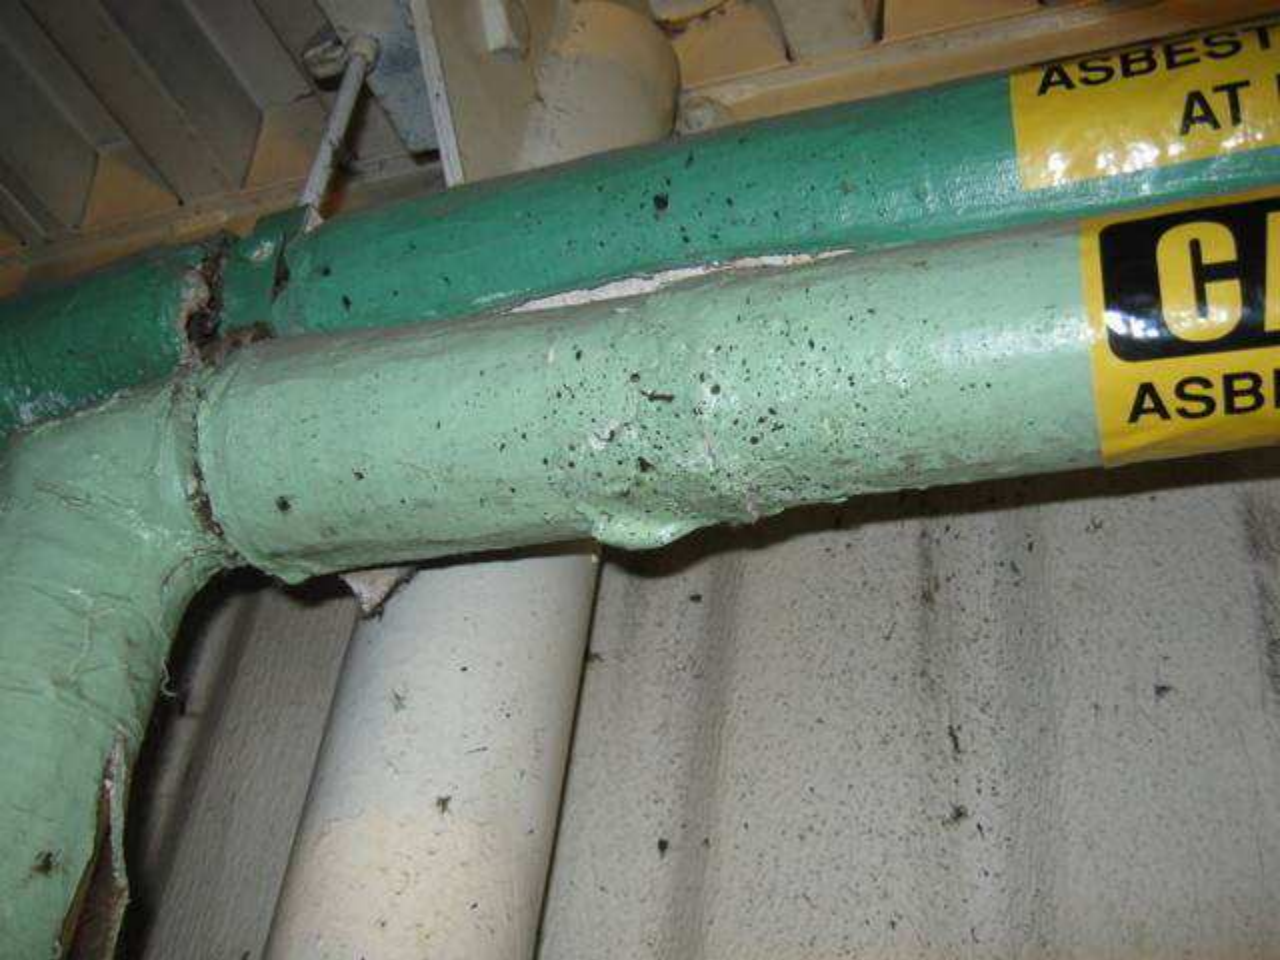
A photograph showing industrial piping. A blue pipe runs horizontally across the frame, with a 90-degree elbow. A yellow warning label is attached to the blue pipe. Above the blue pipe, a green pipe runs horizontally. To the left, a series of white pipes are connected to a grey component. A valve with a silver handle is attached to the blue pipe. The background consists of a white corrugated metal ceiling.

CAUTION
ASBESTOS PRESENT
AT FITTINGS

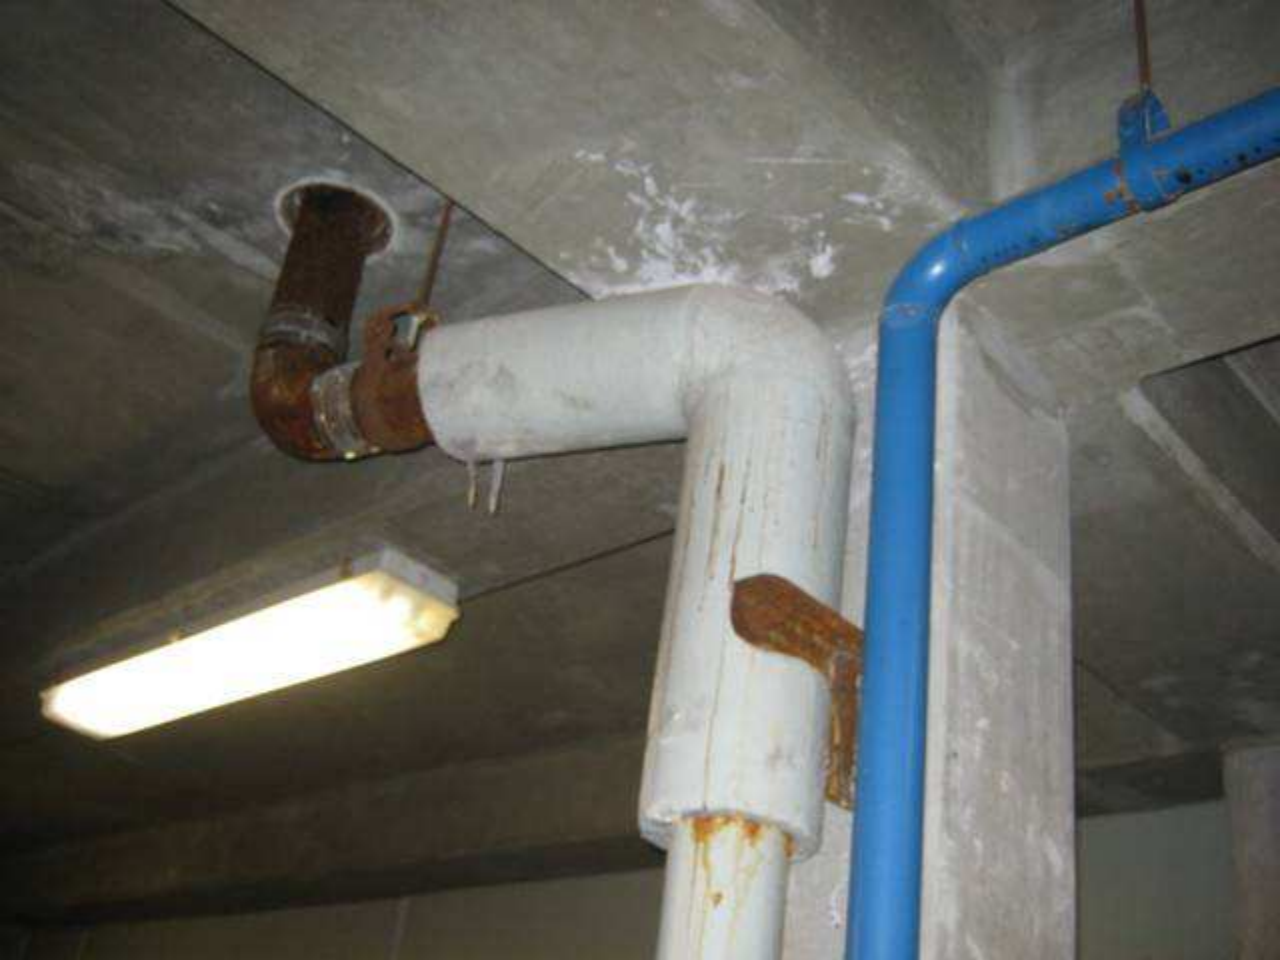
A photograph of a white pipe in an industrial or utility setting. The pipe is wrapped in white insulation. A yellow caution label is affixed to the pipe, with the text "CAUTION" in large bold letters, "ASBESTOS PRESENT" in smaller letters below it, and "AT FITTINGS" at the bottom. A rusty metal bracket is attached to the pipe. In the background, there is a blue metal structure and a glowing fluorescent light fixture. The ceiling is made of acoustic tiles.

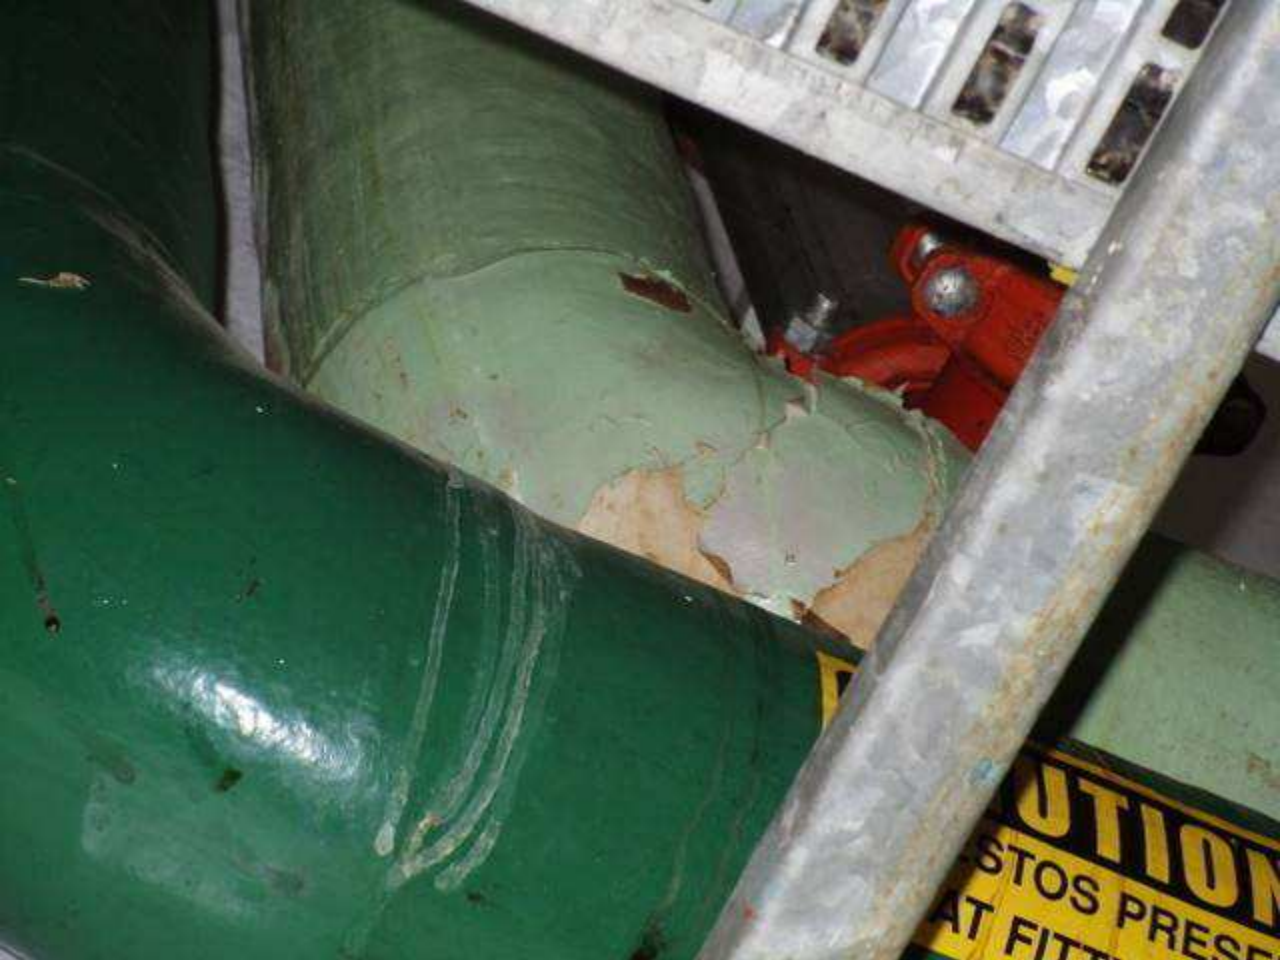
A photograph of a green-painted metal pipe. A yellow rectangular label with black text is affixed to the pipe. To the right of the label, there is a metal fitting with some rust and a metal plate attached to it. The pipe is situated in a mechanical room, with a metal grate floor visible above and a metal support structure to the left. The background is a plain, light-colored wall.

CAUTION
ASBESTOS PRESENT
AT FITTINGS

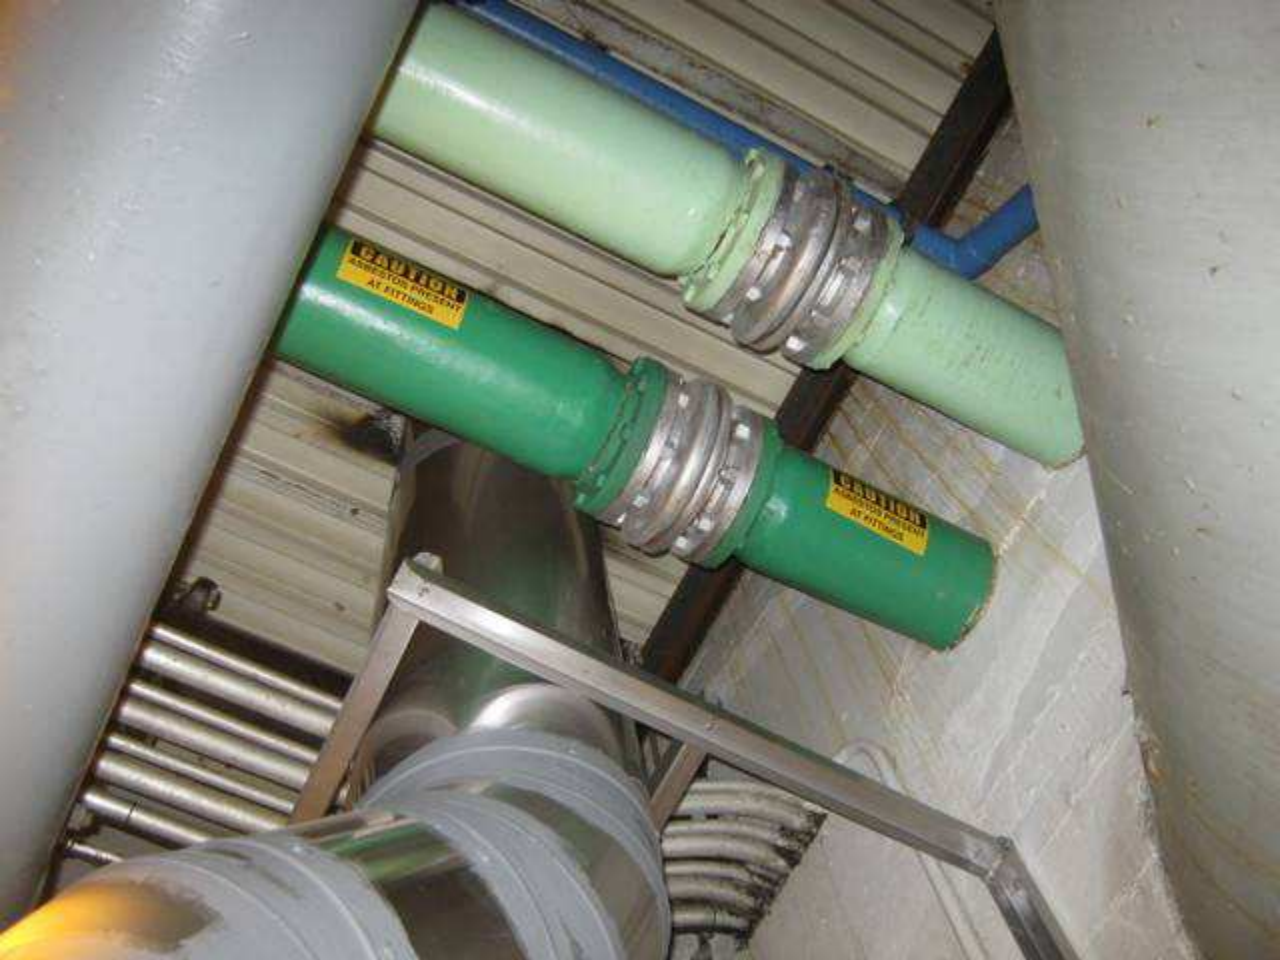
A photograph showing a green pipe or ductwork. A yellow warning label is affixed to the pipe, reading "CAUTION" in large letters, with "ASBESTOS PRESENT" and "AT FITTINGS" in smaller text below. To the right of the label, there is a metal fitting or valve assembly with some rust and debris. The pipe is situated in a confined space, possibly under a metal grate or staircase, with a light-colored wall and floor visible. A vertical metal support post is on the left side of the pipe.

CAUTION
ASBESTOS PRESENT
AT FITTINGS
