ASBESTOS INVENTORY CONTROL

Building Name:	Building A, Maintenance Shop	Inspection Date:	September 2024
Building Code:	TR01	Inspected By:	Winnipeg Air Testing
Building Address:	421 Osborne Street	Construction Date:

ASBESTOS LOCATIONS

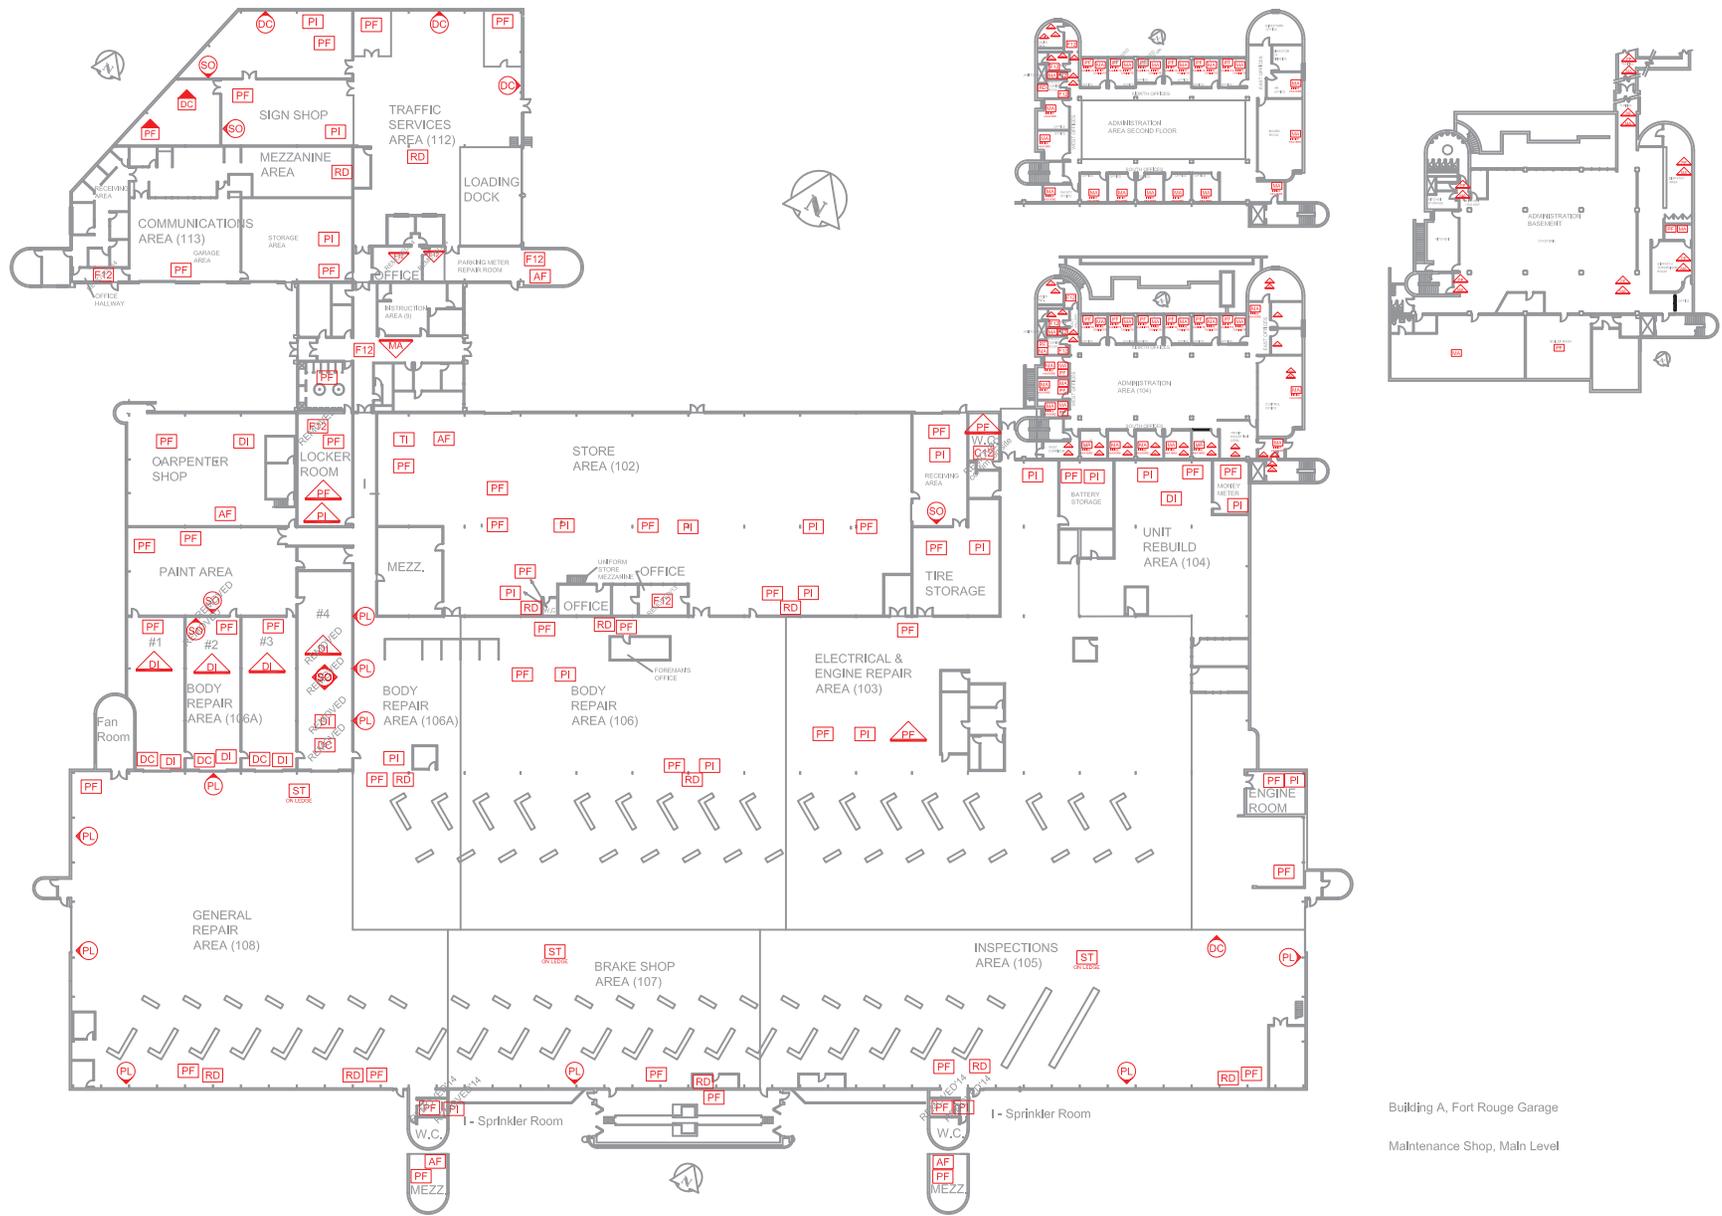
BUILDING:	TRANSIT BUILDING A 421 OSBORNE STREET WINNIPEG, MANITOBA		
REVISED BY:	DATE:	SCALE:	SHEET #:
REM	July 9, 2014	N.T.S.	1/6

Building A, Fort Rouge Garage
Maintenance Shop, Malt Level

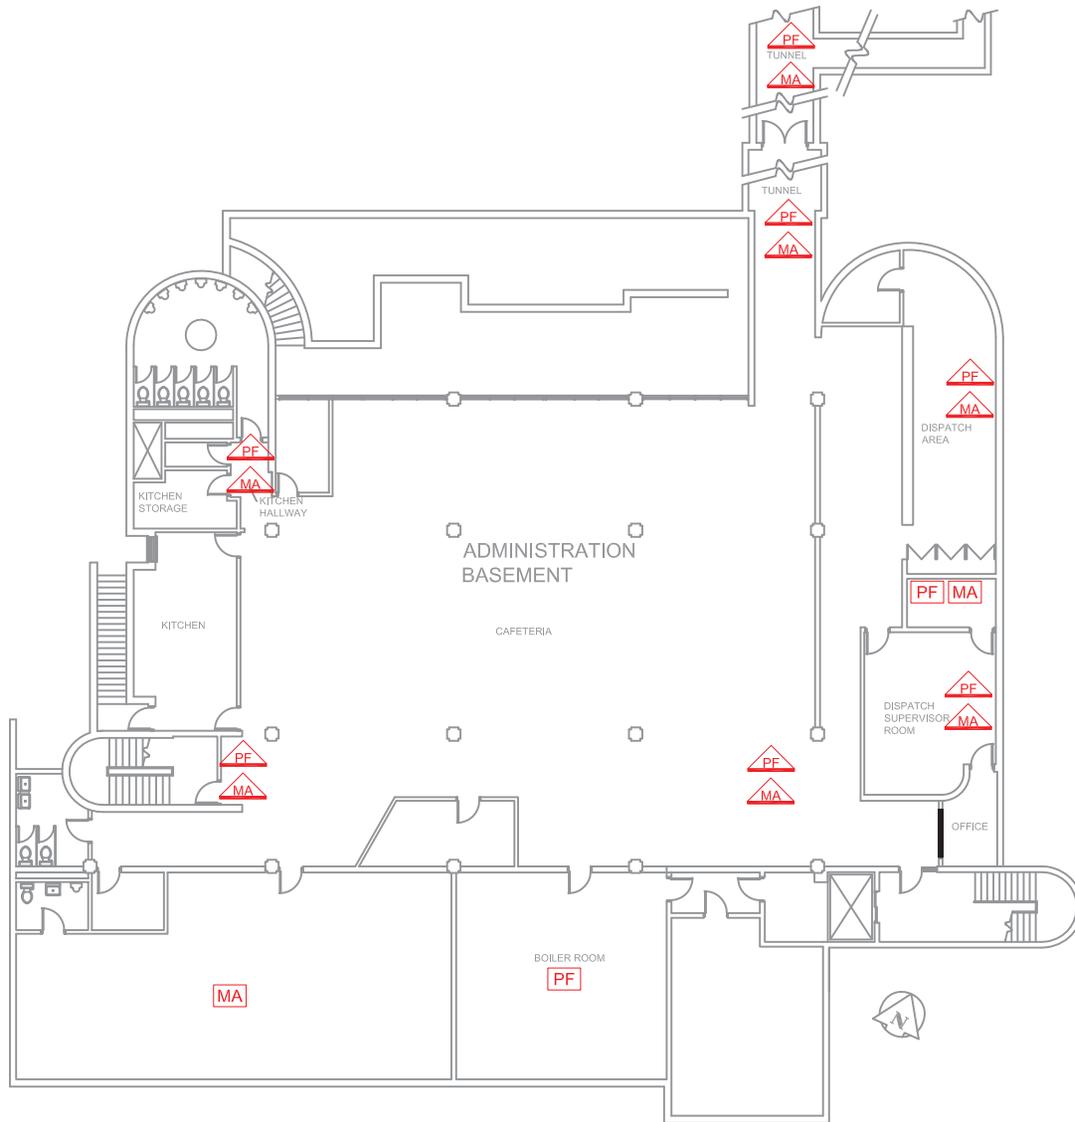
ASBESTOS LOCATIONS

TRANSIT
BUILDING A - BASEMENT
421 OSBORNE STREET
WINNIPEG, MANITOBA
