# Falcon River Diversion and Shoal Lake Aqueduct Bridges – Geotechnical Report

**Project Number:** 0022 005 01

Date: March 25, 2013

TREK Geotechnical Inc. is pleased to submit our Final Report for the geotechnical investigation for the Falcon River Diversion and Shoal Lake Aqueduct (Mile 93) bridge crossings.

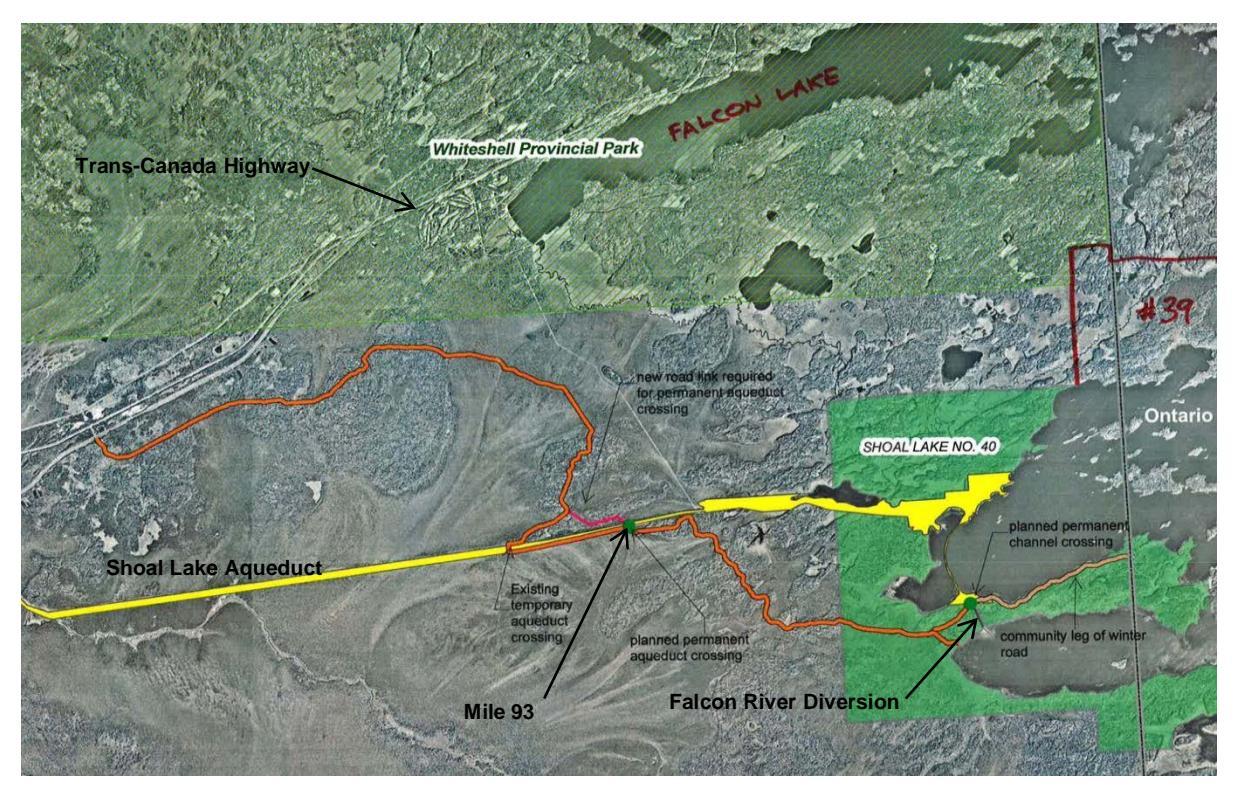
Figure 01 Proposed Bridge Crossings

The proposed bridges consist of prefabricated steel box truss ACROW panel structures, 33.5 m in length. Concrete abutments (on piles) will provide support at either end of the bridge deck. Approach embankments will be required to provide the necessary bridge deck clearance for hydraulic and navigation considerations (Falcon River Diversion) and necessary vertical and horizontal alignments accommodate proposed road alignments and Greater Winnipeg Water District (GWWD) Railway grades (Mile 93). As part of our assignment, TREK evaluated the stability of the slopes at the Mile 93

The crossing locations are based on the proximity of the winter road under construction and the location of a reinforced section of the Aqueduct at a road allowance at Mile 93 as shown on Figure 01. The winter road presently crossing the Aqueduct at Mile 91.69 will be abandoned once the new bridge at Mile 93 has been completed. It is our understanding that the Falcon River Diversion crossing, originally planned to coincide with the all season road constructed on the Shoal Lake Band No. 40 will be shifted approximately 100 m southeast to allow for the horizontal curve necessary on the east side of the diversion channel.

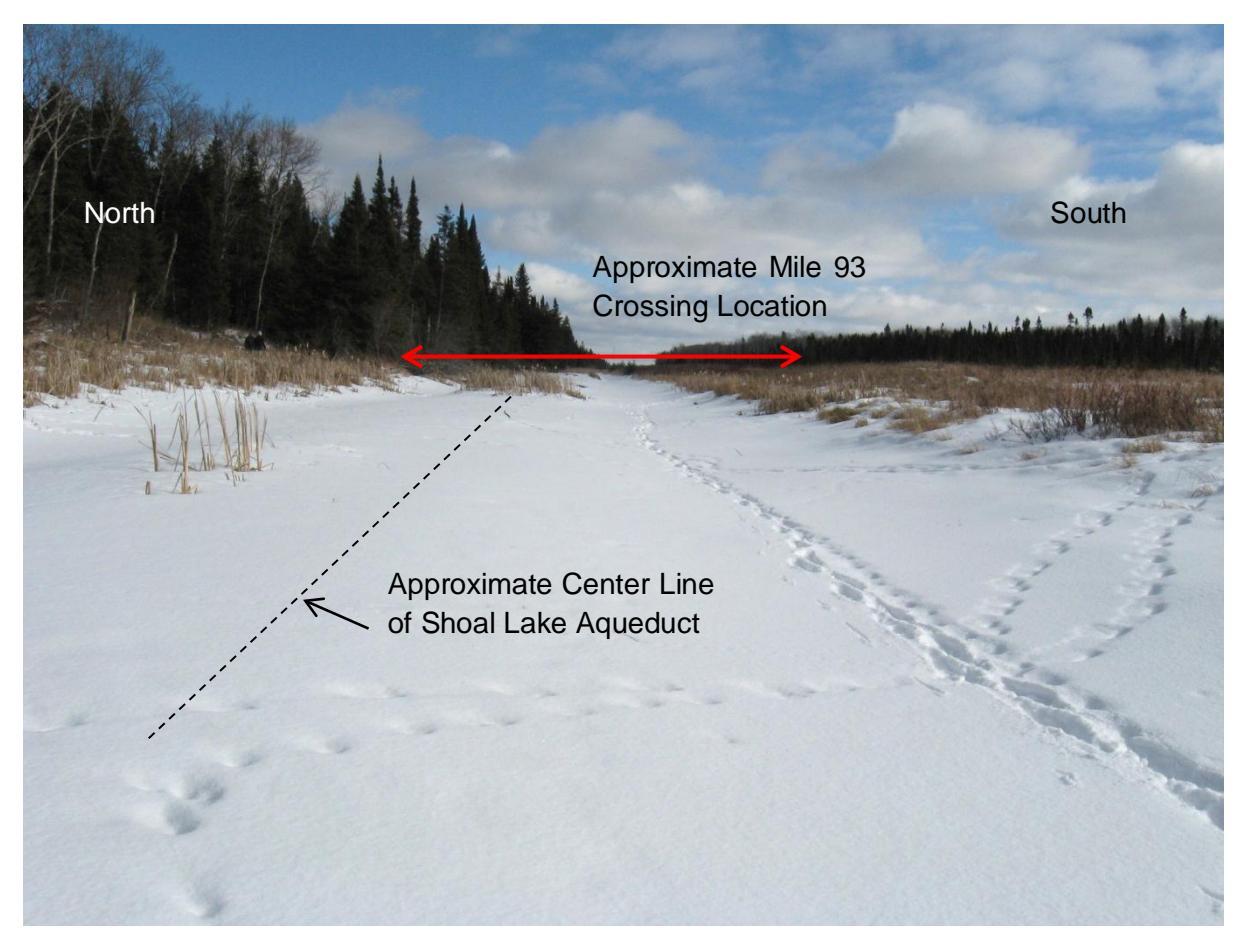
Figure 02 View East Along Aqueduct ROW Taken From WP 341 at From TH5 at Mile 92.992

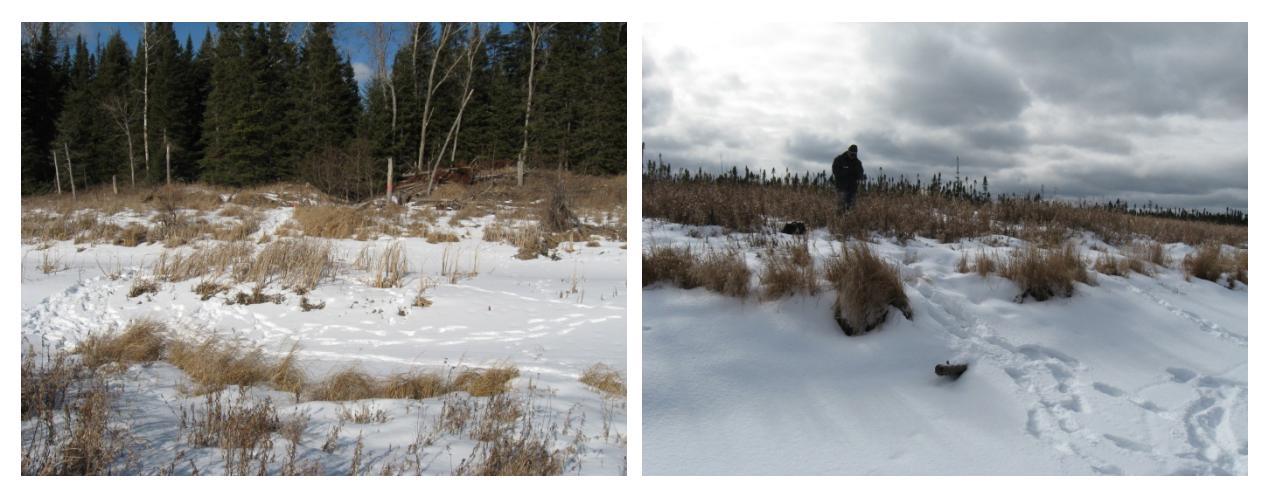
Figure 03 View N at N Abutment Location

Figure 04 View SW at S Abutment Location

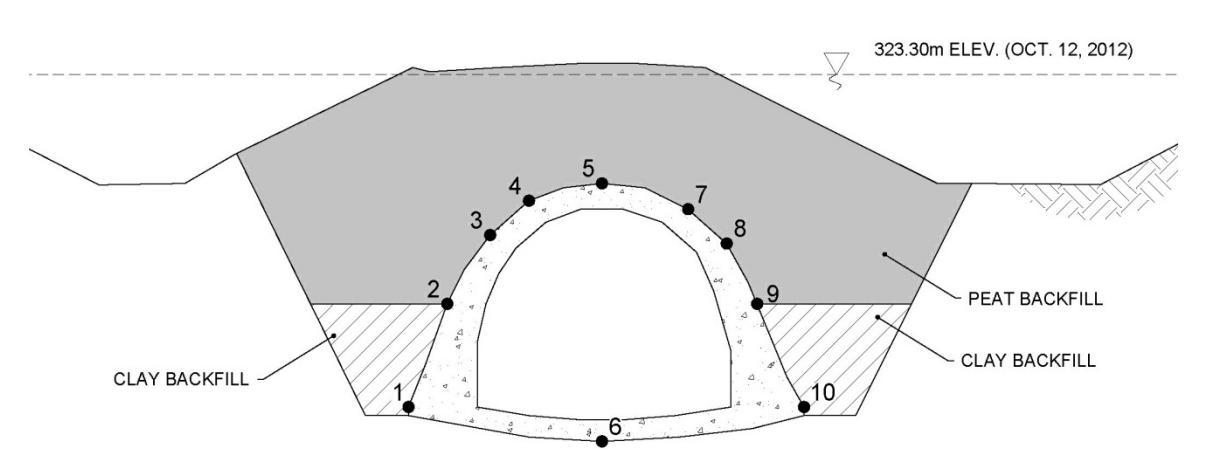
Figure 05 Nodes on Aqueduct For Stress Change Determination

The Aqueduct structure was modelled both as a rigid member (no displacement allowed) and as a free moving member. The model assumes 1.2 m of clay backfill at the Aqueduct base with peat backfill to surface based on previous investigations at Mile 92.99 (UMA, 1994). The estimated increase in stress in both the horizontal (x-direction) and vertical (y-direction) direction were then determined at various locations (nodes) along the outside surface of the structure as shown on Figures 05 and summarized in Table 4.4. Detailed model outputs are included in Appendix C.

Aqueduct Boundary Condition					
	No Displacement Allowed		Free Moving			
Node	Change in X- Effective Stress (kPa)	Change in Y- Effective Stress (kPa)	Change in X- Effective Stress (kPa)	Change in Y- Effective Stress (kPa)		
1	9	3	1	<1		
2	2	<1	<1	<1		
3	<1	<1	<1	<1		
4	<1	<1	<1	<1		
5	<1	<1	<1	<1		
6	<1	<1	7	<1		
7	<1	<1	<1	<1		
8	<1	<1	<1	<1		
9	<1	<1	<1	<1		
10	2	1	1	<1

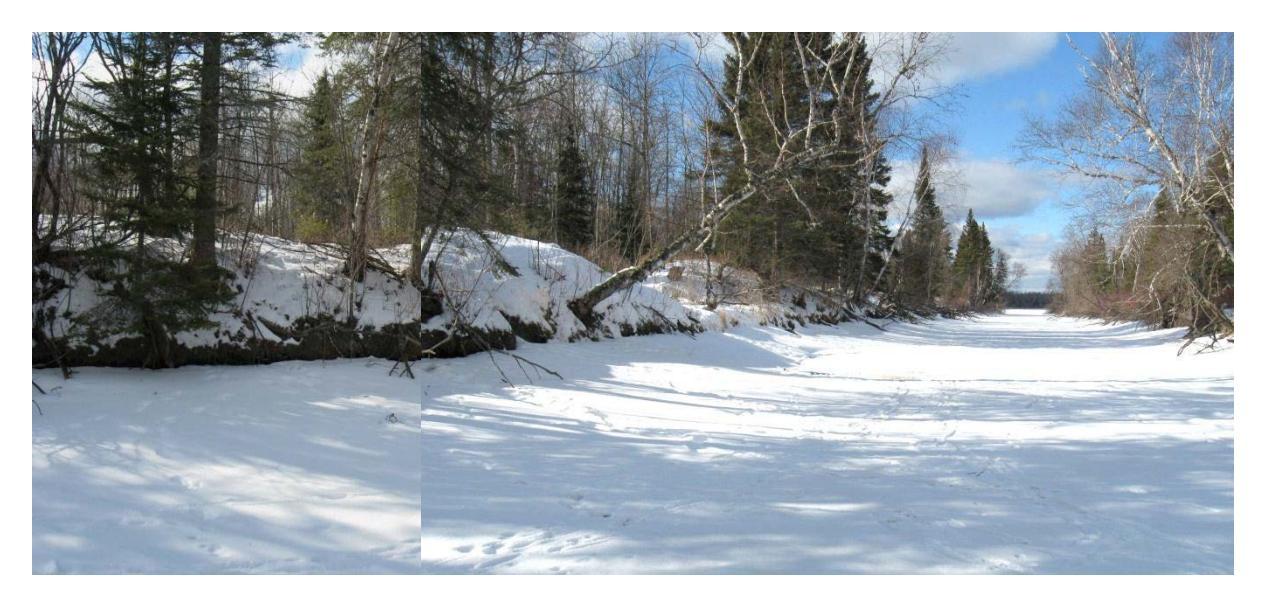
Figure 06 View NW at W Side of Crossing (IMG\_4399&4400)

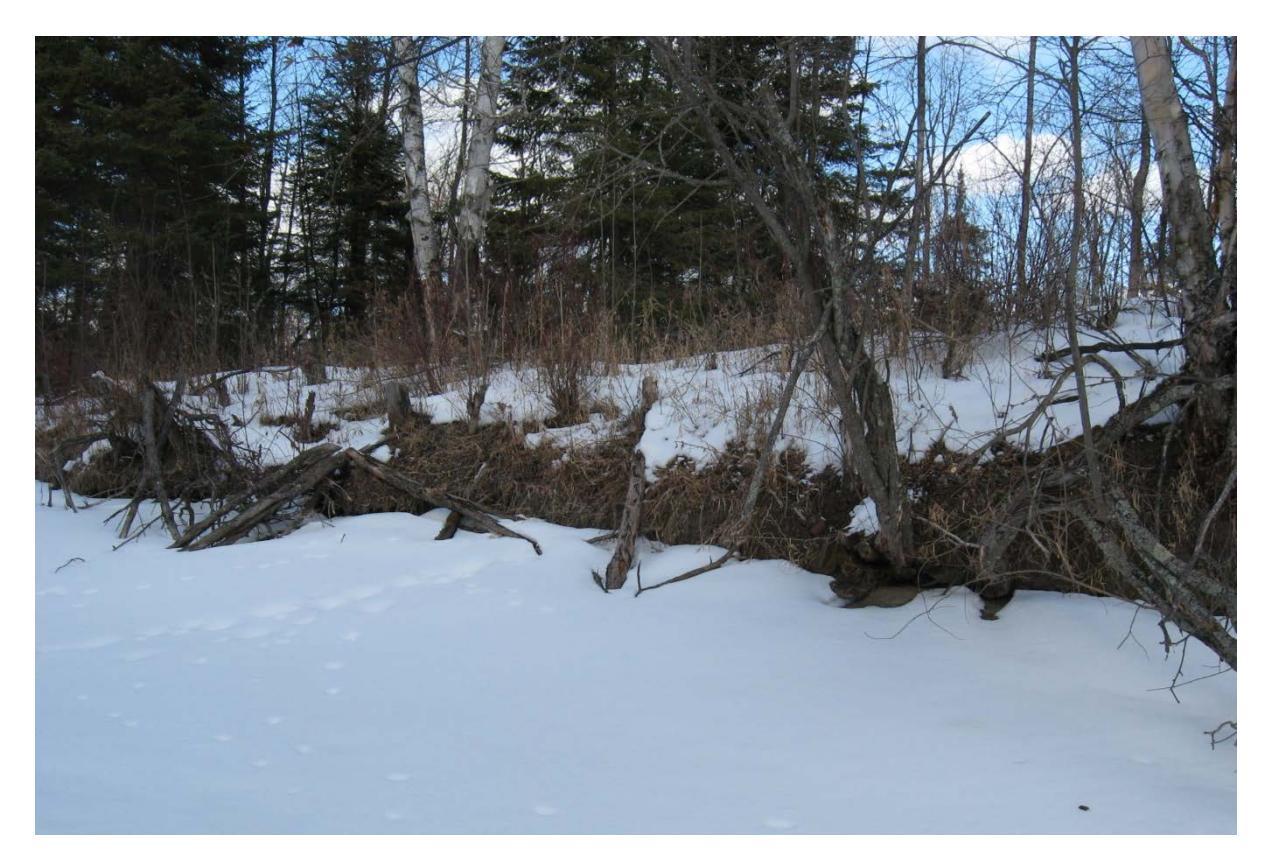
Figure 07 View NE at E Side of Crossing (IMG\_4414)

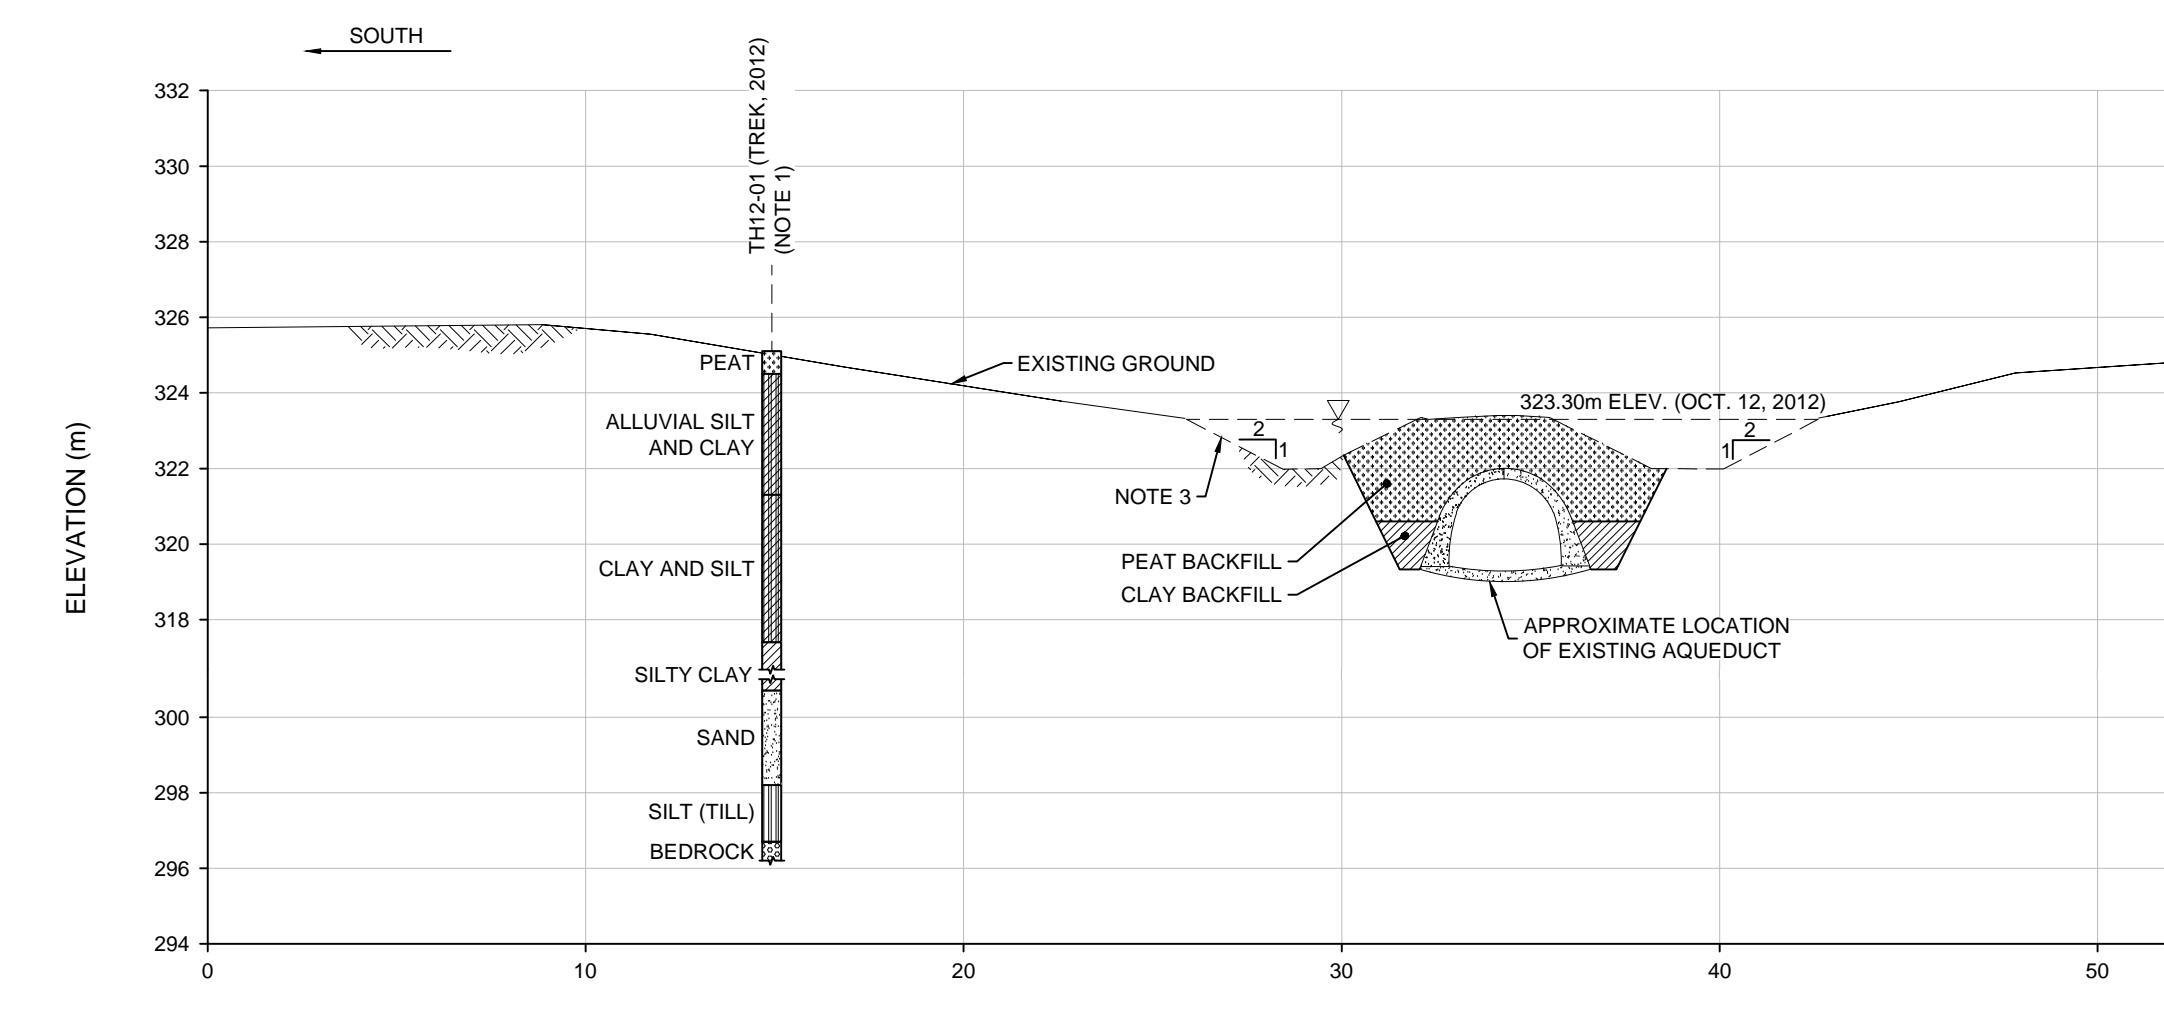
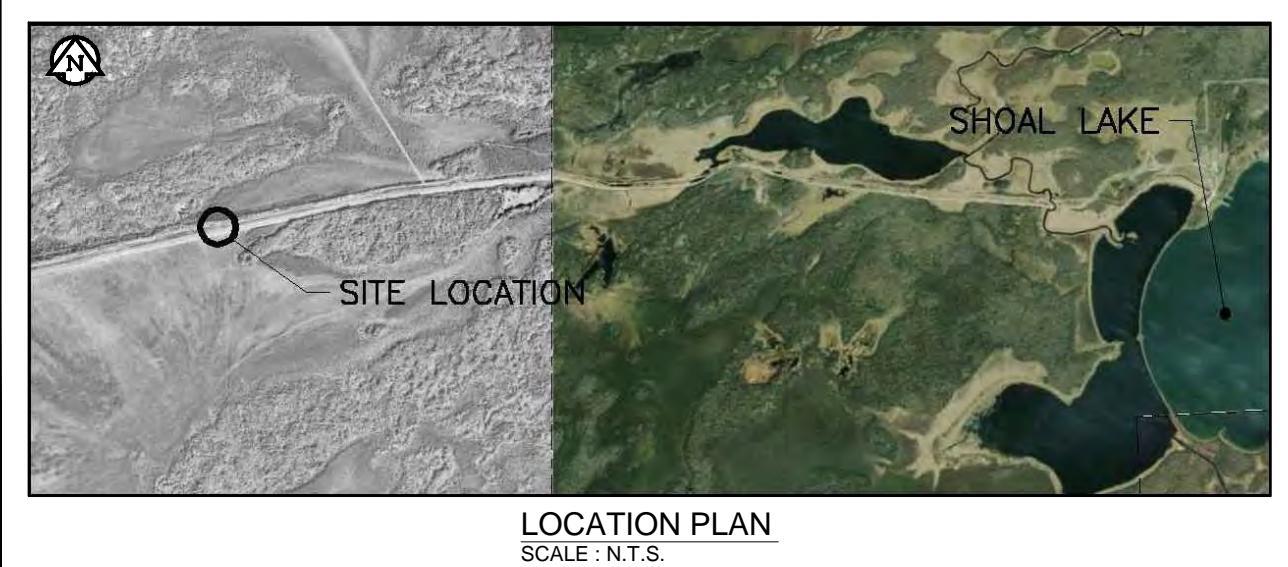
1. TH12-01 OFFSET 4.3m EAST OF CROSS-SECTION.

The soil profile at the Mile 93 crossing generally consists of peat overlying low to high plasticity alluvial silts and clays overlying highly plastic lacustrine clay, till and bedrock. A brief description of the soil units encountered at the test hole locations is provided below. All interpretations of soil stratigraphy for the purposes of design should refer to the detailed test hole logs in Appendix A. A cross section at Mile 93 showing the soil profile from TH 12-01 is shown on Drawing 01.

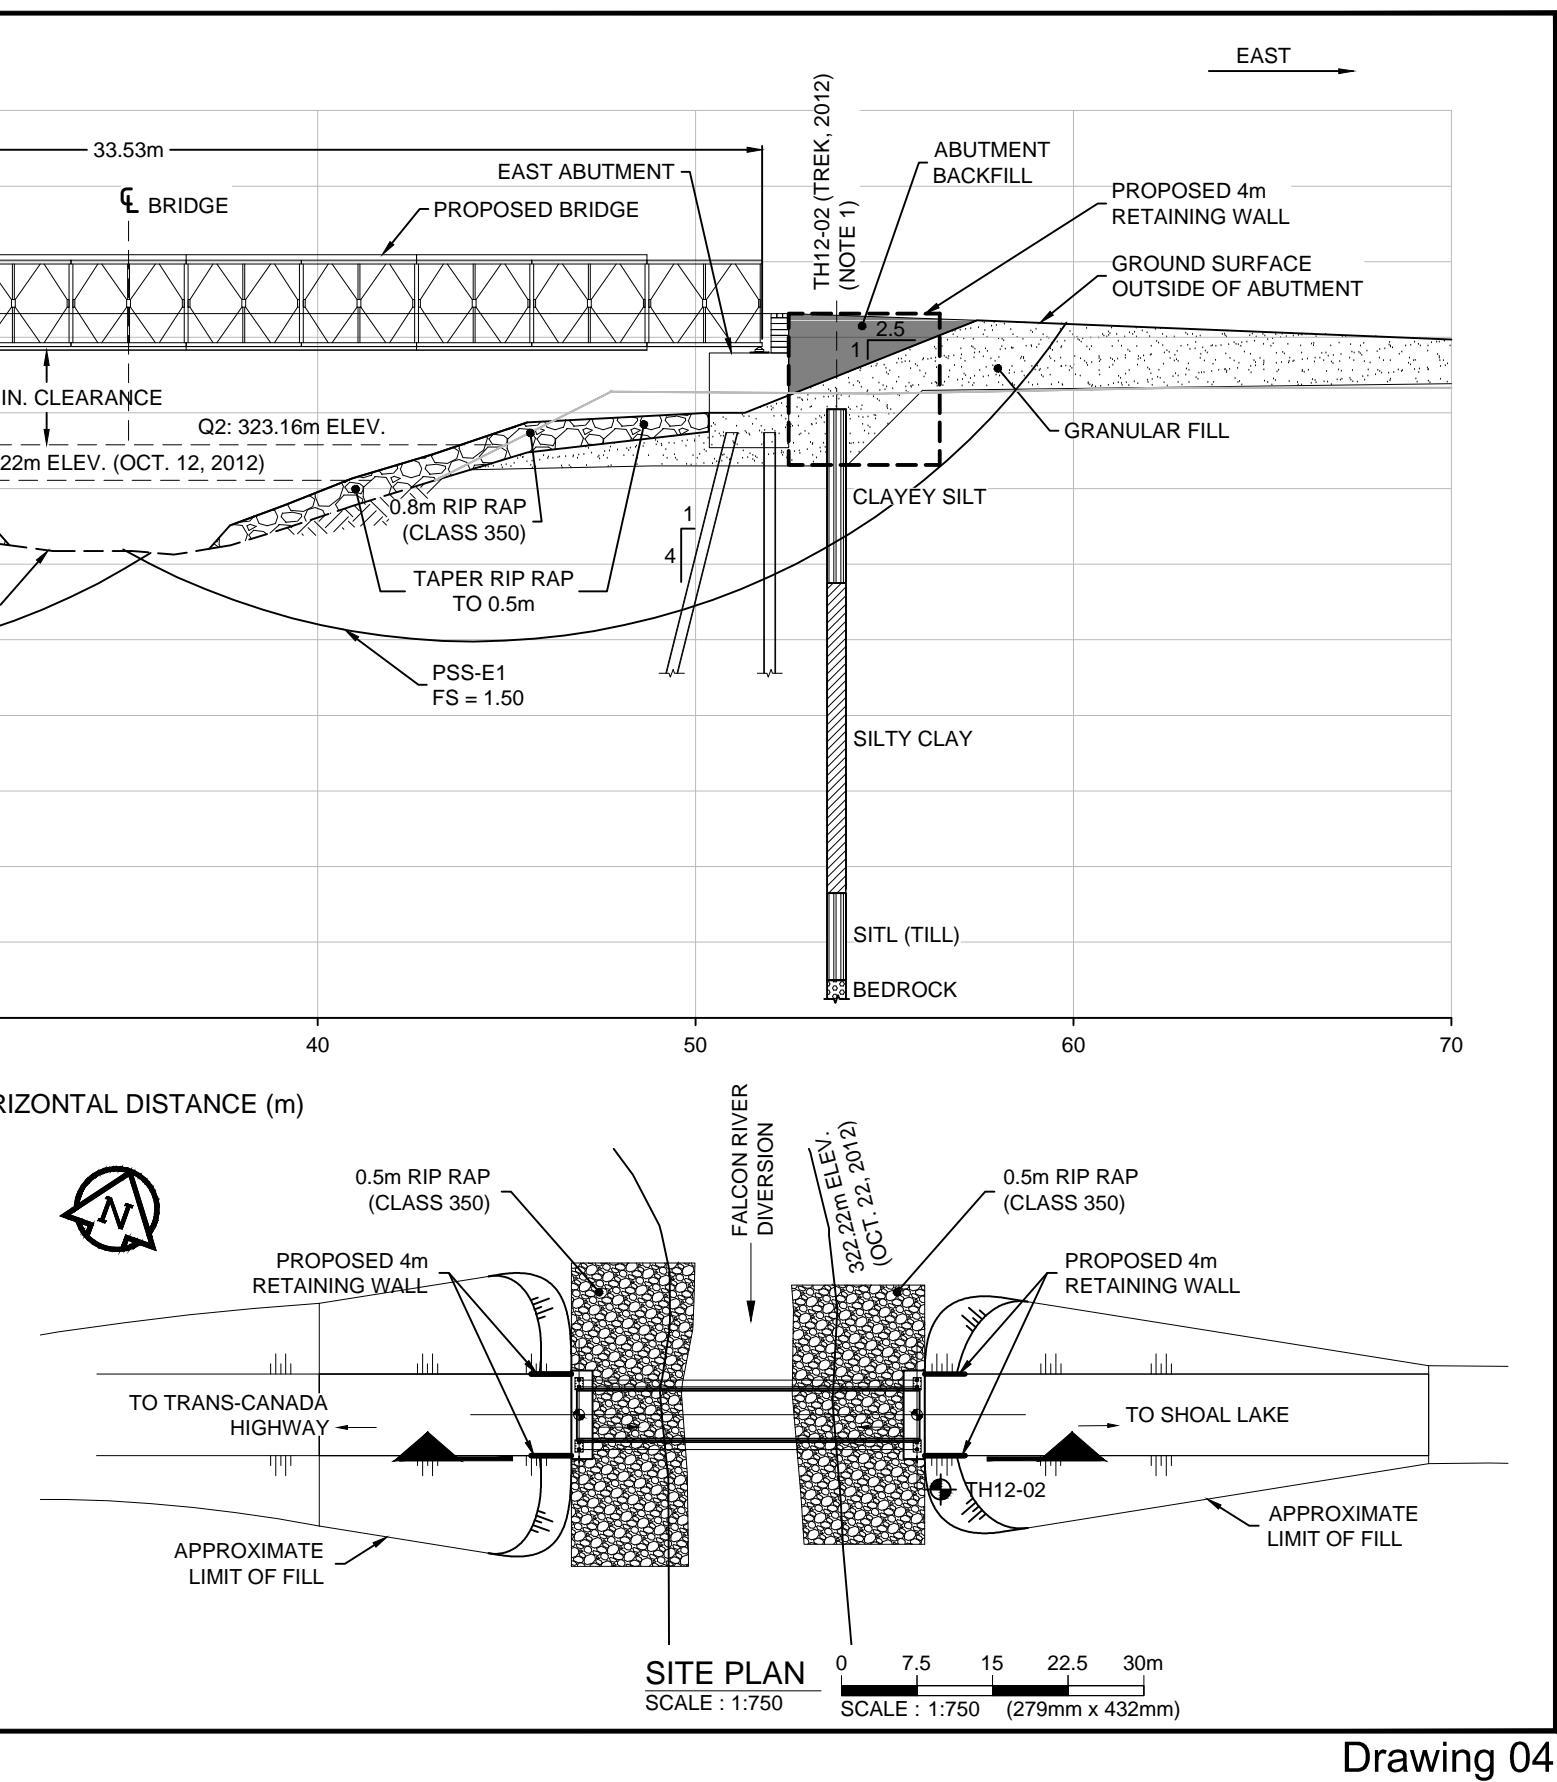
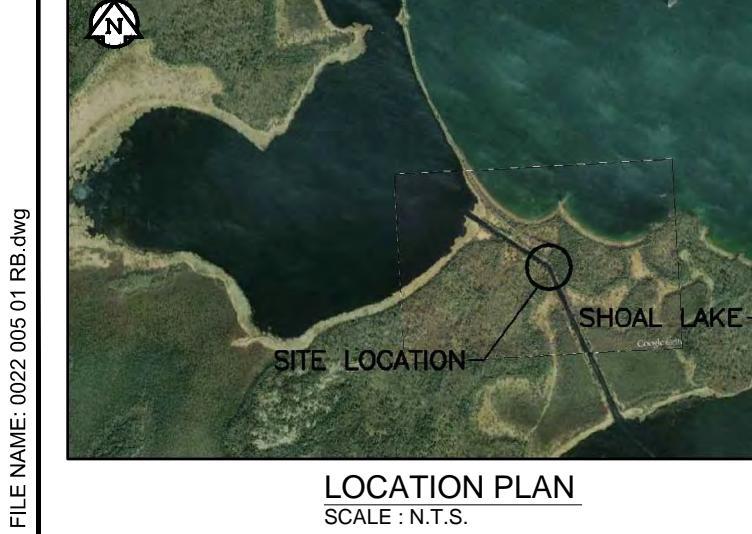
- 1. TH12-02 OFFSET 3.0m SOUTH OF CROSS-SECTION.
- 2. CROSS-SECTION GEOMETRY BASED OFF OF DILLON OCTOBER 12, 2012 SURVEY OF ORIGINAL PROPOSED CROSSING LOCATION. NEW PROPOSED CROSSING LOCATION IS APPROXIMATELY 100m SOUTH EAST OF ORIGINAL PROPOSED CROSSING LOCATION.
- 3. CHANNEL GEOMETRY BELOW WATER LEVEL NOT SURVEYED. CHANNEL GEOMETRY TAKEN FROM UMA ENGINEERING LTD. 2000 SURVEY CROSS SECTION D, APPROXIMATELY 110m SOUTH EAST OF ORIGINAL PROPOSED CROSSING LOCATION.

The surveyed water level of the channel was Elev. 322.22 m on October 12, 2012. Historical records obtained from Dillon show that the lowest water level to date in the FRD channel was Elev. 321.87 m recorded on March 28, 1930. Between 2000 and 2011, the lowest water Elev. was 322.26 m. At ice level, the channel is about 17 m wide with banks in the order of 2 m high. Spoil material from the original excavation has been piled on the tops of both banks ranging in height from about 2 m on the west side to about 1.5 m on the east bank. The channel spoil banks show evidence of undercutting although no instabilities of the banks were visible. A cross section and site plan of the existing ground profile is presented on Drawing 03. A cross section of the proposed crossing at the Falcon River Diversion is shown on Drawing 04.

Table 5.2 presents the results of the modelling with the proposed modifications and with a 4 m long wing wall on both sides of the channel. The locations of the PSS in relation to the proposed bridge are shown on Drawing 04. The concept for Drawing 04 is based on the information at the original channel crossing location. Once a final crossing location has been determined, the design should be optimized based on site specific geometry, and soil and groundwater conditions. For example, it may be possible to reduce the rip rap blanket thickness by incorporating a 5 m long (rather than 4 m) wing wall.

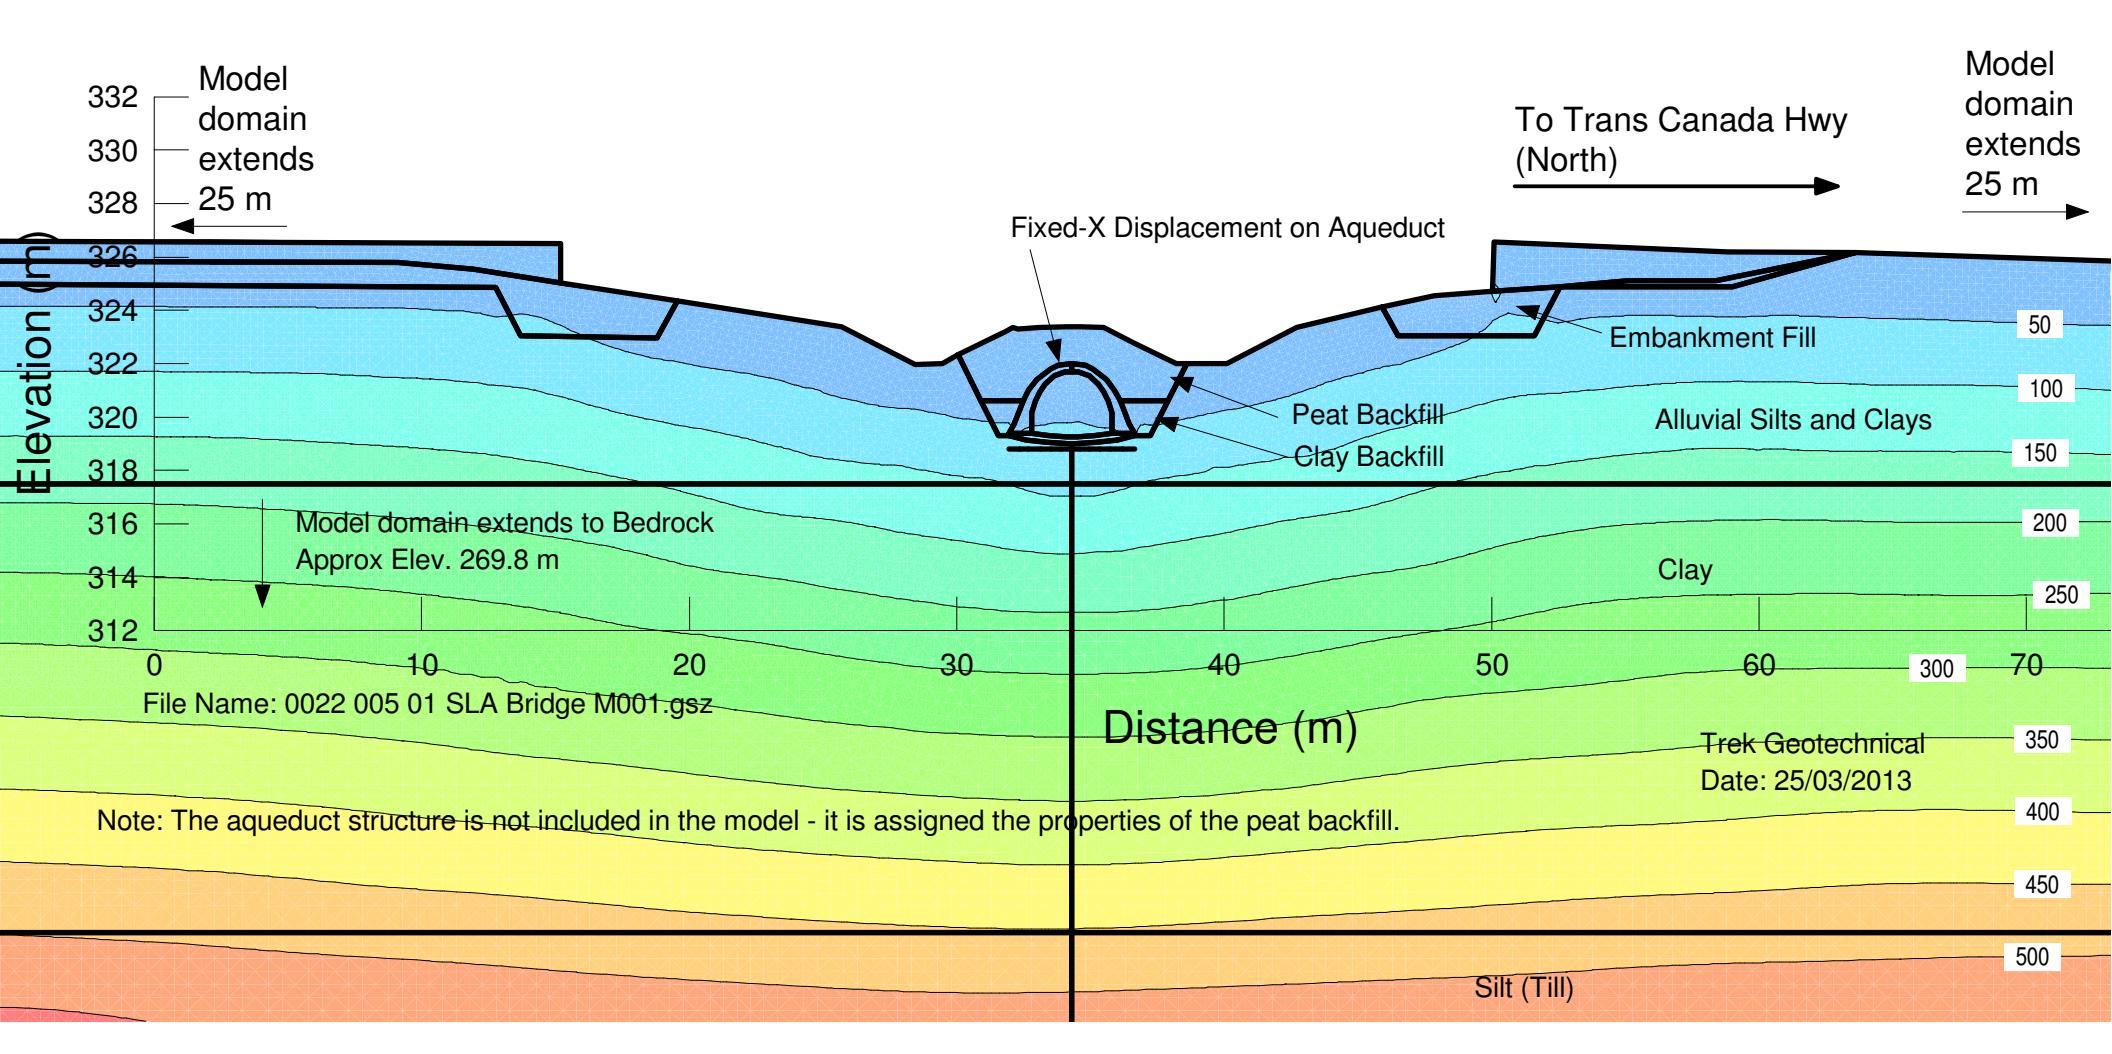
Name: ClayEffective Young's Modulus (E'): 5000 kPaPoisson's Ratio: 0.4Unit Weight: 19 kN/m³Name: Peat BackfillEffective Young's Modulus (E'): 200 kPaPoisson's Ratio: 0.4Unit Weight: 14 kN/m³Name: Clay BackfillEffective Young's Modulus (E'): 5000 kPaPoisson's Ratio: 0.4Unit Weight: 19 kN/m³Name: Embankment FillEffective Young's Modulus (E'): 40000 kPaPoisson's Ratio: 0.3Unit Weight: 21 kN/m³Name: Alluvial Silts and ClaysEffective Young's Modulus (E'): 15000 kPaPoisson's Ratio: 0.4Unit Weight: 20.5 kN/m³Name: Silt (Till)Effective Young's Modulus (E'): 100000 kPaPoisson's Ratio: 0.4Unit Weight: 19 kN/m³

Type: Y-Effective Stress kPa Starting Contour Value: 0kPa Increment by: 50kPa

#### 0022 005 01 Dillon Consulting Ltd. City of Winnipeg Shoal Lake Aqueduct Proposed Bridge Crossing at Mile 93 Load/Deformation
