APPENDIX B

GEOTECHNICAL BASELINE REPORT

Revision: Final Rev 0 KGS Group Project: 23-0107-009 Client Project:

Date: March 8, 2024

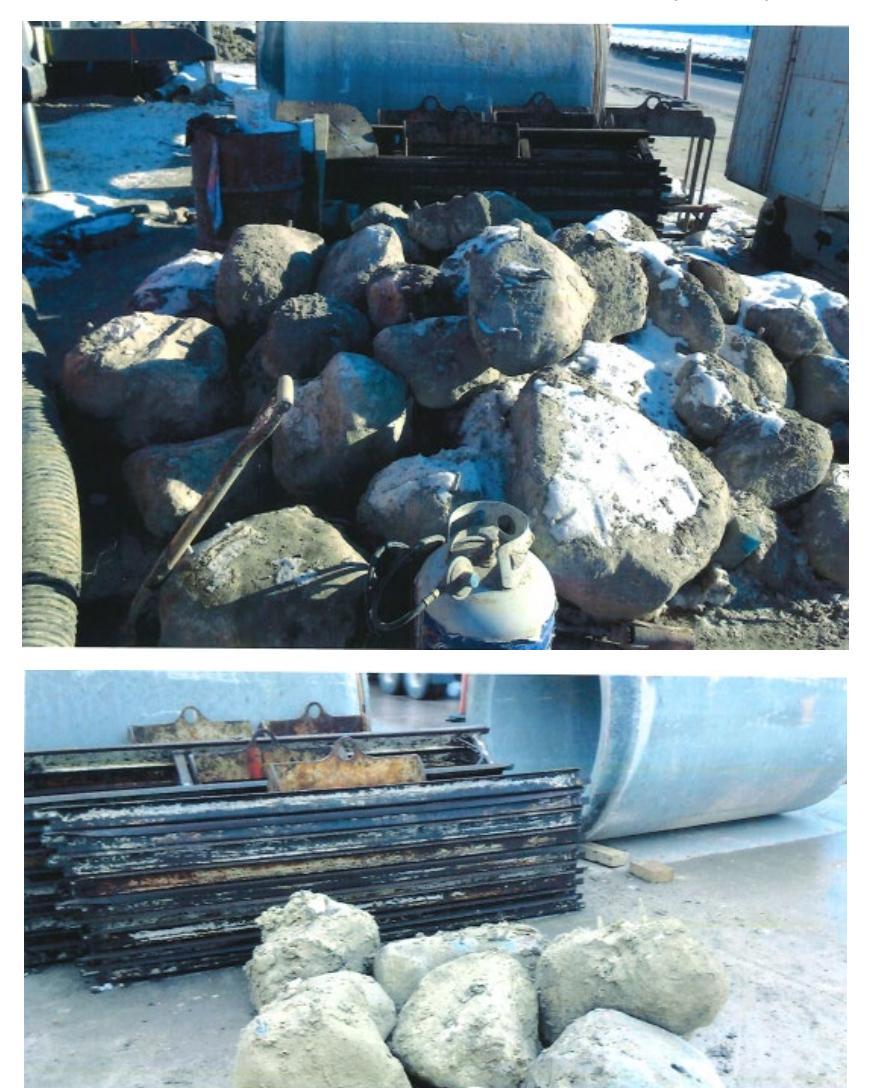
FIGURE 5-1: BOULDERS REMOVED DURING TUNNELLING FOR THE NW INTERCEPTOR SEWER PROJECT (2015)

• An MTBM outfitted with a rock cutting wheel performed well in both overburden, bedrock, and mixed face ground conditions in Winnipeg. No significant issues were encountered when transitioning between the overburden and bedrock layers with the selected MTBM cutting tools. The MTBM was launched through the overburden, transitioned into bedrock, then transitioned into overburden before entering the reception shaft.

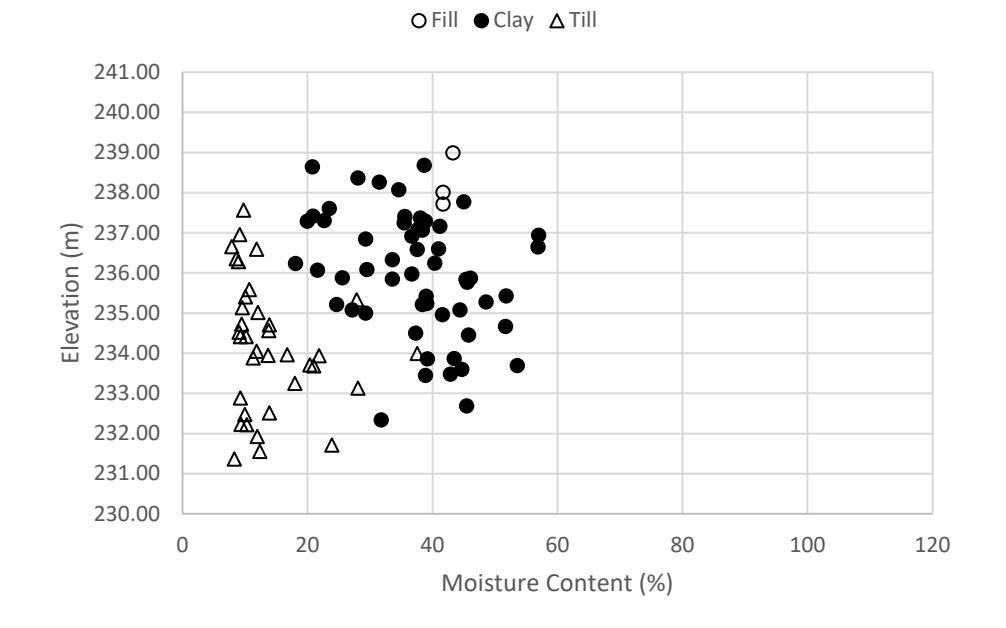
FIGURE 4-3: MOISTURE CONTENT OF OVERBURDEN WITH ELEVATION

The variability of moisture content in the overburden with elevation in the project area is shown in Figure 4-3.

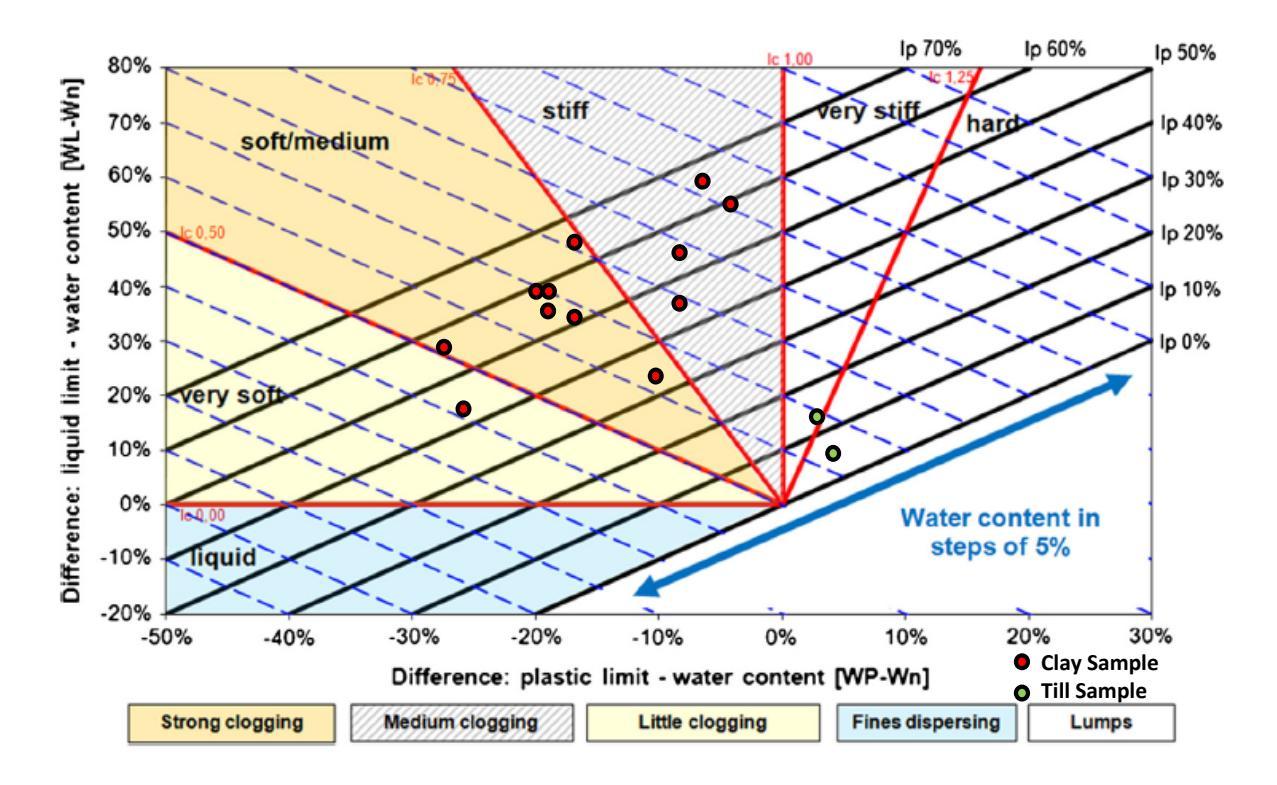
FIGURE 4-4: STICKINESS POTENTIAL OF COHESIVE SOIL

The potential for clogging while tunnelling through the clay and glacial till formations was evaluated using the chart suggested by Hollmann and Thewes (2013). Atterberg Limits (Liquid limit, Plastic limit, and natural moisture content) of cohesive samples tested in the Laboratory and their Plasticity Indices were plotted on Figure 4-4 to determine the corresponding clogging potential of the clay and glacial till. It should be noted that the Hollman and Thewes chart was developed from data collected from fluid supported trenchless shield drives, but are assumed to be applicable to other tunnelling methods.

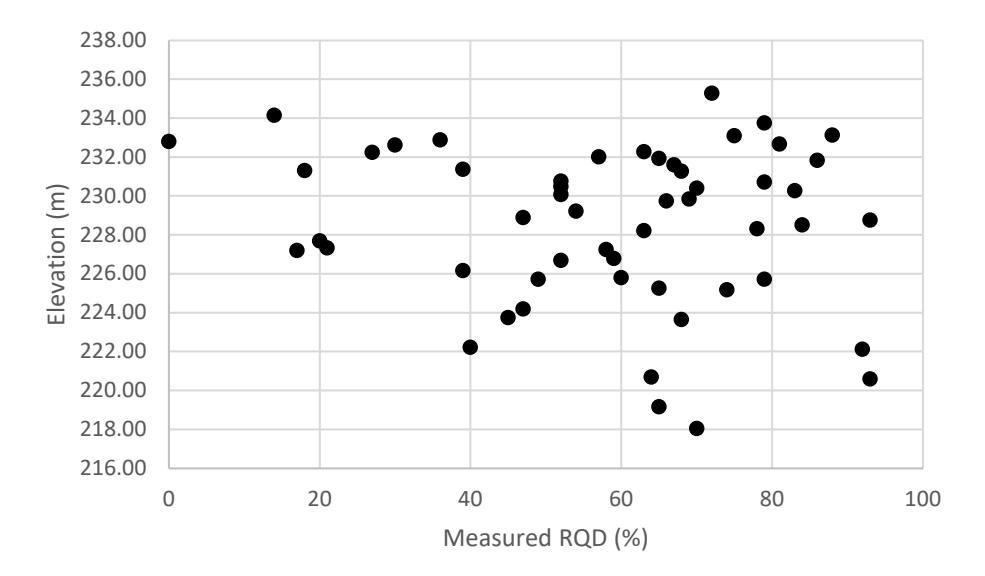
FIGURE 4-7: BEDROCK RQD WITH ELEVATION

The bedrock consists of argillaceous limestone to calcareous shale and occasionally overlain by argillaceous dolomite. The dolomite was observed in boreholes/test pits TH23-08, TH23-09, TH23-26, TP24-01, and TP24-02. The measured RQD of the bedrock with elevation is shown in Figure 4-7 below, and a histogram with the RQD distribution is shown on Figure 4-8.

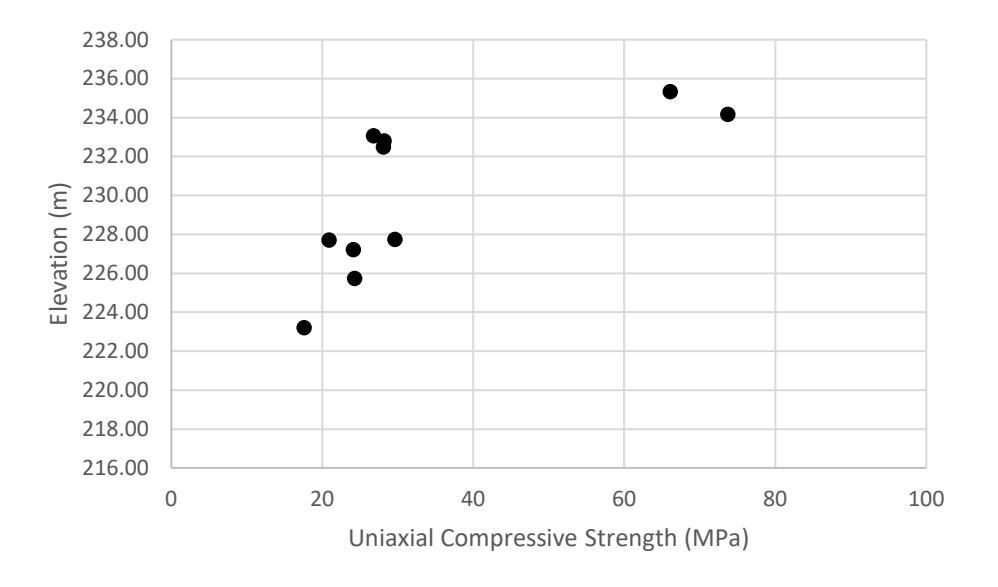
FIGURE 4-10: UCS OF BEDROCK WITH ELEVATION

Uniaxial compressive strength testing was completed on bedrock samples from boreholes TH23-01, TH23-08, TH23-17, TH23-18, TH23-25, and TH23-26. The results for compressive strength testing are summarized in Figure 4-10.

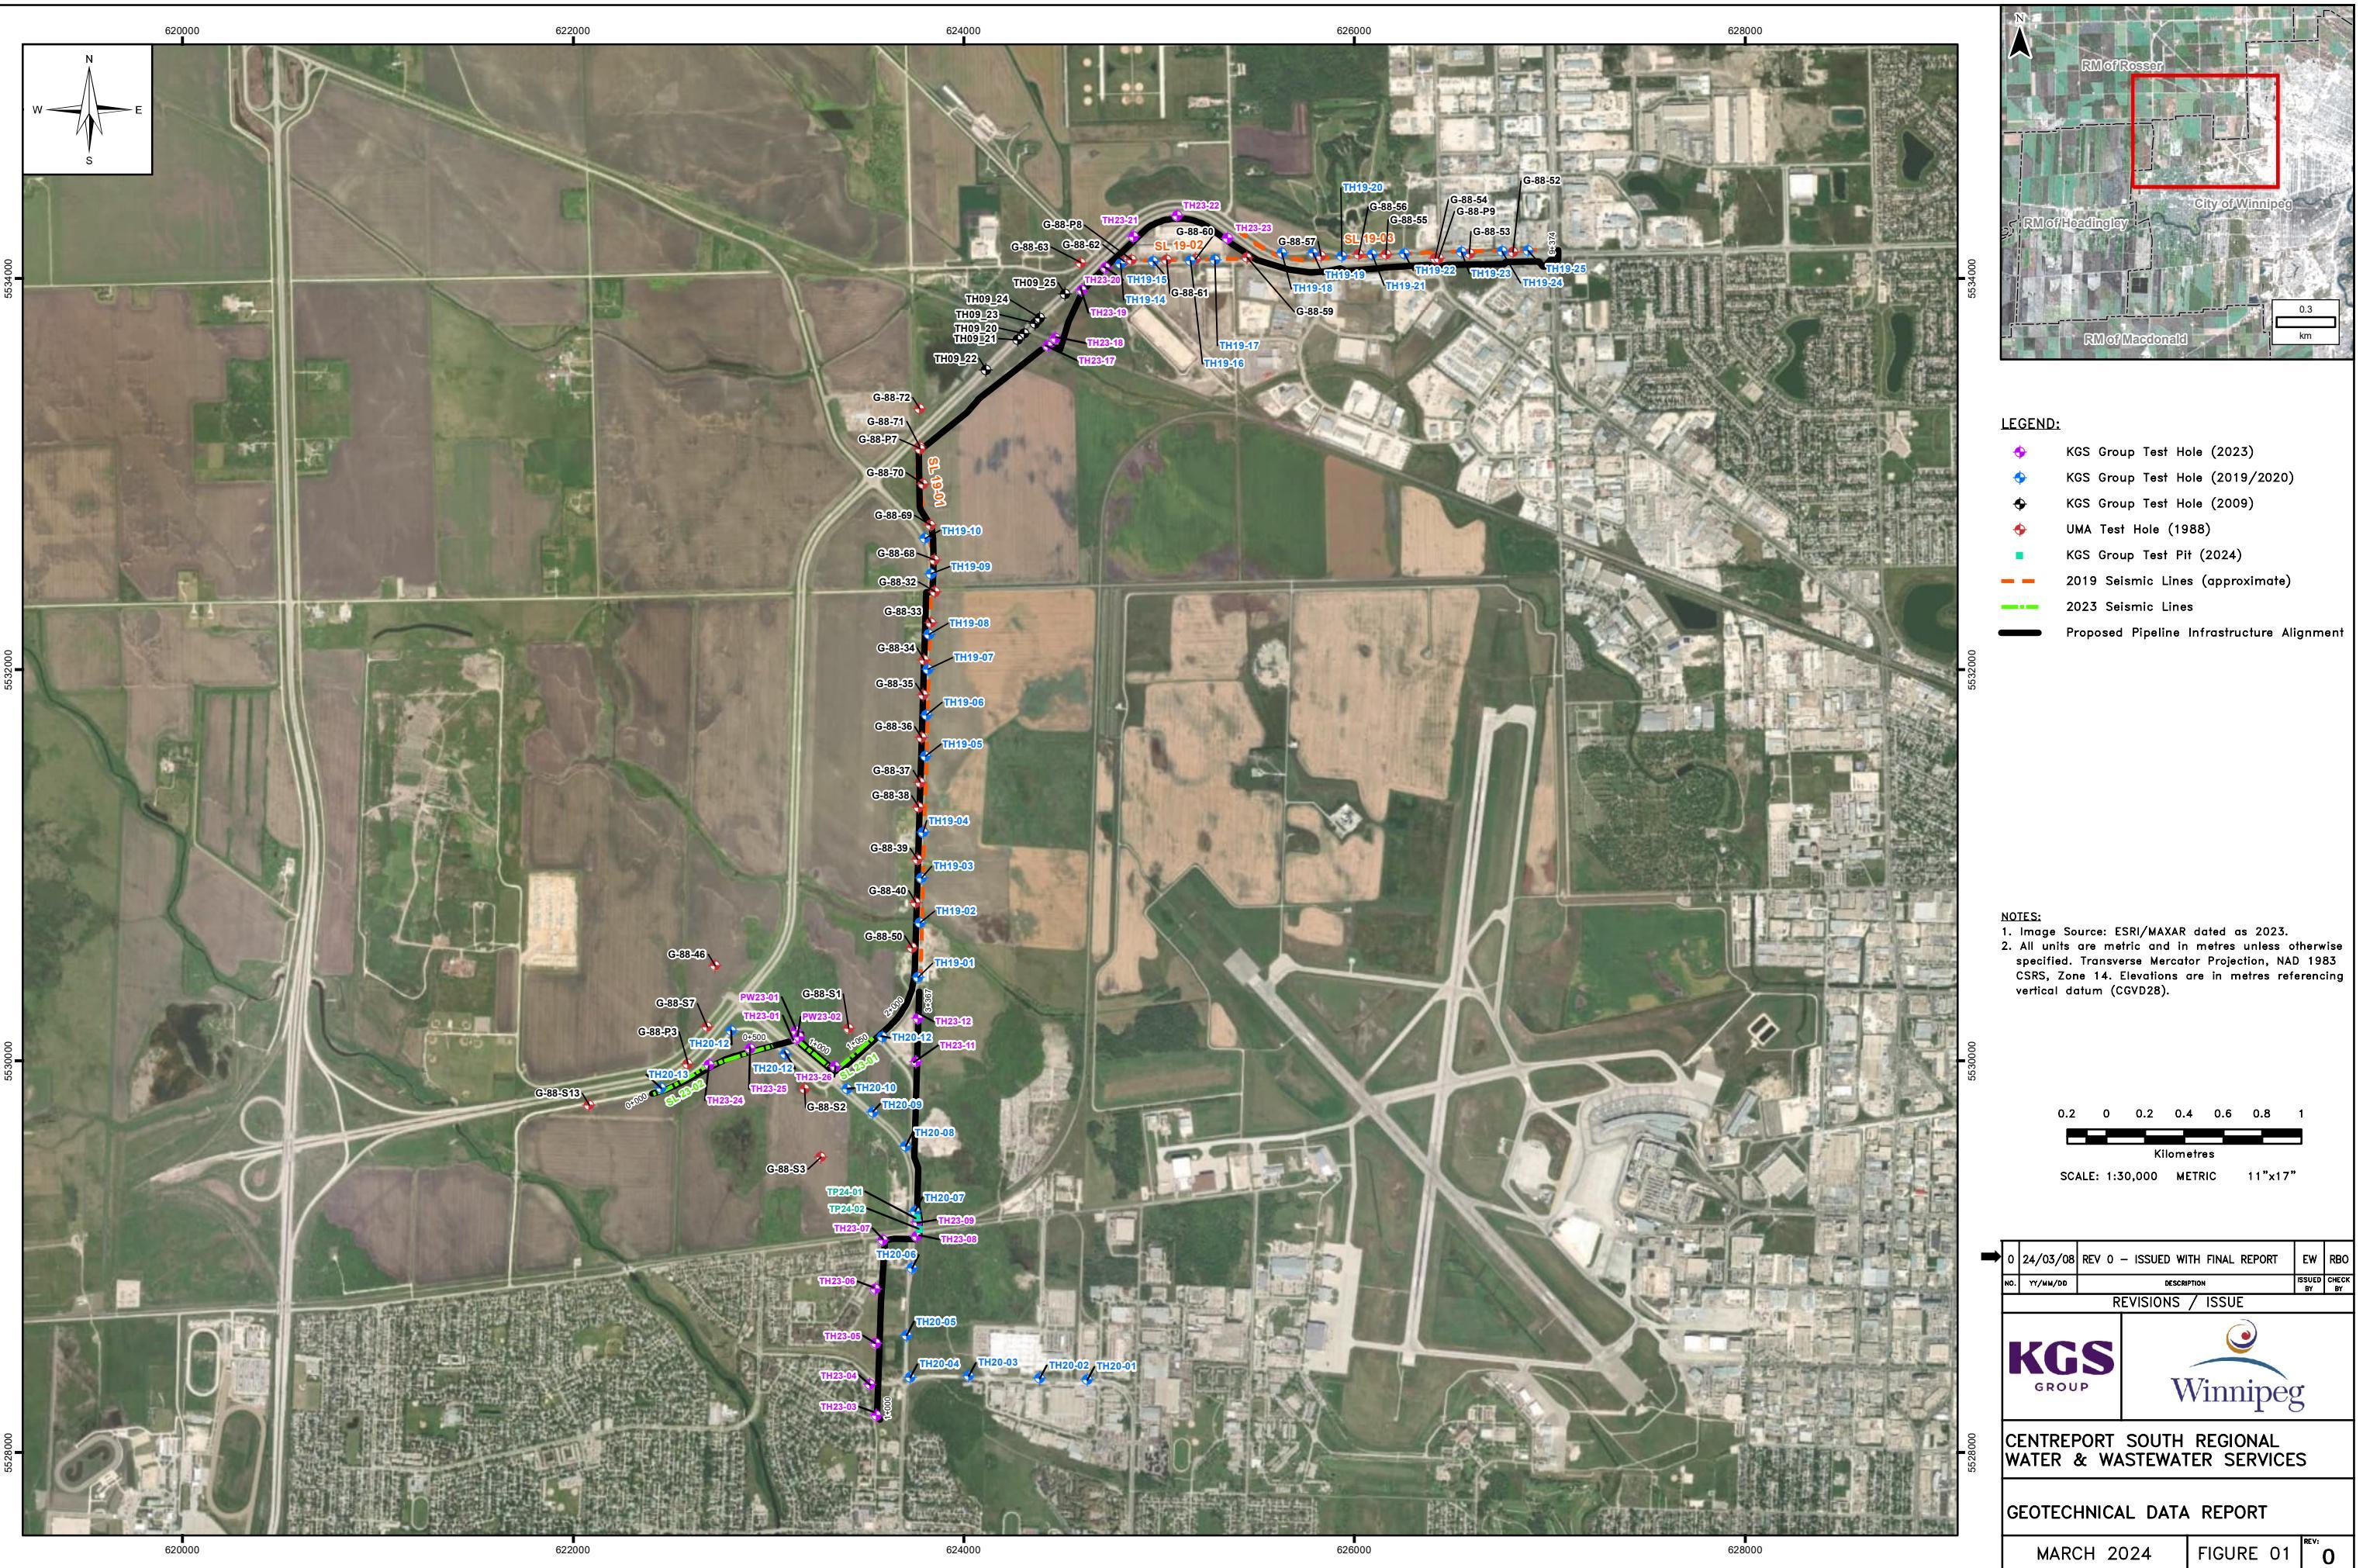
•	KGS Group Test Hole (2023)
+	KGS Group Test Hole (2019/2020)
•	KGS Group Test Hole (2009)
•	UMA Test Hole (1988)
	KGS Group Test Pit (2024)
	2019 Seismic Lines (approximate)
	2023 Seismic Lines

Bedrock was cored in seven (7) boreholes during the 2023 KGS Group investigation and within forty-seven (47) boreholes during previous geotechnical investigations. Based on the borehole drilling and test pitting, bedrock was encountered below the silt till at elevations ranging from 222.1 to 237.4 m. The estimated bedrock elevation from the 2019 seismic refraction survey ranged from approximate El. 223 m to 238.5 m along Sturgeon Road and ranged from approximate El. 225 m to 235 m along the northern portion of CentrePort Canada Way (CCW). The estimated bedrock elevation from the 2023 seismic refraction survey ranged from approximate El. 221 m to 231 m on the south side of Sturgeon Access and ranged from approximate El. 225.5 m to 232 m on the north side of Sturgeon Access. The seismic refraction survey results are generally consistent with observations from the drilling. The seismic refraction lines from the 2019 and 2023 surveys are shown on Figure 1.
