OPPORTUNITIES

CONSTRAINTS

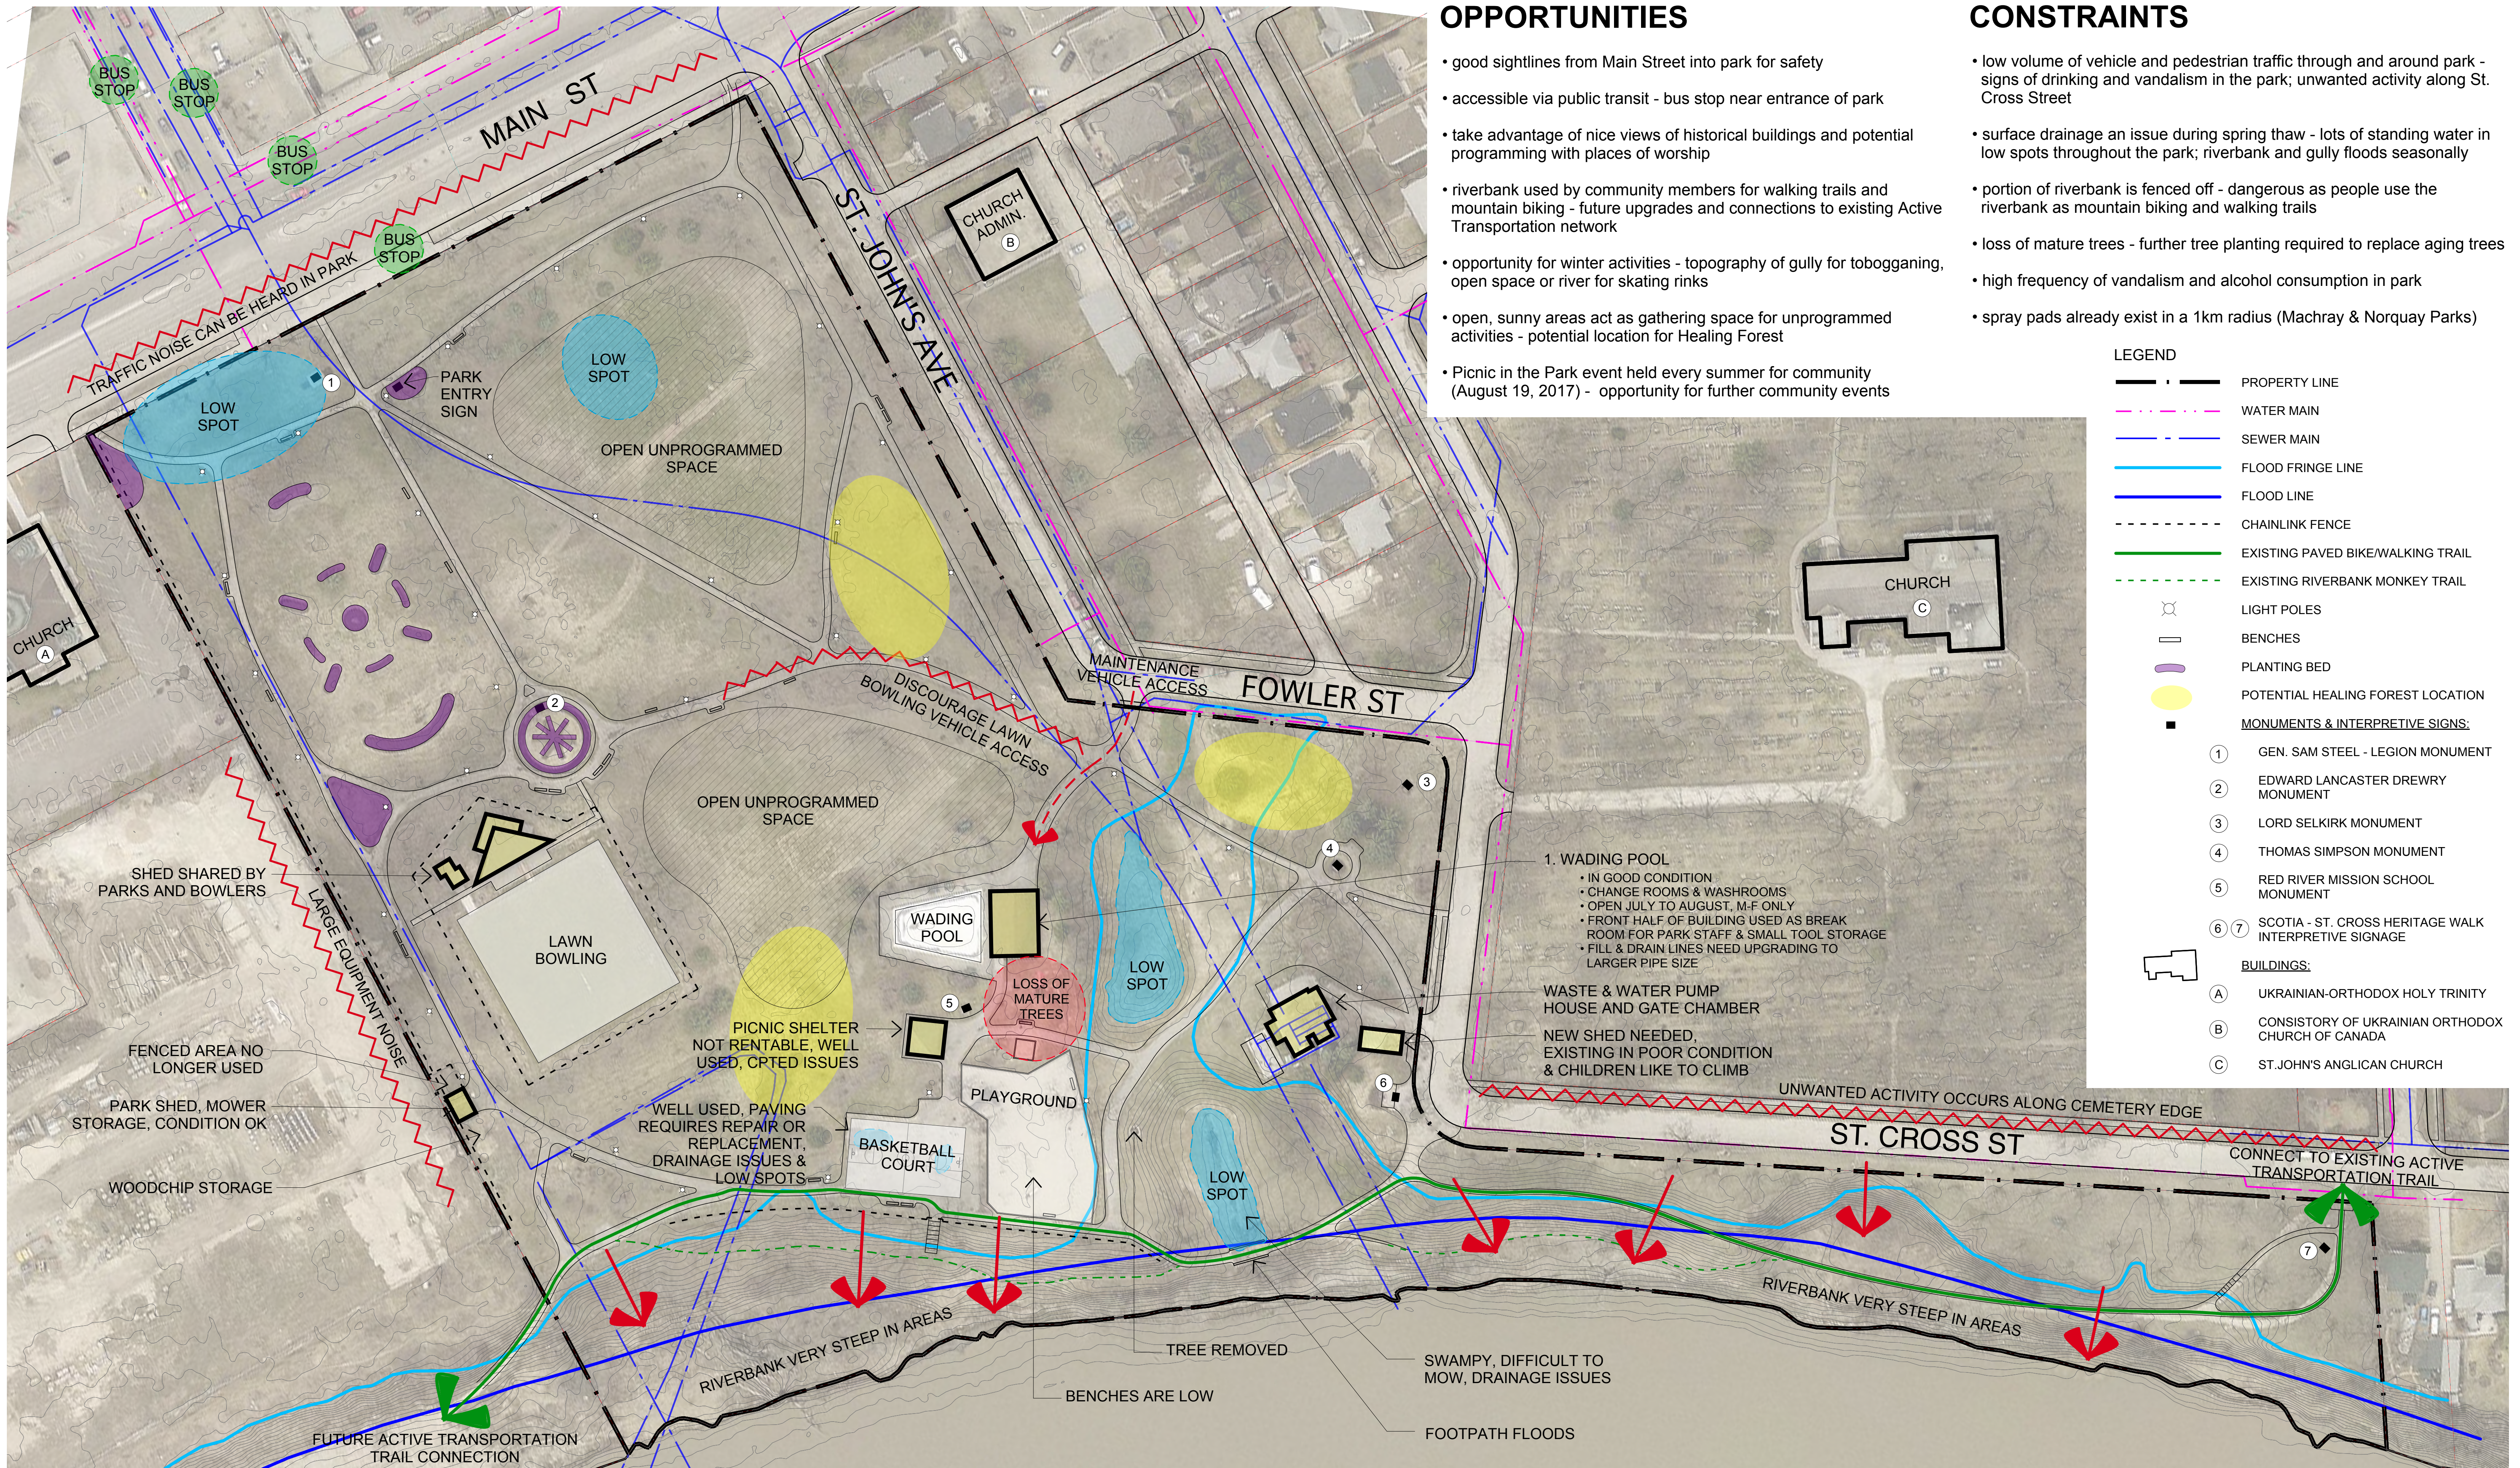
- good sightlines from Main Street into park for safety
- accessible via public transit - bus stop near entrance of park
- take advantage of nice views of historical buildings and potential programming with places of worship
- riverbank used by community members for walking trails and mountain biking - future upgrades and connections to existing Active Transportation network
- opportunity for winter activities - topography of gully for tobogganing, open space or river for skating rinks
- open, sunny areas act as gathering space for unprogrammed activities - potential location for Healing Forest
- Picnic in the Park event held every summer for community (August 19, 2017) - opportunity for further community events

- low volume of vehicle and pedestrian traffic through and around park - signs of drinking and vandalism in the park; unwanted activity along St. Cross Street
- surface drainage an issue during spring thaw - lots of standing water in low spots throughout the park; riverbank and gully floods seasonally
- portion of riverbank is fenced off - dangerous as people use the riverbank as mountain biking and walking trails
- loss of mature trees - further tree planting required to replace aging trees
- high frequency of vandalism and alcohol consumption in park
- spray pads already exist in a 1km radius (Machray & Norquay Parks)

1. WADING POOL
 • IN GOOD CONDITION
 • CHANGE ROOMS & WASHROOMS
 • OPEN JULY TO AUGUST, M-F ONLY
 • FRONT HALF OF BUILDING USED AS BREAK ROOM FOR PARK STAFF & SMALL TOOL STORAGE
 • FILL & DRAIN LINES NEED UPGRADING TO LARGER PIPE SIZE

WASTE & WATER PUMP HOUSE AND GATE CHAMBER
 NEW SHED NEEDED, EXISTING IN POOR CONDITION & CHILDREN LIKE TO CLIMB

UNWANTED ACTIVITY OCCURS ALONG CEMETERY EDGE

RIVERBANK VERY STEEP IN AREAS

SWAMPY, DIFFICULT TO MOW, DRAINAGE ISSUES

FOOTPATH FLOODS
