**Phase II & III Environmental Site Assessment  
Former Dominion Bridge Facility  
Winnipeg, Manitoba**

SEPTEMBER 1999

**WARDROP** | Engineering Inc.

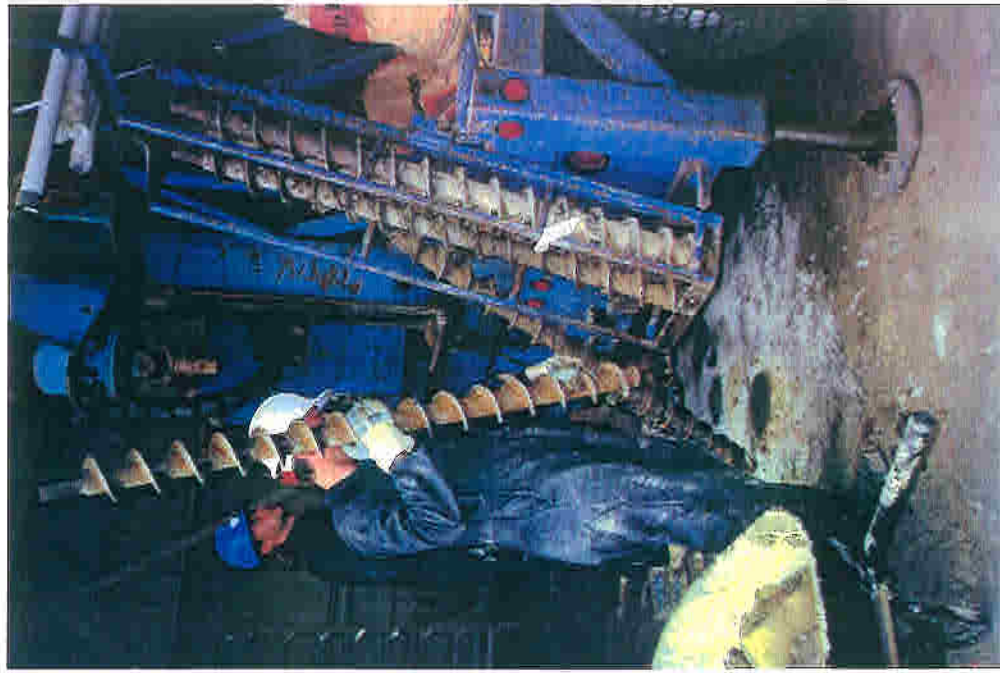
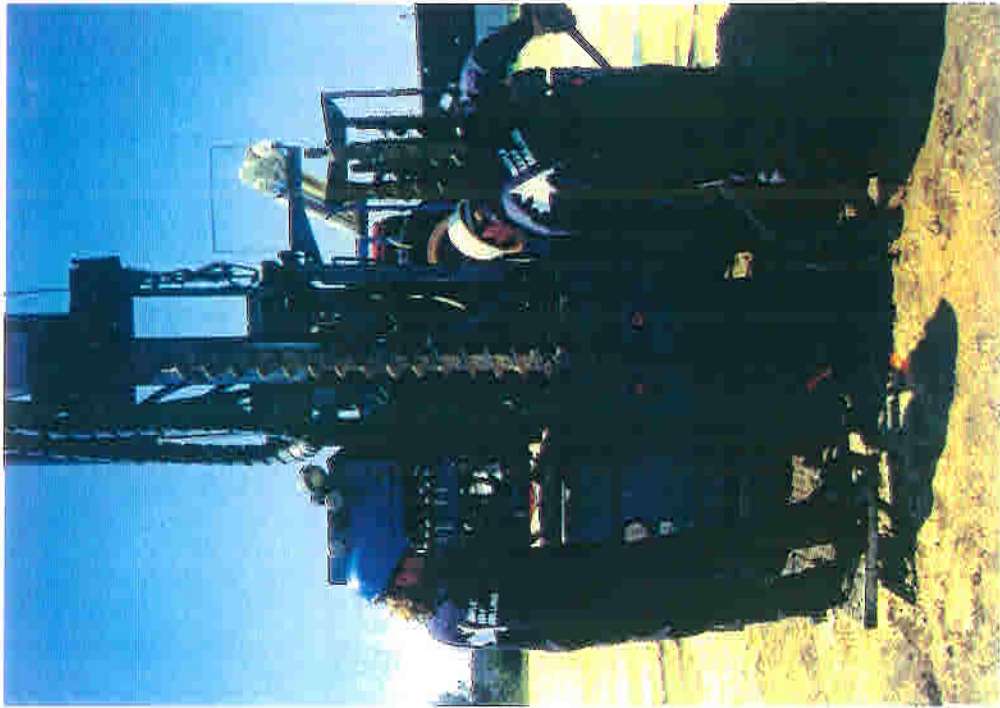
Photo 1: The worker is operating the machine with the auger bit. Photo 2: The worker is operating the machine with the auger bit.
