Agassiz Consulting Group Ltd.

East End Cultural & Leisure Ctr.  
575 Larsen Ave.

Drawing No. R-1 addendum1

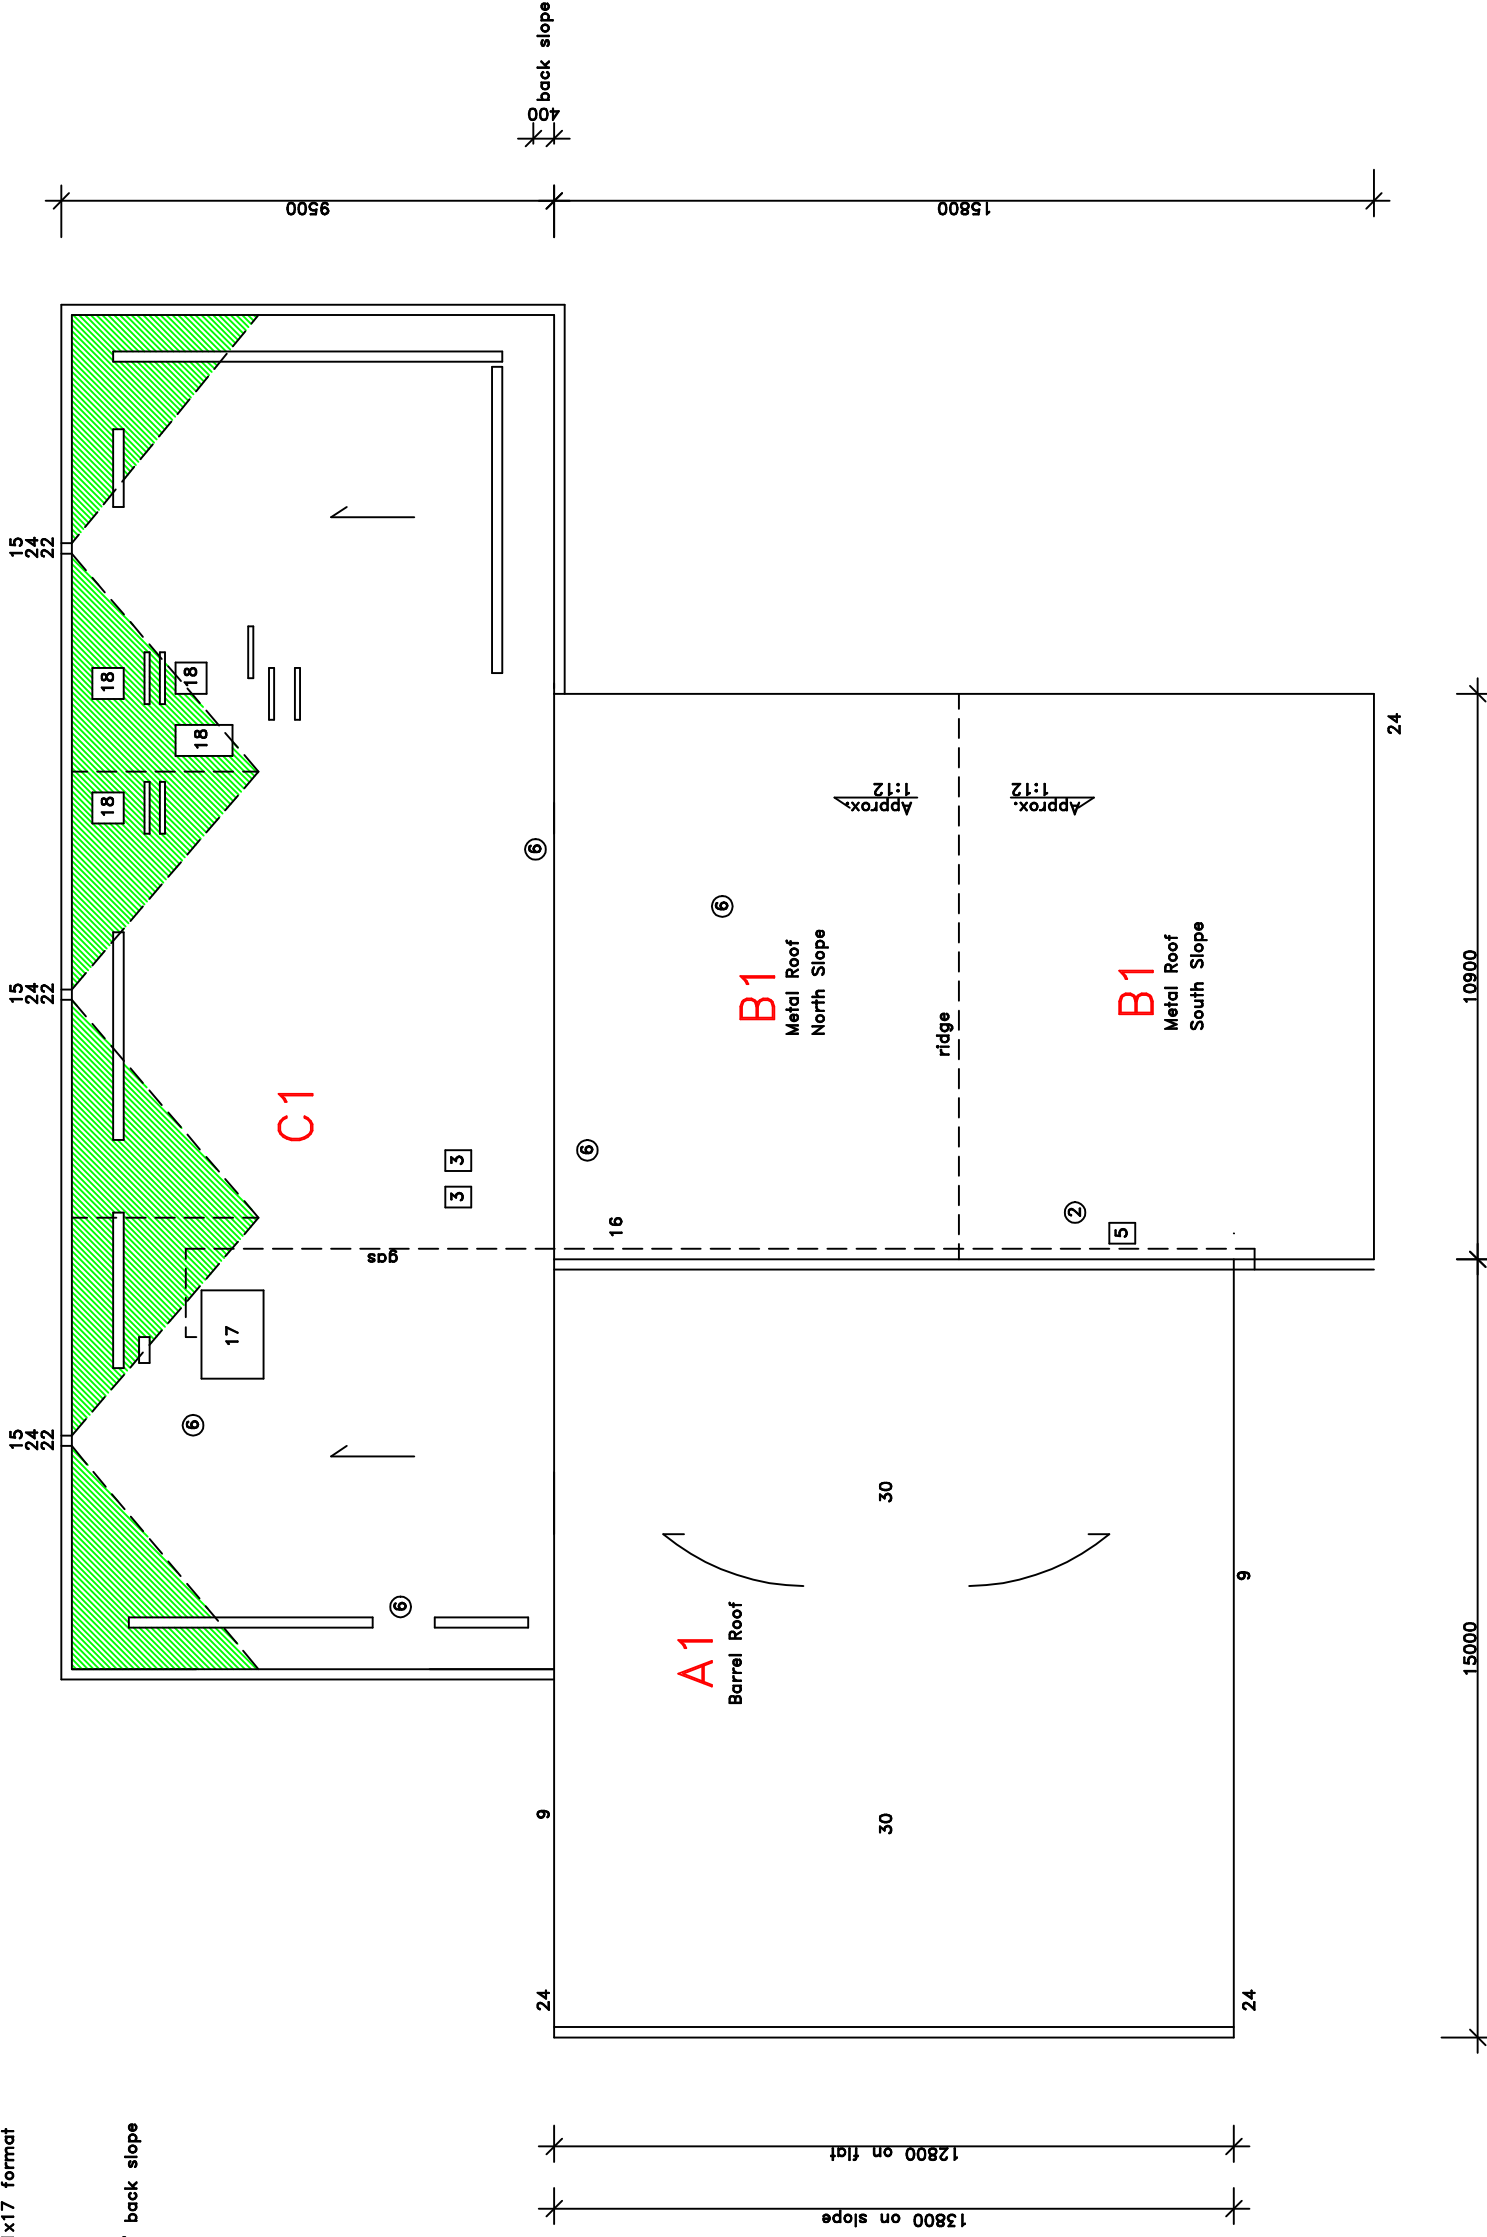
6"-0" x 12' back slope

A1 Construction (2001)

- insulated attic space
- 5/8" T&G plywood
- 180 gram SBS torch adhered base
- 250 gram SBS torch adhered cap

C1 Construction (2019)

- plywood deck
- 1/2" DensDeck
- self adhering SBS vapor barrier
- 2% sloped type 2 EPS min 2"
- 2" polyisocyanurate
- 1/2" HD polyisocyanurate with SBS base
- SBS composite cap sheet

B1 North Slope Construction (2019)

- metal roof panels
- custom fit type 2 expanded polystyrene
- 1/2" HD polyisocyanurate with SBS base
- SBS composite cap sheet

Note: 12" strip 1/2" plywood around perimeter of roof slope
