APPENDIX A
TEST HOLE LOGS

PROJECT: CSO Abatement and 290 Waterfront Drive	CLIENT: The City of Winnipeg, W&W Dept.	TESTHOLE NO: TH-05-01
LOCATION: South Side of Bannatyne, East of Rorie St.		PROJECT NO.: D265-177-00-07
CONTRACTOR: Paddock Drilling Ltd.	METHOD: 125 mm Solid Stem Augers	ELEVATION (m):
SAMPLE TYPE	<input checked="" type="checkbox"/> GRAB <input type="checkbox"/> SHELBY TUBE <input checked="" type="checkbox"/> SPLIT SPOON <input type="checkbox"/> BULK <input type="checkbox"/> NO RECOVERY <input type="checkbox"/> CORE

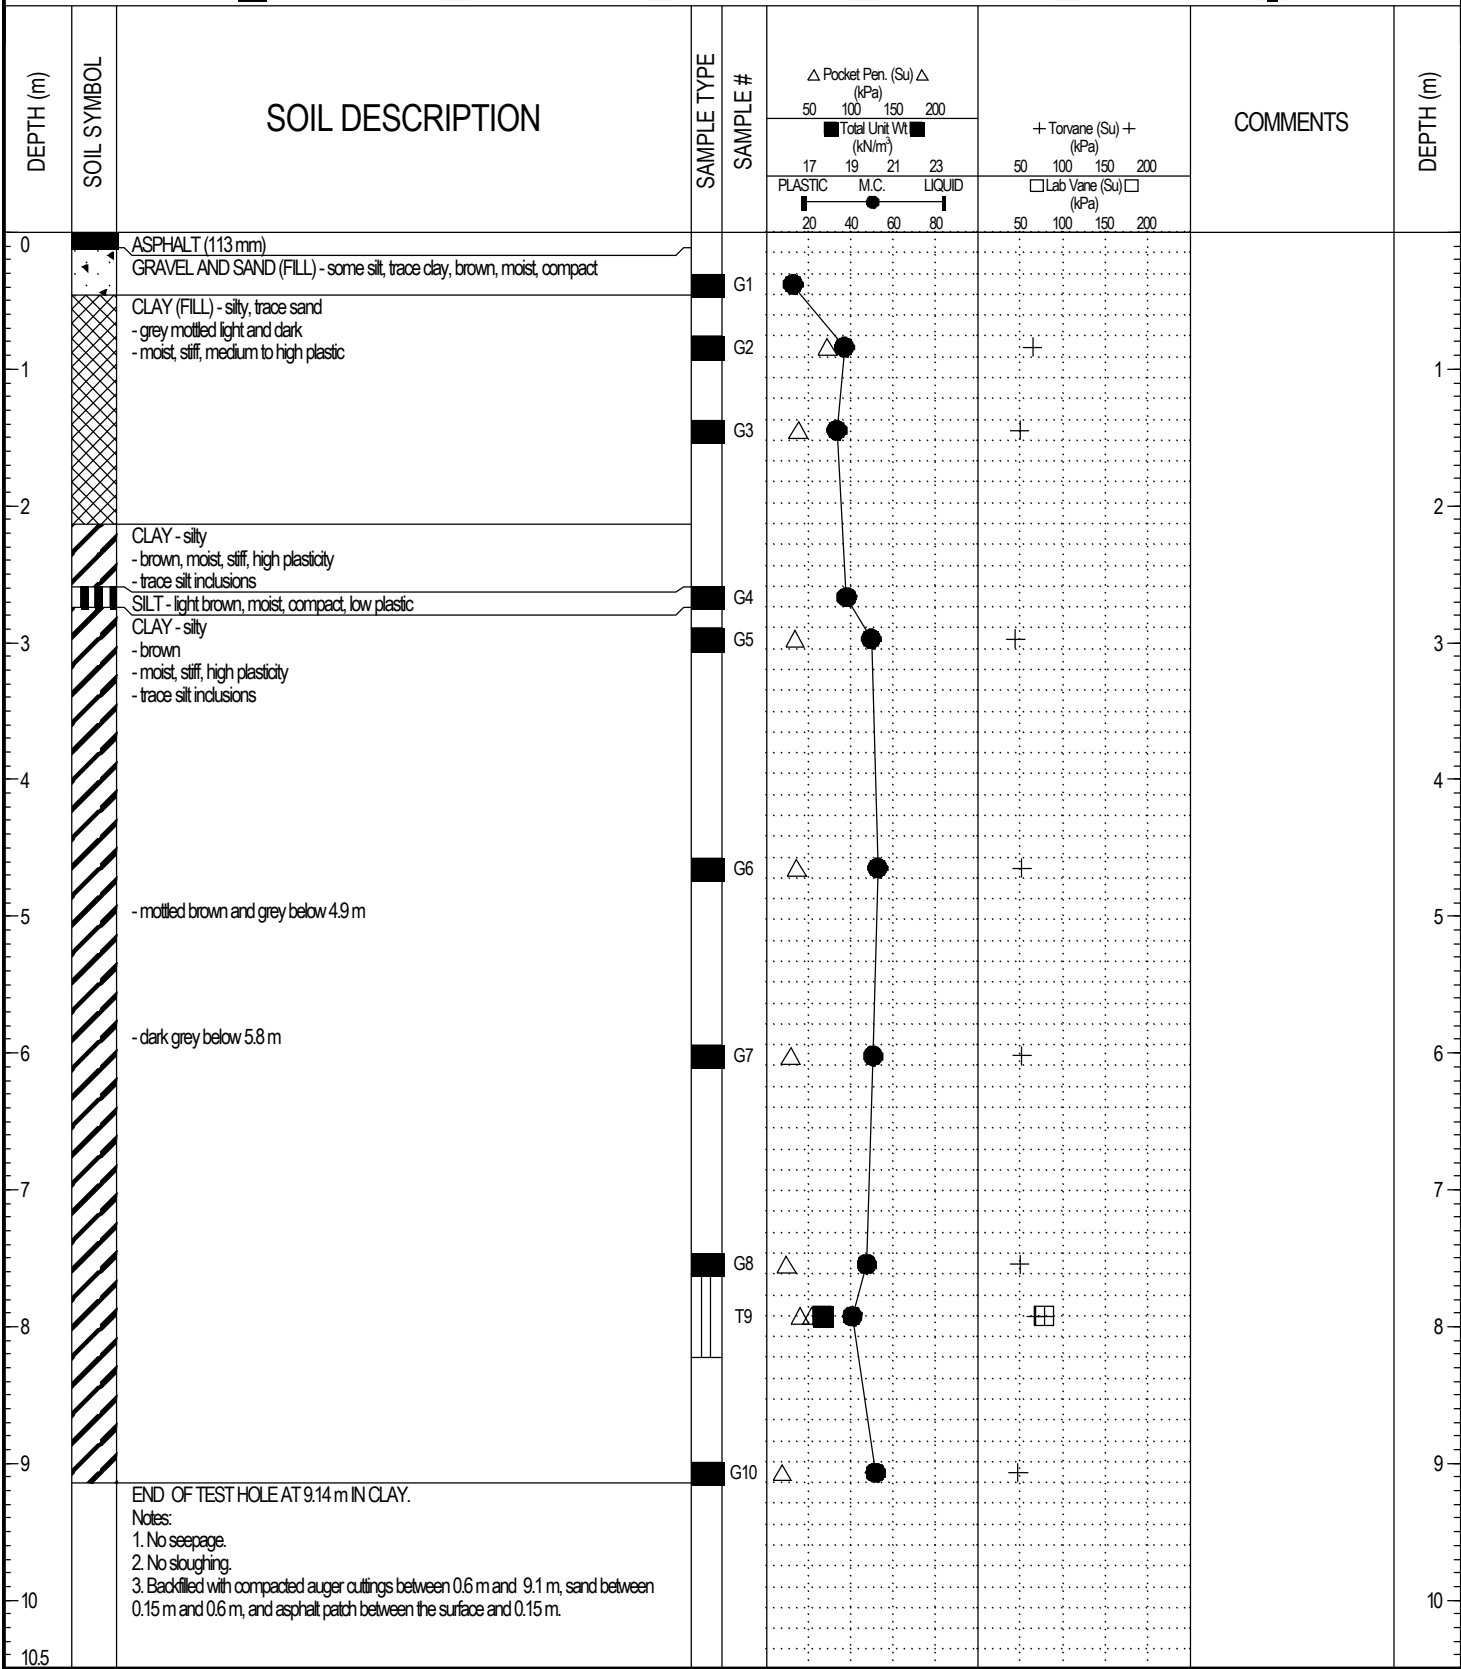
END OF TEST HOLE AT 9.14 m IN CLAY.
Notes:
1. No seepage.
2. No sloughing.
3. Backfilled with compacted auger cuttings between 0.6 m and 9.1 m, sand between 0.15 m and 0.6 m, and asphalt patch between the surface and 0.15 m.

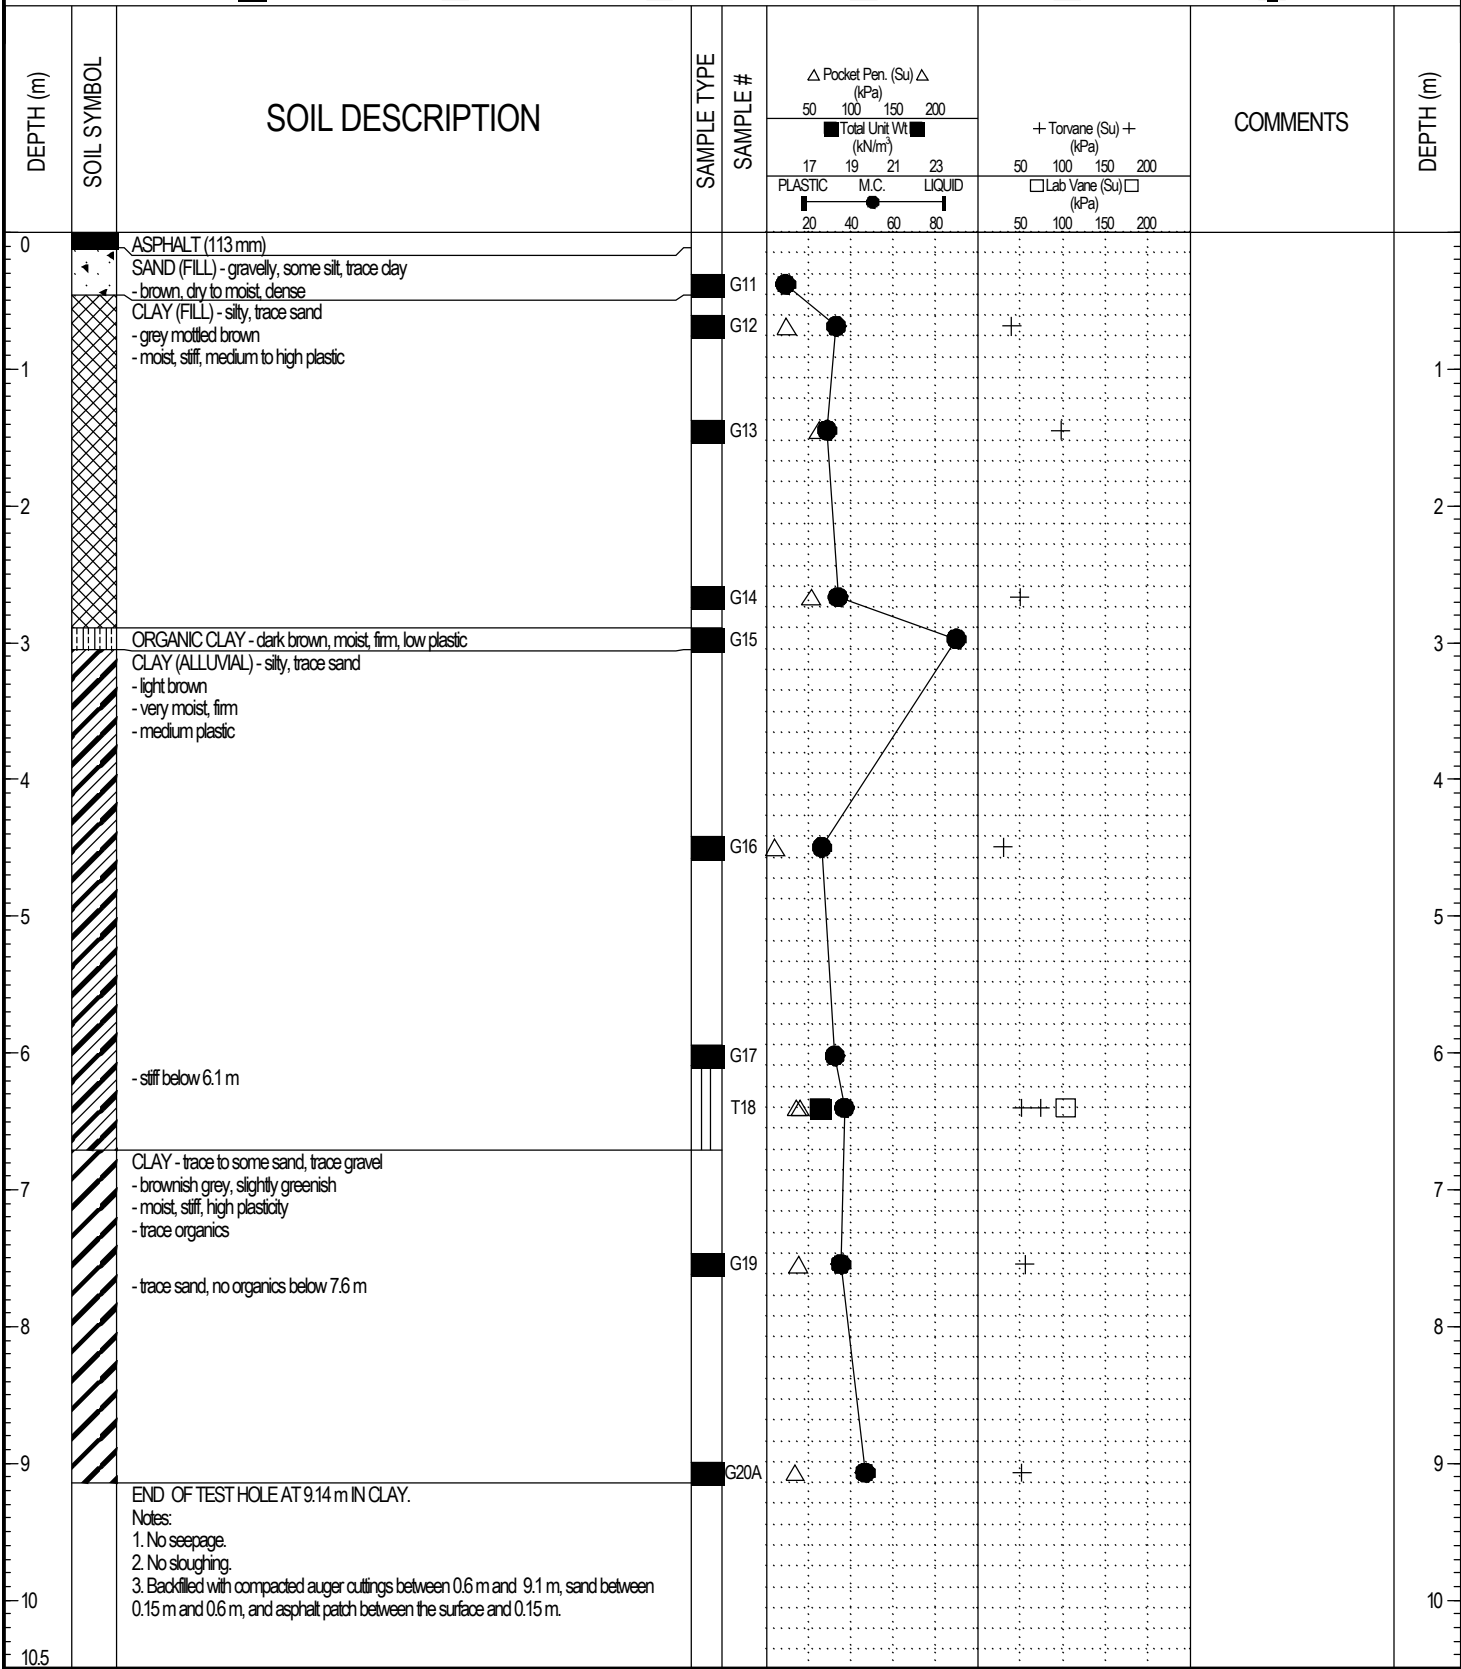
PROJECT: CSO Abatement and 290 Waterfront Drive	CLIENT: The City of Winnipeg, W&W Dept.	TESTHOLE NO: TH-05-02
LOCATION: South Side of Bannatyne, West of Ship St.		PROJECT NO.: D265-177-00-07
CONTRACTOR: Paddock Drilling Ltd.	METHOD: 125 mm Solid Stem Augers	ELEVATION (m):
SAMPLE TYPE	<input checked="" type="checkbox"/> GRAB <input type="checkbox"/> SHELBY TUBE <input checked="" type="checkbox"/> SPLIT SPOON <input type="checkbox"/> BULK <input type="checkbox"/> NO RECOVERY <input type="checkbox"/> CORE

- Notes:
1. No seepage.
 2. No sloughing.
 3. Backfilled with compacted auger cuttings between 0.6 m and 9.1 m, sand between 0.15 m and 0.6 m, and asphalt patch between the surface and 0.15 m.

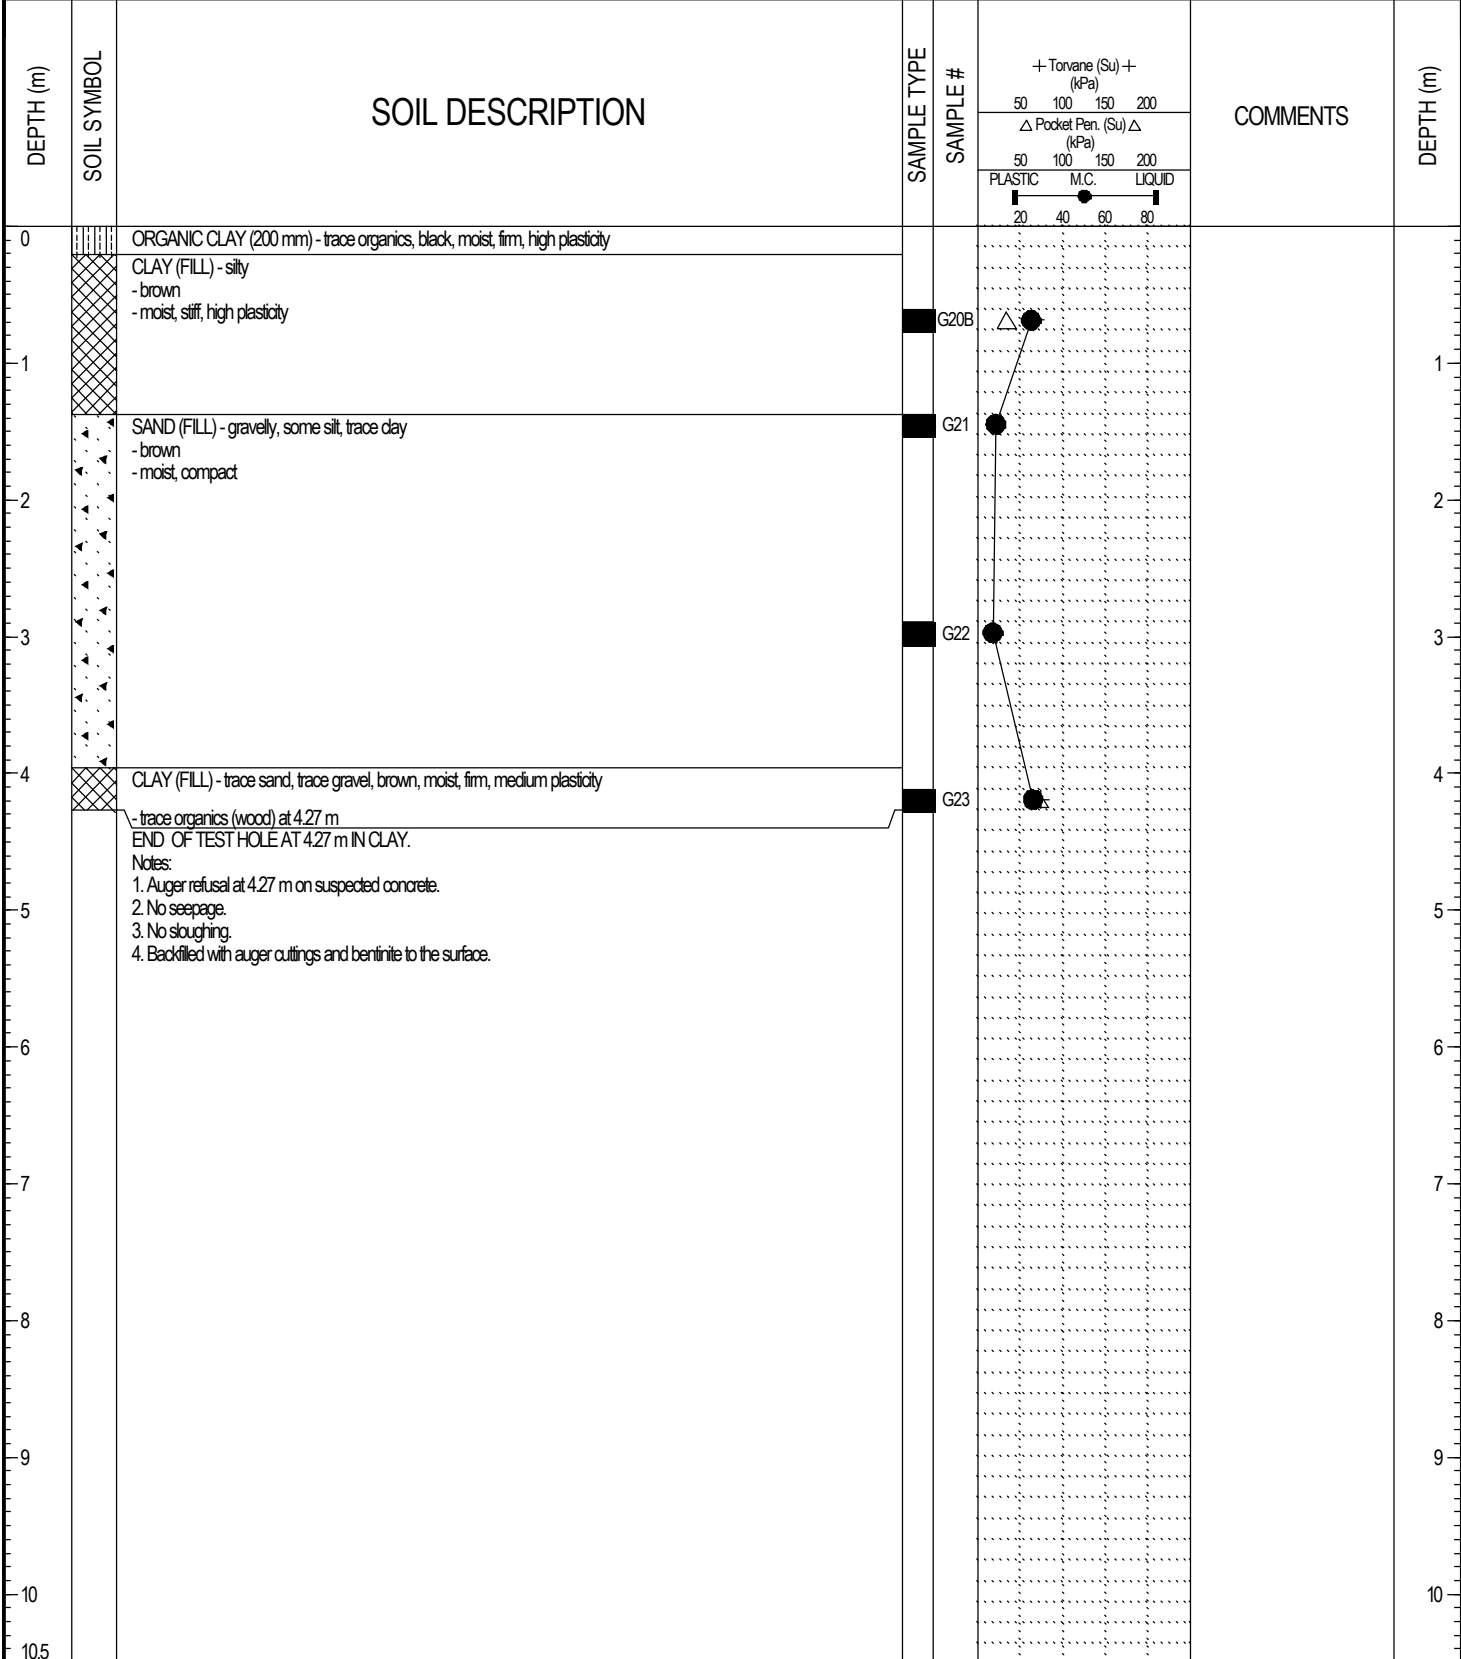
PROJECT: CSO Abatement and 290 Waterfront Drive	CLIENT: The City of Winnipeg, W&W Dept.	TESTHOLE NO: TH-05-03
LOCATION: South Side of Bannatyne, East of Ship St.		PROJECT NO.: D265-177-00-07
CONTRACTOR: Paddock Drilling Ltd.	METHOD: 125 mm Solid Stem Augers	ELEVATION (m):
SAMPLE TYPE	<input checked="" type="checkbox"/> GRAB <input type="checkbox"/> SHELBY TUBE <input type="checkbox"/> SPLIT SPOON <input checked="" type="checkbox"/> BULK	<input checked="" type="checkbox"/> NO RECOVERY <input type="checkbox"/> CORE
