EAST SIDE OVERHANG DELAMINATED CONCRETE REPAIRS

B.M. ELEV. DESIGNED BY: R.A.W. DRAWN BY: N.B.G. CHECKED BY: R.A.W. REVIEWED BY: S.S.R.	HOR. SCALE: AS NOTED VERTICAL: AS NOTED	DILLON CONSULTING R.A. WIEBE REGISTERED PROFESSIONAL ENGINEER	PROVINCE OF MANITOBA S.S. RIHAL REGISTERED PROFESSIONAL ENGINEER	THE CITY OF WINNIPEG PUBLIC WORKS DEPARTMENT MARYLAND TWIN BRIDGES REHABILITATION PROJECT EAST BRIDGE REHABILITATION	CITY DRAWING NUMBER: B108-06-11 SHEET 11 OF 38
2 ISSUED FOR TENDER 02/02/06 N.B.G. 1 ISSUED FOR CITY REVIEW 12/14/05 N.B.G.	DATE: DEC. 2005	RELEASED FOR CONSTRUCTION DATE: 01-31-06	REHABILITATED BRIDGE DECK

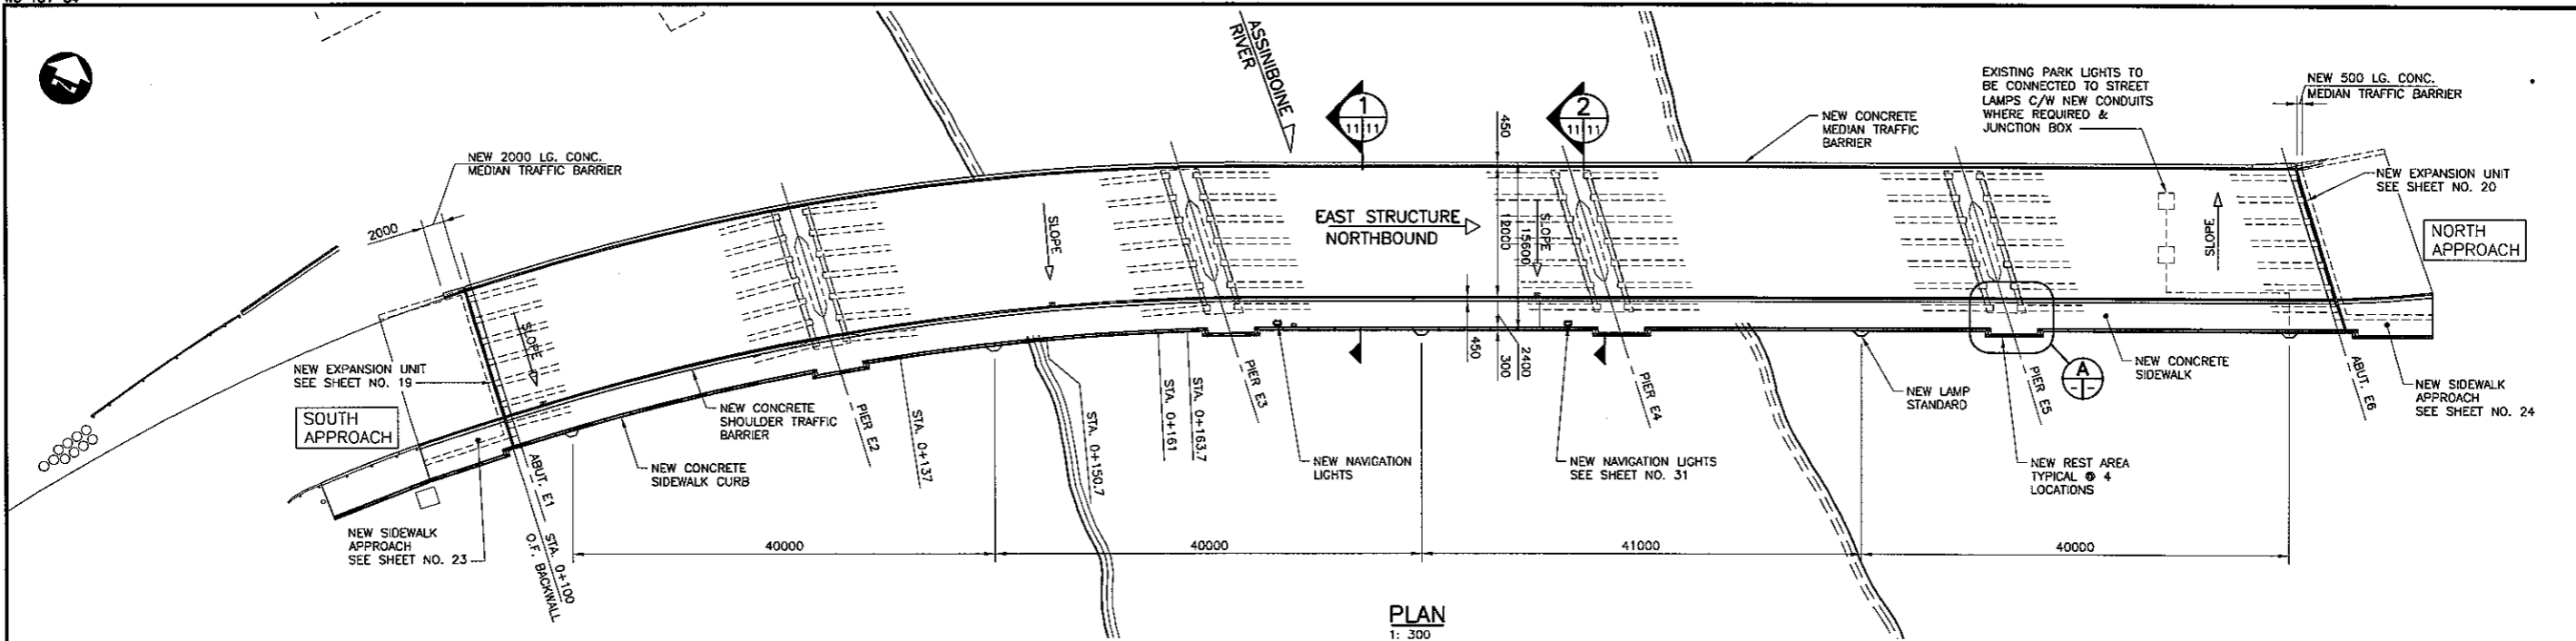
PLAN
1: 300

APPROX. AREAS OF EAST SIDE OVERHANG DELAMINATED CONCRETE		
STATION	DESCRIPTION (APPROX. LENGTH (m) X WIDTH (m))	APPROX. AREA (m ²)
0+ 137	APPROX. 1.5 X 0.5 UNDERSIDE OF DECK	0.75
0+ 150.7	APPROX. 0.3 X 0.3 UNDERSIDE OF DECK	0.09
0+ 161	APPROX. 0.3 m ON THE VERTICAL SIDE OF THE OVERHANG	0.08
0+ 163.7	APPROX. 0.3 m ON THE VERTICAL SIDE OF THE OVERHANG	0.08
APPROX. TOTAL AREA =		1.0 m ²

1. A CONDITION SURVEY WAS COMPLETED IN OCTOBER 2005 BY THE CONTRACT ADMINISTRATOR TO FIND THE DELAMINATIONS IN THE OVERHANG AREA OF THE BRIDGE DECK. THESE LOCATIONS ARE NOTED IN THE TABLE ABOVE. THE CONTRACTOR SHALL REPAIR THESE AREAS BY SAWCUTTING THE PERIMETER OF THE AREA TO A MINIMUM DEPTH OF 20MM, REMOVING ALL LOOSE AND DELAMINATED CONCRETE, CLEANING ANY RUSTED REINFORCING THAT MAY EXIST, AND FILLING THE CAVITY WITH AN APPROVED GROUT OR IN CONJUNCTION WITH THE PLACEMENT OF THE NEW SIDEWALK CONCRETE.
2. NO OTHER DELAMINATED AREAS WERE FOUND TO EXIST AT THE TIME OF THE INSPECTION. SHOULD ANY ADDITIONAL AREAS OF REPAIR DEVELOP AT THE TIME OF DEMOLITION, THEY SHALL BE DEEMED TO BE AS A RESULT OF THE EFFORTS OF THE DEMOLITION PROCESS, UNLESS OTHERWISE DETERMINED AND WILL BE REPAIRED BY THE CONTRACTOR AT NO ADDITIONAL COST TO THE CITY.
