Project:
MAYFAIR
RECREATION
CENTRE

Drawing Title:
ROOF AND MISC
DETAILS

Sheet No: **A4.4**

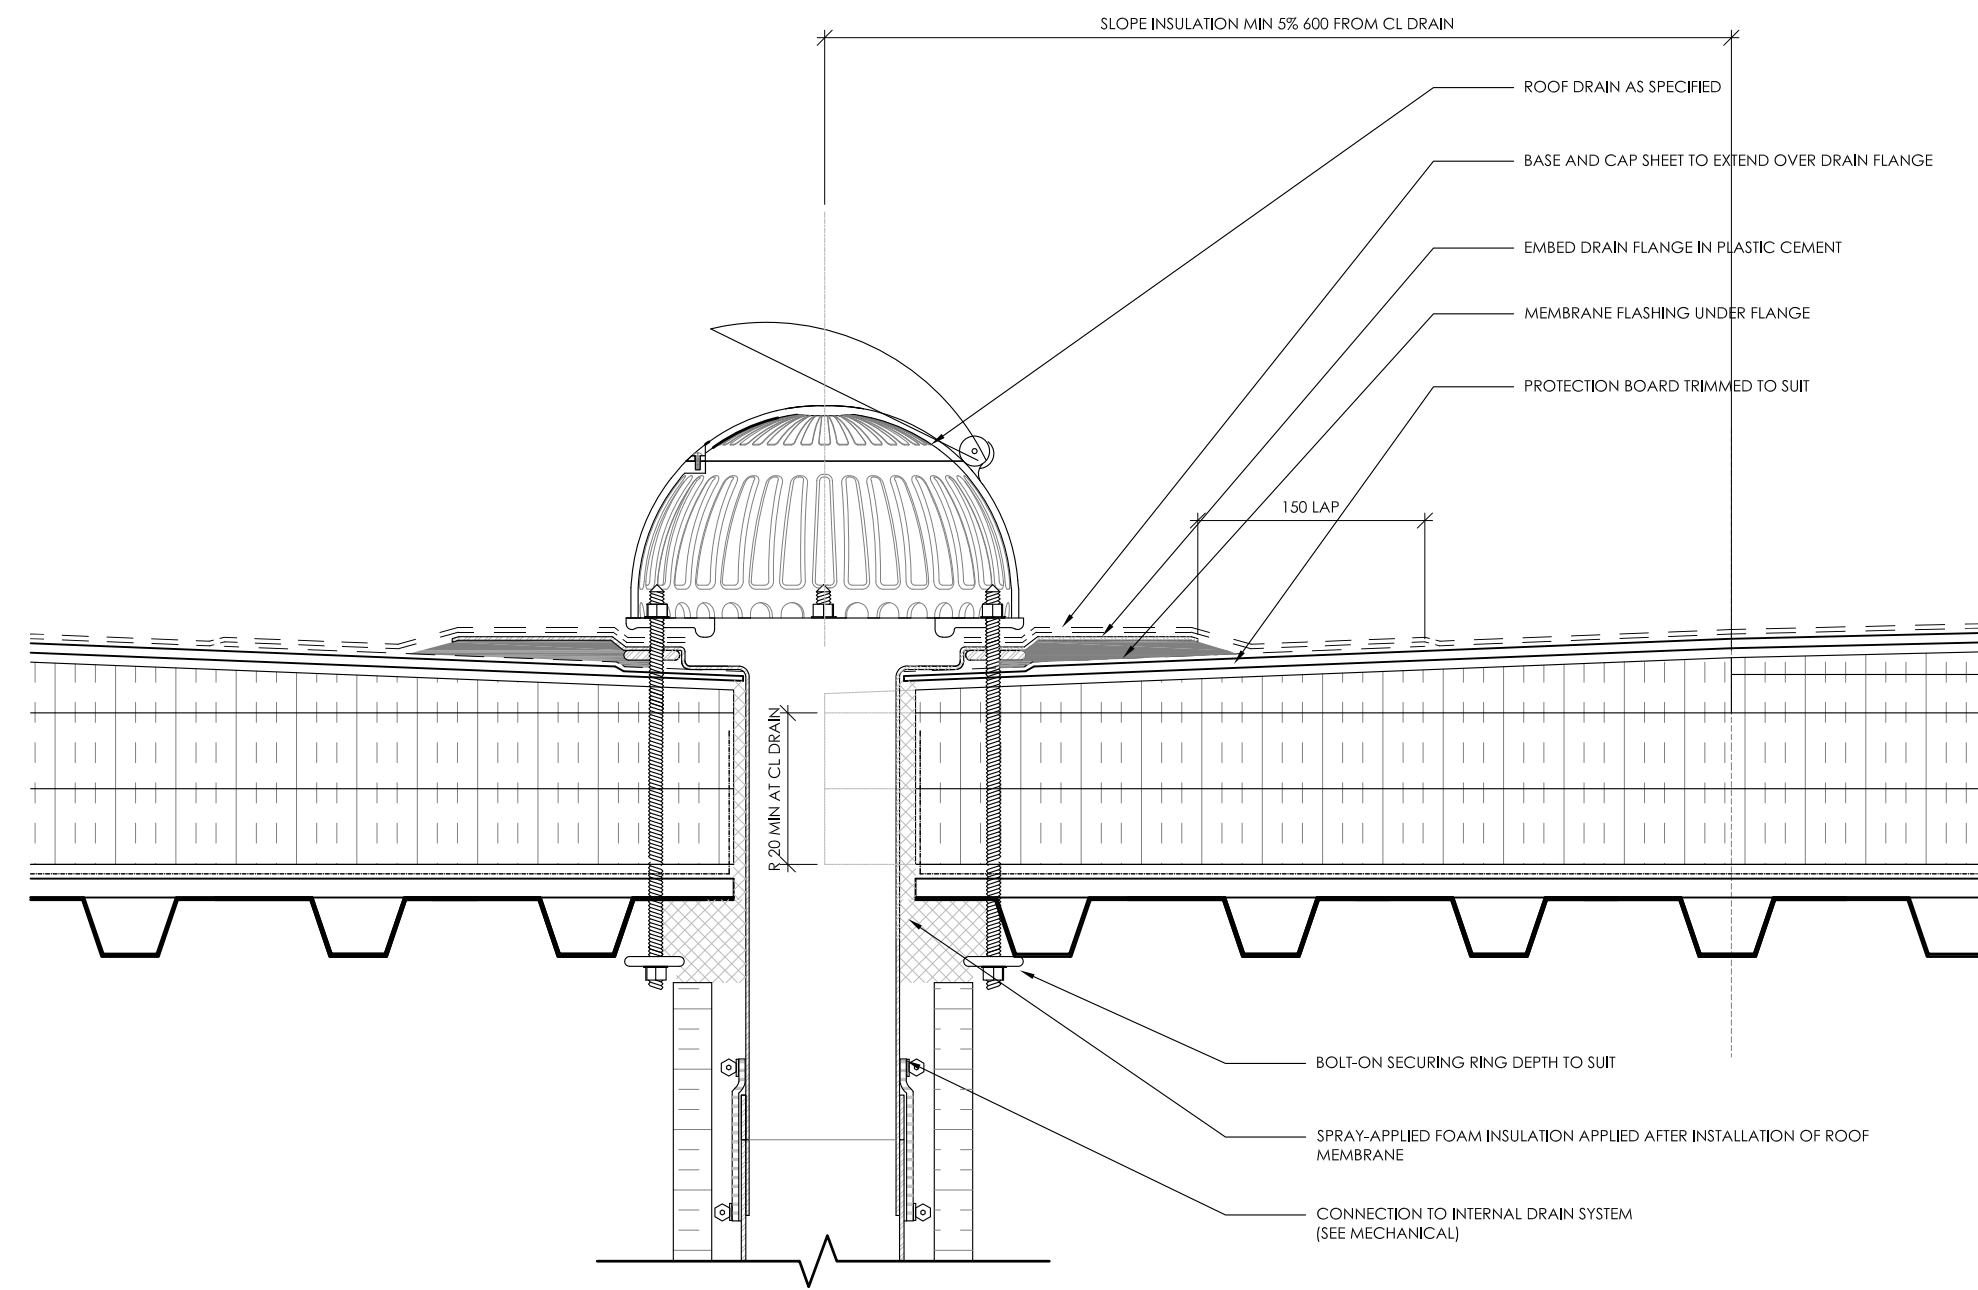
1 TYPICAL ROOF DRAIN
1:5

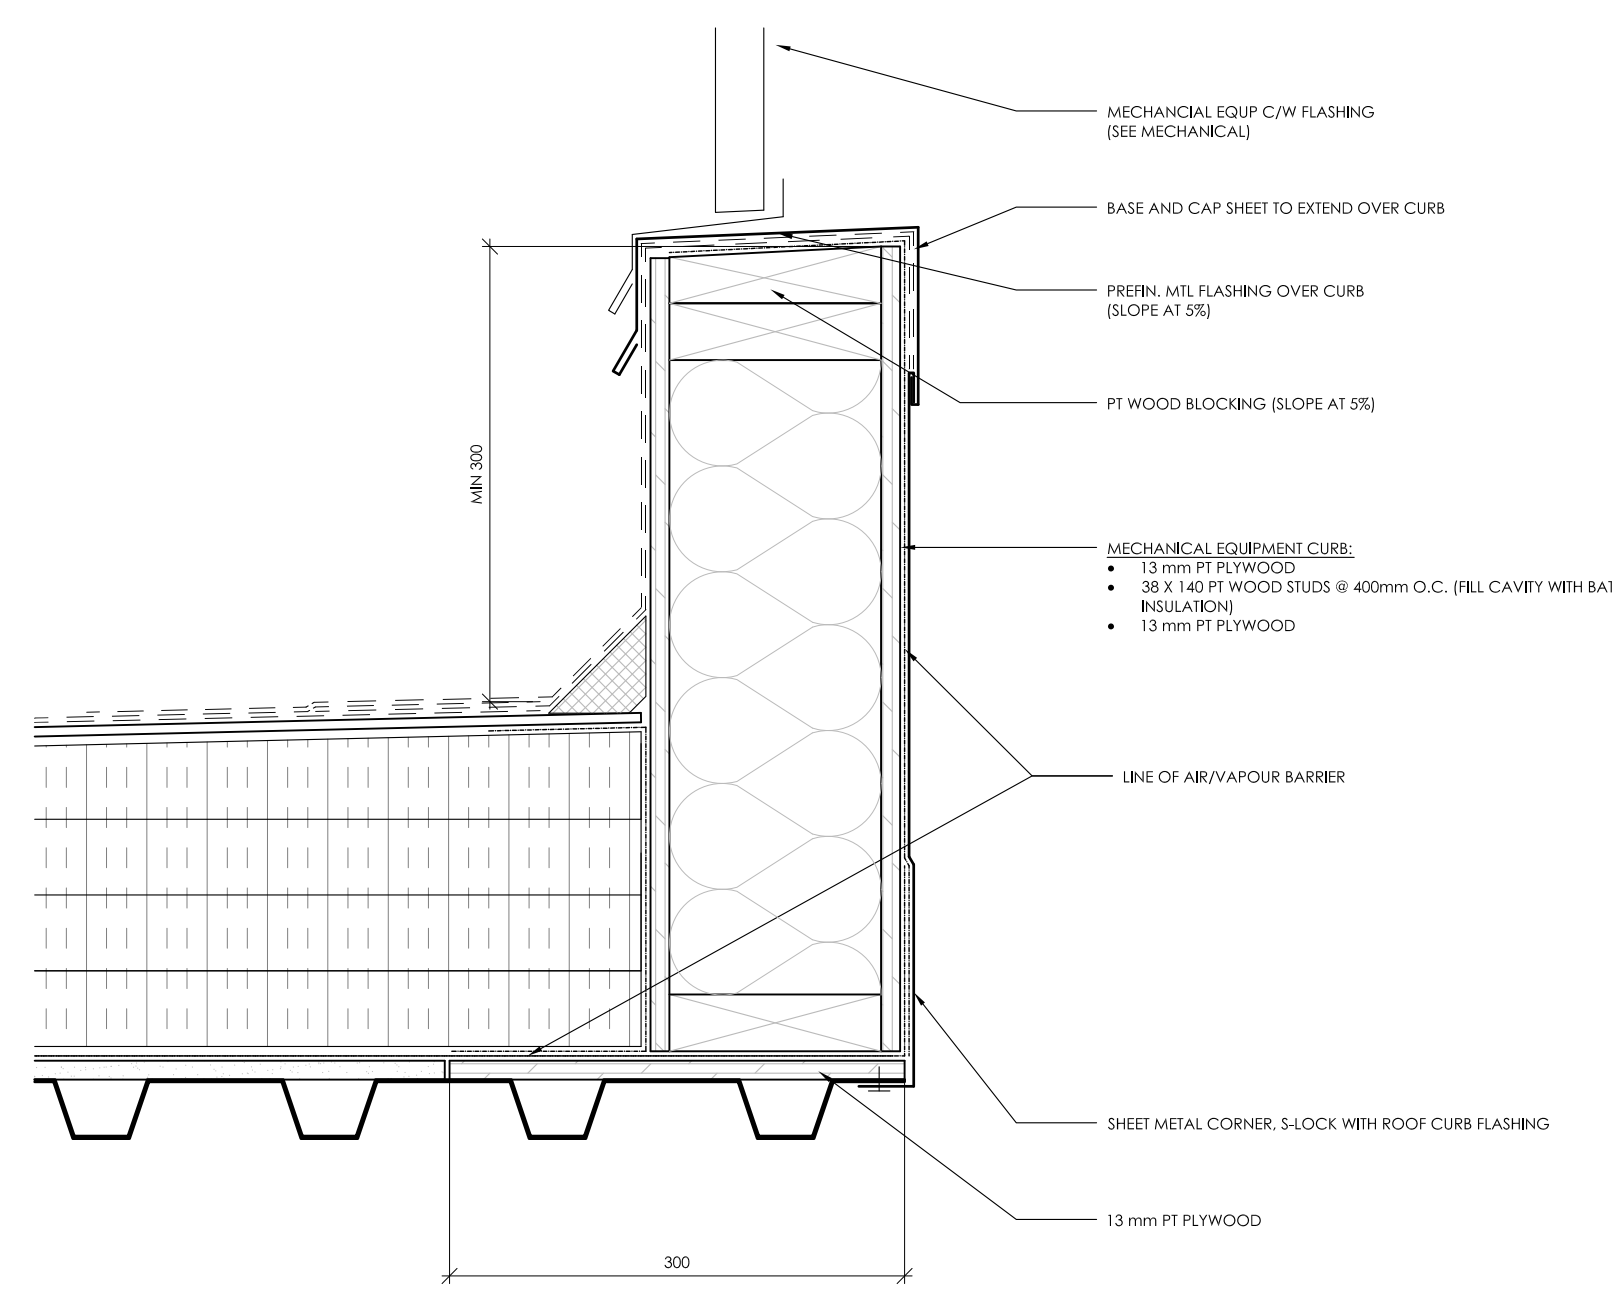
2 TYPICAL MECHANICAL EQUIPMENT/GOOSENECK CURB
1:5

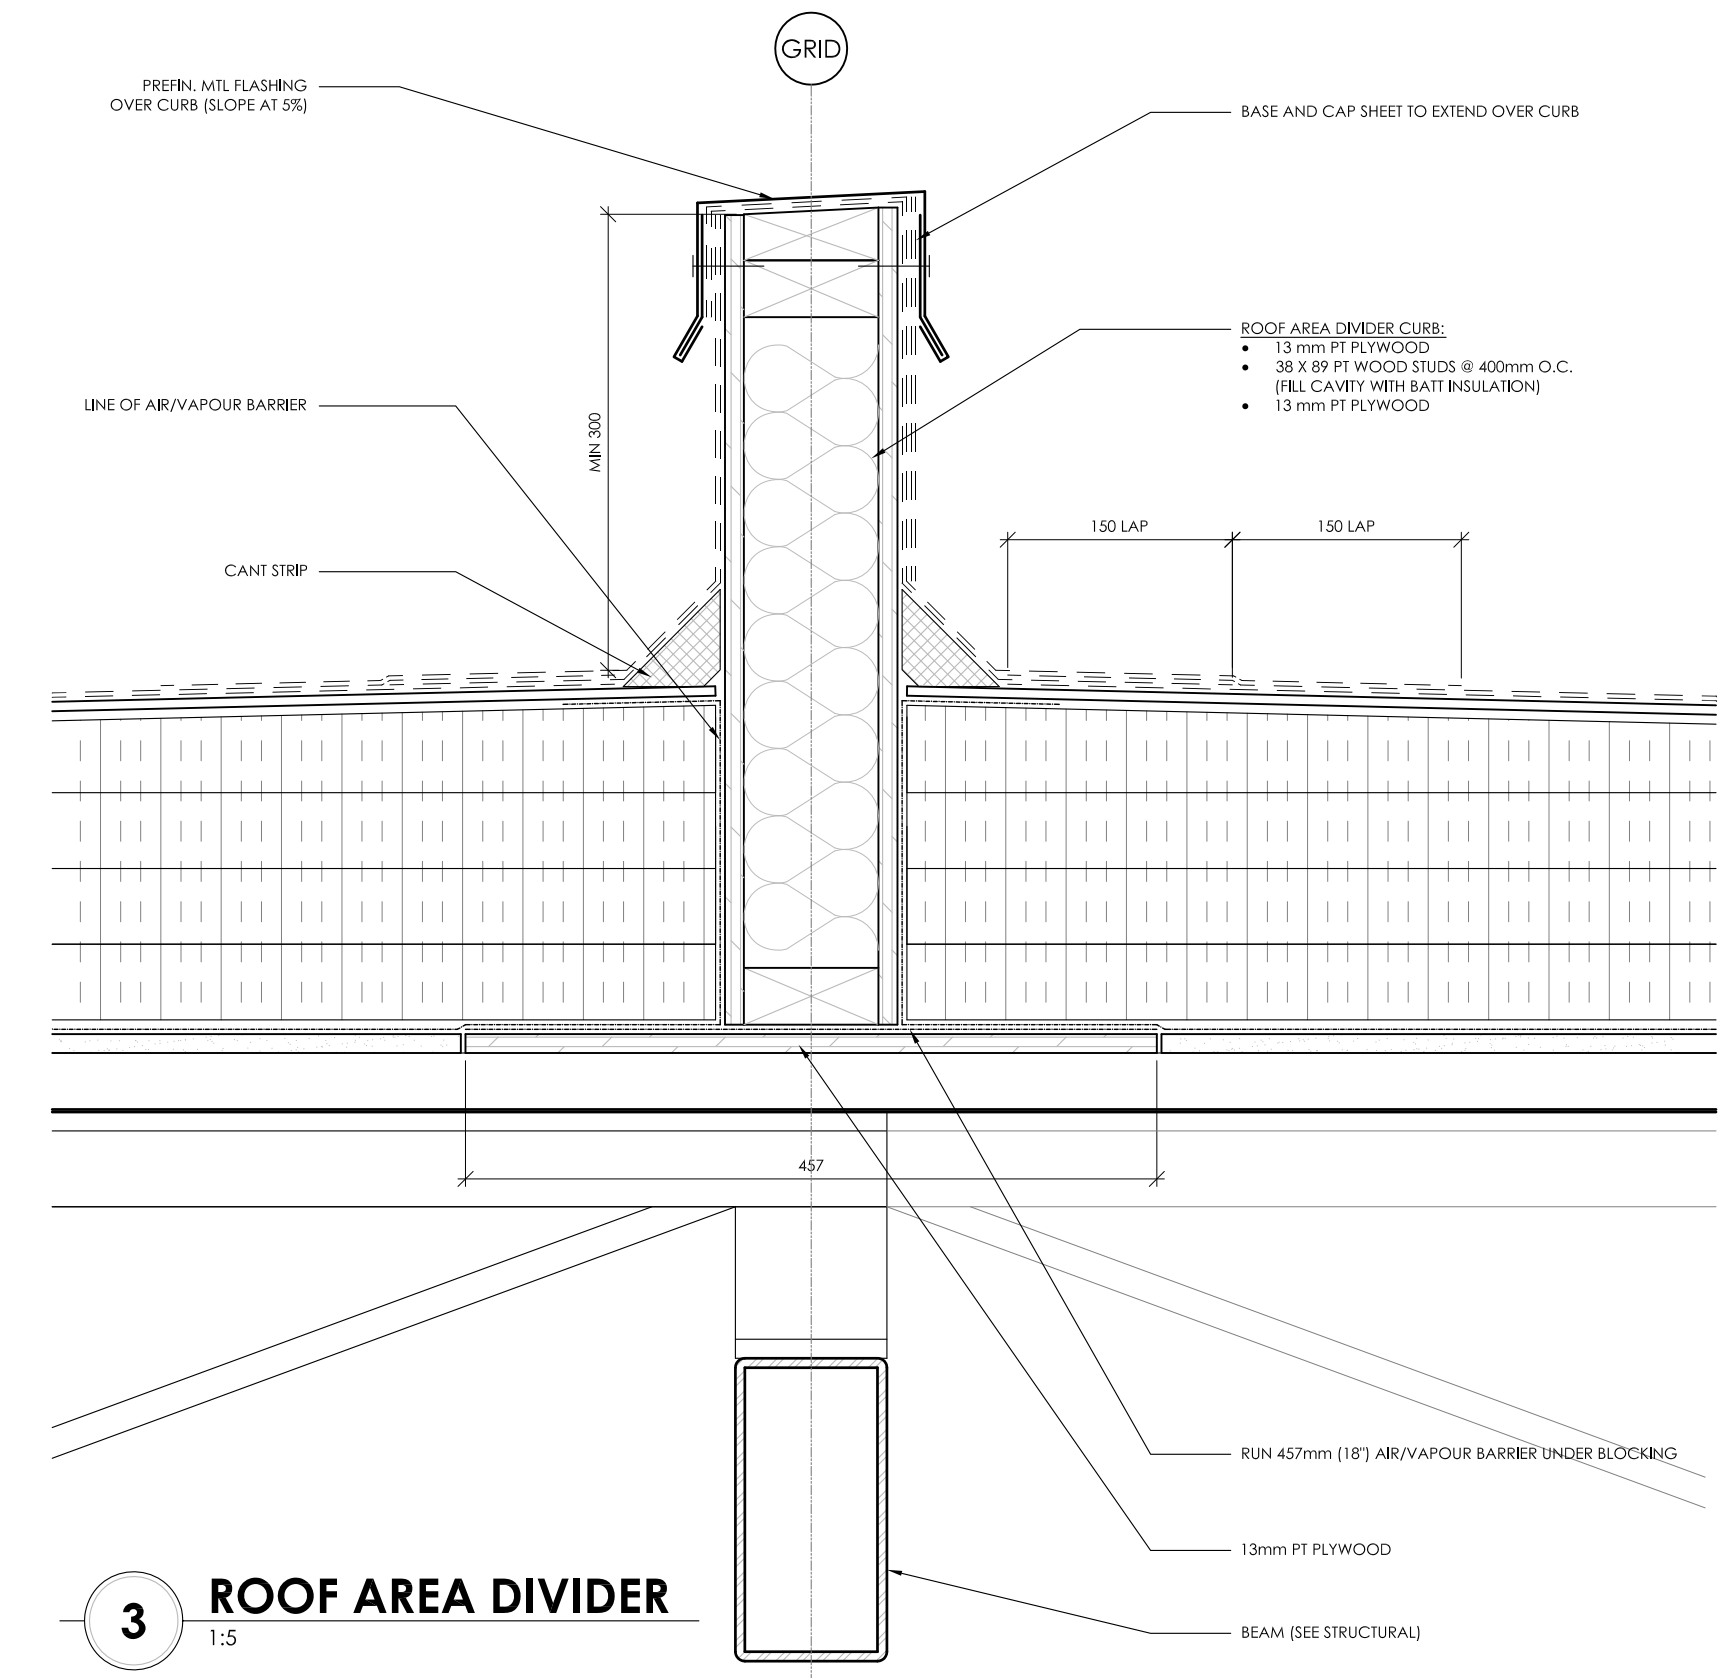
3 ROOF AREA DIVIDER
1:5

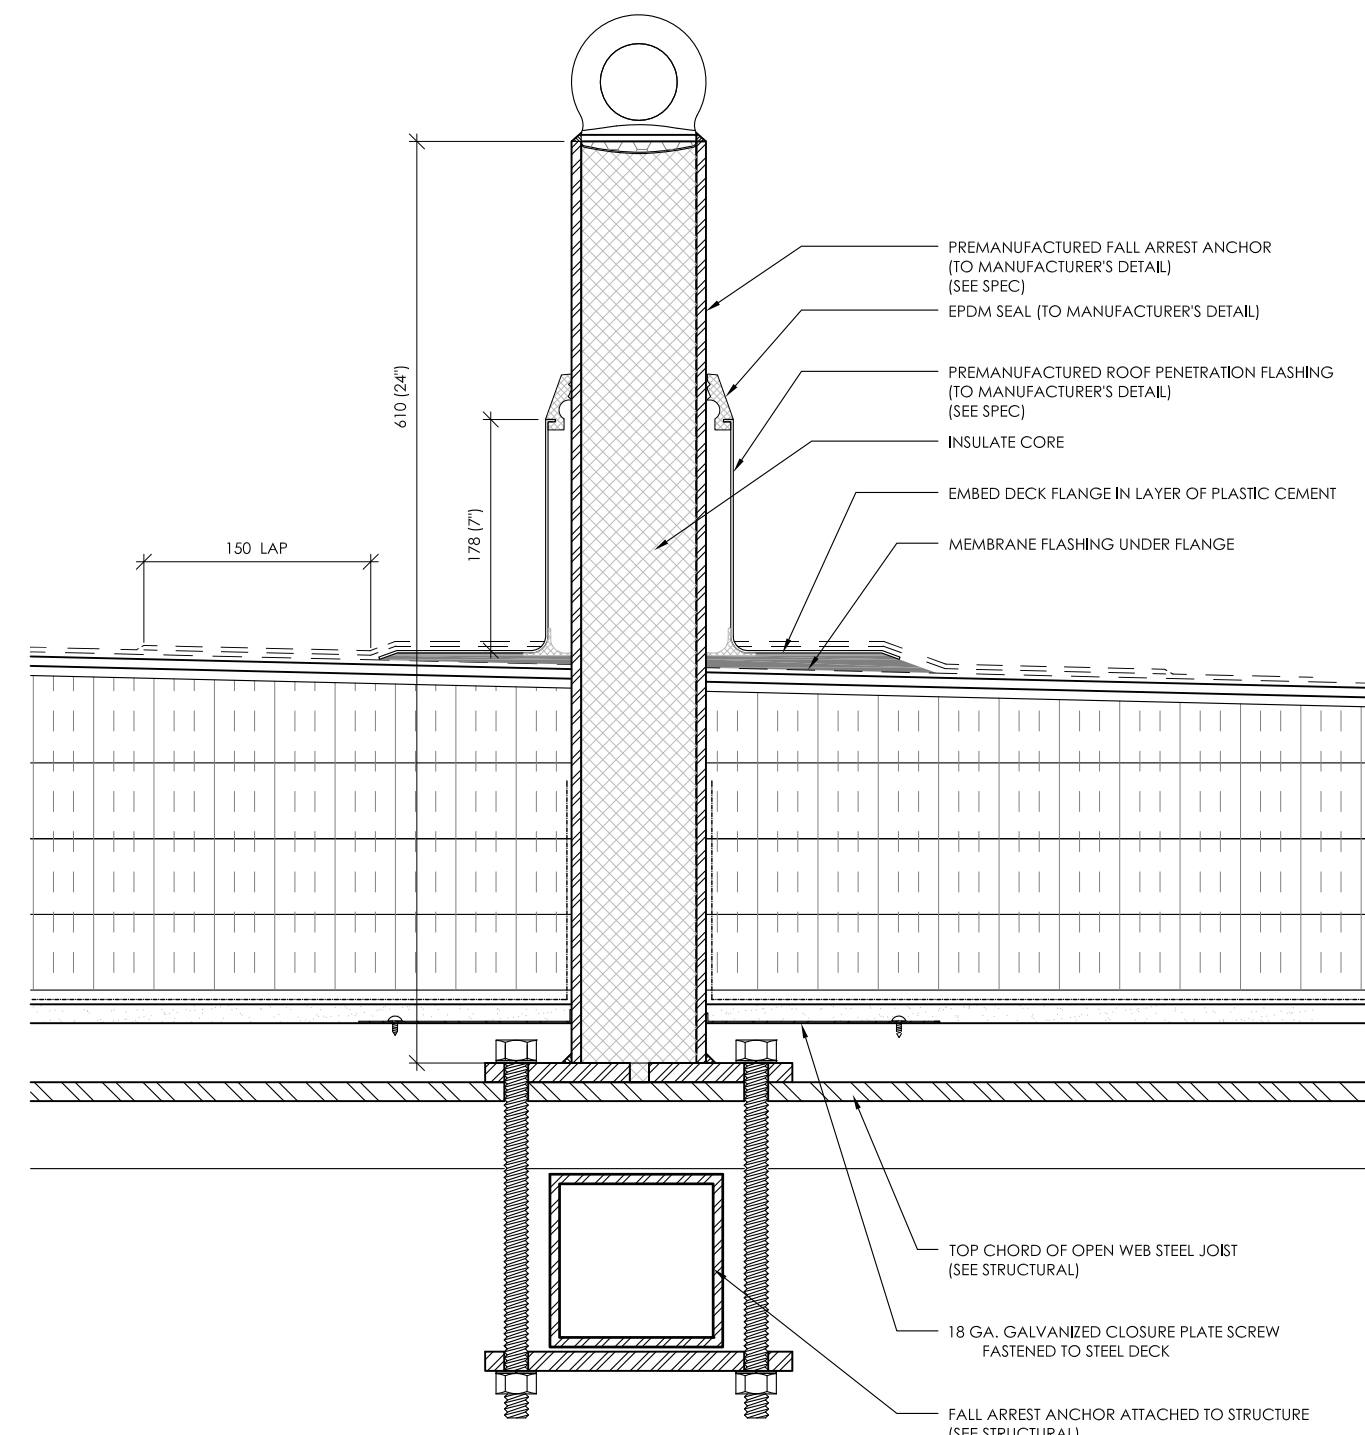
4 TYPICAL FALL ARREST ANCHOR
1:5

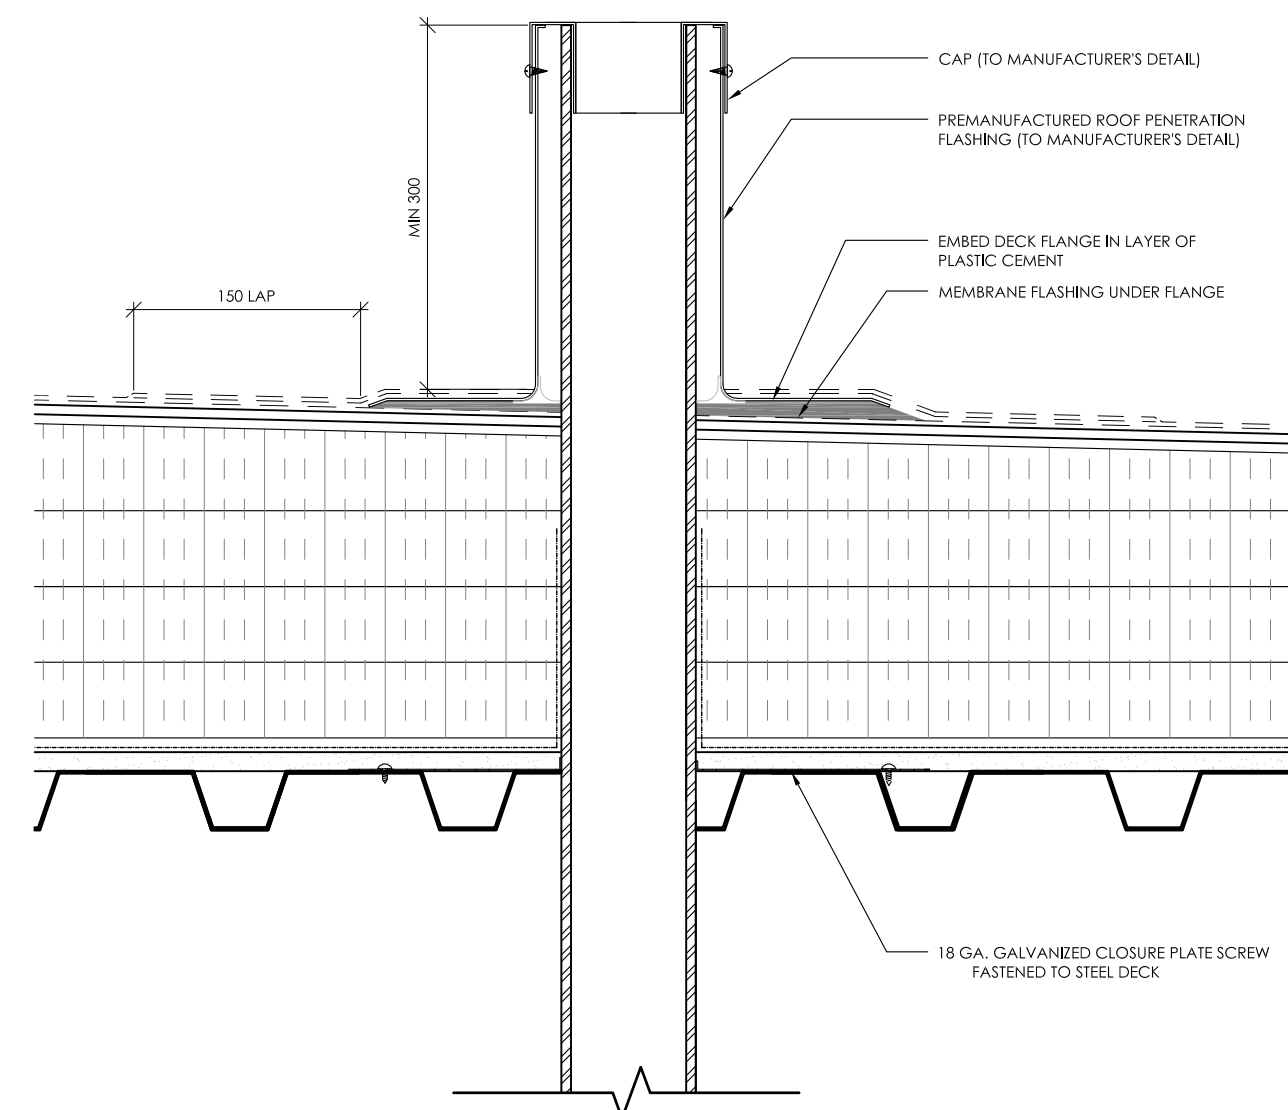
5 TYPICAL ROOF PIPE PENETRATION
1:5

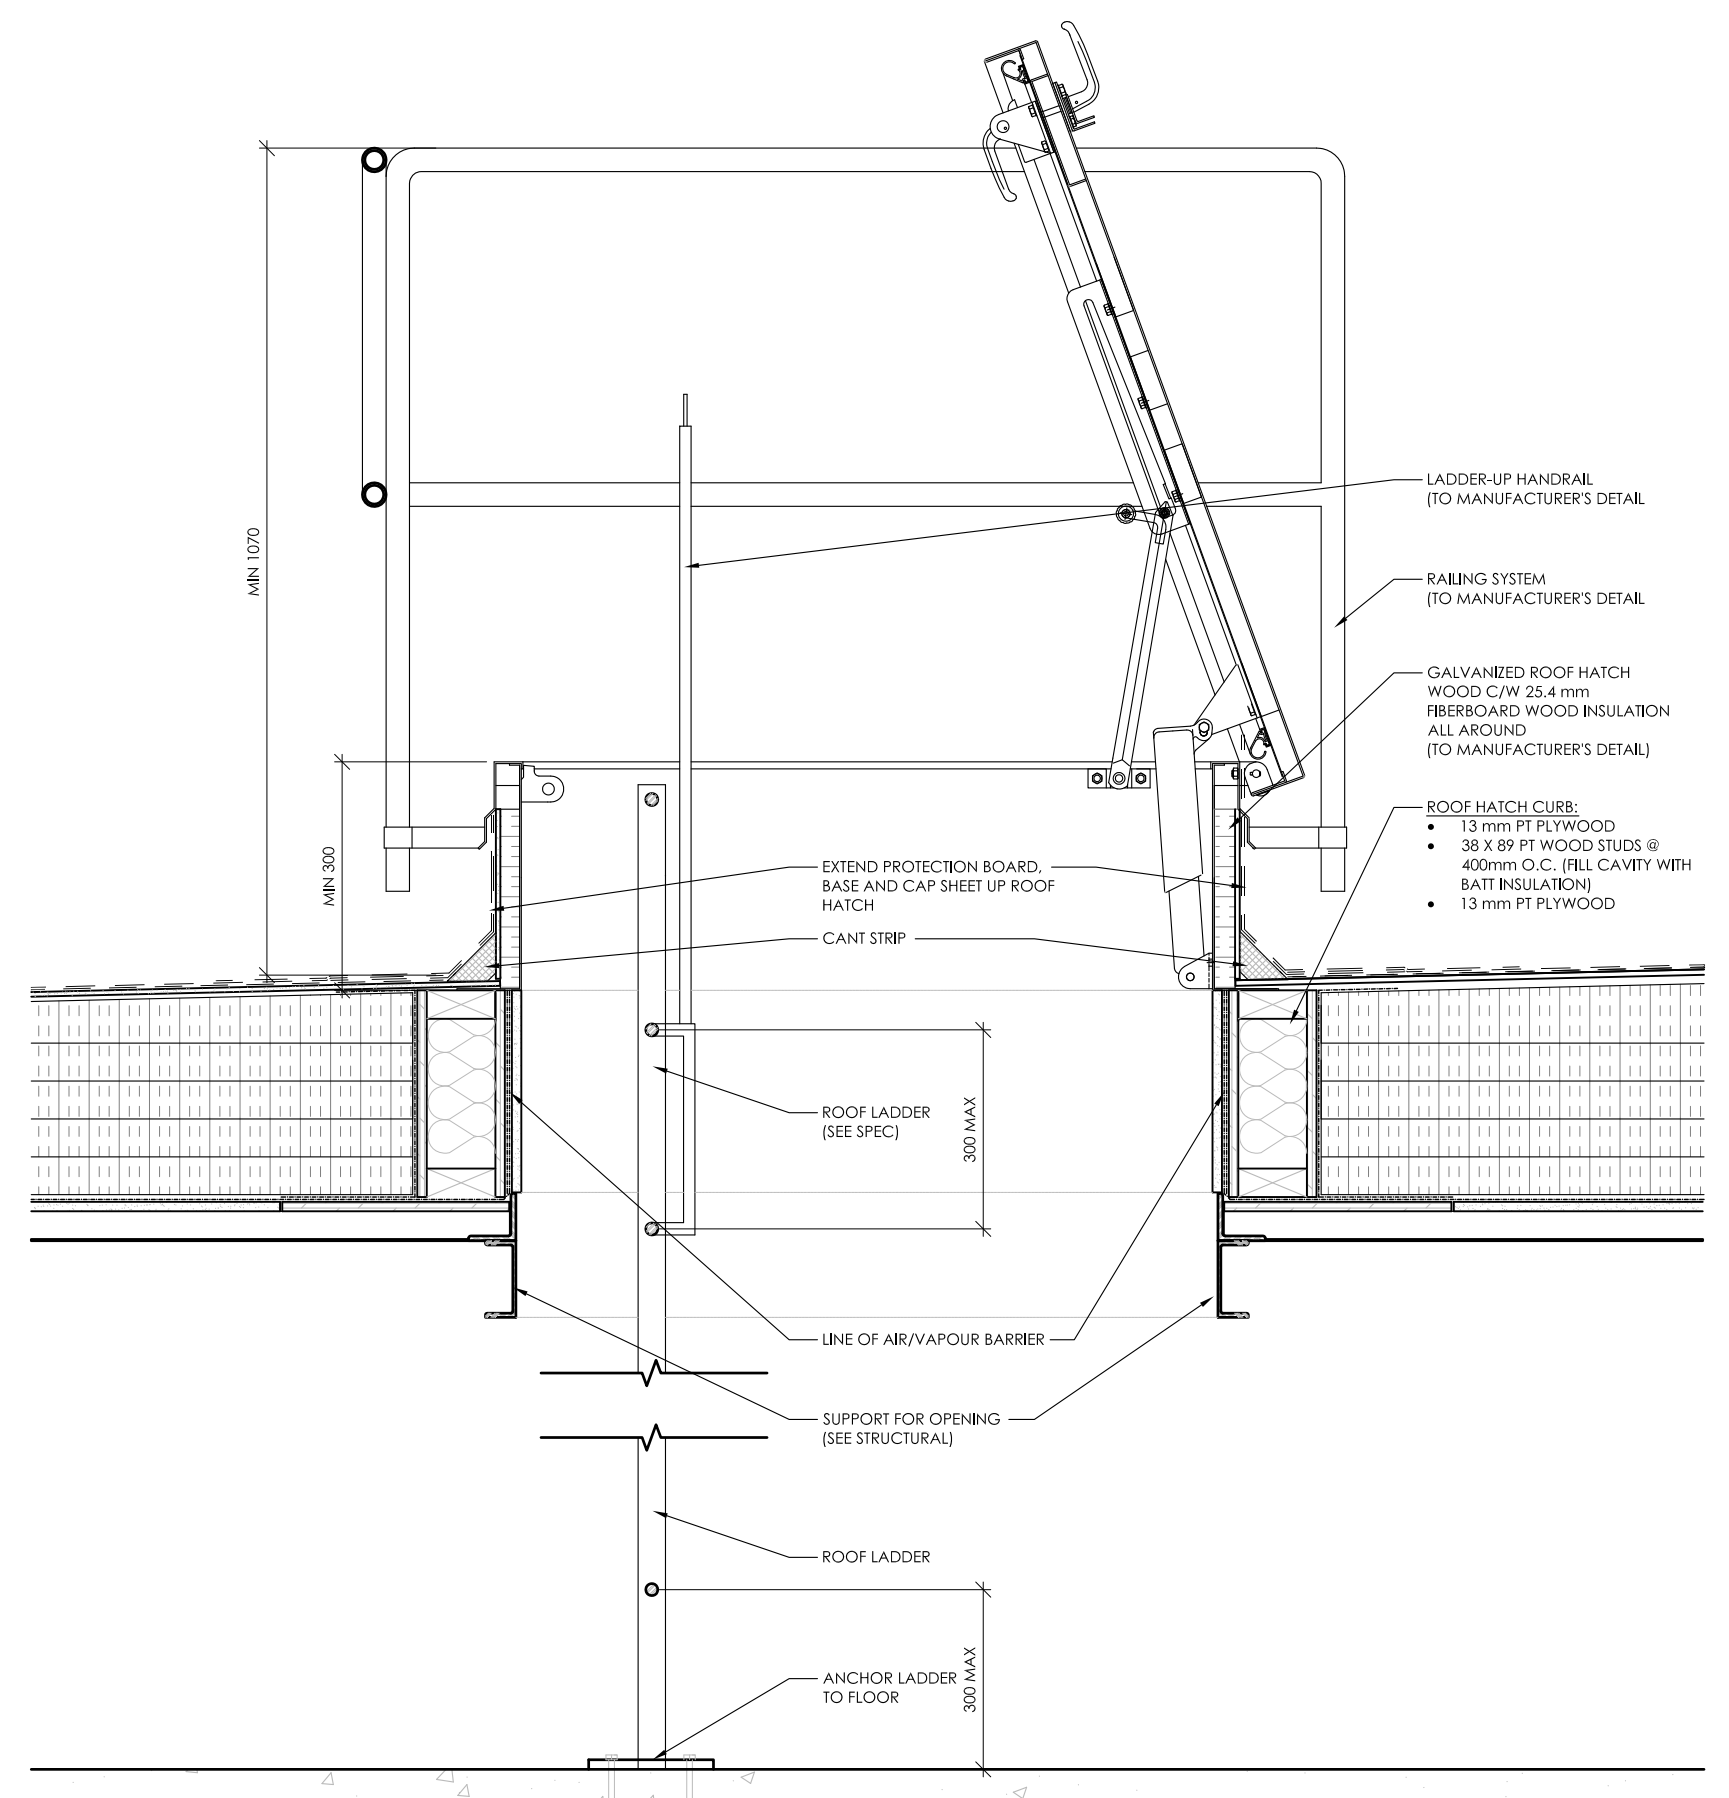
6 ROOF HATCH
1:10

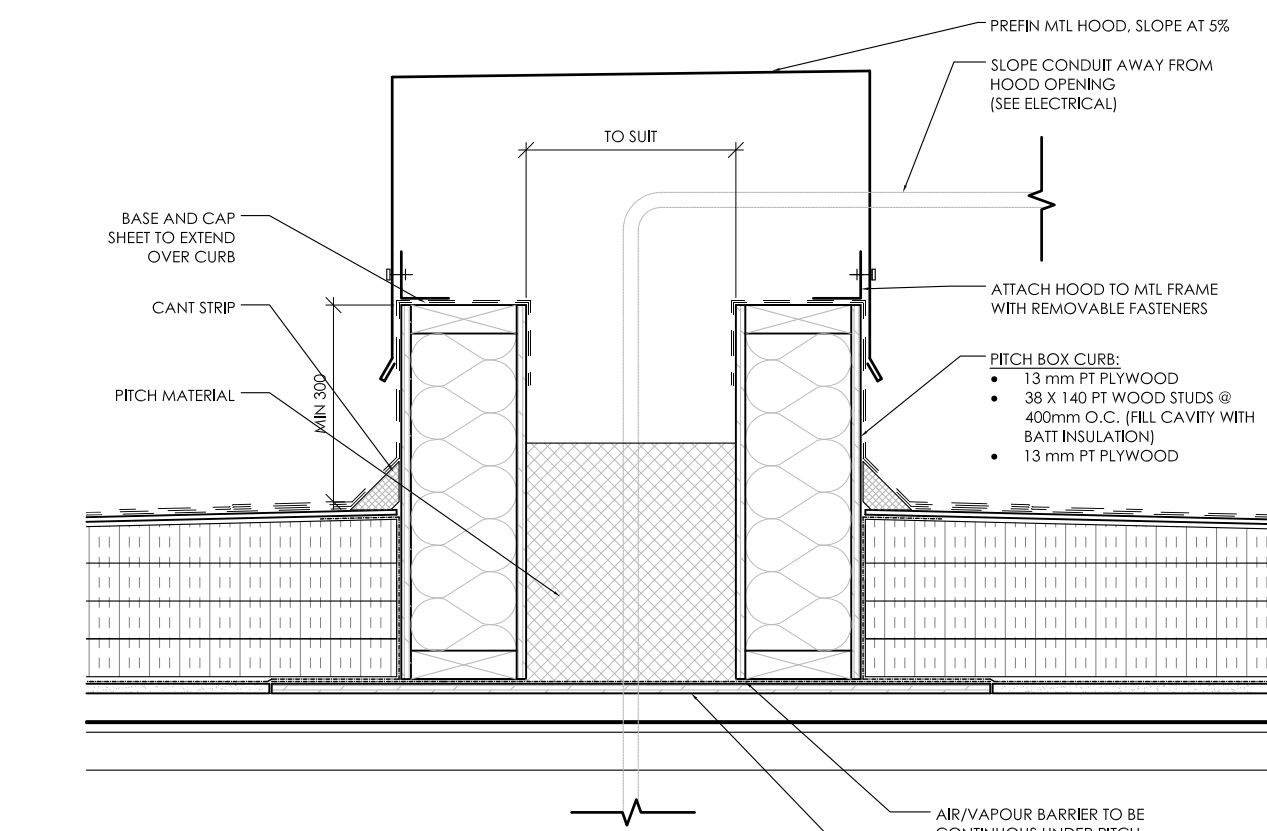
7 GUM BOX
1:10

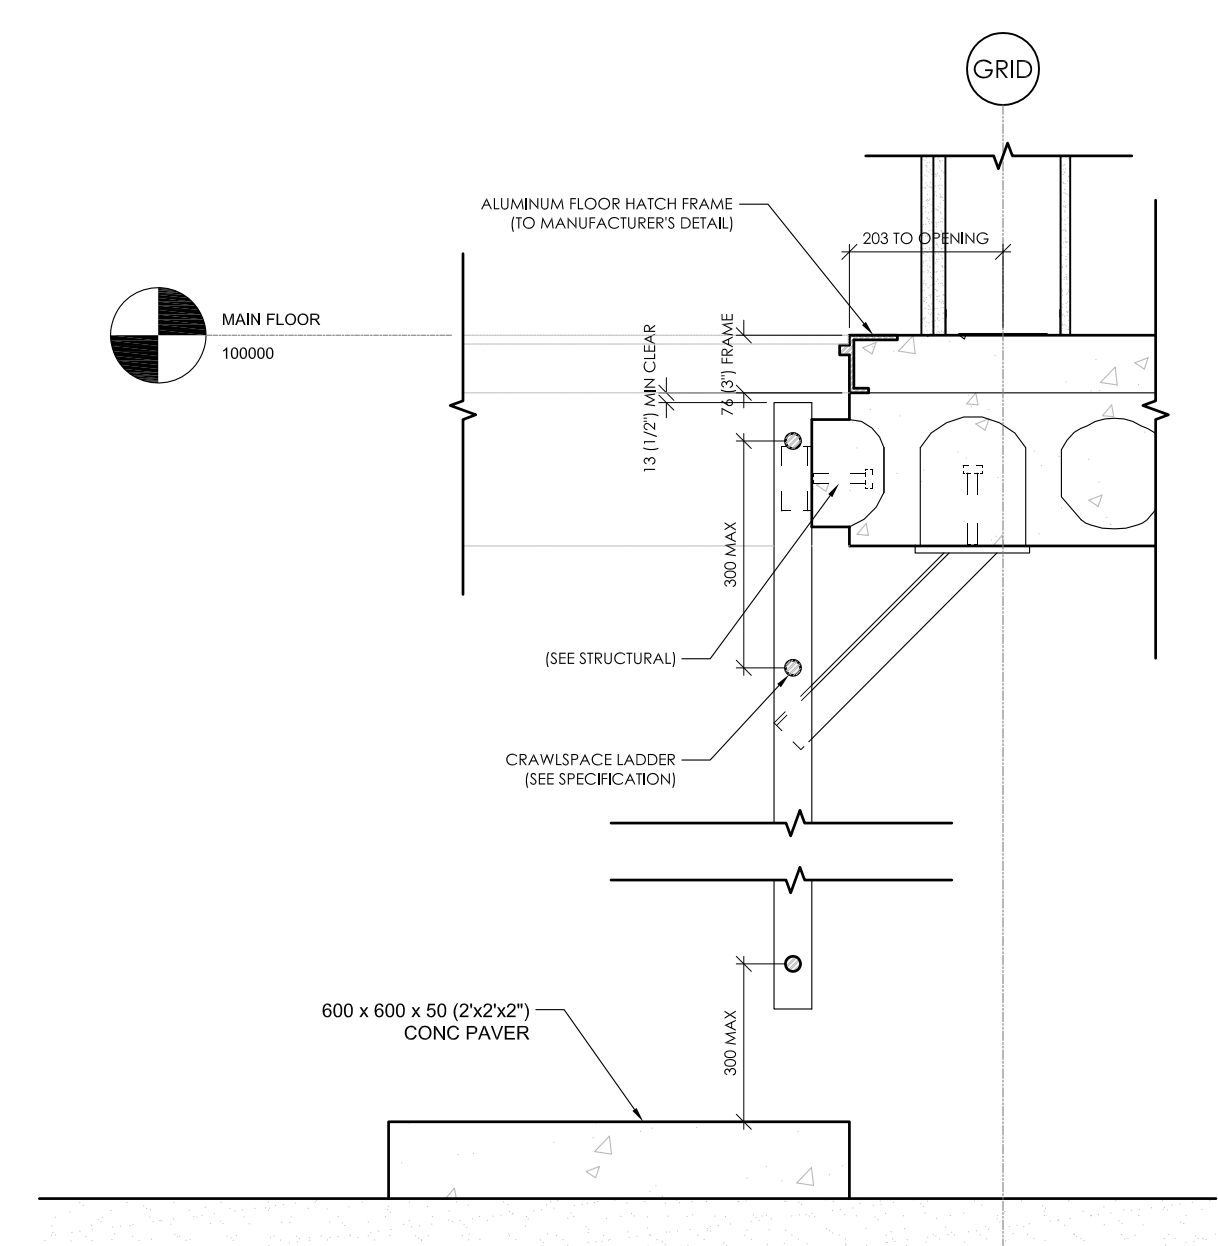
7 FLOOR ACCESS HATCH
1:10
