**THE CITY OF WINNIPEG**  
WATER AND WASTE DEPARTMENT

NEWPCC  
SLUDGE CAKE STORAGE BIN REPAIRS  
**ROOF REPAIR**  
SECTIONS & DETAILS

SHEET 1 OF 1  
CITY DRAWING NUMBER  
1-0101W-S0002-001

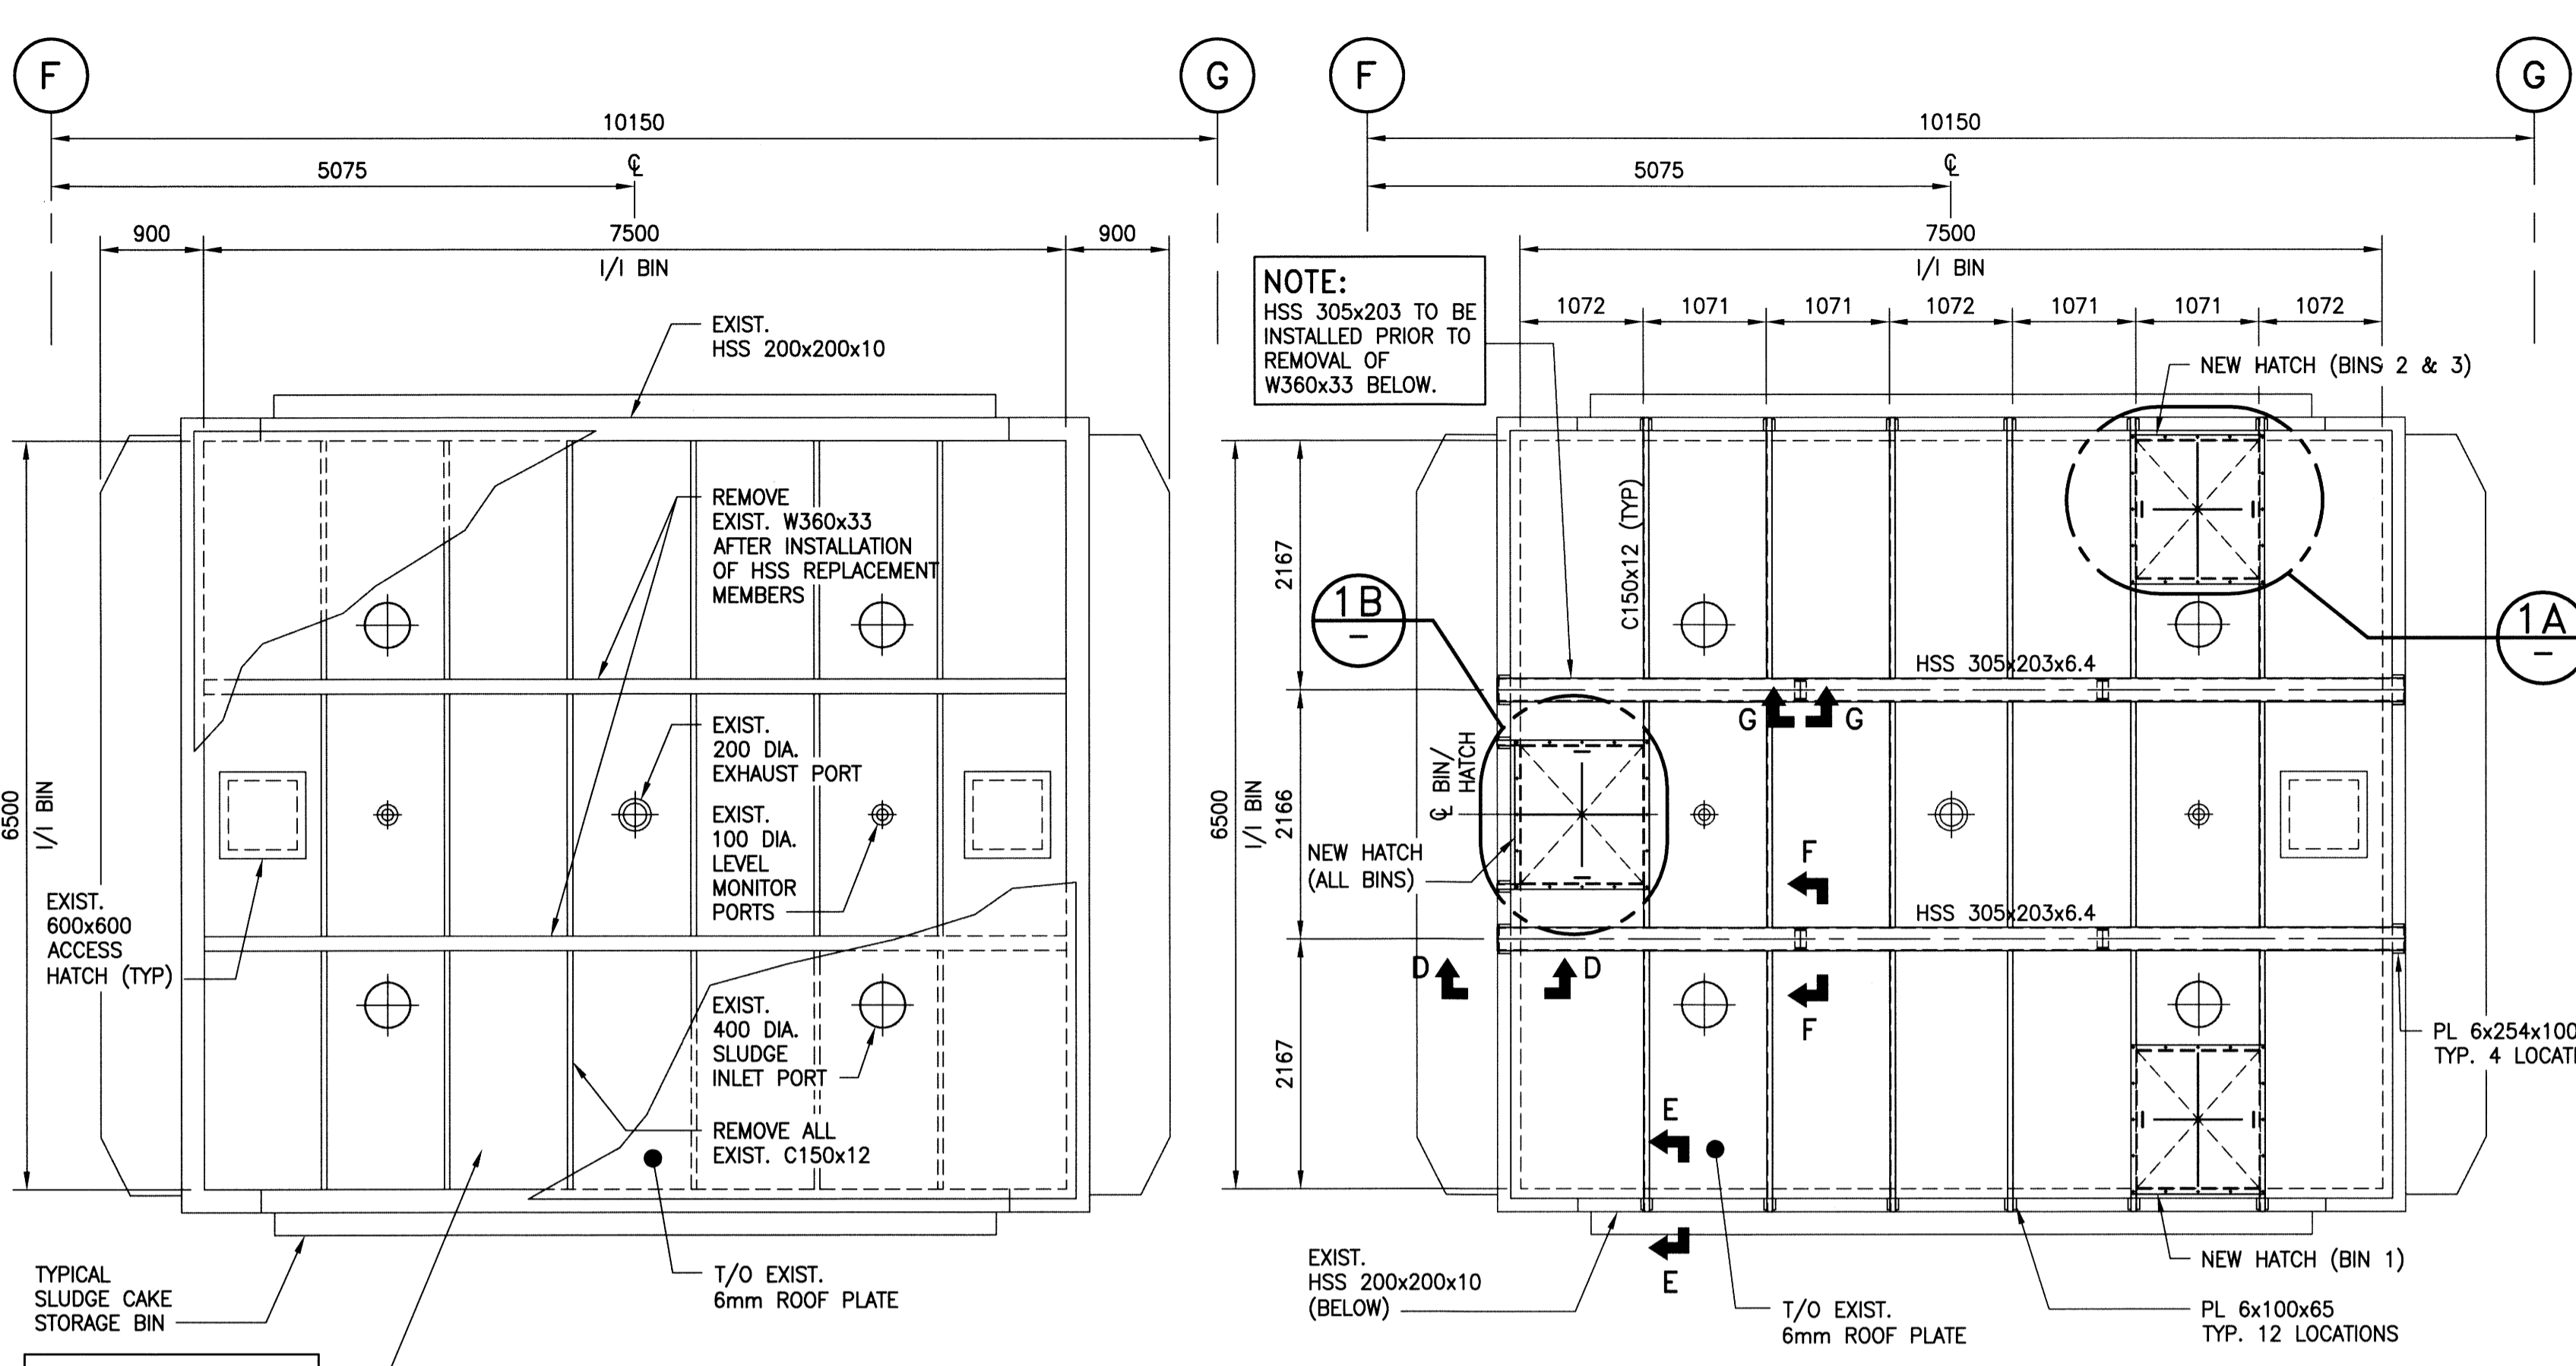
**B SECTION**  
S01 SCALE: 1:50

**NOTE:**  
TEMPORARY PLATFORMS ARE REQUIRED FOR BIN ROOF ACCESS PRIOR TO REINFORCEMENT & REPAIR DUE TO THE DETERIORATED CONDITION.
