B.M. ELEV.	DESIGNED BY: DRA			<b>THE CITY OF WINNIPEG</b> PUBLIC WORKS DEPARTMENT	DRAWN BY: KB	2016 BRIDGE MAINTENANCE - ST. JAMES SOUTHBOUND BRIDGE REPAIRS	CITY DRAWING NUMBER: B101-16-05
	CHECKED BY: RJT				SHEET 05 OF 11		
	APPROVED BY: SSR				CONSULTANT PROJECT NUMBER: 16-3513		
	HOR. SCALE: - VERTICAL: -				CONSULTANT DRAWING NUMBER: --		
0 ISSUED FOR CITY REVIEW	6/15/16 RJT	DATE: JUNE 21, 2016	RELEASED FOR CONSTRUCTION	DATE: -	ST. JAMES SB BARRIER REPAIR LAYOUT 2

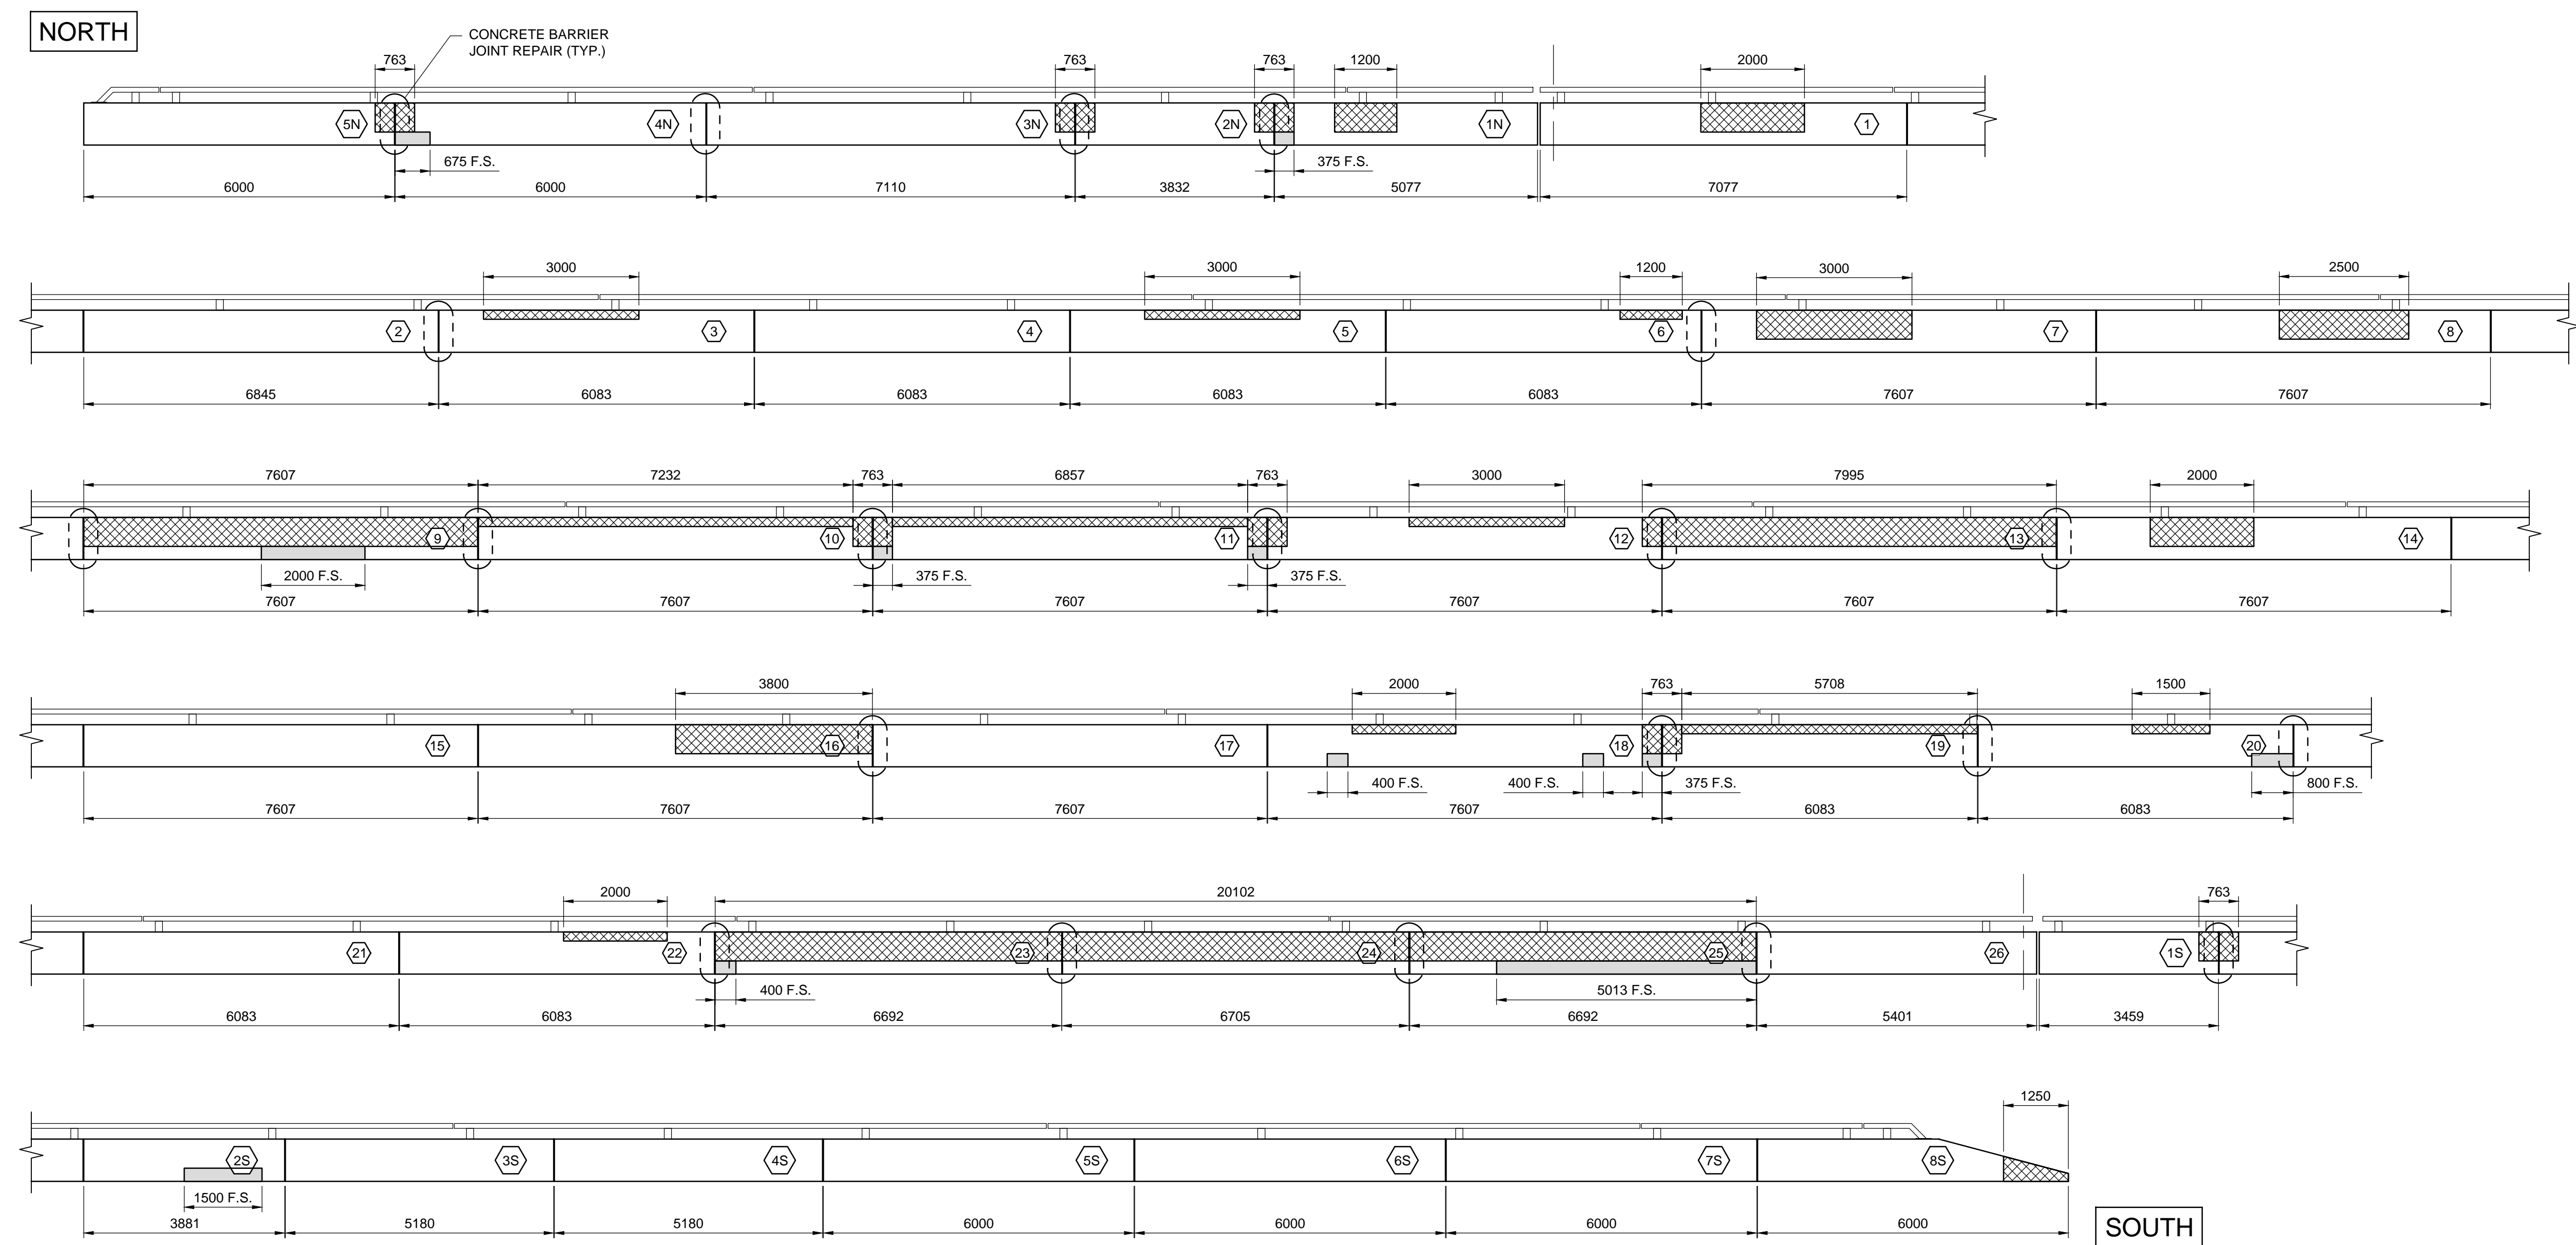
**MEDIAN LANE BARRIER ELEVATION**  
1:75  
LOOKING EAST
