THE CITY OF WINNIPEG
PUBLIC WORKS DEPARTMENT

2017 BRIDGE MAINTENANCE - MIDTOWN
BRIDGE & ST. VITAL BRIDGE REPAIRS

MIDTOWN BARRIER REPAIR LAYOUT 1

CITY DRAWING NUMBER	B114-17-03
SHEET	03 OF 17
CONSULTANT DRAWING NUMBER	--

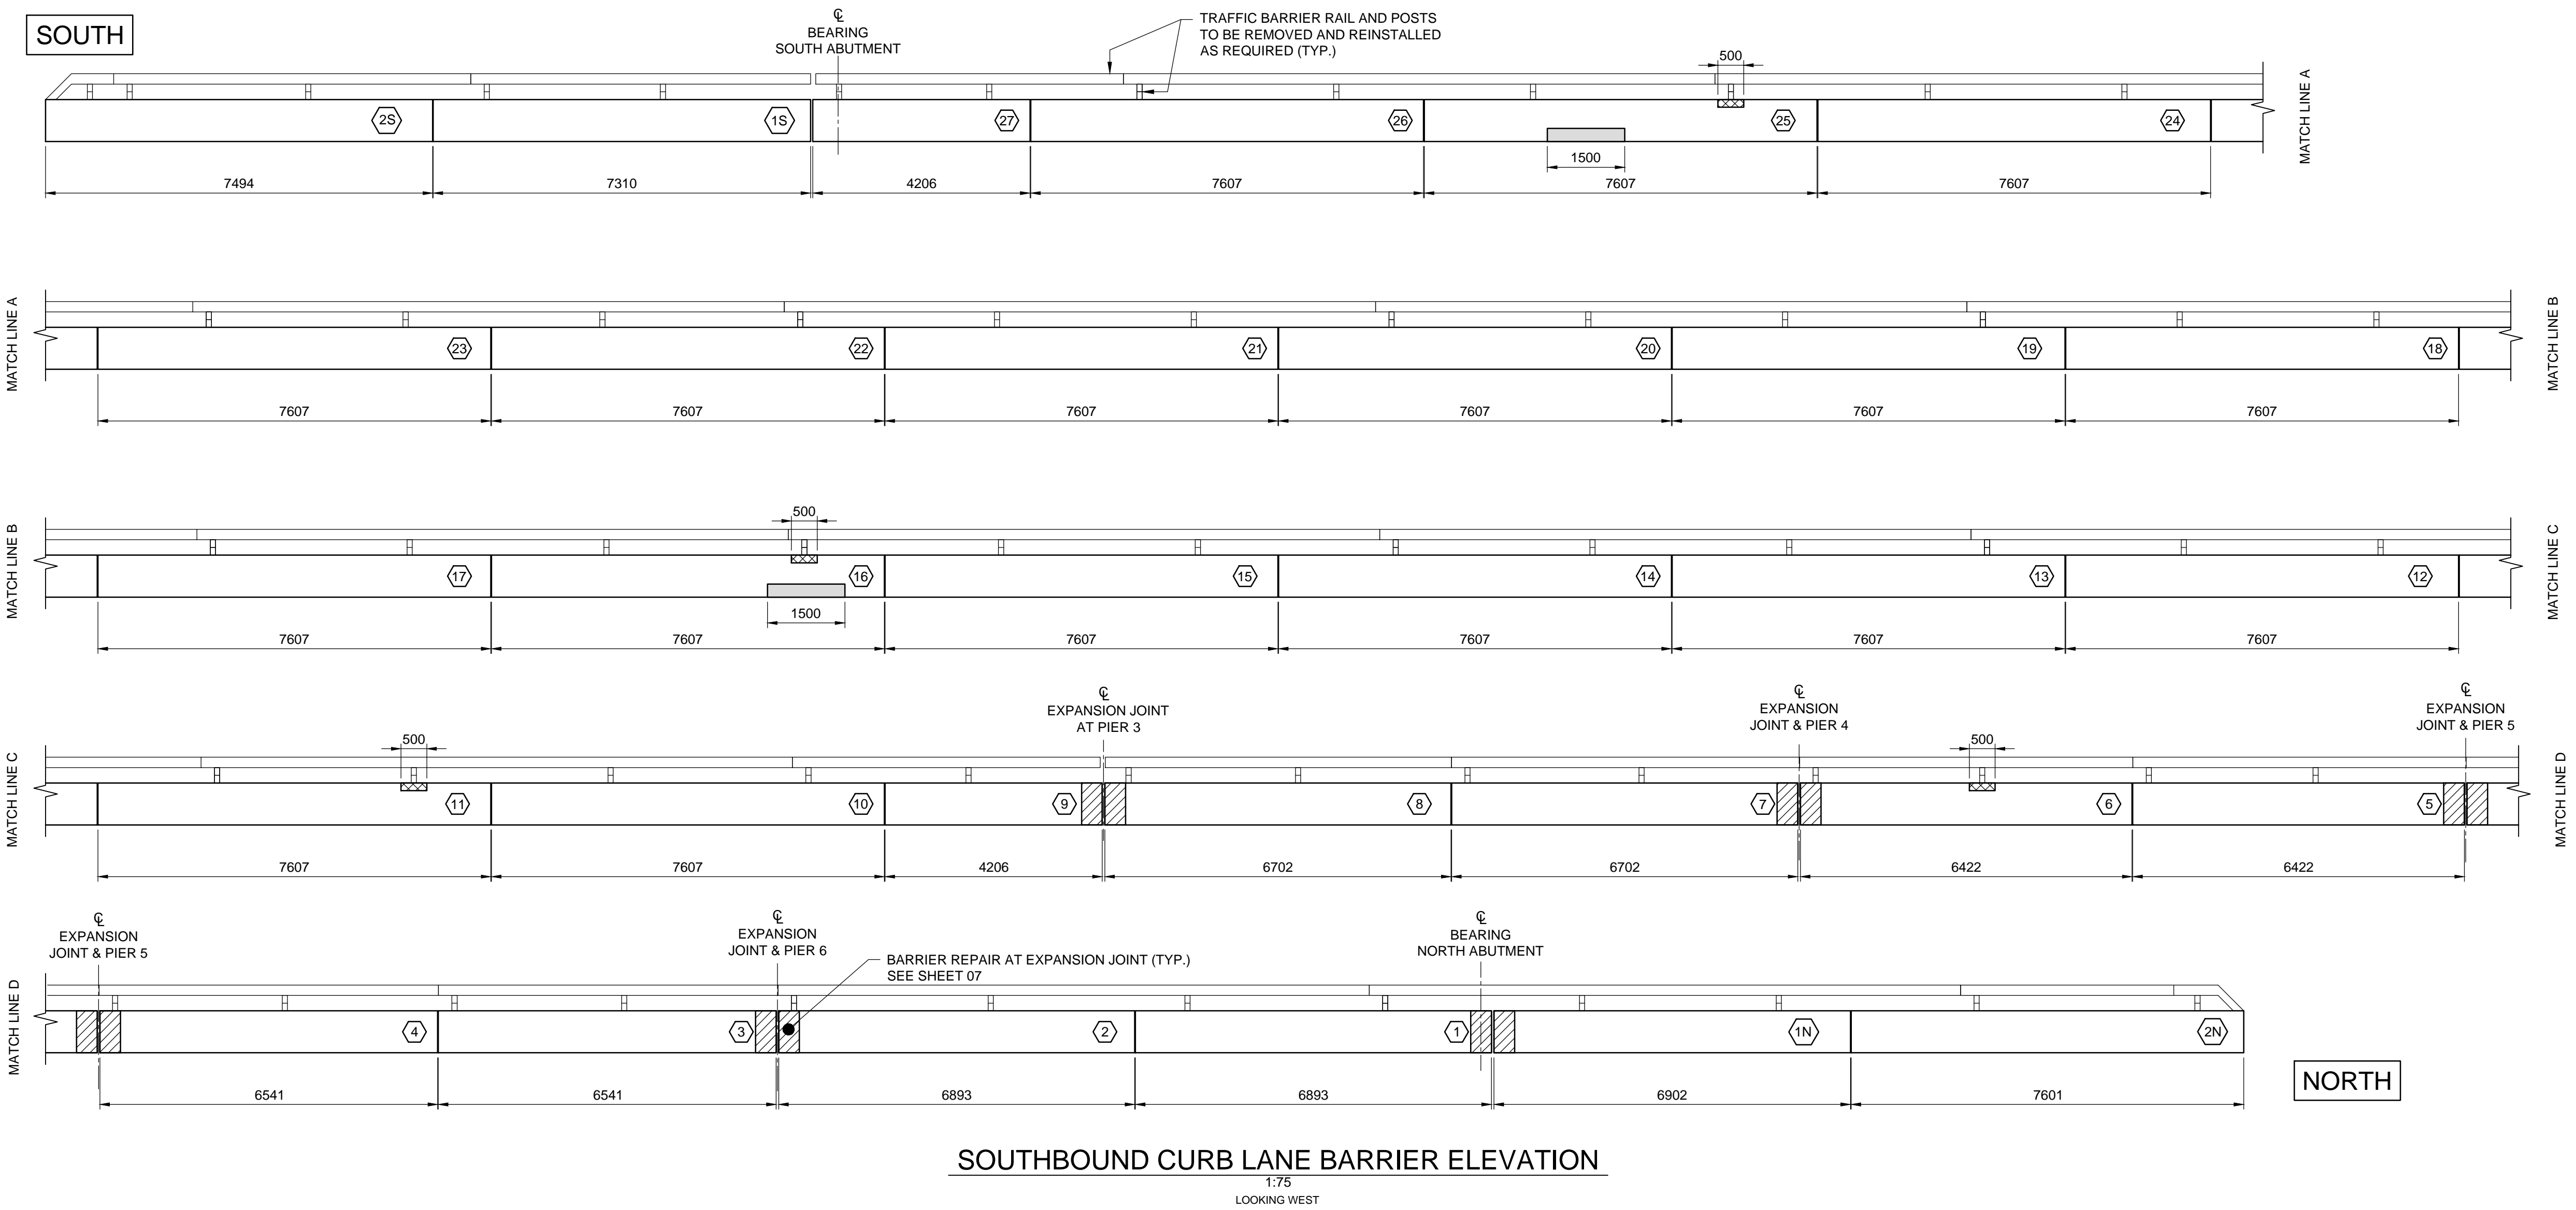
SOUTHBOUND CURB LANE BARRIER ELEVATION
1:75
LOOKING WEST

TYPE 1 CONCRETE BARRIER REPAIR	2.0 m

TYPE 2 CONCRETE BARRIER REPAIR	0.76 m ²

CONCRETE BARRIER JOINT REPAIR	24

- NOTES:
1. DIMENSIONS SHOWN OF EXISTING BARRIERS ARE APPROXIMATE.
 2. DIMENSIONS SHOWN OF REPAIR AREAS ARE APPROXIMATE. LAYOUT ACTUAL REPAIR AREAS WITH CONTRACT ADMINISTRATOR ON SITE.
 3. SEE SPECIFICATION FOR REPAIR PREPARATION & CONCRETE REPLACEMENT DETAILS.
 4. REPLACE ALL BARRIER JOINT SEALS WITH EMSEAL BEJS-ON-A-REEL
