2017 BRIDGE MAINTENANCE - MIDTOWN BRIDGE & ST. VITAL BRIDGE REPAIRS

ST. VITAL SIDEWALK REPAIR DETAILS

CITY DRAWING NUMBER: B116-17-01
SHEET 12 OF 17
CONSULTANT DRAWING NUMBER: --

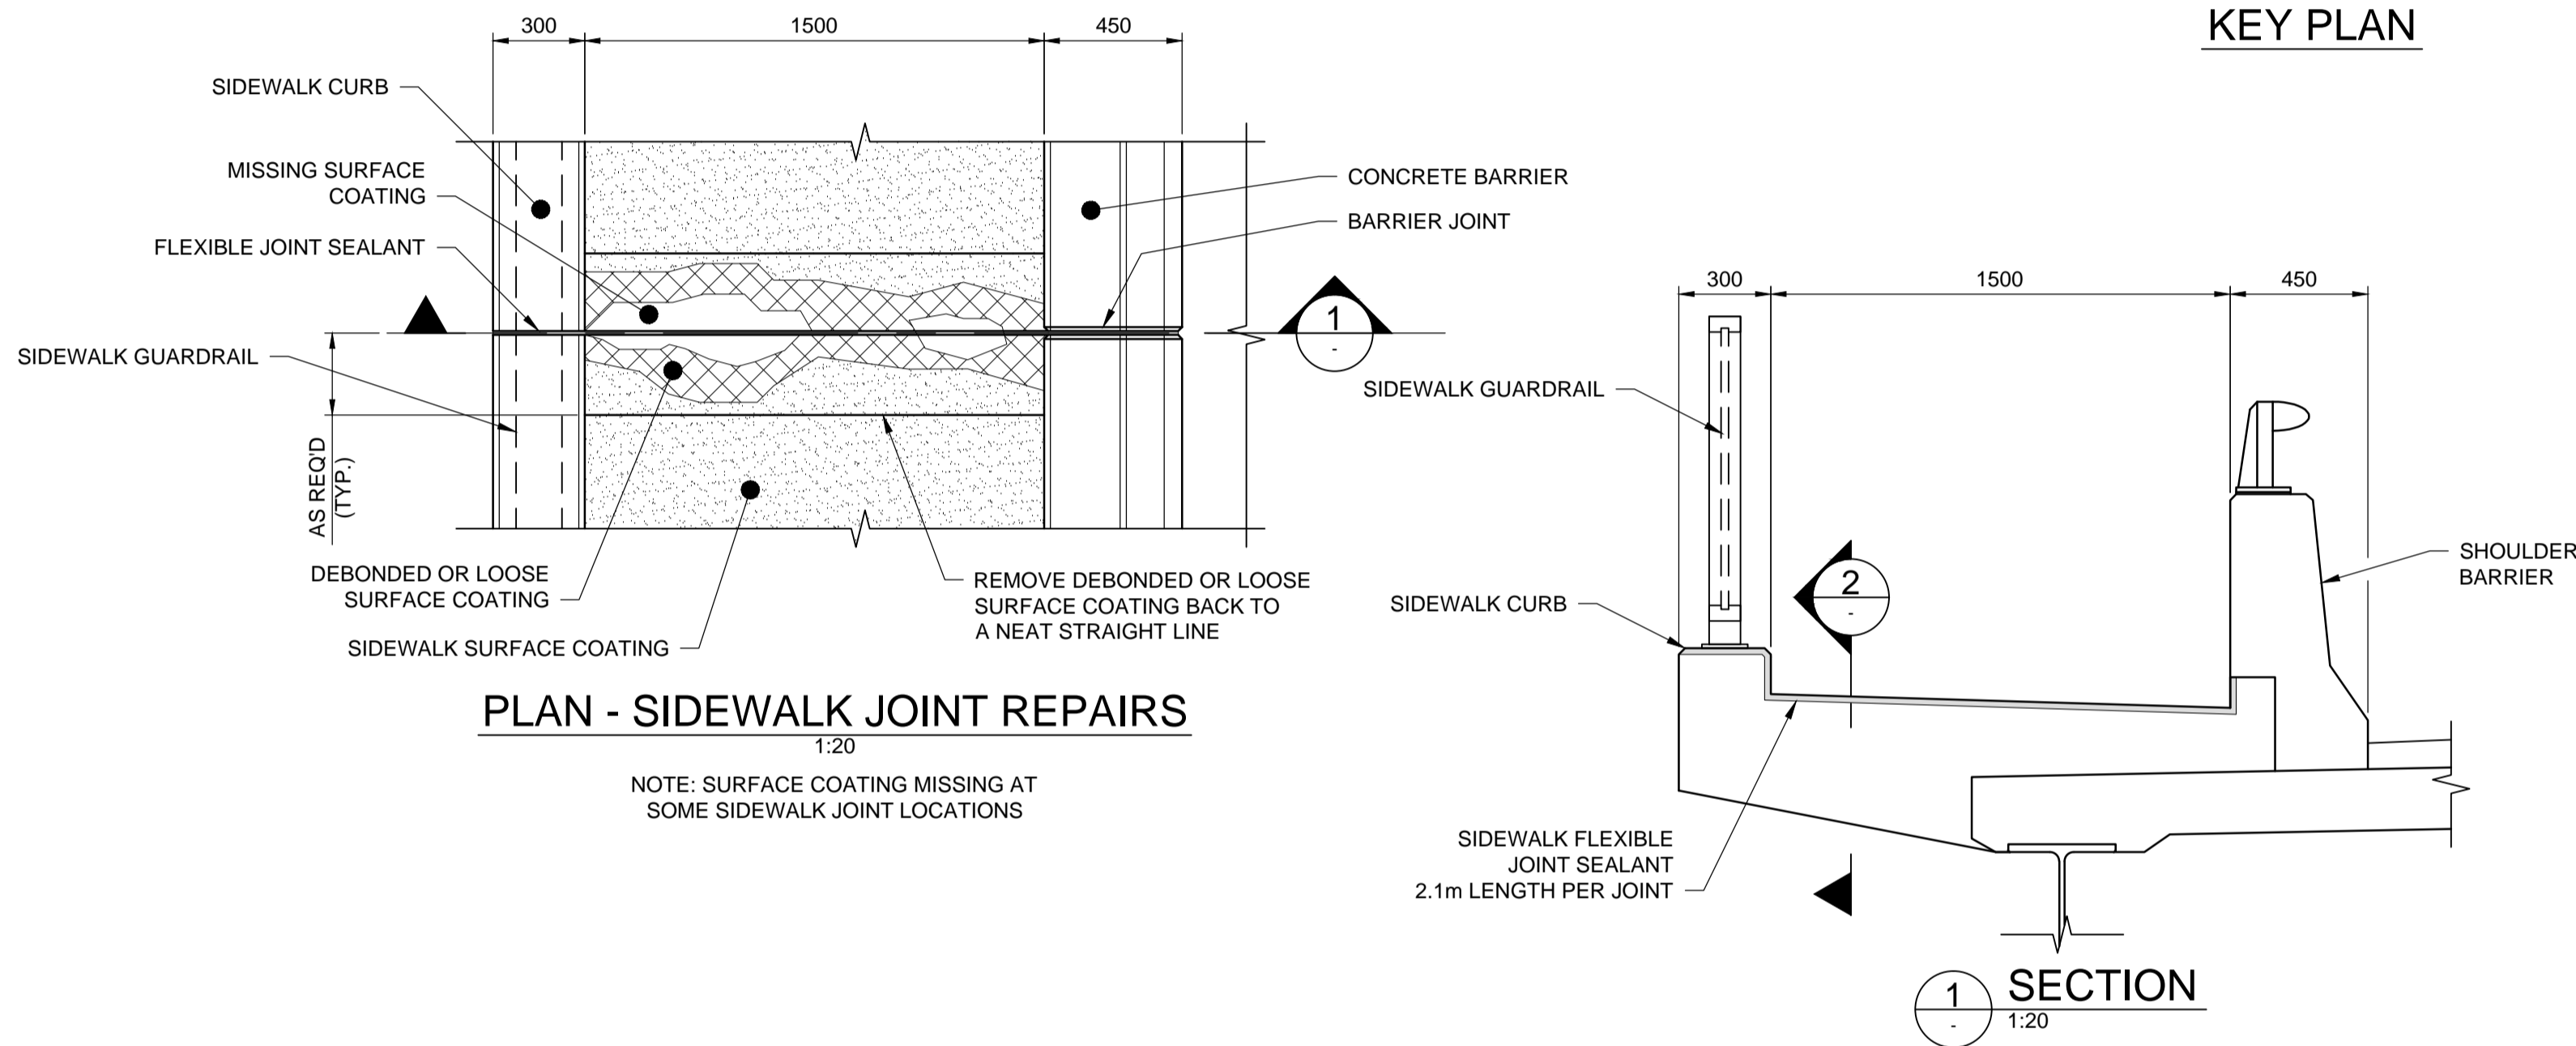
PLAN - SIDEWALK JOINT REPAIRS
1:20

NOTE: SURFACE COATING MISSING AT SOME SIDEWALK JOINT LOCATIONS

SIDEWALK JOINT REPAIR FOR EAST AND WEST SIDEWALKS

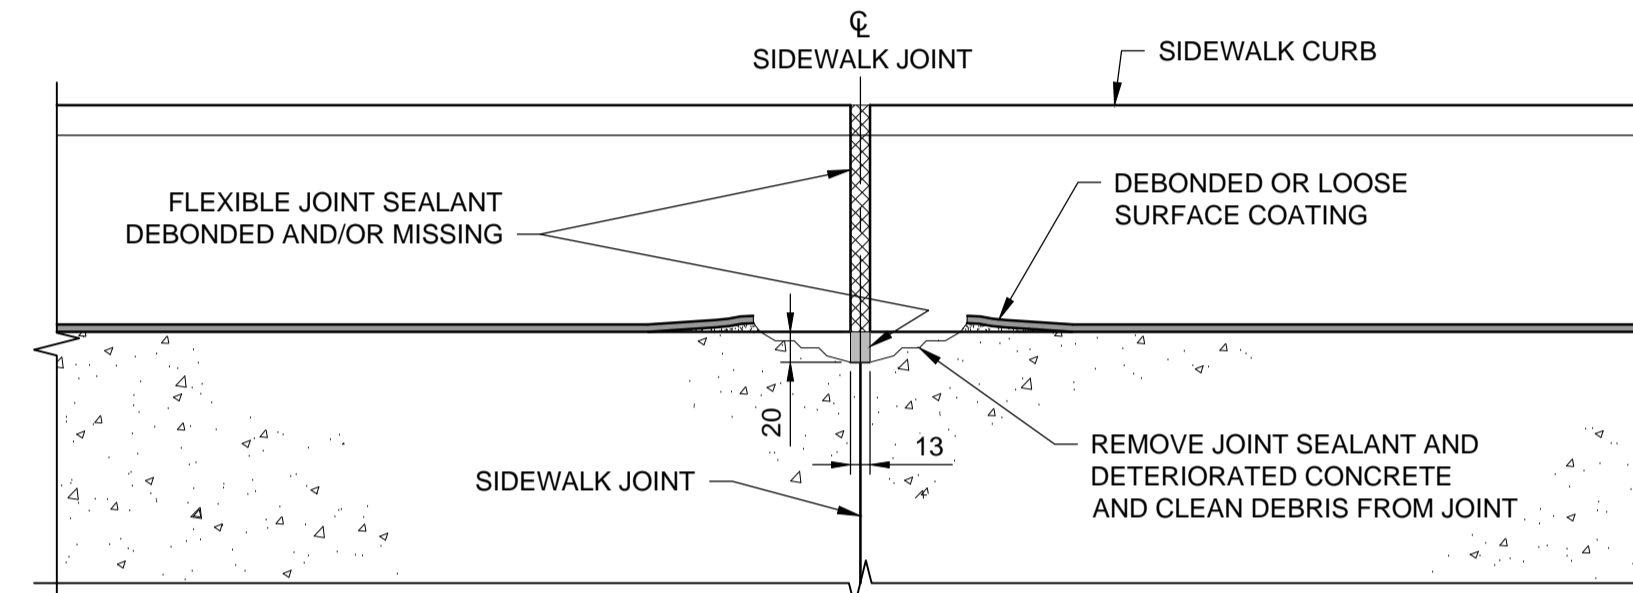
EXISTING

SECTION 1
1:20

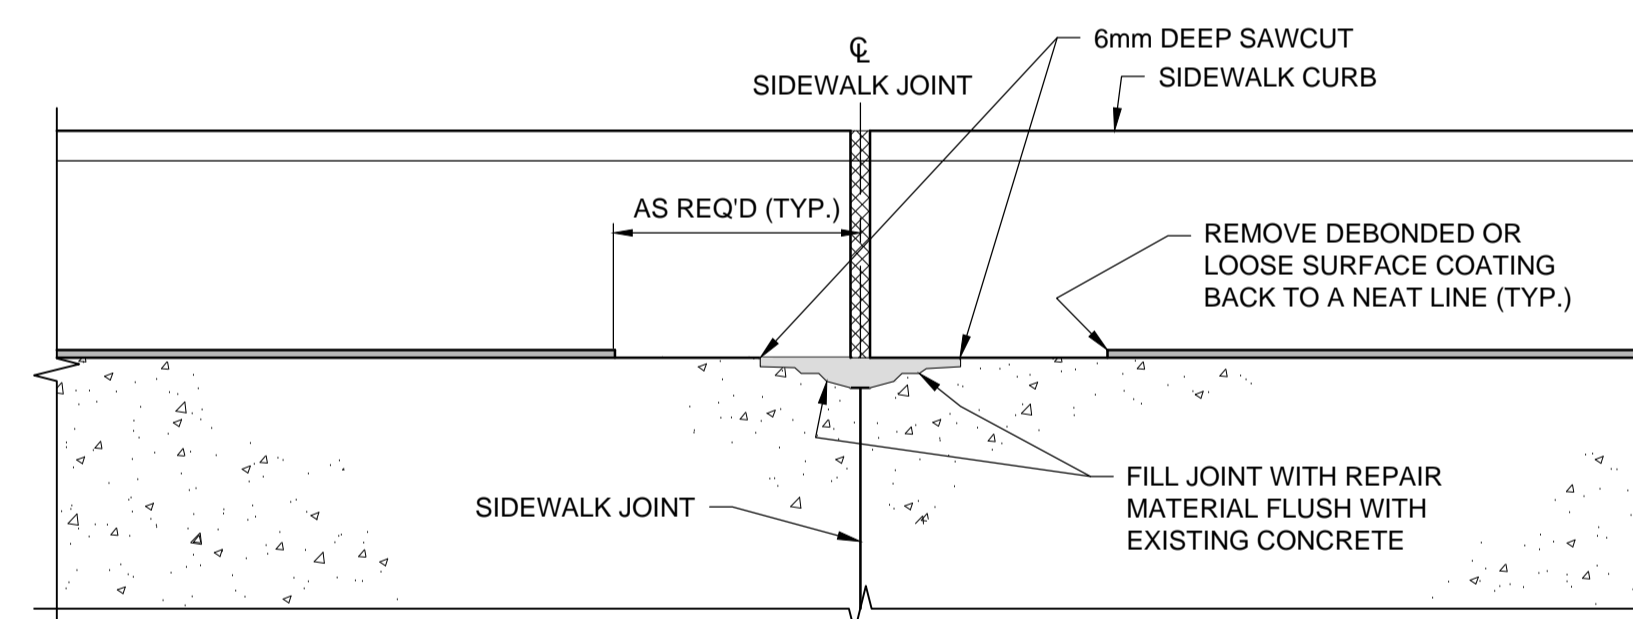
PROPOSED

SECTION 2
1:5

- SIDEWALK REPAIR METHOD:**
1. REMOVE SEALANT FROM FULL LENGTH OF SIDEWALK JOINT.
 3. REMOVE DEBONDED OR LOOSE SURFACE COATING BACK TO A NEAT STRAIGHT LINE.
 4. WHERE CONCRETE REPAIRS ARE REQUIRED:
 - 4.1. SAW CUT MIN. 6mm AROUND PERIMETER OF CONCRETE REPAIR AREA.
 - 4.2. REMOVE DETERIORATED CONCRETE TO SOUND CONCRETE OR A MIN. 6mm.
 - 4.3. PLACE SIDEWALK REPAIR MATERIAL FLUSH WITH EXISTING CONCRETE.
