THE CITY OF WINNIPEG
PUBLIC WORKS DEPARTMENT

2017 BRIDGE MAINTENANCE - MIDTOWN BRIDGE & ST. VITAL BRIDGE REPAIRS

ST. VITAL BARRIER REPAIR LAYOUT 1

CITY DRAWING NUMBER
B116-17-03

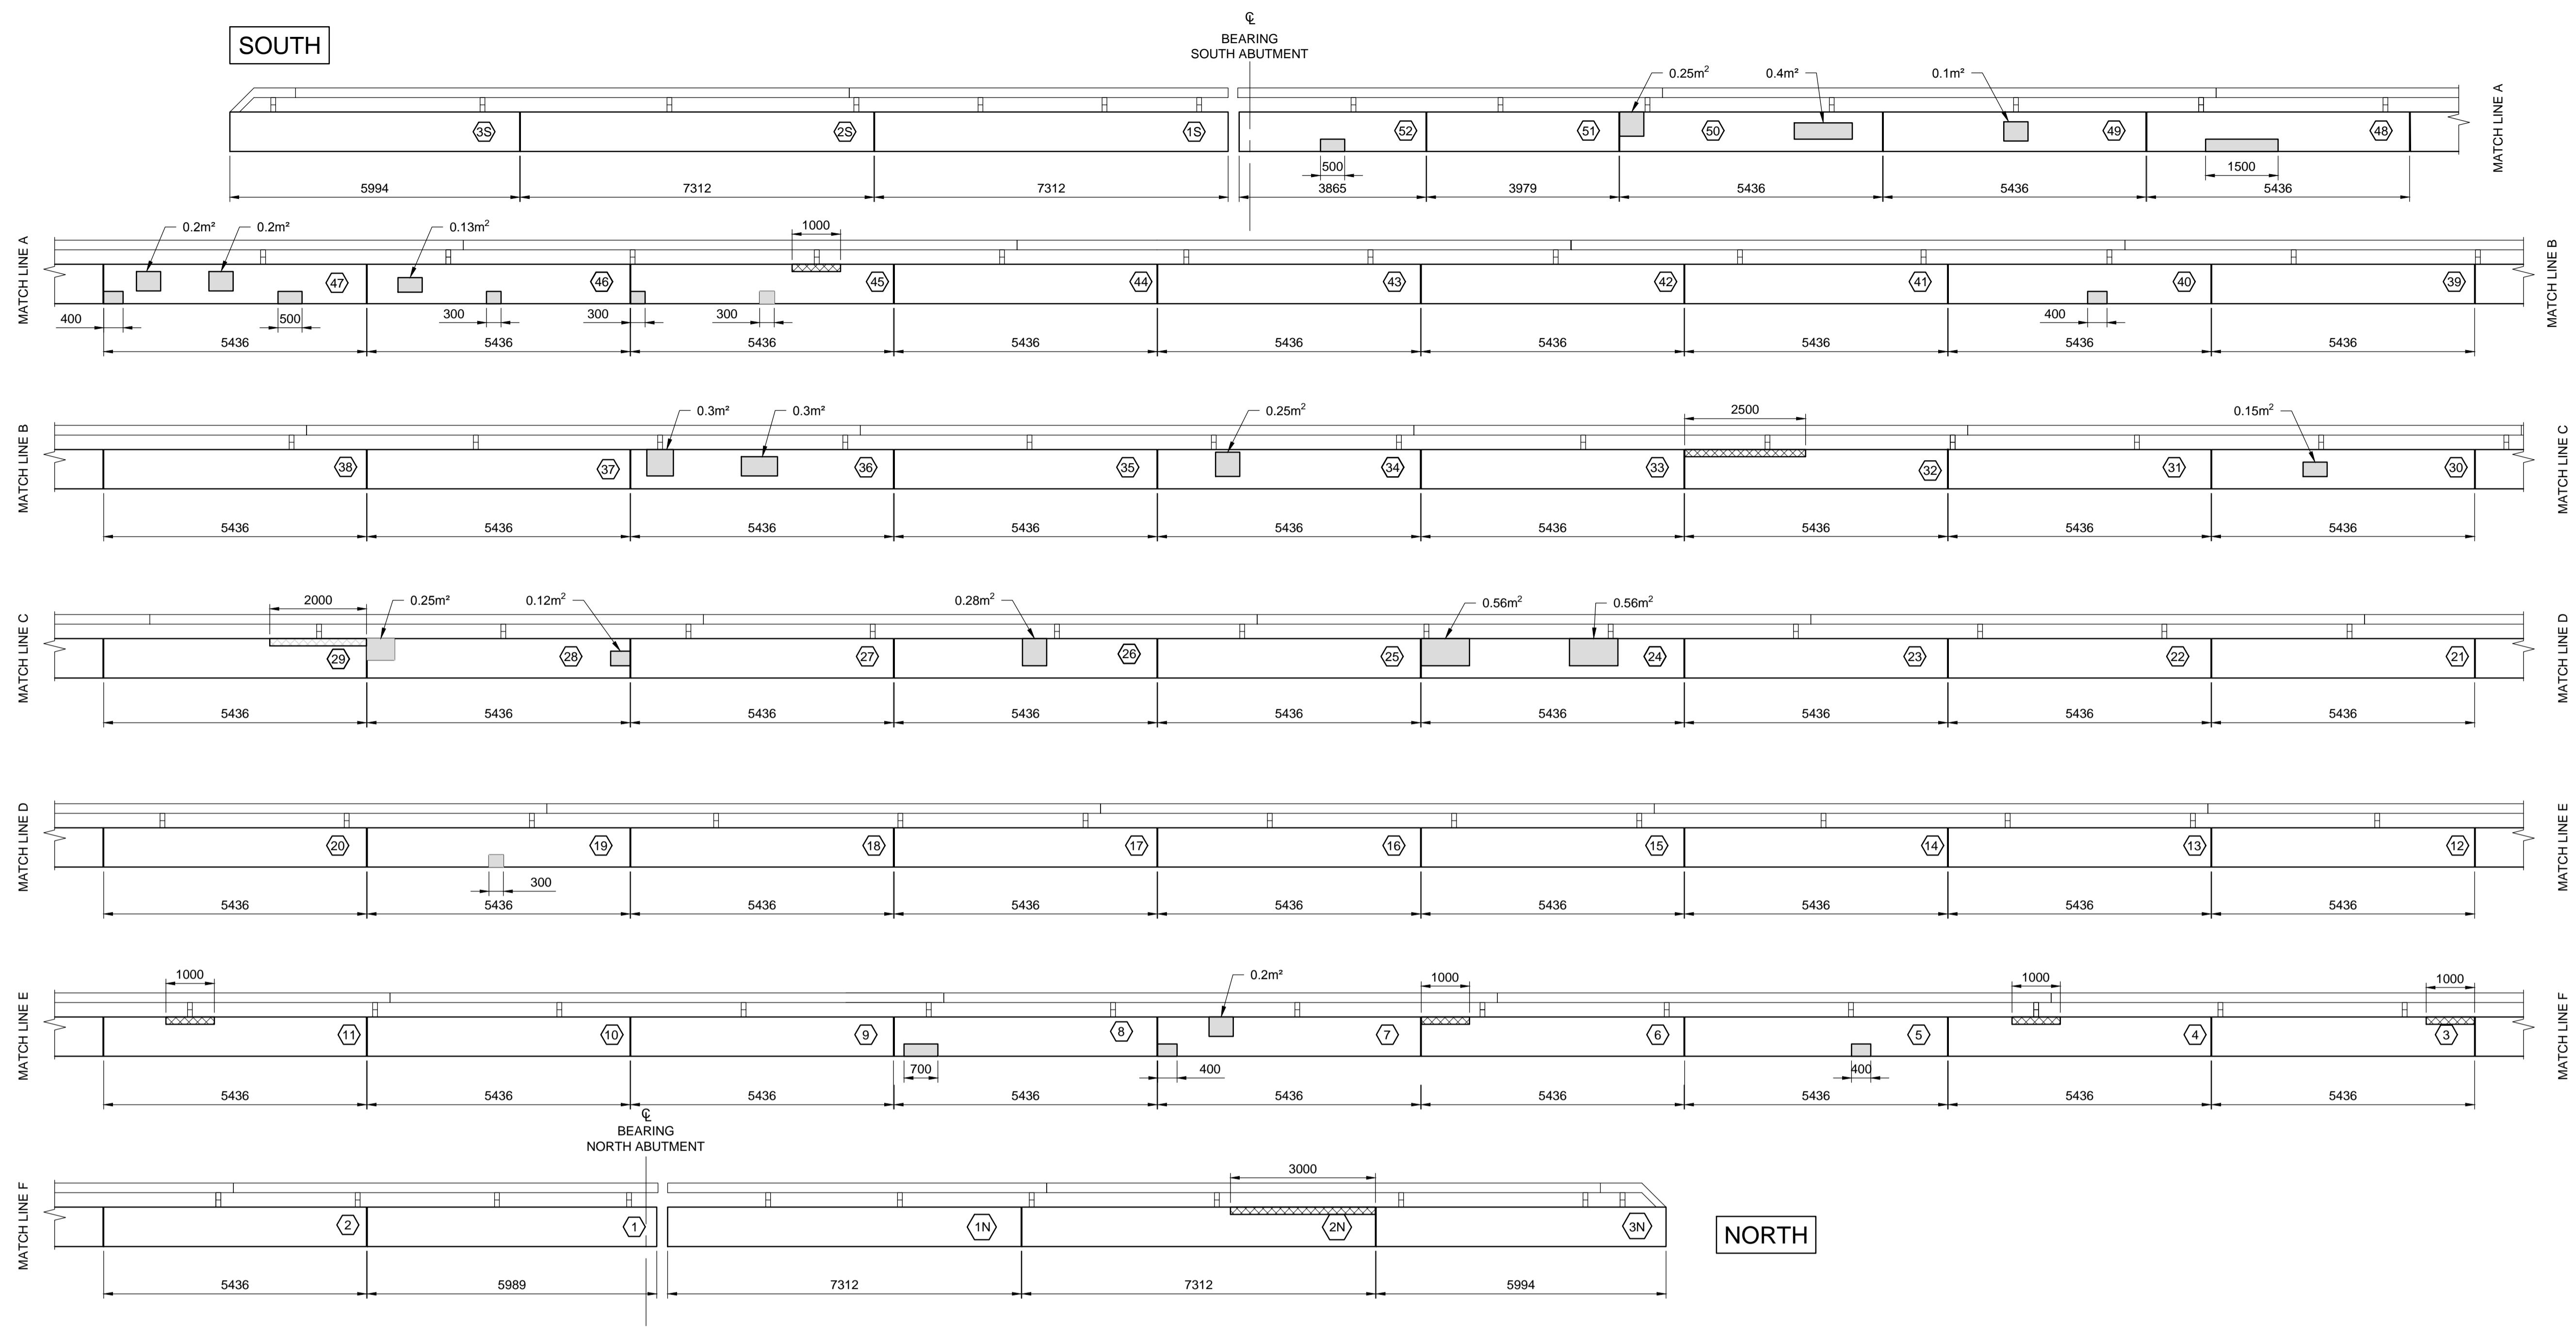
NORTH BOUND MEDIAN LANE BARRIER ELEVATION

1:75
LOOKING WEST

- TYPE 1 CONCRETE BARRIER REPAIR
- TYPE 2 CONCRETE BARRIER REPAIR
- BARRIER LOCATION NO.

- 12.5 m
- 5.77 m²
