Project
St. John's Library Renovation

Drawing
Wall Sections and Details

Reviewed By
PS
Drawing No.
A-500

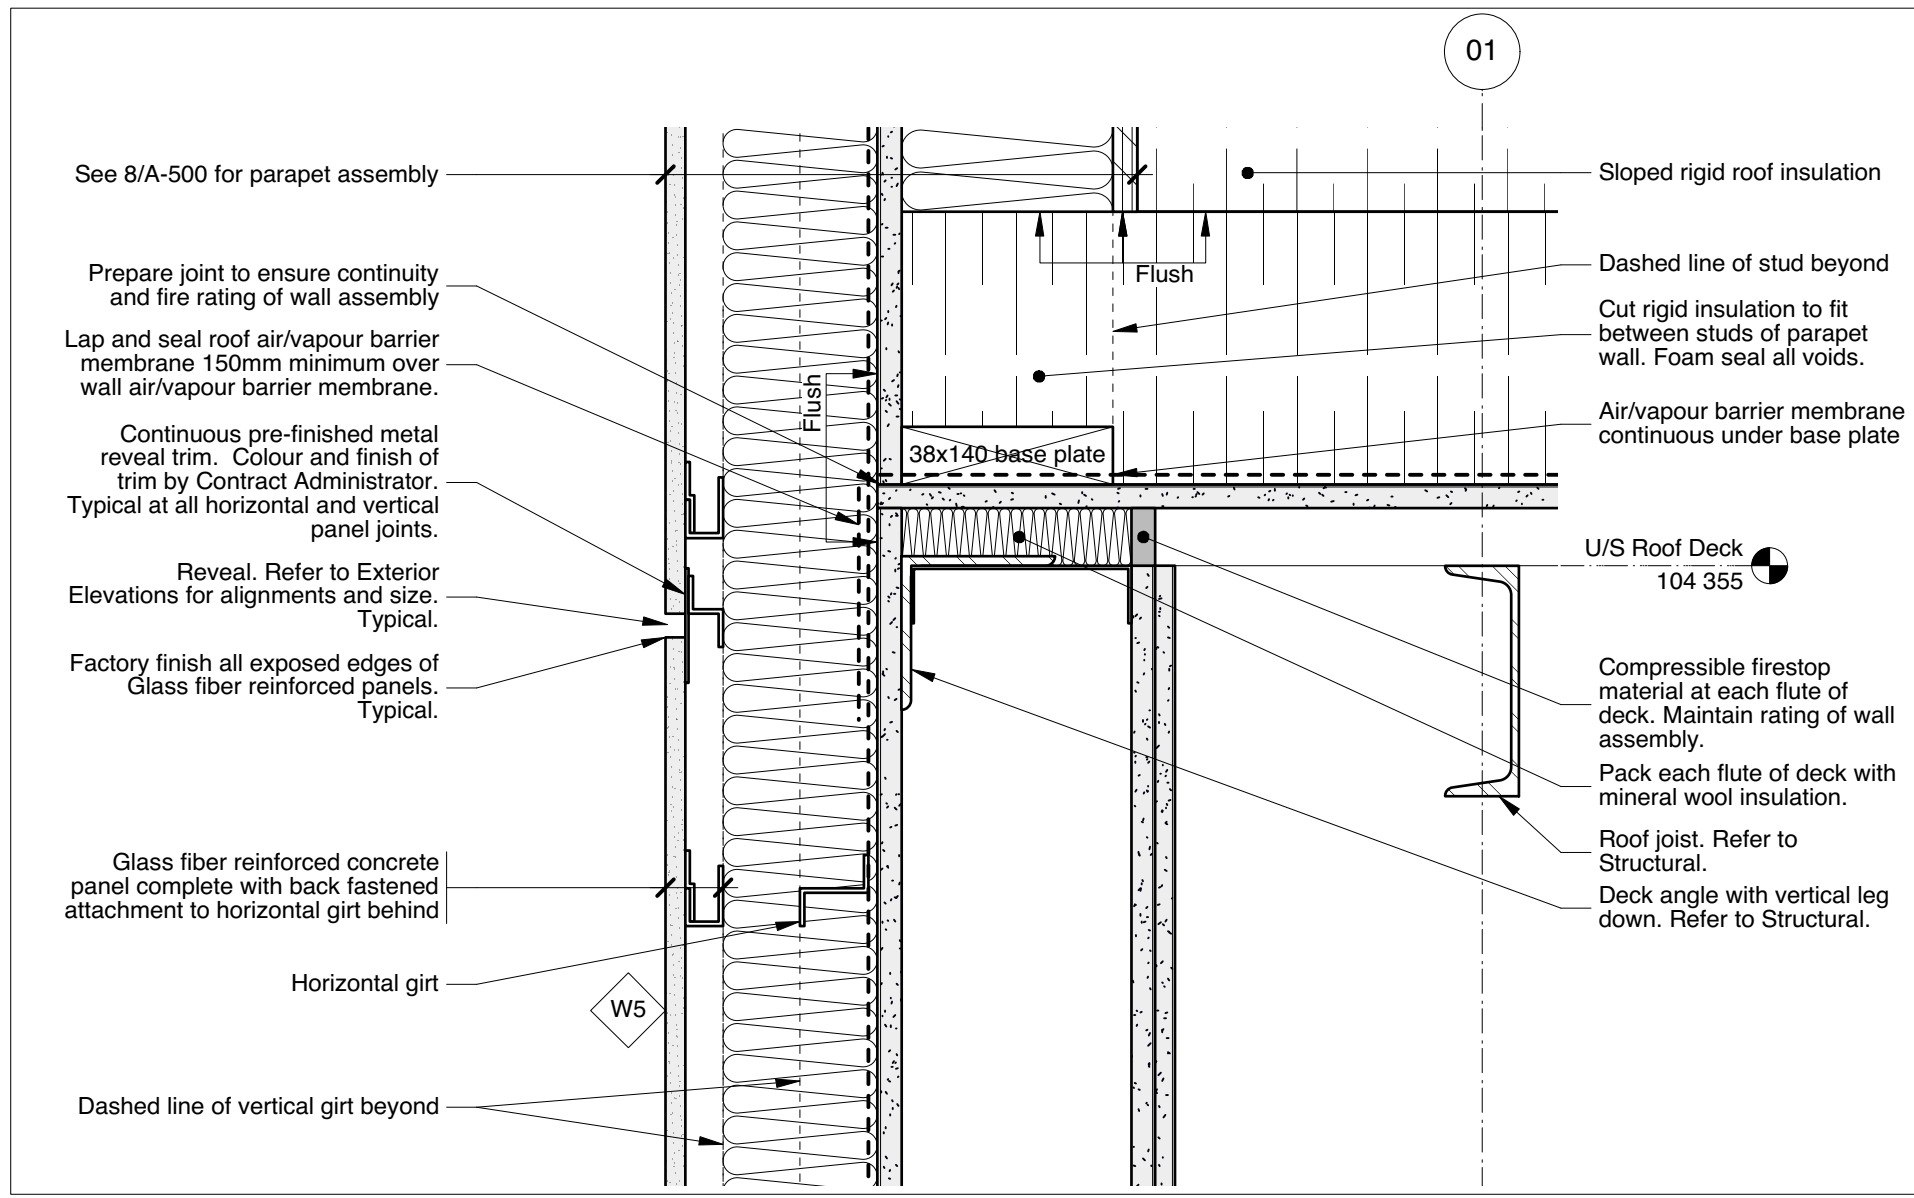
7 Section Detail - Rated Main Floor Wall Abutting underside of Roof Deck
1:5

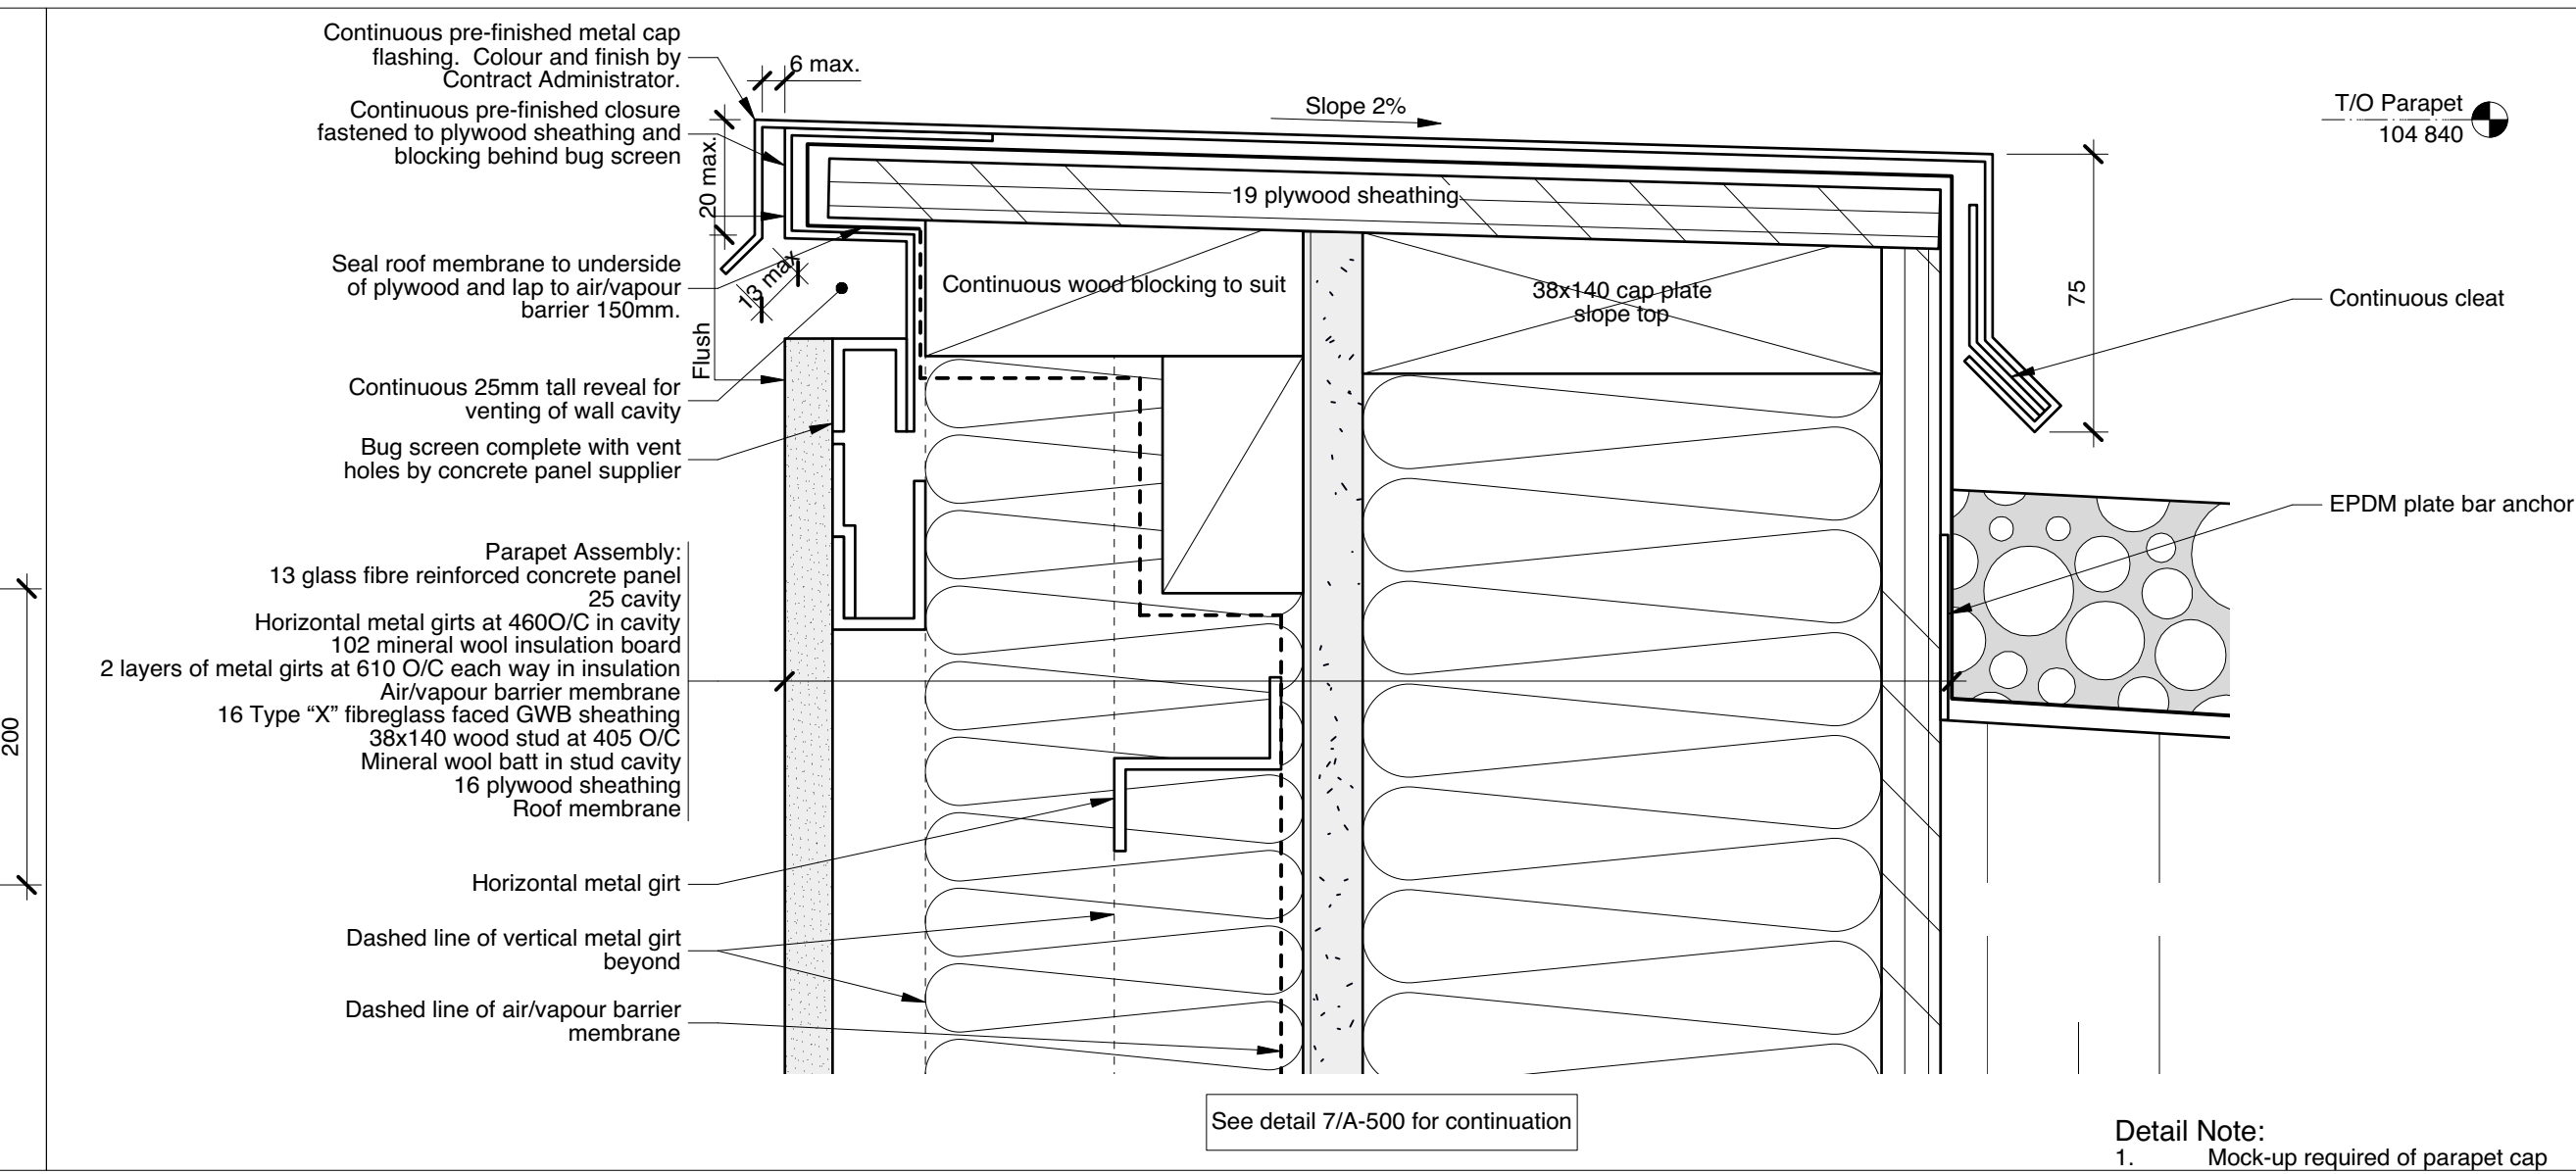
8 Section Detail - Parapet Cap at Concrete Panel Finished Parapet above Rated Wall on Grid 01
1:2

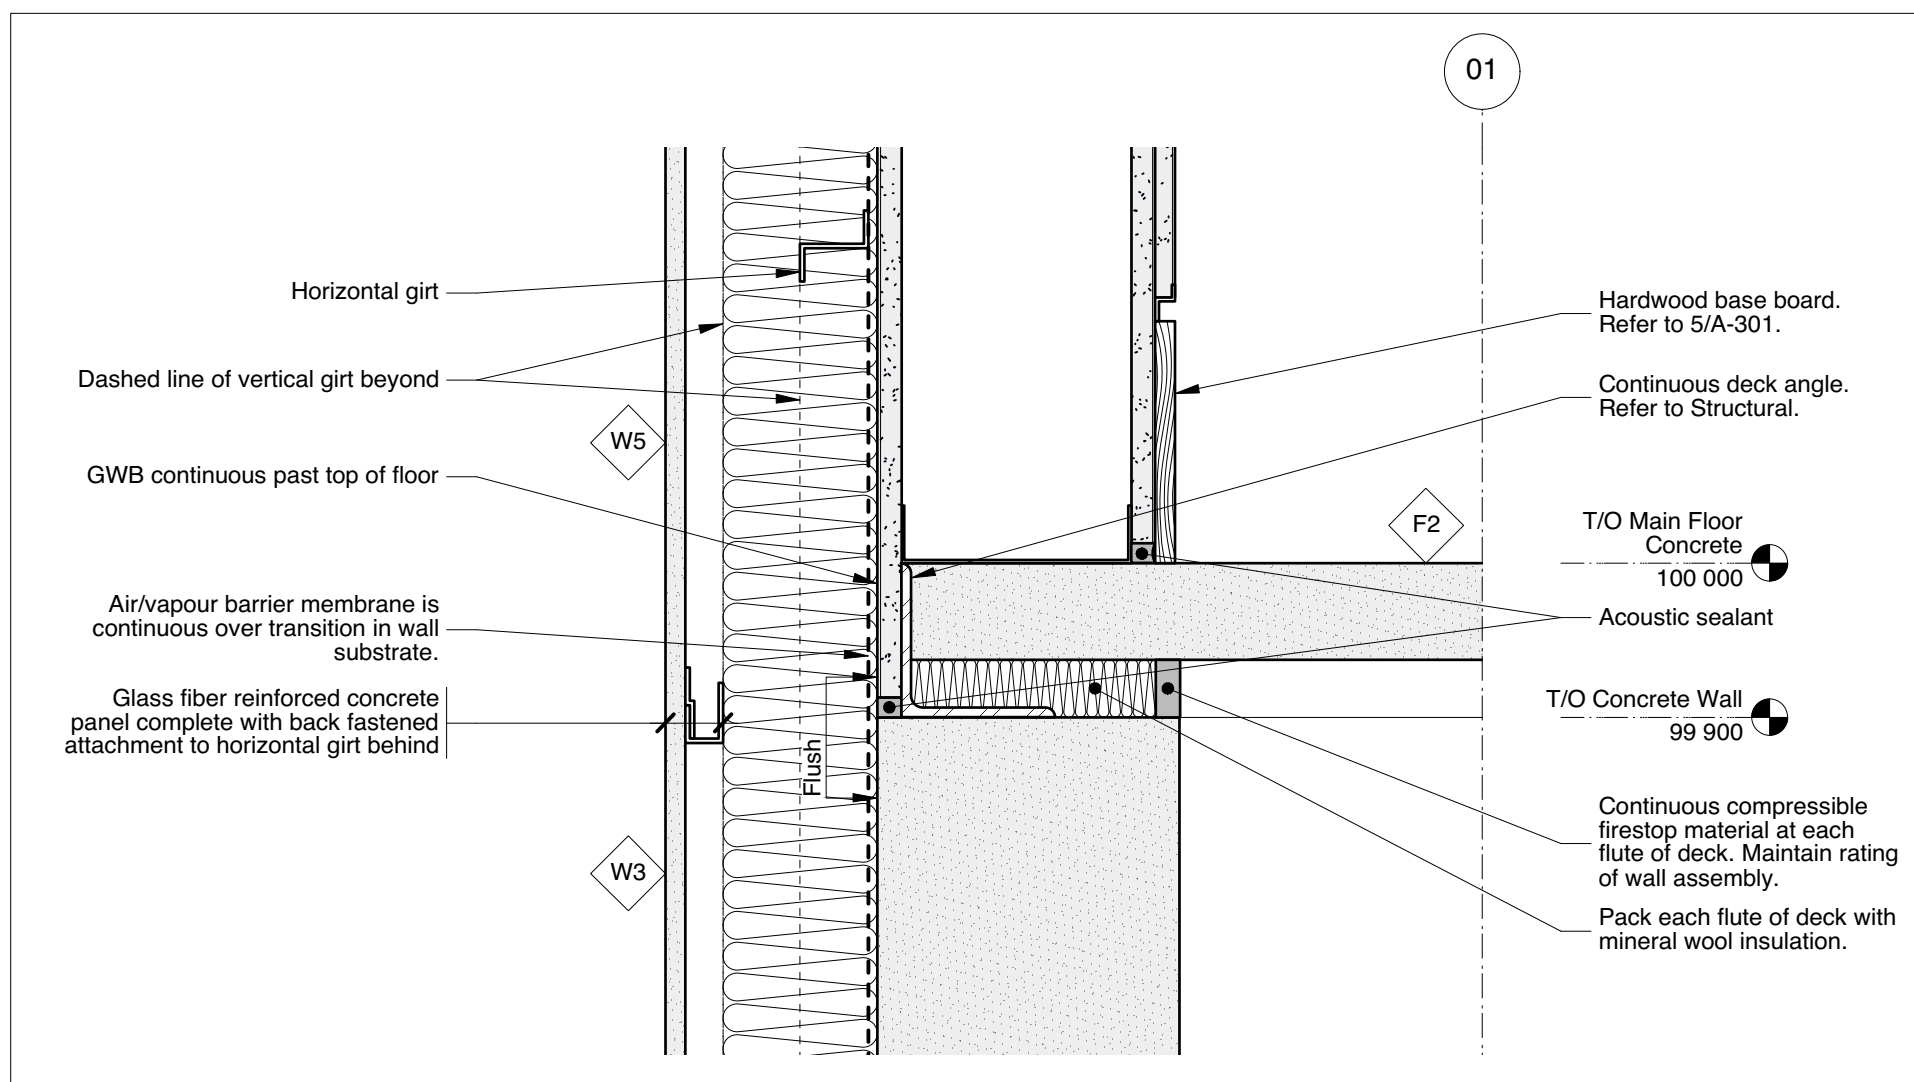
6 Section Detail - Rated Foundation Wall and Rated Main Floor Wall Meeting at Main Floor
1:5

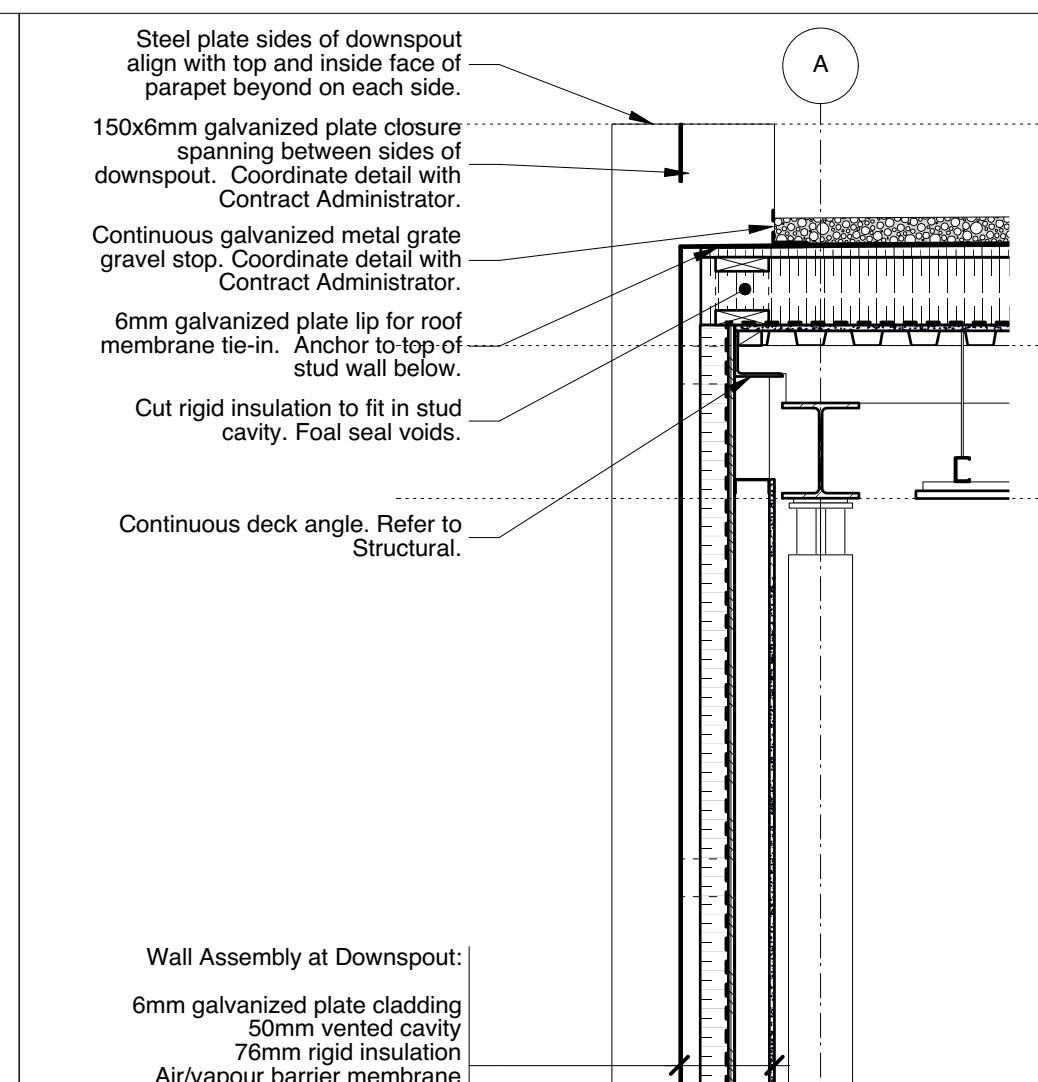
4 Wall Section - Downspout
1:20

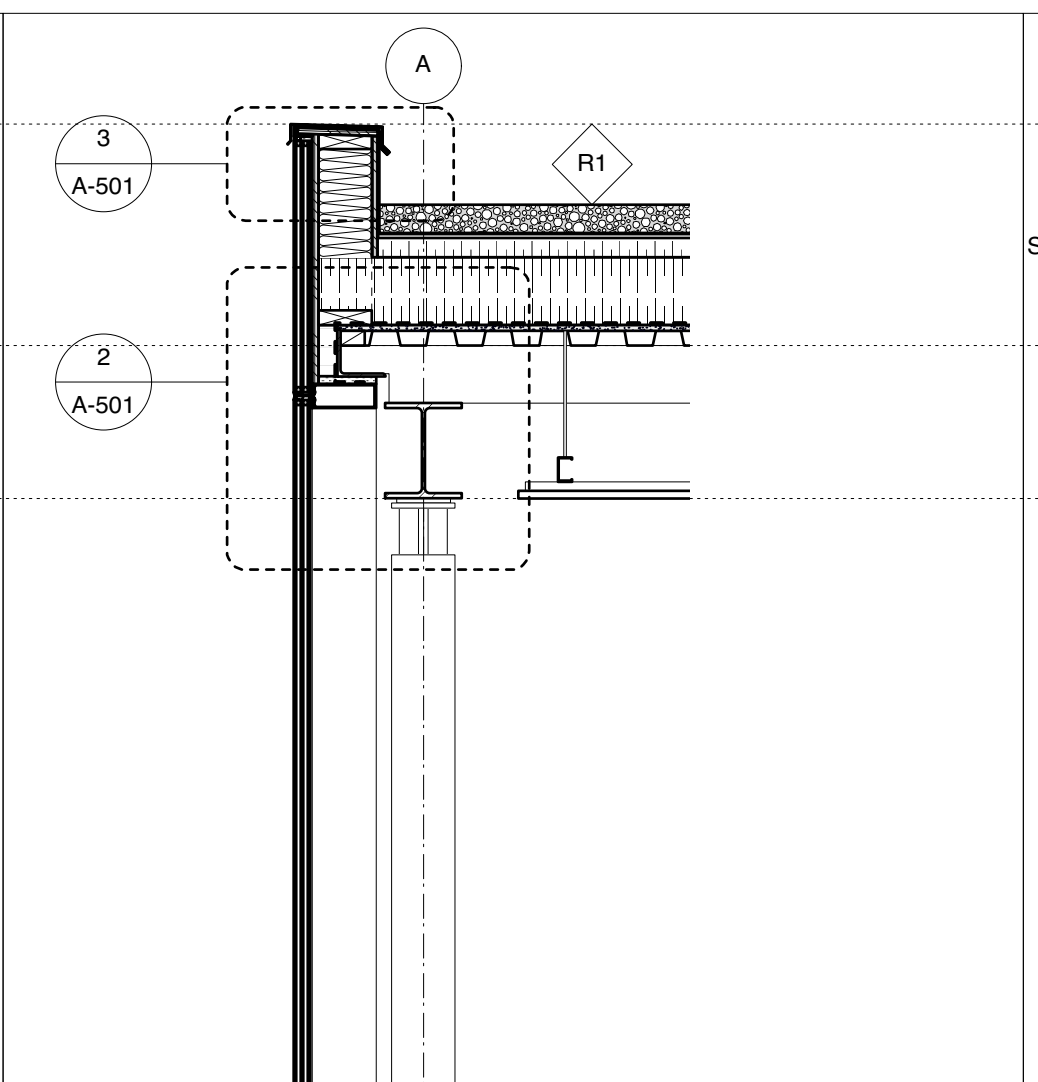
3 Wall Section - South Wall at Glazing
1:20

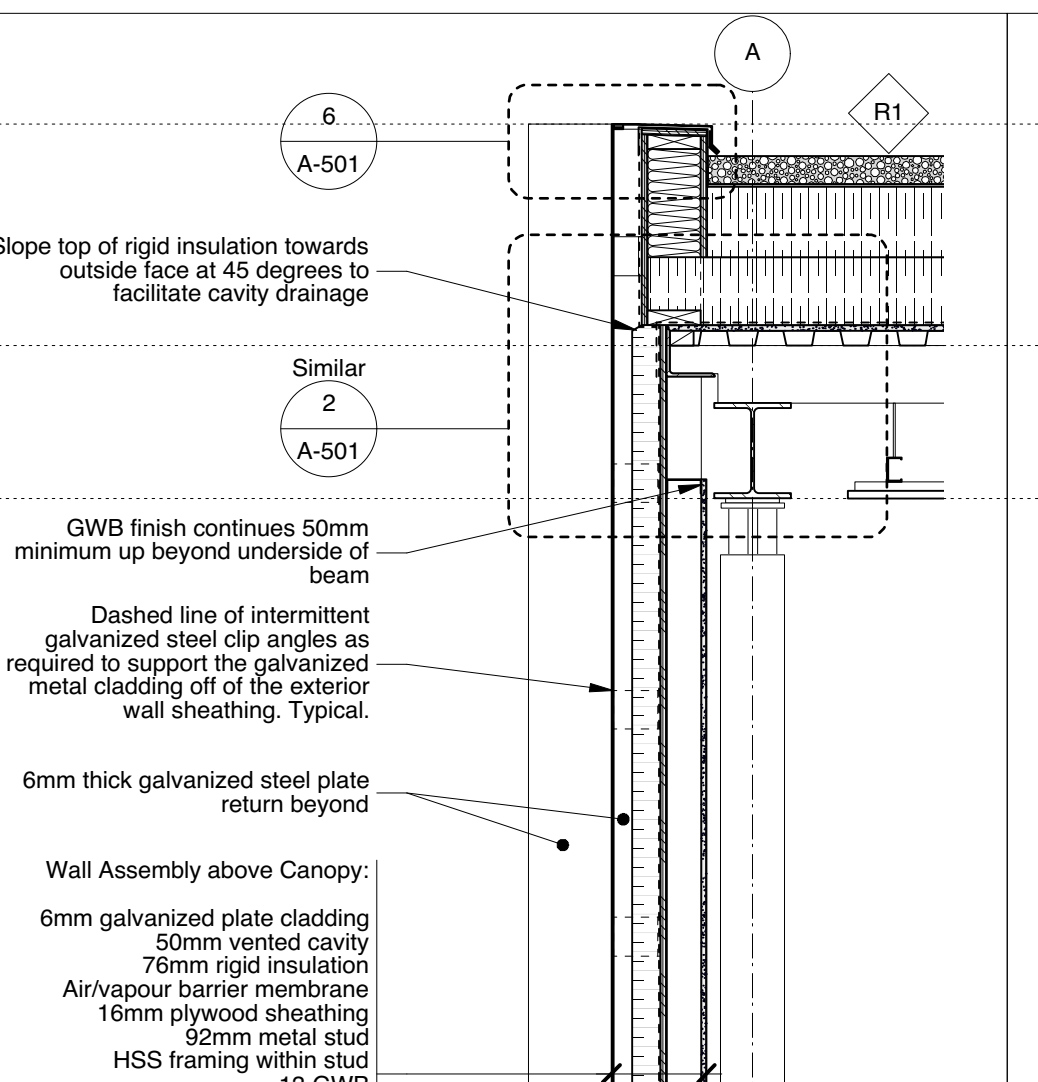
2 Wall Section - South Glazed Wall at Entry Door
1:20

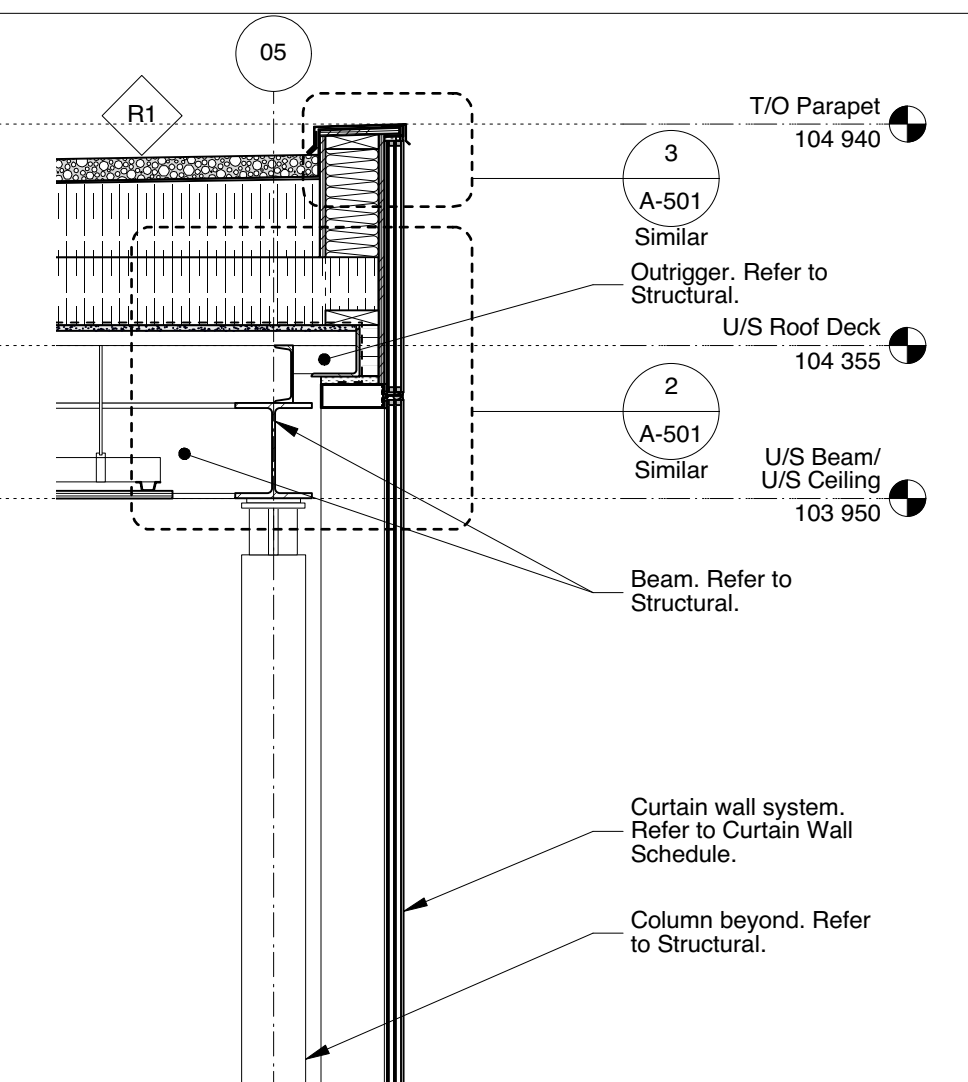
1 Wall Section - East Glazed Vestibule Wall
1:20
