Project  
**CENTURY ARENA**  
 GLULAM REPAIRS  
 1377 CLARENCE AVENUE  
 WINNIPEG, MANITOBA

Sheet Title  
 GLULAM REPAIR SECTIONS & ELEVATIONS

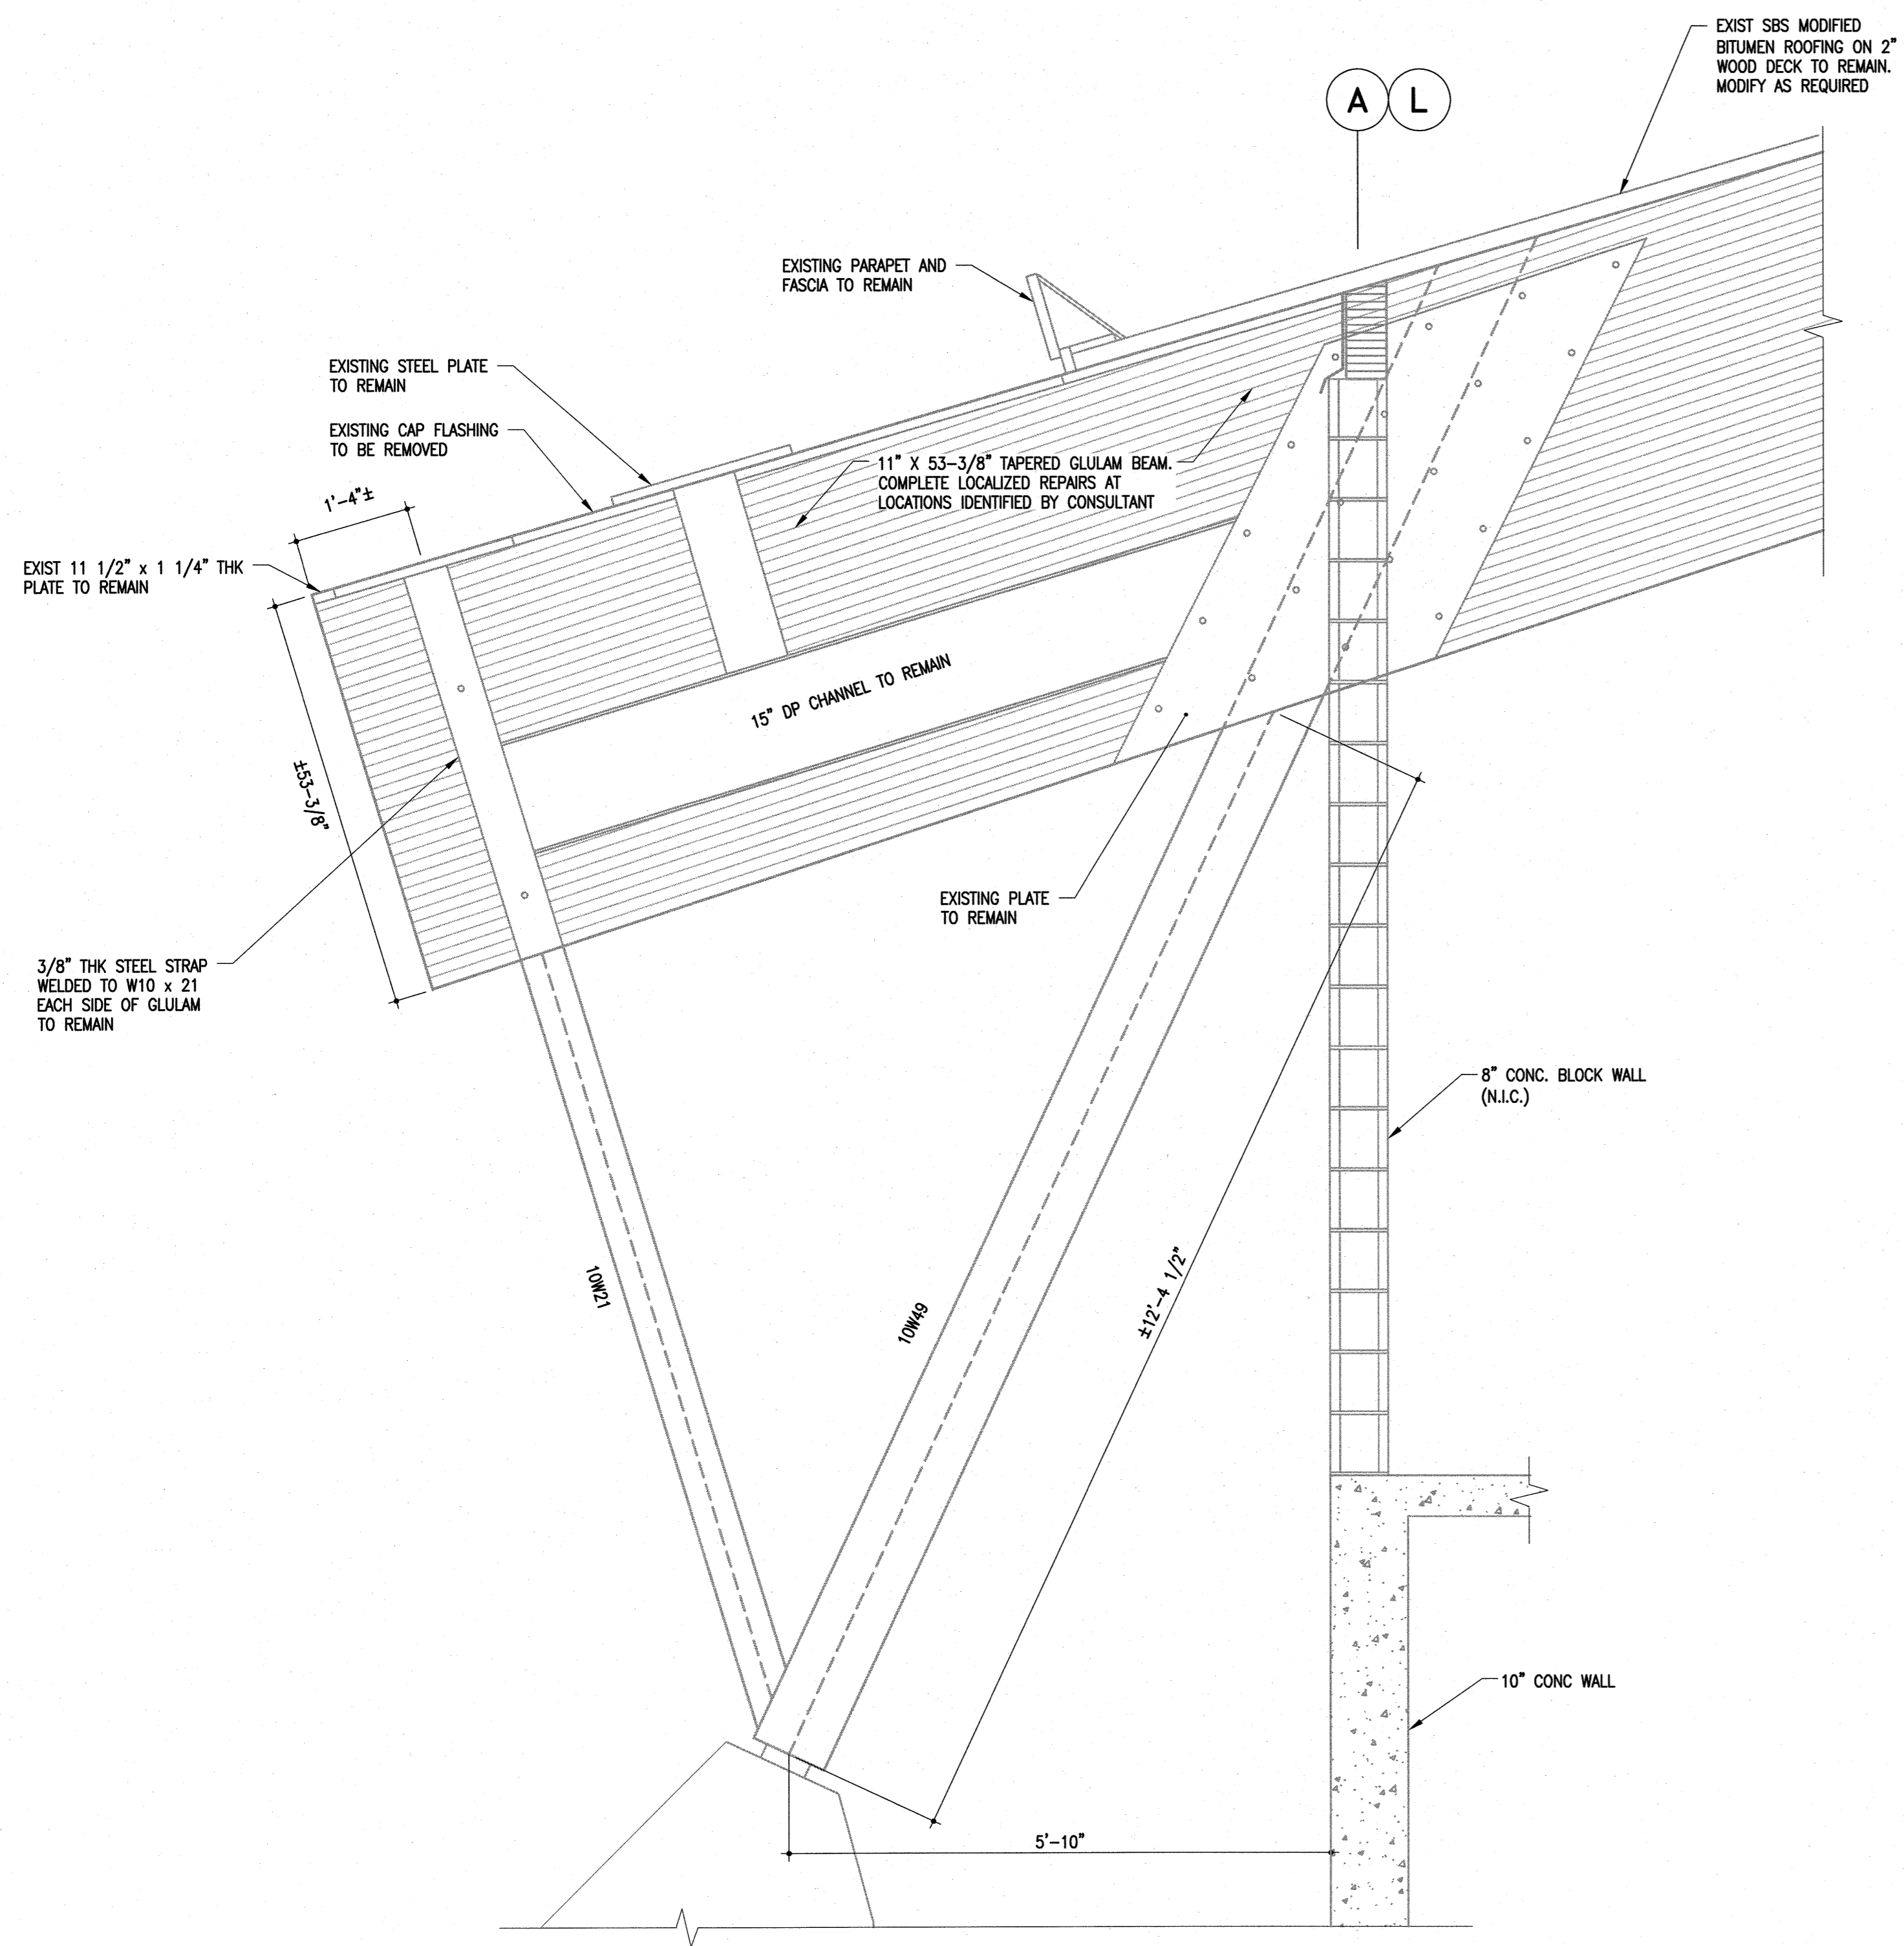
**1** EXISTING TYPICAL GLULAM SECTION  
 S2.1 S4.1 3/4" = 1'-0"

\*ALL STEEL RECEIVING AIR BARRIER TO BE REMOVED OF PAINT TO WHITE METAL PRIOR TO APPLICATION (REFER TO SPECIFICATIONS)
