RECORD DRAWING
DATE: 09/20/02
DRAWN BY: [Signature]

DATE: NOV 1998	SCALE: AS SHOWN	DATE: NOV 1998	SCALE: AS SHOWN
DILLON CONSULTING 2100 W. BROADWAY WINNIPEG, R3M 1G8 TEL: 948-8888 FAX: 948-8889		THE CITY OF WINNIPEG STREETS AND TRANSPORTATION DEPARTMENT BRIDGE ENGINEERING DIVISION 1996 BRIDGE MAINTENANCE CHAINLINK FENCING SASKATCHEWAN AVE AT STURGEON CREEK PLANS AND DETAILS B-6004-1

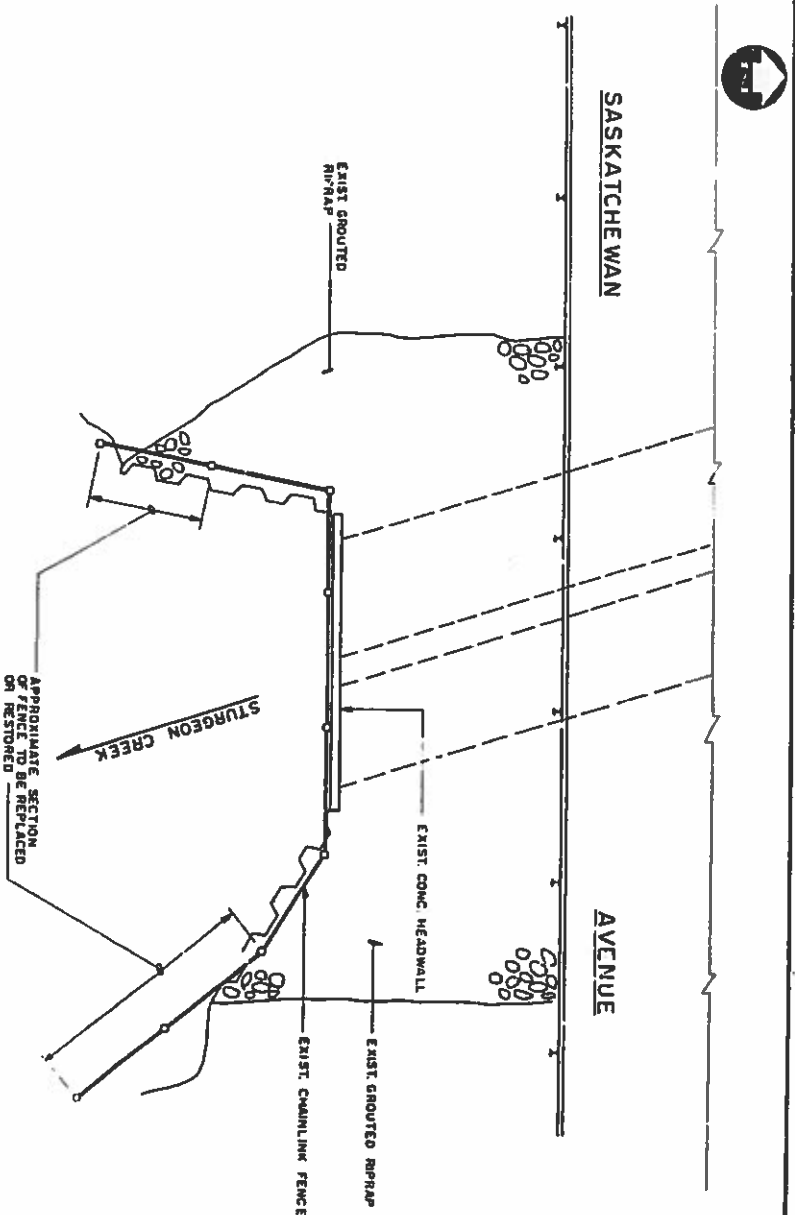
PLAN - SOUTH END OF BOX CULVERT
SCALE: 1:75

- NOTES:**
1. DAMAGED SECTION OF EXISTING CHAINLINK FENCE INCLUDING ITS COMPONENTS ARE TO BE REPLACED OR RESTORED TO ITS ORIGINAL POSITION CONDITION (NOT OR GALLY WHERE REQ'D)
 2. RECONNECT FENCE FABRIC TO POSTS AND RAILS AS BUILT NOTE
 3. THE SOUTHERN SECTION OF FENCE ON THE EAST SIDE OF STURGEON CREEK WAS PRE-FABRICATED DUE TO HIGH WATER LEVELS
