LOCATION APPROVED UNDERGROUND STRUCTURES SUPV. U/G STRUCTURES COMMITTEE _____ DATE _____ NOTE: LOCATION OF UNDERGROUND STRUCTURES AS SHOWN ARE BASED ON THE BEST INFORMATION AVAILABLE BUT NO GUARANTEE IS GIVEN THAT ALL EXISTING UTILITIES ARE SHOWN OR THAT THE GIVEN LOCATIONS ARE EXACT. CONFIRMATION OF EXISTENCE AND EXACT LOCATION OF ALL SERVICES MUST BE OBTAINED FROM THE INDIVIDUAL UTILITIES BEFORE PROCEEDING WITH CONSTRUCTION.		B.M. ELEV. _____ CONSTRUCTION COMPLETION DATE: YYYY MM DD _____	DESIGNED BY: JDB CHECKED BY: JDB DRAWN BY: JDB APPROVED BY: _____ SCALE: HORIZONTAL 1:150 VERTICAL _____ DATE: 2019 01 11 PLOT DATE: 2019 01 11	ENGINEER'S SEAL ORIGINAL SIGNED BY x.x. xxxxxxxx YY/MM/DD CONSULTANT DRAWING NUMBER _____	THE CITY OF WINNIPEG WATER AND WASTE DEPARTMENT ENGINEERING DIVISION 552 PLINGUET AVENUE FIRE PROTECTION UPGRADES BUILDING - 552 NORTH AND SOUTH ASBESTOS CONTAINING MATERIALS INVENTORY PLANS	SHEET 10 OF 18 CITY DRAWING NUMBER 1-0702N-M0009-001

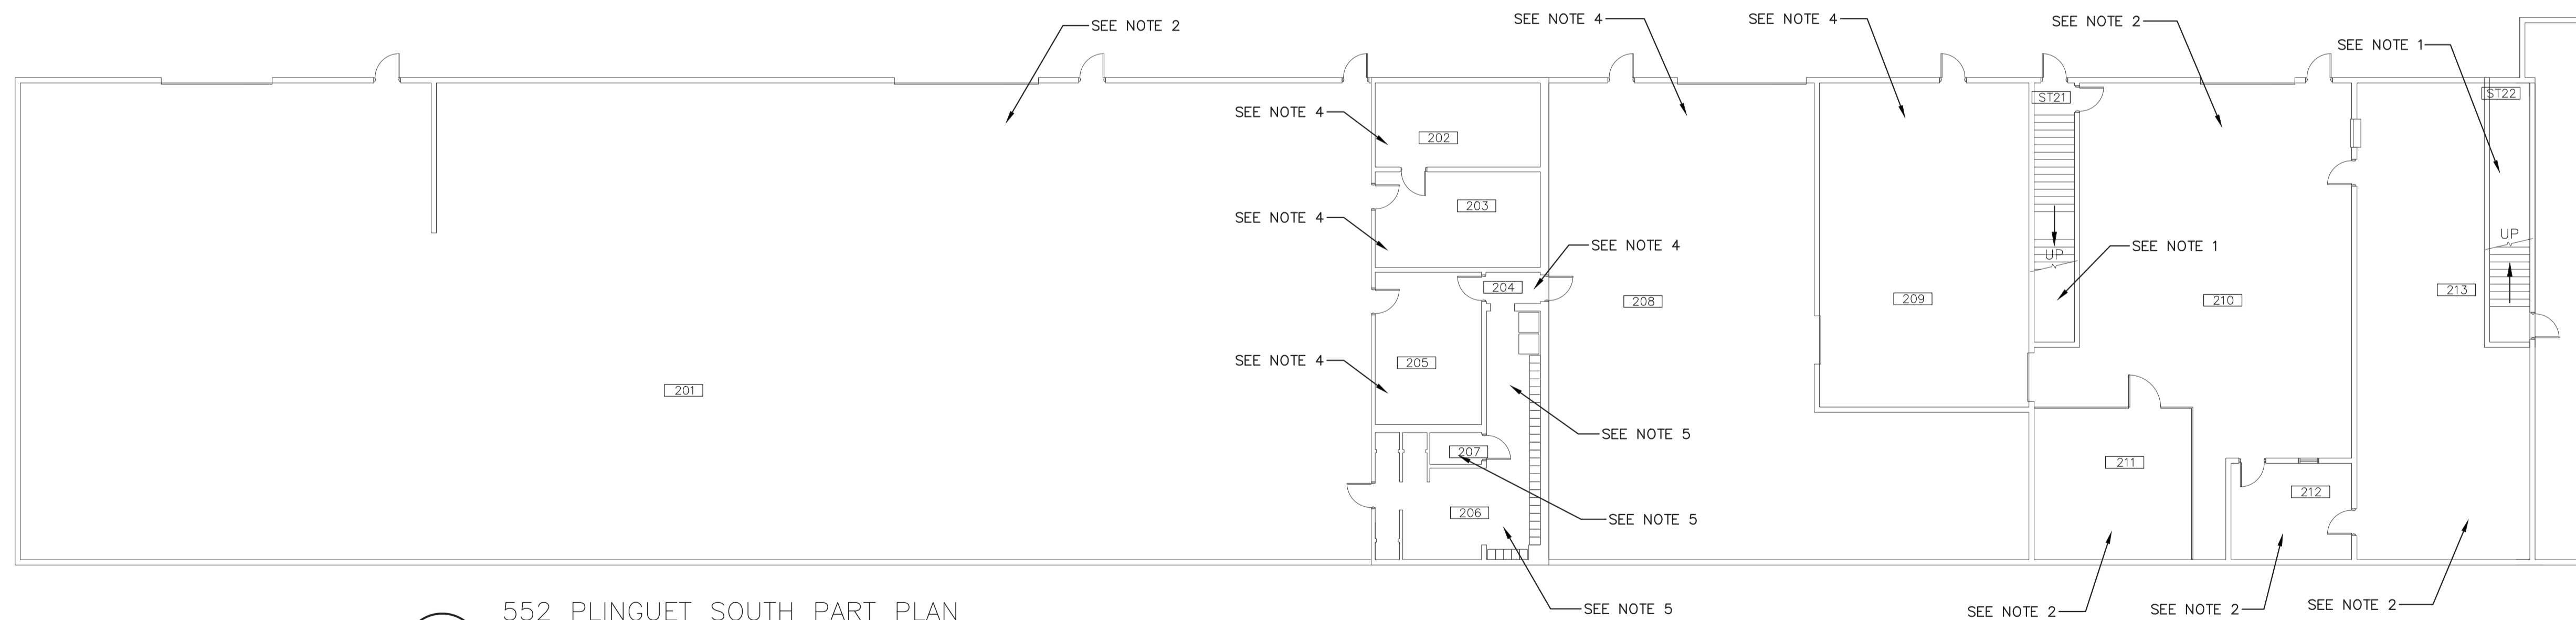
552 PLINGUET SOUTH PART PLAN MAIN FLOOR
1 : 150

1. PRESUMED ACM IN DRYWALL COMPOUND ON THE WALLS AND CEILING.
2. PRESUMED VERMICULITE IN CONCRETE BLOCK WALLS.
3. CONFIRMED ACM IN TRANSITE CEILING. PRESUMED VERMICULITE IN CONCRETE BLOCK WALLS.

4. PRESUMED ACM IN DRYWALL COMPOUND ON THE WALLS. PRESUMED VERMICULITE IN THE CONCRETE BLOCK WALLS.
5. PRESUMED ACM DRYWALL COMPOUND ON THE WALLS AND CEILING. PRESUMED VERMICULITE IN THE CONCRETE BLOCK WALLS.

6. PRESUMED ACM IN DRYWALL COMPOUND ON THE WALLS. PRESUMED VERMICULITE IN THE CONCRETE BLOCK WALLS. CONFIRMED TRANSITE IN THE CEILING ABOVE LAY-IN CEILING TILES.

7. PRESUMED ACM IN DRYWALL COMPOUND ON THE WALLS. CONFIRMED TRANSITE ON THE WALLS BELOW DRYWALL. PRESUMED VERMICULITE IN THE CONCRETE BLOCK WALLS. CONFIRMED TRANSITE IN THE CEILING ABOVE LAY-IN CEILING TILES.

8. PRESUMED ACM IN DRYWALL COMPOUND ON THE WALLS. PRESUMED VERMICULITE IN THE CONCRETE BLOCK WALLS. PRESUMED ACM IN PLASTER ON THE CEILING.
9. CONFIRMED TRANSITE ON THE WALLS BELOW DRYWALL. PRESUMED VERMICULITE IN THE CONCRETE BLOCK WALLS.

10. CONFIRMED ACM IN VINYL TILE AND ADHESIVE ON THE FLOOR. PRESUMED VERMICULITE IN THE CONCRETE BLOCK WALLS.
