Project: Eldon Ross Pool
 1887 Pacific
 Winnipeg, MB

Date: April 16, 2018

Drawing No.: D-1

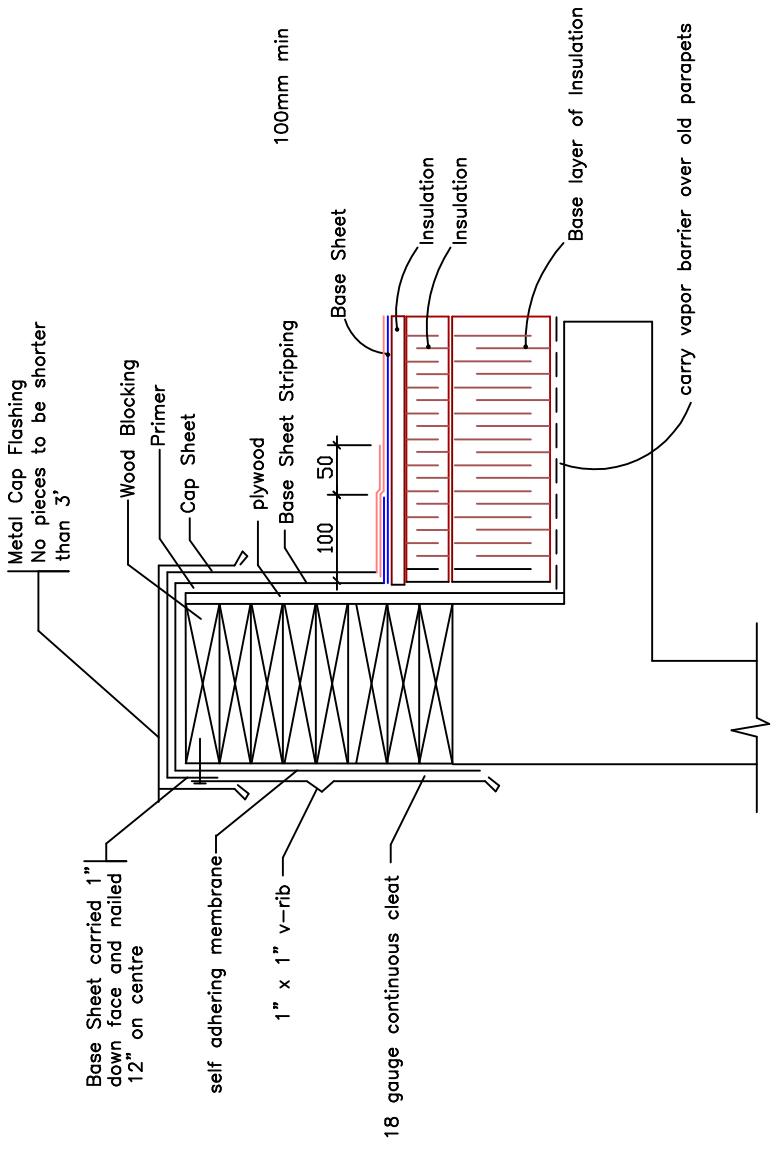
Typical Stucco Wall Parapet

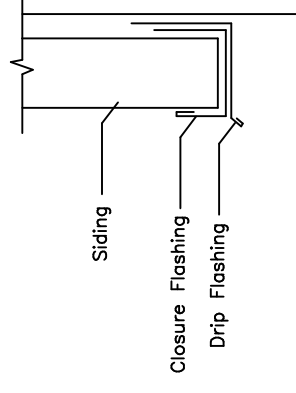
Siding Bottom Flashing
