Project  
**WINNIPEG TRANSIT GARAGE BUILDING**  
 HOIST REPLACEMENT PROGRAM  
 421 OSBORNE STREET  
 WINNIPEG, MANITOBA

Sheet Title  
**NEW DETAILS**

Revision 1 Sheet No. **S4.3**

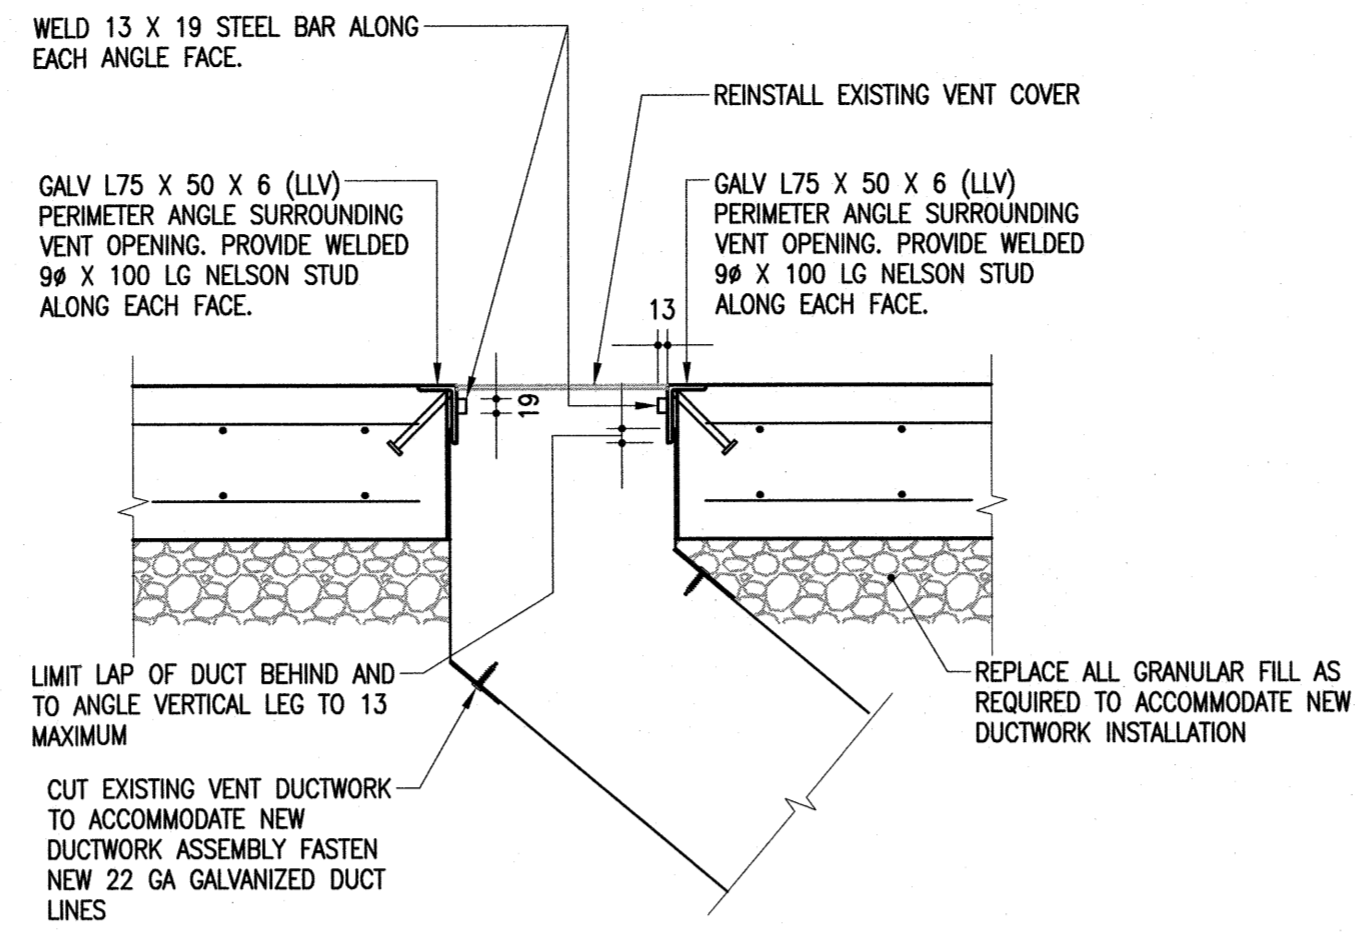
**1 SECTION - VENT PENETRATION**  
 S2.3 | S4.3 | 1:10 (UNIT PRICE)
