CITY OF WINNIPEG
PUBLIC WORKS DEPARTMENT
ENGINEERING DIVISION

ARLINGTON OVERPASS (OPR. YARDS)
2020 STRUCTURAL STEEL REPAIRS

STRUCTURAL STEEL AND
MISCELLANEOUS DETAILS (6 OF 6)

SHEET 12 OF 12
HORIZONTAL: N.T.S.
VERTICAL: N.T.S.
CITY DRAWING NUMBER:
B106-20-12

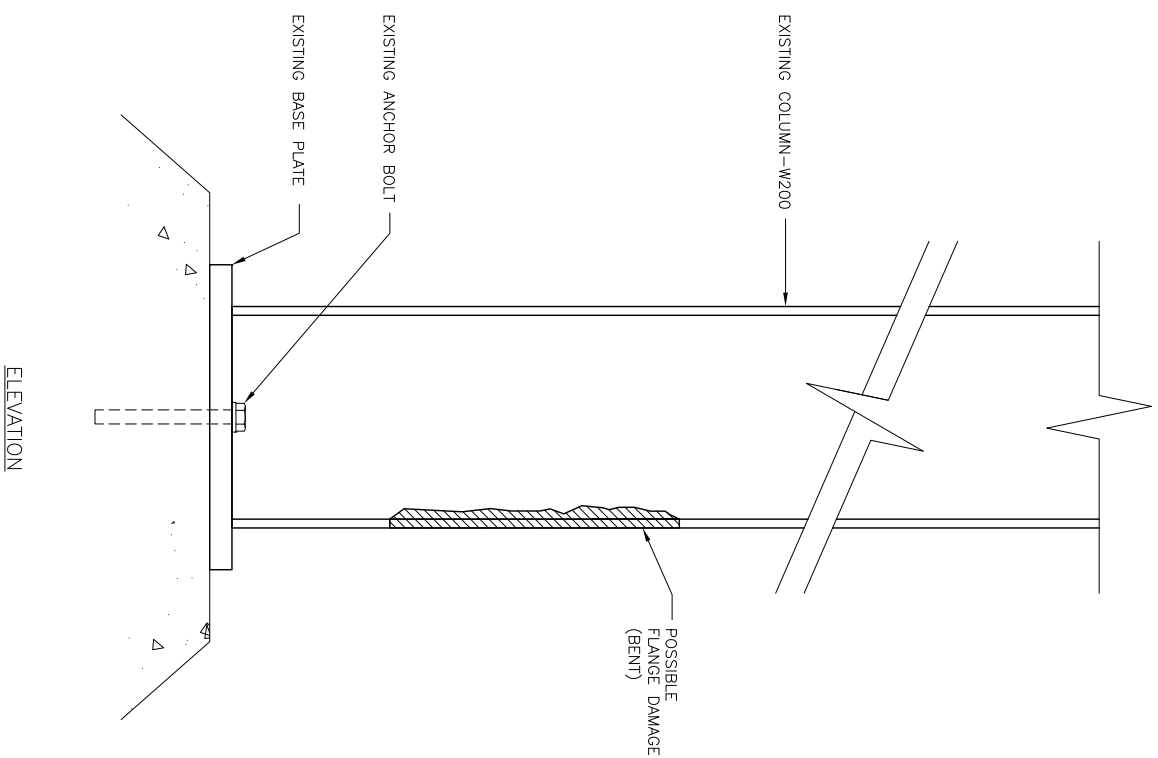
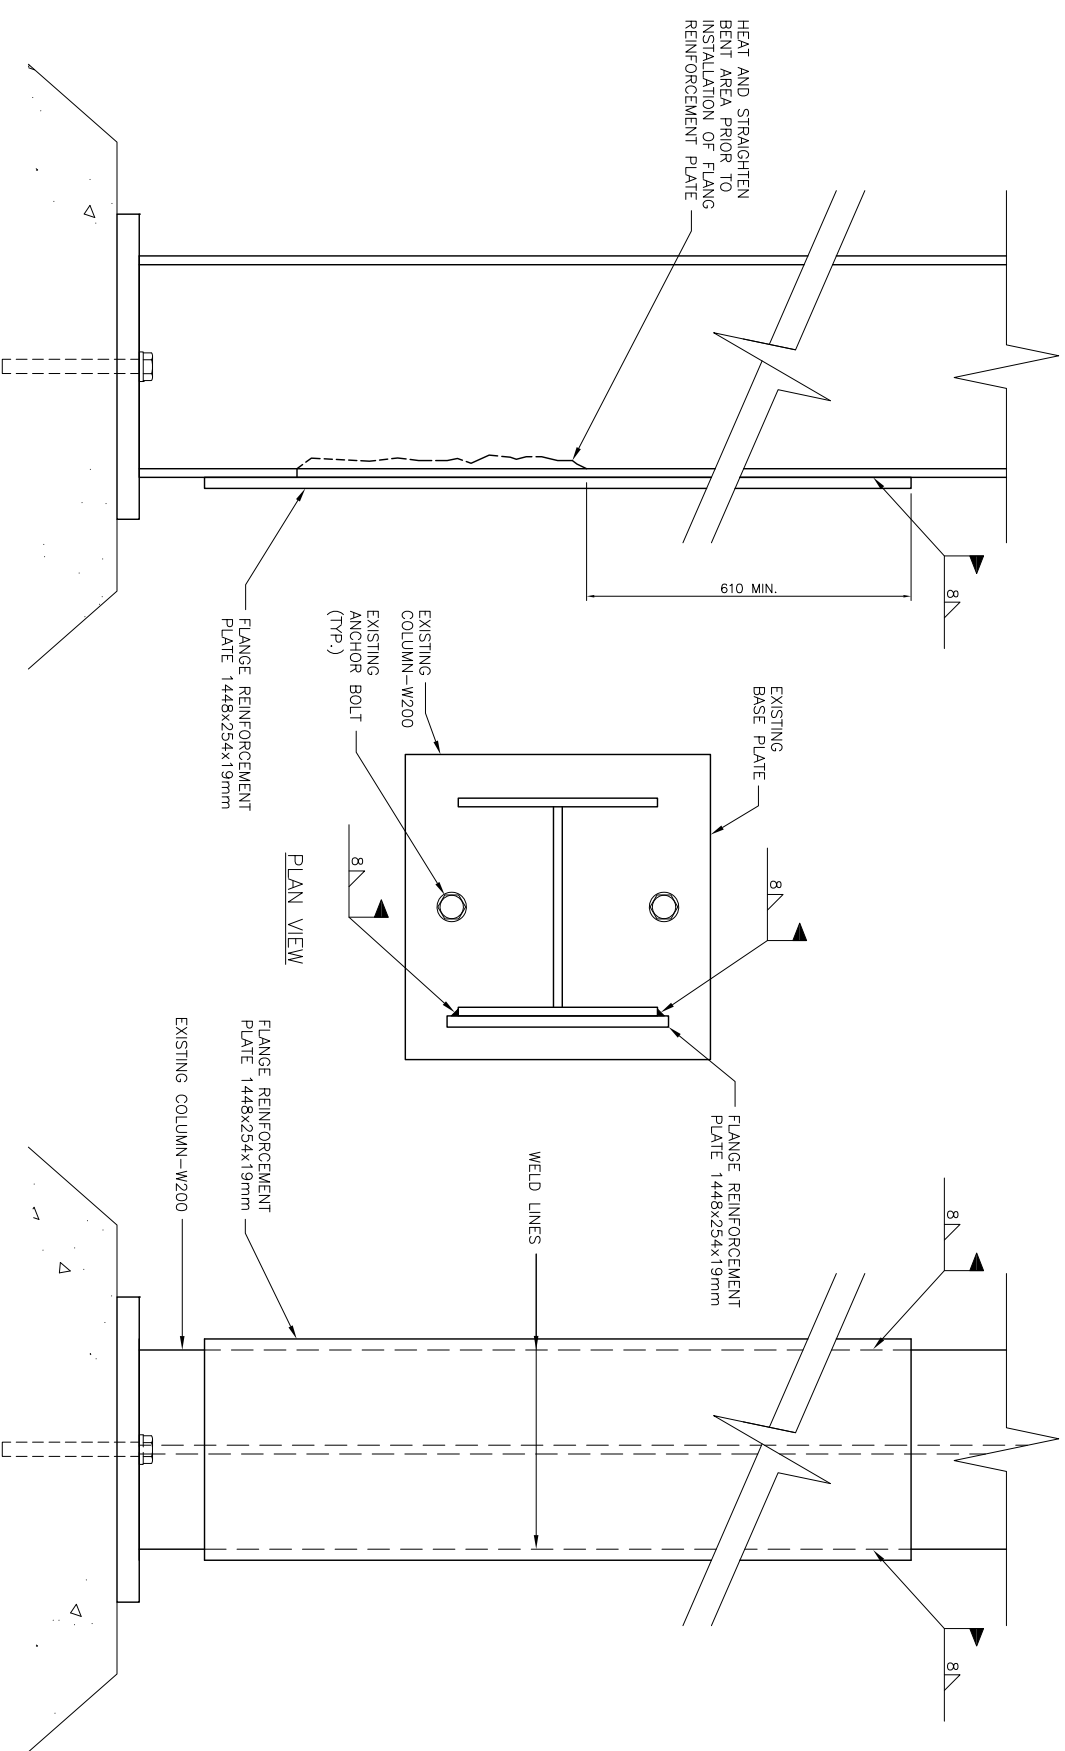
TYPE 7 REPAIR

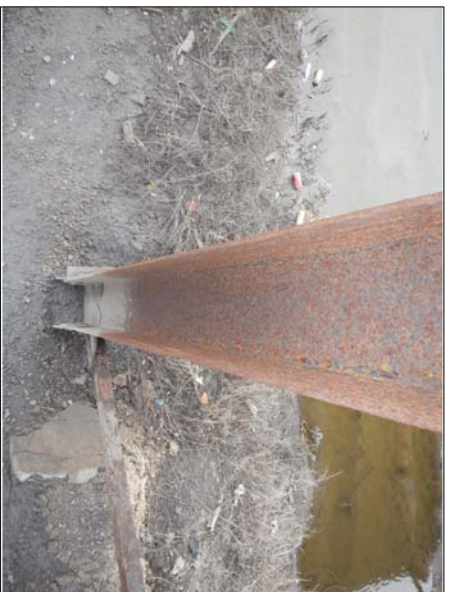
EXISTING CONDITION @ EAST COLUMN ABOVE FOOTING #25
