TRANSIT MAINTENANCE AND REPAIR BUILDING MECHANICAL UPGRADE - WEST HIGH BAY

PARTIAL ROOF PLAN PLUMBING NEW CONSTRUCTION

0	M2.2	7 OF 10
Revision Number	Drawing Number	Sheet Order
Scale 1/16"=1'-0"	Date JUNE 2022	Project No. 20-349-01
RNS	XZ	JH
Drawn By	Checked By	Approved By

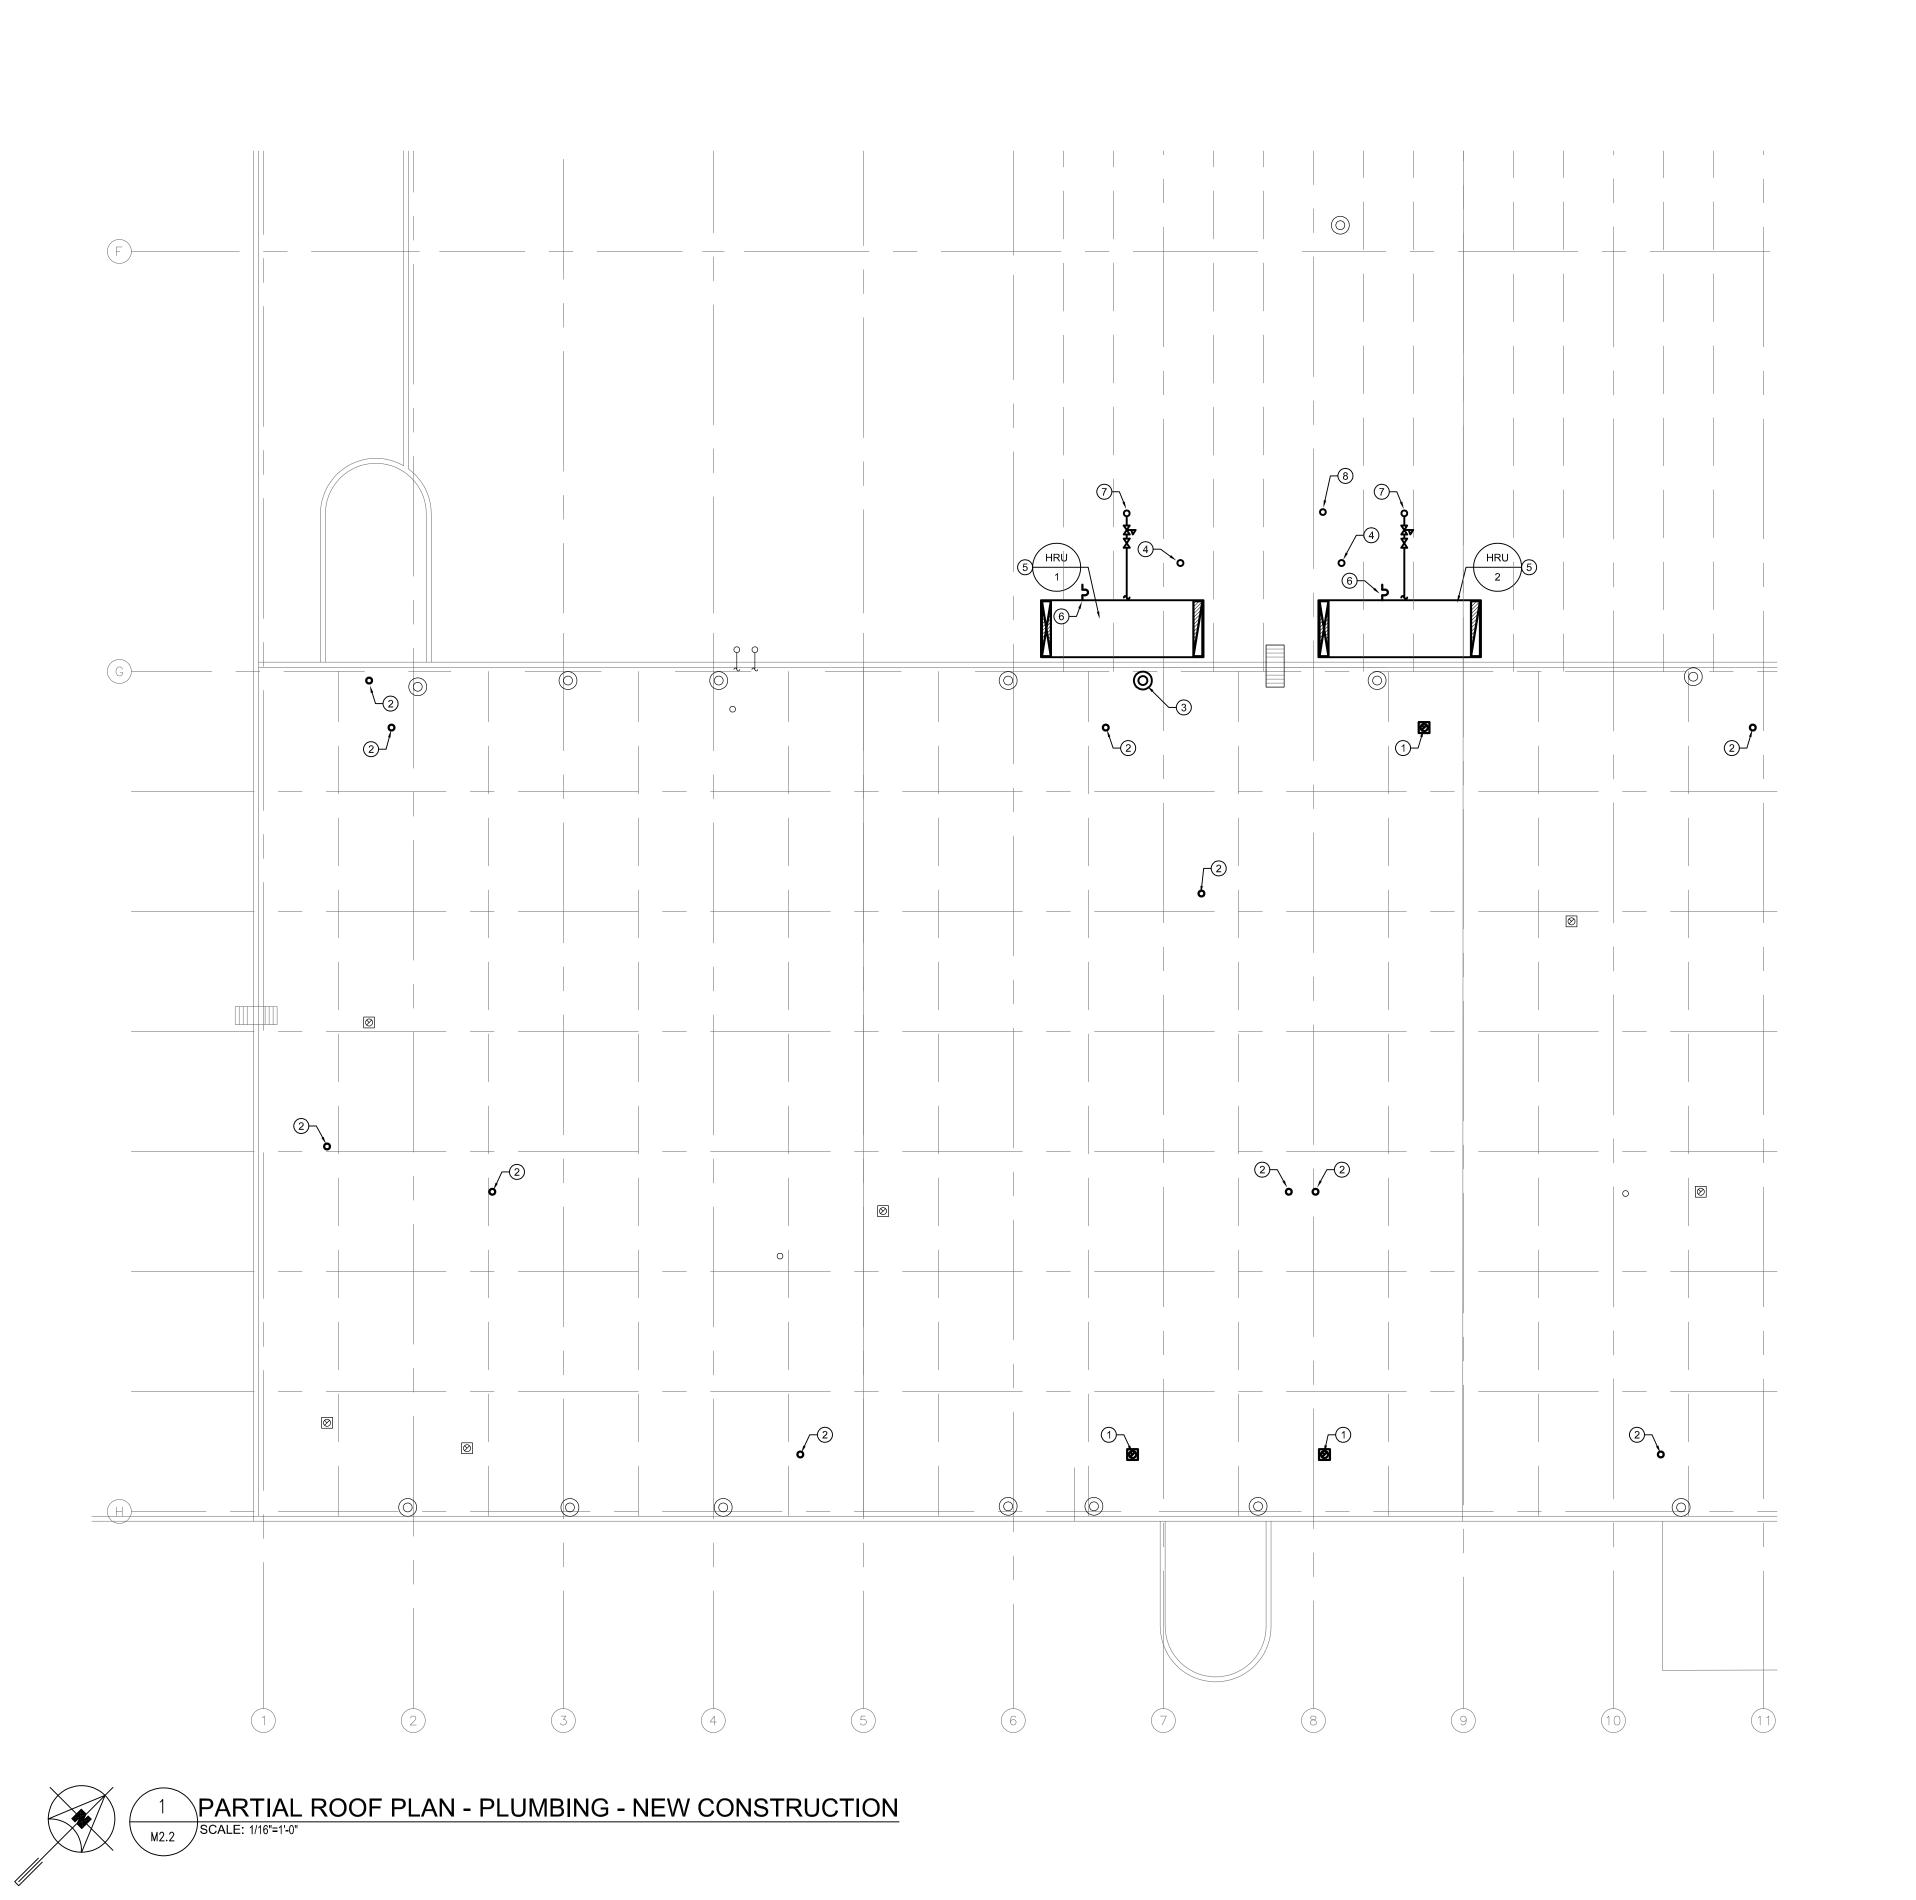
- 1. INSTALL FLUE VENT IN ACCORDANCE WITH MANUFACTURER REQUIREMENTS. PROVIDE WEATHER TIGHT SEAL IN ACCORDANCE WITH ROOF DETAIL AND MATCH THE CONSTRUCTION AND FINISH FROM ADJACENT CONDITION. CONTRACTOR TO CONFIRM EXACT LOCATION ON SITE.

- COMBUSTION AIR INTAKE THROUGH ROOF, PROVIDE WEATHER
 TIGHT SEAL IN ACCORDANCE WITH ROOF DETAIL AND MATCH THE
 CONSTRUCTION AND FINISH FROM ADJACENT CONDITION.
 CONTRACTOR TO CONFIRM EXACT LOCATION ON SITE.

- 3. REINSTALL EXISTING ROOF DRAIN AND OFFSET RWL. SLOPE ROOF TO NEW ROOF DRAIN LOCATION.
- 4. NEW ROOF HYDRANT LOCATED BESIDE HRU. COORDINATE FINAL LOCATION ON SITE.

- 5. NEW HRU. REFER TO M4.2 FOR FURTHER INFORMATION.
- 6. PROVIDE CONDENSATE DRAIN TO DISCHARGE ONTO ROOF C/W HEAT TRACE (BY ELECTRICAL) AND INSULATION.

- 7. PROVIDE NEW NATURAL GAS TO NEW HRU.
- 8. RELOCATE PRV VENT THROUGH ROOF. PROVIDE WEATHER TIGHT SEAL. CONTRACTOR TO CONFIRM THE EXACT LOCATION ON SITE.
