A = 4	
					AE	
						CHECKE
					K. SIDDALL	
					DRAWN BY: G.PROFETA	APPRO
					SCALE:	RELEAS
						BY:
1	ISSUED FOR ADDENDUM 4	2022-11-14	KS	MH	DATE: 2022-11-14	DATE:
0	ISSUED FOR CONSTRUCTION	2022-10-11	KS	MH	CONSULTANT NO.:	
NO.	REVISIONS	DATE	DESIGN	CHECK	60661011	-

TACHE SURGE TOWER REPAIR LEGEND

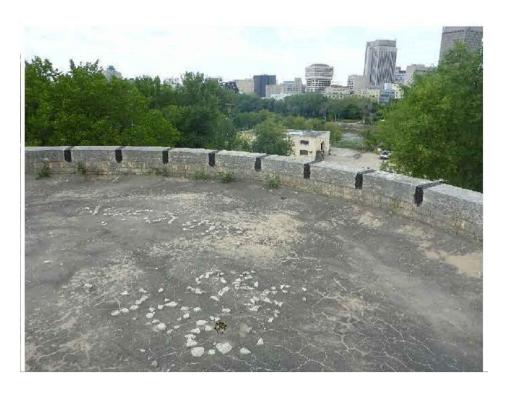
NOTE: 1

RETIONER REMEDIATION ACTION
1	DEMOLISH AND REMOVE EXISTING ROOFING SYSTEM. REFER TO DETAILED DRAWINGS AND STRUCTURAL DRAWINGS.
2	EXISTING ROOF ACCESS LADDER TO REMAIN. SUPPLY AND INSTALL SIGN "DO NOT USE".
3	RE-POINT ALL DETERIORATED MORTAR JOINTS ON EXTERIOR FACE OF TOWER.
4	RE-POINT ALL PARAPET AND COPING STONE JOINTS. REMOVE AS MUCH BLACK TAR FROM STONE SURFACES AT PARAPET AND CORNICE STONES AS POSSIBLE, VIA NON-DESTRUCTIVE OR CHEMICAL MEANS.
5	REPAIR ALL HOLES ON THE CORNICE AND PARAPET STONE.
6	REPLACE ALL BROKEN LIMESTONE OR CLAY BRICK UNITS TO MATCH EXISTING AS CLOSE AS POSSIBLE. SAMPLES TO BE SUBMITTED FOR REVIEW AND APPROVAL PRIOR TO INSTALLATION.
7	REPAIR CHIP AND CRACKS IN STONE AND BRICK UNITS WITH REPAIR PASTE TO MATCH EXISTING AS CLOSE AS POSSIBLE. SAMPLES TO BE SUBMITTED FOR REVIEW AND APPROVAL PRIOR TO INSTALLATION.
8	REPAIR BRICK VENEER AND SALVAGE BRICK VENEER WHERE POSSIBLE AT THE PARTAPET INSIDE FACE . REPLACE VENEER WHEN BRICK VENEER IS POOR. REPAIR MORTAR JOINTS BY REPOINTING.

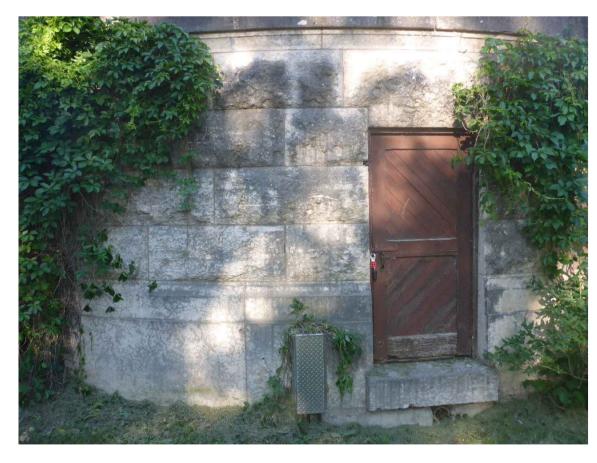
DOOR 9

9	INSTALL NEW FIBERGLASS DOOR AND FRAME. COLOUR TO MATCH EXISTING C/W NEW HARDWARE.
10	BRUSH WASH THE ENTIRE EXTERIOR OF THE TOWER AFTER REPAIRS HAVE BEEN COMPLETED
