CONSULTANT DRAWING NO.	704-INF-MB103029.01-DWG-S1007
------------------------	-------------------------------

THE CITY OF WINNIPEG PUBLIC WORKS DEPARTMENT	
LOUISE BRIDGE SUBSTRUCTURE REHABILITATION WORKS - PHASE 1	CITY DRAWING NUMBER B107-25-007 SHEET 7 OF 23
SU.1 BEARING REPLACEMENT DETAILS	
7

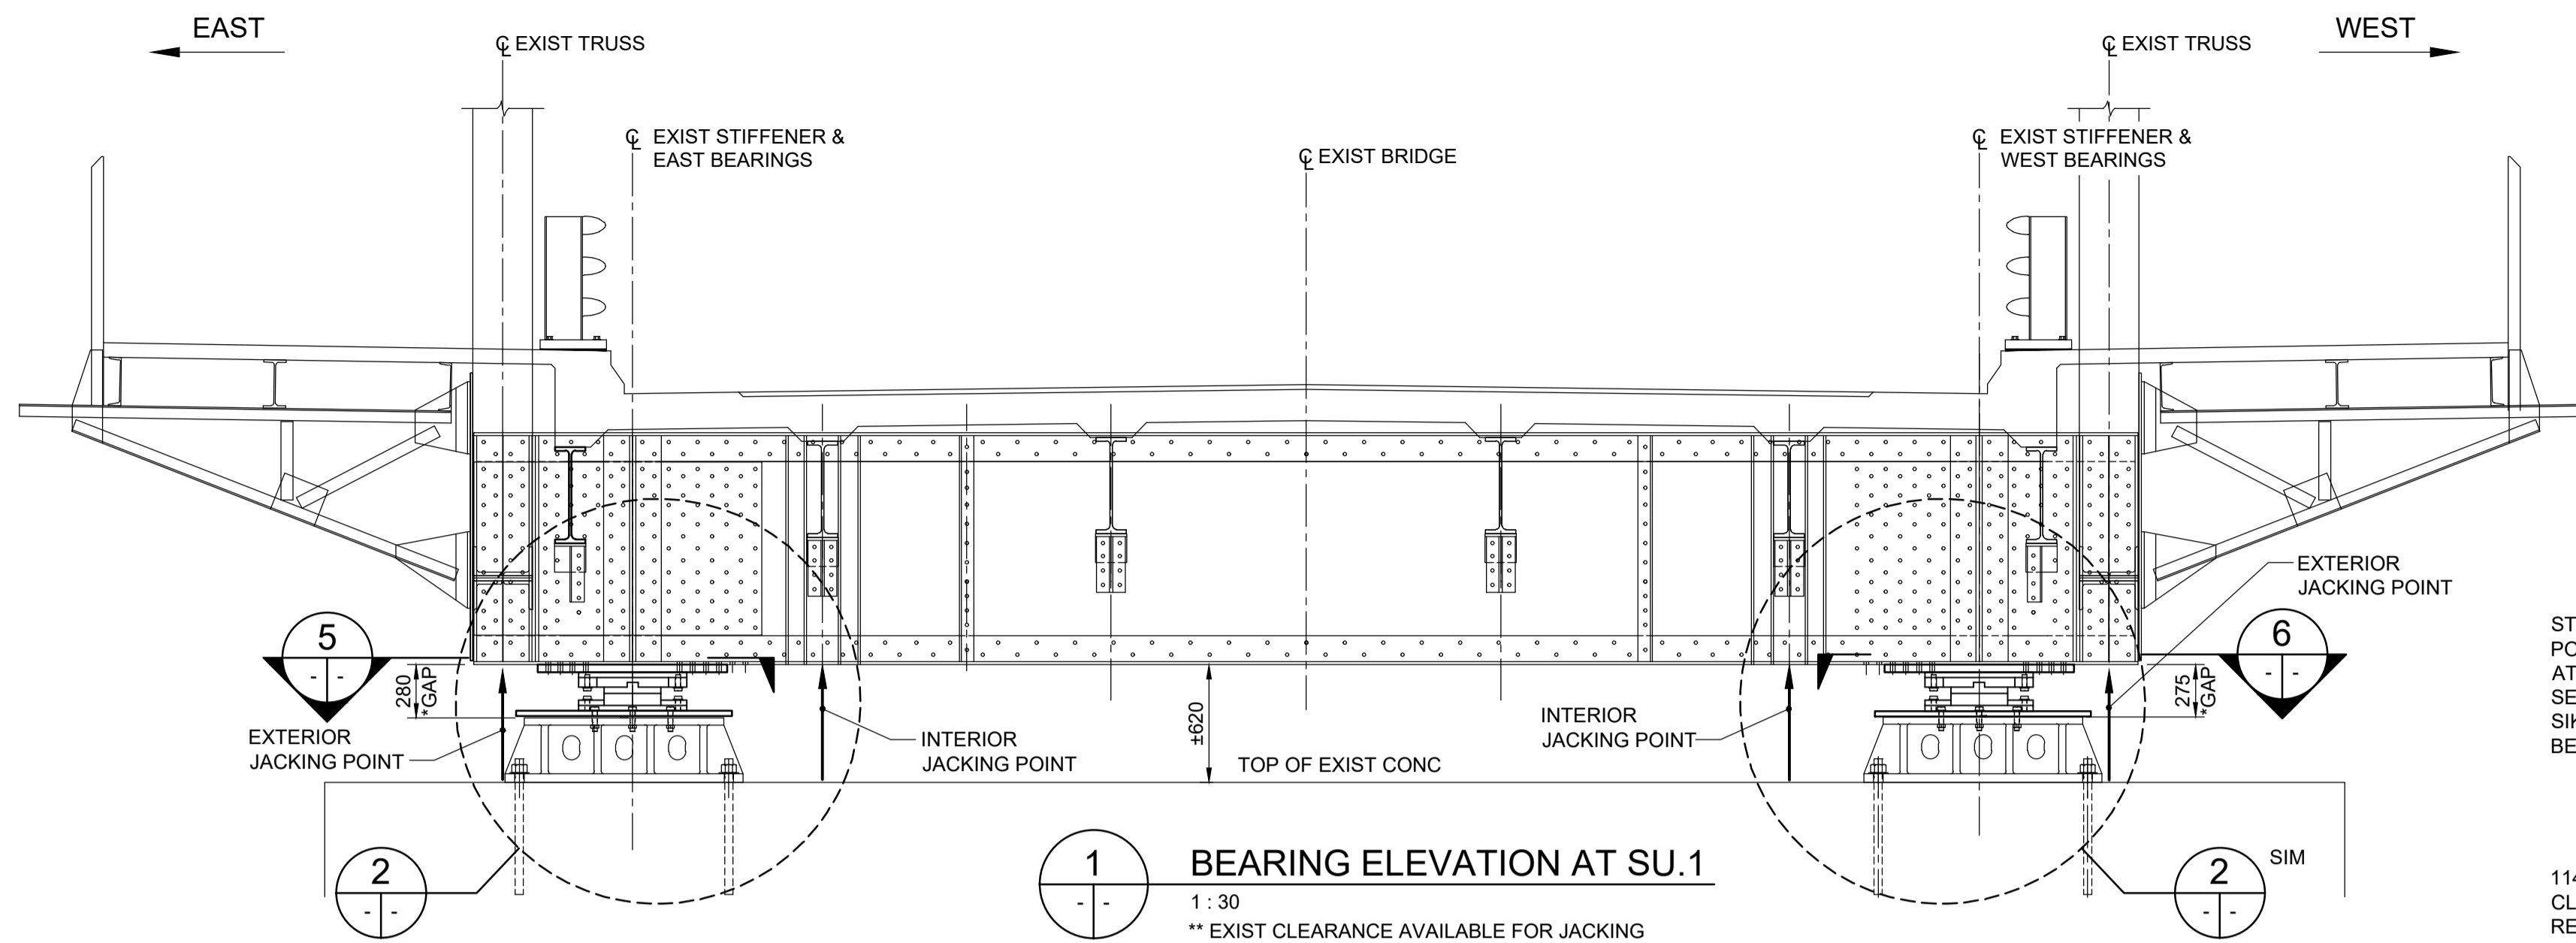
NOTE:
* GAP BETWEEN PEDESTAL AND FLOOR BEAM MUST REMAIN UNCHANGED AFTER BEARING REPLACEMENT
