## Old St. Boniface Fire Hall No. 1: 212 Dumoulin

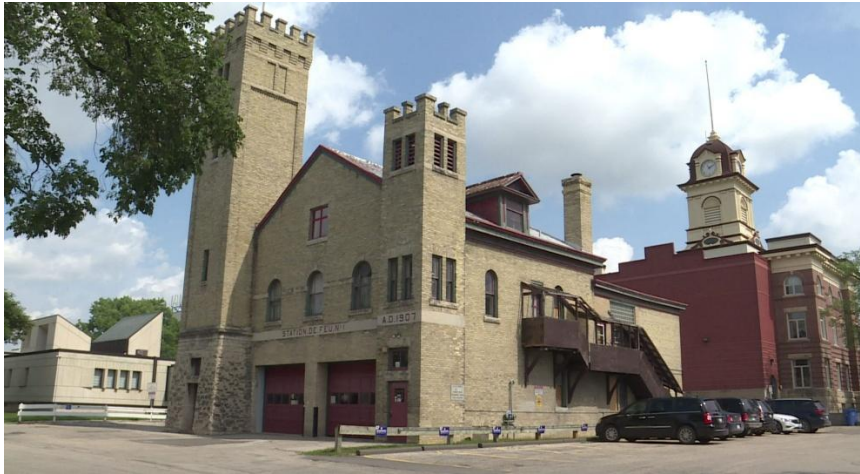
The facility at 212 Dumoulin Street (St. Boniface Firehall Museum) was originally constructed in 1907, with an addition completed in 1965.

The building is a historic multi-storey structure consisting primarily of wood framing with brick exterior walls, while the addition includes reinforced concrete construction with stucco over wood stud walls. The roofing systems consist of original metal tile roofing on portions of the historic structure and built-up roofing on the addition.

The building retains many original architectural elements, though several components have reached or are approaching the end of their expected service life.

Interior finishes, including washrooms, flooring, plaster partitions, ceilings, and millwork, show signs of age and wear.

The current steam boiler is not functional and locked out. There is currently no source of heat for this building. The building includes perimeter heating piping, which has reached the end of its useful life and the HVAC controls consist of an older pneumatic control system, installed in the 1970s.

Plumbing systems include custodial sinks and standard restroom fixtures, many of which date from approximately the 1950's.

The building is served by an older electrical service with approximately 200-amp capacity at 208 volts, including switchgear and distribution wiring installed around 1940. The main

electrical service equipment and distribution panels are considered at the end of their useful life.

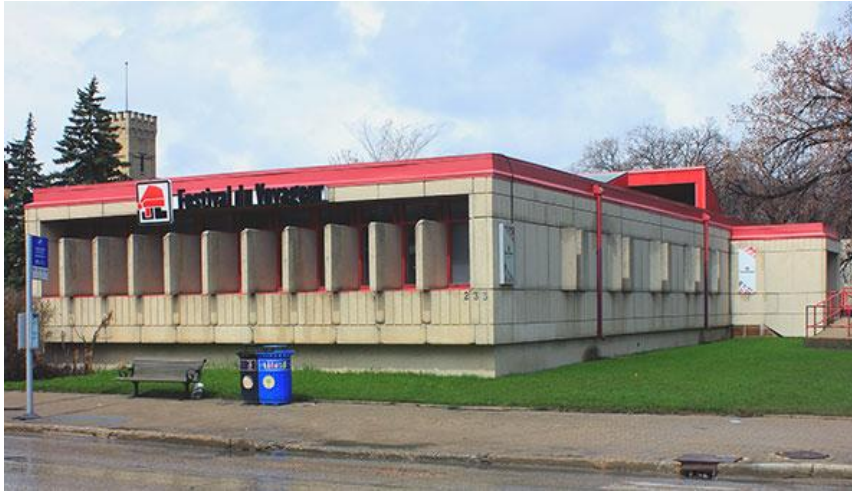
## Festival Du Voyageur: 233 Provencher

This facility was constructed in 1962, with several upgrades completed over time including storefront door replacements and a newer SBS modified bitumen roofing system installed in 2009.

The building structure consists primarily of reinforced concrete foundations, suspended concrete floor assemblies, and precast concrete exterior walls with an exposed aggregate finish. Overall, the structure appears to be in reasonable condition, though several building components are approaching the end of their expected service lives.

Heating and ventilation are provided through a central air handling unit (AHU) with heating and cooling coils and VAV ducted distribution, including diffusers and plenum return air systems throughout the building. The HVAC system also includes perimeter wall-mounted cabinet fan coil units providing heating, as well as steam heat distribution piping with condensate return.

Much of the HVAC equipment, including the central AHU, fan coil heating units, and steam piping systems, dates back several decades and is approaching the end of its expected service life.

The plumbing systems include domestic water distribution piping, restroom fixtures, custodial sinks, kitchenettes, and water coolers, many of which date back to the original construction period and are nearing the end of their expected service life.

The building is served by an electrical switchgear system rated at approximately 200 amps and 120/240 volts, with associated breakers, conduit, and distribution wiring. The electrical system includes branch wiring devices serving interior and exterior equipment and building systems.

Several electrical components, including branch wiring and communication systems, date back to the original construction period and are approaching the end of their expected service life, and future replacement should be anticipated.

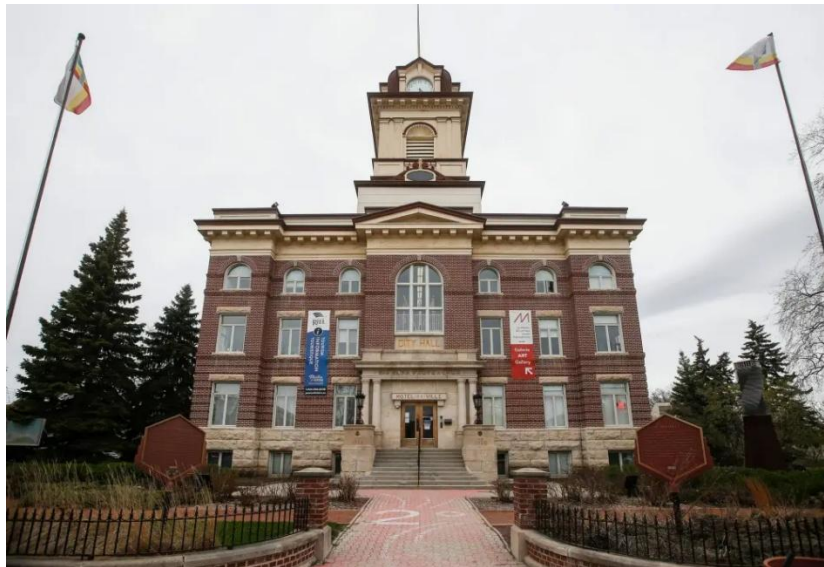
## St Boniface City Hall: 219 Provencher

This facility, located at 219 Provencher Boulevard (World Trade Centre / Tourisme Riel – formerly St. Boniface City Hall), was originally constructed in 1906, with significant renovations completed in 1987.

The building structure consists primarily of concrete footings and foundation walls with a full basement, along with wood-framed floor and roof construction supported on load-bearing masonry walls and columns. The exterior enclosure includes brick masonry walls, concrete masonry units, stone veneer, and areas of stucco. The building also includes insulated aluminum window assemblies and steel and wood exterior door assemblies.

The roofing system consists of a built-up roof assembly with insulation, which has exceeded or is nearing the end of its expected service.

Heating is provided by a gas-fired condensing hot water boiler installed in 2012. The boiler provides space heating to the facility and does not include redundant equipment.

Domestic hot water is provided by a 120-gallon commercial electric water heater with recirculation pump, while the plumbing system includes a cast iron sanitary waste piping system discharging by gravity to the municipal sewer system.

Much of the mechanical equipment, including the gas supply system and boiler, dates back several decades and is approaching the end of its expected service life.

The building is served by an electrical service and distribution system consisting of a 600-amp, 208-volt disconnect switch with associated feeders and distribution panels, originally installed around 1960 with upgrades completed in 1986.

The electrical distribution includes panelboards, branch wiring devices, lighting fixtures, and utilization equipment serving interior and exterior building systems. Several electrical components, including the main service equipment, panelboards, branch wiring and life-safety systems, are approaching the end of their expected service life.

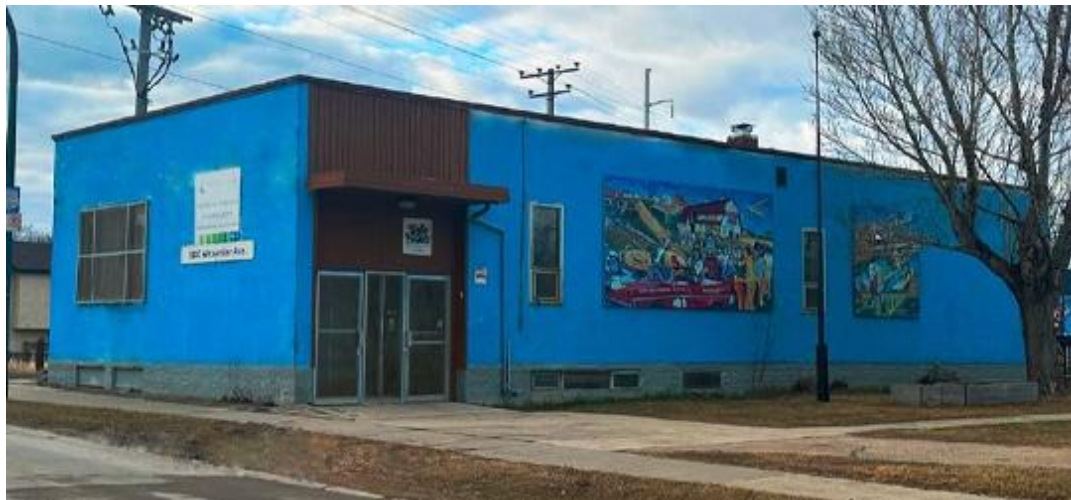
## NorWest (NOA) Resource Centre: 1880 Alexander

This facility was constructed in 1955 and consists of a single-storey wood-framed structure with concrete foundations, basement foundation walls, and a structural slab-on-grade floor assembly.

The exterior walls consist primarily of stucco over wood studs, with painted EIFS finishes on portions of the façade. The building includes steel-framed exterior windows with insulating glass installed in the early 1990s and a combination of steel and glazed aluminum storefront door assemblies.

The roofing system consists of a built-up roofing (BUR) assembly with insulation, installed around 1980.

Several building envelope components, including the roofing system, exterior doors, and portions of the exterior wall finishes, are approaching or have exceeded their expected service lives

Heating is provided through a natural gas service supplying gas-fired heating equipment, along with warm-air furnace units paired with air-cooled condensers for heating and cooling. Air distribution is provided through ducted return air systems with centrifugal or in-line return air fans. HVAC controls include a basic DDC control system used for simple building control functions.

Plumbing systems include domestic water distribution piping, sanitary waste piping discharging by gravity to the municipal sewer system, roof drainage piping, sump pumps, restroom fixtures, custodial sinks, and a small kitchenette with sink and cabinets. Domestic hot water is provided by a 30-gallon commercial electric water heater with recirculation pump.

Several plumbing and HVAC components date back multiple decades and are approaching the end of their expected service life.

The building is served by an average electrical service rated at approximately 200 amps at 120/240 volts, with associated conduit, wiring, and distribution equipment. Electrical distribution includes panelboards, branch wiring, receptacles, and utilization equipment throughout the facility, with exterior lighting provided by HID lighting fixtures.

The electrical system also includes standard branch wiring devices serving interior and exterior equipment and building systems. Several electrical components, including service feeders, panelboards, and branch wiring, date from earlier upgrades and are approaching the end of their expected service lives.

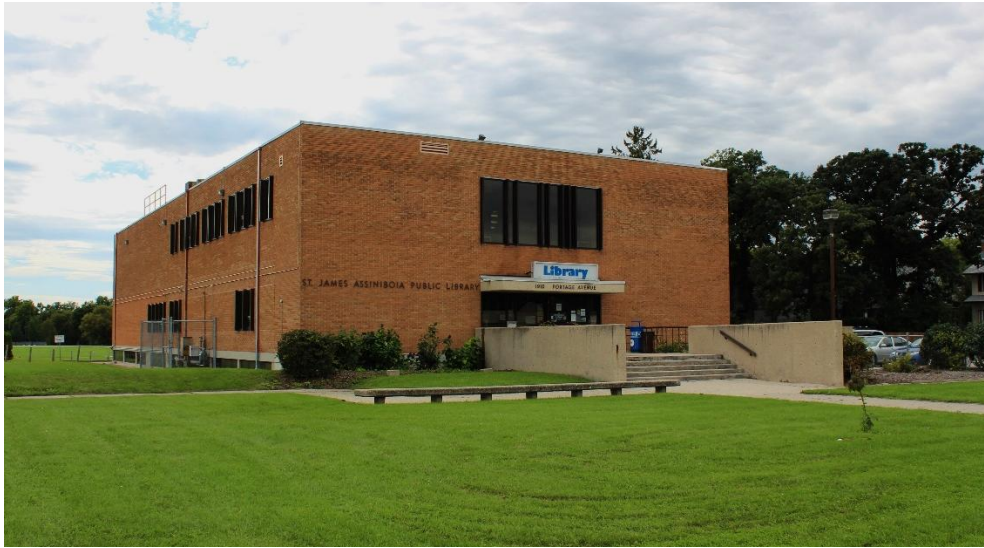
## St. James-Assiniboia Library: 1910 Portage Ave

This facility was constructed in 1958, with additions and renovations completed in 1970 and subsequent interior upgrades over time.

The building structure consists of cast-in-place concrete columns and roof elements with a steel framed roof structure supported on bearing walls, along with reinforced concrete foundations and a full basement with slab-on-grade construction.

Exterior walls consist primarily of brick veneer assemblies, and the building includes aluminum-framed windows with insulating glass installed around 1990 and glazed aluminum storefront entrance doors installed in the mid-1990s. The roofing system consists of a built-up roofing (BUR) assembly with insulation, which is nearing the end of its expected service life.

Heating is provided by three gas-fired hot water boilers installed in 2007, supplying a hydronic distribution system with circulating pumps.

Air distribution throughout the building is provided by a constant volume ducted system with diffusers and plenum return, supplemented by perimeter induction units and radiators located throughout the building.

Ventilation is provided through roof-mounted exhaust fans and restroom exhaust systems, and cooling is provided through packaged rooftop units with gas heat and air conditioning, installed primarily around 2007 with some older equipment remaining

The building plumbing systems include domestic water distribution piping with a 2-inch main line, sanitary waste piping discharging by gravity to the municipal system, storm water ejector pumps, and natural gas distribution piping. Plumbing fixtures include restroom fixtures, custodial sinks, water coolers, and a small kitchenette. Domestic hot water is provided by a 60-gallon electric water heater installed in 2021.

The building electrical systems include standard electrical service, distribution panels, branch wiring, and lighting systems serving interior and exterior equipment and building systems. While many distribution components remain serviceable, portions of the electrical infrastructure date back several.

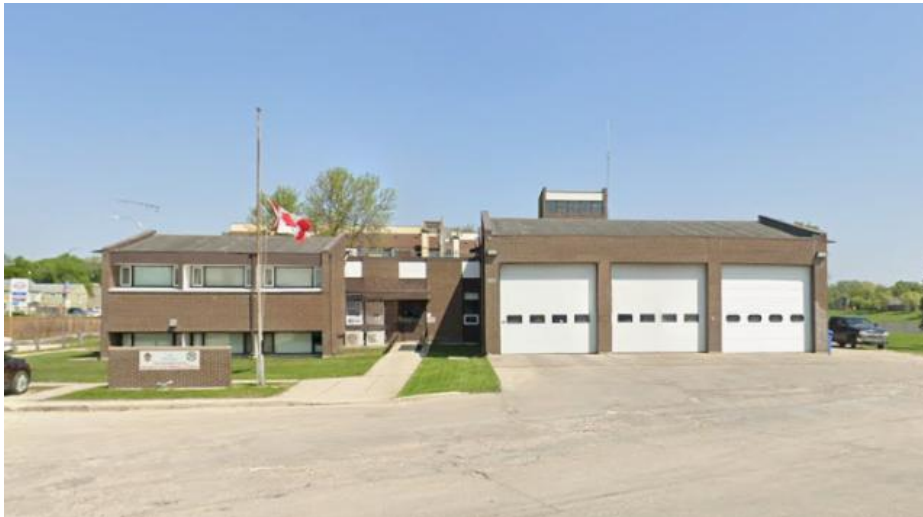
## WFPS Station 23: 880 Dalhousie Dr

This facility was constructed in 1962 and consists of a single-storey structure with a partial basement, including apparatus bays and operational areas.

The building structure includes reinforced concrete foundations, concrete block structural walls, and a roof structure supported on steel framing, with brick cavity exterior walls backed by CMU construction.

The exterior enclosure includes wood-framed windows with insulating glass, overhead sectional vehicle bay doors, and steel entrance door assemblies. The roofing system consists primarily of built-up roofing on flat areas and modified bitumen roofing on sloped sections. Overall, many building components date back to the original construction period and several systems are approaching the end of their expected service lives.

Heating within the facility is provided by a hydronic hot water heating system with perimeter fin-tube radiation served by two gas-fired boilers. The boilers are Laars NeoTherm units rated at approximately 600,000 BTU/hr each and manufactured in 2010. The hydronic distribution system circulates heating hot water through perimeter units located throughout the building. The hydronic heating distribution equipment and some terminal units are at end of life.

Cooling within the building is provided by split-type direct expansion (DX) cooling systems with air-cooled remote condensers, serving selected areas of the facility. These systems provide localized cooling for operational spaces within the building. As with other building systems, portions of the HVAC equipment are near there end of life.

Domestic hot water is provided by a commercial water heater with approximately 100-gallon storage capacity and recirculation pump, supplemented by an electric domestic hot water tank installed in 2007. Plumbing fixtures include restroom fixtures, showers, lavatories, and urinals serving the firefighter facilities. Portions of the domestic water distribution and sanitary piping systems date back to the original construction period and are approaching the end of their expected service lives

The building is served by standard electrical distribution systems supporting lighting, equipment, and operational systems within the facility. Electrical components associated with building systems and equipment are generally functional; however, portions of the electrical infrastructure date back several decades and may require upgrades soon.

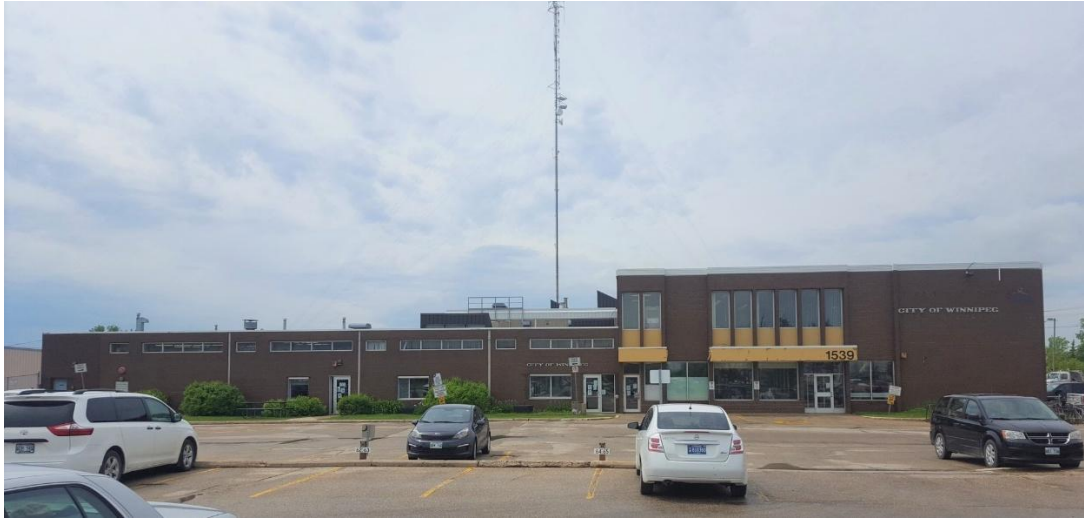
## Public Works Yard & Administrative Offices: 1539 Waverley Street

This facility was constructed in 1965 and consists of a steel-framed structure with concrete foundations and slab-on-grade construction, along with concrete mezzanine levels and a combination of brick veneer and metal panel exterior wall systems. The building is generally in fair condition, though many components are original and approaching the end of their expected service lives. Future anticipated expenditures include replacement of built-up roofing systems, aging aluminum windows, exterior doors, overhead doors, interior finishes, and code upgrades to stair handrails and guards. Part of the flooring, wall coverings and washroom accessories are in the process of being replaced as a result of a water damage claim.

The building is served by a central constant volume air handling unit (Trane, approximately 20,000 CFM, installed in 1986) with ducted distribution, diffusers, and plenum return air systems. Heating within the garage areas is provided by suspended gas-fired unit heaters, and ventilation systems include dedicated exhaust systems such as dust collectors and fume hood exhaust systems.

HVAC controls consist of a hybrid DDC/pneumatic control system, which is now beyond its expected service life and will require replacement or upgrade. Much of the HVAC equipment, including the air handling unit, control systems, and exhaust systems, is aging and approaching the end of its useful life.

Plumbing systems include custodial sinks and emergency eyewash/shower units, many of which are also approaching renewal.

The building is served by a typical electrical distribution system consisting of panelboards, feeders, and associated wiring supplying interior and exterior building systems. While the electrical systems remain functional, much of the infrastructure dates back several decades and is approaching the end of its expected service life.

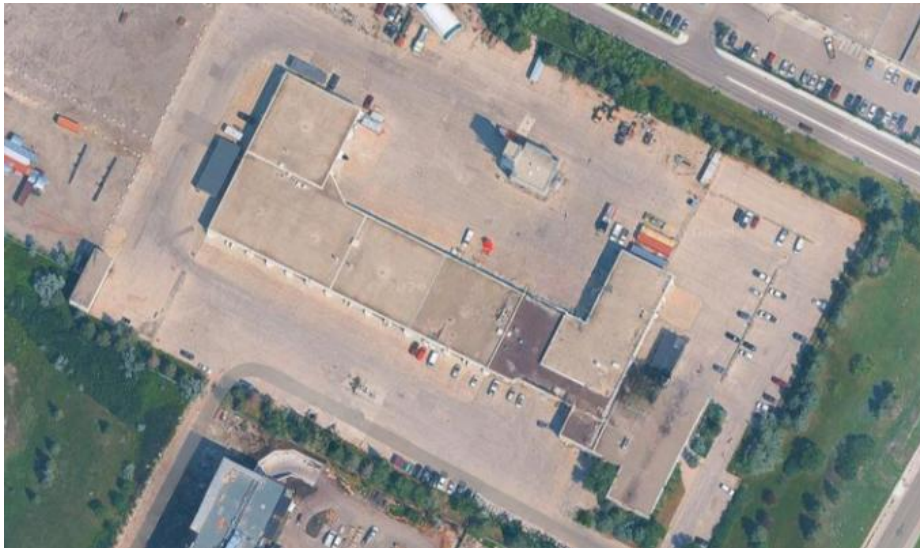
## Winnipeg Fire Paramedic Service Academy: 2546 McPhillips

This facility was constructed in 1962 and consists of a single-storey structure with a partial basement, including apparatus bays and support spaces. The building is in fair condition, though many components date back to the original construction period and are approaching the end of their expected service lives. Future anticipated expenditures include roofing replacement, renewal of exterior doors and overhead bay doors, interior finish upgrades (including firefighter change rooms and washrooms), and replacement of aging electrical distribution equipment and wiring systems.

The building is heated by a hydronic hot water heating system served by gas-fired boilers, distributing heat through perimeter radiation and terminal units located throughout the facility. Cooling is provided by split-type direct expansion (DX) systems with air-cooled condensers serving select areas.

Plumbing systems include domestic water distribution, sanitary waste piping, restroom fixtures, showers, and sump pump drainage systems, including a submersible sump pump installed around 2000. While some plumbing components have been updated, much of the mechanical and plumbing infrastructure is aging.

The hydronic heating system, terminal units, and associated piping systems are approaching the end of their expected service lives.

The building is served by a main electrical service rated at approximately 400 amps, 120/240 volts, with associated panelboards, feeders, and branch wiring throughout the facility. The electrical distribution system includes lighting, receptacles, and building service connections supporting operational systems. The 600v and 208V breakers and associated Buss on the Main Distribution were all replaced in 2025.
