| LOUISE BRIDGE SUBSTRUCTURE REHABILITATION AND RIVERBANK STABILIZATION WORKS | |
| SU.2 & SU.4 BEARING REPLACEMENT DETAILS | |
| CITY DRAWING NUMBER | B107-26-036 |

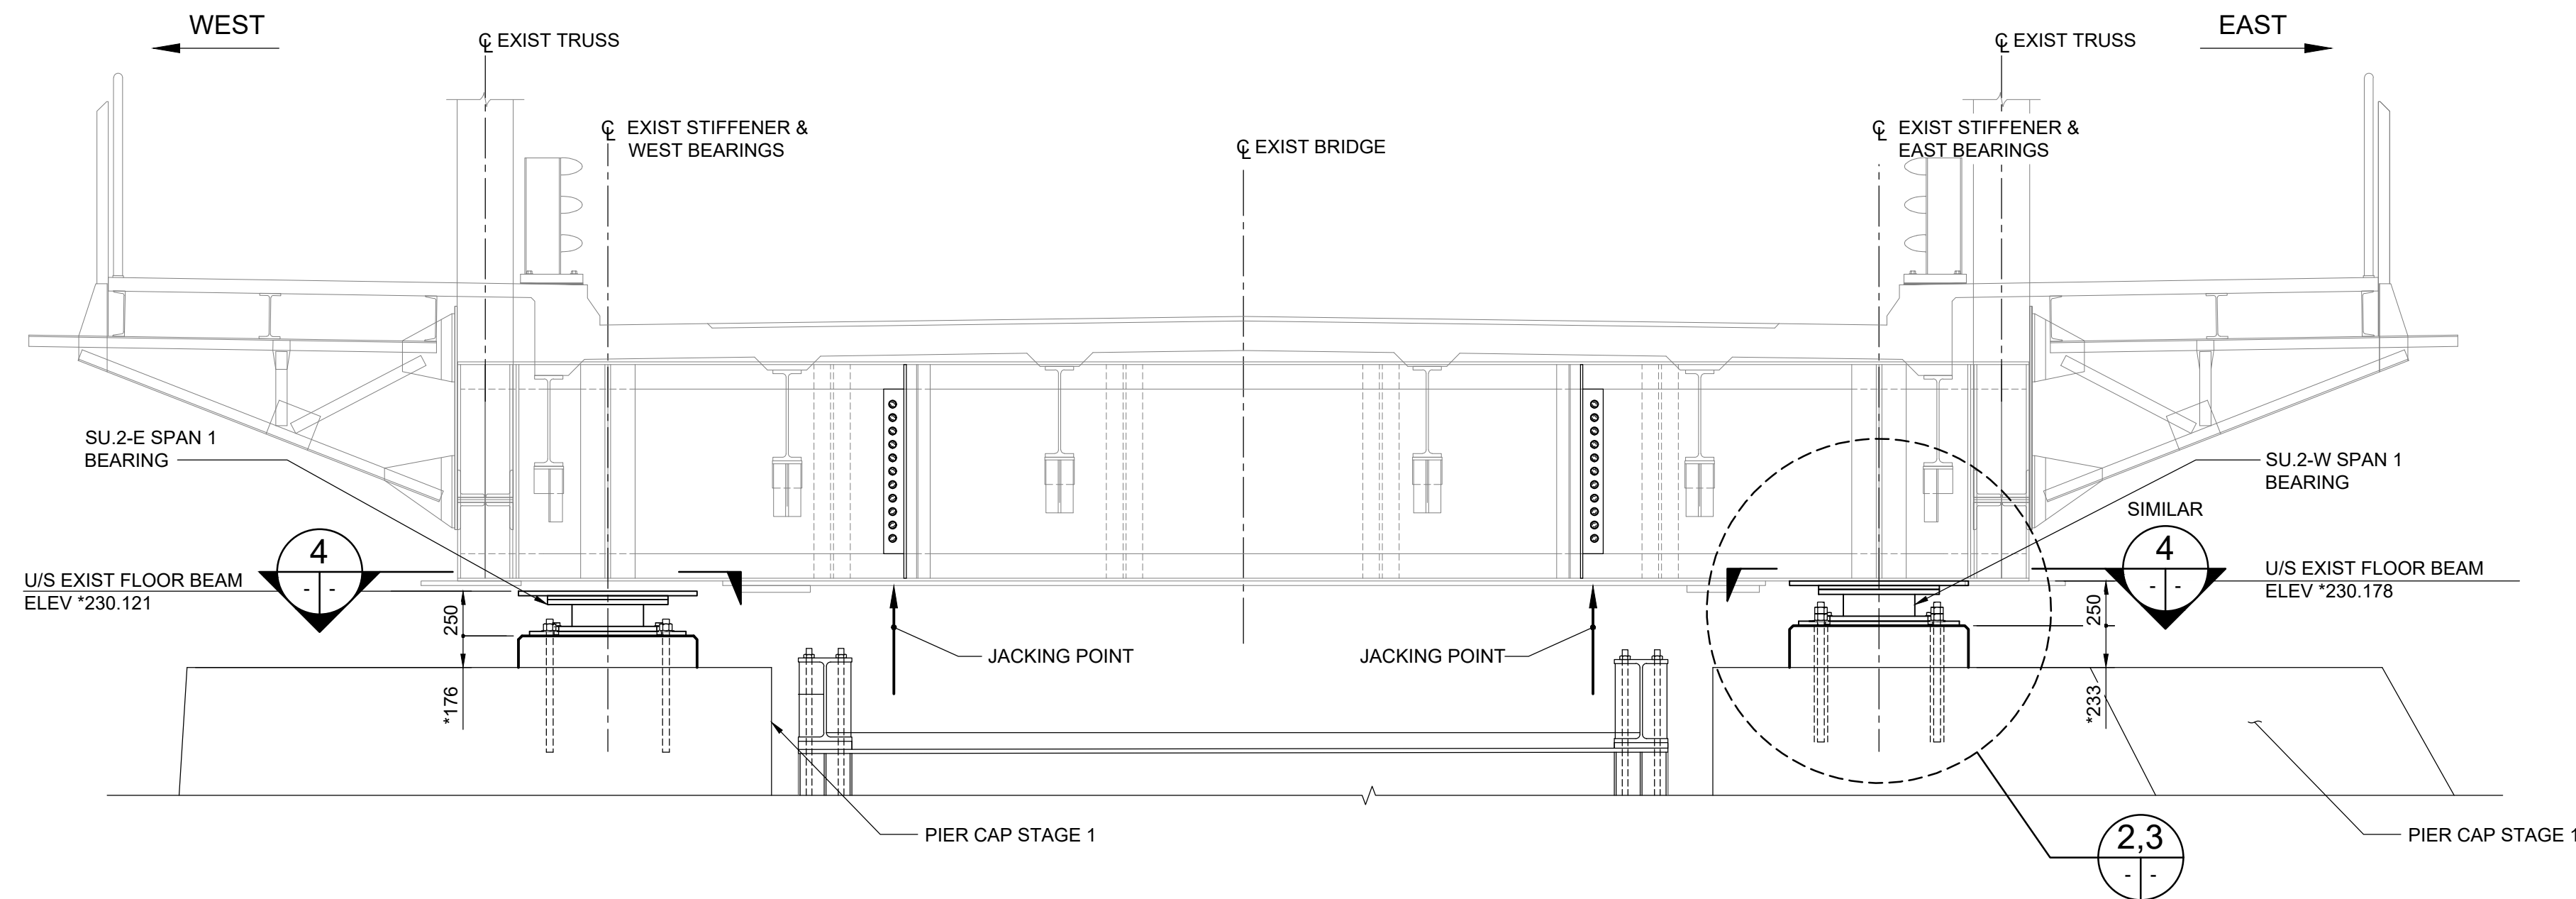
**1 BEARING ELEVATION AT SU.2 - SPAN 1**  
1 : 30  
SHOWN FOR PIER SU.2 SPAN 1 LOCATION, SIMILAR AT PIER SU.4 SPAN 4 EXCEPT FOR PEDESTAL HEIGHTS

NOTE:  
\* GAP BETWEEN PEDESTAL AND FLOOR BEAM MUST REMAIN UNCHANGED AFTER BEARING REPLACEMENT

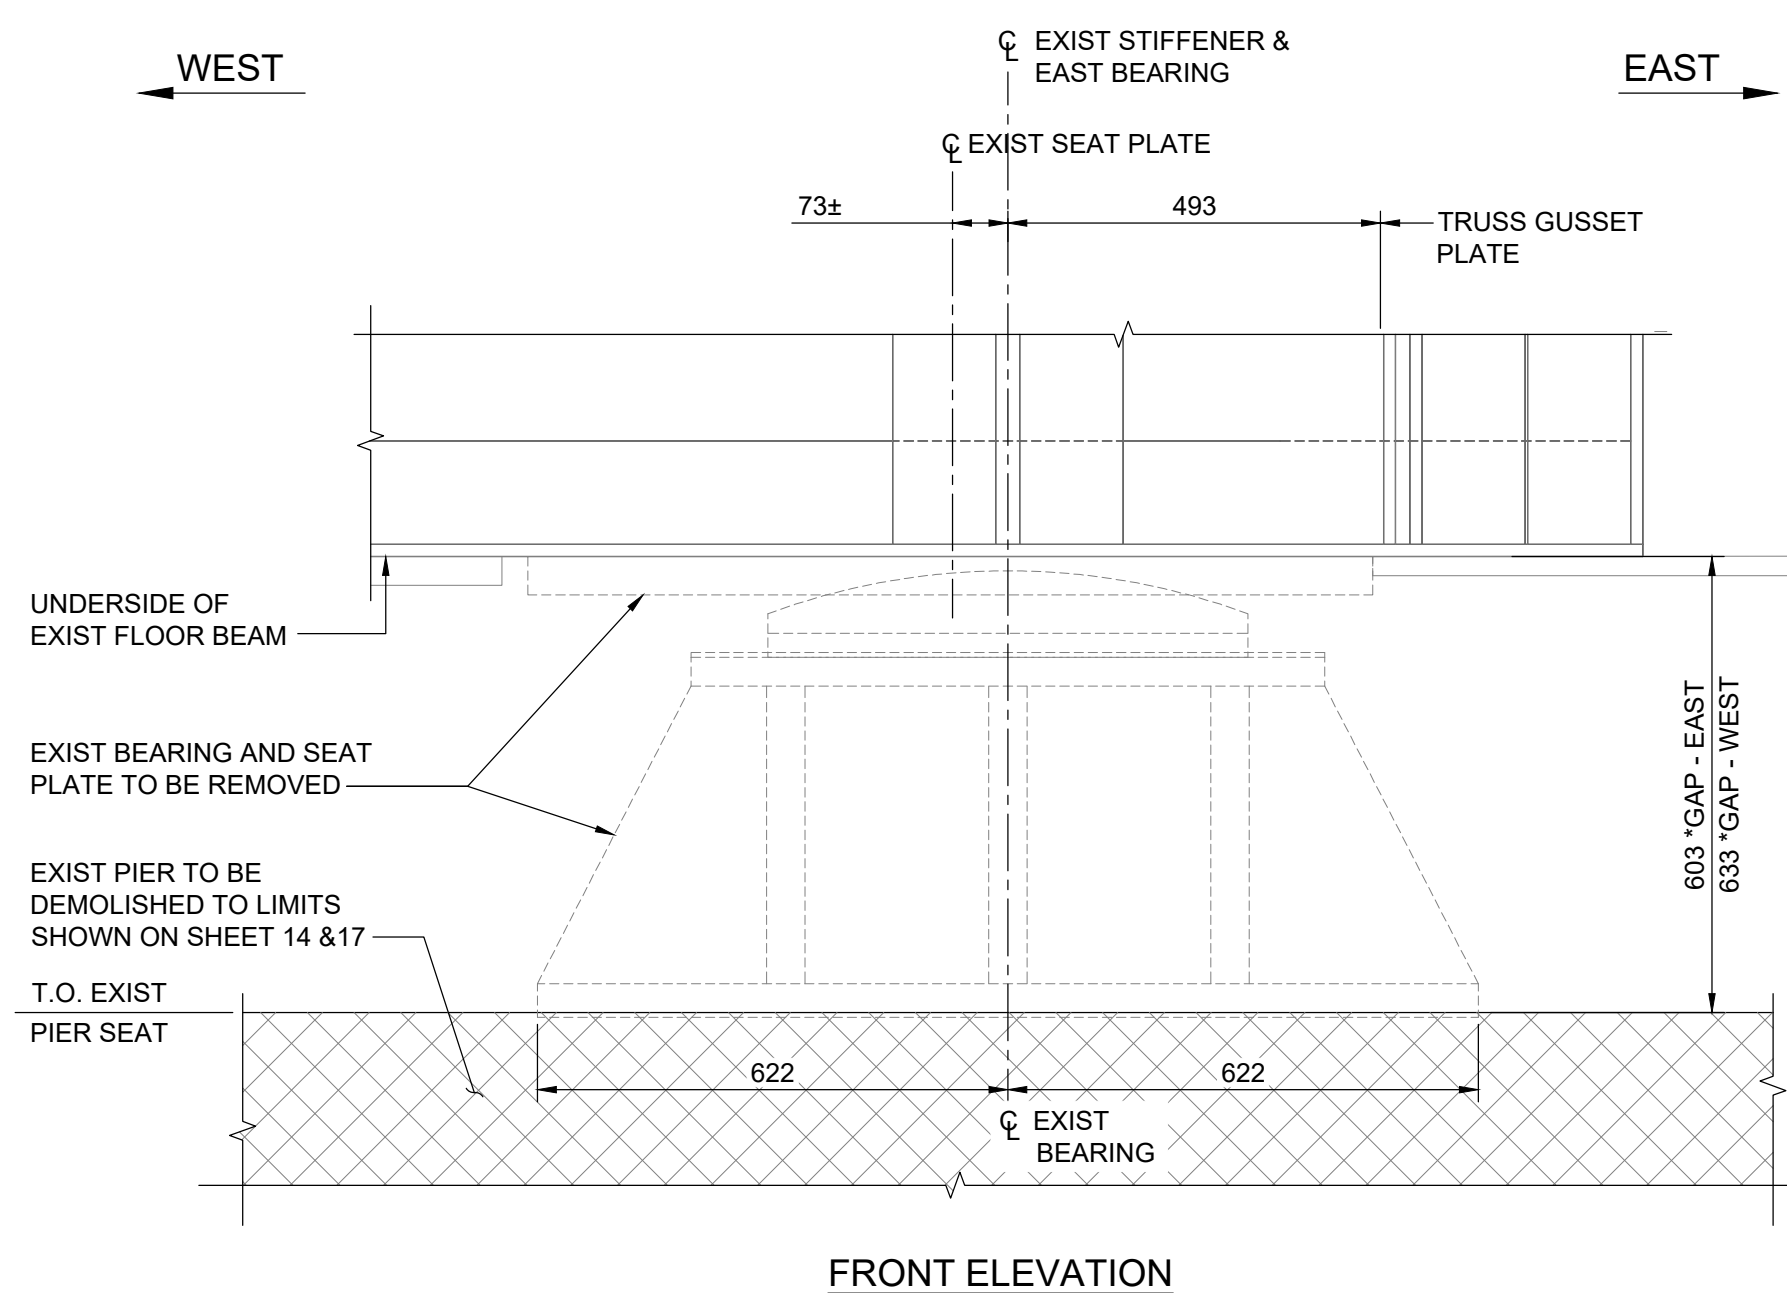
**2 BEARING AND PLATES DETAIL - EXISTING**  
1 : 10  
- SU.2-E SPAN 1 SHOWN, SU.2-W SPAN 1 OPPOSITE HAND AND SIMILAR  
- SU.4-E SPAN 4 SIMILAR, SU.4-W SPAN 4 OPPOSITE HAND AND SIMILAR

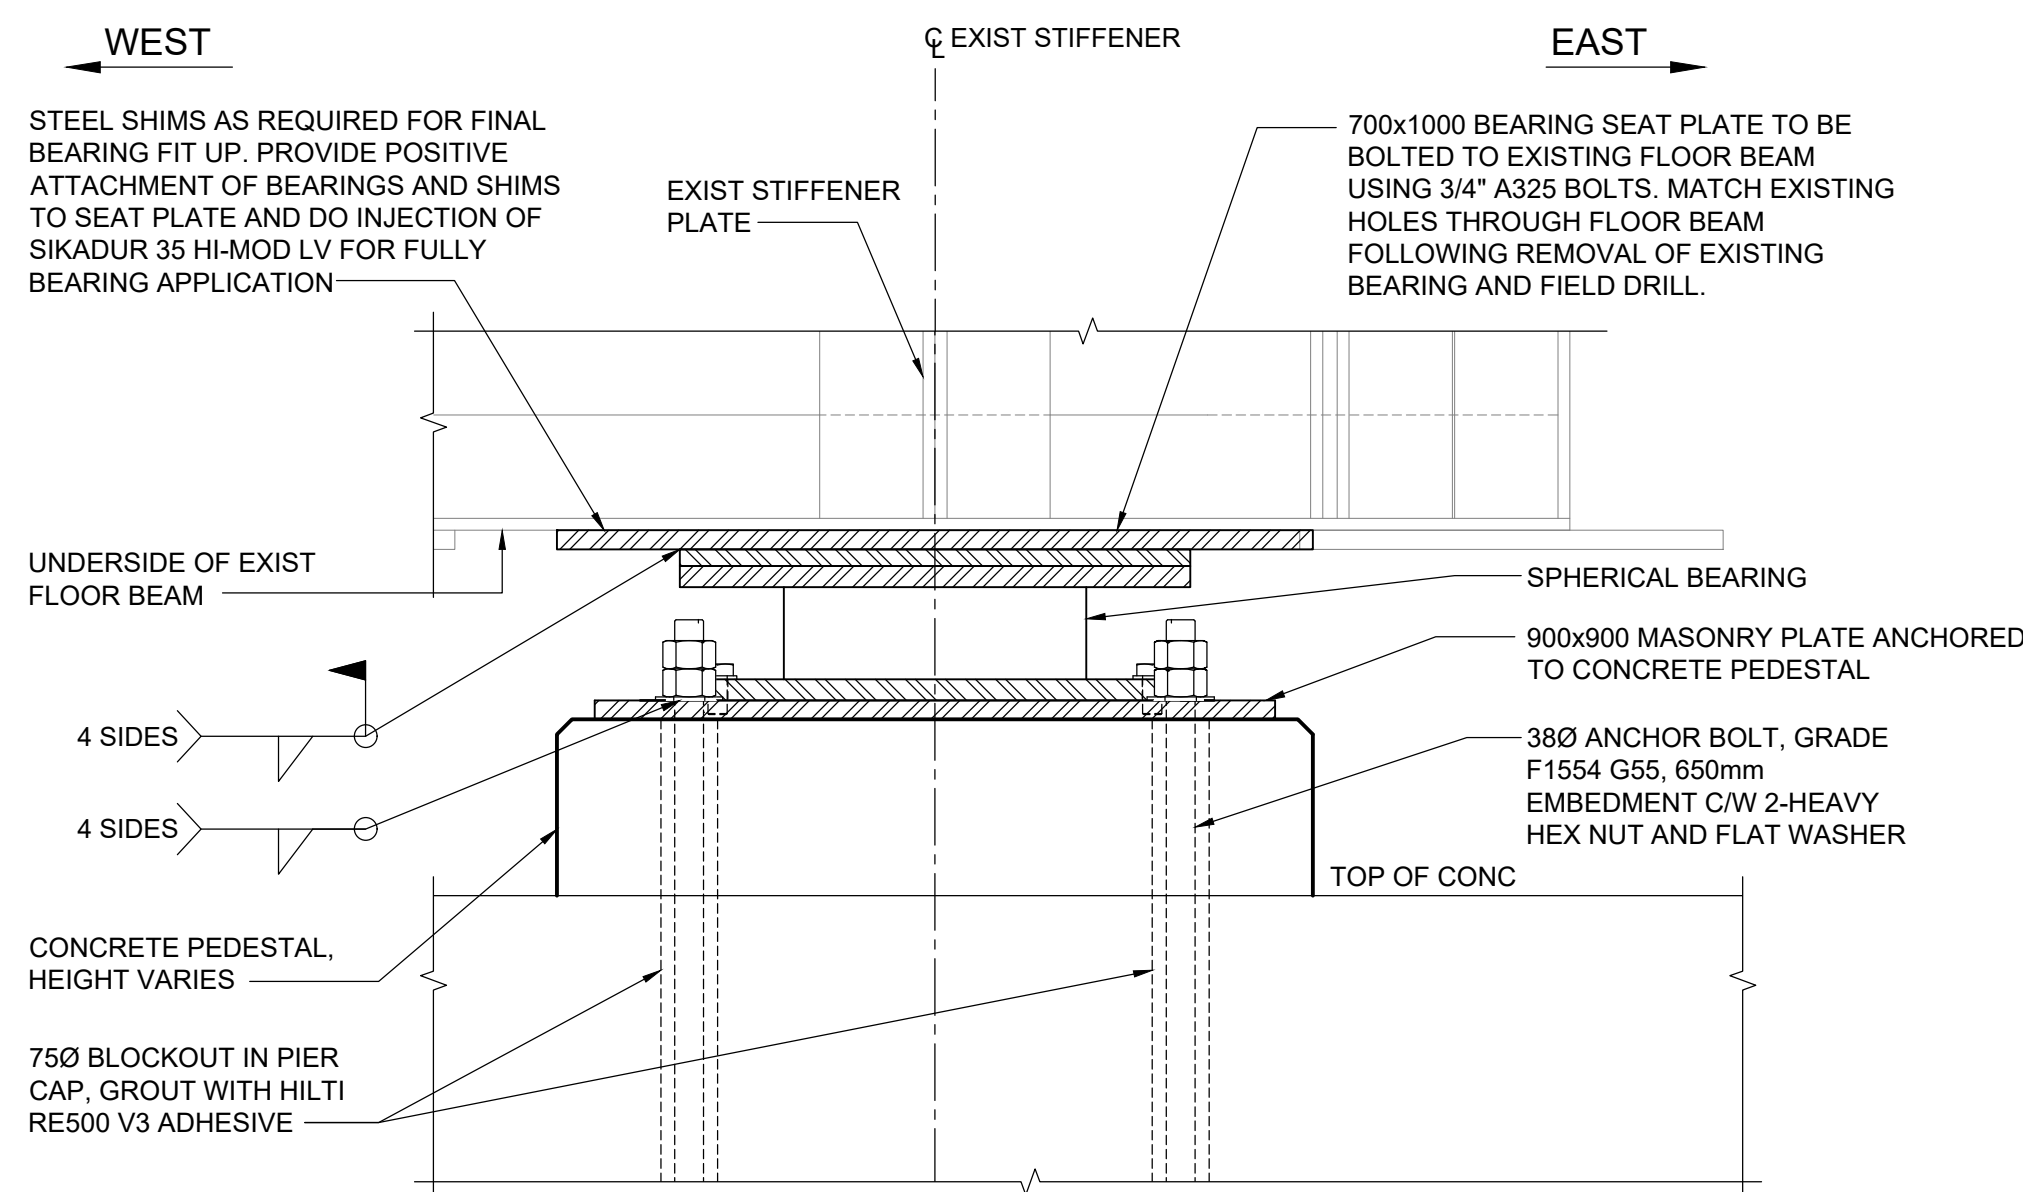
**3 BEARING AND PLATES DETAIL - REPLACEMENT**  
1 : 10  
- SU.2-E SPAN 1 SHOWN, SU.2-W SPAN 1 OPPOSITE HAND AND SIMILAR  
- SU.4-E SPAN 4 SIMILAR, SU.4-W SPAN 4 OPPOSITE HAND AND SIMILAR

NOTE:  
EXISTING TRUSS SHOWN FOR REFERENCE.  
EXISTING RIVETS NOT SHOWN FOR CLARITY

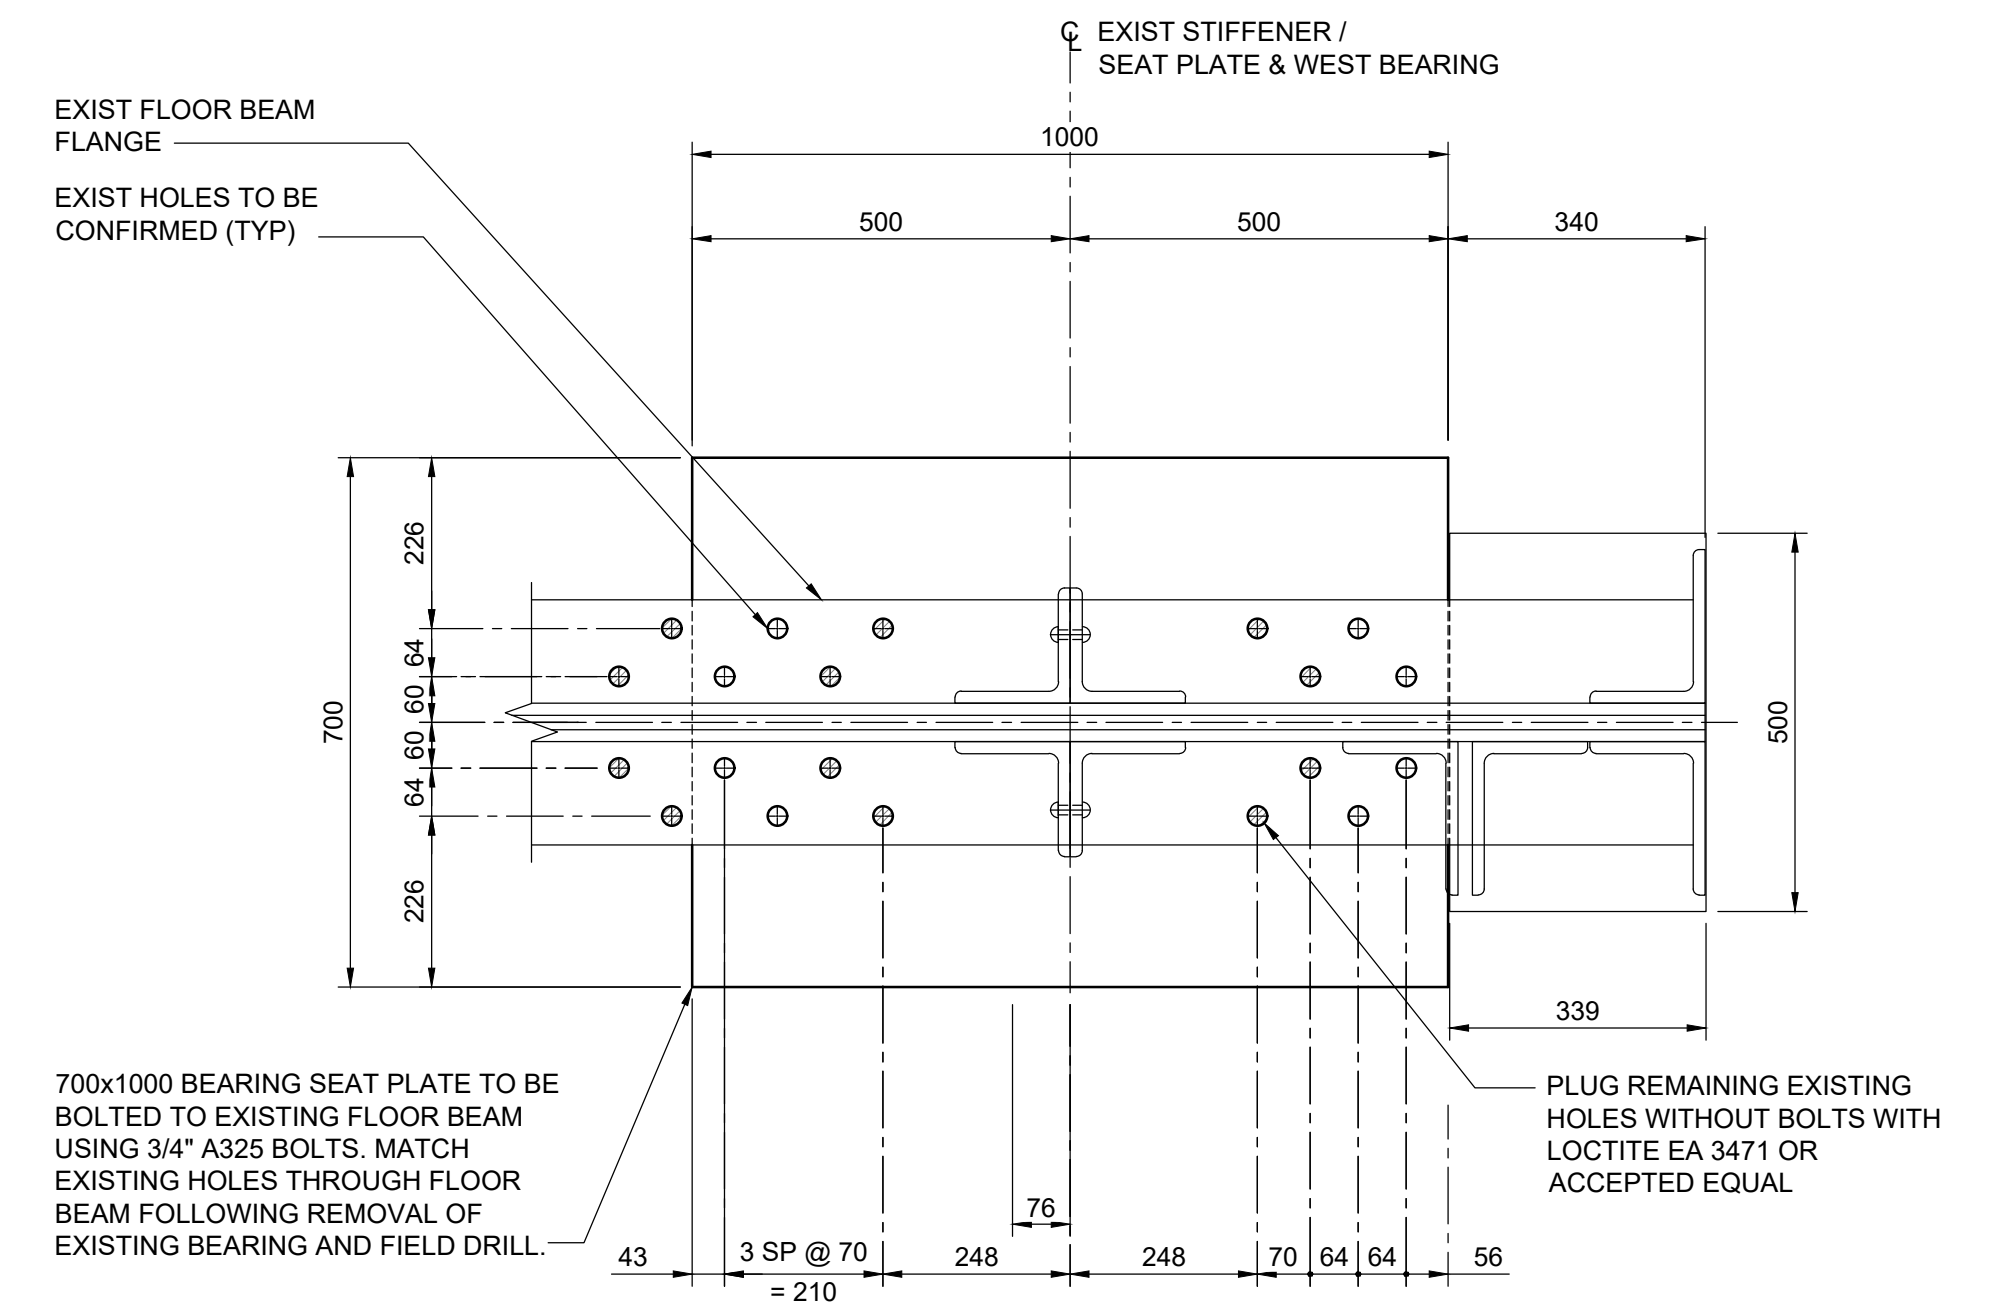
**4 SU.2-E SPAN 1 SEAT PLATE**  
1 : 10  
- SU.2-E SPAN 1 SHOWN, SU.2-W SPAN 1 OPPOSITE HAND AND SIMILAR  
- SU.4-E SPAN 4 SIMILAR, SU.4-W SPAN 4 OPPOSITE HAND AND SIMILAR

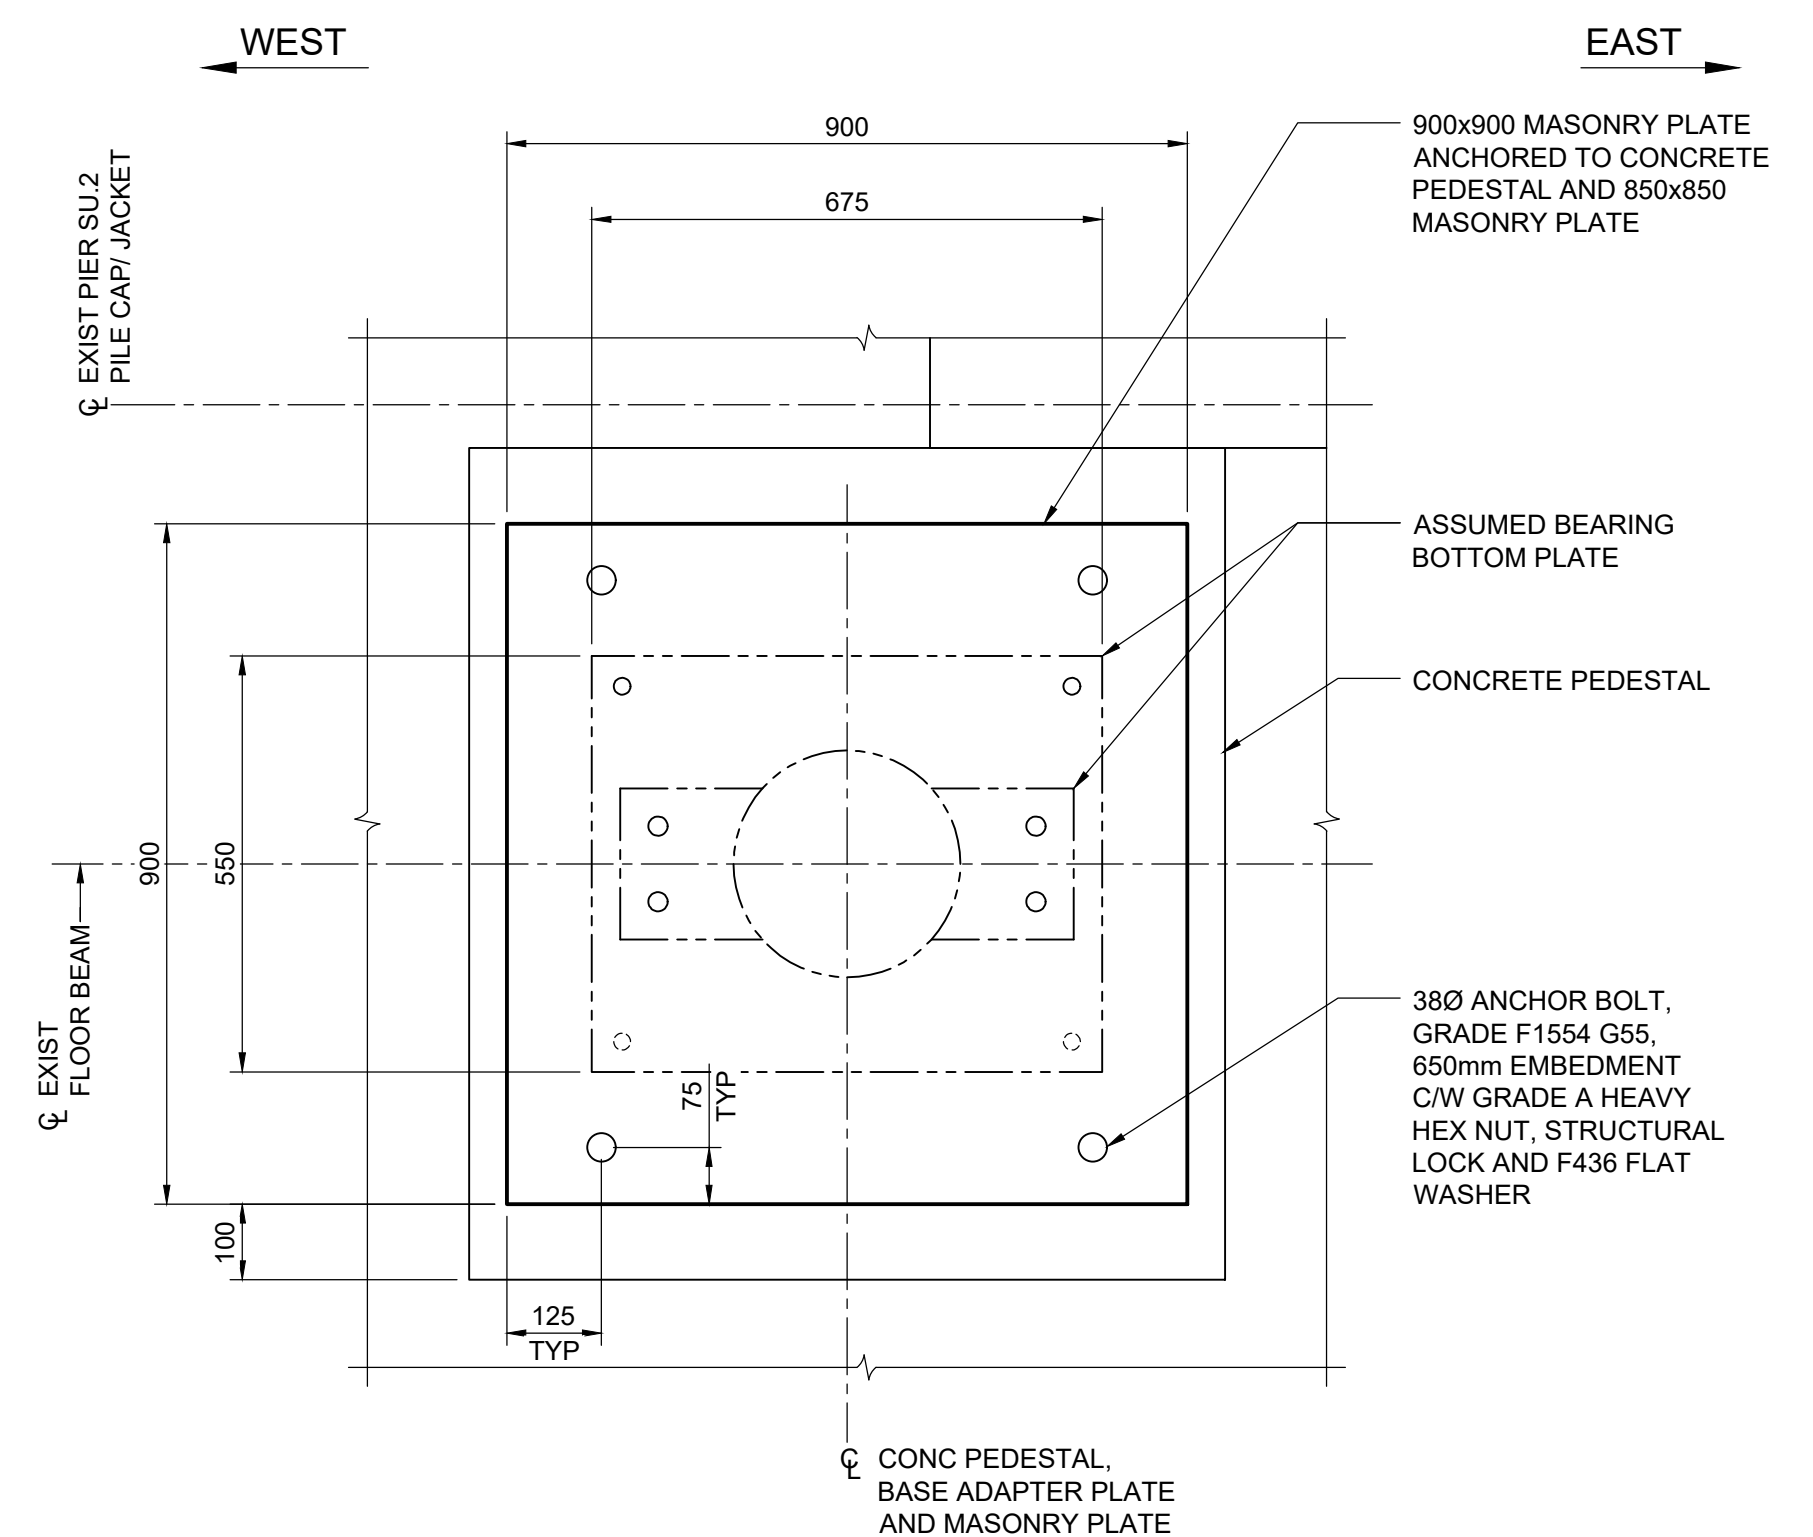
**5 SU.2-E SPAN 1 MASONRY PLATE DETAIL**  
1 : 10  
- SU.2-E SPAN 1 SHOWN, SU.2-W SPAN 1 OPPOSITE HAND AND SIMILAR  
- SU.4-E SPAN 4 SIMILAR, SU.4-W SPAN 4 OPPOSITE HAND AND SIMILAR
