1 PARTIAL ROOF PLAN - PLUMBING - DEMOLITION
M1.2 SCALE: 1/16"=1'-0"

0	ISSUED FOR CONSTRUCTION	JH	27/03/2026	 ENGINEERS GEOSCIENTISTS MANITOBA Certificate of Authorization SMS Engineering Ltd. No. 166		 770 Bradford Street Winnipeg, Canada (204) 775-0291 smseng.com	Project Title TRANSIT MAINTENANCE AND REPAIR BUILDING MECHANICAL UPGRADE - EAST HIGH BAY	Drawing Title PARTIAL ROOF PLAN - PLUMBING - DEMOLITION	Drawn By AP	Revision Number 0
	LETTER OR NUMBER	DESCRIPTION	BY				DDMMYY	Approved By JH	Drawing Number M1.2	Scale AS NOTED

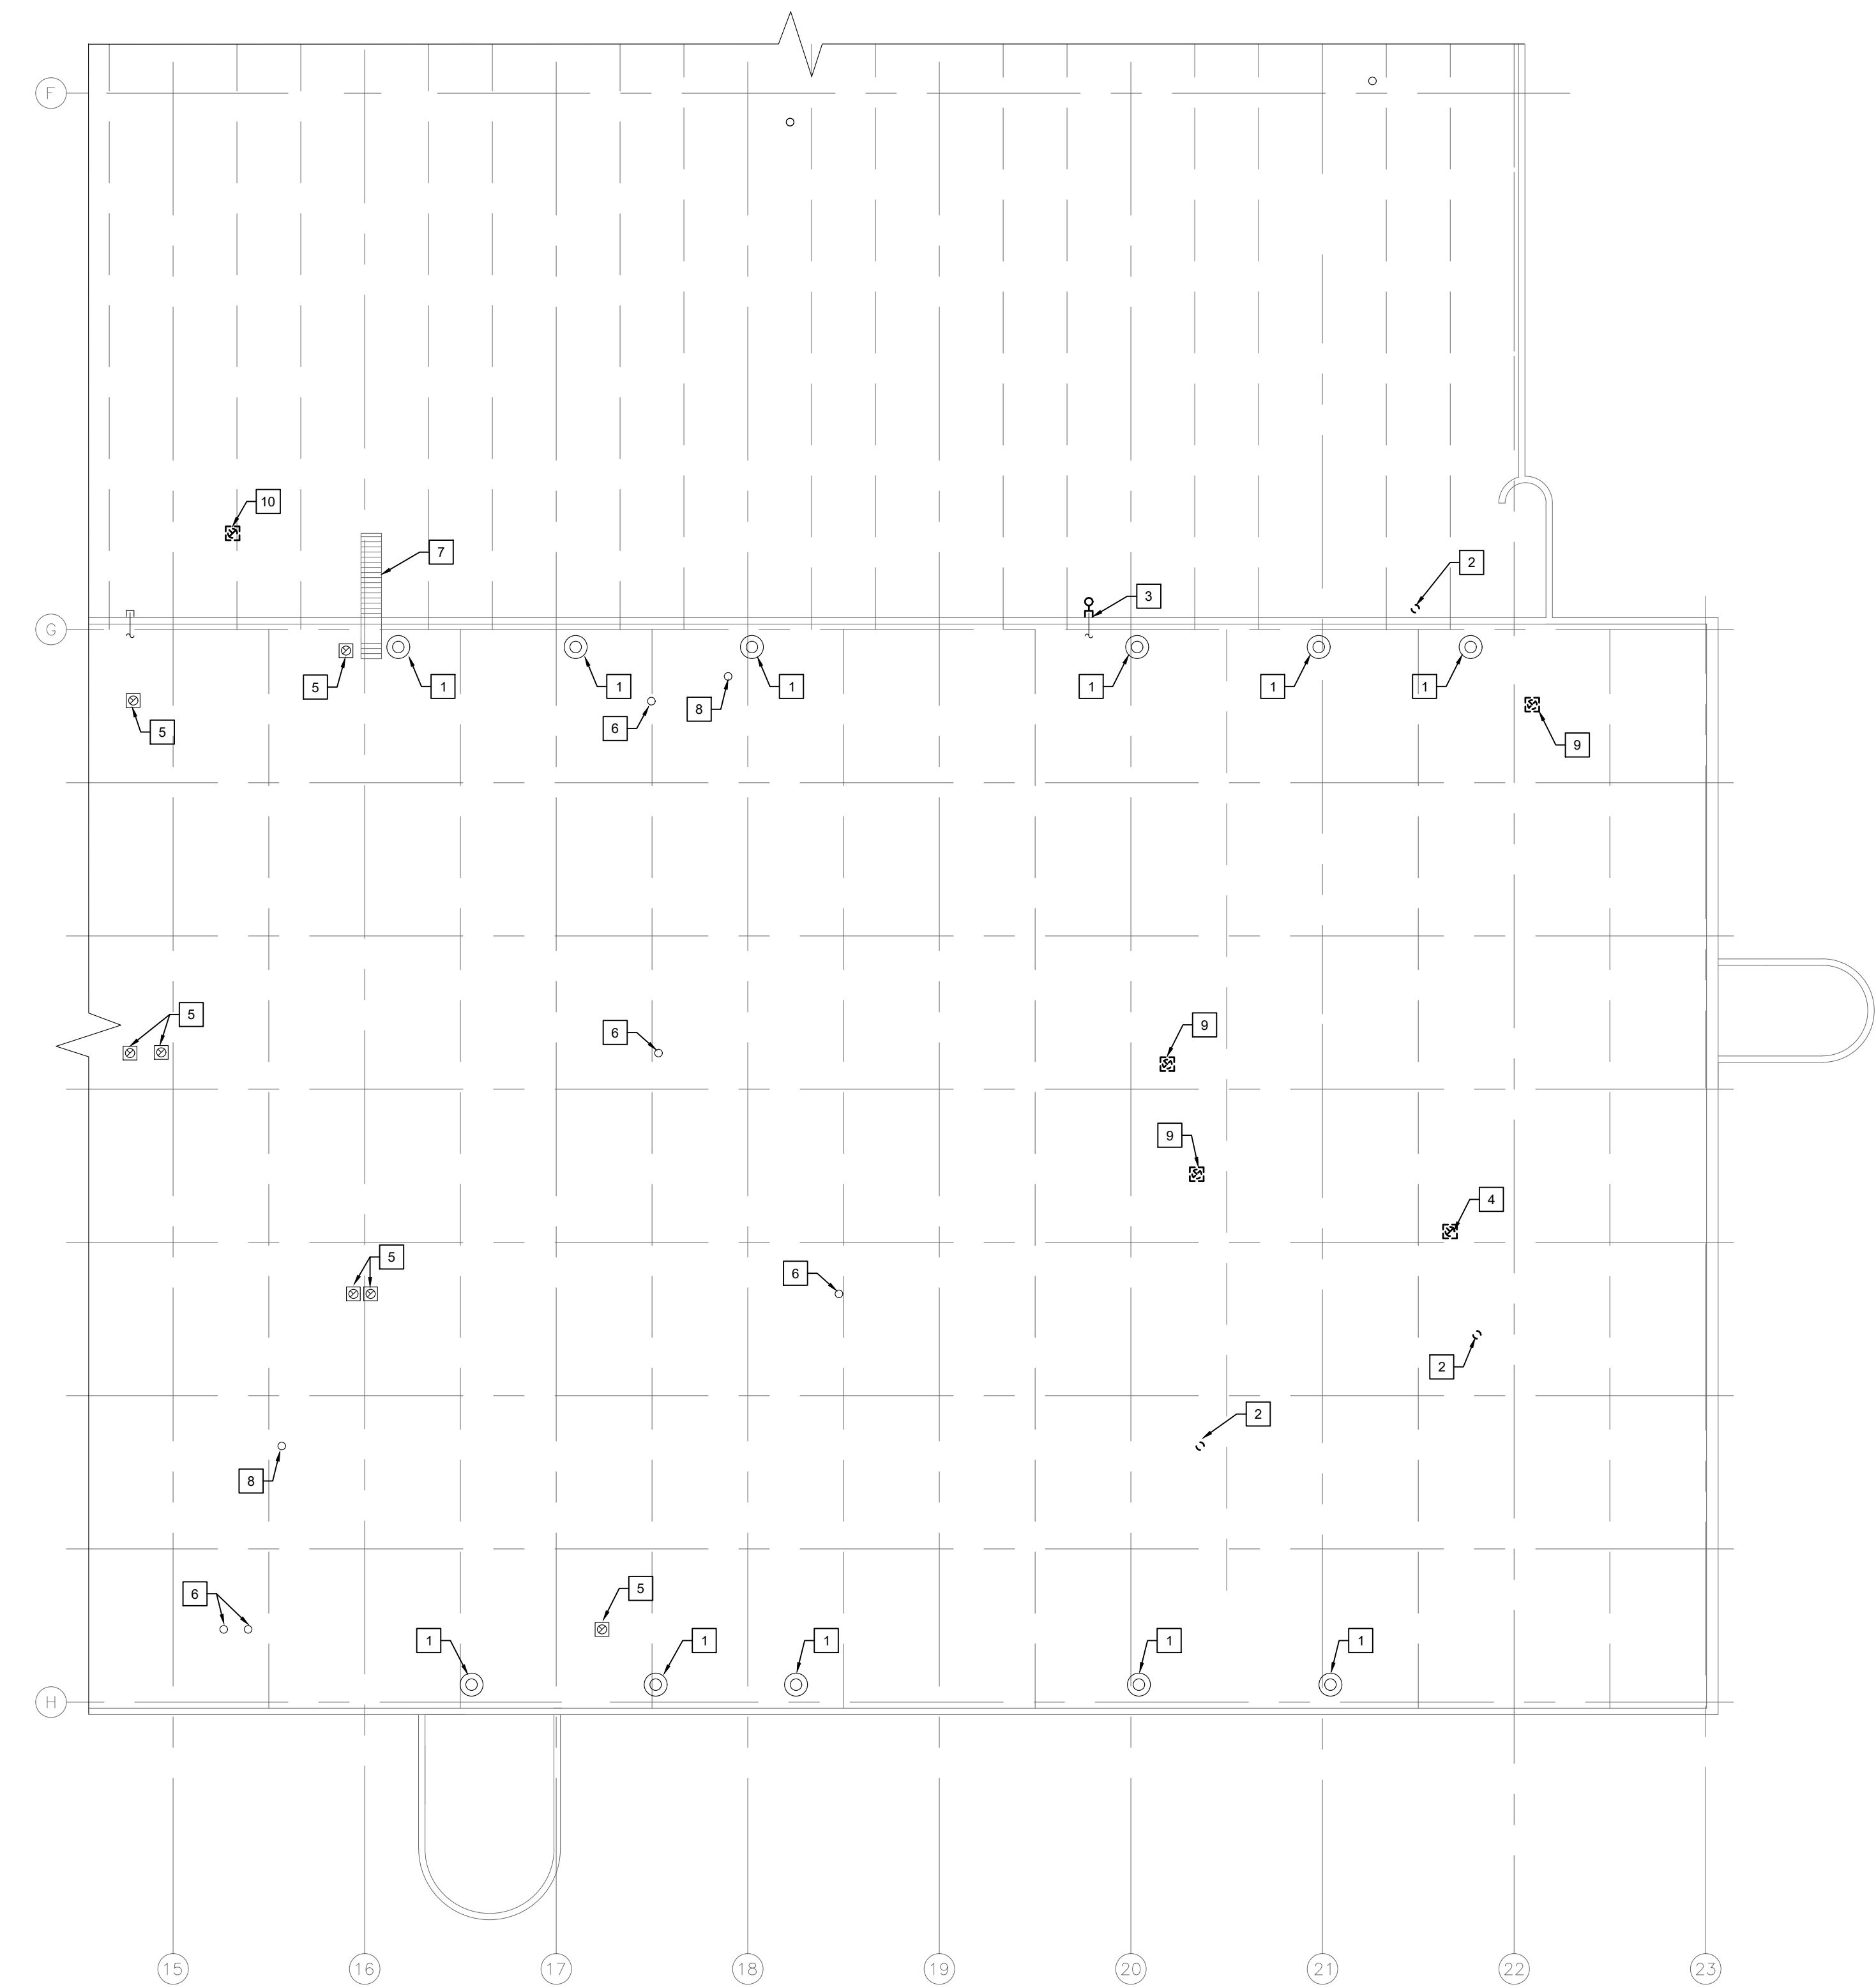
- 1. EXISTING ROOF DRAIN TO REMAIN.
- 2. DEMOLISH AND REMOVE NATURAL GAS PRV VENT BACK TO PRV. REPAIR AND SEAL PRV VENT ROOF OPENING. REFER TO ROOFING SPECIFICATION/DETAILS.
- 3. EXISTING INFRARED HEATER VENT THROUGH WALL BETWEEN HIGH BAY AND LOW BAY ROOF TO BE DEMOLISHED, CAPPED AND ABANDONED AS SHOWN.
- 4. DEMOLISH AND REMOVE MUA VENT. REPAIR AND SEAL ROOF OPENING. REFER TO ROOFING SPECIFICATION/ DETAILS.
- 5. EXISTING INFRARED HEATER VENT TO REMAIN.
- 6. EXISTING INFRARED HEATER COMBUSTION AIR INTAKE TO REMAIN.
- 7. EXISTING LADDER TO BE RELOCATED, REFER TO STRUCTURAL DRAWINGS.
- 8. EXISTING NATURAL GAS REGULATOR VENT TO REMAIN.
- 9. EXISTING INFRARED HEATER VENT TO BE DEMOLISHED. REPAIR AND SEAL VENT ROOF OPENING. REFER TO ROOFING SPECIFICATION/ DETAILS.
- 10. EXISTING ABANDONED VENT TO BE DEMOLISHED. REPAIR AND SEAL VENT ROOF OPENING. REFER TO ROOFING SPECIFICATION/ DETAILS.
