Project Title	TRANSIT MAINTENANCE AND REPAIR BUILDING MECHANICAL UPGRADE - EAST HIGH BAY	Drawing Title	SECTION AND DETAILS
WINNIPEG	MAINTOBA	Drawn By	KGT
		Checked By	AL
		Approved By	JAL
		Scale	AS NOTED
		Date	MARCH 2026
		Project No.	25-330-01
		Revision Number	0
		Drawing Number	S1.3
		Sheet Order	3 OF 3

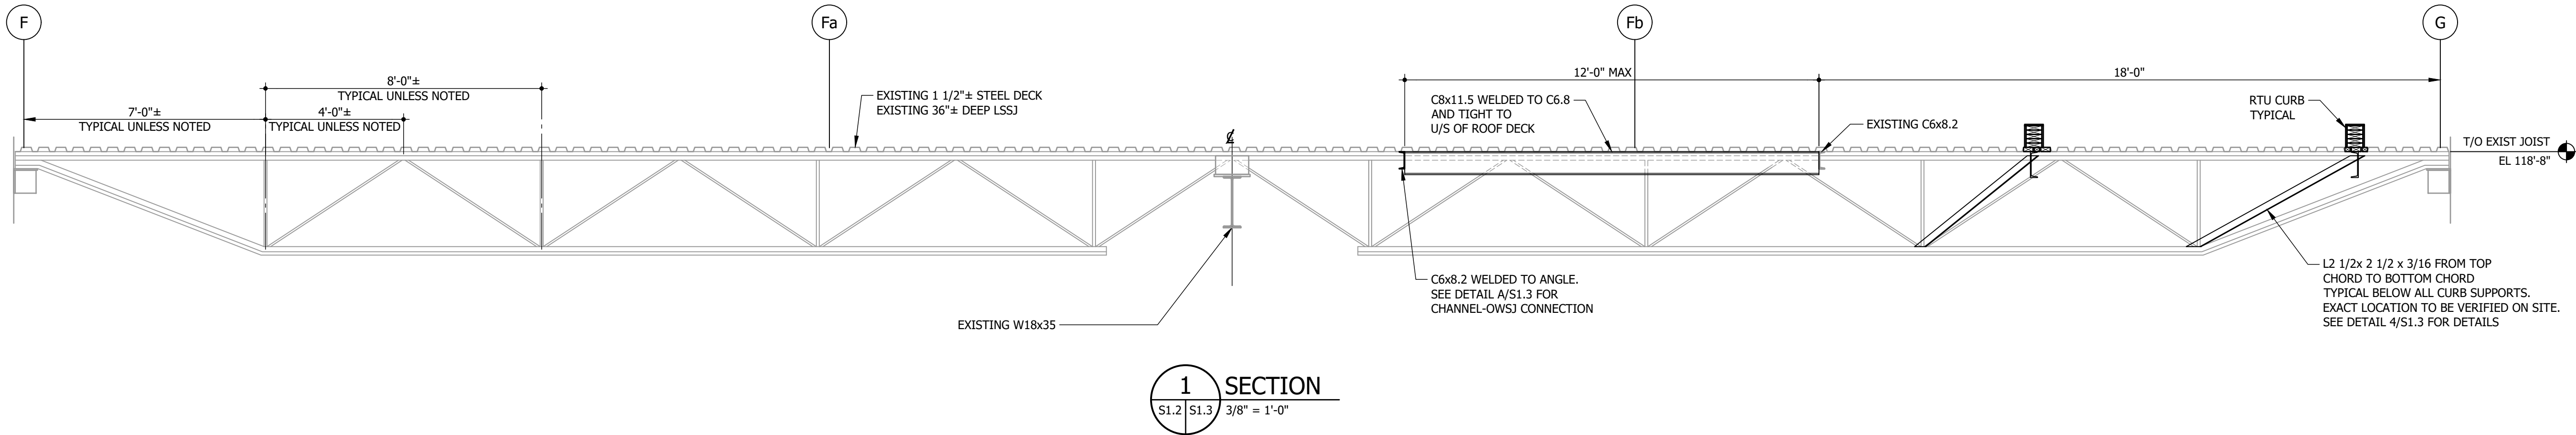
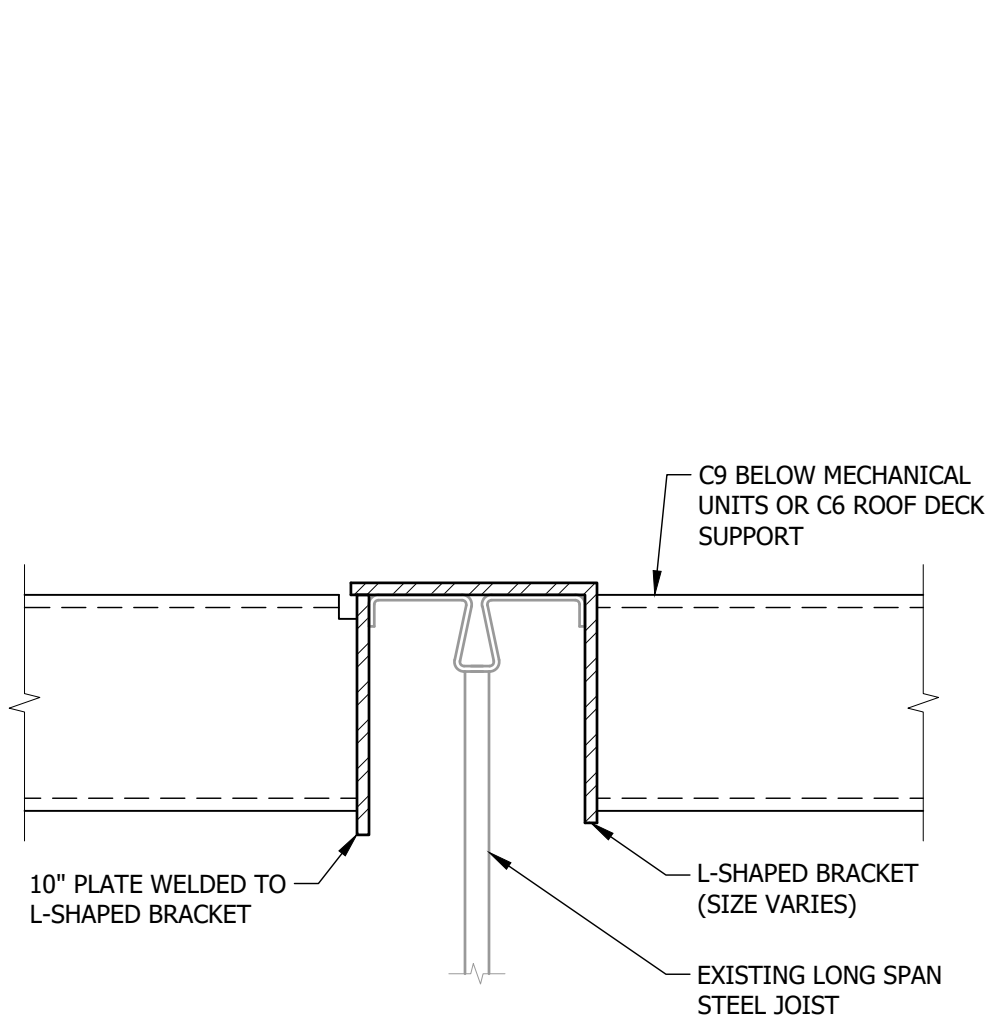
**2 SECTION**  
S1.2 S1.3 1'-1/2" = 1'-0"

- TYPICAL CHANNEL TO EXISTING JOIST CONNECTION DETAIL
- EXISTING STEEL DECK NOT SHOWN FOR CLARITY
